OFFICE MEMORANDUM

SUBJECT: Performance Evaluation of Non-Reinforced Ramps
Research Project 78 TI-528, Research Report No. R-1115

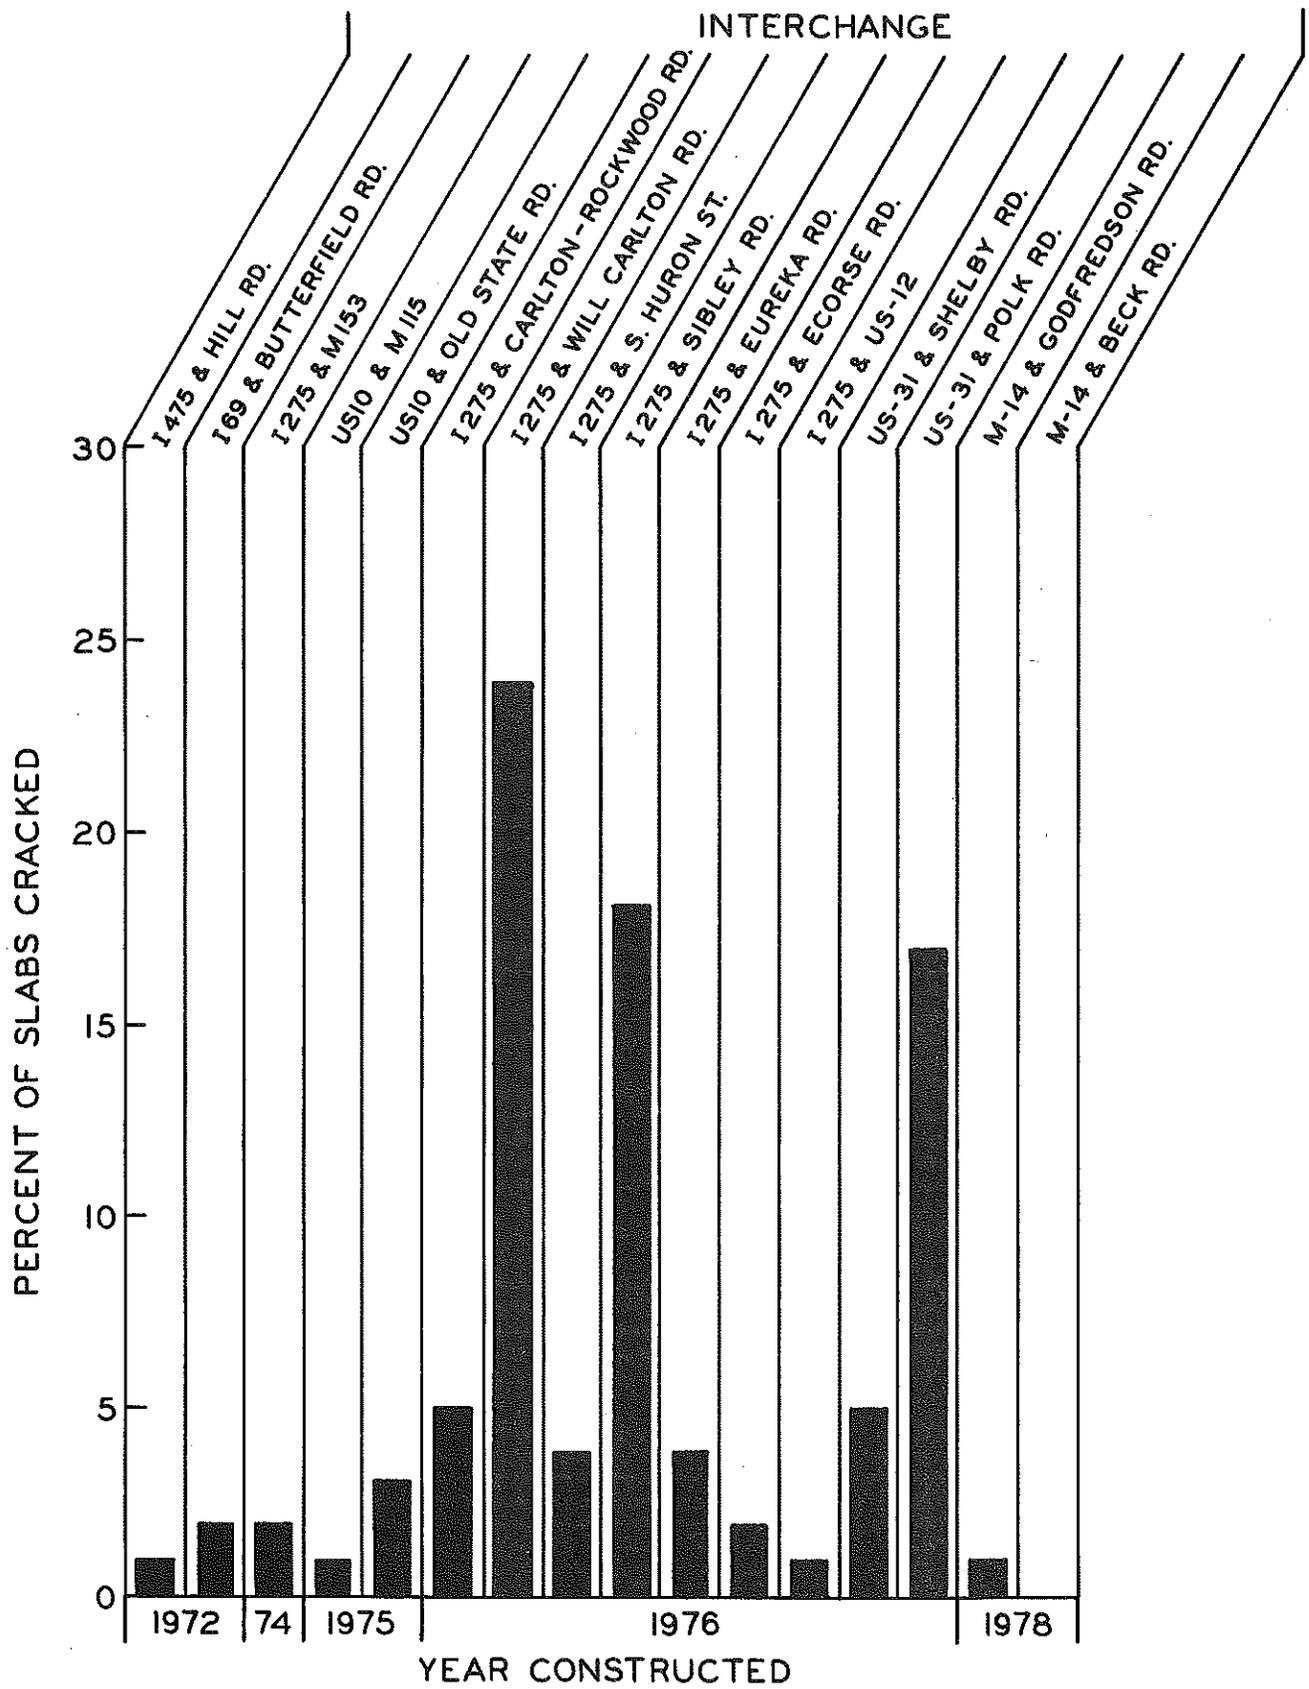
Figure 1. Overall performance of interchanges having non-reinforced ramps.

The performance of the ramps at each interchange with respect to the percentage of slabs cracked is shown in Figure 1. As can be seen, only three interchanges have unusually large percentages of cracked slabs. They are: I 275 at Will Carlton Rd, I 275 at Sibley Rd, and US 31 at Polk Rd. It appears the cracks on the two I 275 interchange pavements have occurred as a result of loss of base support or from non-uniform frost heaving. The cracking at the US 31 and Polk Rd is mainly on the northbound US 31 'off' ramp and the southbound US 31 'on' ramp; these two ramps were used as connector routes until late 1978 when the freeway was extended further north. It is, therefore, concluded that cracks on these two ramps were primarily caused by traffic loadings.

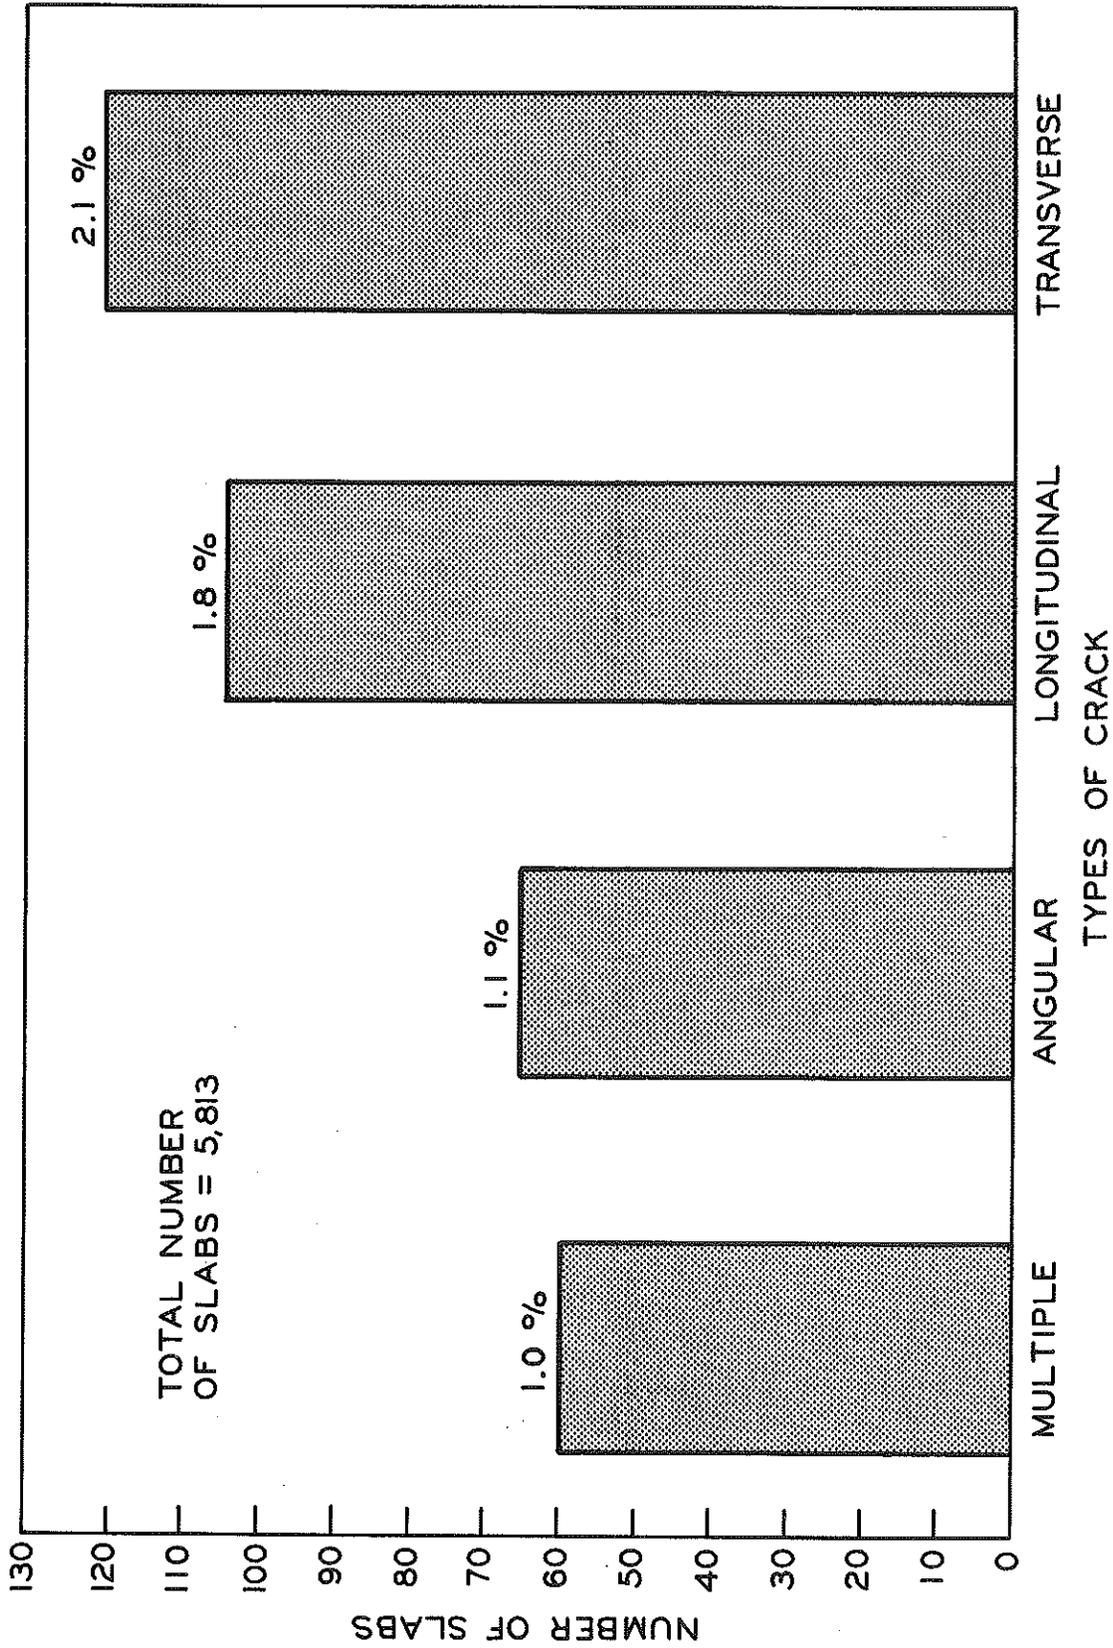
Figure 2. Distribution of crack types in non-reinforced ramps.

Of the total number of non-reinforced slabs, 6 percent, or 348 slabs were noted to have cracked. The crack distribution with respect to crack type is shown in Figure 2.

As can be seen, 60 slabs (1 percent) were found to have multiple cracks, 65 slabs (1.1 percent) exhibited angular cracks, 102 slabs (1.8 percent) had cracked longitudinally, and 121 slabs (2.1 percent) contained transverse cracks.
