INVESTIGATION OF STEEL BEAM
GUARDRAIL CHEMISTRIES

C. J. Arnold
L. J. Pearson

Research Laboratory Section
Materials and Technology Division
Research Project 84 TI-978
Research Report No. R-1291

This project was initiated by a request from the Traffic and Safety Division to investigate whether a length of guardrail, fractured in service, had the specified physical properties. The Structural Research Unit of the Research Laboratory conducted the investigation.

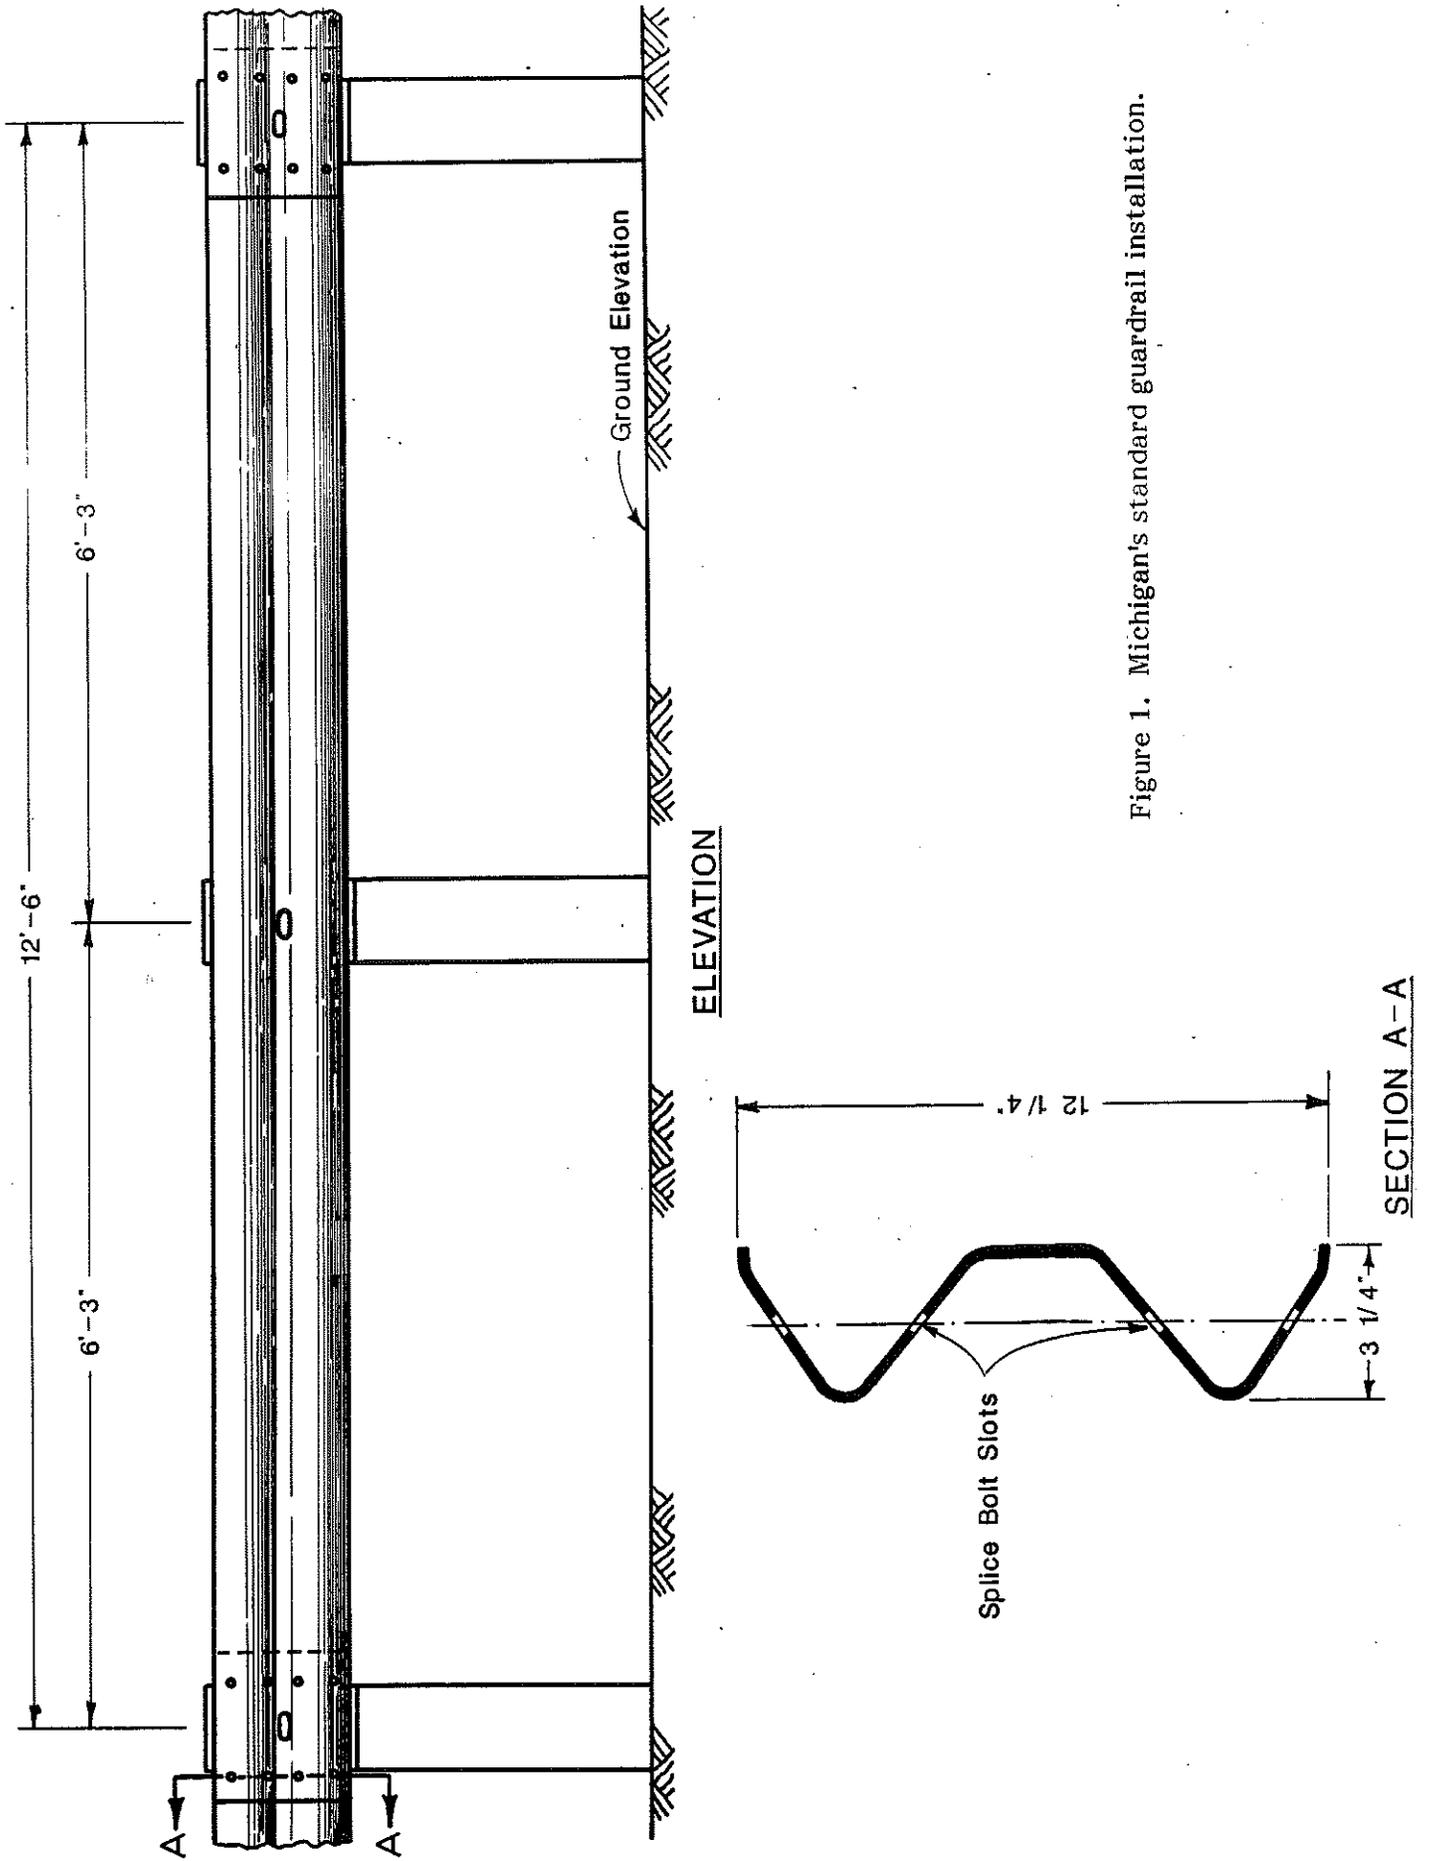
Figure 1. Michigan's standard guardrail installation.

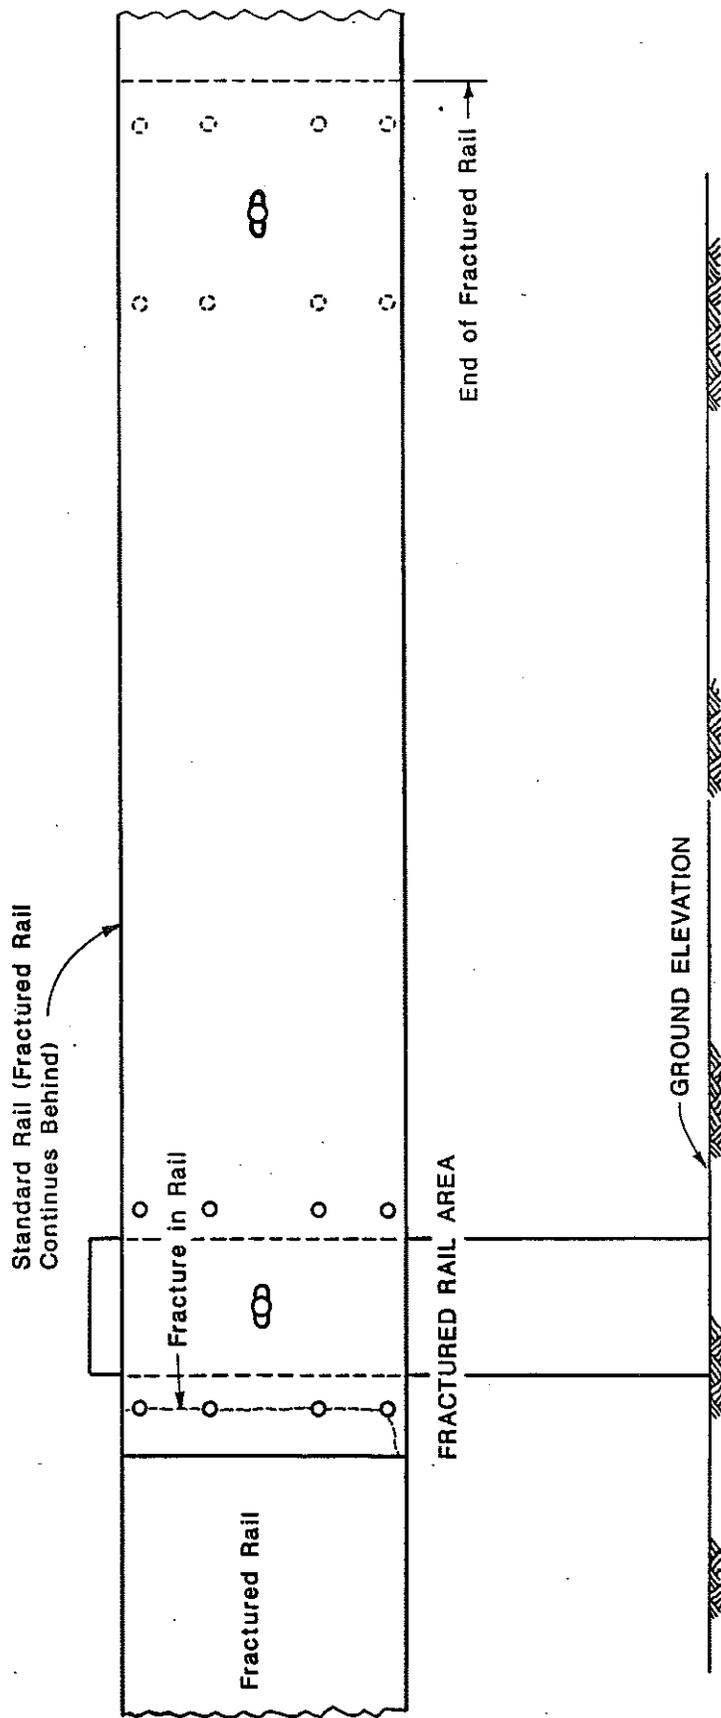
The fracture occurred through the four splice holes in the center of the replacement rail (Fig. 2). Temperature at the time of failure was reported to be quite low, probably about 10 F or less, which would tend to make steel with a high Rockwell hardness more brittle. Eight holes had been torch-cut through the guardrail in this area. The four holes where the fracture occurred were close to the end of the other section and were thus at a stress concentration point in the beam section.

Figure 2. Retrofit installation and fracture location.

relatively soft and plastic state. If the carbon content (or CE) is high enough, the steel is said to be hardenable by heat treating. To increase the hardness of such steel, it is heated to a temperature in excess of 1350 F and then cooled quickly. The heating changes the normal and soft pearlitic structure to a solid solution structure called 'austenite.' If the steel is then quenched, or cooled quickly to a temperature of below 200 F, the austenite changes to a hard structure known as 'martensite,' which is the structure of fully hardened steel and is quite brittle unless toughened by subsequent heat treating or tempering. Special precautions such as preheating, etc., are required to prevent or diminish the probability of forming this brittle microstructure upon cooling. By using a cutting torch to cut holes for splicing in the subject guardrail section, the steel was heated enough to form the brittle martensitic microstructure upon cooling, thus making the steel in close proximity of the holes very brittle, initiating and contributing to the failure of the guardrail.

Due to the results of this investigation, it appears that a more appropriate method for altering guardrail beams (adding holes, changing lengths) is to use a saw for changing the length of sections and to drill or punch all holes. We realize that any alterations done in the field using hand tools (drills, saws) are extremely difficult, so extra care should be taken when installing guardrail posts to ensure proper spacing. Another possible solution would be to design and build a portable punch that could be used in the field.

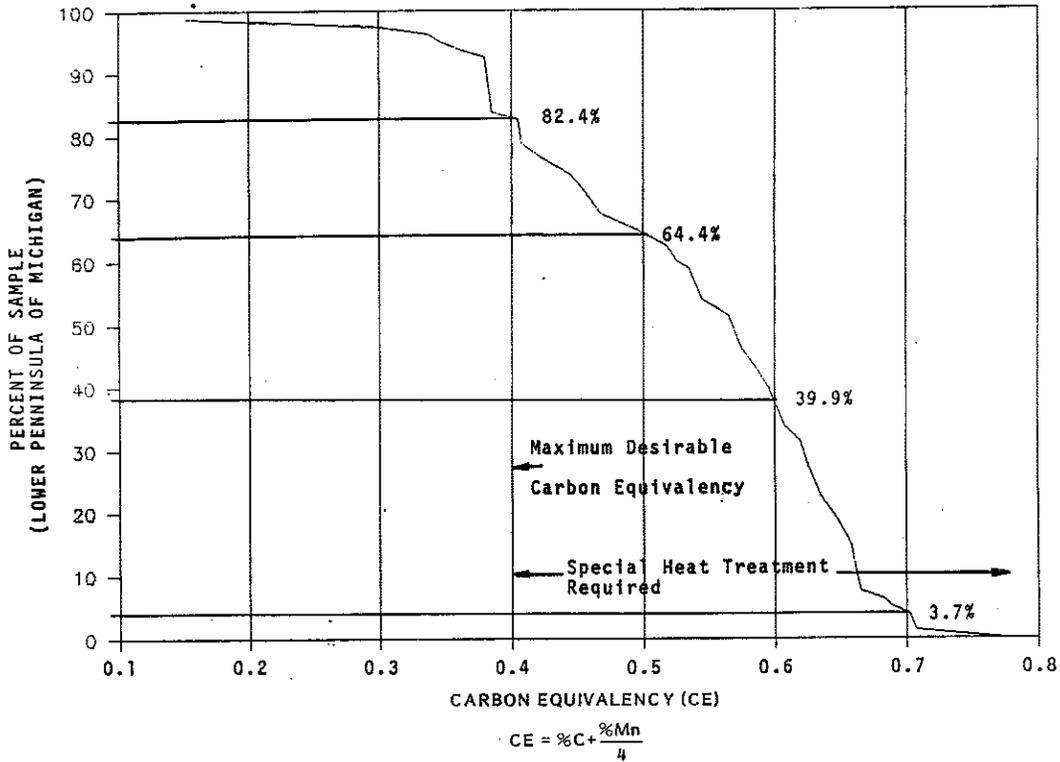
The highest CE recorded in this investigation was 0.78 percent, the lowest CE was 0.15 percent, the mean CE was 0.58 percent. Figure 3 shows a graphical representation of the results.

Figure 3. Carbon Equivalency results.

Because such a high percentage of the guardrail sections tested (82.4 percent) had a Carbon Equivalency greater than 0.40 percent, steel beam guardrail should not be altered by use of a cutting torch. Excessive amounts of heat may cause the localized microstructure of the guardrail to change

and become very brittle, thus preventing the guardrail from absorbing as much energy as it should under deformation. In the long-term, specification changes should be made to limit the Carbon Equivalency of materials for such rail.
