***FIELD EVALUATION OF  
EXPERIMENTAL LOW VOC  
BRIDGE PAINTS***

1. Report No. Research Report R-1400	2. Government Accession No.	*3. MDOT Project Manager B. Beck, Project Manager.	
4. Title and Subtitle Field Evaluation of Experimental Low VOC Bridge Paints		5. Report Date July 2002

**Testing and Research Section  
Construction and Technology Division  
Research Project G-303  
Research Report R-1400**

### Structure Number S14 of 11015 - Livingston Road over I-94 in Berrien County

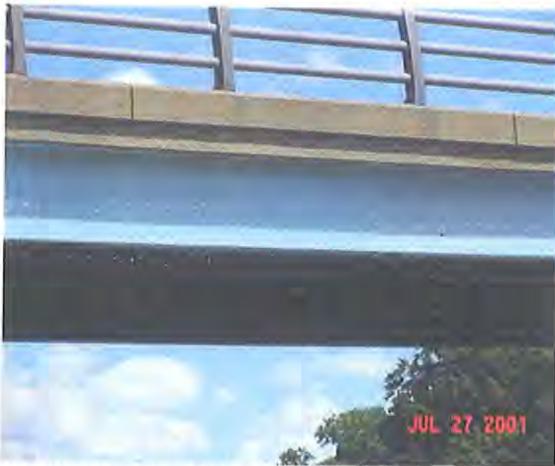
In October 1992, two experimental systems were applied to portions of the bridge carrying Livingston Road over I-94 in Berrien County. A Glidden system was applied to the fascia beams over the right lane of west bound I-94, and a Davis system was applied to the fascia beams over the center lane of west bound I-94. Both systems had low VOCs and limited amounts of hazardous metals. The Davis system consisted of a zinc-rich epoxy primer with water-based vinyl acrylic intermediate and top coat. The VOCs for the Davis System were 3.2 lbs./gal for the primer, 1.8 lbs./gal for the intermediate and 1.3 lbs./gal for the top coat. The Glidden system consisted of a three coat water-based vinyl system. The VOCs for the Glidden System were 0.4 lbs./gal for the primer and the intermediate and 0.7 lbs./gal. for the top coat. The results of the early performance were discussed in the August 7, 1995, interim report (included in Appendix A). These systems were inspected in July 2001, and after nine years the Glidden system has areas of pinpoint rust and the Davis system has one area of pinpoint rust over the skip line between the center and right lanes of WB on the north fascia. The pinpoint rust is on the web of both fascia beams, near the top flange on the south fascia (see Figure 1) and random areas of the web of the north fascia (see Figure 2).

**Figure 1** - South Fascia Pinpoint rust over right lane which is Glidden system.

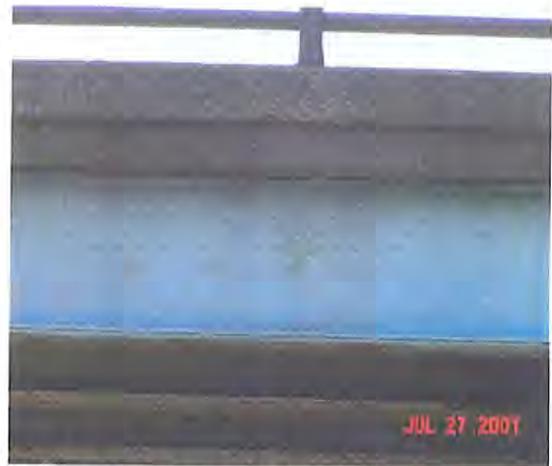
**Figure 2**- Close up of north fascia pinpoint rust over skip line between center and right lanes.

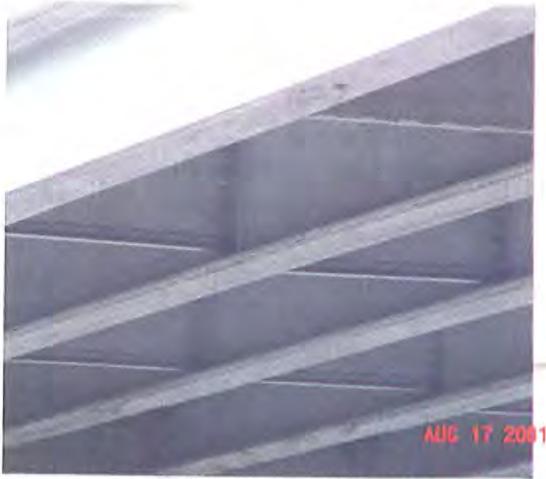
In 1994, the Glidden system used on S14 of 11015 was applied to the west half of the structure. These systems were inspected in August, 2001 and after seven years, is performing adequately, with only a few areas of pinpoint rust (see Figure 3). The Davis system was mistakenly changed from an epoxy zinc-rich primer and two coats of water-based acrylics, to a three-coat vinyl acrylic system and applied to the east half of the structure. VOCs for the primer and the topcoat were 1.6 lbs/gal and 1.5 lbs/gal for the intermediate coat. The modified system did not allow for thick enough film builds on the edges of the bottom flange to prevent pinpoint rusting, and it began failing after only two years. Figures 4, 5, and 6 show areas of pinpoint rust on the Davis system as of August 7, 2001. Figure 7 shows the performance difference between the two systems.

**Figure 3-** Glidden system showing small area of pinpoint rust on bottom flange - lower center of photograph.

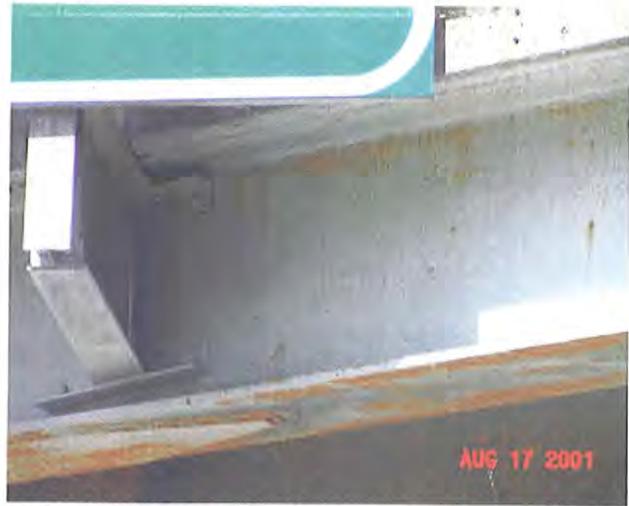
**Figure 4-** Closeup of Davis system on the south fascia.

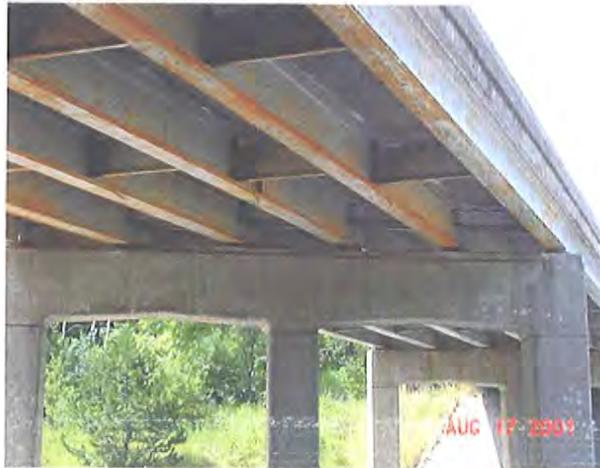
**Figure 5-** Incorrect Davis system pinpoint rust.

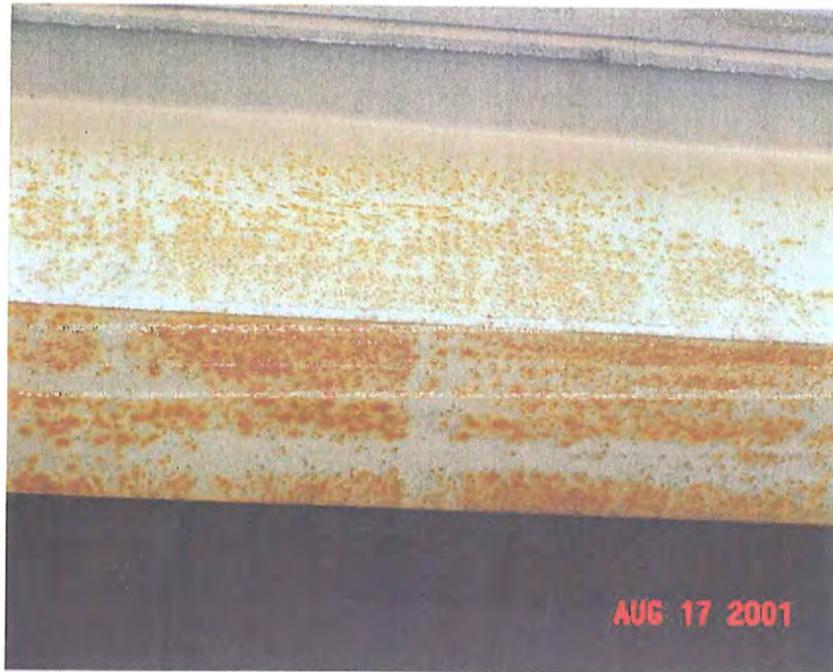
**Figure 6-** Closeup of pinpoint rust in Davis system on north fascia.

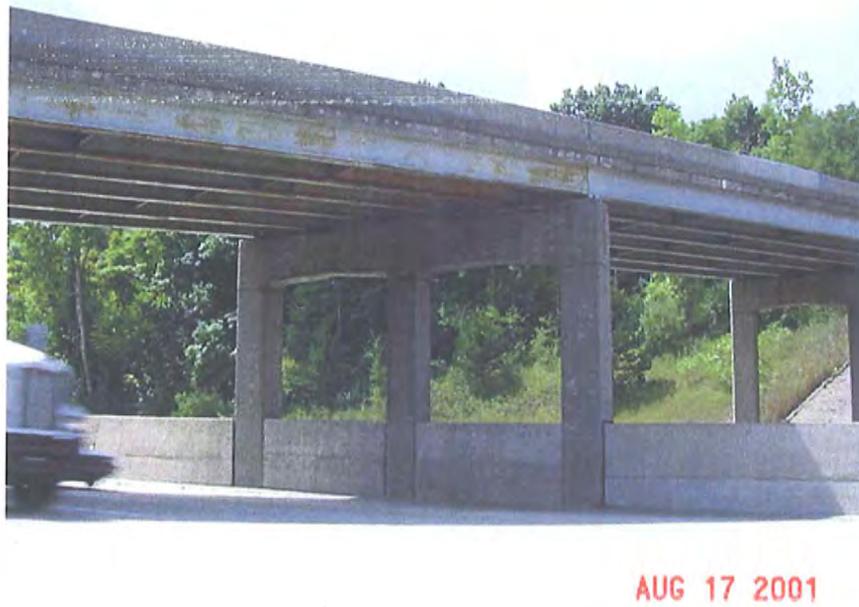
**Figure 7-** North fascia Davis left, Glidden right.

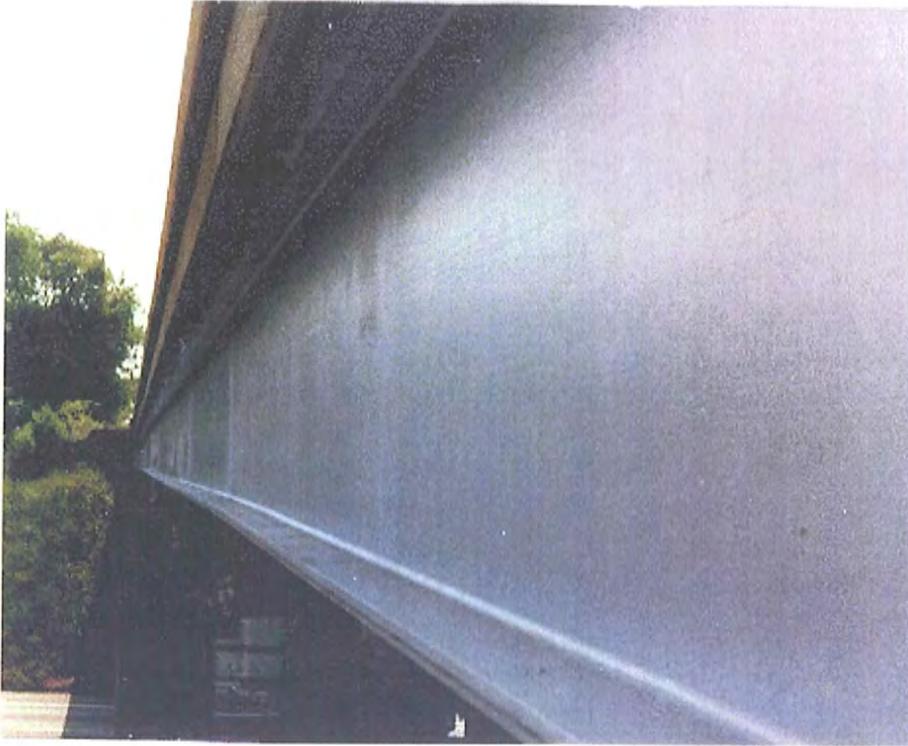
Photo 1. Livingston Rd. over I-94 (S14 of 11052)  
North side: Three systems on fascia beam.

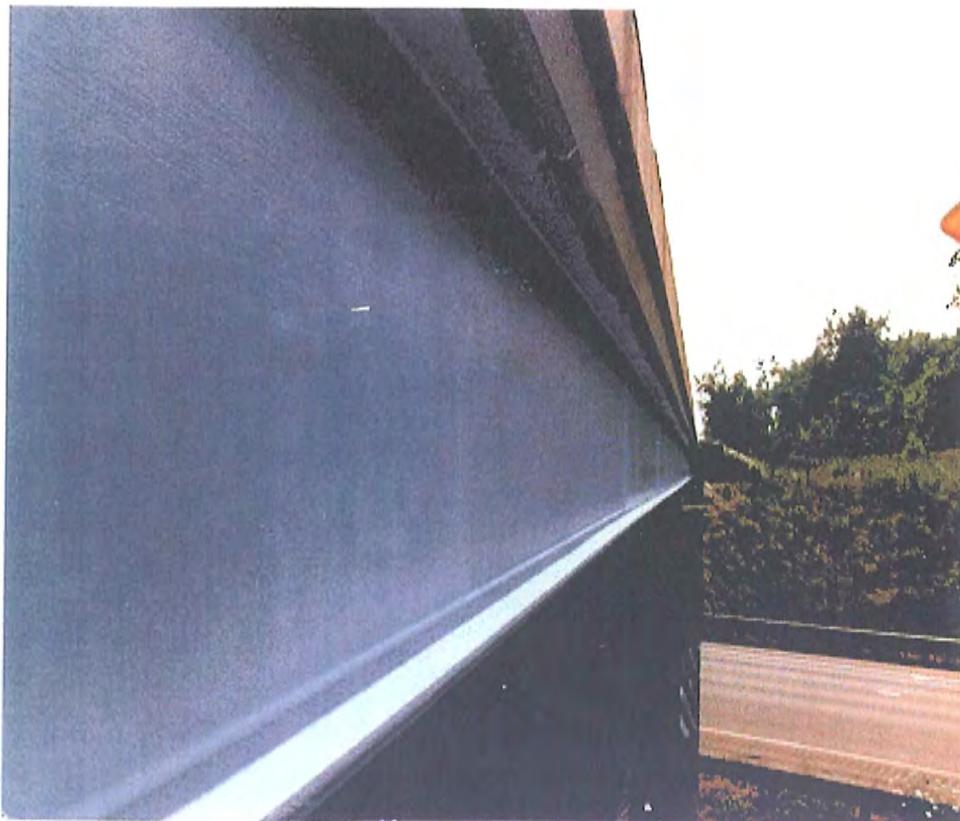
The inspection revealed that the Glidden system faded on the south outside fascia beam and had some limited pinpoint rust as well as rust staining from tack welds on the inside portion of the beam as described in the field inspection report and photographs (see attachment B and C). This staining occurred on all areas of the bridge including the Davis and the control portions. Inspectors saw a flat appearance on the north outside fascia but no chalking was evident. The inner beams were spot painted with this system as well, but were not part of the original evaluation and will not be discussed in this report. They are mentioned in the field inspection report. Inspectors did not see any performance problems with the Davis system, but, again, it showed staining from the tack weld as did the rest of the structure. The topcoat was not fading, but has a flat appearance as compared to the polyurethane used in our current system.

Photo 2. Livingston Rd. over I-94 (S14 of 11052)  
South side: Three systems on fascia beam.

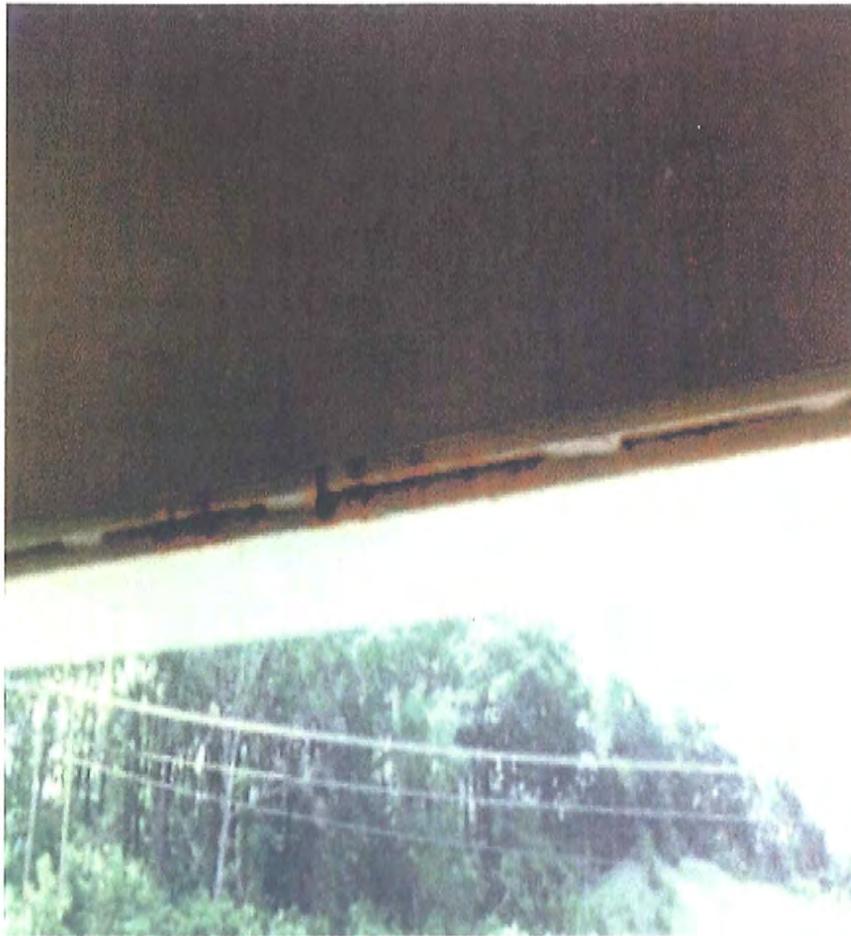
Photo 3. Livingston Rd. over I-94 (S14 of 11052)  
Typical cover plate staining.
