**APPENDIX D**

**Selected Site Photos**

## **Appendix D. Selected Site Photos**

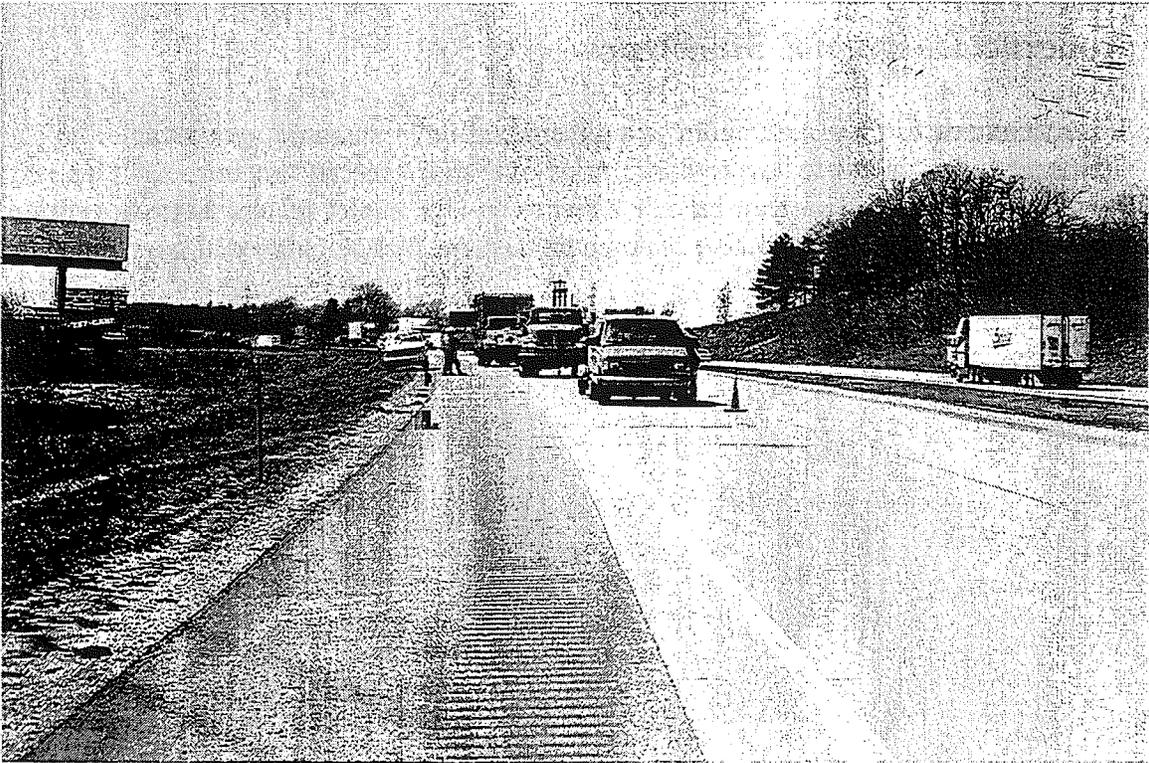
*Photo C1. An overview of CSN# 11017-32516A (Section A), EB looking west. The 14 ft widened truck lane design and asphalt shoulder can be seen.*

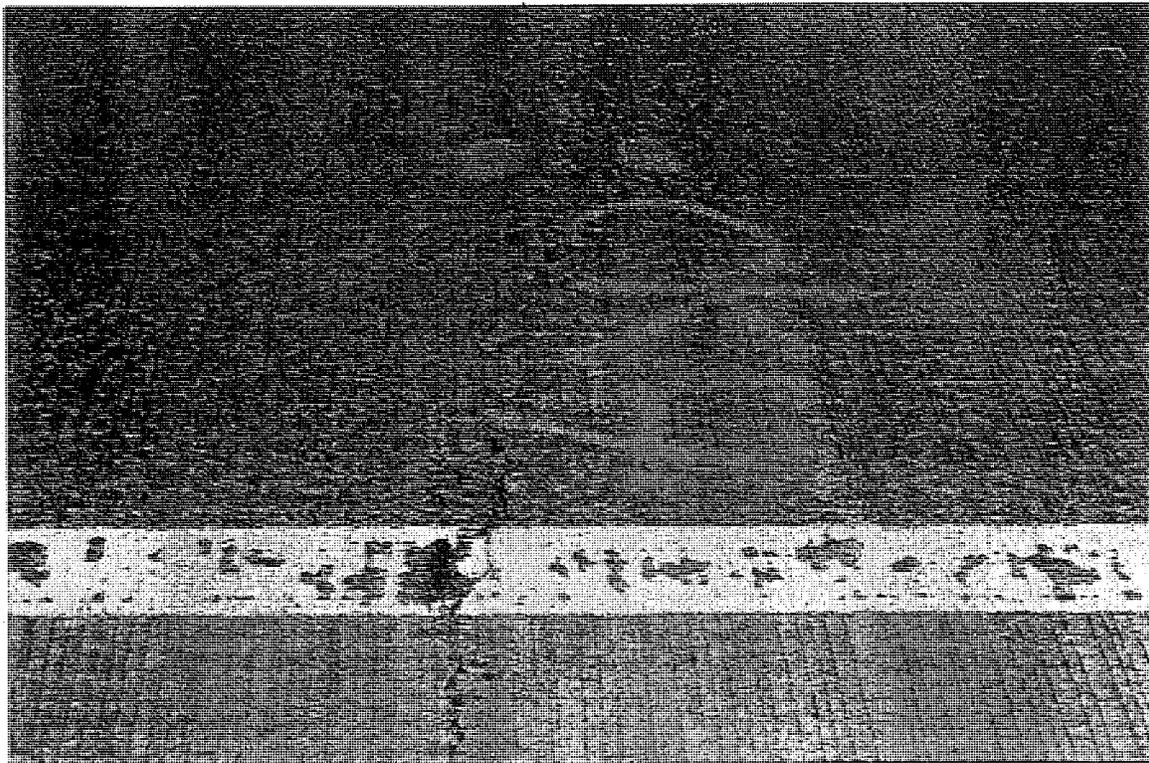
*Photo C2. A typical midslab crack on CSN# 11017-32516A (Section A), EB. The beginning of some spalling can be seen at the bottom of the photo.*

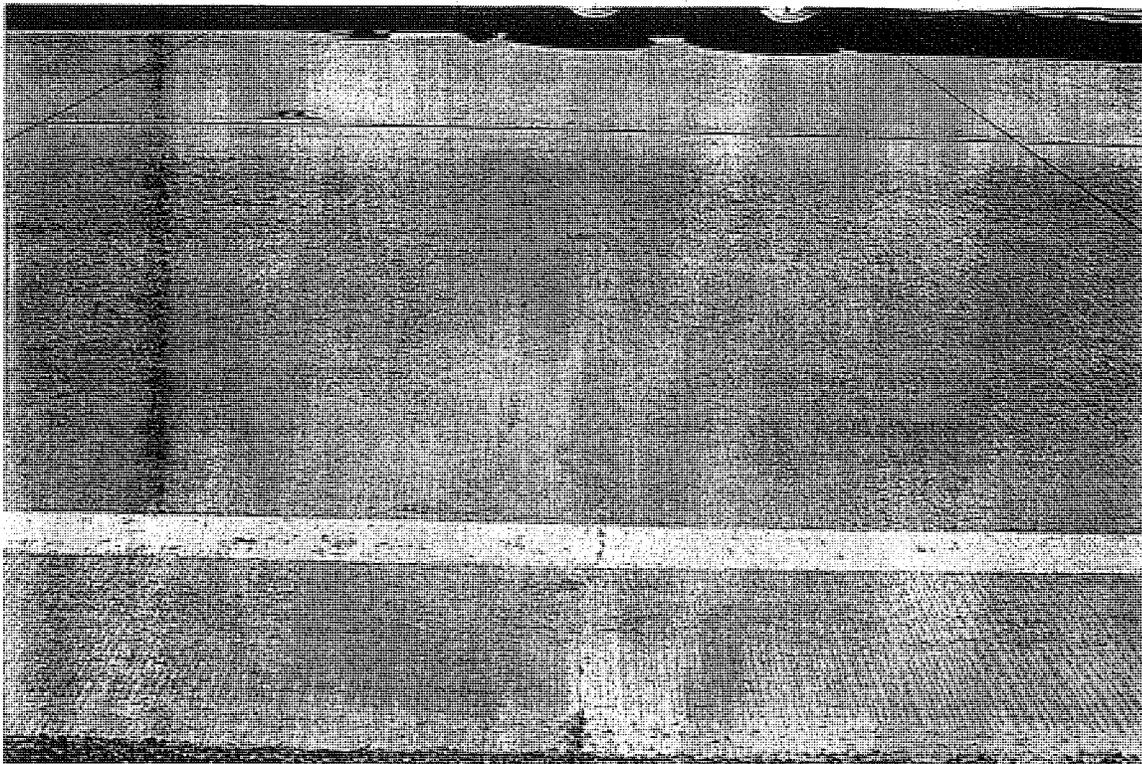
*Photo C3. A midslab crack on CSN# 11017-32516A (Section A), EB. The location of core #C1 can also be seen. The crack extends through the passing lane. Transverse joints are spaced at 16 ft.*

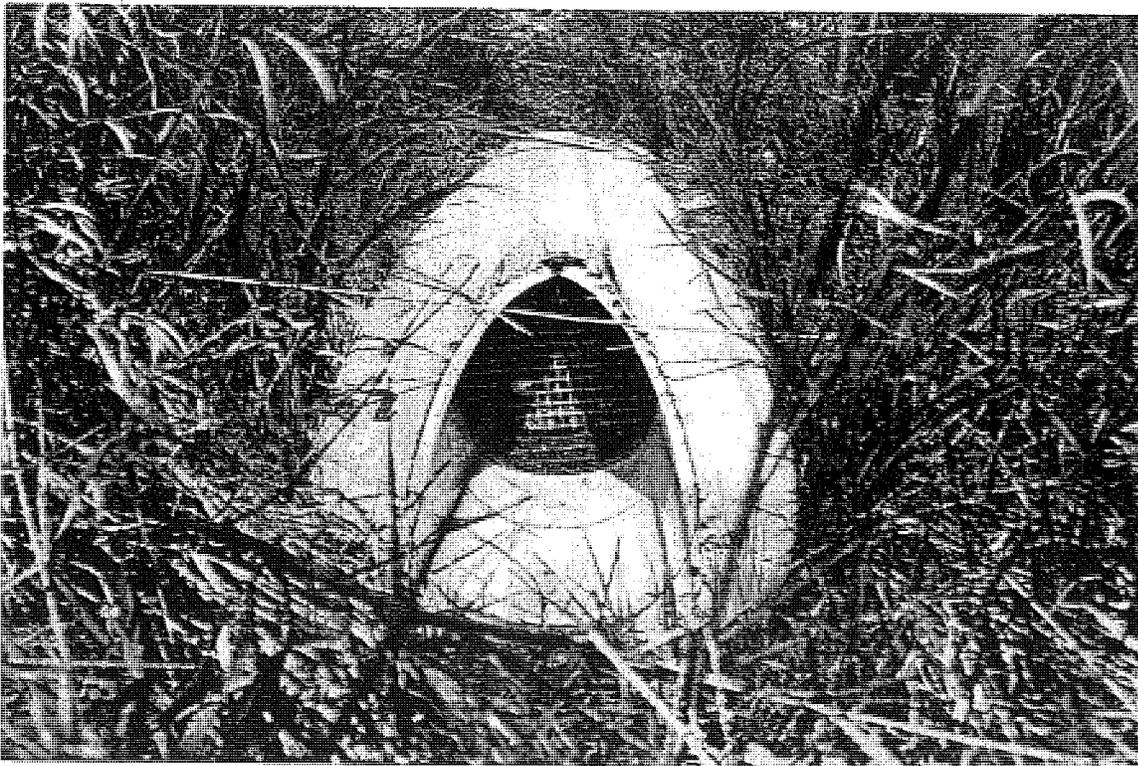
*Photo C4. A typical drainage structure of CSN# 11017-32516A (Section A), EB. Water can be seen flowing freely from the drain after coring.*

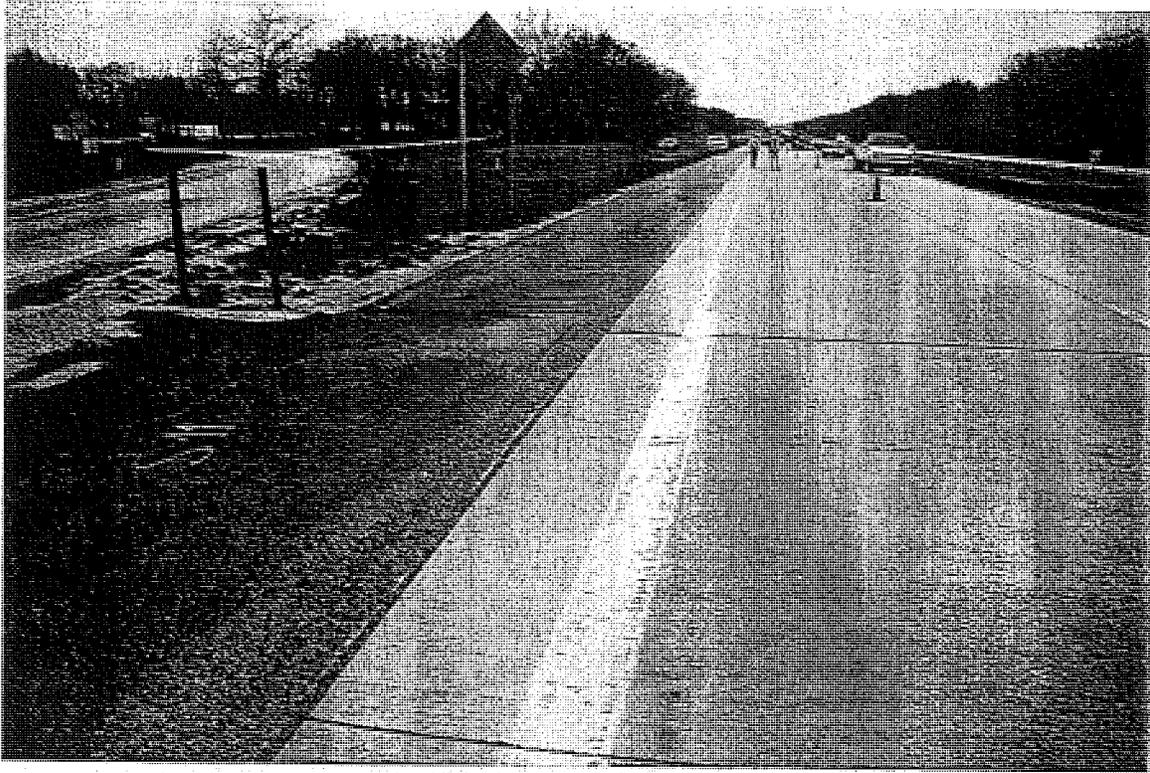
*Photo C5. An overview looking west on CSN# 11017-32516A (Section C), EB. This section has a 14 ft widened truck lane and an asphalt shoulder. Transverse joint spacing varies from 15 to 17 ft.*

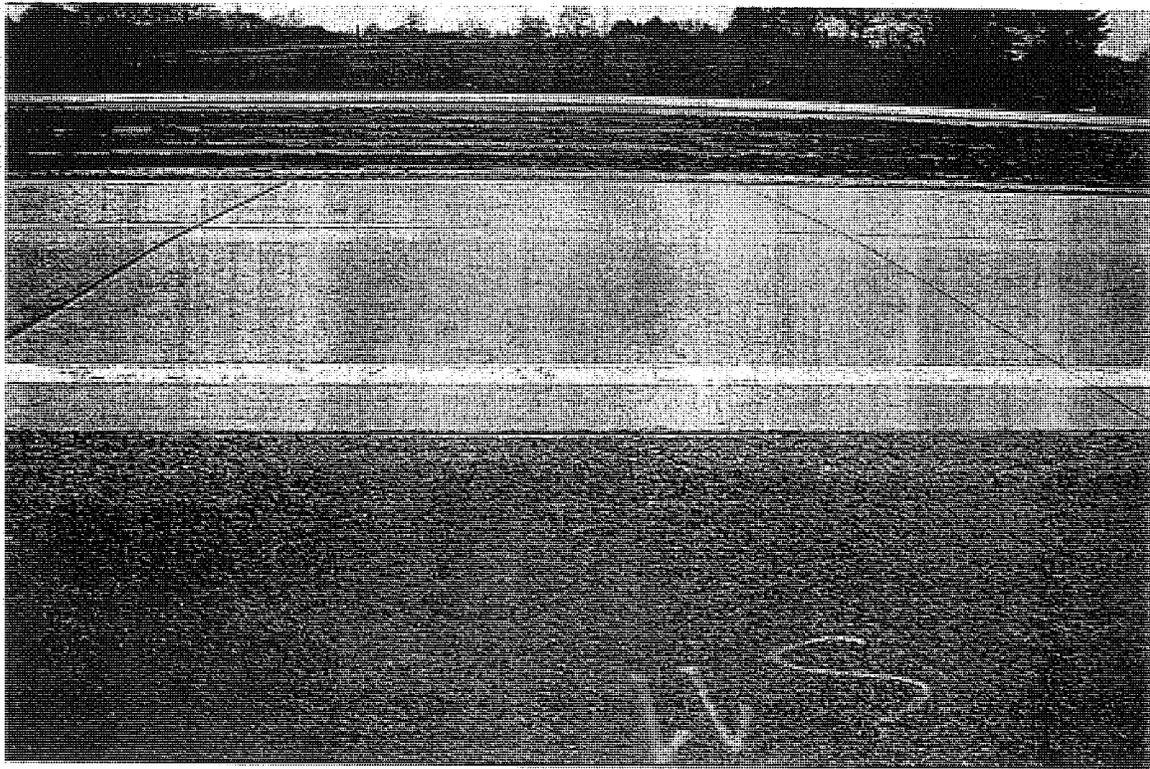
*Photo C6. A full width transverse crack on CSN# 11017-32516A (Section C), EB. An expansion joint can be seen in the left side of the photo.*

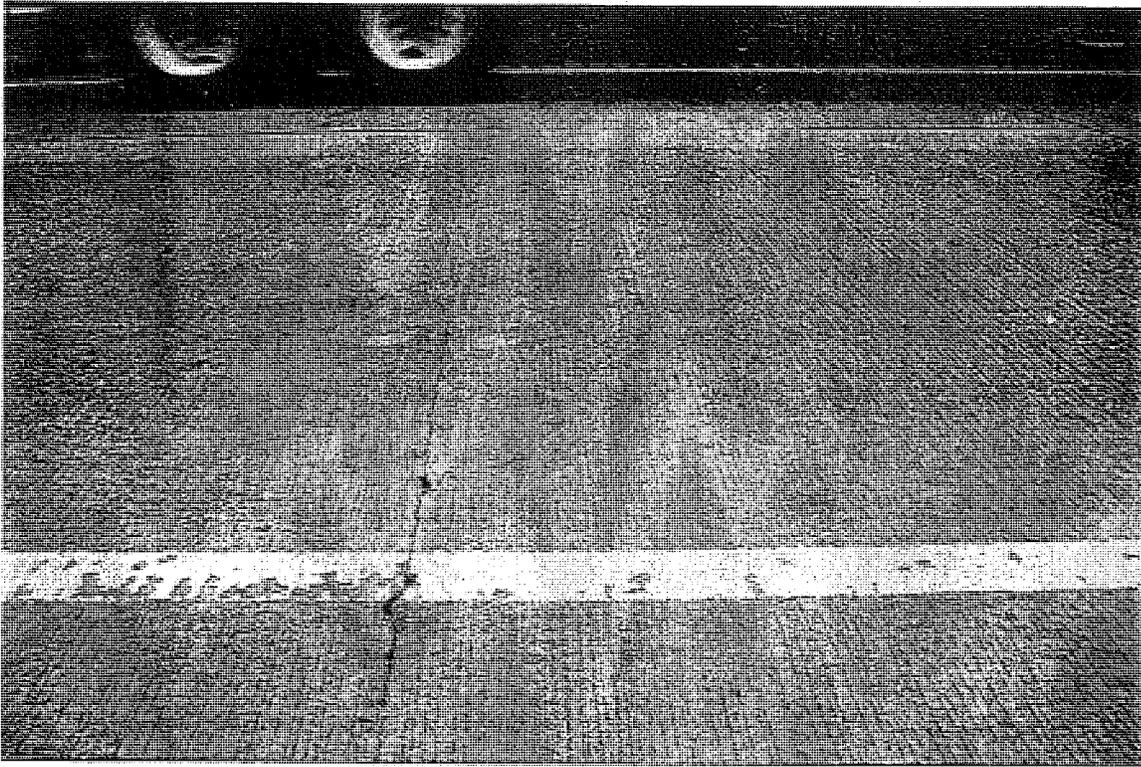
*Photo C7. A close-up of a full width transverse crack in CSN# 11017-32516A (Section C), EB. The beginnings of spalling can be seen at the bottom of the photo.*

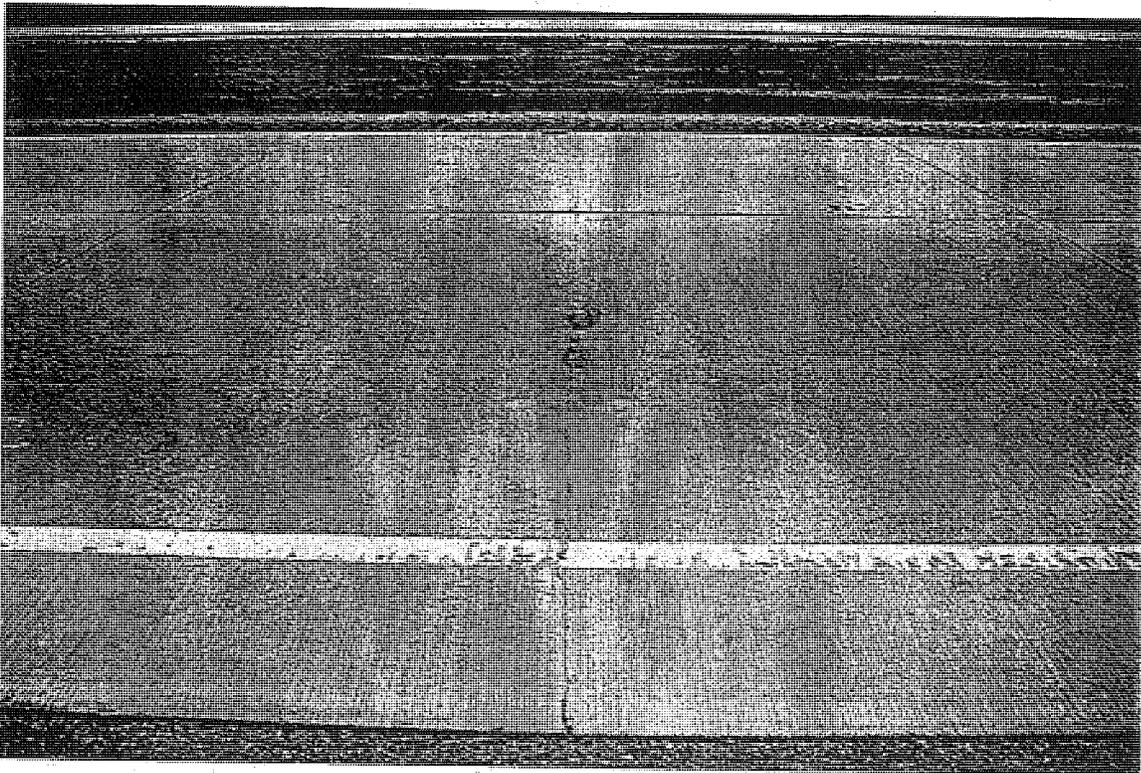
*Photo C8. A transverse crack at midslab in CSN# 11017-32516A (Section C), EB. Moderate spalling is present.*

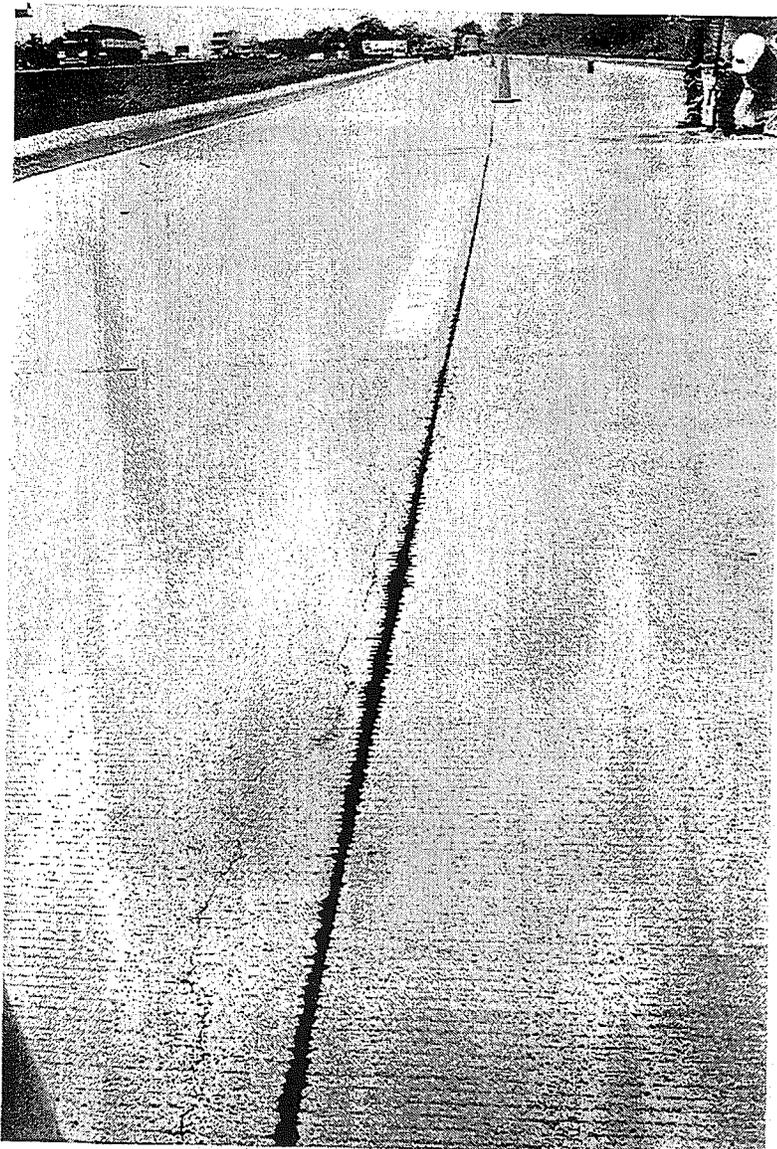
*Photo C9. An overview looking west on CSN# 11017-32516A (Section D), WB. A tight longitudinal crack running parallel to the longitudinal joint can be seen.*

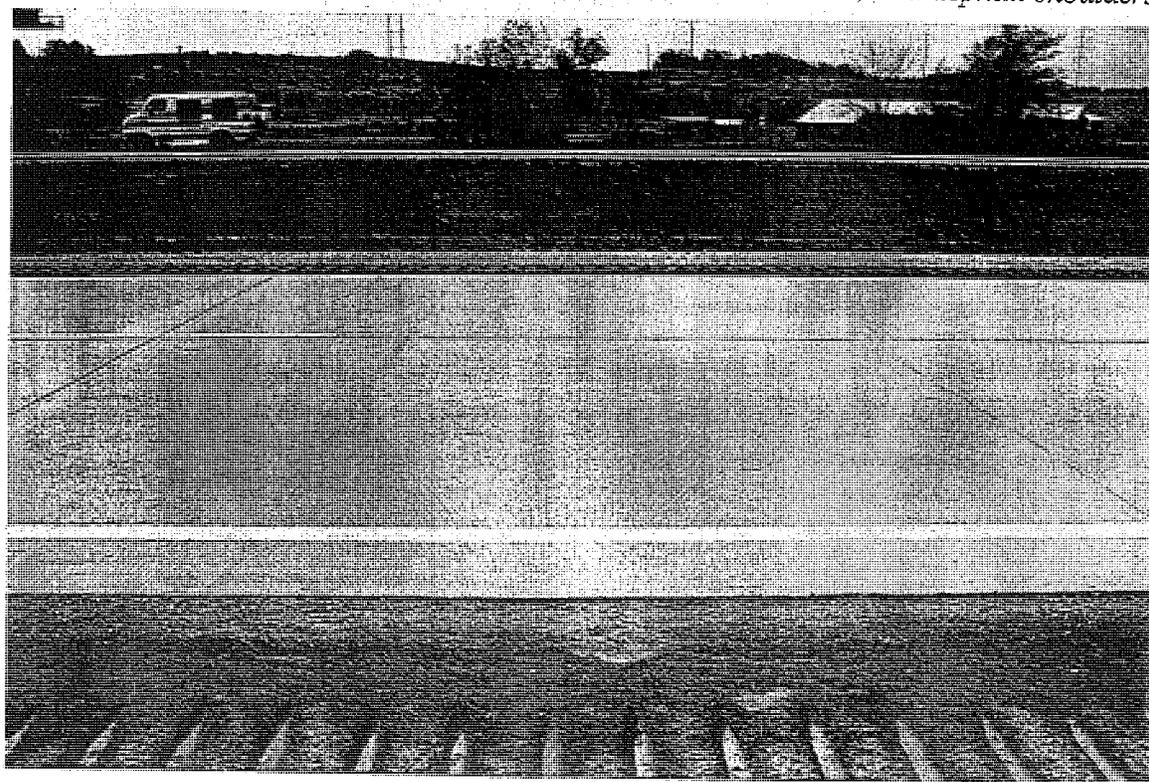
*Photo C10. A view of a typical uncracked slab in CSN# 11017-32516A (Section D) WB. This section has 15 ft joint spacing, 14 ft widened truck lane, and asphalt shoulders.*

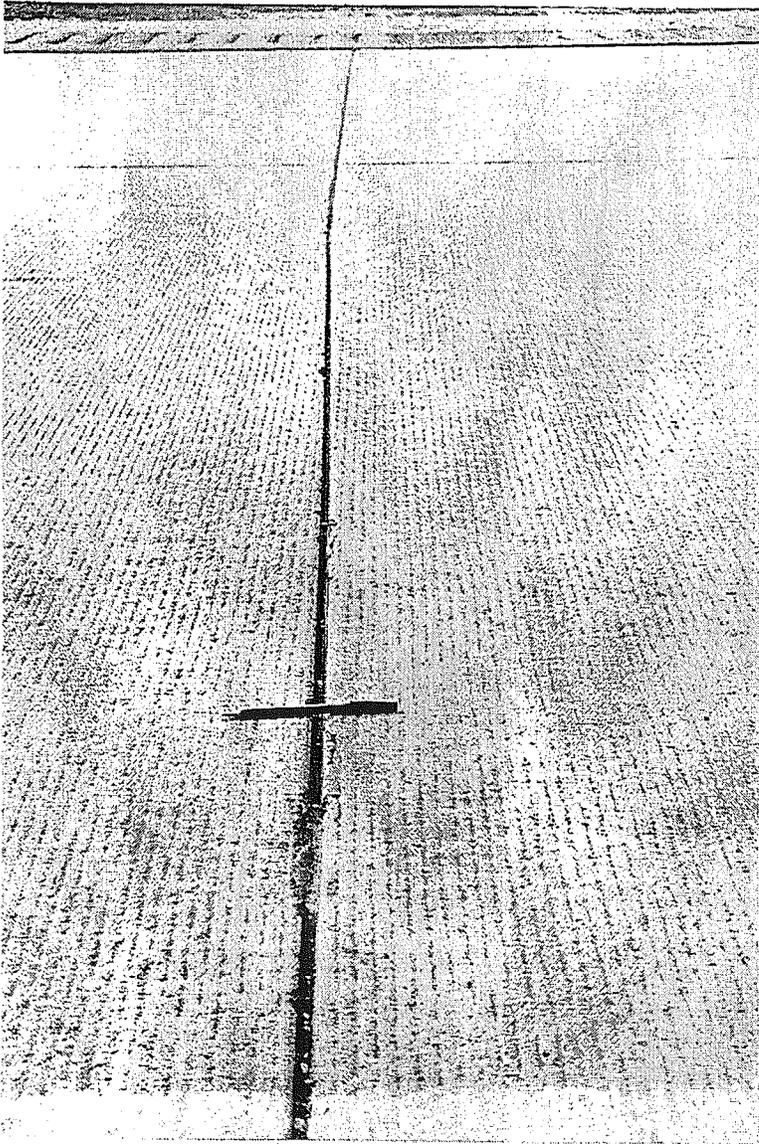
*Photo C11. A typical contraction joint on CSN# 11017-32516A (Section D) WB, showing some spalling along the joint.*

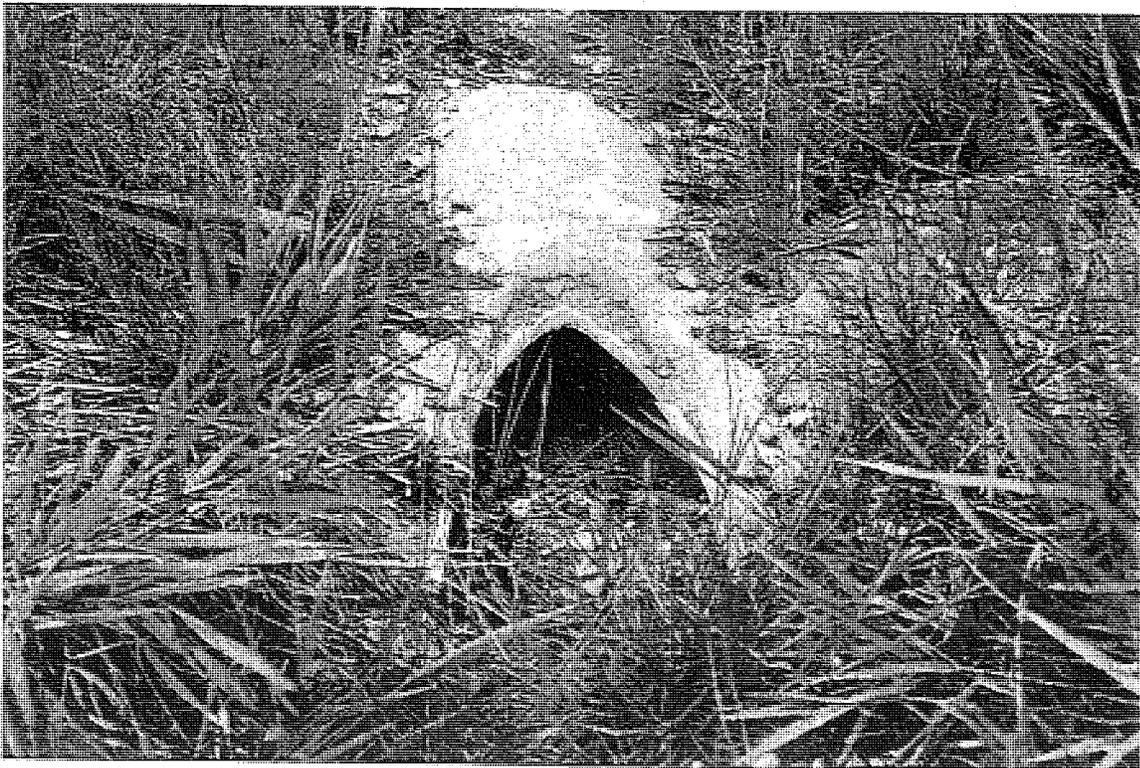
*Photo C12. A partially clogged edge drain outlet on CSN# 11017-32516A (Section D) WB.*

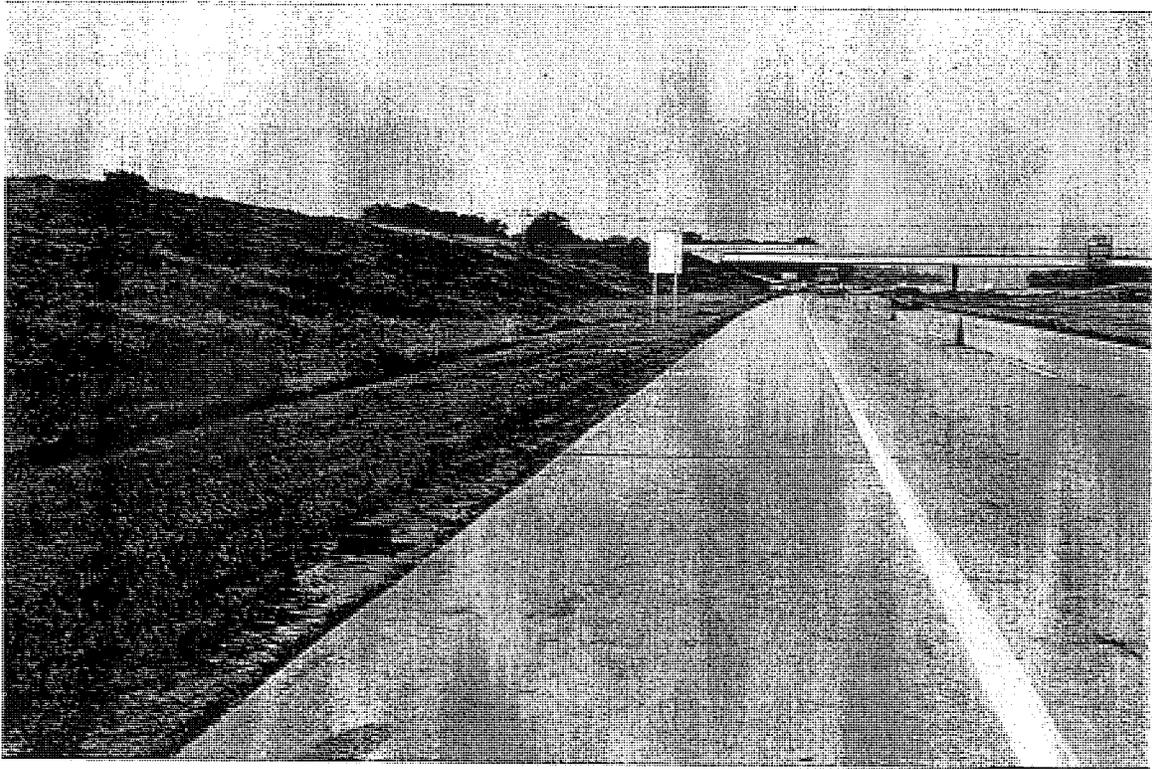
*Photo C13. An overview of CSN# 19042-24680A (Section B) EB looking west. This section has 41 ft slabs and concrete shoulders with no intermediate joints.*

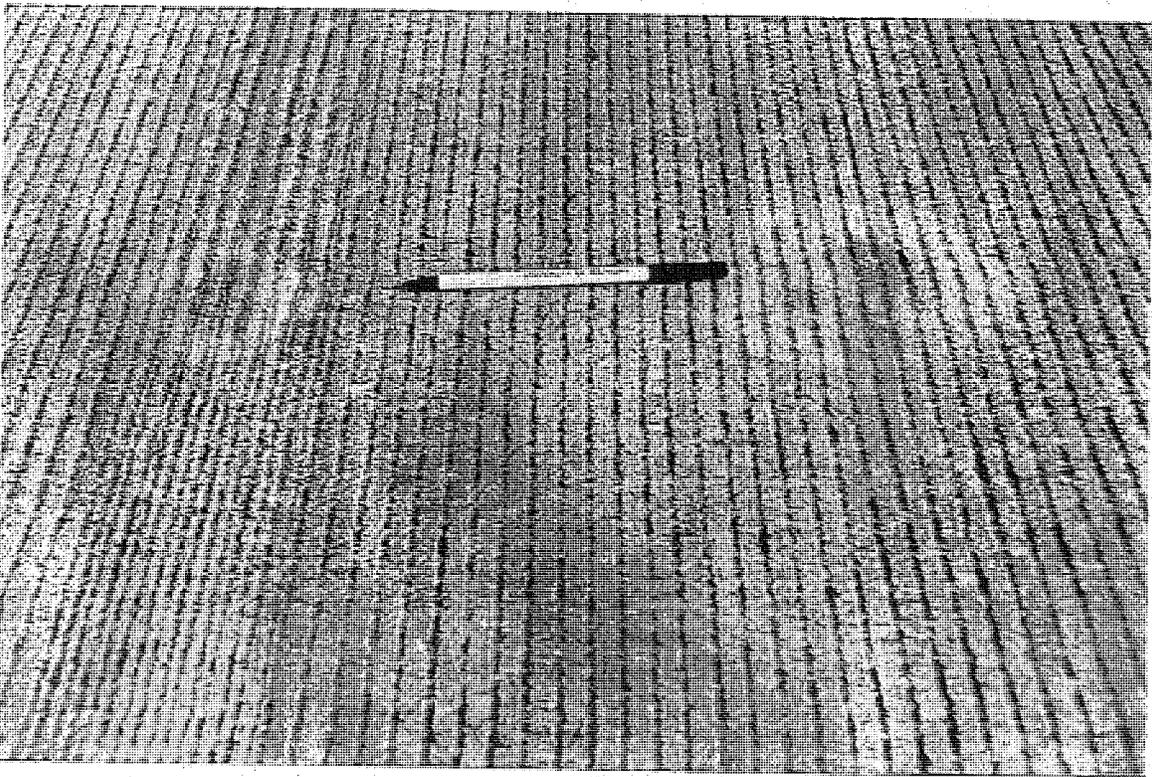
*Photo C14. A tight transverse crack on CSN# 19042-24680A (Section B) EB, typical of those seen in the test section.*

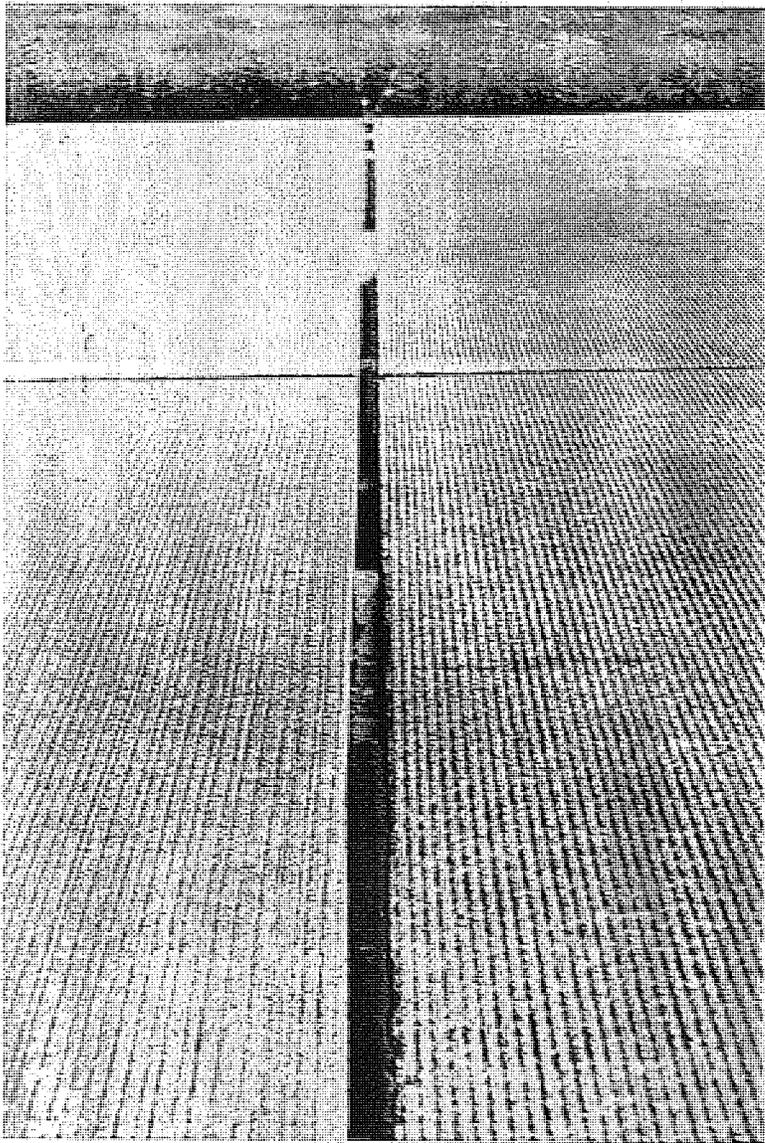
*Photo C15. An expansion joint on CSN# 19042-24680A (Section B) EB showing some distress in the joint sealant. Sealant damage was present in several locations in the test section.*

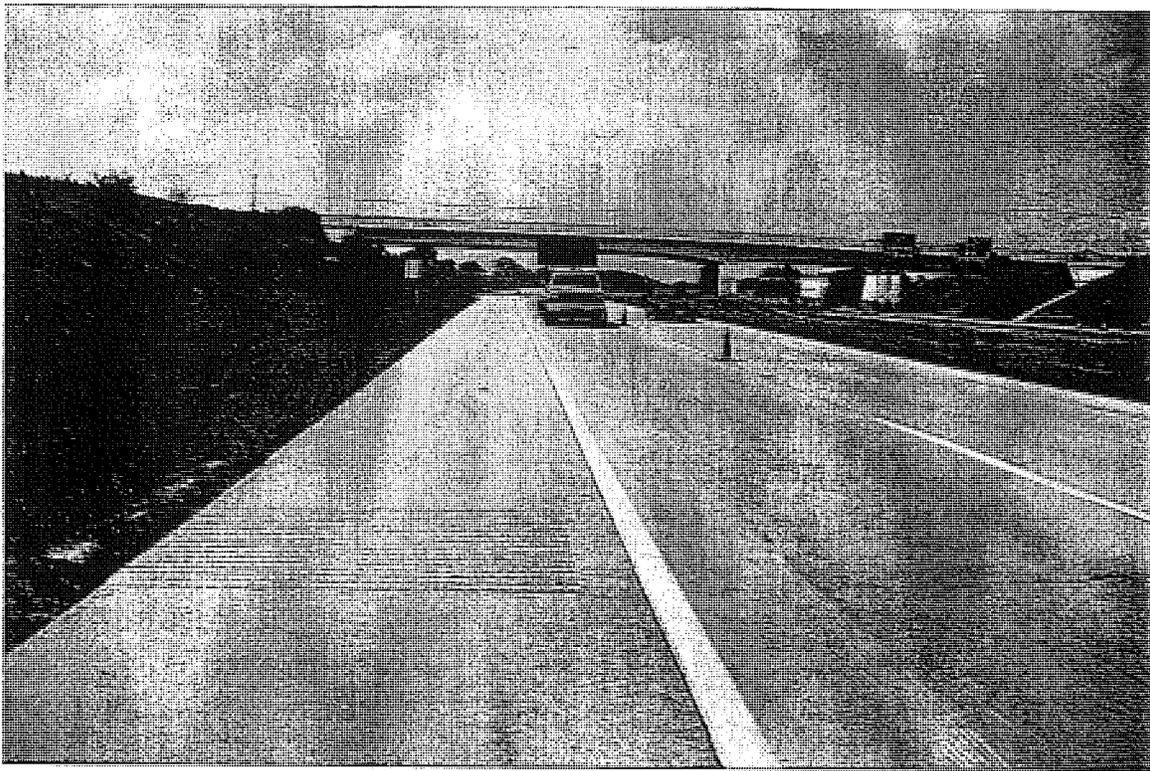
*Photo C17. A overview looking west on CSN# 19042-02233A (Section C) EB. Slabs are 41 ft long. The concrete shoulder slabs have the same length.*

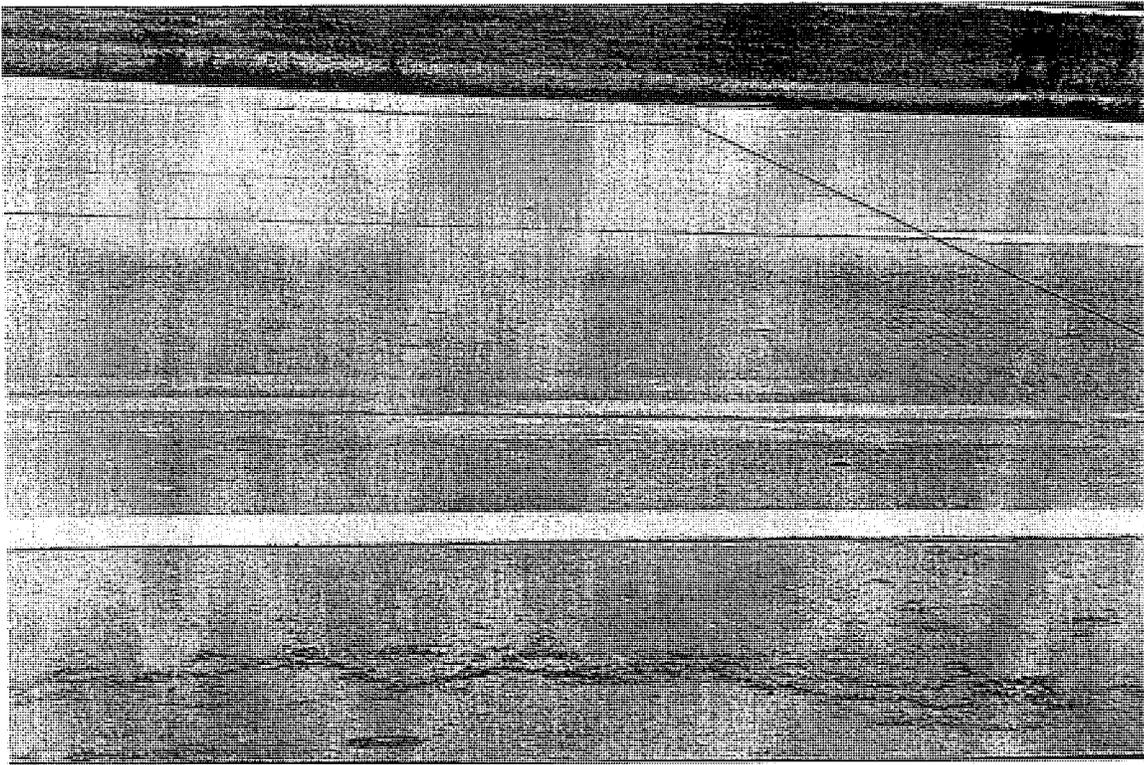
*Photo C19. A tight crack on CSN# 19042-02233A (Section C) EB, joints are in good condition as can be noted here.*

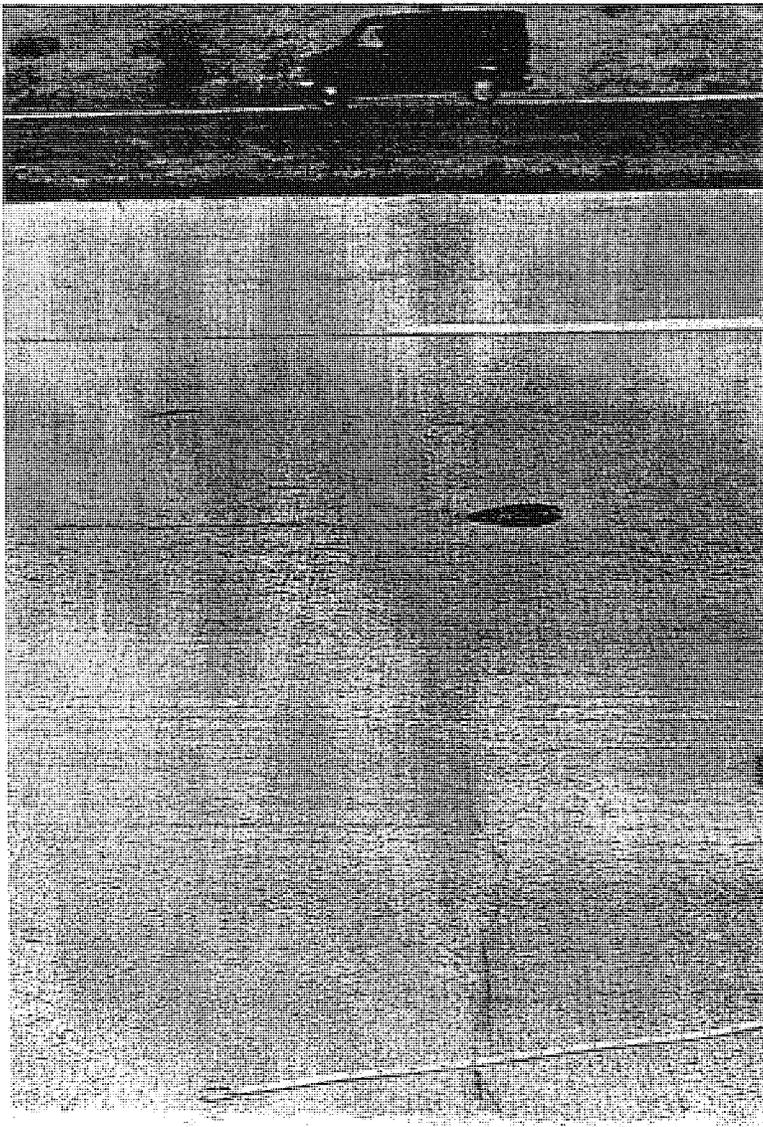
*Photo C20. A tight midslab crack in the truck lane of CSN# 19042-02233A (Section C) EB, the crack extends into the shoulder, but is not visible in the passing lane.*

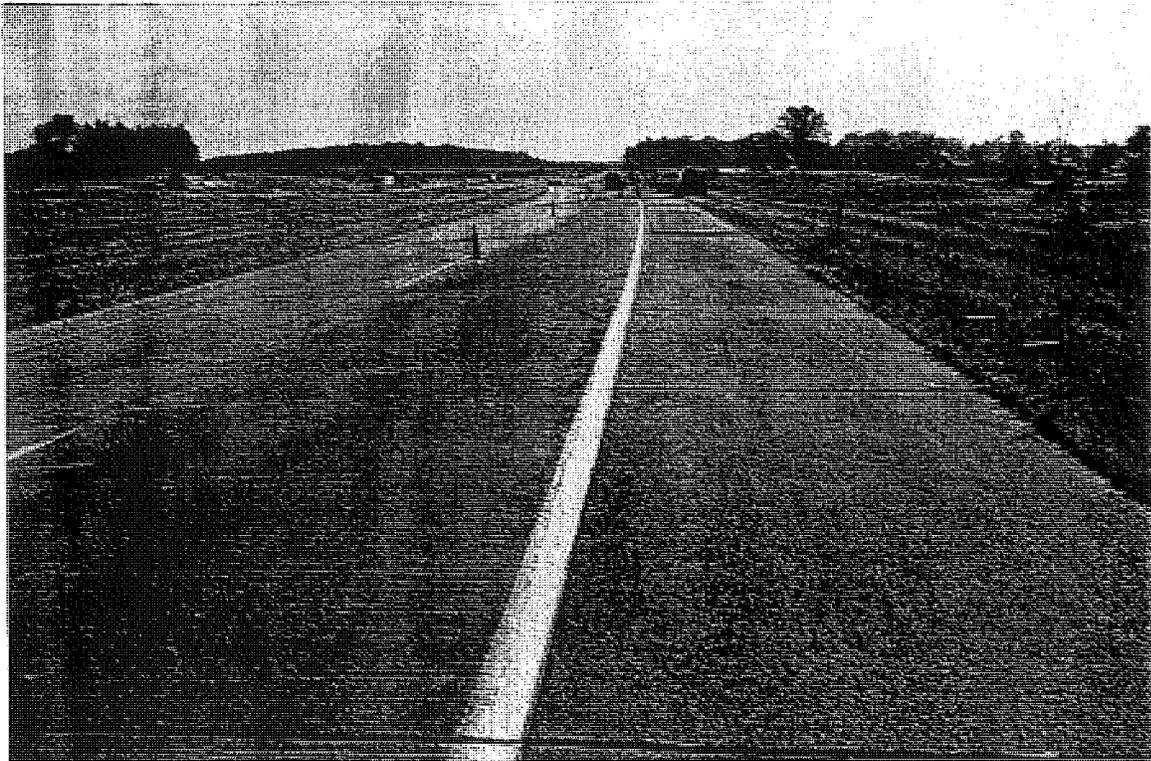
*Photo C21. An overview looking east along CSN# 19043-02234A, EB, showing the third point intermediate shoulder joints. The slabs in the driving lanes are 41 ft long.*

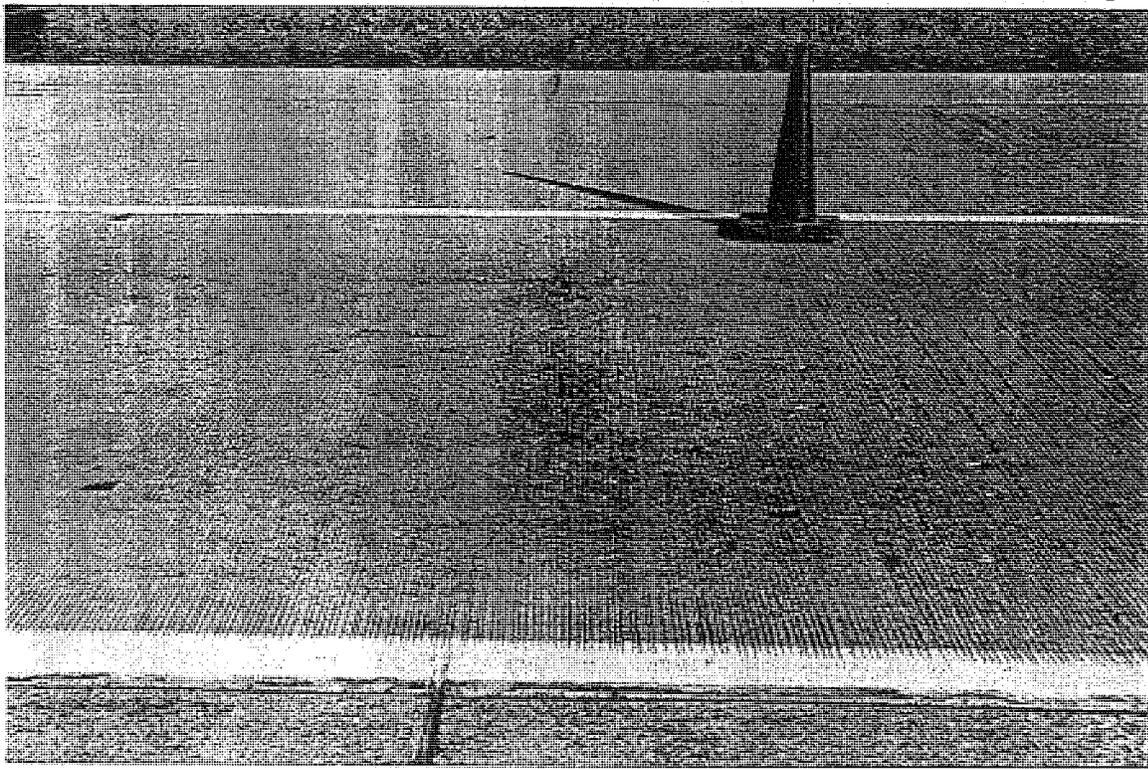
*Photo C22. A typical midslab crack on CSN# 19043-02234A, EB, initiated by the third point intermediate shoulder joint.*

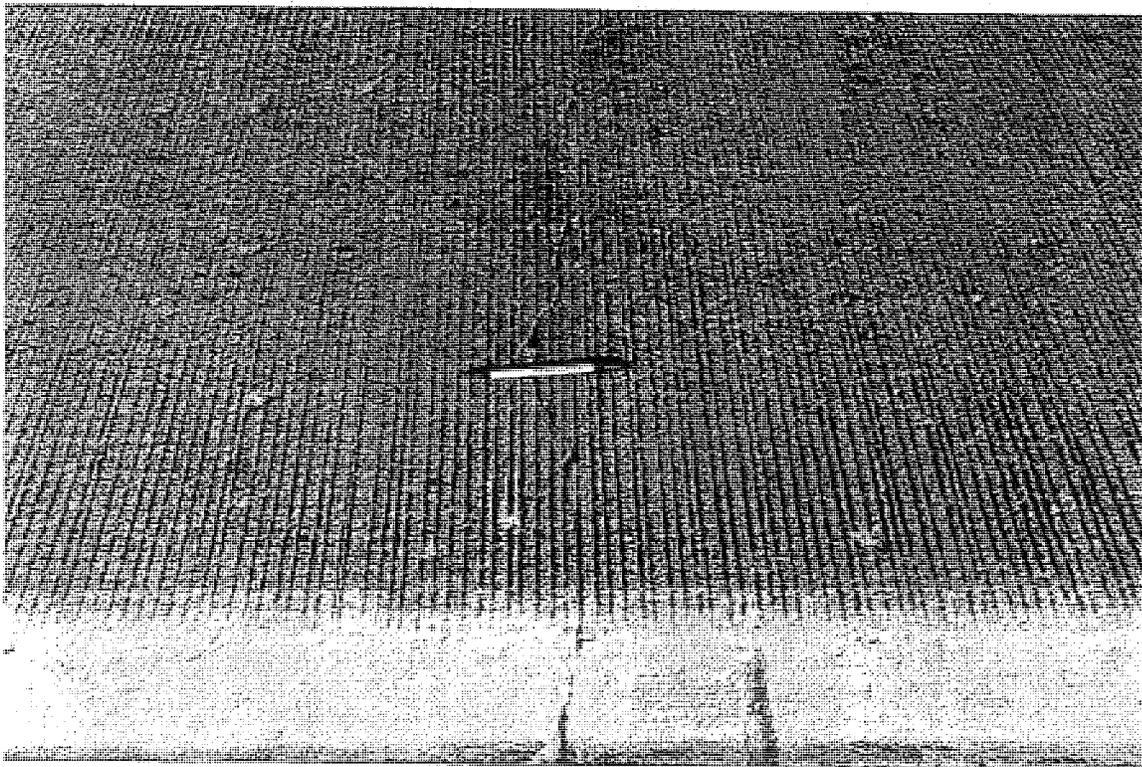
*Photo C24. A close-up of a typical crack on CSN# 19043-02234A EB. The beginning of spalling can be seen.*

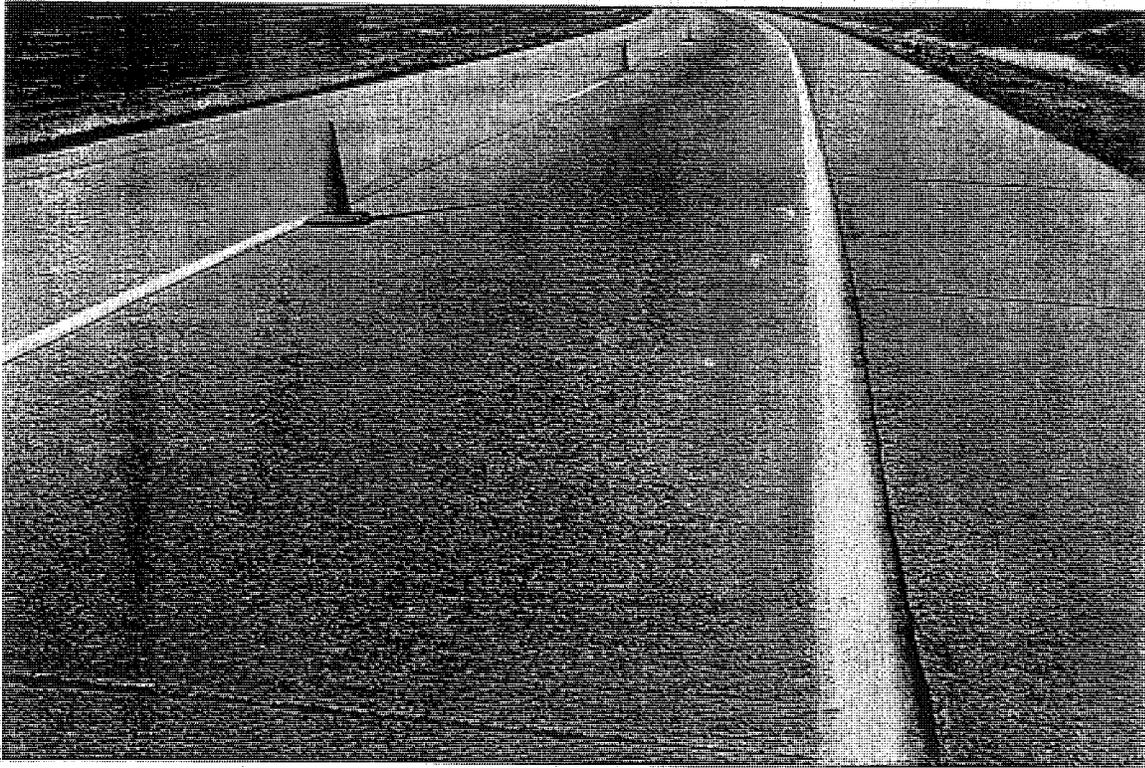
*Photo C25. An overview of the end of the test section of CSN# 19043-02234A WB, looking west. This section has 41 ft joint spacings in the driving lanes, but only 14 ft joint spacing in the shoulders.*

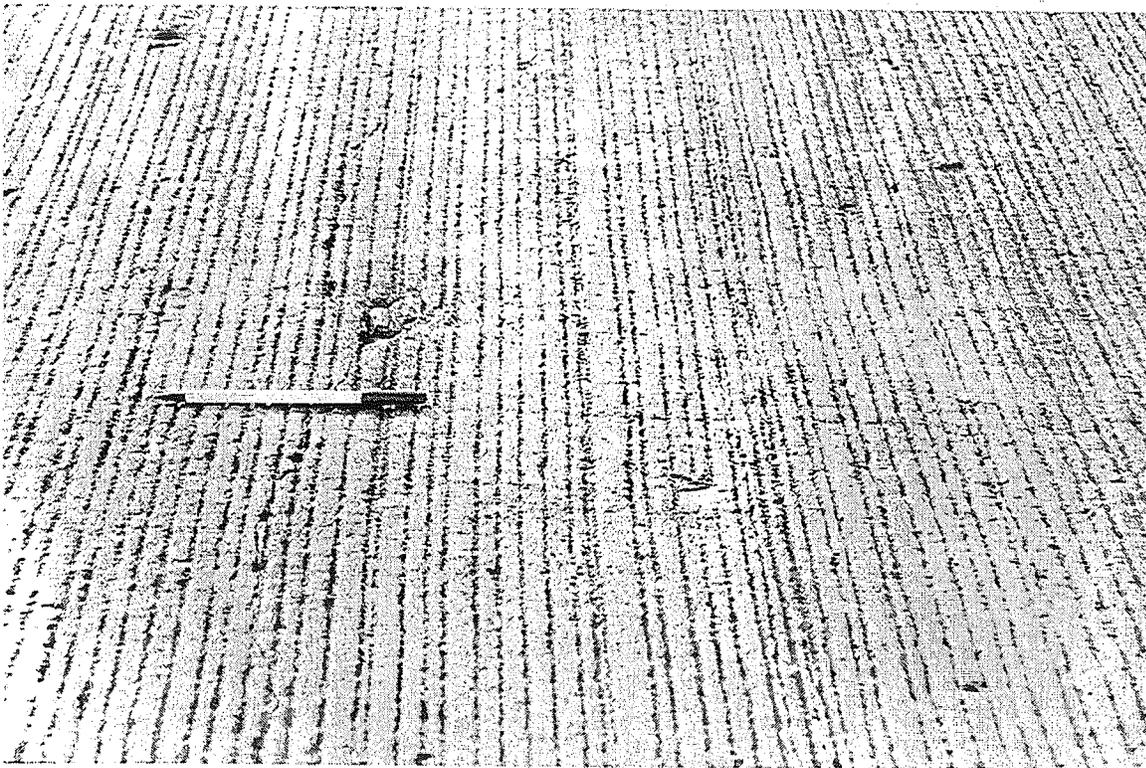
*Photo C26. A closeup view of a tight crack on CSN# 19043-02234A, WB. The beginning of spalling can be seen in the center of the photo.*

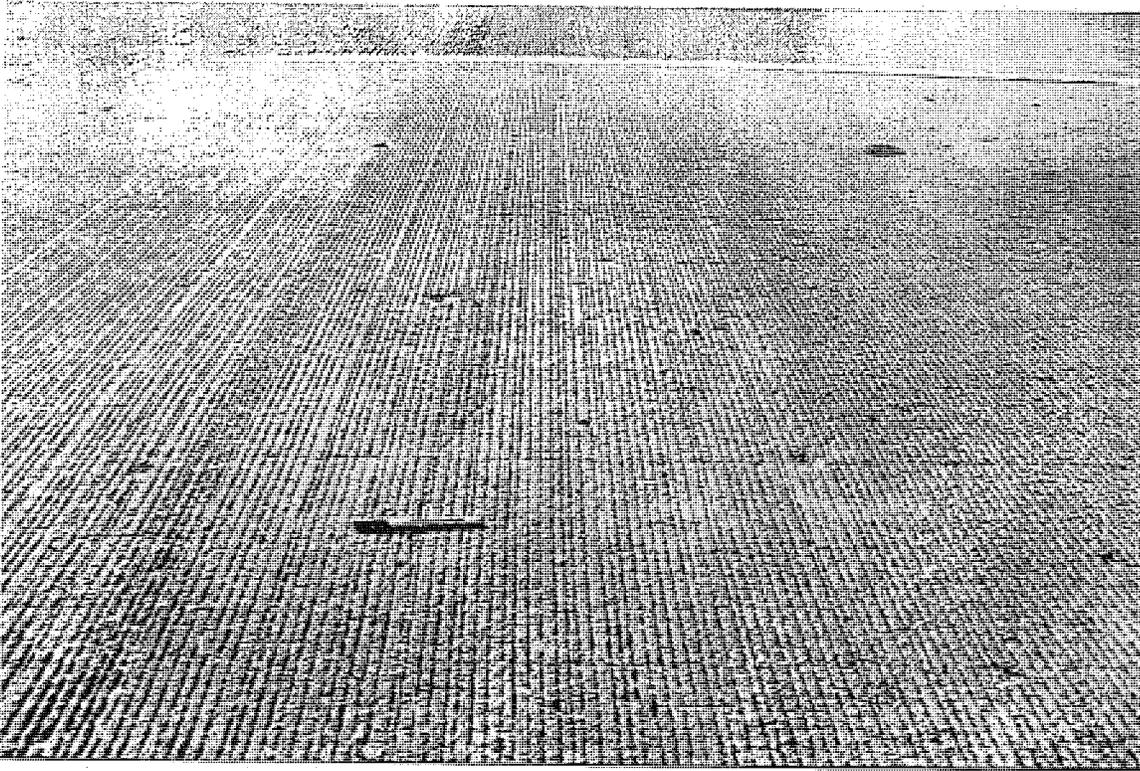
*Photo C27. A midslab crack along CSN# 19043-02234A, WB. The crack propagates from the intermediate shoulder joint, which is typical for this section.*

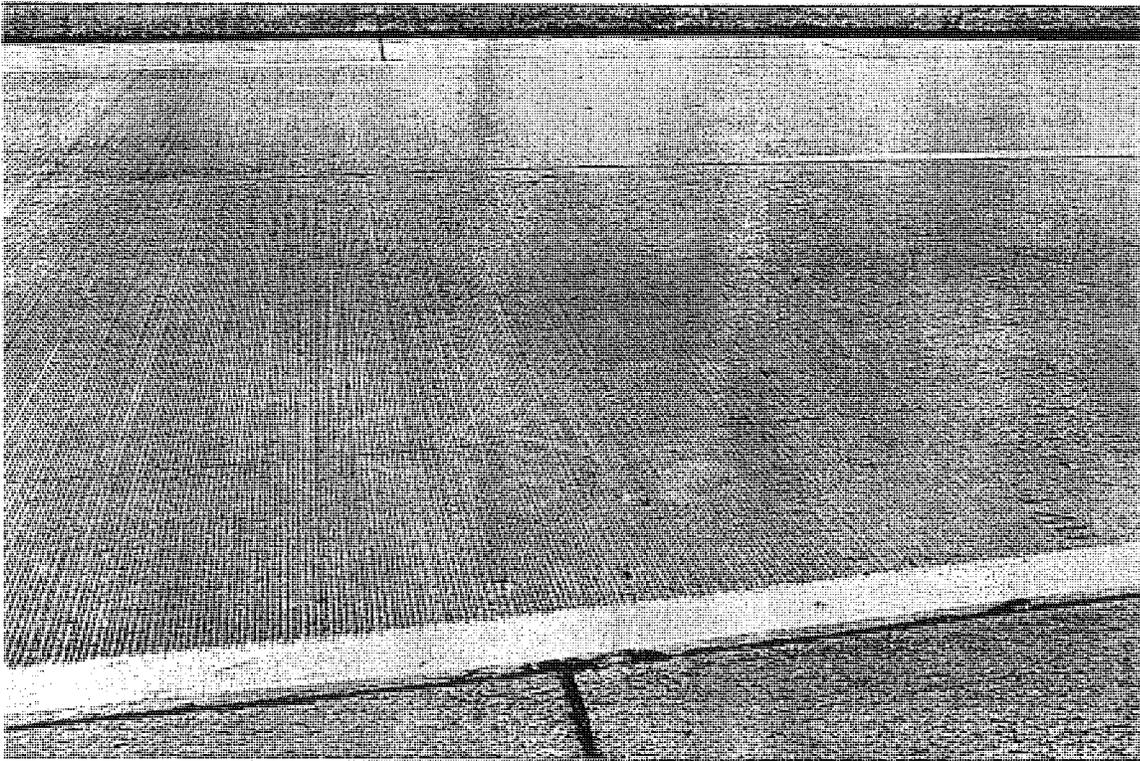
*Photo C28. A typical full width mid slab crack on CSN# 19043-02234A, WB. This crack was initiated by the third point intermediate shoulder joint seen at the bottom of the photo.*
