**APPENDIX D**

**Selected Site Photos**

## **Appendix D. Selected Site Photos**

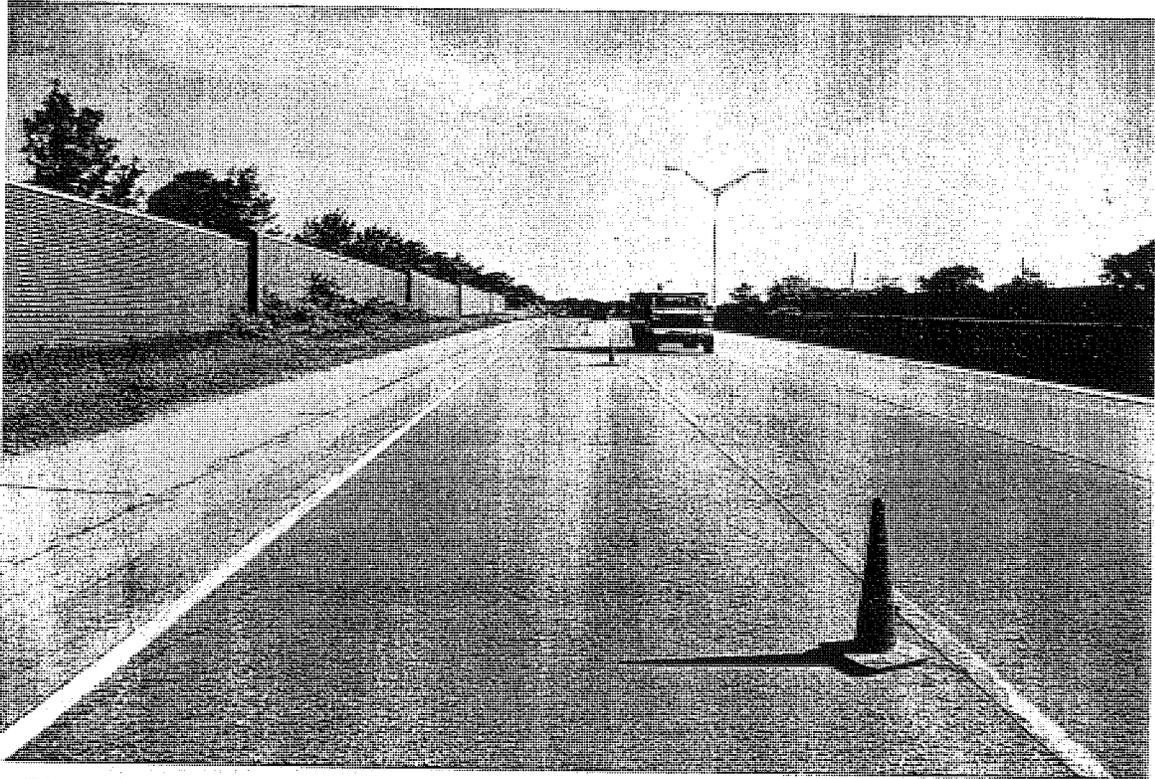
*Photo C29. An overview looking north on CSN# 25132-06582A SB. This photo shows the 3 lanes of traffic and the third point intermediate shoulder joints. The slab length is 44 ft in the driving lanes.*

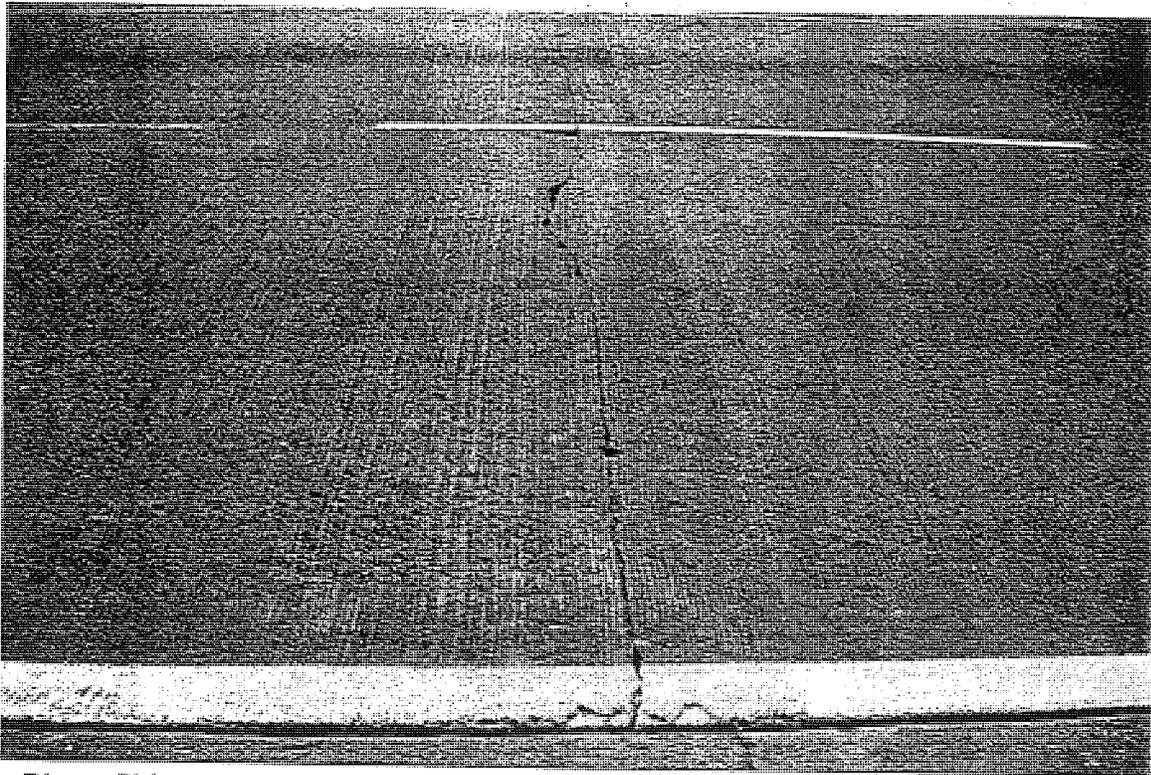
*Photo C30. A typical third point full width crack showing the beginnings of spalling on CSN# 25132-06582A SB.*

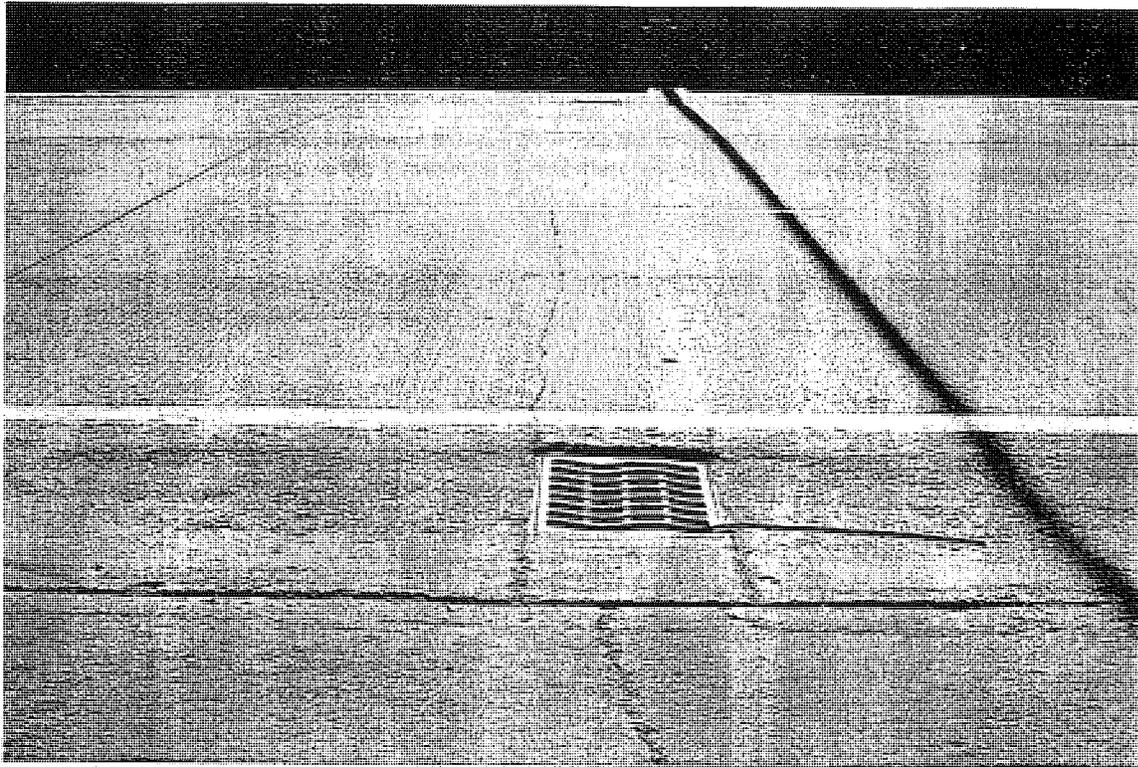
*Photo C31. A drainage structure that has induced a full width transverse crack on CSN# 25132-06582A SB.*

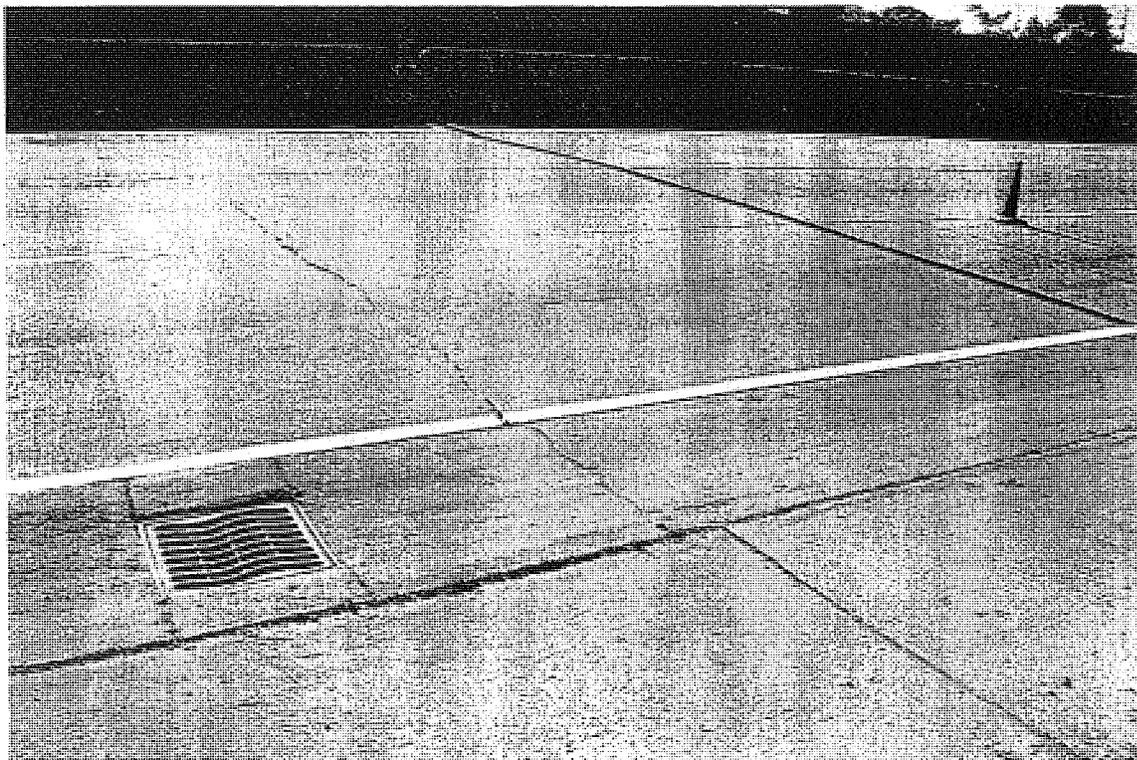
*Photo C32. A full width transverse crack induced by the third point intermediate shoulder joints on CSN# 25132-06582A SB.*

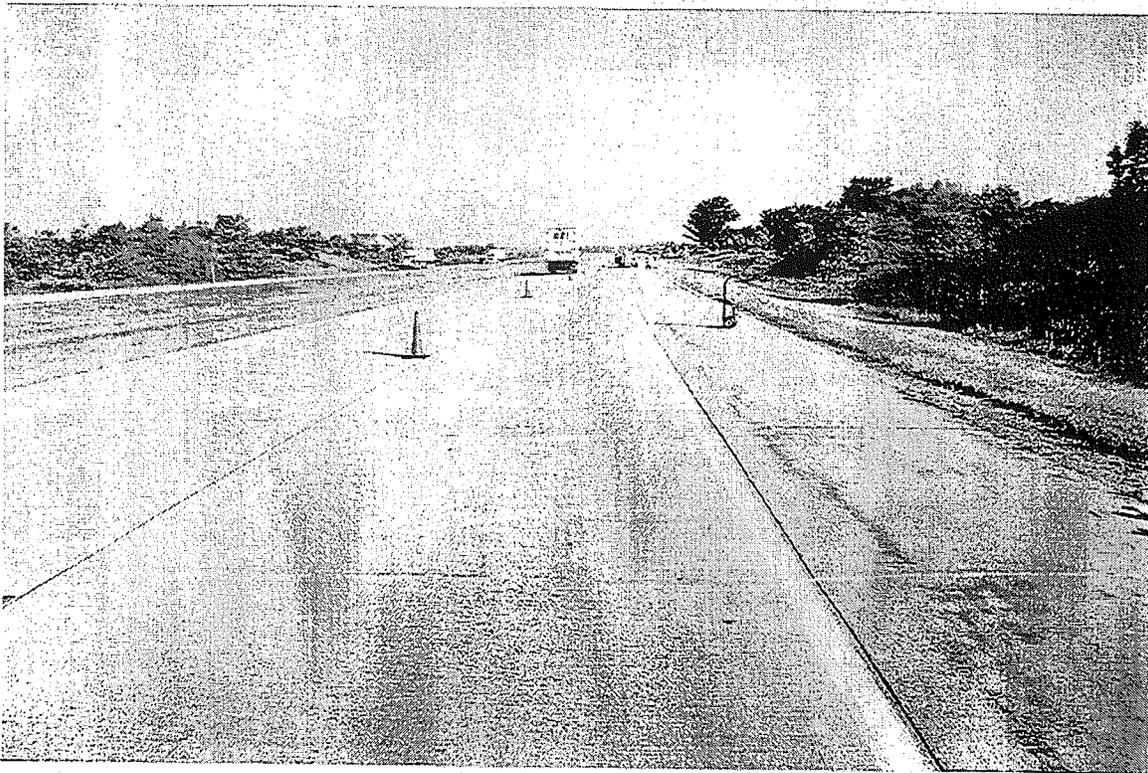
*Photo C33. An overview looking west on CSN# 44044-18804 WB, showing the intermediate shoulder joints. Slabs in the driving lanes are 41 ft long. Swamp vegetation in the ditches can be seen on the right side of the photo.*

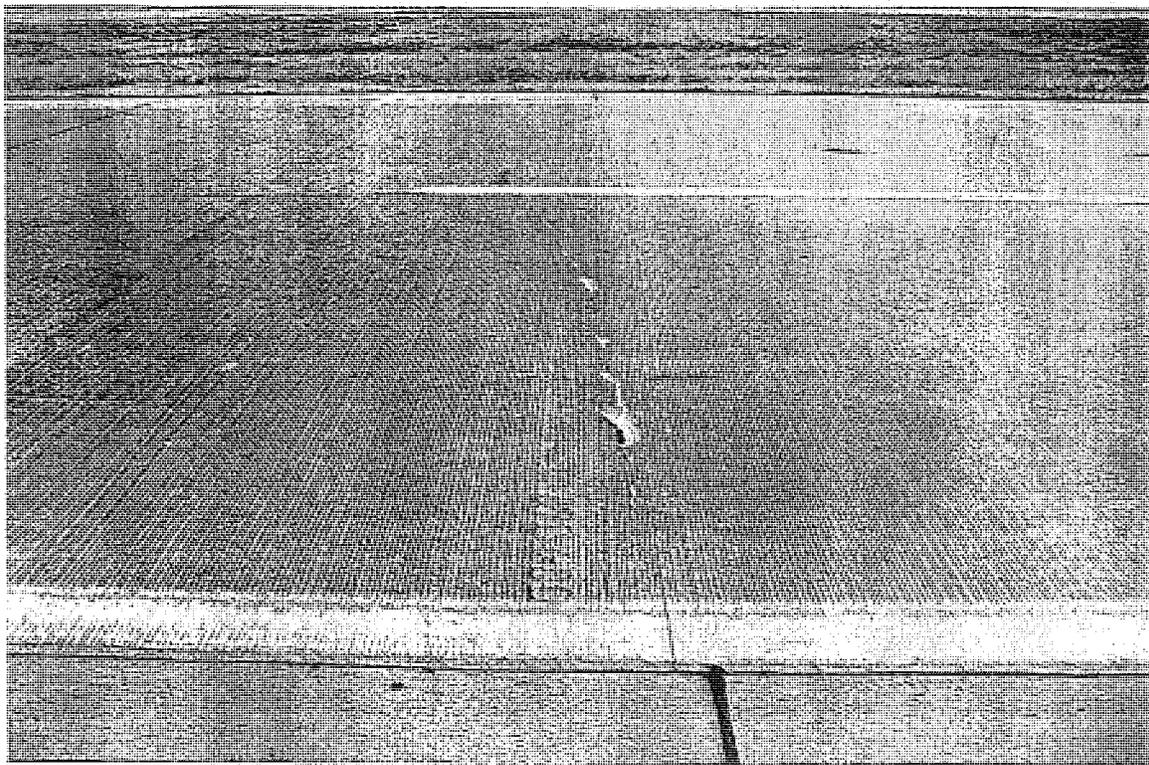
*Photo C34. A third point crack that is spalling on CSN# 44044-18804A WB.*

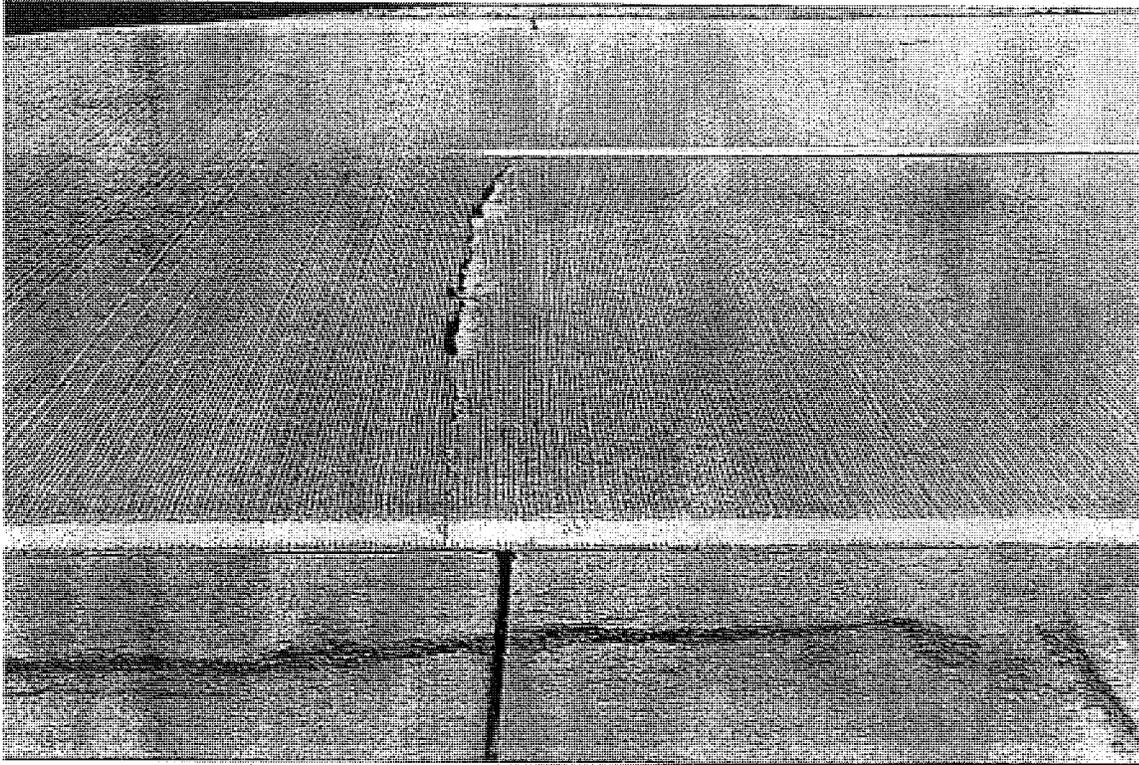
*Photo C35. A full width transverse crack on CSN# 44044-18804A WB. The crack is tight in the passing lane and is spalling in the truck lane. This crack, was induced by the intermediate shoulder joint.*

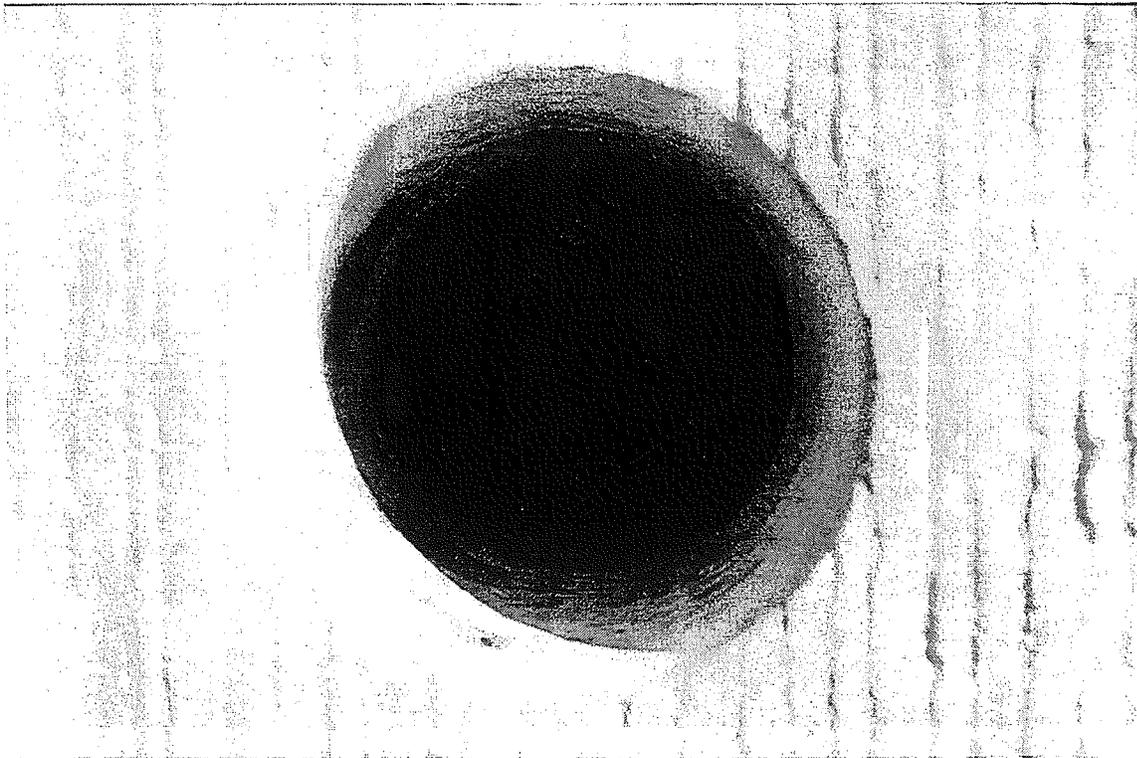
*Photo C36. A close-up of a corehole on CSN# 44044-18804A WB. showing the OGDC base course.*

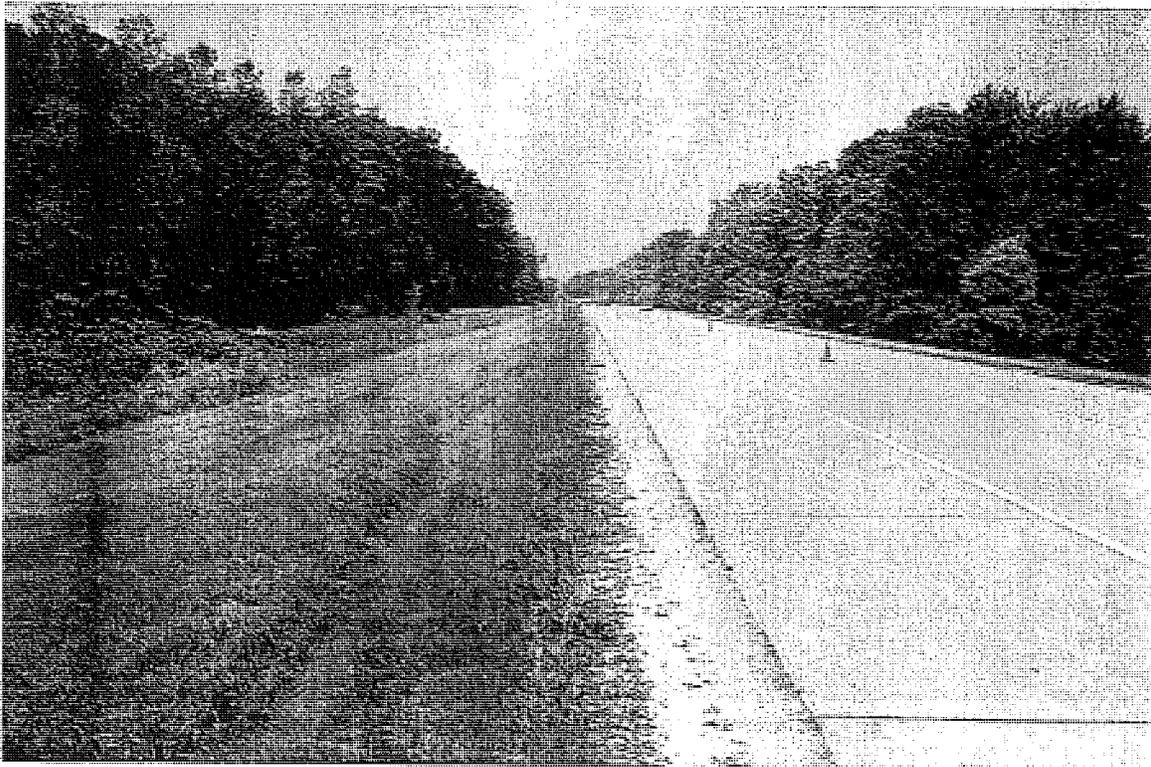
*Photo C41. An overview looking west showing intermediate shoulder joints on CSN# 77023-21586A EB. The slabs in the driving lanes are 41 ft long.*

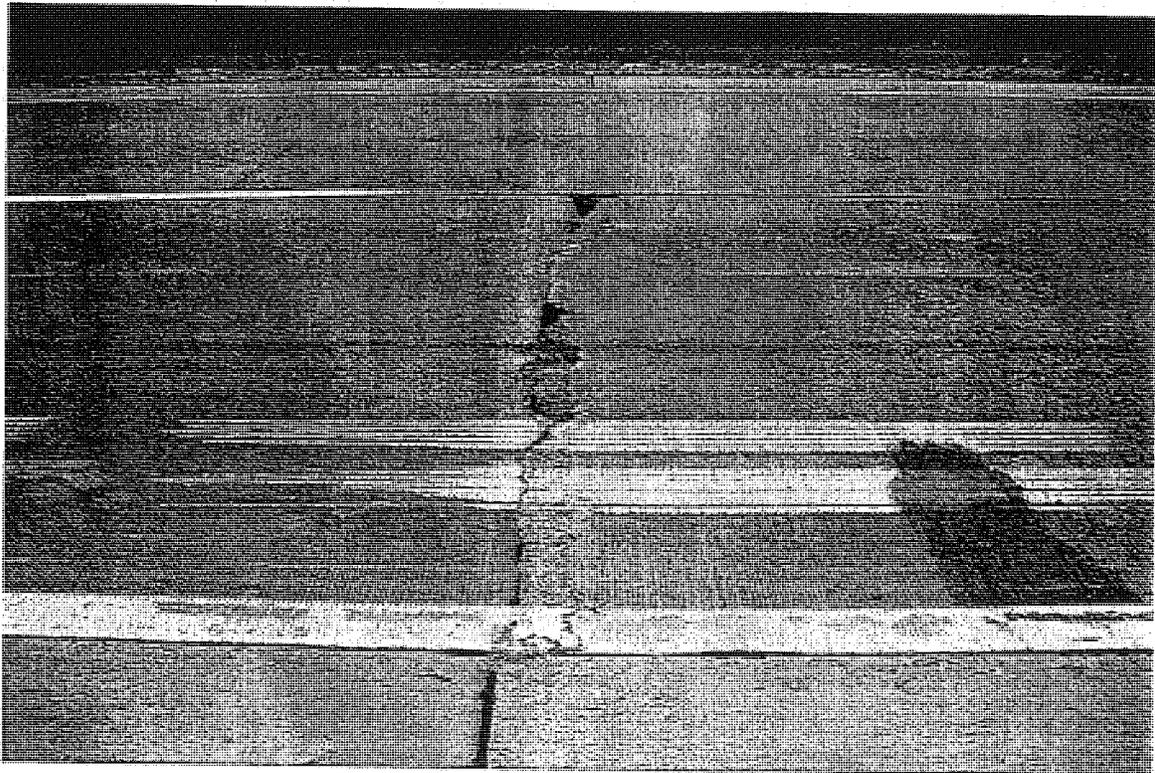
*Photo C42. A transverse crack at a third point intermediate shoulder joint on CSN# 77023-21586 EB. Severe spalling is present in the truck lane and has been cold patched.*

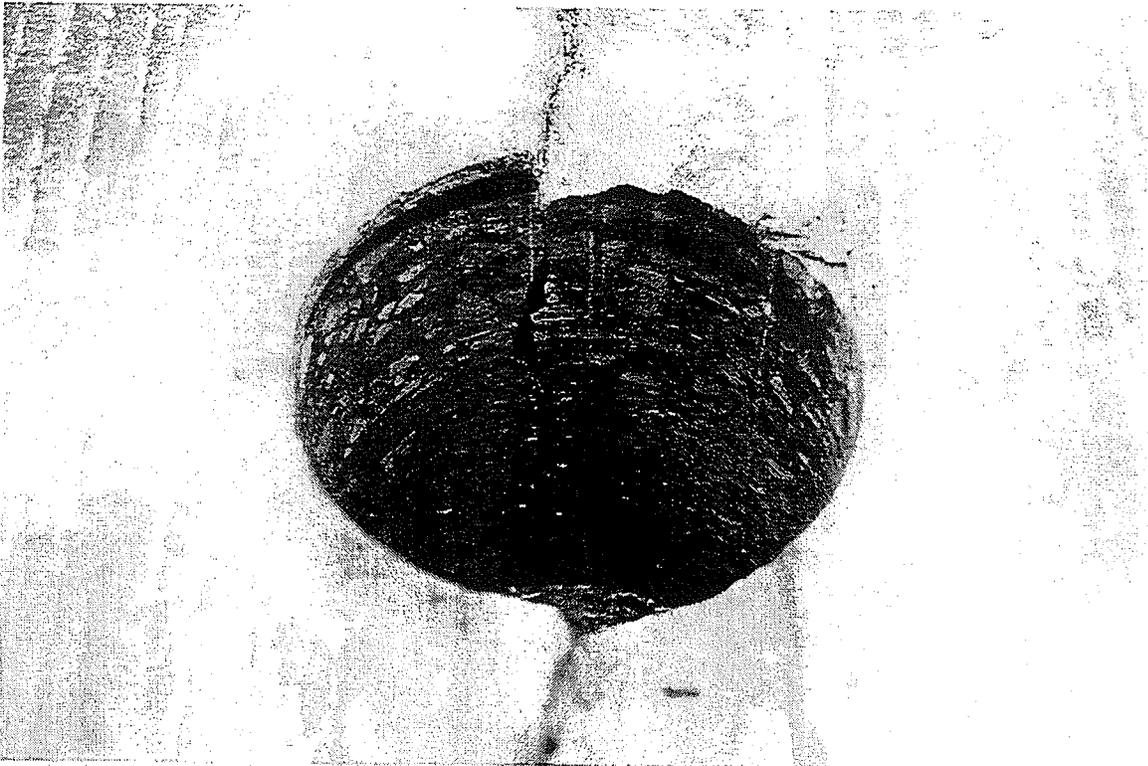
*Photo C43. A core hole showing the effects of severe faulting and spalling on the crack faces of a transverse crack on CSN# 77023-21586A EB.*

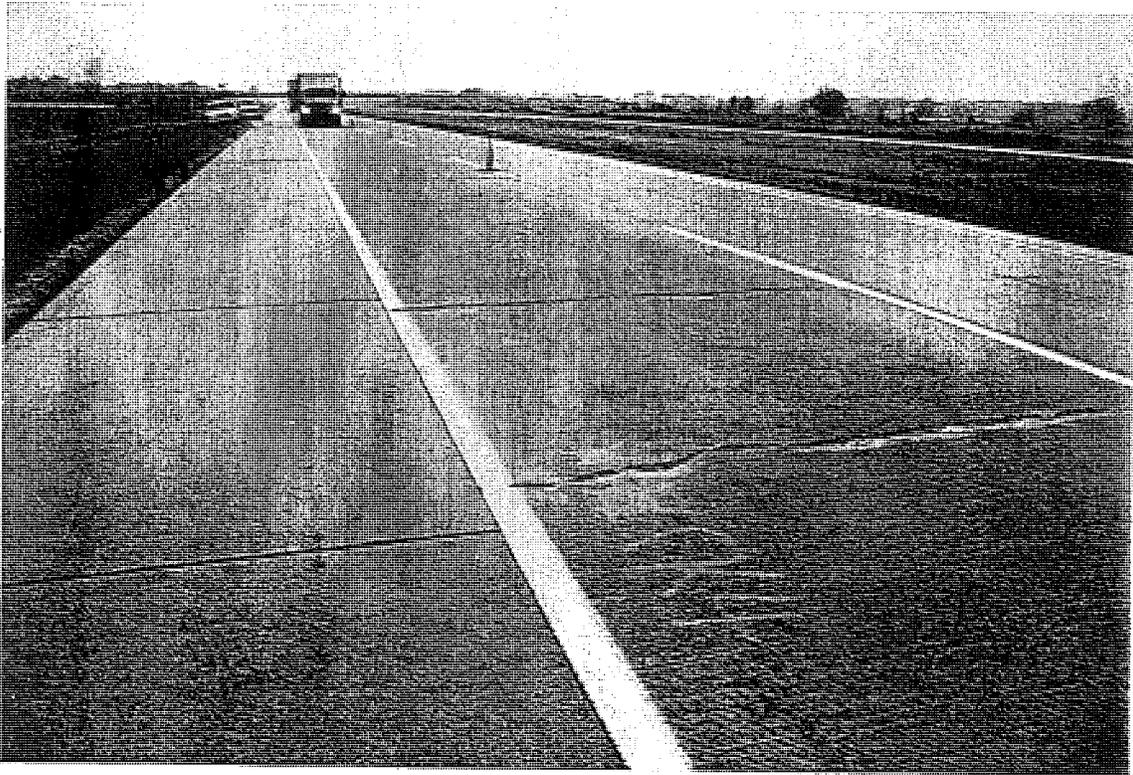
*Photo C45. An overview of CSN# 77024-20821A (Section A), EB, showing severely spalled and faulted cracks at third point shoulder joints. The joint spacing in the driving lanes is 41 ft.*

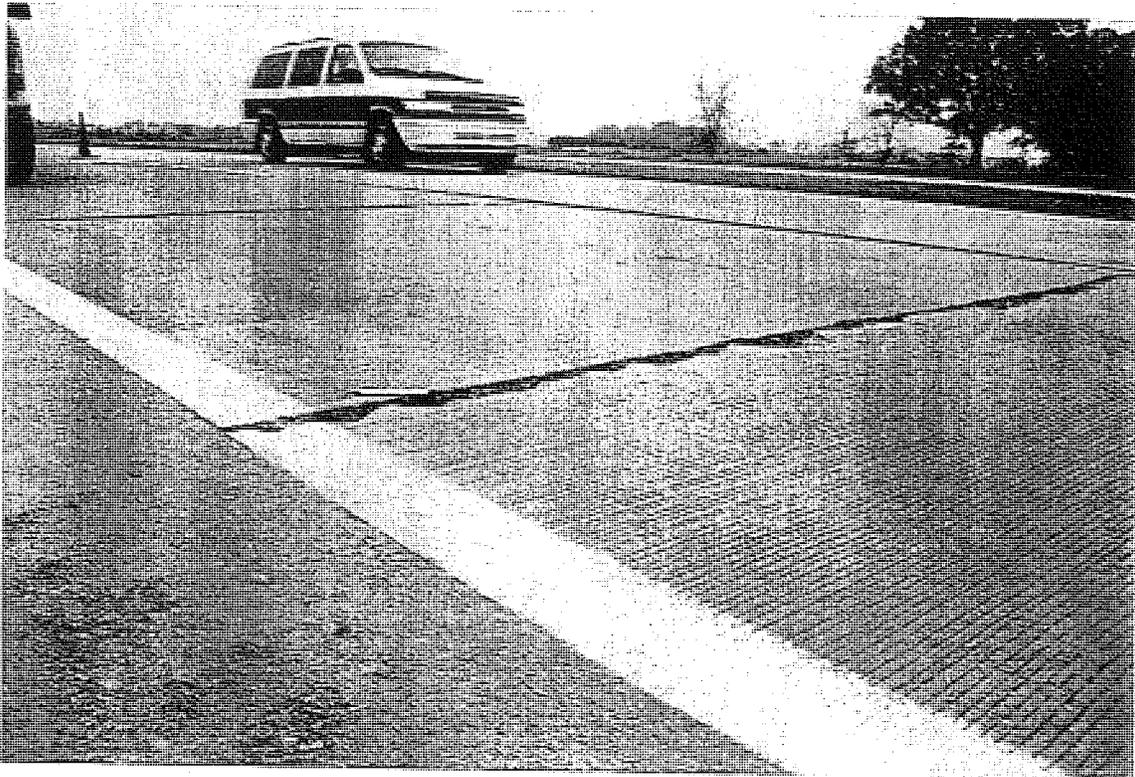
*Photo C46. A severely spalled and faulted transverse crack in CSN# 77024-20821A (Section A), EB.*

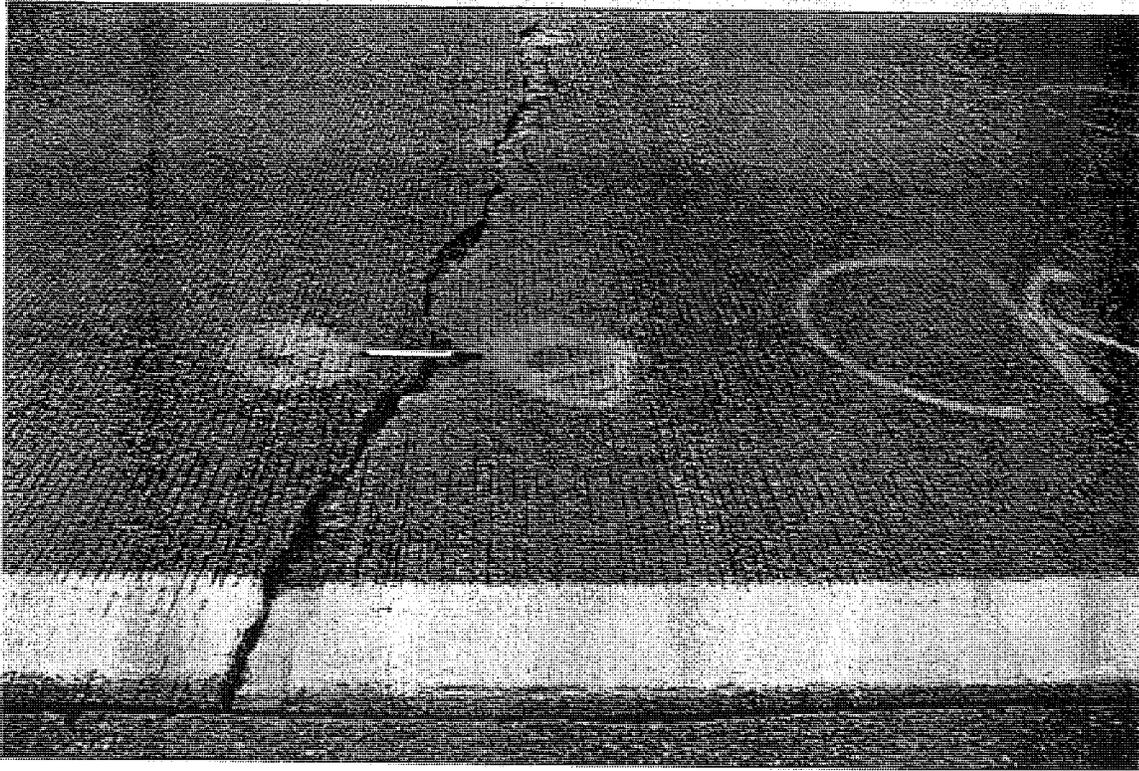
*Photo C47. A typical transverse crack on CSN# 77024-20821A (Section A), EB, showing severe spalling and faulting.*

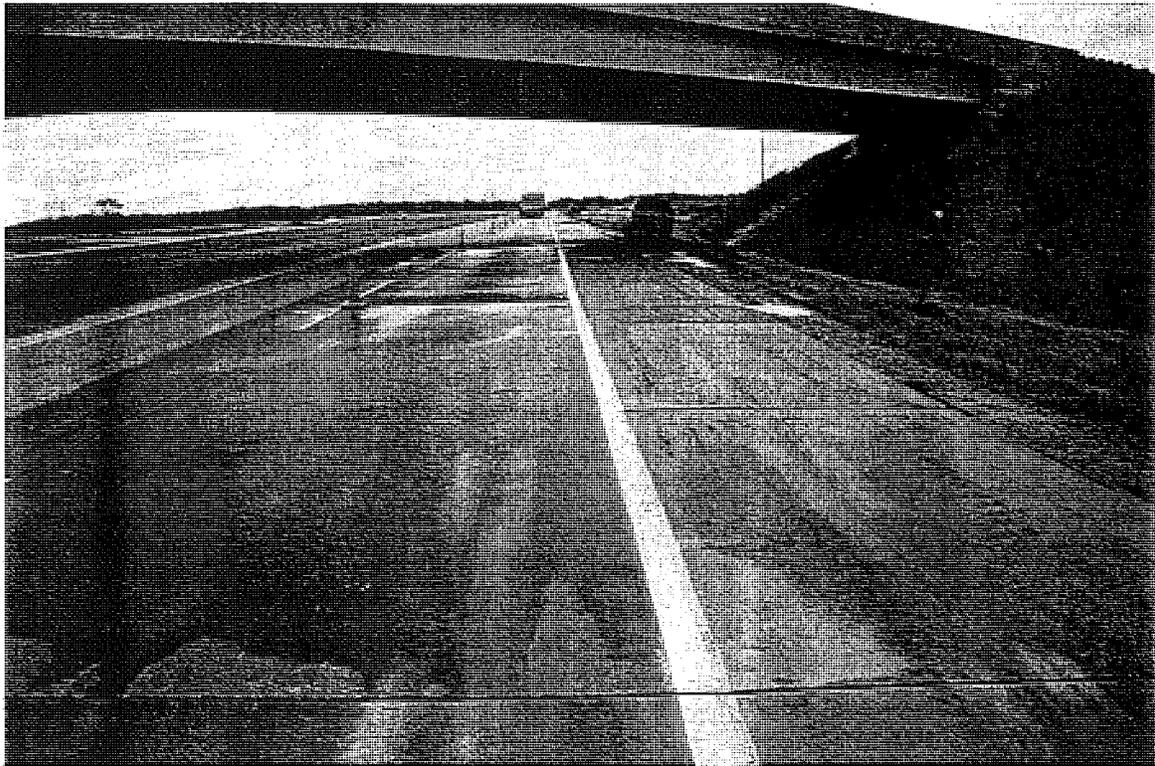
*Photo C49. An overview looking east on CSN# 77024-17988A (Section B), EB. The third point intermediate shoulder joints can be seen. Slabs are 41 ft long in the driving lanes.*

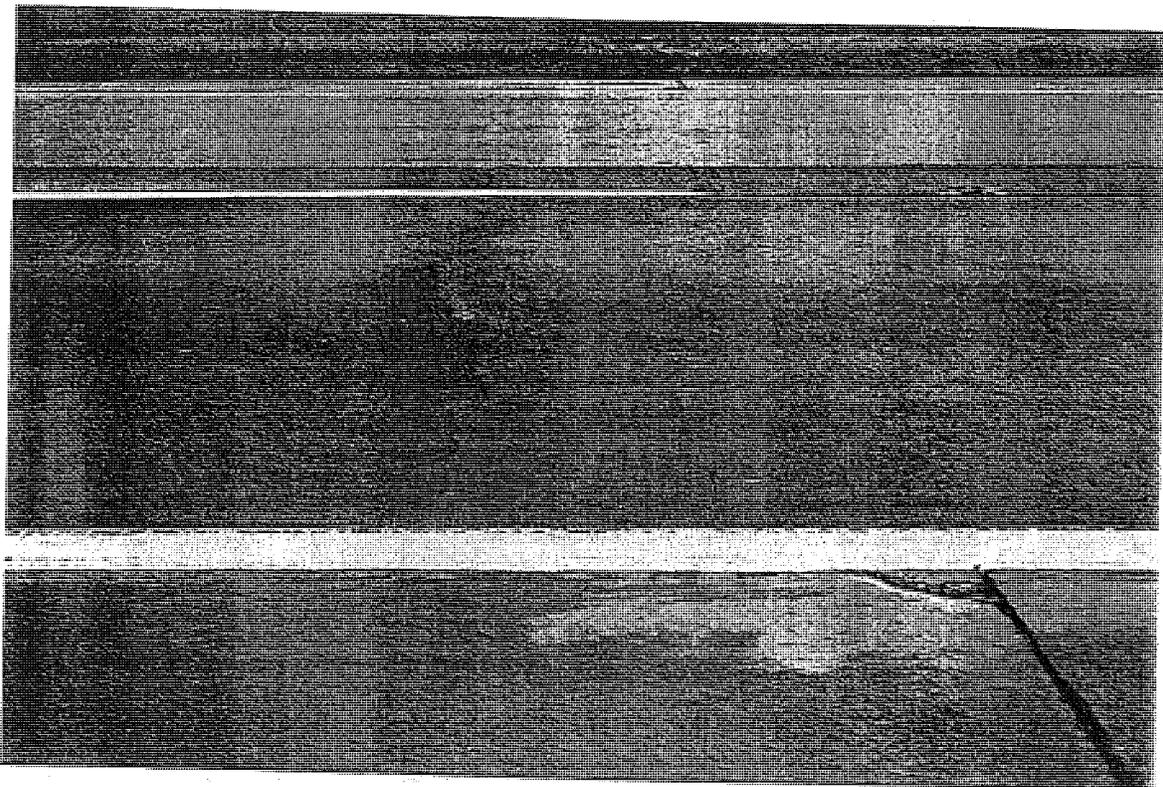
*Photo C50. A typical third point transverse crack on CSN# 77024-17988A, (Section B), EB. The beginnings of spalling are visible here.*

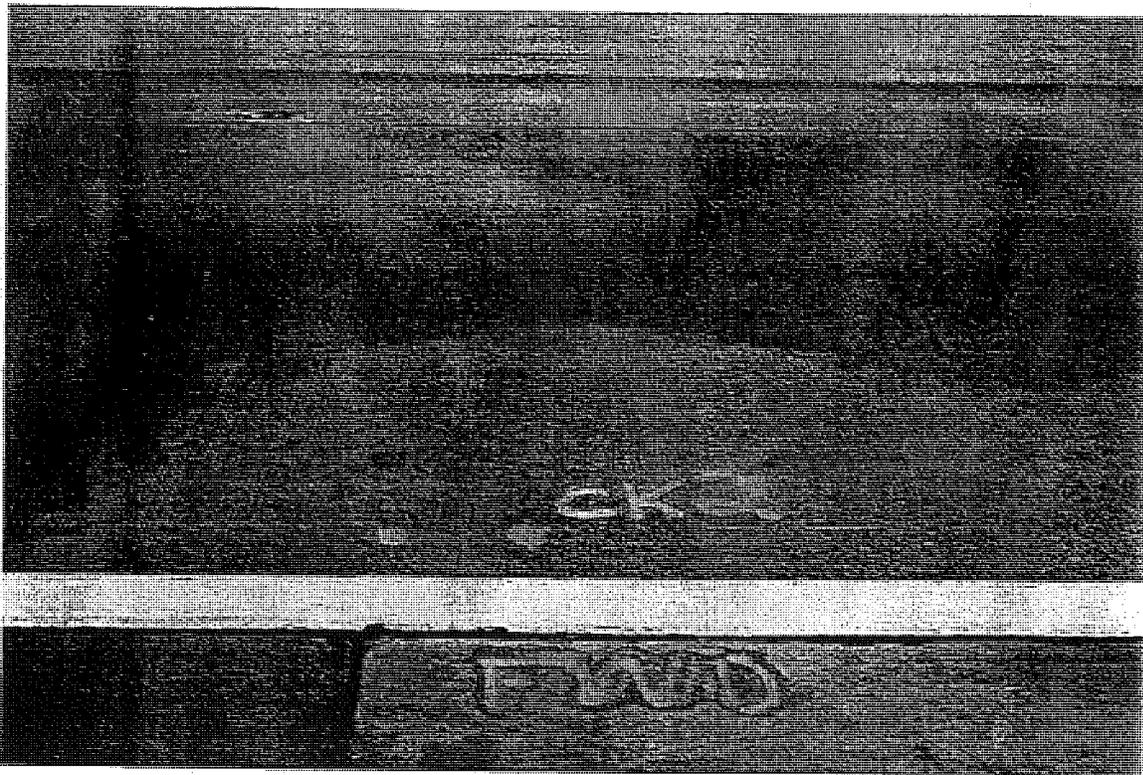
*Photo C51. A tight transverse crack induced by the intermediate shoulder joint on CSN# 77024-17988A, (Section B), EB.*

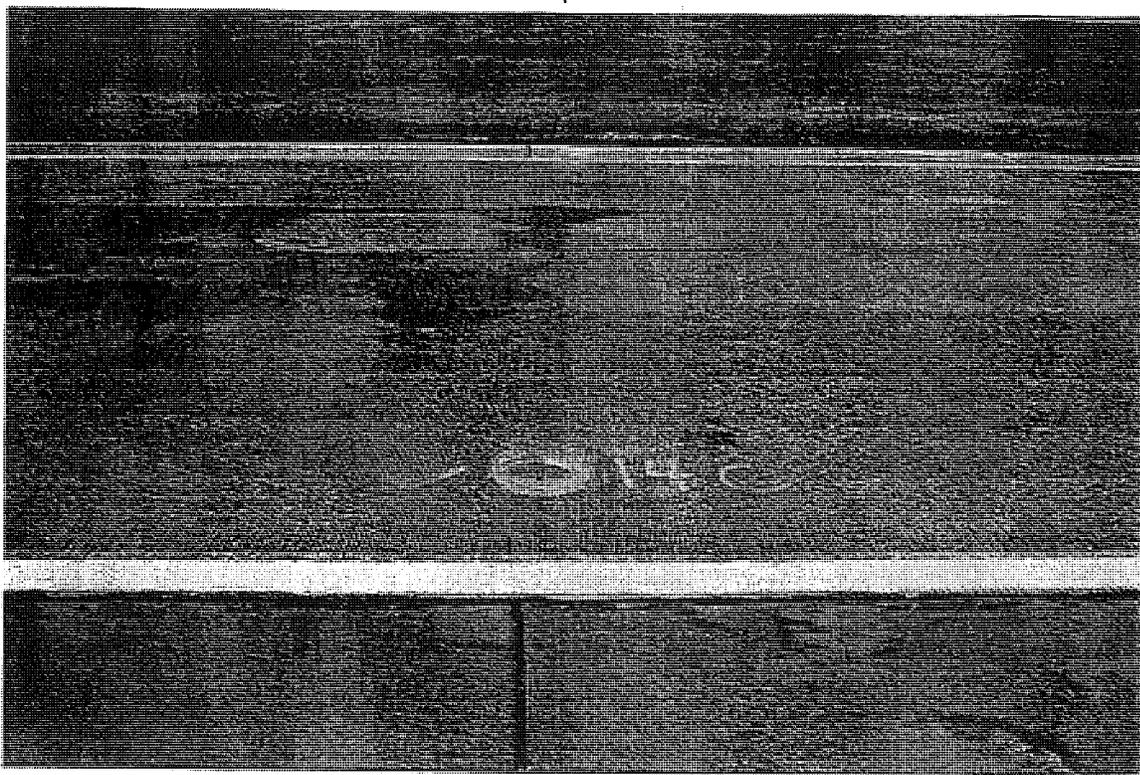
*Photo C52. A typical transverse crack on CSN# 77024-17988A, (Section B), EB. Showing the location of core 14.*
