11.0 Performance Evaluation of Partial Depth Repair Materials (Task 11)

11.1 Introduction

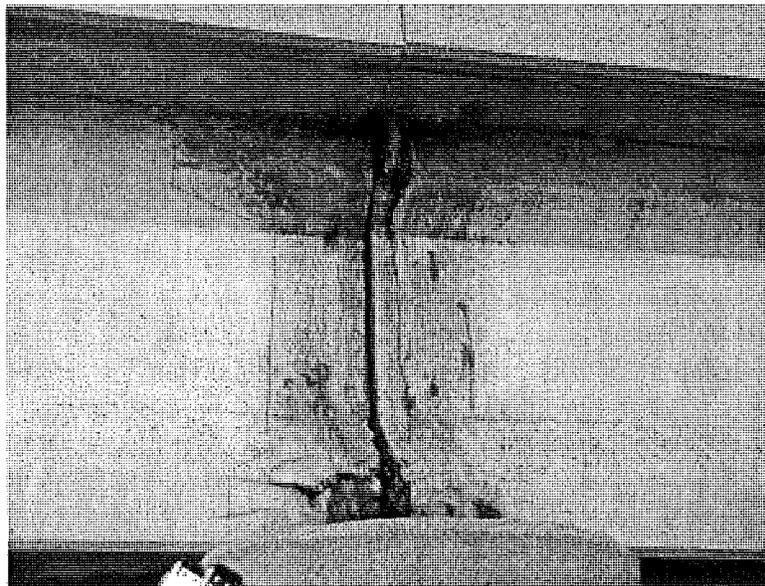
Corrosion induced deterioration has been identified through field investigations as the major cause of beam end distress for I-beams in Michigan bridges. The resulting forms of distress include concrete spalling, delamination, cracking, and corrosion of reinforcement. The loss of concrete permits accelerated deterioration of reinforcing and prestressing steels, allows detensioning of prestressing steel, and increases the stress demand (bearing, shear, flexural) on the remaining section (see Photo 11-1).

Photo 11-1. Typical beam-end deterioration

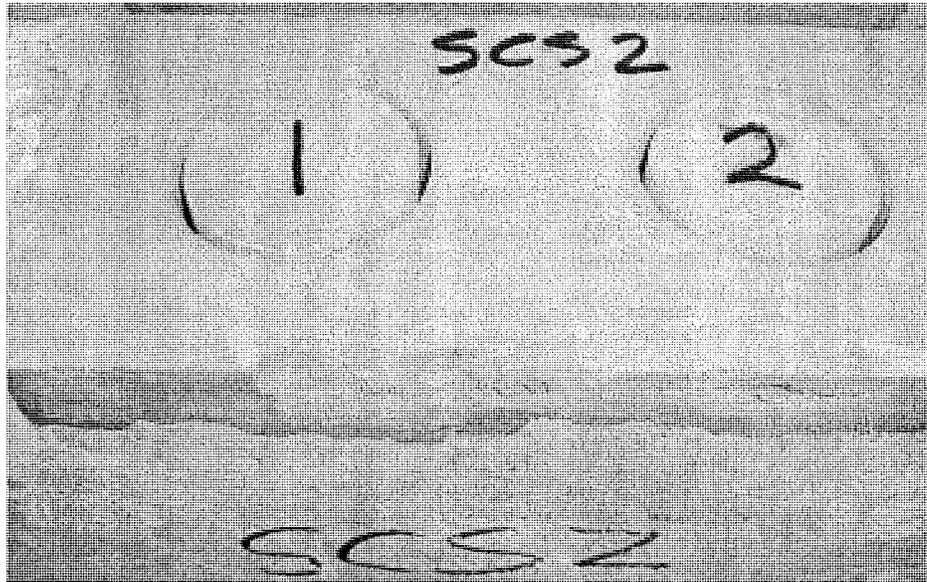
Specimens SCS2, SAS1, SAS2 had signs of edge spalling along the length of the repairs (see Photo 11-25, note that the specimens have been drilled for bond tensile strength testing). Additionally, specimens SCS1, SCS3, SAS2, and DCS3 exhibited diagonal cracking along the long repair edge of the finished face. Both of these distresses are possibly due to early form removal and/or insufficient release agent on the repair formwork that was noticed after form removal.

Photo 11-25. Typical edge spalling on repair specimens

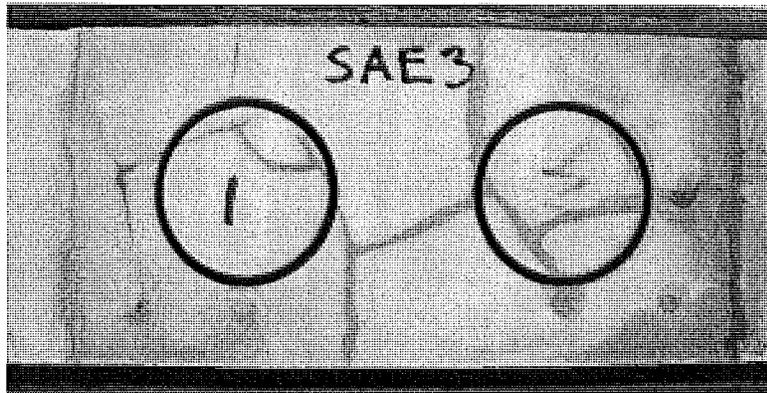
Thirteen specimens were repaired with Brand Y repair material. Most developed pattern cracking at roughly three weeks after installing the repair materials. Deep and shallow repairs made with the Brand Y material exhibited fine openings on the concrete surface that were generally parallel and normal to the length of the specimen (see Appendix H of Kasper, 2002, and Photo 11-26). Pattern cracking on the order of 2 to 3 mils in width was observed on 12 of the 13 specimens that were repaired with Brand Y material. Estimation of crack width was made using a hand-held crack comparator. An example of typical pattern cracking observed is shown in Photo 11-26. Cracks in Photo 11-26 were wetted with water to better show their presence. Reasons for pattern-cracking formation are not specifically known, however, mix proportions (dry to liquid component) and mixing time were similar between specimens that exhibited cracking and the specimen that did not crack.

Photo 11-26. Typical pattern cracking observed on Brand Y specimens

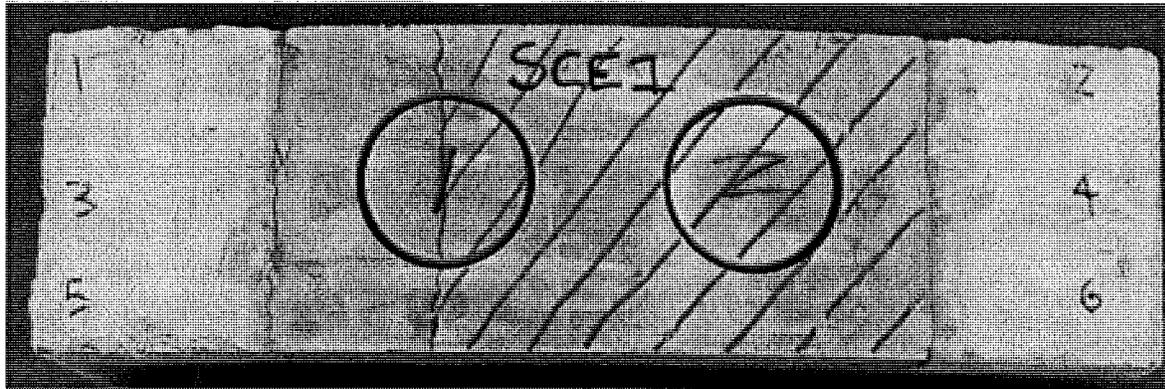
Acoustic impact testing was performed to assess the presence of delamination between the repair mortar and concrete substrate. Delaminations were revealed through the testing on 2 of the 6 Brand Y material shallow repair specimens and are shown as hatched areas on Photo 11-27 and Photo 11-28.

Photo 11-27. Hatched, delaminated region of specimen SCE1

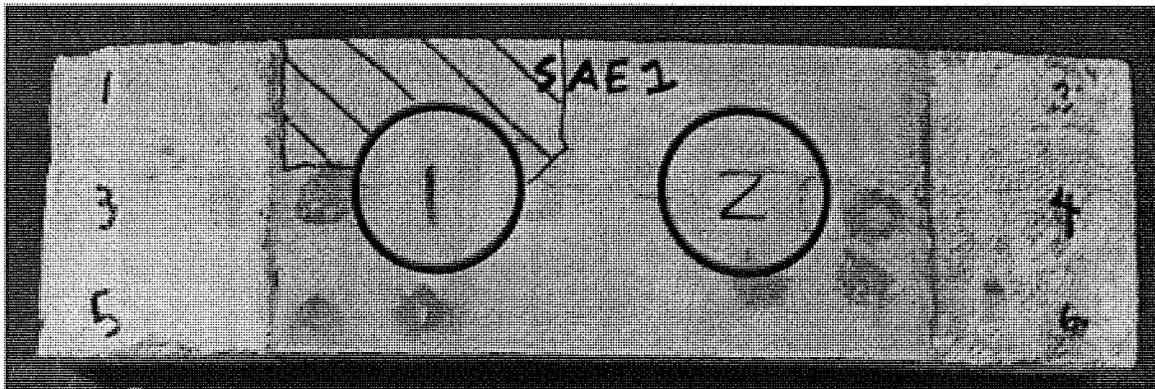
Photo 11-28. Hatched, delaminated region of specimen SAE1

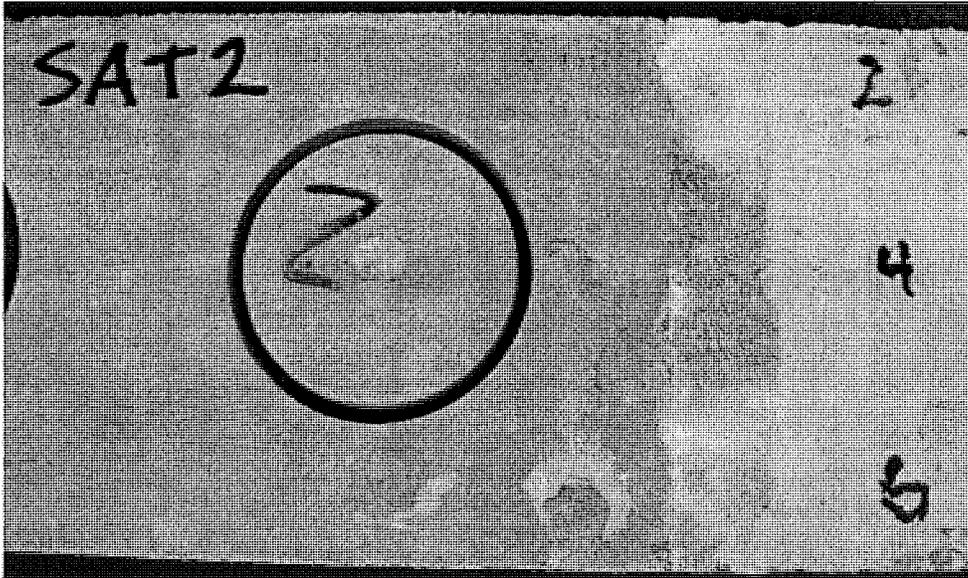
Similar to other repair materials, half of the Brand Z deep repair specimens exhibited sagging of the repair mortar. The bottom 4-in of repair area for specimens DAT 2 and DAT3 as well as the upper 4-1/2-in of the top half of the bottom lift of specimen DAT1 exhibited the sagging. Sagging is likely attributed to excessive weight of the plastic mortar on the lower regions of the repair, prior to these lower regions attaining sufficient set to support the plastic mortar above it.

Photo 11-29. Typical white precipitate leaching from the bottom repair-substrate joint

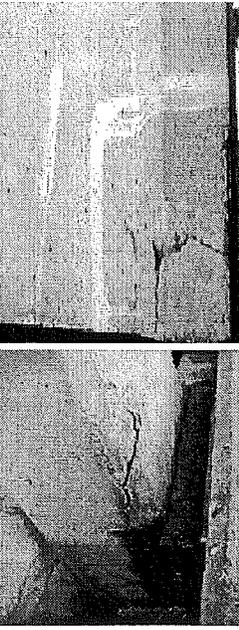
<p>4 -POOR CONDITION</p>	<ul style="list-style-type: none"> ▪ Environment Modification Methods ▪ Partial Depth Beam Repair (<i>Concrete Removal, Concrete Surface Preparation, Reinforcement Cleaning, Reinforcement Surface Preparation, Partial Depth Patching</i>) ▪ Chip and Overcast procedure used by MDOT R-1373 and RR-1380. ▪ Replacement of the superstructure and substructure elements
<p>12</p> <p>Spall, exposed reinforcement and corrosion</p>
