**APPENDIX B**  
**UPDATED**  
**KENT COUNTY GEOLOGIC**  
**STABILITY STUDY FOR THE**  
**JOHN BALL ZOOLOGICAL**  
**GARDEN EXPANSION WEST OF**  
**I-196**

Investigation of the Surface Stability Above  
the Former Domtar Industries, Inc. Gypsum  
Mine Located in Grand Rapids, Michigan

Prepared by  
Stan Vitton, Ph.D., P.E.  
Associate Professor  
Michigan Technological University  
Houghton, Michigan 49931

*Submitted:* September 18, 2002  
*Updated:* February 27, 2004

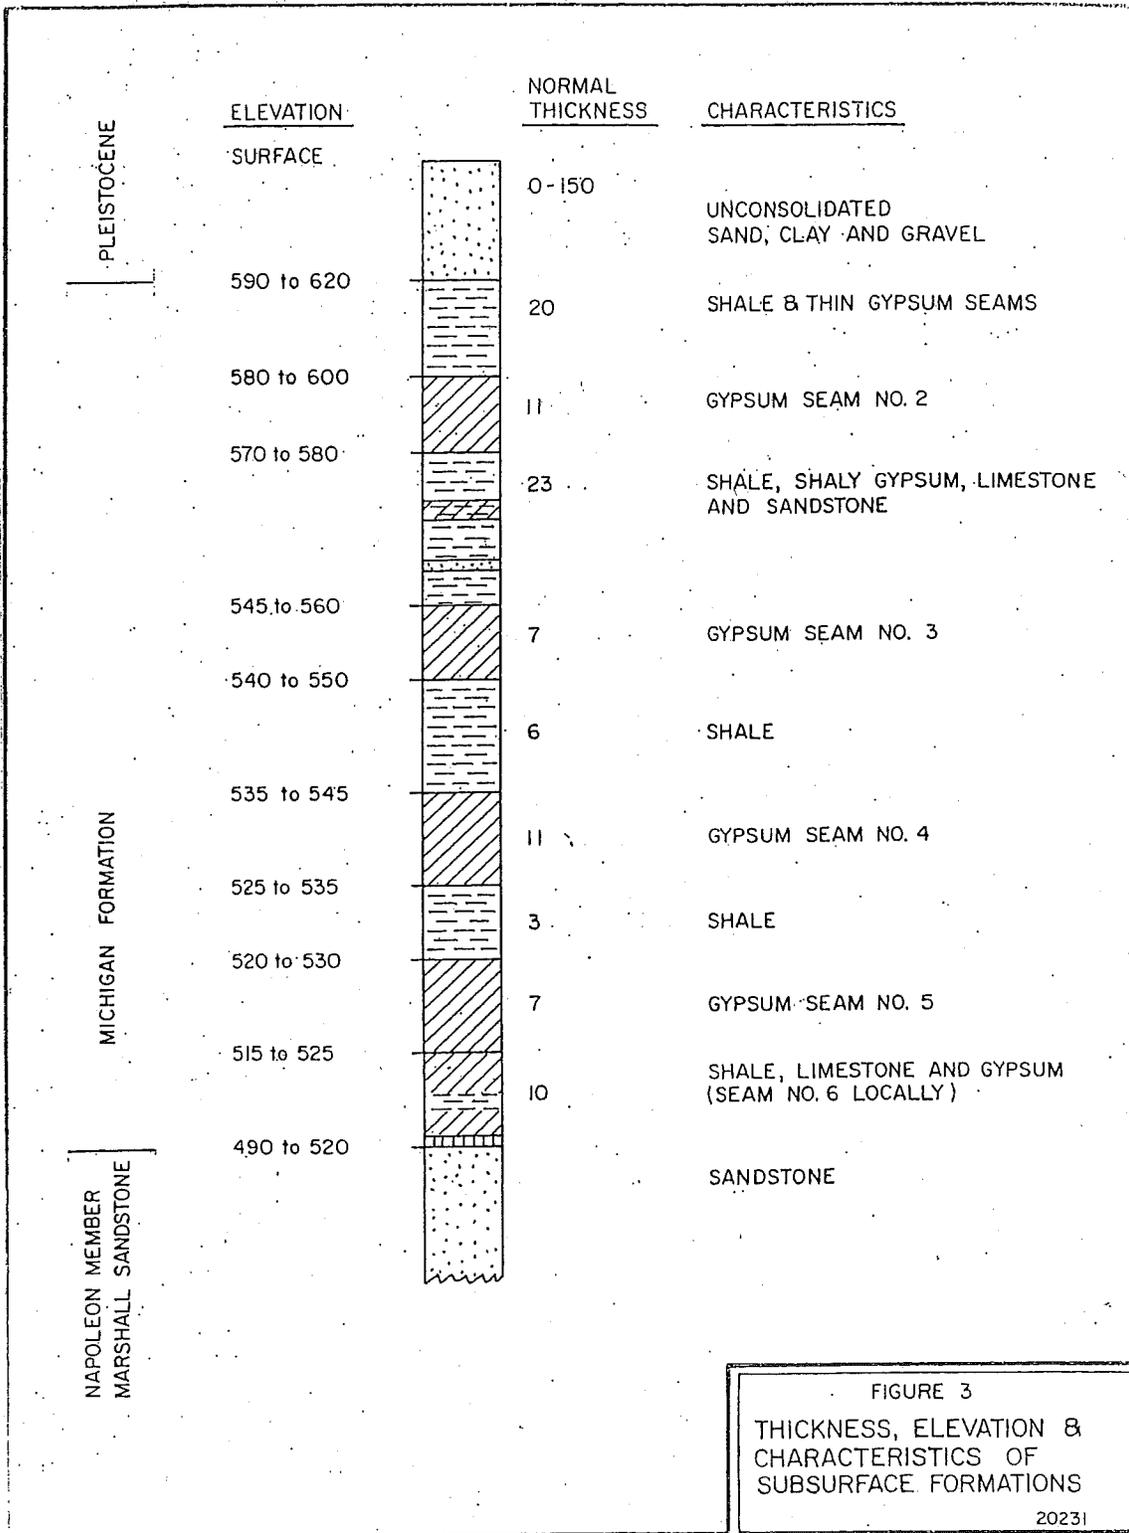
Figure 2 Thickness, elevation and characteristics of the subsurface formations at the Domtar Mine.

- Feature 1: The glacial overburden varies from zero to 150 feet in thickness over the Domtar mine. While the unconsolidated soil consists of some clays and silts, the glacial overburden provides the main source of water that infiltrates the mine. Due to the unconsolidated nature of the overburden, it can be assumed that its full weight or pressure is applied to the roof rock of the mine and that its effective pressure will vary with the rise and fall of the water table level, which is located within the overburden. By most mining standards, this is a relatively shallow mine and the pressures will probably not exceed 140 pounds per square inch (psi), assuming a fully saturated overburden at 135 lbs/ft<sup>3</sup>.

- Feature 4: The bedrock between the unconsolidated overburden and the #2 seam forms the roof rock over the #2 seam. As shown in Figure 2, the average thickness of the roof rock is about 20 feet. However, five drill holes from a 1963 drilling program indicate that the roof rock thickness varies from a high of 35 feet in the north to seven feet at the northeast corner of the mine. Mine maps show that in the southern part of the mine the roof rock was very thin to absent, which precluded mining the #2 seam in portions of the south. A major sinkhole in the southern part of the mine can be correlated with the absence of the roof rock over the #2 seam. There was an additional drilling program in 1966, but this data was not available for inspection. In general, the roof rock tends to be thicker in the north center portion of the mine while thinning to the east, west and south. The primary control on the thickness of the roof rock is the amount of erosion that occurred during the advance and retreat of the glaciers and the action of the Grand River. The stability of the roof of the #2 seam is an important factor in the formation of sinkholes.

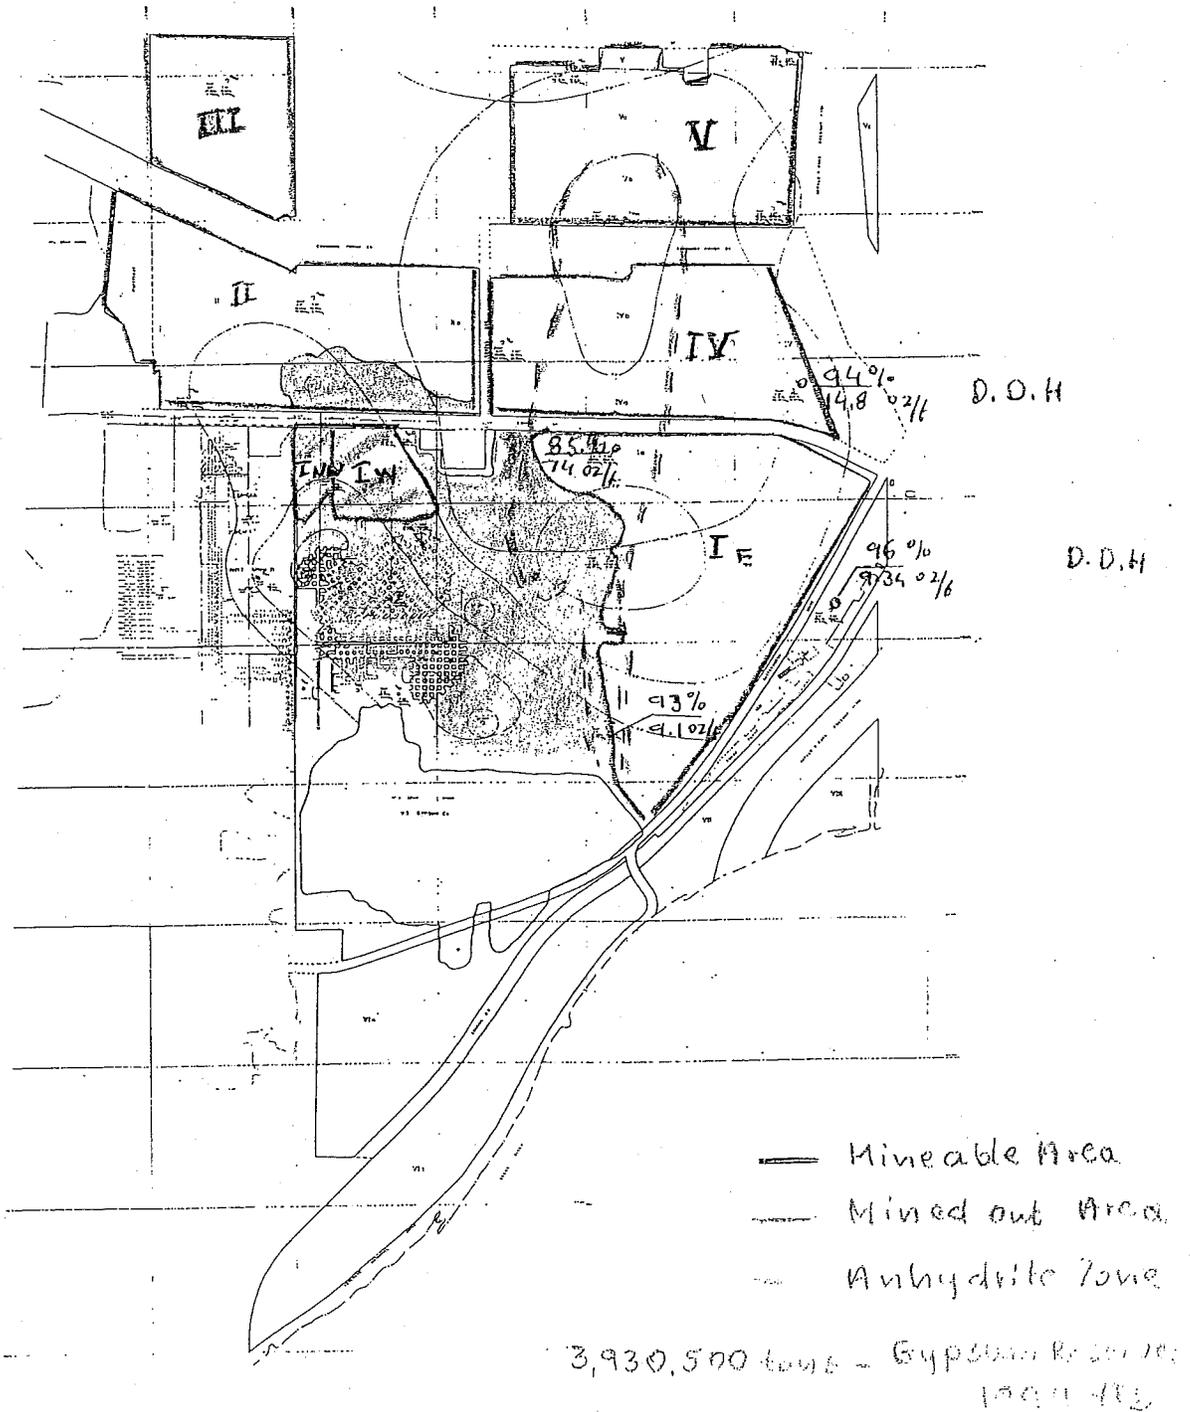
Figure 5. Domtar Mine 1999 gypsum reserve estimate map. Map shows the exclusion zone of mining around the CMS power line and I-96 in addition to the anhydrite zone located in the #4.

1. The mining at Domtar, in general, has been from the south in an area of low cover and short haulage distances, to the north with longer hauling distances. Figure 5 shows the areas of the gypsum reserves lying mostly north of O'Brien Street, with some limited reserves south of O'Brien on the east side of the Domtar property.

3. Only a small portion of the #4 seam was mined below the proposed Zoo site and from records reviewed none of the #5 seam was mined.
4. Although the #2 seam has been mined under the CMS power line and I-196, the 4 million ton reserve estimate excluded mining the #4 and 5 seams under both structures. The exclusion of the reserves under these structures can be seen in Figure 5.

6. An anhydrite zone is located in the #4 seam as shown in Figure 5. Anhydrite, although a calcium sulfate as is gypsum, does not have water in its structures and is unusable for plaster board or other products that gypsum is used in. Consequently, this zone, which occurs in the upper portion of the seam, had to be excluded in the mining process. This significantly altered the mining of the #4 seam. A system known as "bi-level" mining was implemented to mine the base of the #4 seam and the #5 seam together, thus mining underneath the anhydrite zone. The 1996 memo in Appendix D provides the only map that was found showing the area where bi-level mining took place. The bi-level mining area was approximately 300 feet south of O'Brien Street starting on a line directly south of Covell Avenue and moving due east. It appears that the bi-level mining method is associated with surface disturbance and sinkhole development. However, the full extent of the bi-level mining activity at the mine was not determined in this investigation. It appears, though, that between 1996 and 1999 the bi-level mining continued due east working under the anhydrite zone. It does not appear that any bi-level mining occurred under the proposed Zoo extension site or was within 300 feet of O'Brien Street.

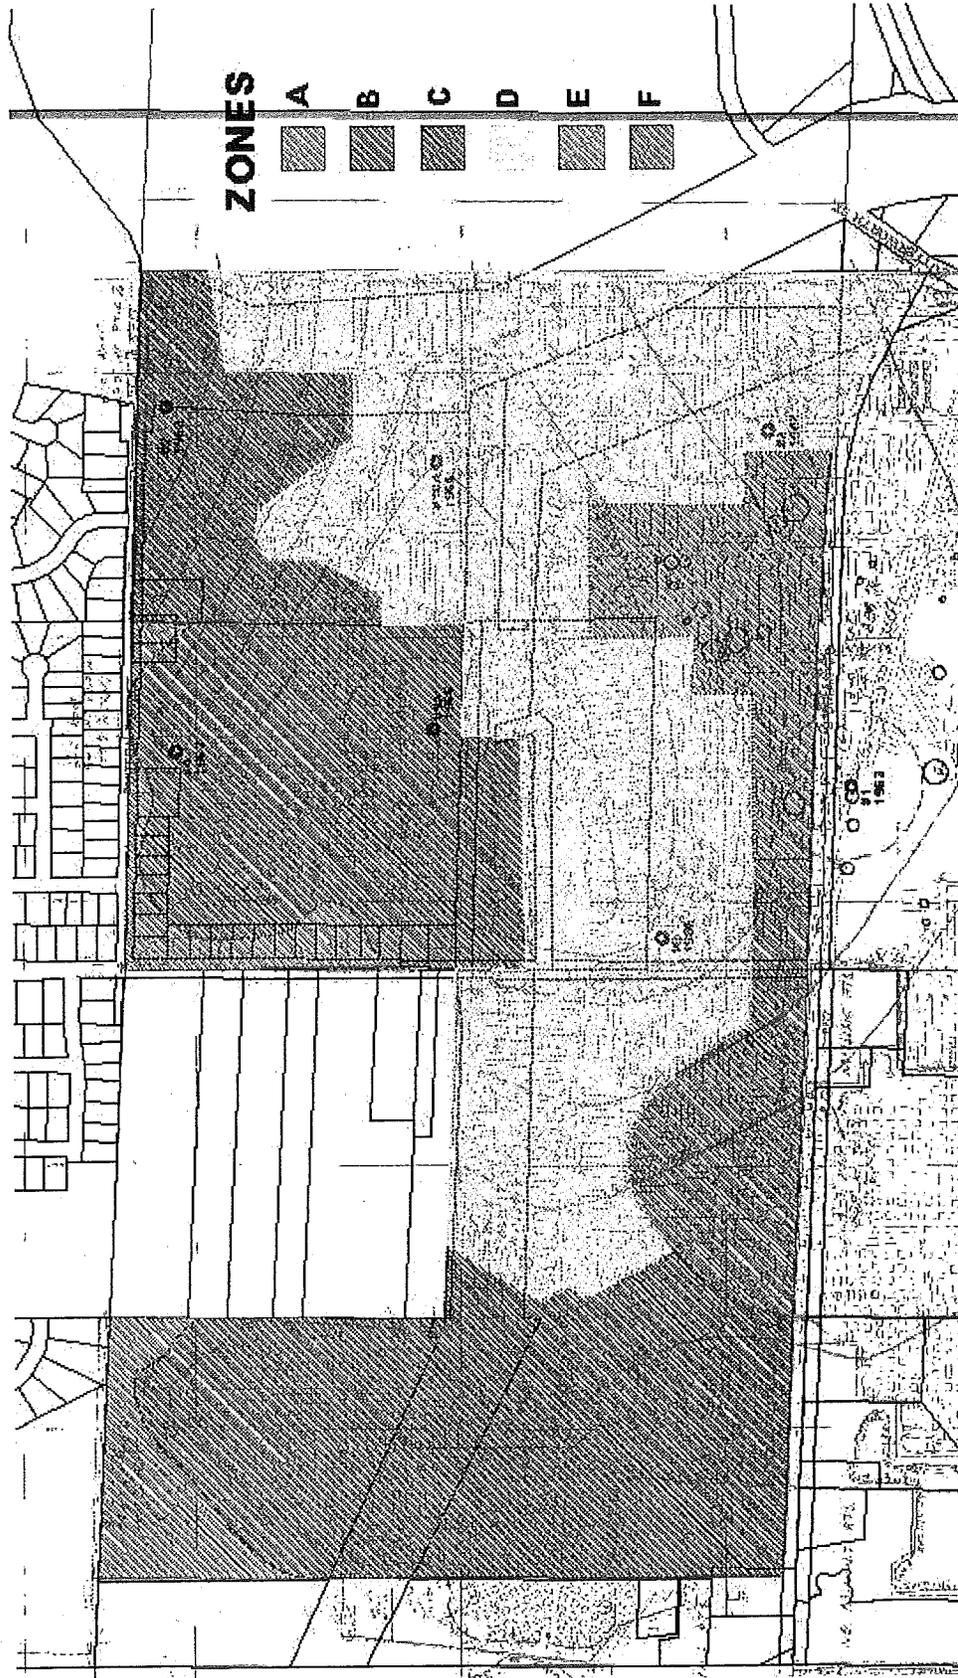
Figure 6. Map of Stability Zones.

**Zone A** - No gypsum mining has occurred in this zone. The stability of this zone is high and is outside any potential underground mining instability. The boundary of the zone is based on an angle of draw of thirty degrees, i.e., the limit of mining is an additional distance from this zone measured by a vertical angle of thirty degrees.

**Zone B** - Only the #2 seam has been mined in this zone and no evidence of sinkholes was found. It is assumed that the mining below this zone was relatively recent, occurring in the 1960s and 70's using systematic room and pillar mining methods. It is also based on no reduction (shaving) of pillars or pillar removal has occurred in this area. The roof rock appears to be relatively thick in this area and the floor rock appears stable. Therefore, short-term stability of this zone appears good. However, the issue of dissolution of the pillars over time must be considered, since decreasing stability may result if the pillar dimensions are reduced in size.

**Zone C** – Only the #2 seam has been mined in this zone and no evidence of sinkholes has been found. This zone has a less systematic mining method and with very irregular pillar shapes and sizes. It is not known why this type room and pillar method and orientation of mining was used. As with Zone B it is also assumed that no reduction (shaving) of pillars or pillar removal has occurred. However, the roof rock in this zone is significantly thinner and according to exploration borehole #3 is composed of only 5.5 feet of gypsum and 1.5 feet of shale. This is the only exploration borehole that showed the gypsum being in direct contact with the glacial overburden. However, no sinkholes or land subsidence are evident in this zone. While the short-term stability of this zone appears to be adequate, there are stability issues that increase the probability of future instability. Again, the issue of dissolution of the pillars over time must be considered, since decreasing stability may result if the pillar dimensions are reduced in size.
