PREVENTIVE MAINTENANCE OF CONCRETE PAVEMENTS

MICHIGAN DEPARTMENT OF STATE HIGHWAYS

J. E. Simonsen

Research Laboratory Section  
Testing and Research Division  
Research Project 72 F-123  
Research Report No. R-859

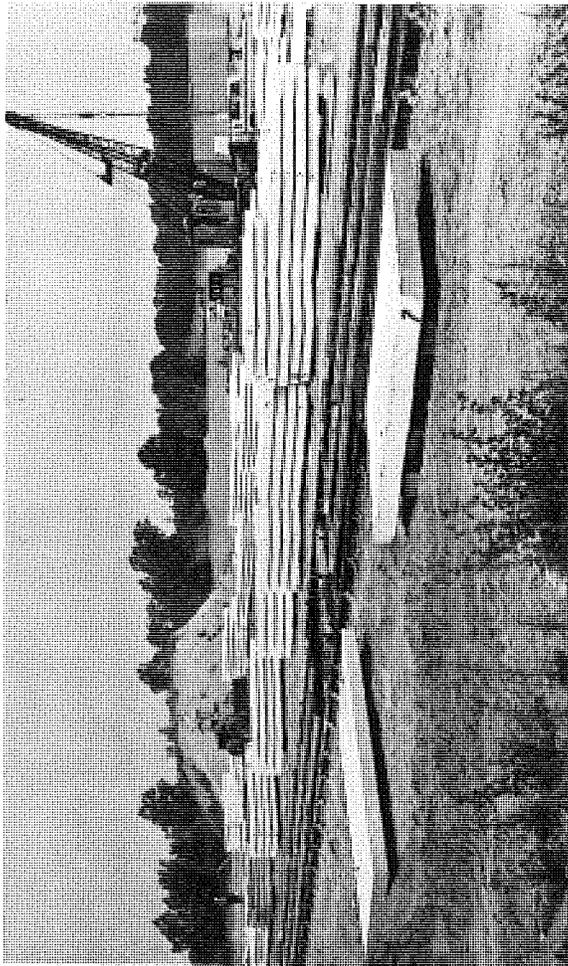
Figure 1. The slabs were cast at the contractor's yard on an I 75 job and transported to this project.

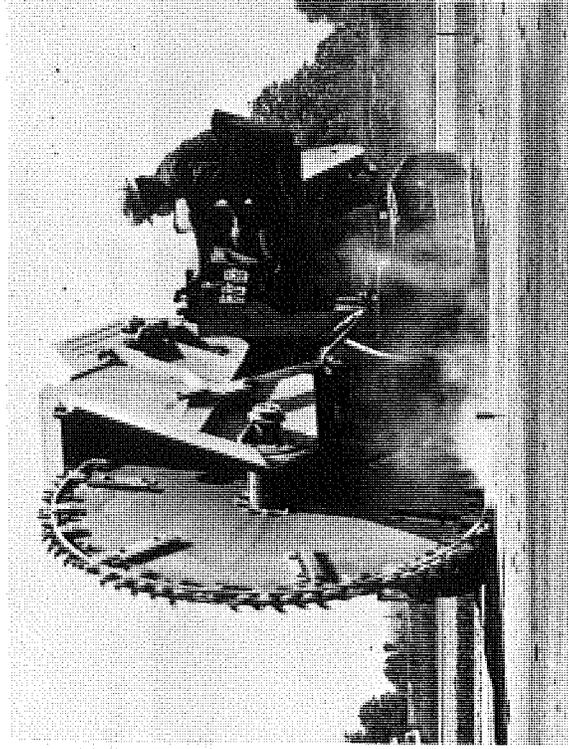
Figure 2. A Vermeer saw was used to make a relief cut in the area to be removed.

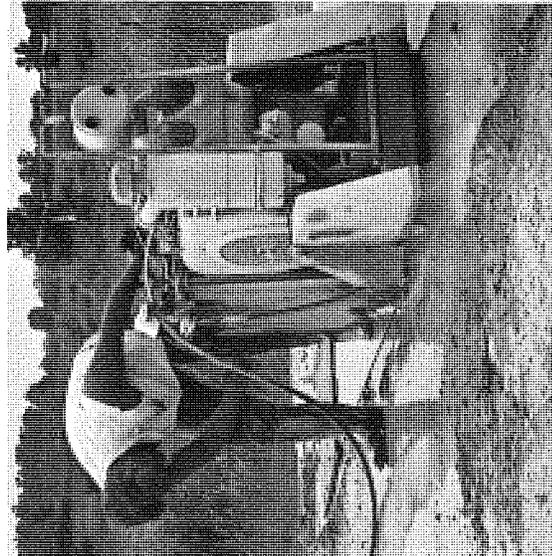
Figure 3. The repair limits were sawed full depth with a diamond blade saw.

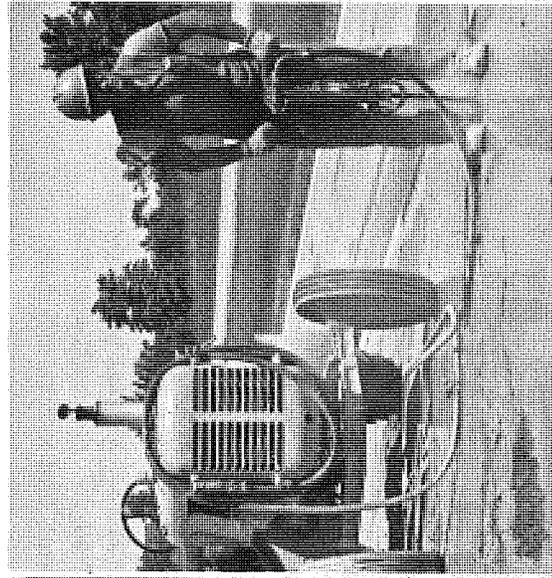
Figure 4. Holes were drilled through the slab for inserting lift pins.

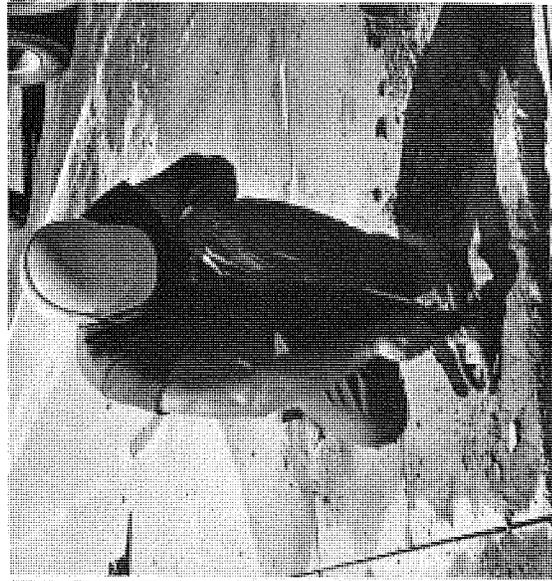
Figure 5. The lift pins were inserted in the holes.

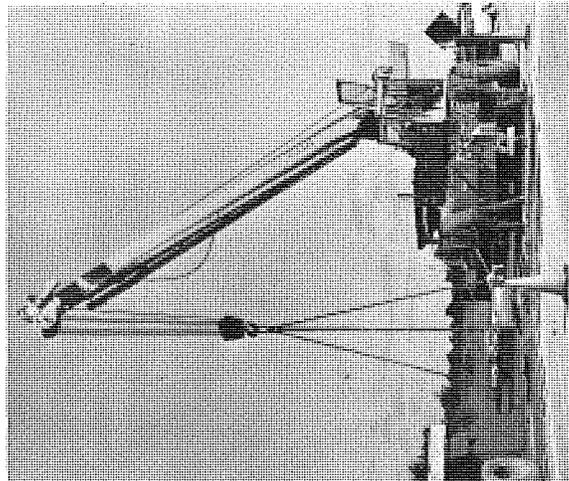
Figure 6. The deteriorated joint area was lifted out.

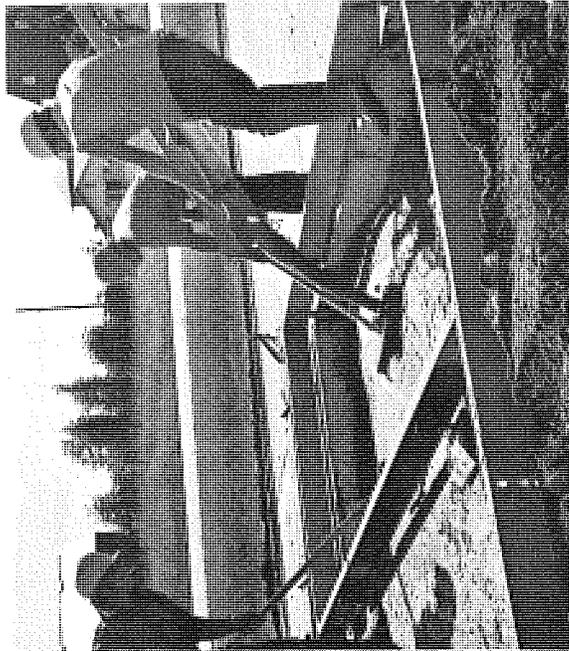
Figure 7. Mortar was poured and struck-off to the correct elevation by use of a frame and strike-off guide.

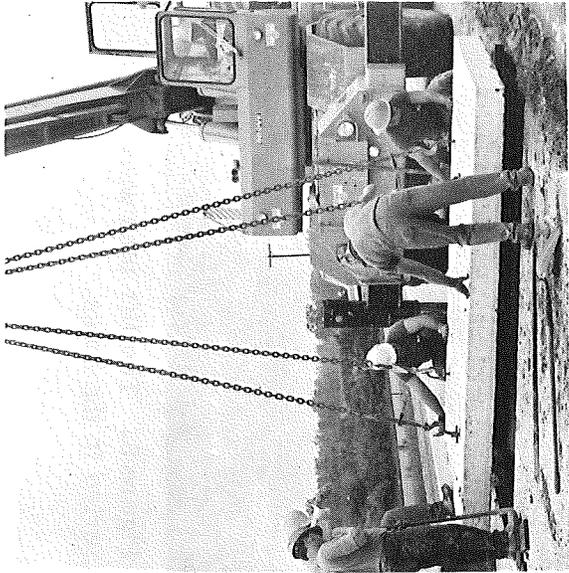
Figure 8. The precast slab is installed.

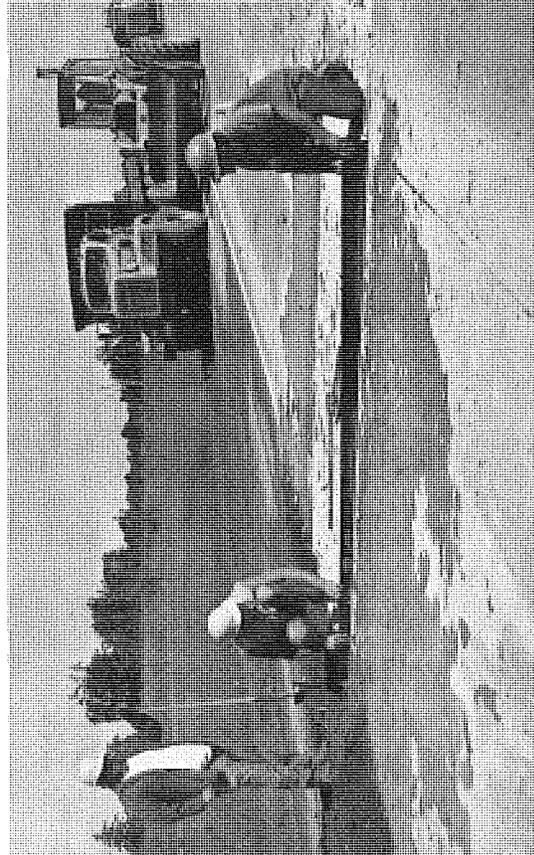
Figure 9. The bituminous filler is installed in the joint and, once in place, the joint is sealed.

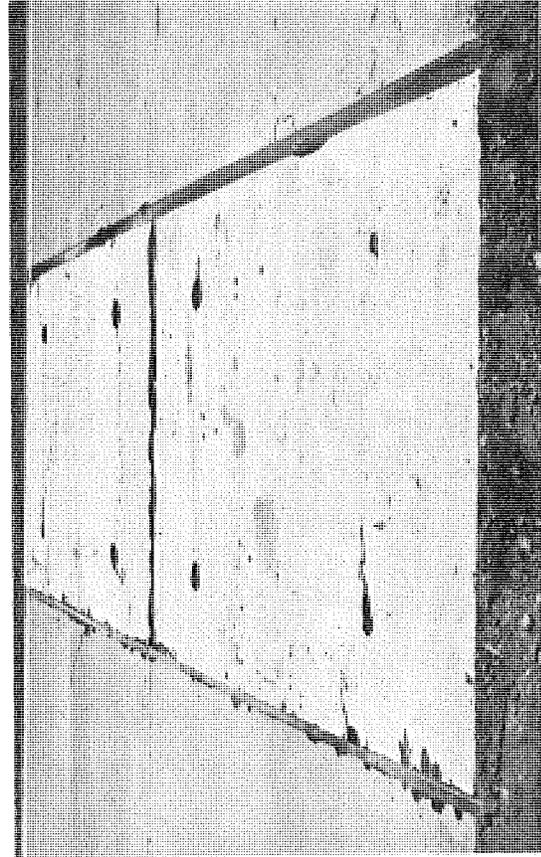
Figure 10. A completed precast slab repair.

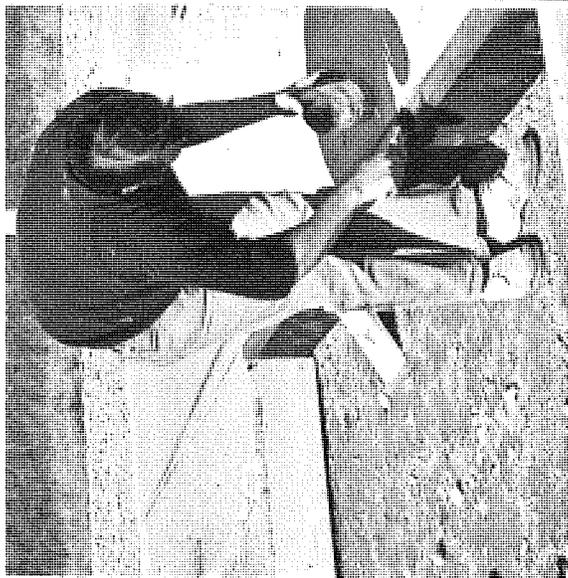
Figure 11. The sawing and removalal operations were the same as for precast slabs. Here the filler has been placed and the wood forming strip is being oiled.

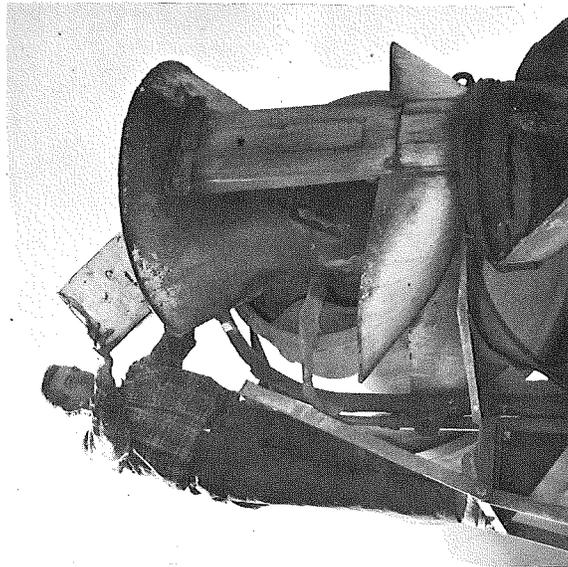
Figure 12. The  $\text{CaCl}_2$  was added to the mixer at the site just prior to pouring.

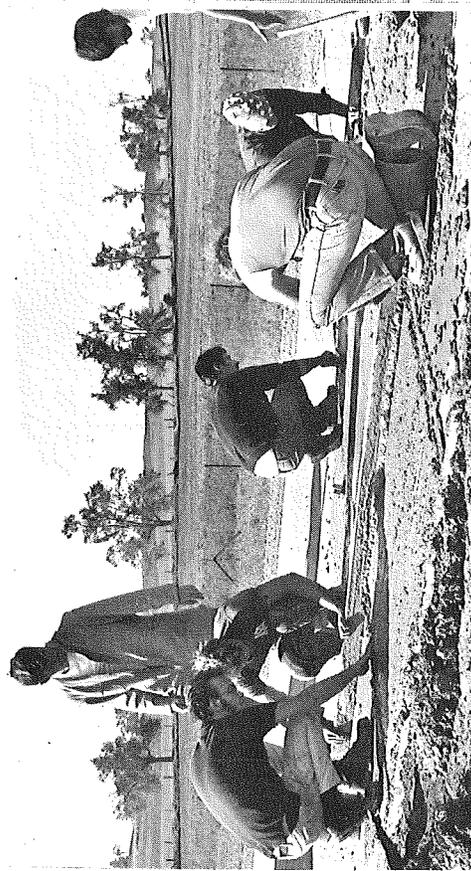
Figure 14. The concrete is struck-off to height of existing slab.

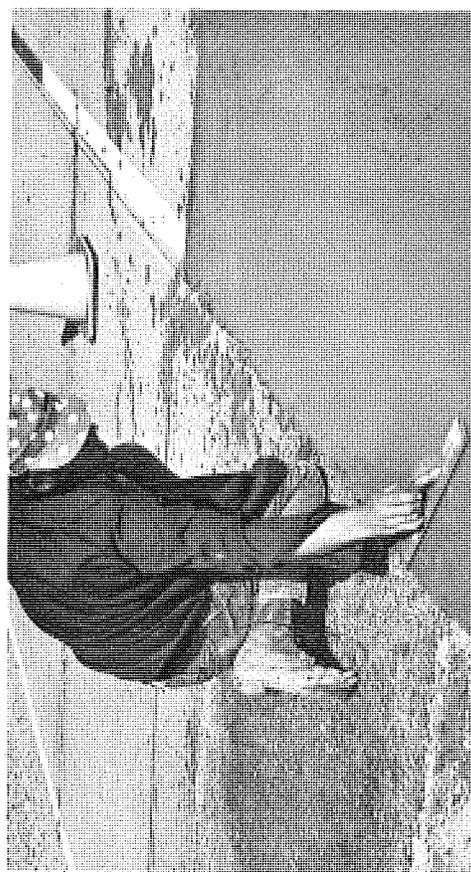
Figure 15. The concrete was finished with hand trowels.

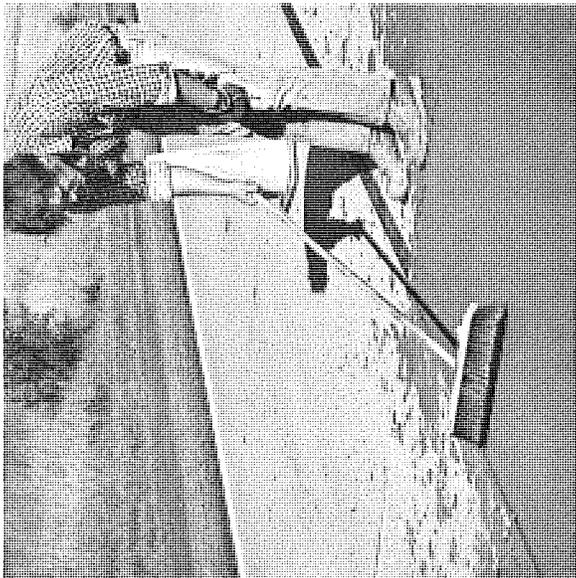
Figure 16. The concrete was broomed to obtain a rough surface.

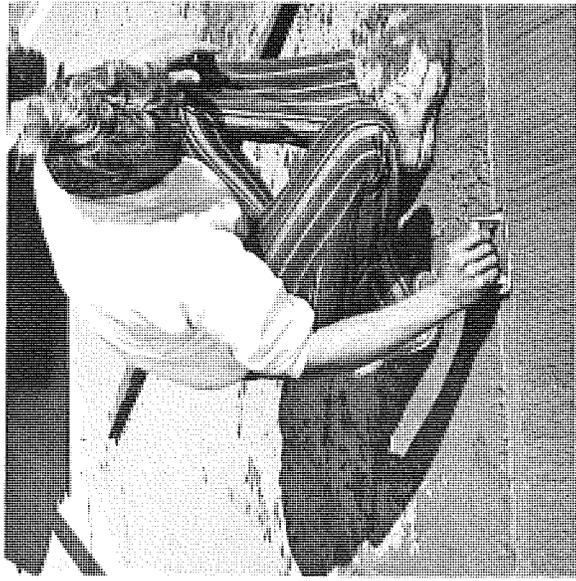
Figure 17. An edging trowel was used along the wood strip.

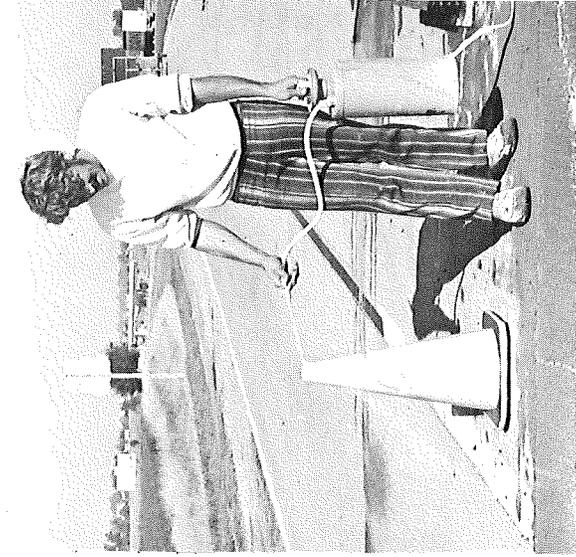
Figure 18. The slabs were cured with a membrane curing compound.

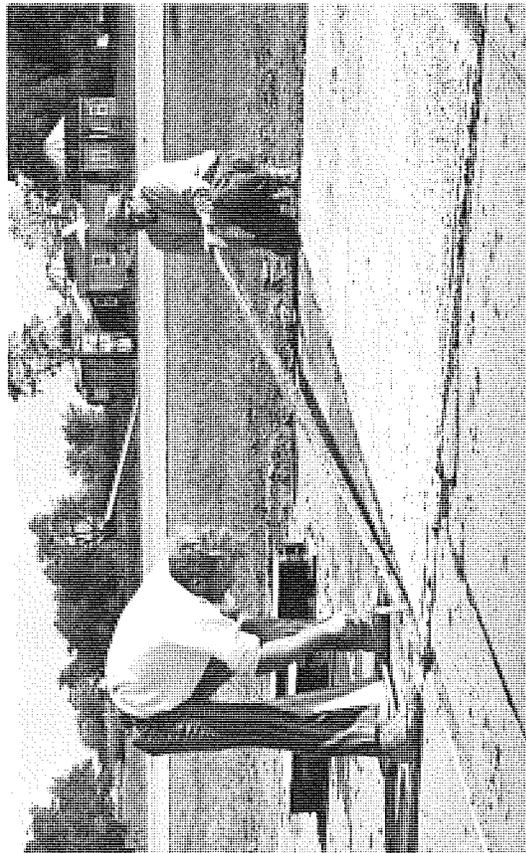
Figure 19. The wood forming strip was removed 15 to 30 min. after the repair was finished.

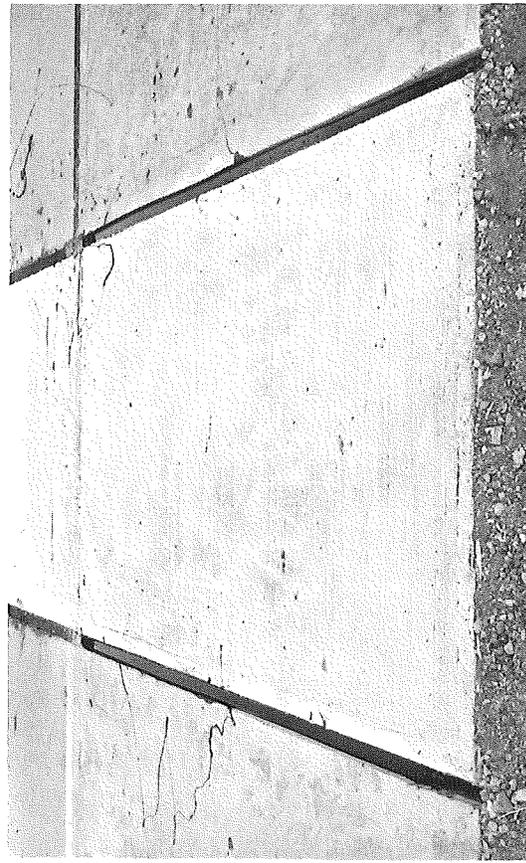
Figure 20. A completed cast-in-place repair.

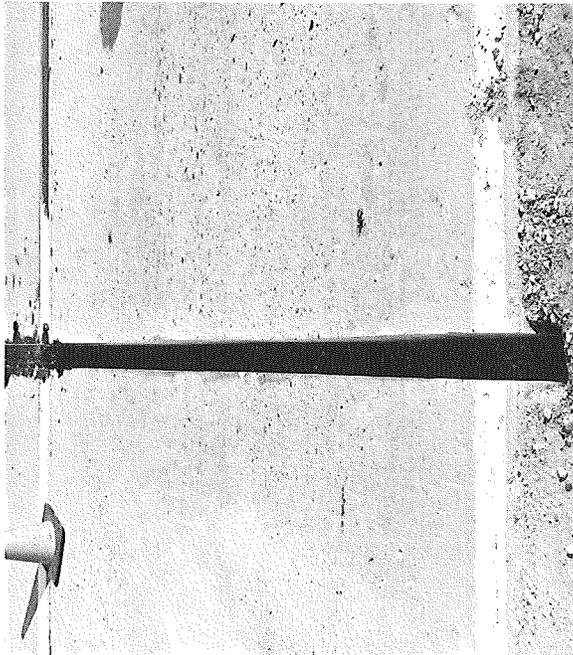
Figure 21. Full-depth diamond blade cuts were made 4 in. apart and the concrete removed to form a joint.

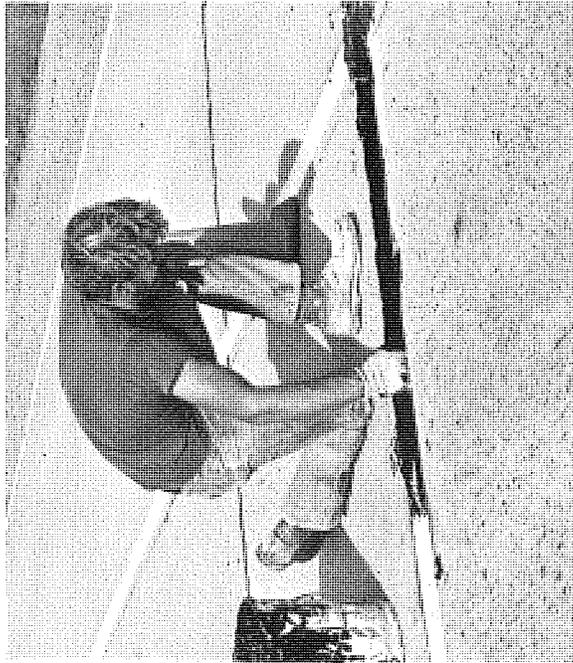
Figure 22. The joint walls were coated with a lubricant adhesive.

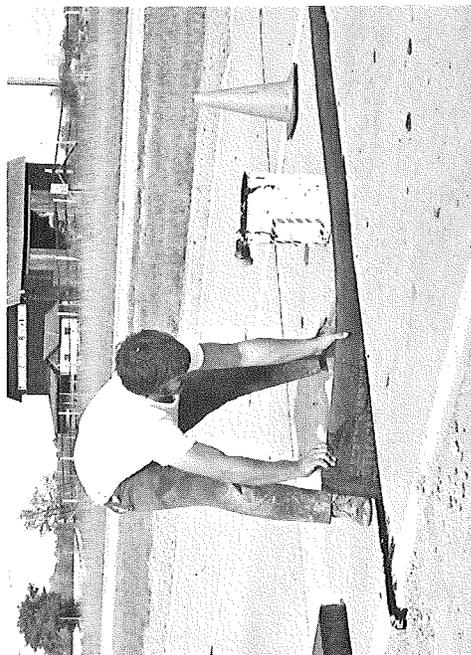
Figure 23. The filler was inserted into the joint.

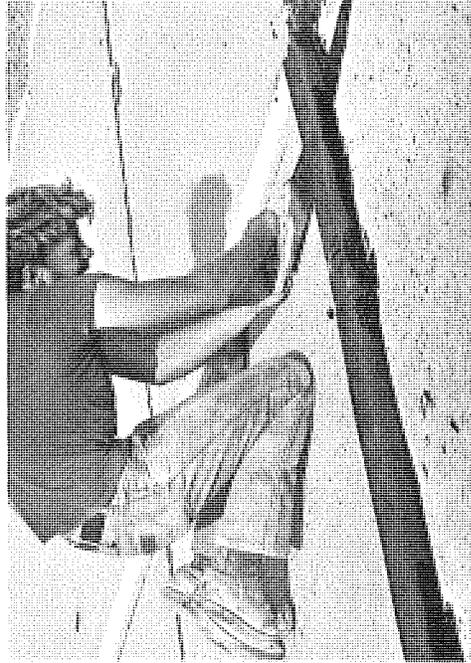
Figure 24. Excess joint filler was sawed off flush with the pavement surface.
