OFFICE MEMORANDUM

SUBJECT: Comparative Performance of Contraction Joints on I 75, Saginaw
and Genesee Counties.
Research Project 75 TI-303. Research Report No. R-⁹⁹⁶~~966~~.

Subject: Inspection of Pavement Joints on US 127: Hudson to Ohio State Line.
Project 39 F-7(14). Research Report No. R-555R.

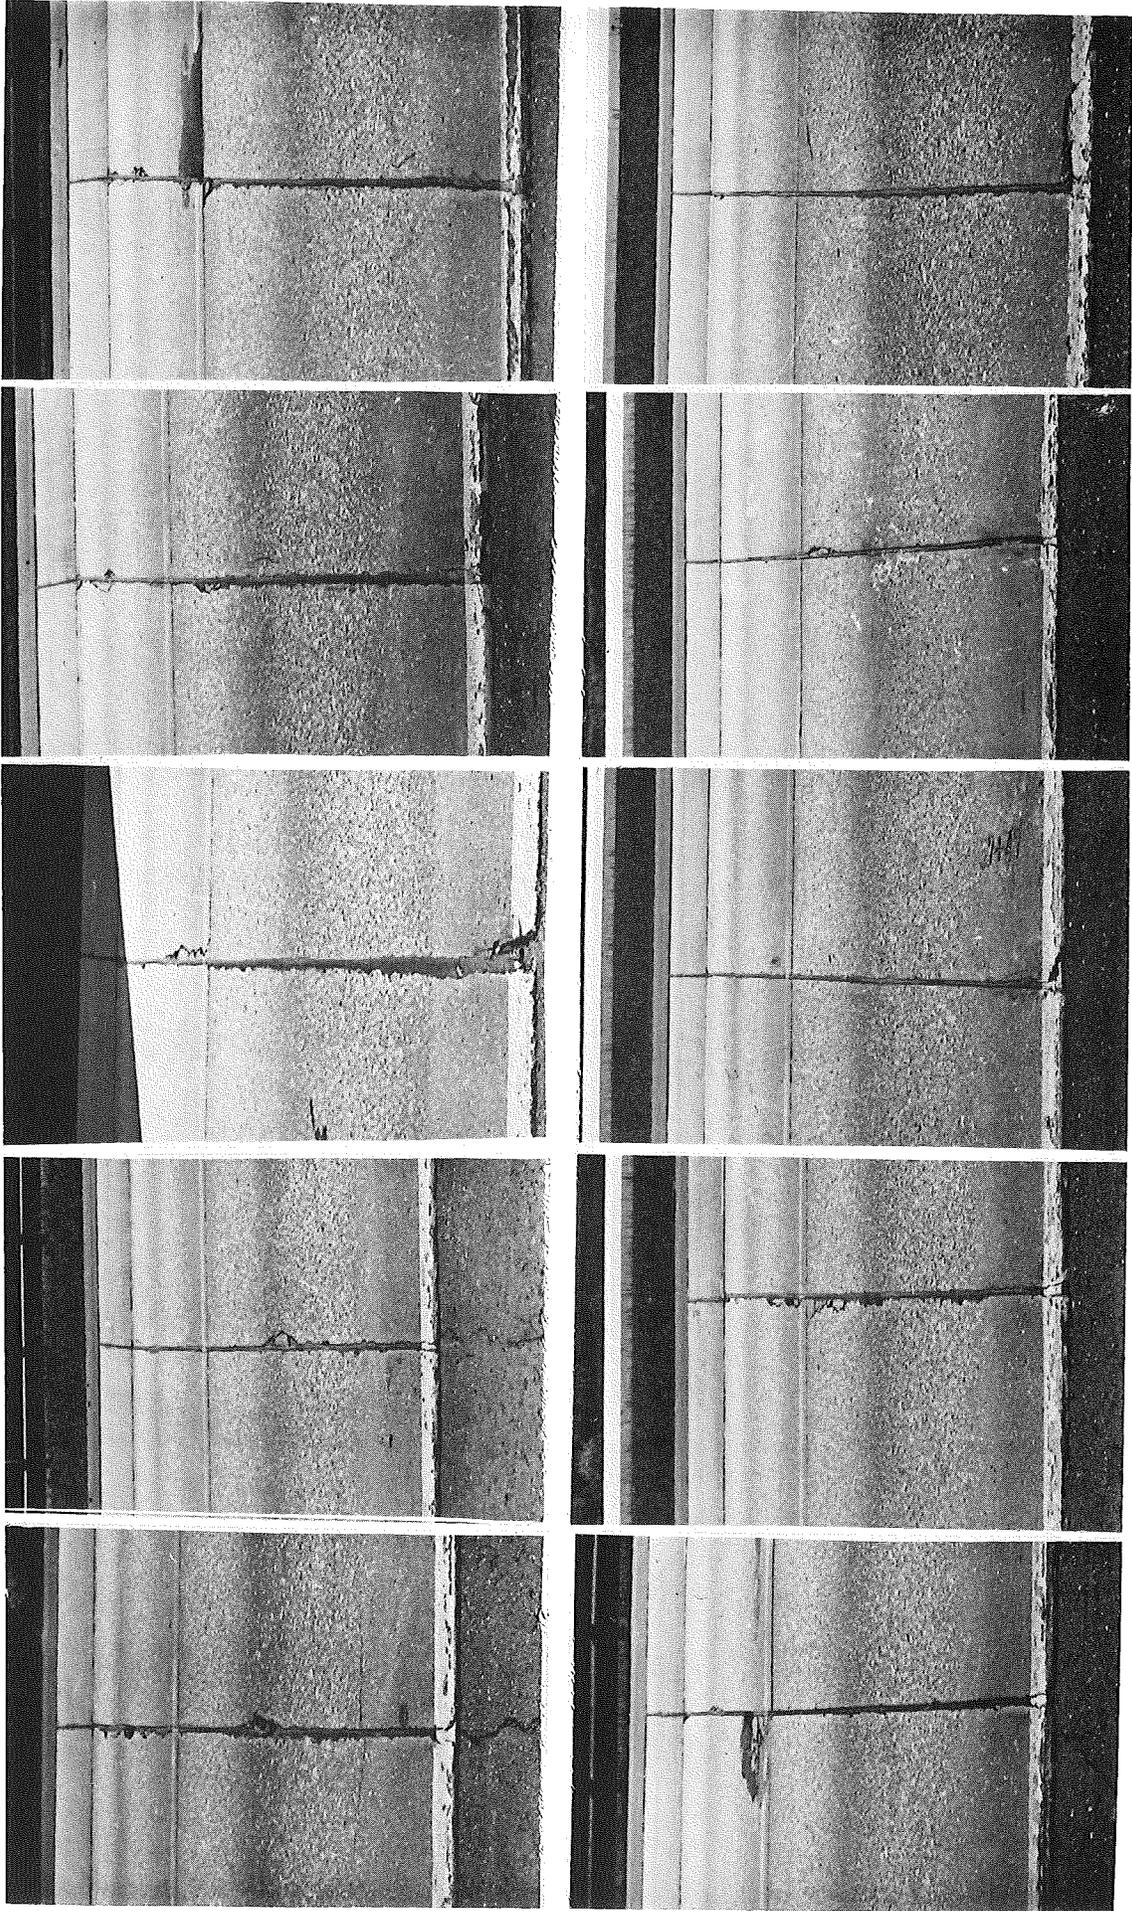
Figure 1 shows locations of the areas of highway under investigation. The northern length of pavement, Construction Projects 73171, C4, C6, and C8 had joints which appeared to be virtually perfect while the southern length, Construction Projects 25131, C3 and C5, showed serious deterioration at almost every joint.

L. D. Abbey, Assistant District Maintenance Engineer at Saginaw, reported the northern length of pavement, which was constructed in 1961, had no blowups and only about one percent of the joints showed serious deterioration. He estimated an annual joint maintenance cost of about \$500 per mile. In contrast, Mr. Abbey reported the southern length of pavement, constructed in 1962, had 185 joint (single lane) blowups, about 85 percent of the joints showed serious deterioration, and estimated annual joint maintenance costs of \$5,000 to \$8,000 per mile. Figures 2 and 3 show photographs of a few joints on each project.

Figure 2. I 75 Saginaw County (between Birch Run and Bridgeport).
First 10 joints starting 300 ft north of South County Line.

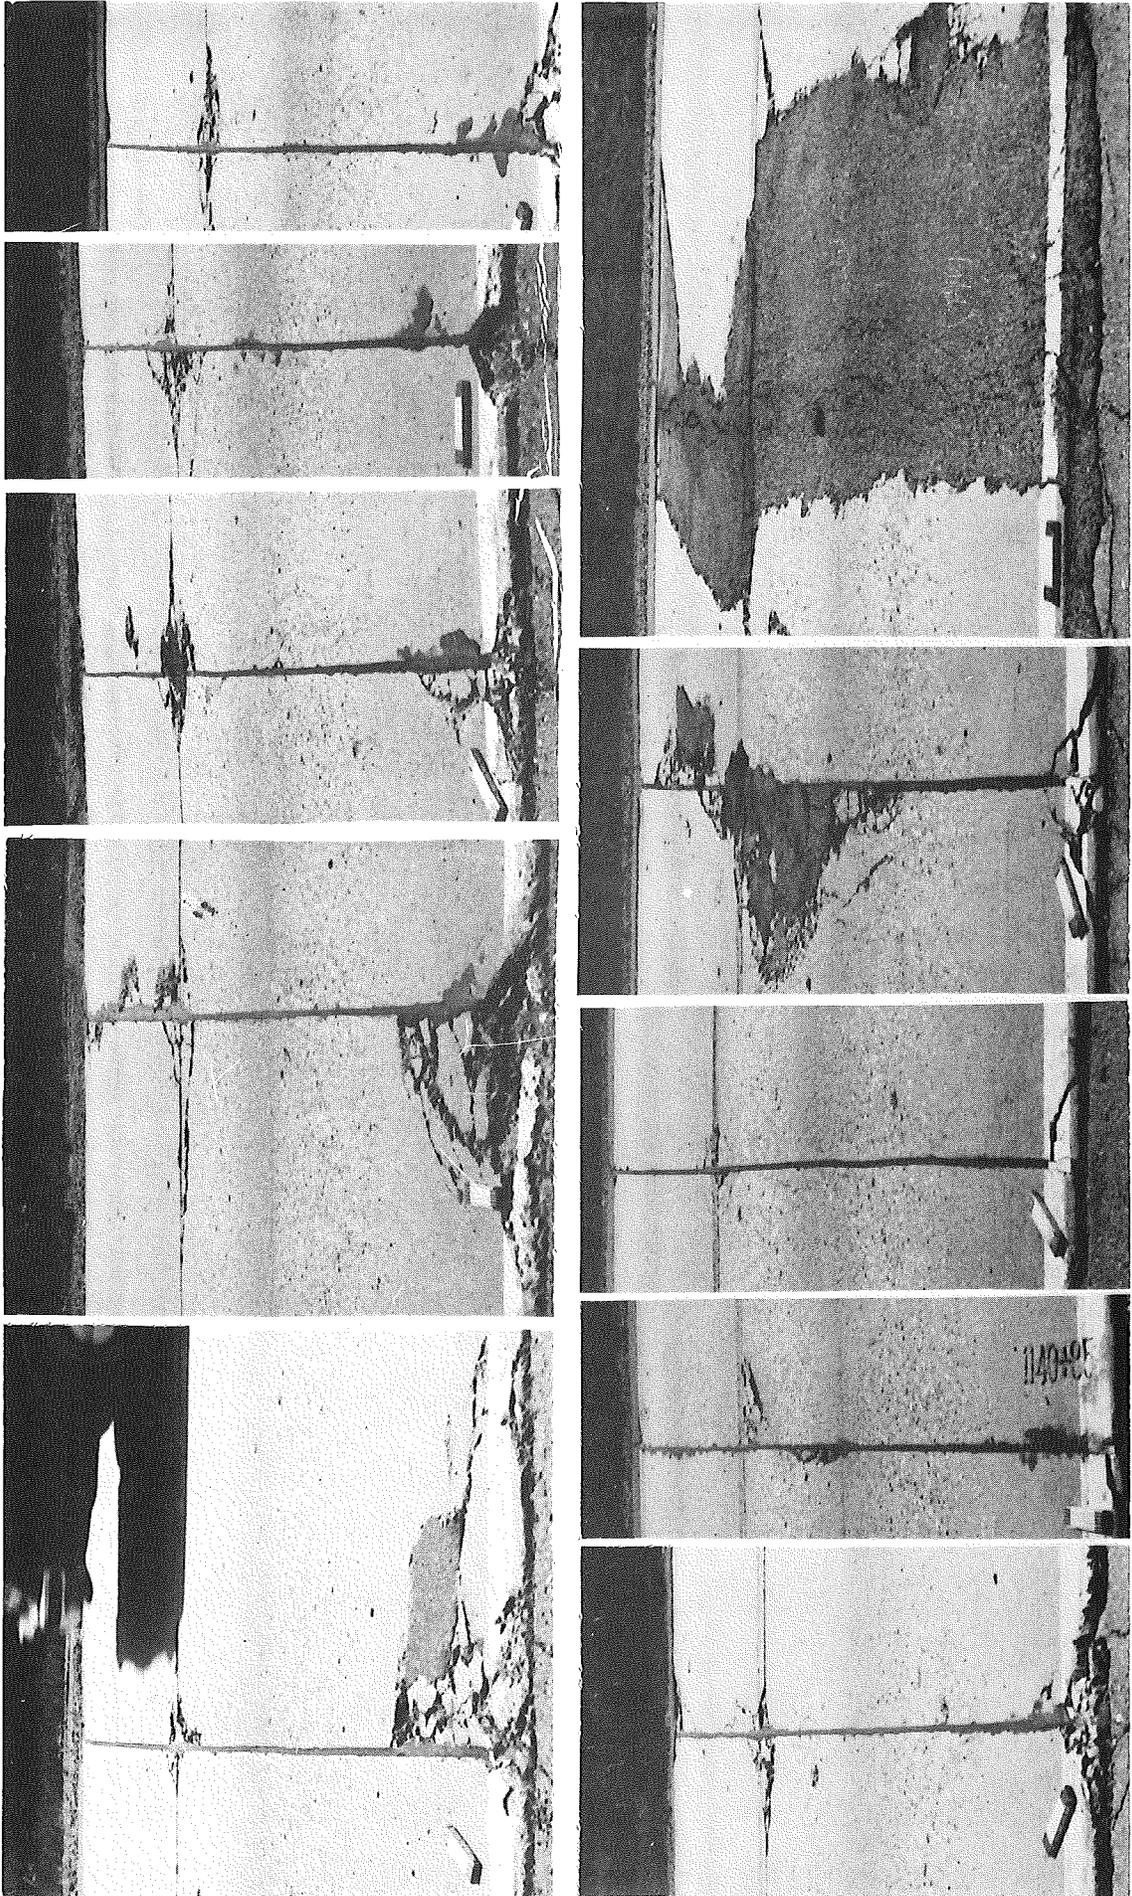
An investigation of factors involved showed that the coarse aggregate was the only major difference between the two lengths of pavement. The projects with poor joints used coarse aggregate from American Aggregates Corporation at its pit near Oxford (25131, C3) and from the Groveland Pit (25131, C5). The projects with good joints used coarse aggregate from the Inland Lime and Stone Pit (limestone).

Figure 3. I 75 Genesee County (between South County Line and US 23).
First 10 joints starting 300 ft north of Oakland County Line.

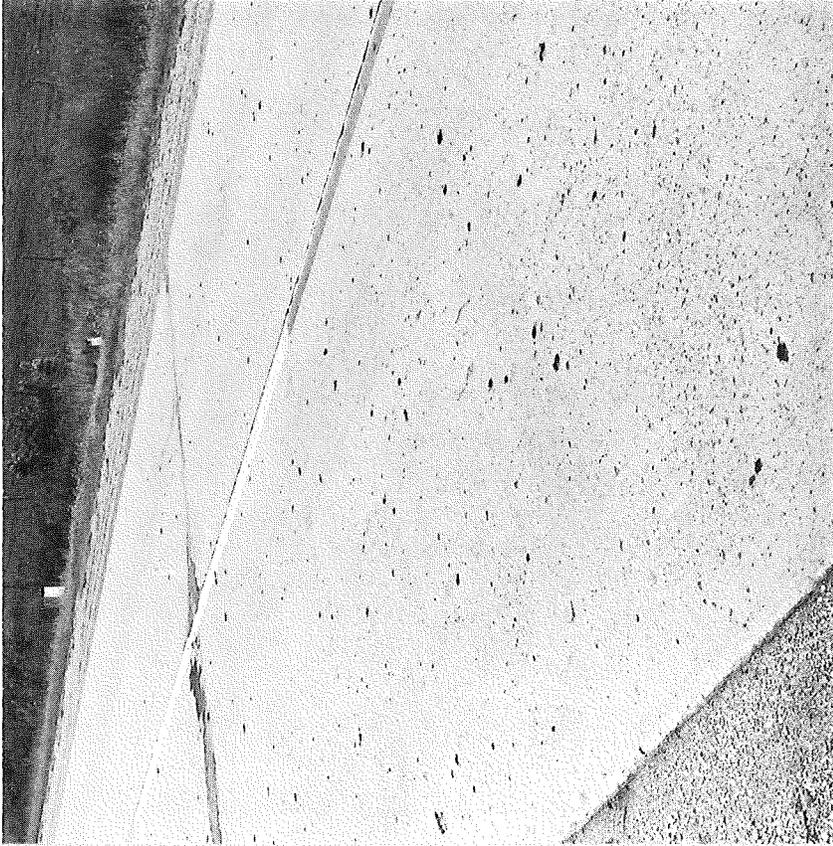
The concrete at the joint had disintegrated in a wedge shape, tapering up to the dowel bars from the plastic base plate. The concrete above the dowels was fractured into small pieces, as though subjected to severe compression. The surface of this project had numerous popouts (Figs. 1 and 2).

Figure 2. Numerous popouts in pavement surface:
Construction Project 30-04, C3.

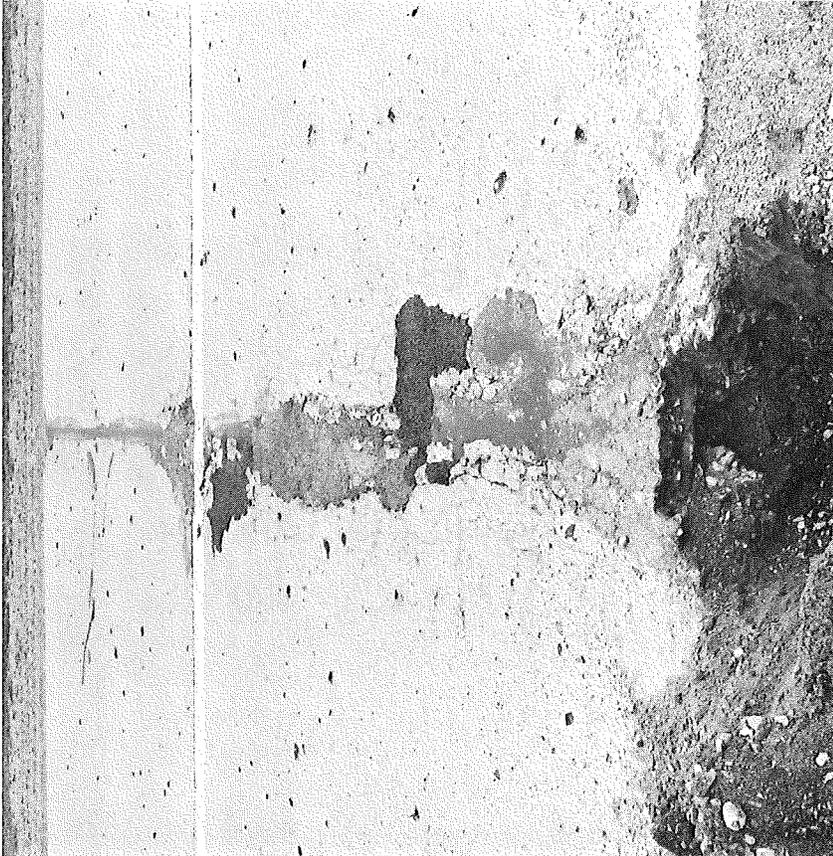
Almost every joint in this project, which extends about 5 miles south from Hudson, was distressed to some degree, with about 50 percent of the joints in very bad condition. Figure 1 shows a badly distressed joint typical of this project with its profile revealed through a hole dug in the shoulder.

Figure 1. Distressed joint with end exposed: Con-
struction Project 30-04, C3.

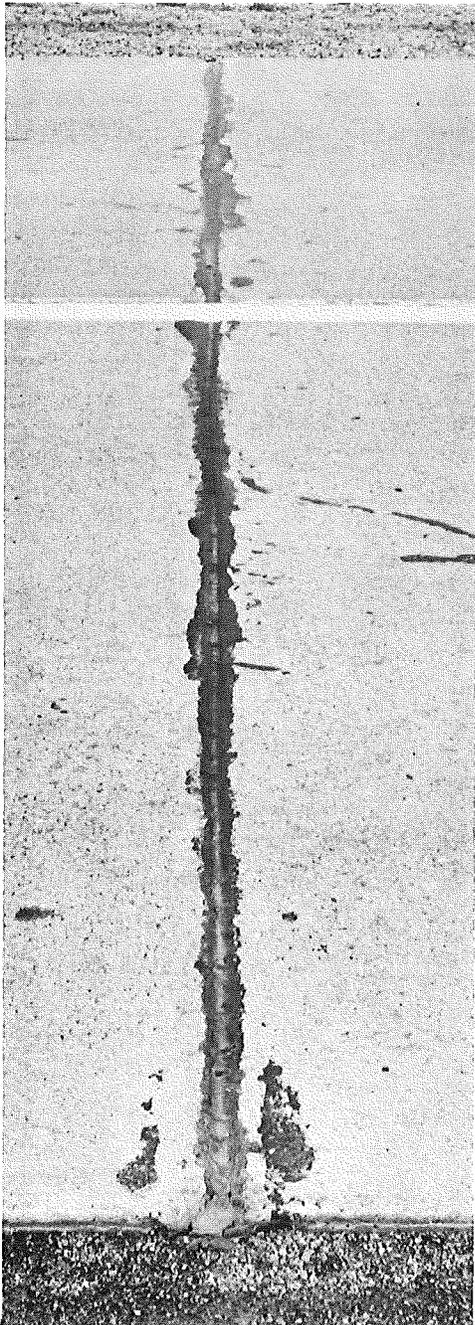
Joints in the northern portion (Sta. 105+27 to 266+00) of this project were in excellent condition with almost no distress evident. Figure 3 shows a typical joint in this area. However, from Sta. 105+27 south to the Ohio border, numerous joints had serious spalls where maintenance was required.

Figure 3. Typical joint in Construction Project 30-04, C5, between Stations 102+57 and 266+00.

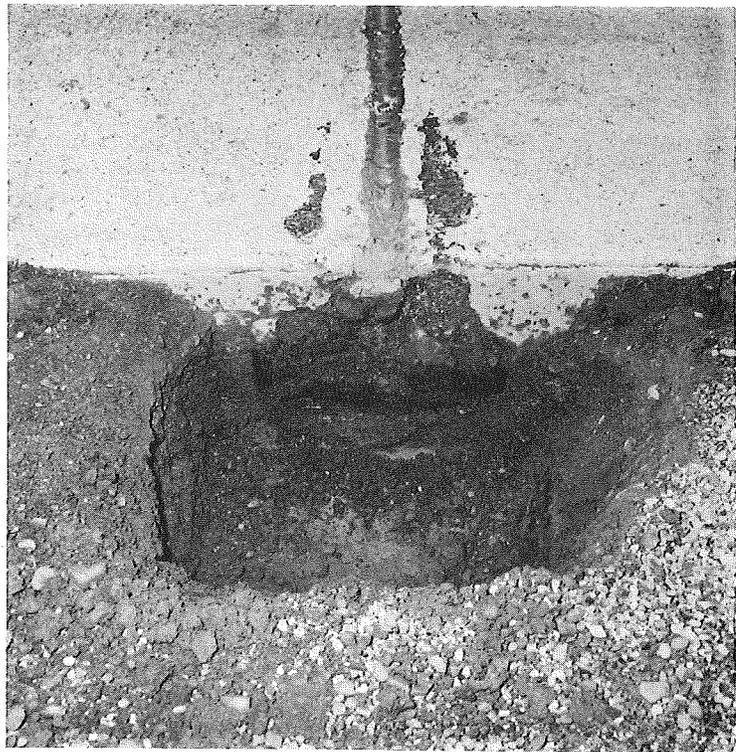
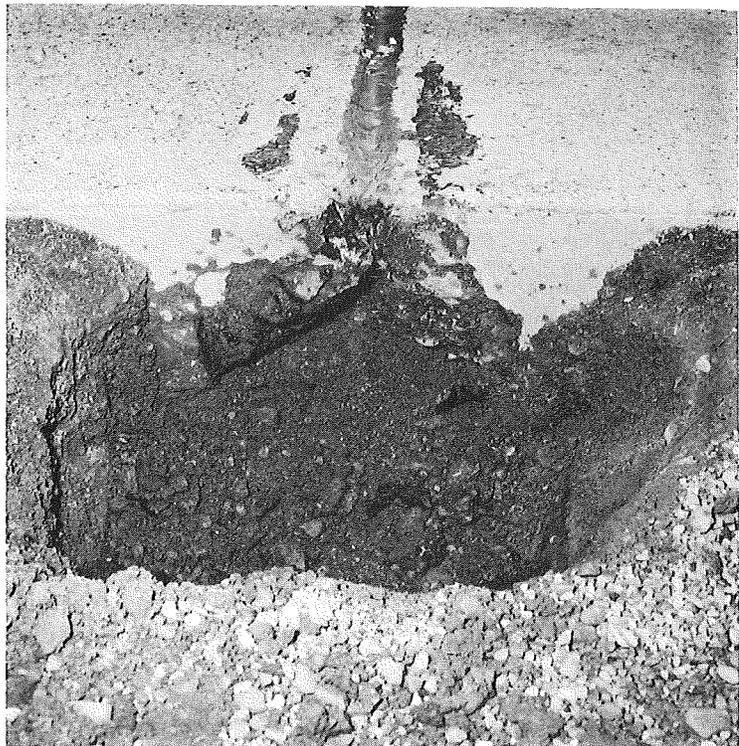
By digging through the shoulder, the profile of an apparently sound joint in the northern portion was revealed as shown in Figure 4. In this area, the concrete had disintegrated in a typical wedge, with its wider end across the plastic base plate, tapering to an apex near the dowel bars. This suggests that a series of joint failures may be imminent in the currently satisfactory northern portion of this project.

Samples of the crumbly concrete material were taken from the rotted wedges of joints in both construction projects. Analysis of this material indicated 0.34 lb of free sodium chloride per ton of concrete in Project C3 and 0.62 lb per ton in Project C5. These results support the theory that concrete deterioration in the lower section of joints is aggravated by the penetration of salt solutions (from ice control chemicals) into the pavement joints, and their subsequent impoundment by joint base plates.

Figure 4. End view of sound joint in Construction Project 30-04, C5, before removal of end plate (top), and after removal of end plate (bottom). Note disintegration of concrete above base plate.

It is proposed to make an annual condition survey of sample lengths of Project 30-04, C5 to determine if and when the joints begin to fail.

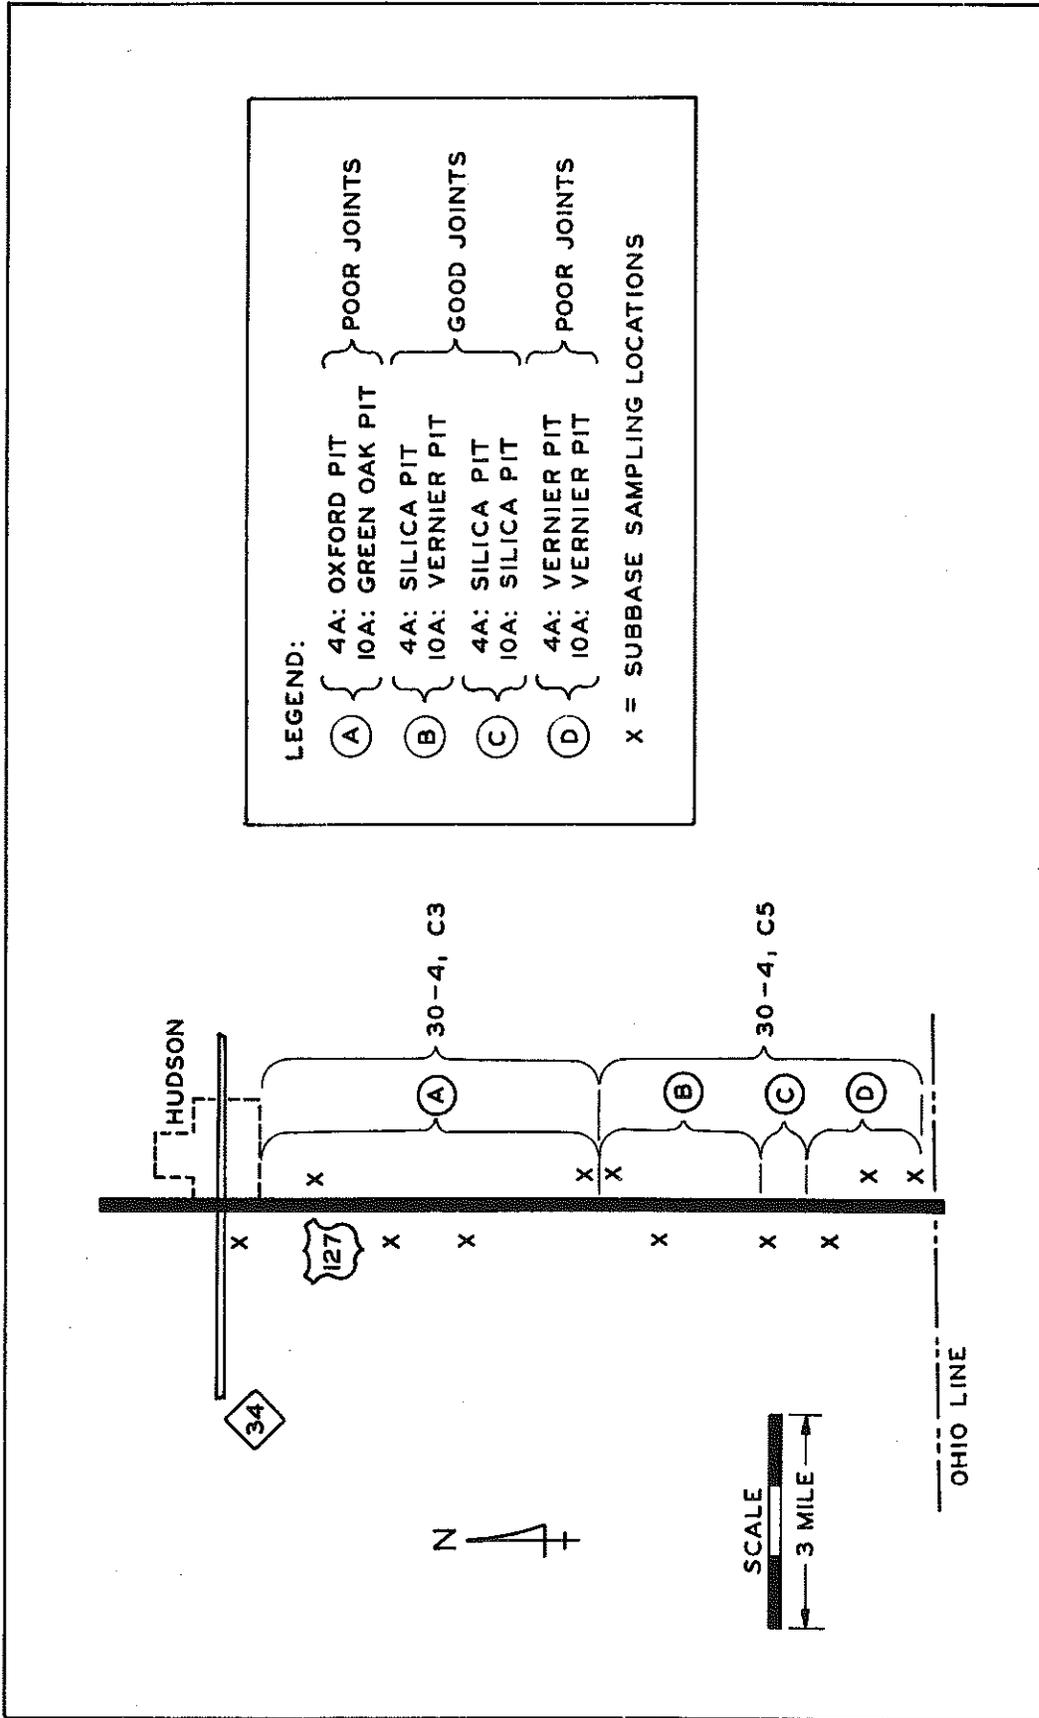
Comparison of these three data tabulations shows that the only apparent difference in the construction factors of pavements with excellent and poor joints is the coarse aggregate used in the concrete. The pavement constructed using coarse aggregate from the Silica Pit (limestone) had joints that performed excellently. Figure 5 shows the distribution of the various sources of concrete coarse aggregate used in the projects.

Figure 5. Distribution of coarse aggregates used in concrete on US 127 projects from Hudson to Ohio State Line.
