# Bridge Deck Delamination Report

Bridge: 1282 24 mile rd  
Talon Research, Inc.  
09/16/2013

Client:	MTU Study
Bridge Name:	1282 24 mile rd
Number of Lanes:	2
Length of Bridge [ft]:	225.22
Width of Bridge [ft]:	30.00
Bridge Code:	
Year Built:	
State Name:	Michigan
State Code:	265
County Name:	Calhoun
County Code:	test
Control Section:	
Location:	
Facility Carried by Structure:	24 mile rd
Features Intersected:	I94

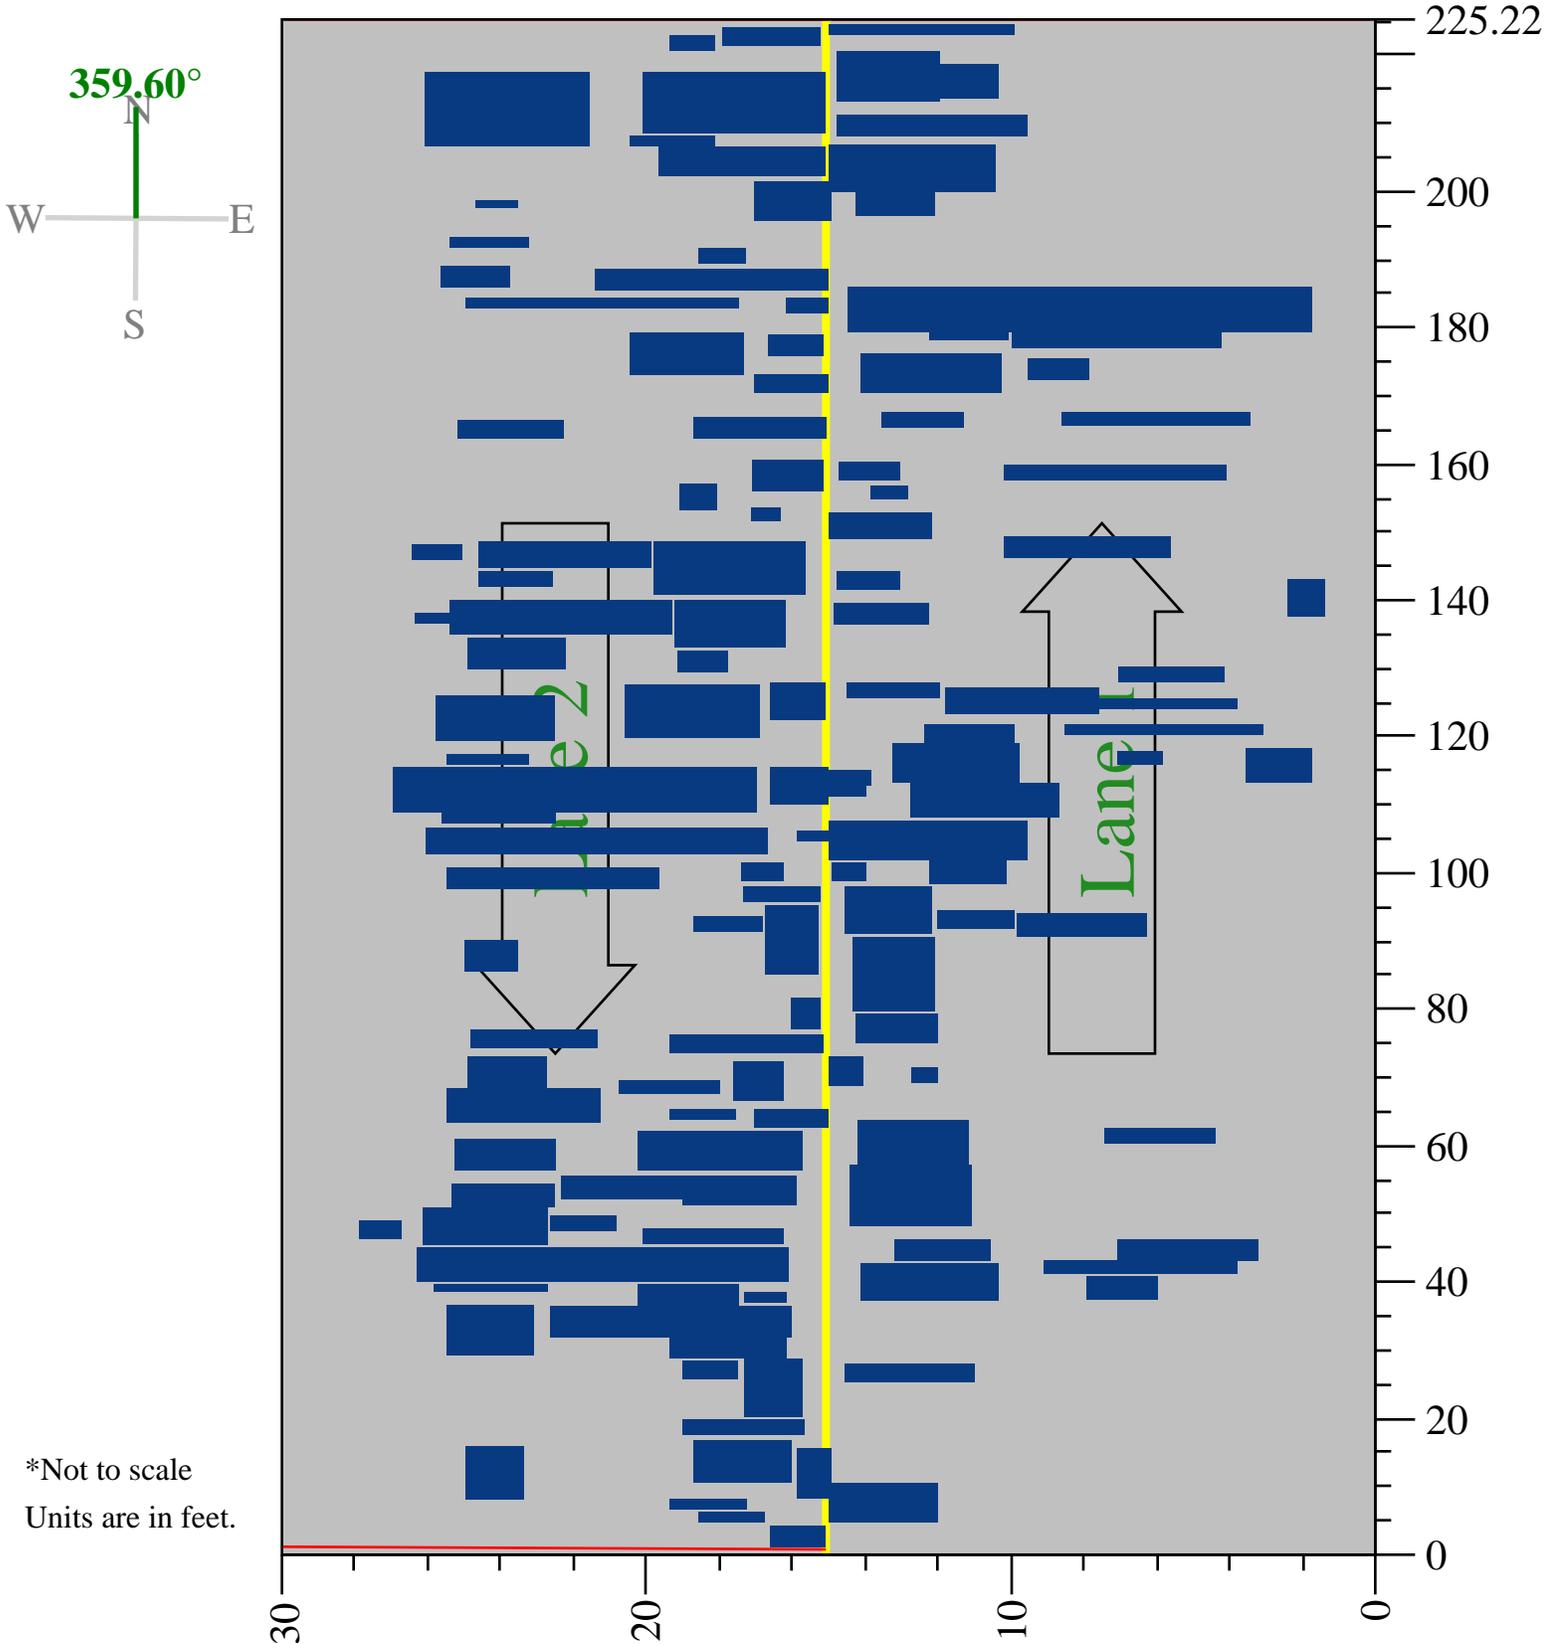
# Pattern Overview

Total Bridge Area (sq ft): 6756.56  
Defect Area (sq ft): 1765.61

# of Defects: 133  
% Defective: 26.13

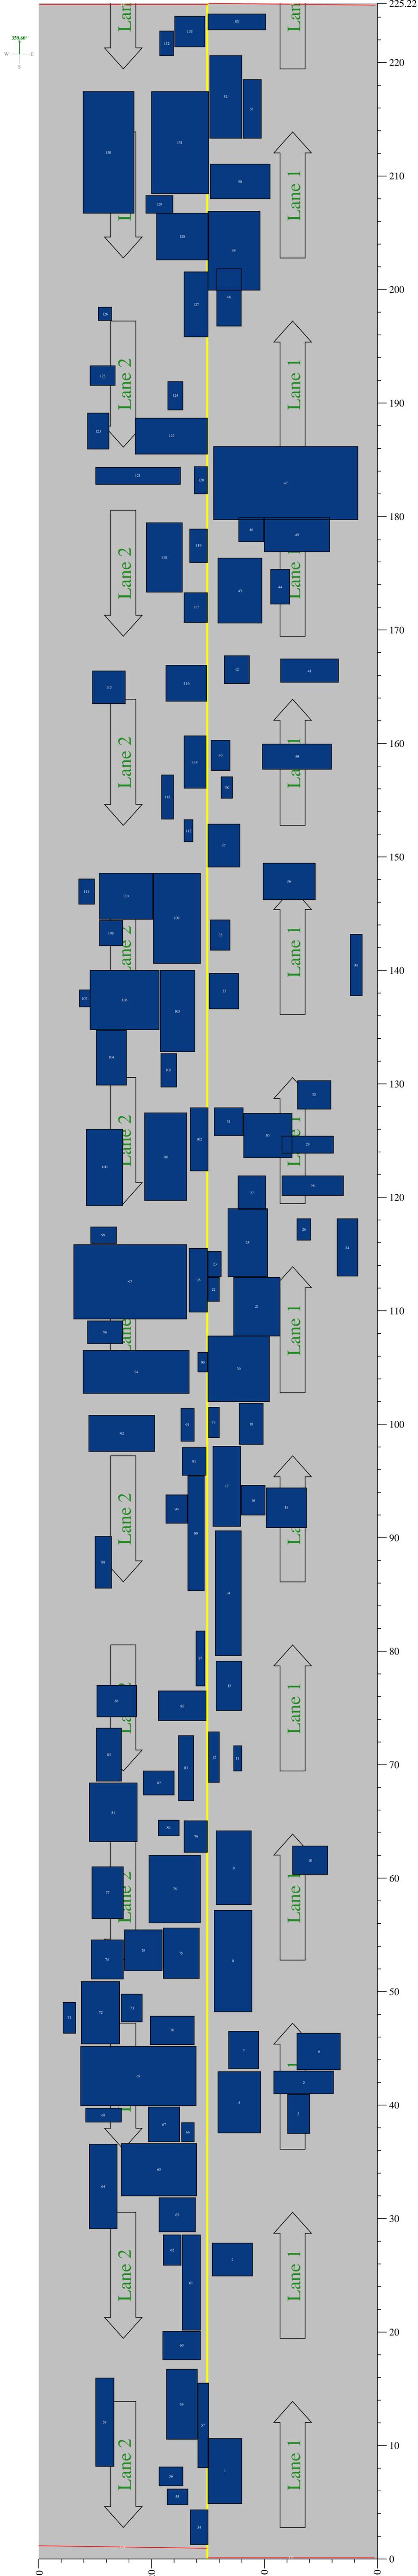
# Overview (Scaled)

Total Bridge Area (sq ft): 6756.56      # of Defects: 133  
 Defect Area (sq ft): 1765.61      % Defective: 26.13

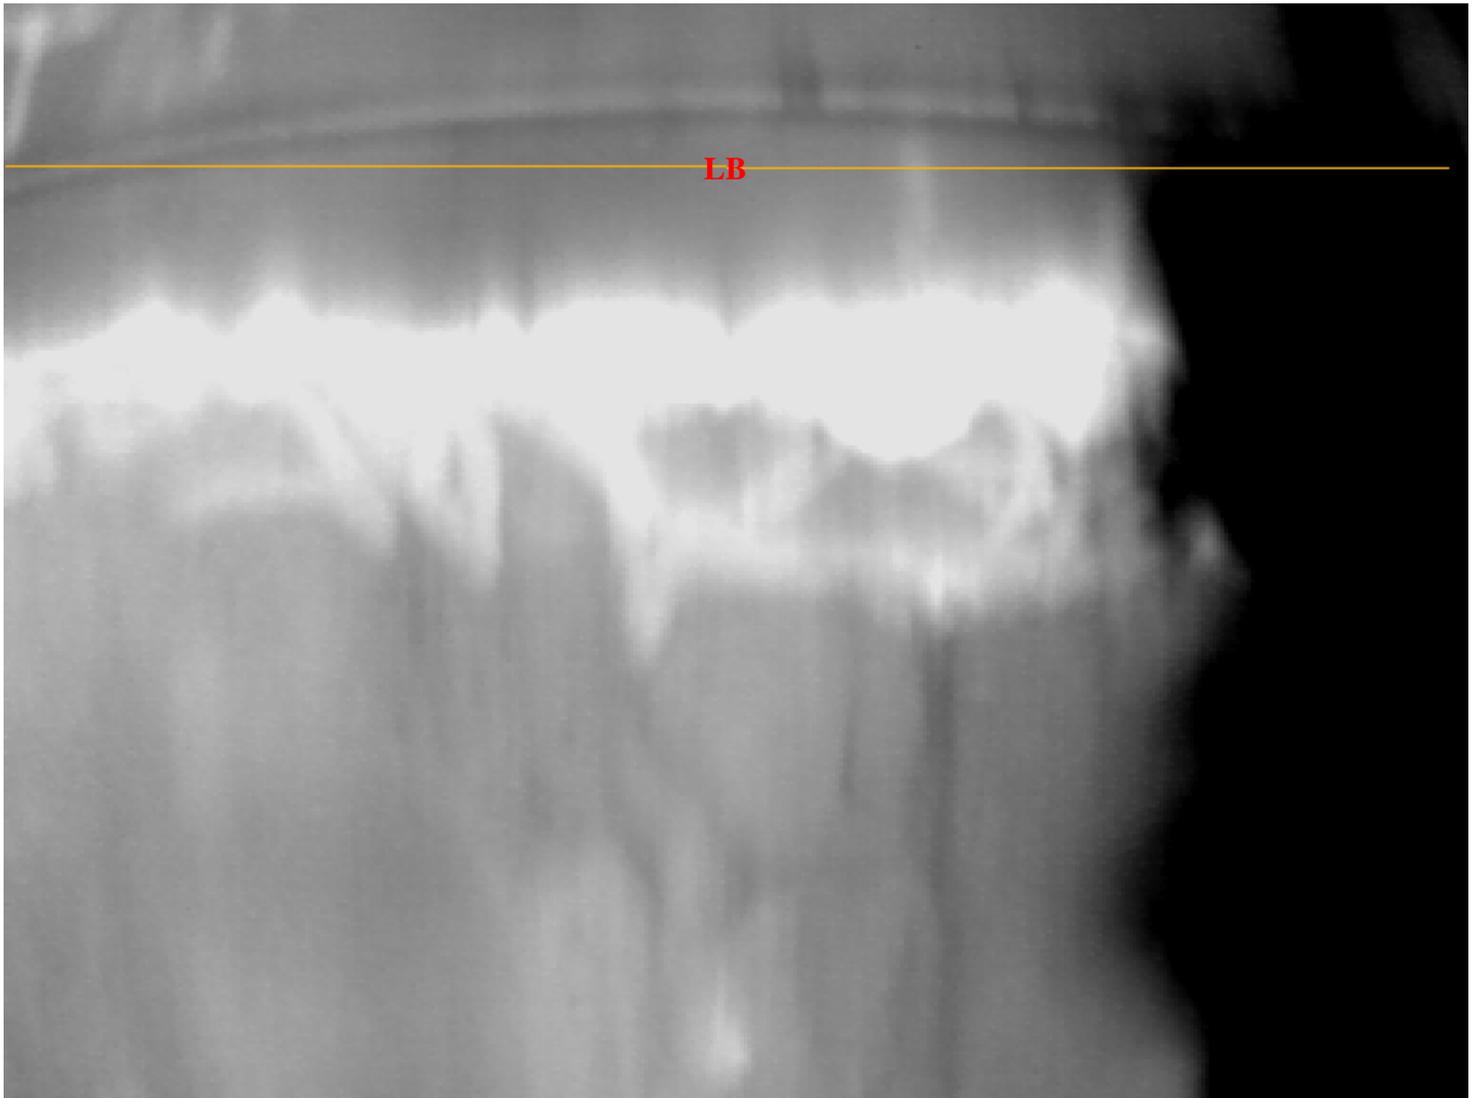
Image Name: 1\_3426000\_46766\_0.tif

Defect #	LB
Feet from Start	0.12
Feet from Right	7.60
Defect Size	NA
Length x Width (ft)	NA
Type	Lane Bound

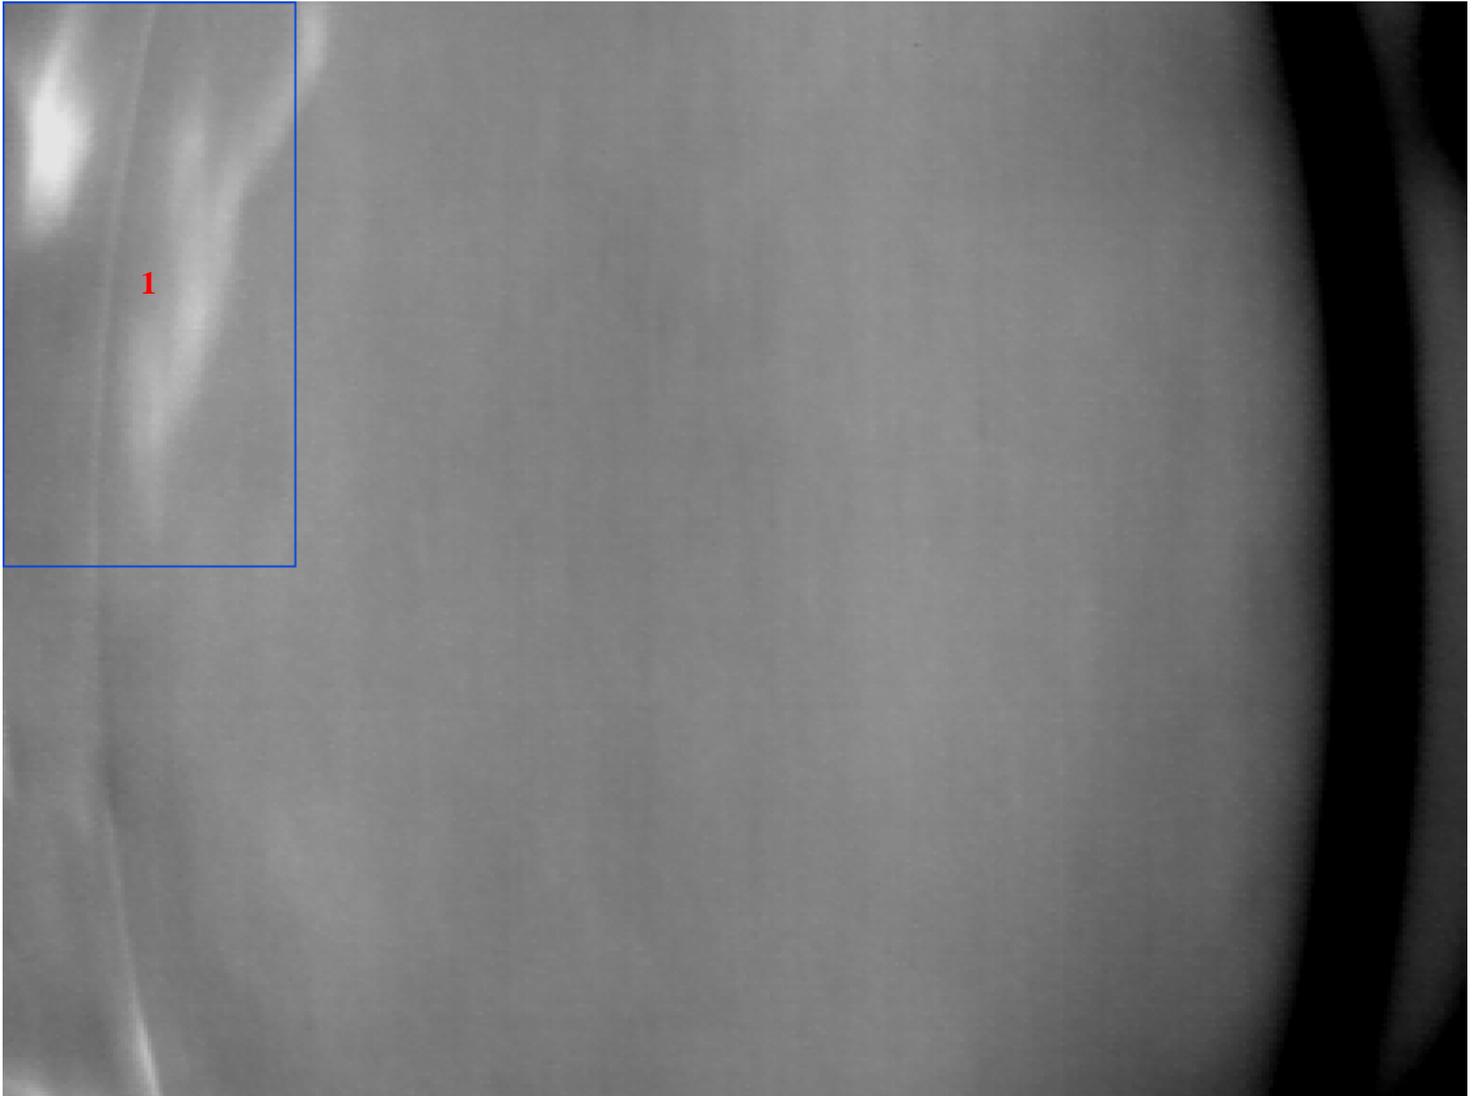
Image Name: 1\_3709000\_46766\_0.tif

Defect #	1
Feet from Start	7.75
Feet from Right	13.50
Defect Size	18.01 sq ft
Length x Width (ft)	5.71 x 3.01
Type	Delam

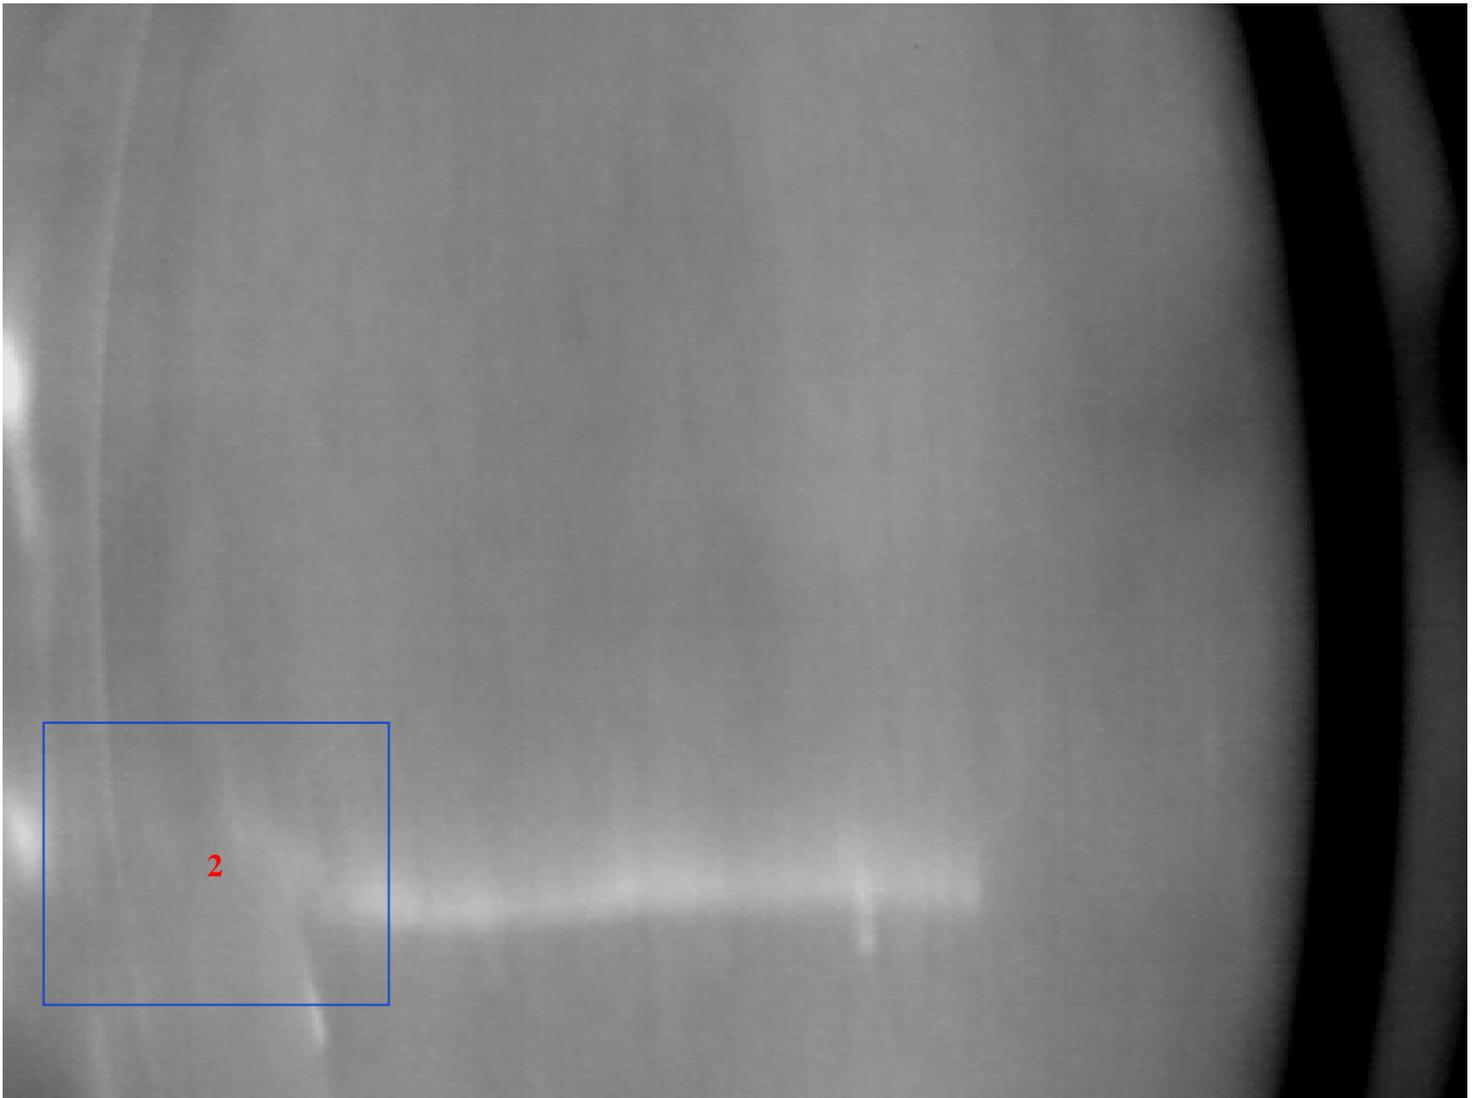
Image Name: 1\_4284000\_46280\_1.tif

Defect #	2
Feet from Start	26.41
Feet from Right	12.81
Defect Size	10.68 sq ft
Length x Width (ft)	2.87 x 3.55
Type	Delam

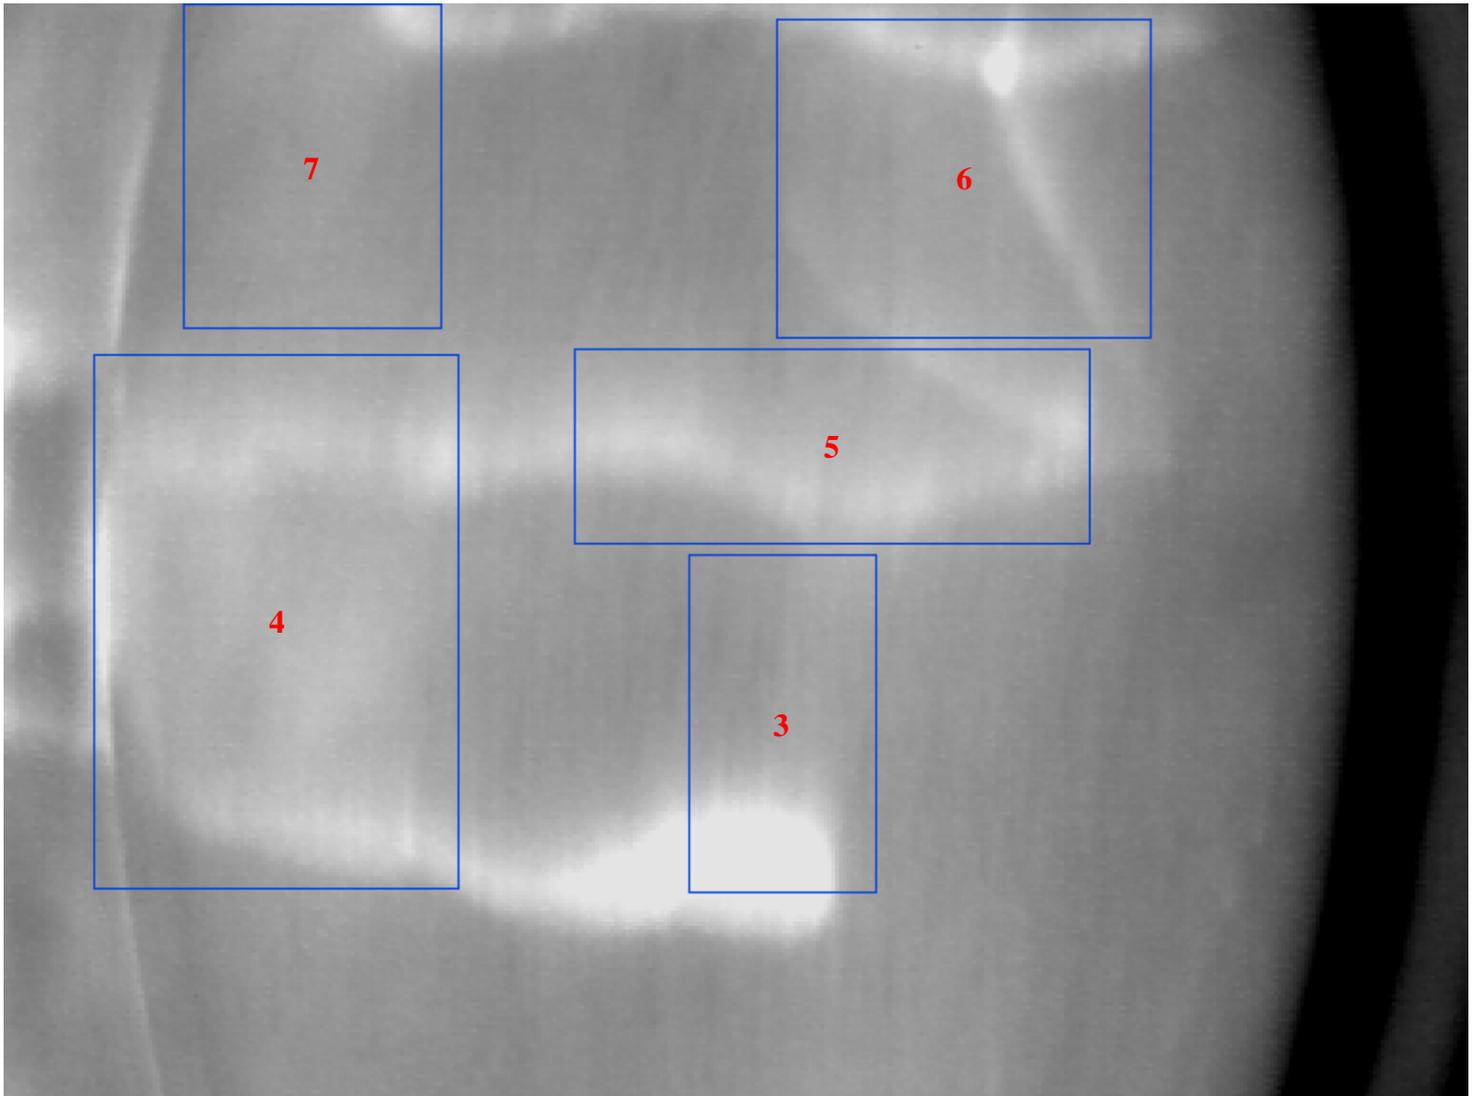
Image Name: 1\_4579000\_46280\_1.tif

21.25	0.31	40.23	12.21	1_4579000_46280_1.tif	4	<a href="#">11</a>
21.18	0.31	187.09	18.20	2_3624000_44335_1801.tif	122	<a href="#">46</a>

Defect #	3	4	5	6	7
Feet from Start	39.20	40.23	42.00	44.70	44.82
Feet from Right	7.02	12.21	6.51	5.17	11.84
Defect Size	6.94 sq ft	21.25 sq ft	10.99 sq ft	13.03 sq ft	9.16 sq ft
Length x Width (ft)	3.42 x 1.93	5.40 x 3.75	1.98 x 5.29	3.23 x 3.85	3.29 x 2.66
Type	Delam	Delam	Delam	Delam	Delam

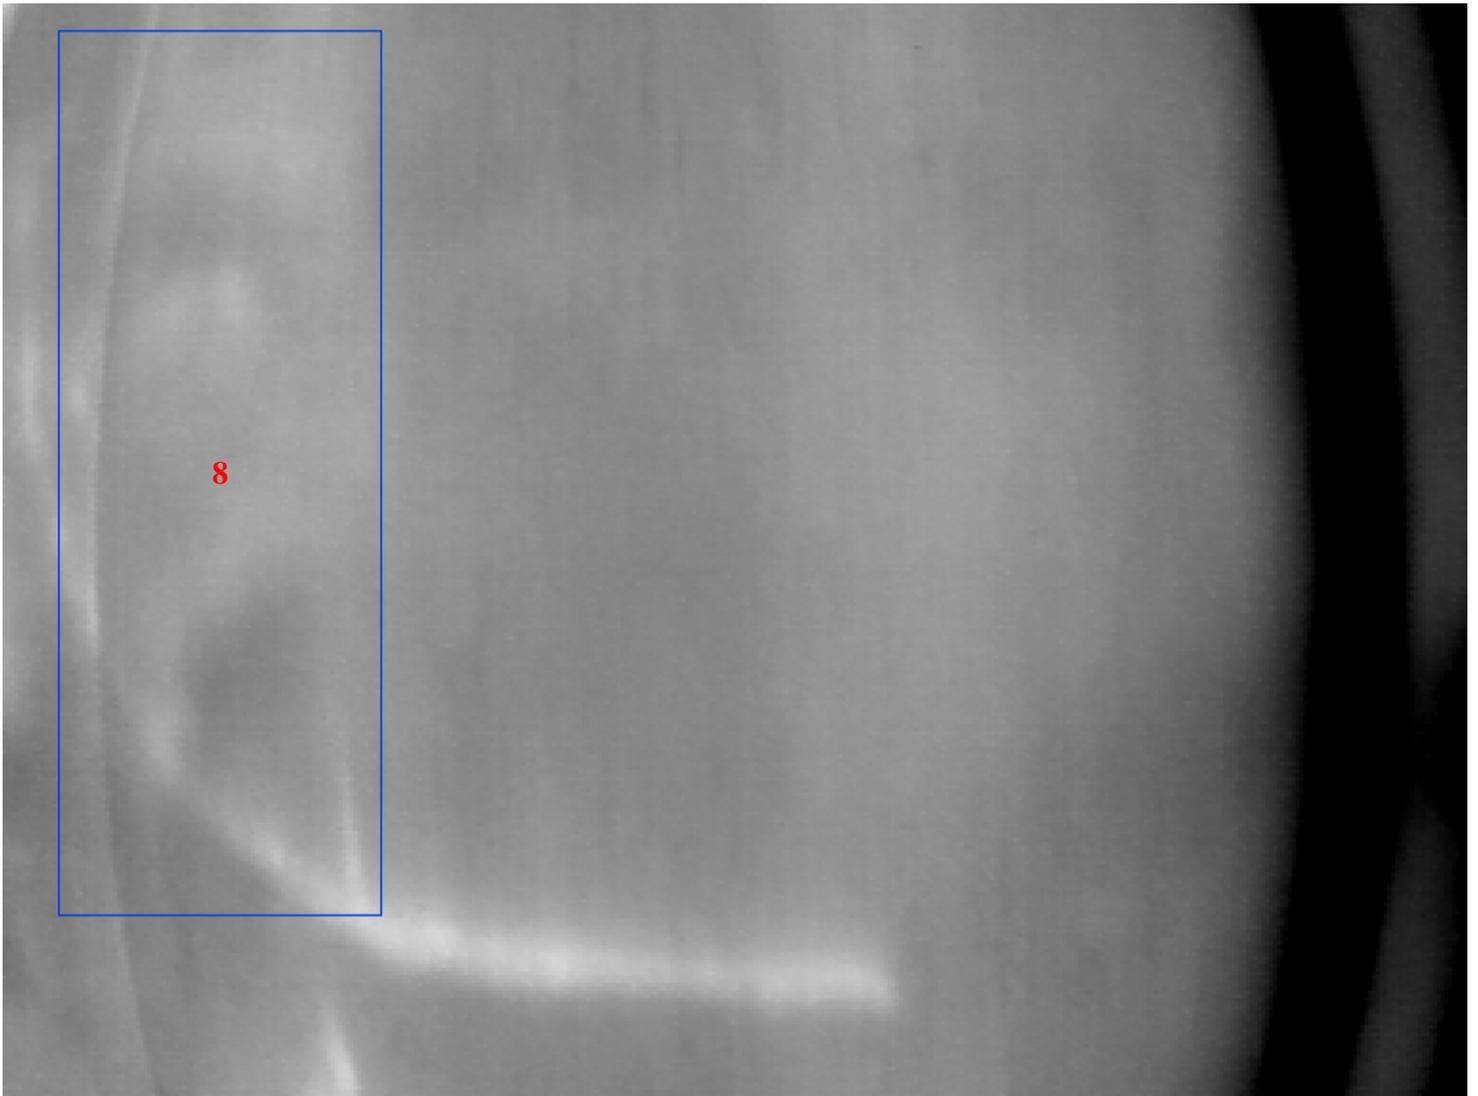
Image Name: 1\_4864000\_46280\_1.tif

32.10	0.48	34.34	19.33	2_7804000_44862_1798.tif	65	<a href="#">32</a>
31.13	0.46	52.72	12.77	1_4864000_46280_1.tif	8	<a href="#">12</a>
30.24	0.45	123.58	18.70	2_5423000_44821_1799.tif	101	<a href="#">40</a>

Defect #	8
Feet from Start	52.72
Feet from Right	12.77
Defect Size	31.13 sq ft
Length x Width (ft)	8.94 x 3.32
Type	Delam

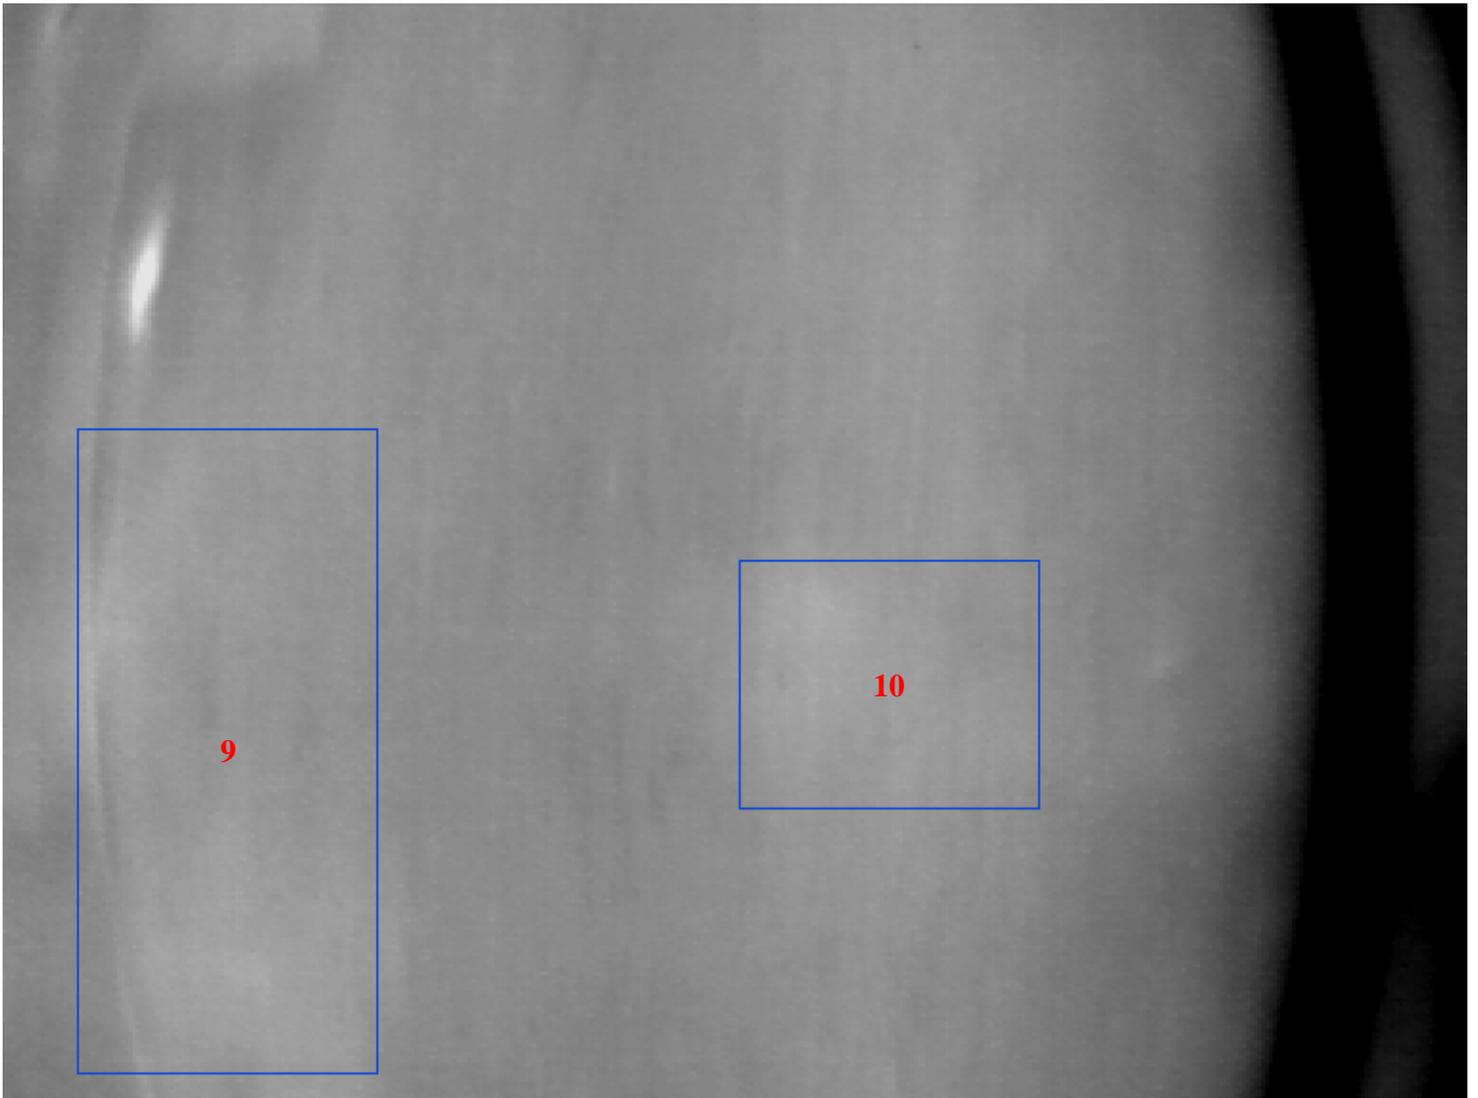
Image Name: 1\_5148000\_46280\_1.tif

Defect #	9	10
Feet from Start	60.86	61.54
Feet from Right	12.70	5.92
Defect Size	21.09 sq ft	8.15 sq ft
Length x Width (ft)	6.52 x 3.09	2.52 x 3.09
Type	Delam	Delam

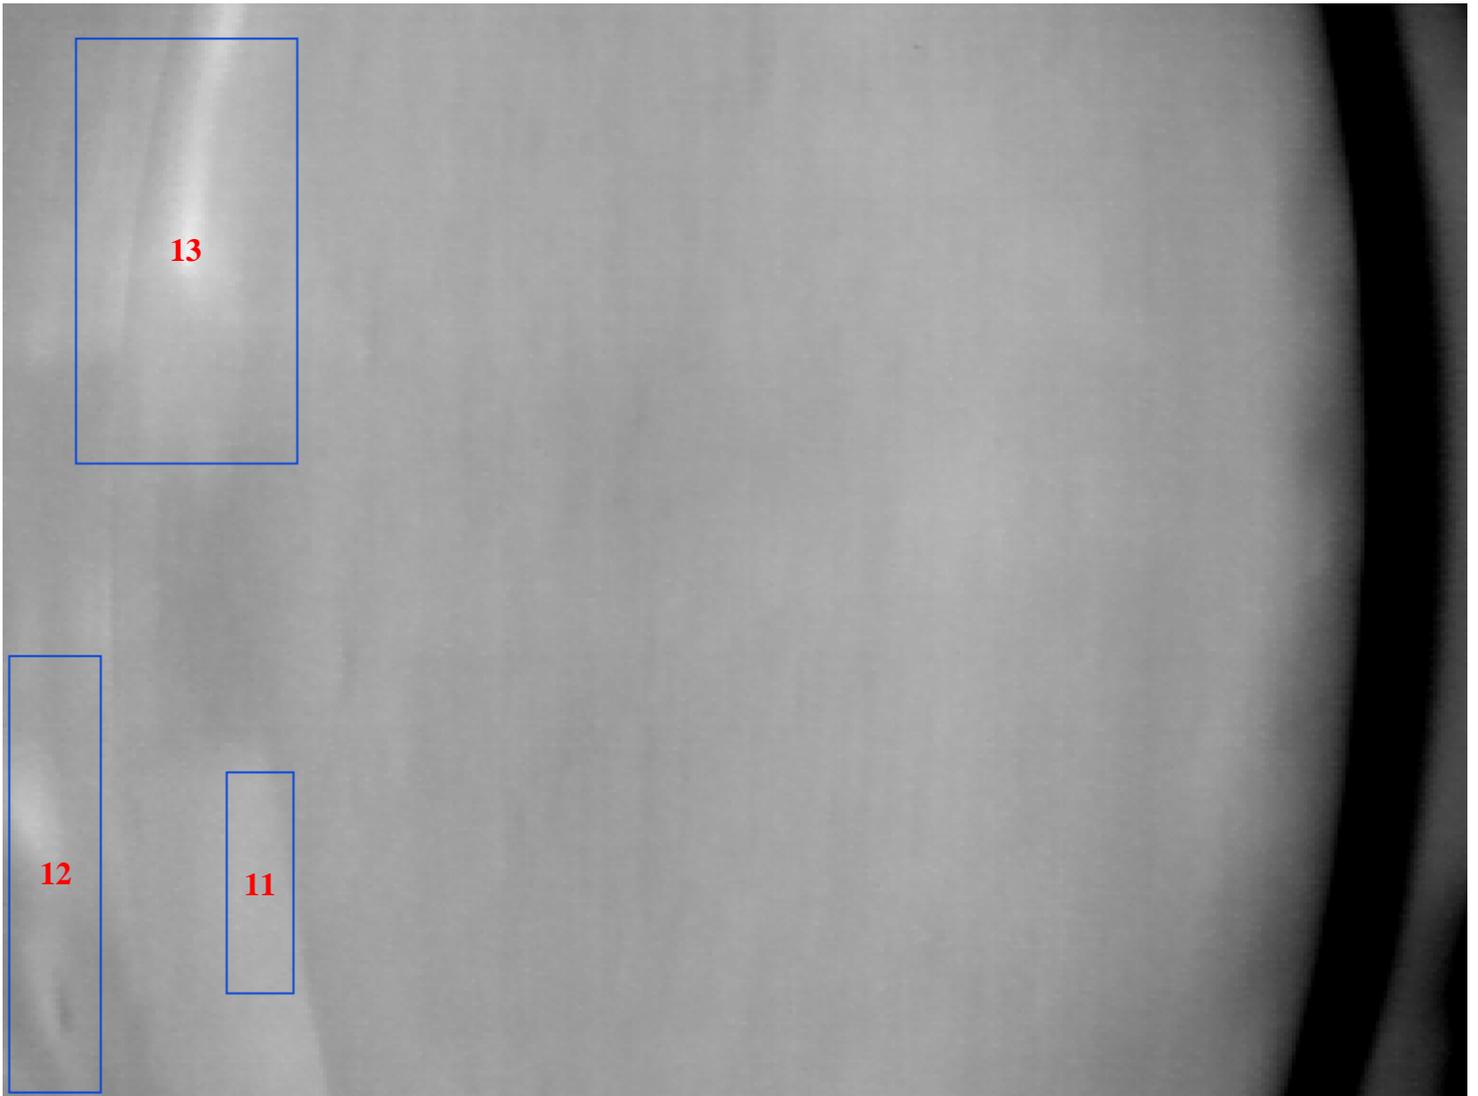
Image Name: 1\_5435000\_46158\_3597.tif

Defect #	11	12	13
Feet from Start	70.58	70.66	76.95
Feet from Right	12.36	14.46	13.12
Defect Size	1.66 sq ft	4.44 sq ft	10.32 sq ft
Length x Width (ft)	2.25 x 0.70	4.42 x 0.96	4.31 x 2.29
Type	Delam	Delam	Delam

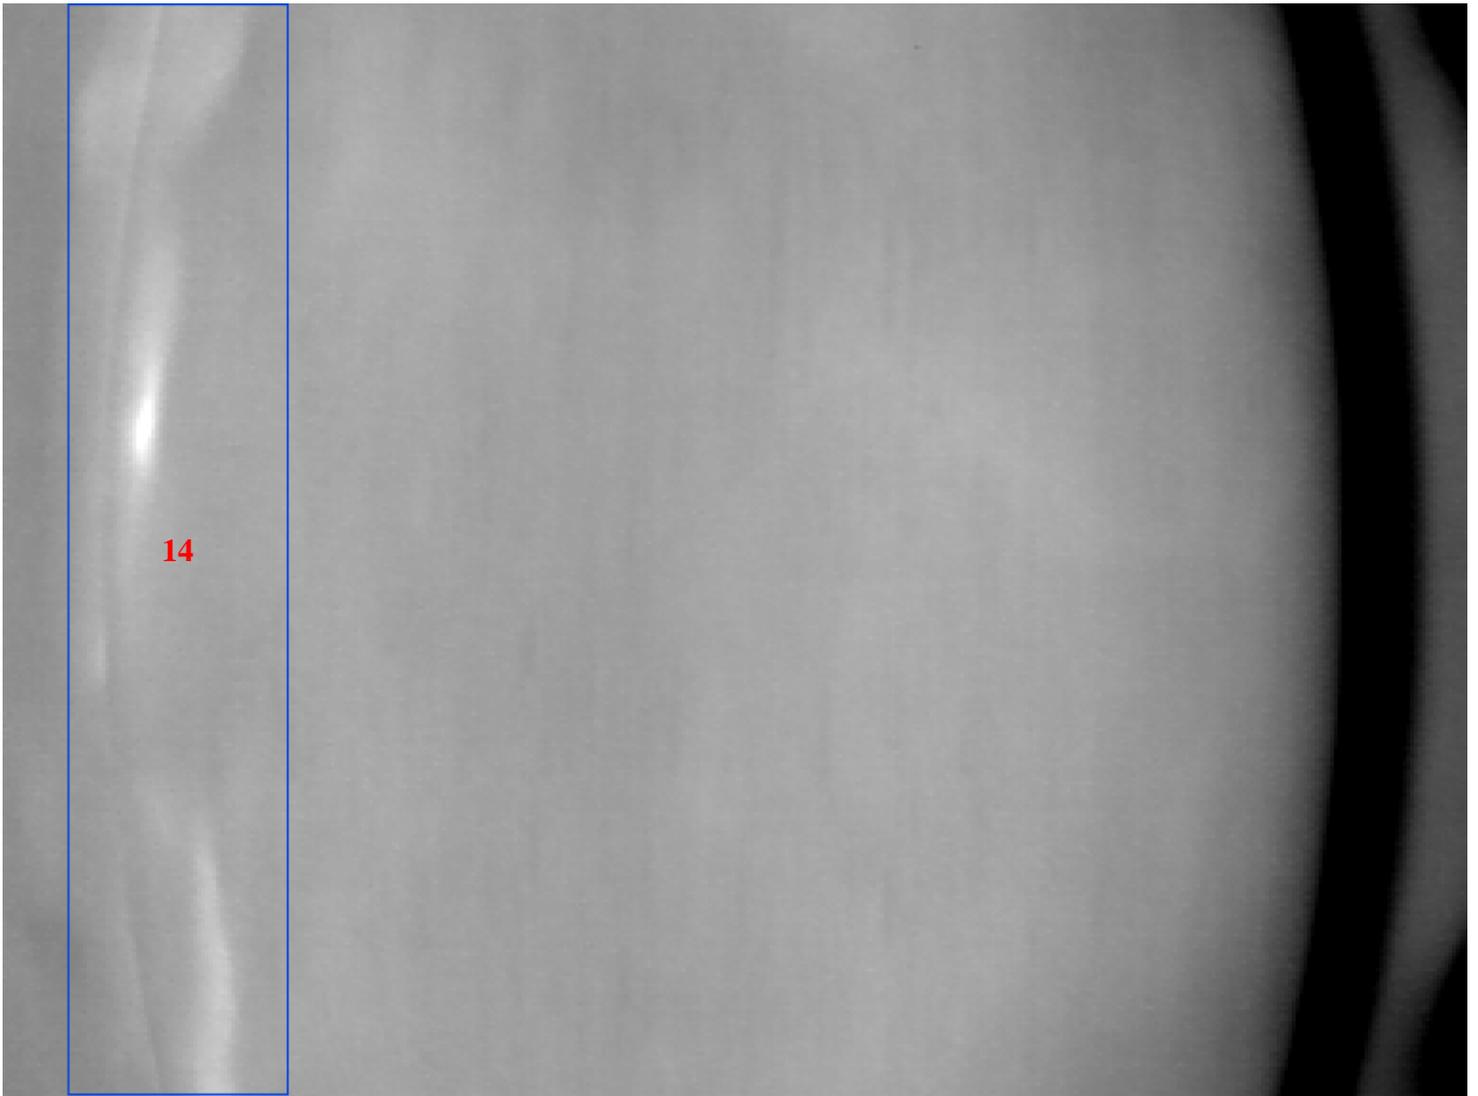
Image Name: 1\_5725000\_46158\_3597.tif

28.23	0.42	59.06	17.97	2_7206000_44862_1798.tif	78	<a href="#">34</a>
26.18	0.39	85.10	13.20	1_5725000_46158_3597.tif	14	<a href="#">15</a>
23.35	0.35	173.44	12.18	1_8047000_46280_3597.tif	43	<a href="#">23</a>

Defect #	14
Feet from Start	85.10
Feet from Right	13.20
Defect Size	26.18 sq ft
Length x Width (ft)	11.02 x 2.27
Type	Delam

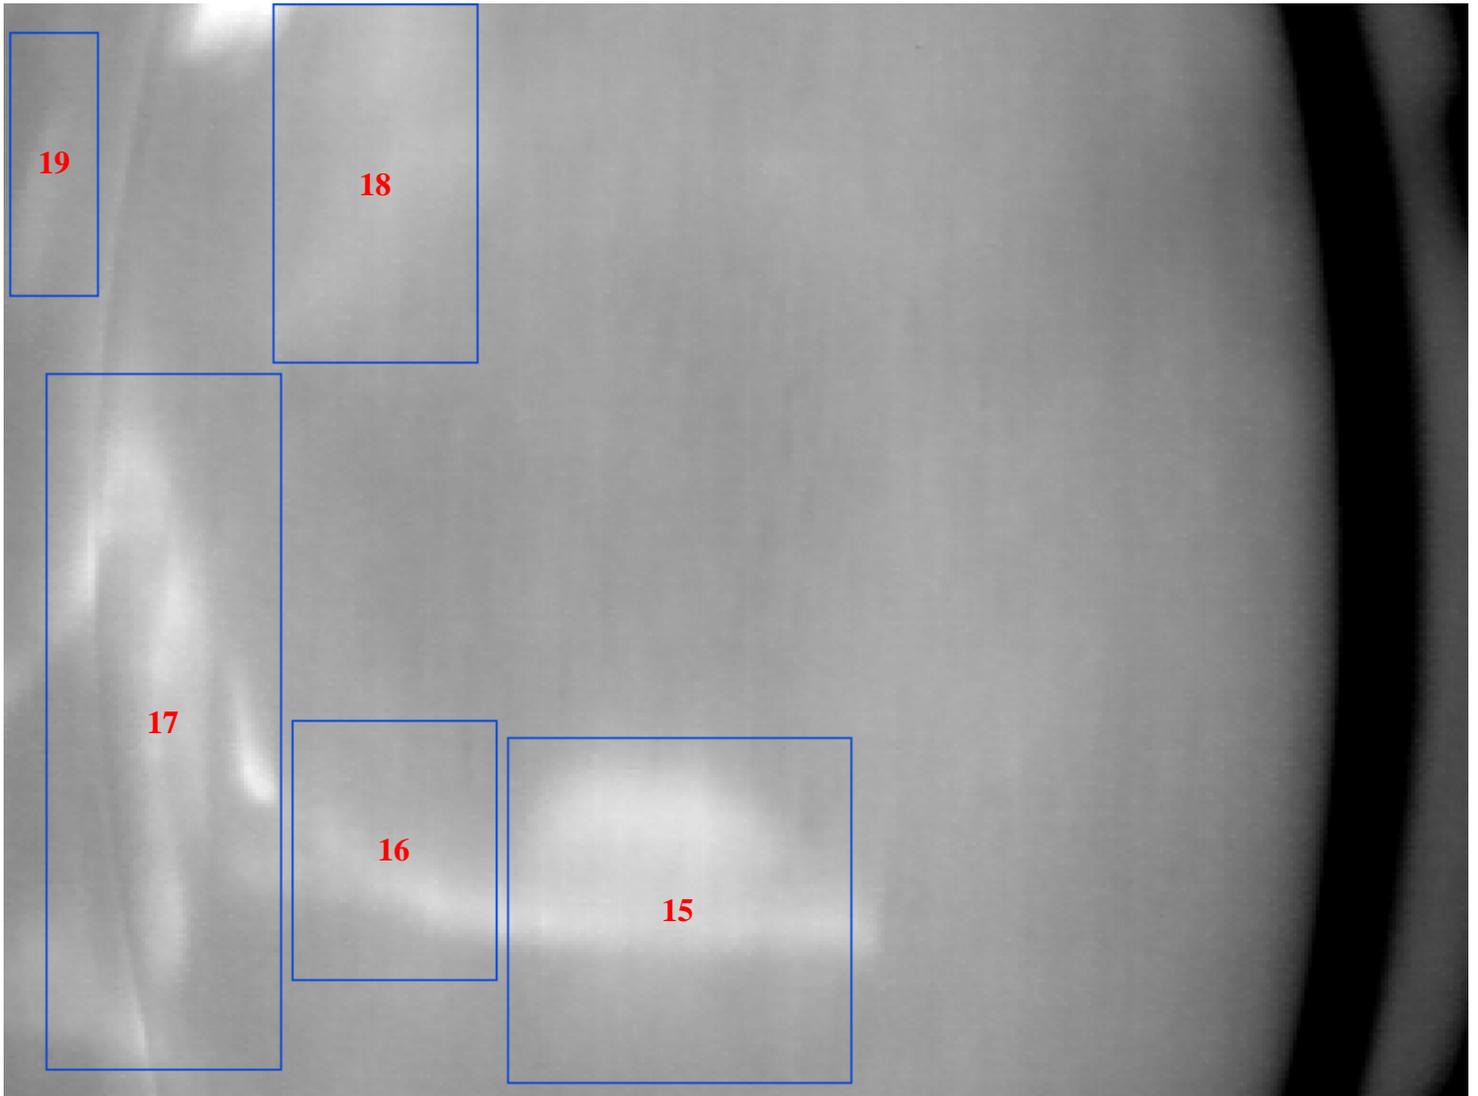
Image Name: 1\_6016000\_46158\_3597.tif

Defect #	15	16	17	18	19
Feet from Start	92.65	93.25	94.55	99.98	100.18
Feet from Right	8.08	11.00	13.36	11.19	14.48
Defect Size	12.97 sq ft	5.83 sq ft	17.87 sq ft	8.04 sq ft	2.57 sq ft
Length x Width (ft)	3.50 x 3.54	2.63 x 2.11	7.04 x 2.42	3.63 x 2.11	2.67 x 0.92
Type	Delam	Delam	Delam	Delam	Delam

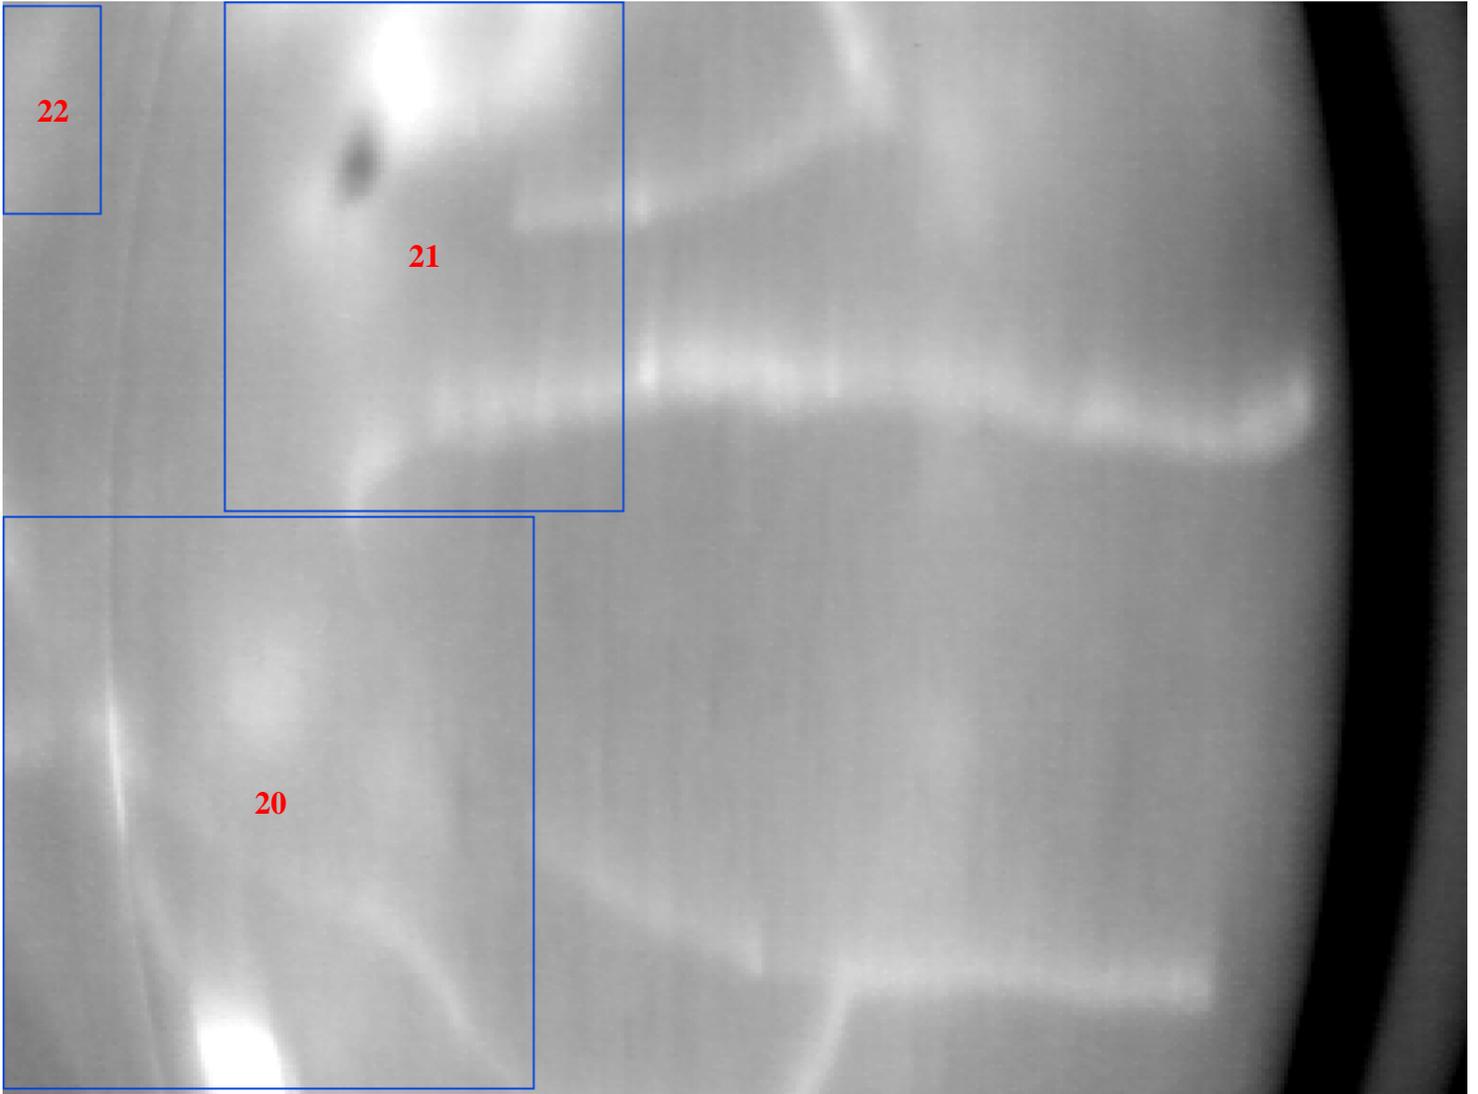
Image Name: 1\_6307000\_46037\_3597.tif

33.41	0.49	203.43	12.71	1_8918000_45895_3598.tif	49	<a href="#">26</a>
33.40	0.49	137.37	22.37	2_5122000_44821_1799.tif	106	<a href="#">41</a>
33.07	0.49	104.88	12.28	1_6307000_46037_3597.tif	20	<a href="#">17</a>

22.16	0.33	110.39	10.68	1_6307000_46037_3597.tif	21	<a href="#">17</a>
21.92	0.32	115.98	11.47	1_6596000_46037_3597.tif	25	<a href="#">18</a>
21.59	0.32	216.99	13.43	1_9208000_45895_3598.tif	52	<a href="#">27</a>

Defect #	20	21	22
Feet from Start	104.88	110.39	111.87
Feet from Right	12.28	10.68	14.49
Defect Size	33.07 sq ft	22.16 sq ft	2.25 sq ft
Length x Width (ft)	5.79 x 5.45	5.15 x 4.10	2.12 x 1.02
Type	Delam	Delam	Delam

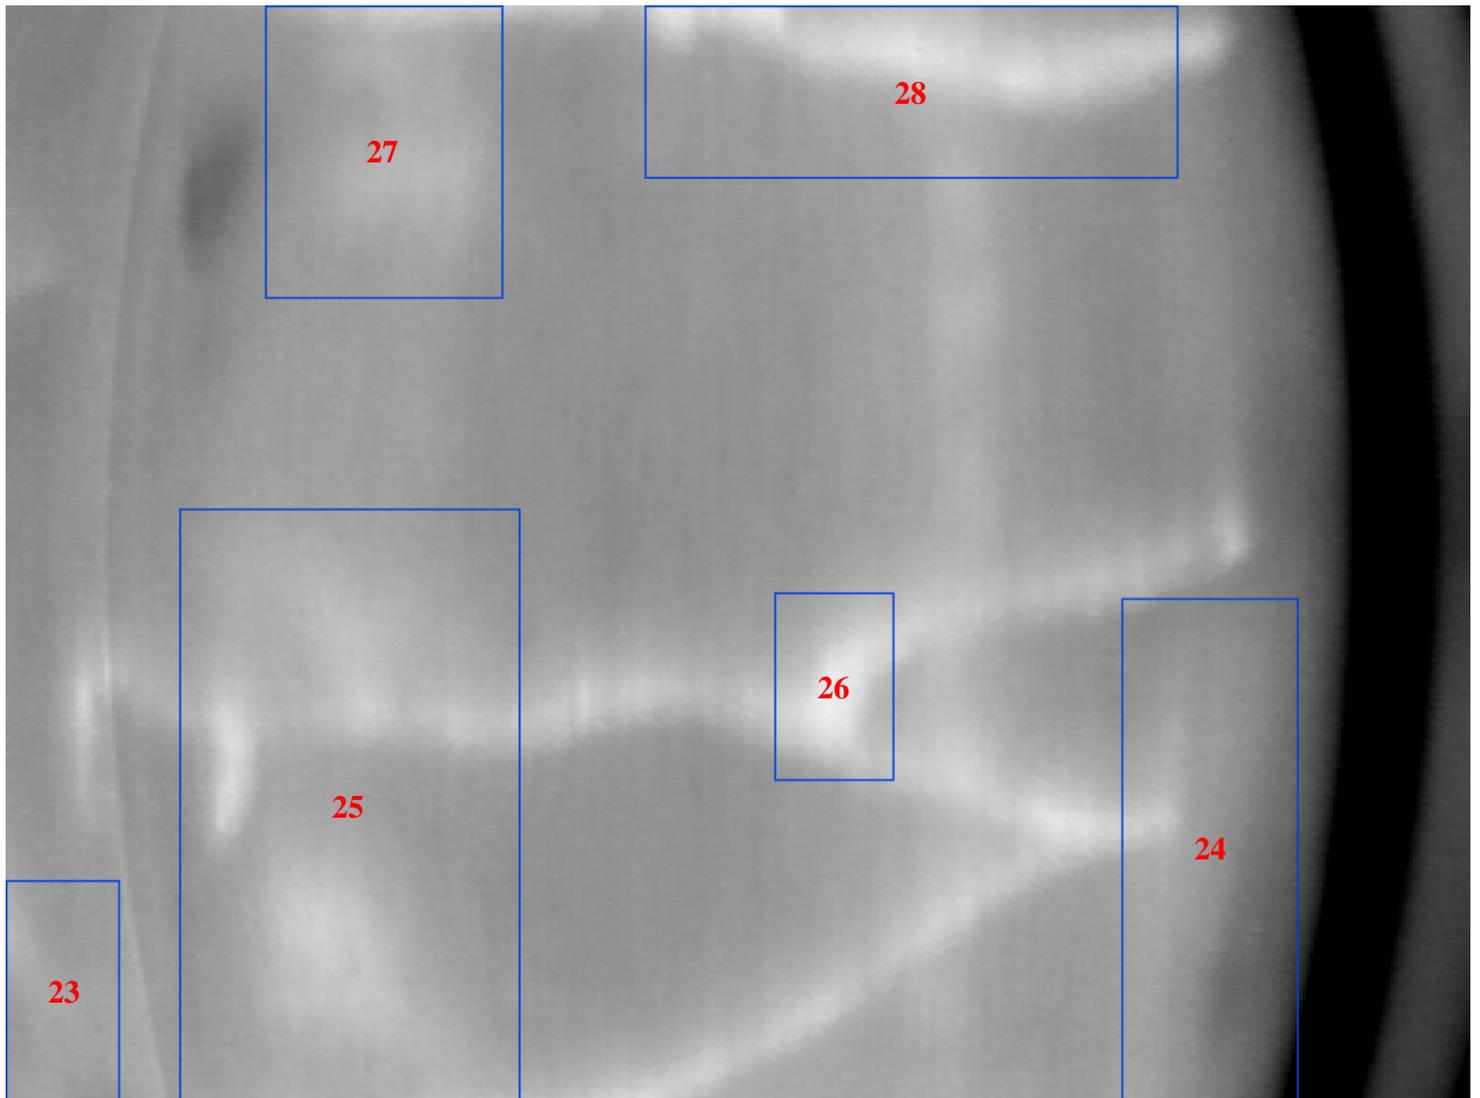
Image Name: 1\_6596000\_46037\_3597.tif

Defect #	23	24	25	26	27	28
Feet from Start	114.11	115.53	115.98	117.18	120.38	120.99
Feet from Right	14.41	2.67	11.47	6.51	11.12	5.72
Defect Size	2.74 sq ft	9.67 sq ft	21.92 sq ft	2.46 sq ft	7.58 sq ft	10.03 sq ft
Length x Width (ft)	2.23 x 1.17	5.08 x 1.82	5.98 x 3.50	1.90 x 1.23	2.96 x 2.44	1.75 x 5.47
Type	Delam	Delam	Delam	Delam	Delam	Delam
