# Bridge Deck Delamination Report

Bridge: 1282 24 mile rd  
Talon Research, Inc.  
09/16/2013

Client:	MTU Study
Bridge Name:	1282 24 mile rd
Number of Lanes:	2
Length of Bridge [ft]:	225.22
Width of Bridge [ft]:	30.00
Bridge Code:	
Year Built:	
State Name:	Michigan
State Code:	265
County Name:	Calhoun
County Code:	test
Control Section:	
Location:	
Facility Carried by Structure:	24 mile rd
Features Intersected:	I94

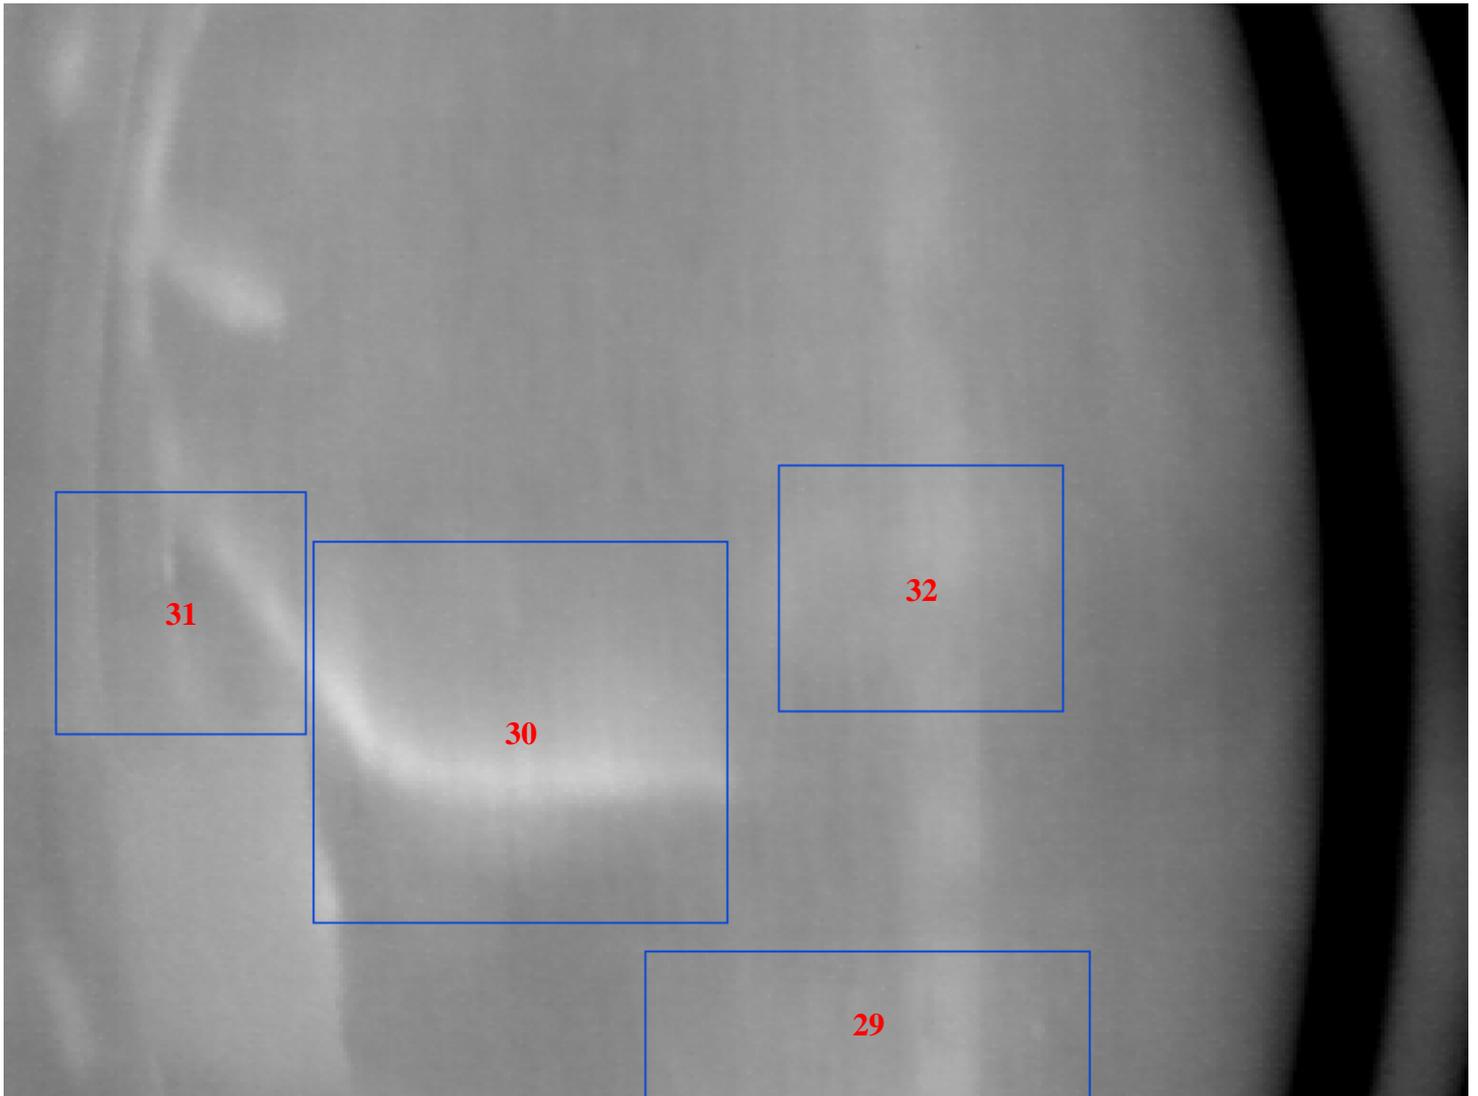
Image Name: 1\_6881000\_46037\_3597.tif

Defect #	29	30	31	32
Feet from Start	124.68	125.44	126.64	129.08
Feet from Right	6.15	9.71	13.18	5.61
Defect Size	7.19 sq ft	17.26 sq ft	6.65 sq ft	7.68 sq ft
Length x Width (ft)	1.50 x 4.57	3.87 x 4.26	2.46 x 2.58	2.50 x 2.93
Type	Delam	Delam	Delam	Delam
