**Appendix D – BridgeGuard US-131 Delamination Report**

# Bridge Deck Delamination Report

Bridge: 5002 SB  
Talon Research, Inc.  
09/16/2013

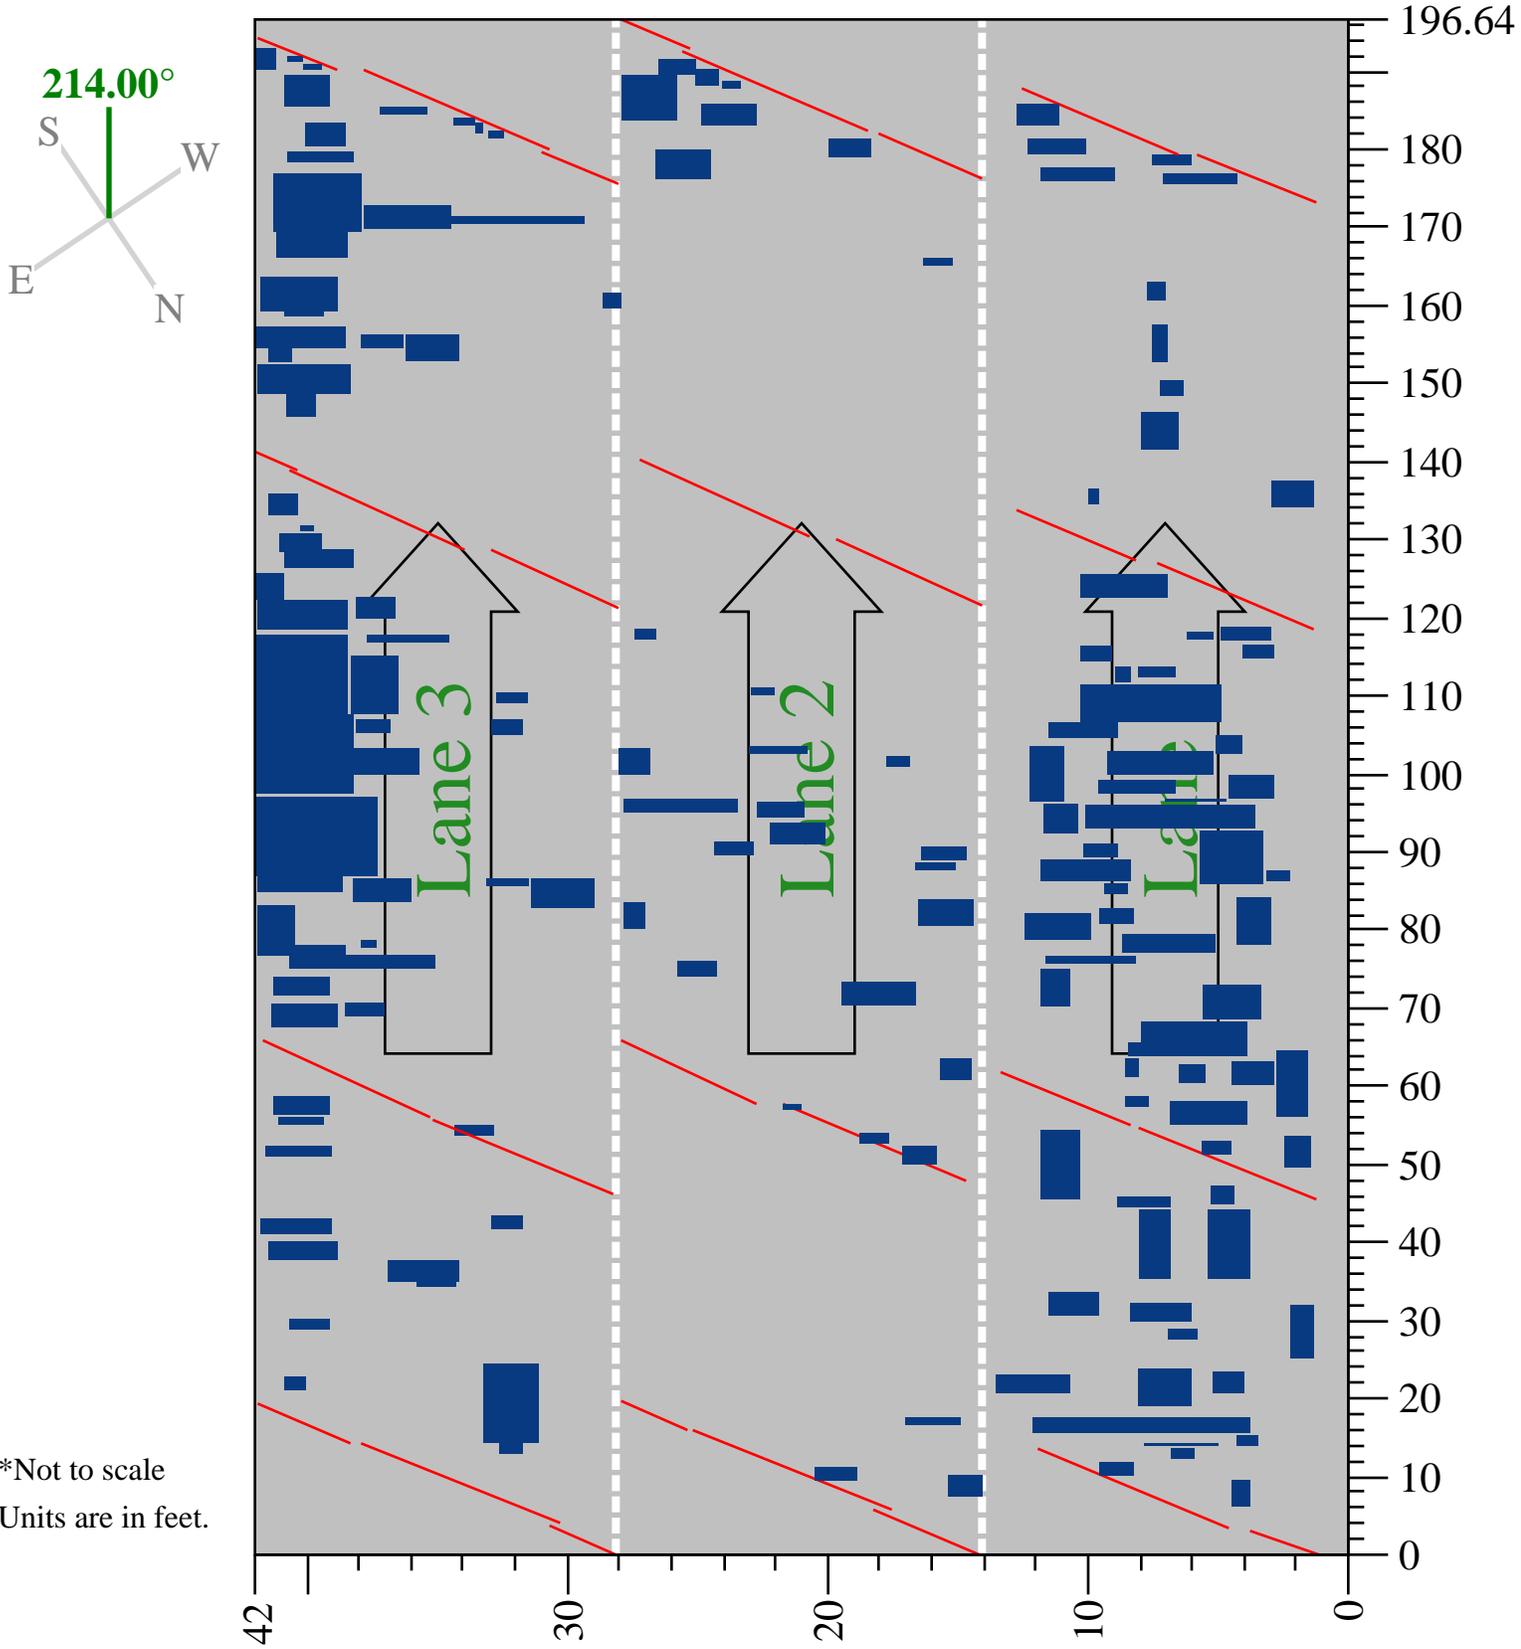
# Pattern Overview

Total Bridge Area (sq ft): 8258.85  
 Defect Area (sq ft): 989.63

# of Defects: 161  
 % Defective: 11.98

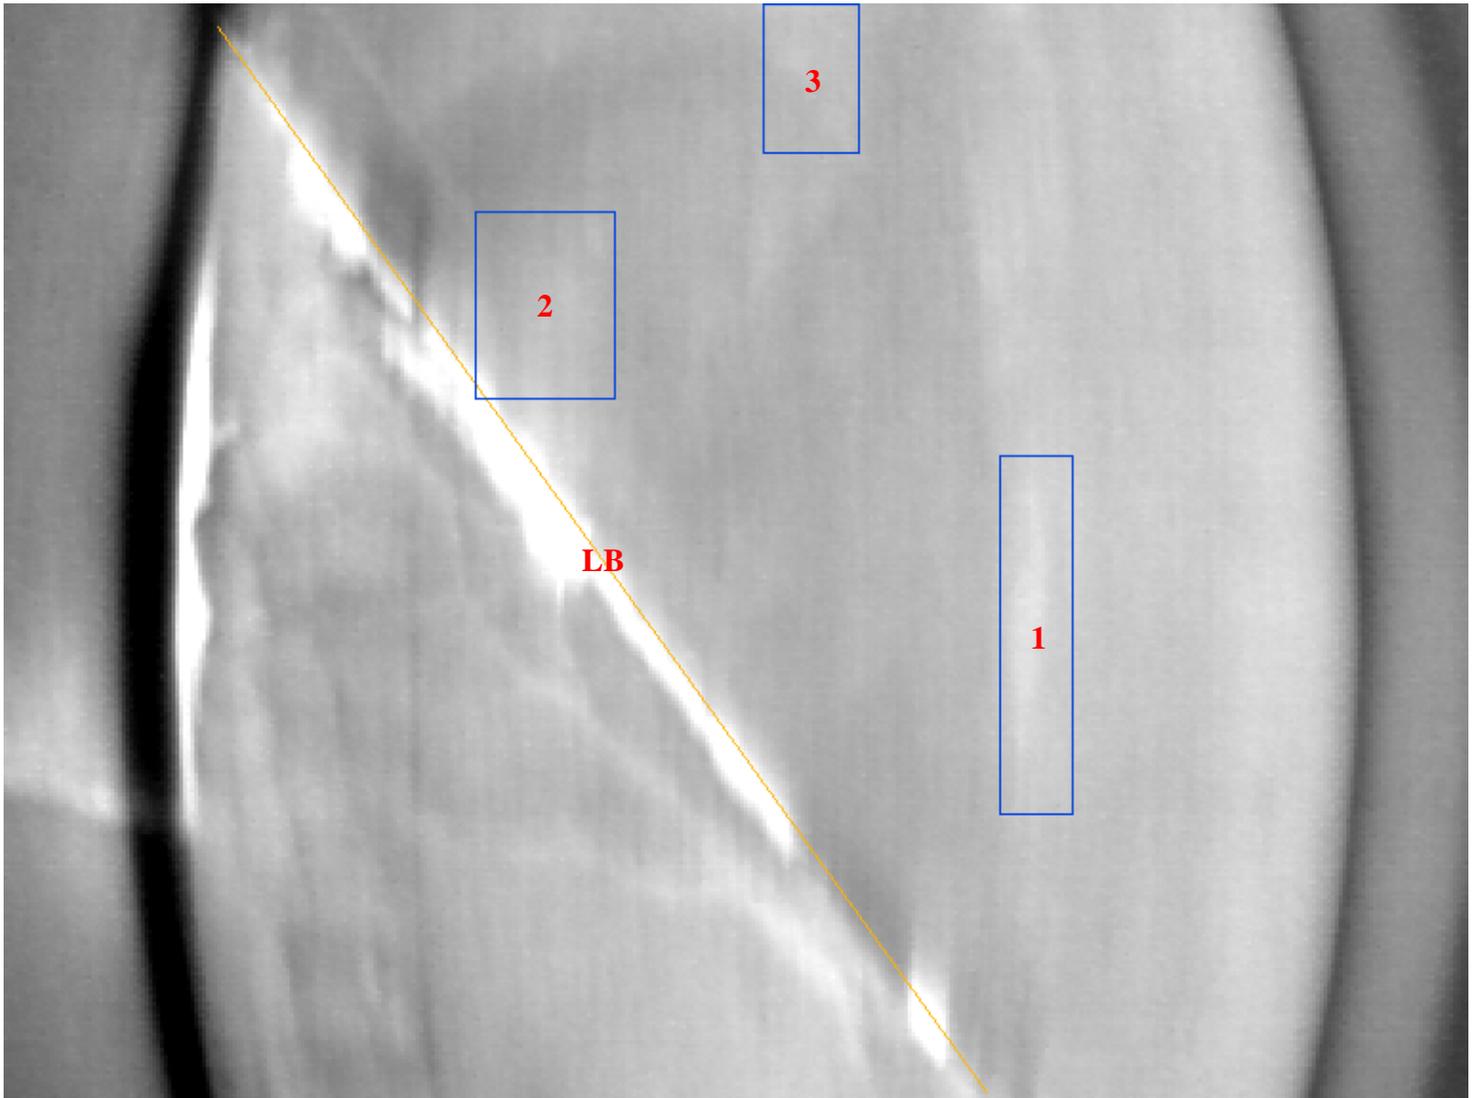
Image Name: 1\_2454000\_57095\_2176.tif

Defect #	1	LB	2	3
Feet from Start	7.81	8.53	10.91	13.06
Feet from Right	4.13	8.29	8.82	6.28
Defect Size	2.52 sq ft	NA	2.50 sq ft	1.38 sq ft
Length x Width (ft)	3.38 x 0.71	NA	1.77 x 1.35	1.41 x 0.93
Type	Delam	Lane Bound	Delam	Delam

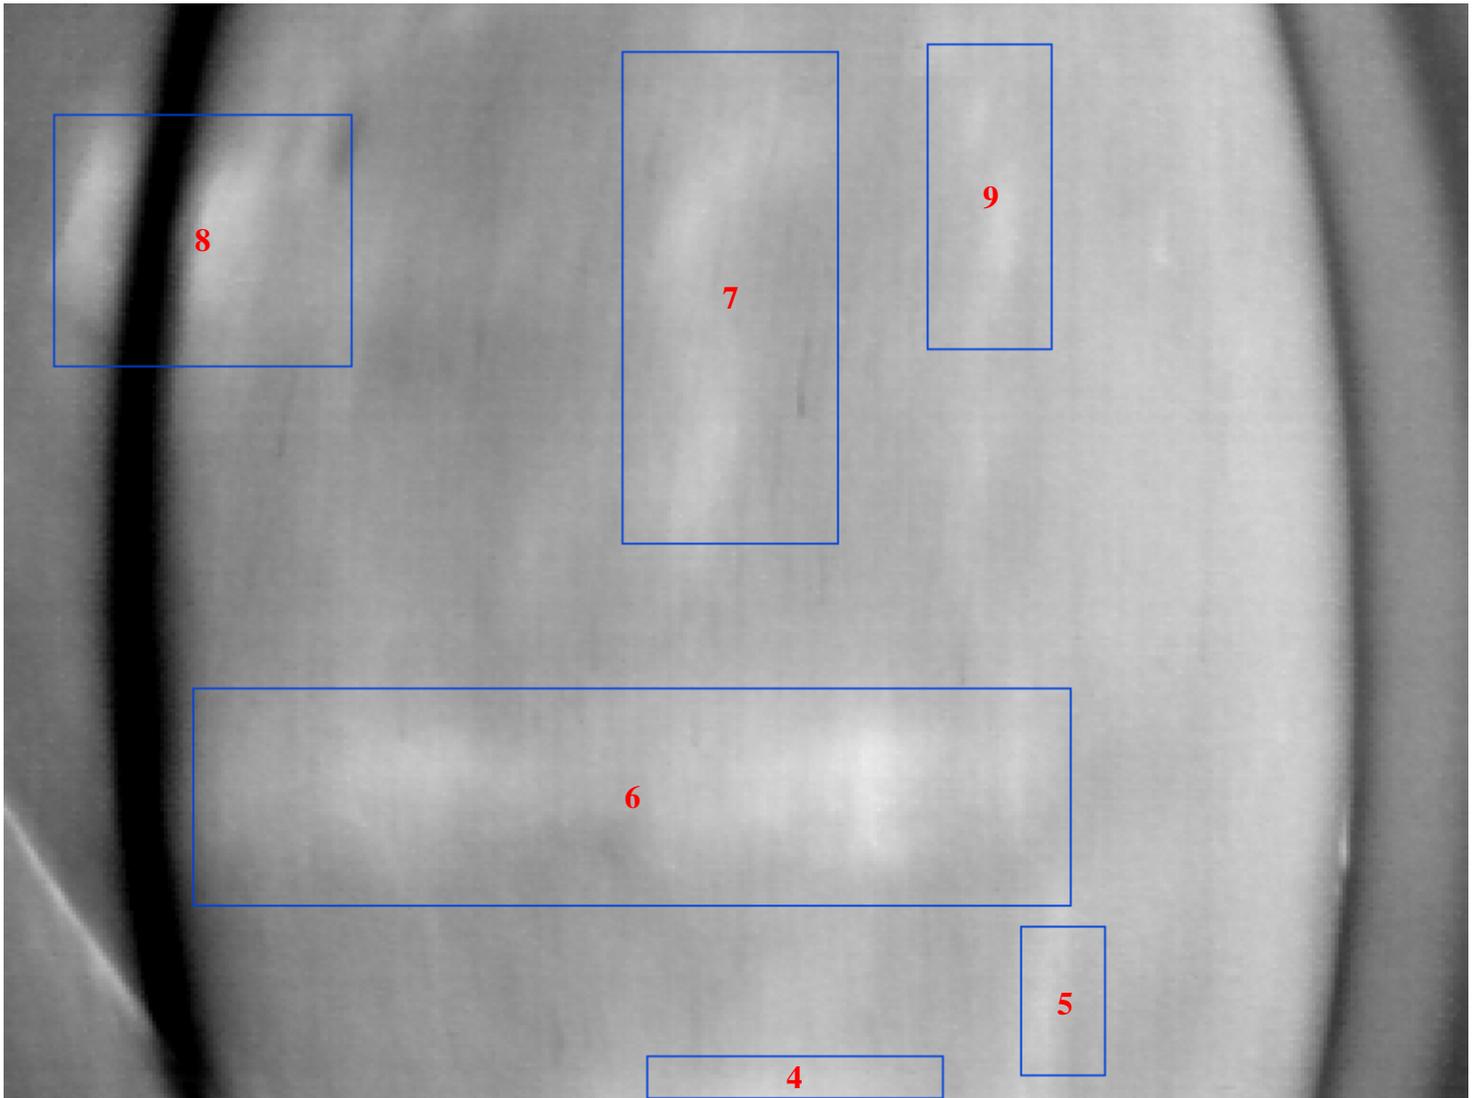
Image Name: 1\_2670000\_57095\_2176.tif

Defect #	4	5	6	7	8	9
Feet from Start	13.95	14.65	16.57	21.26	21.80	22.21
Feet from Right	6.43	3.87	7.99	7.05	12.10	4.58
Defect Size	1.23 sq ft	1.21 sq ft	18.11 sq ft	10.09 sq ft	7.13 sq ft	3.63 sq ft
Length x Width (ft)	0.41 x 2.84	1.41 x 0.82	2.06 x 8.40	4.64 x 2.08	2.38 x 2.86	2.88 x 1.20
Type	Delam	Delam	Delam	Delam	Delam	Delam

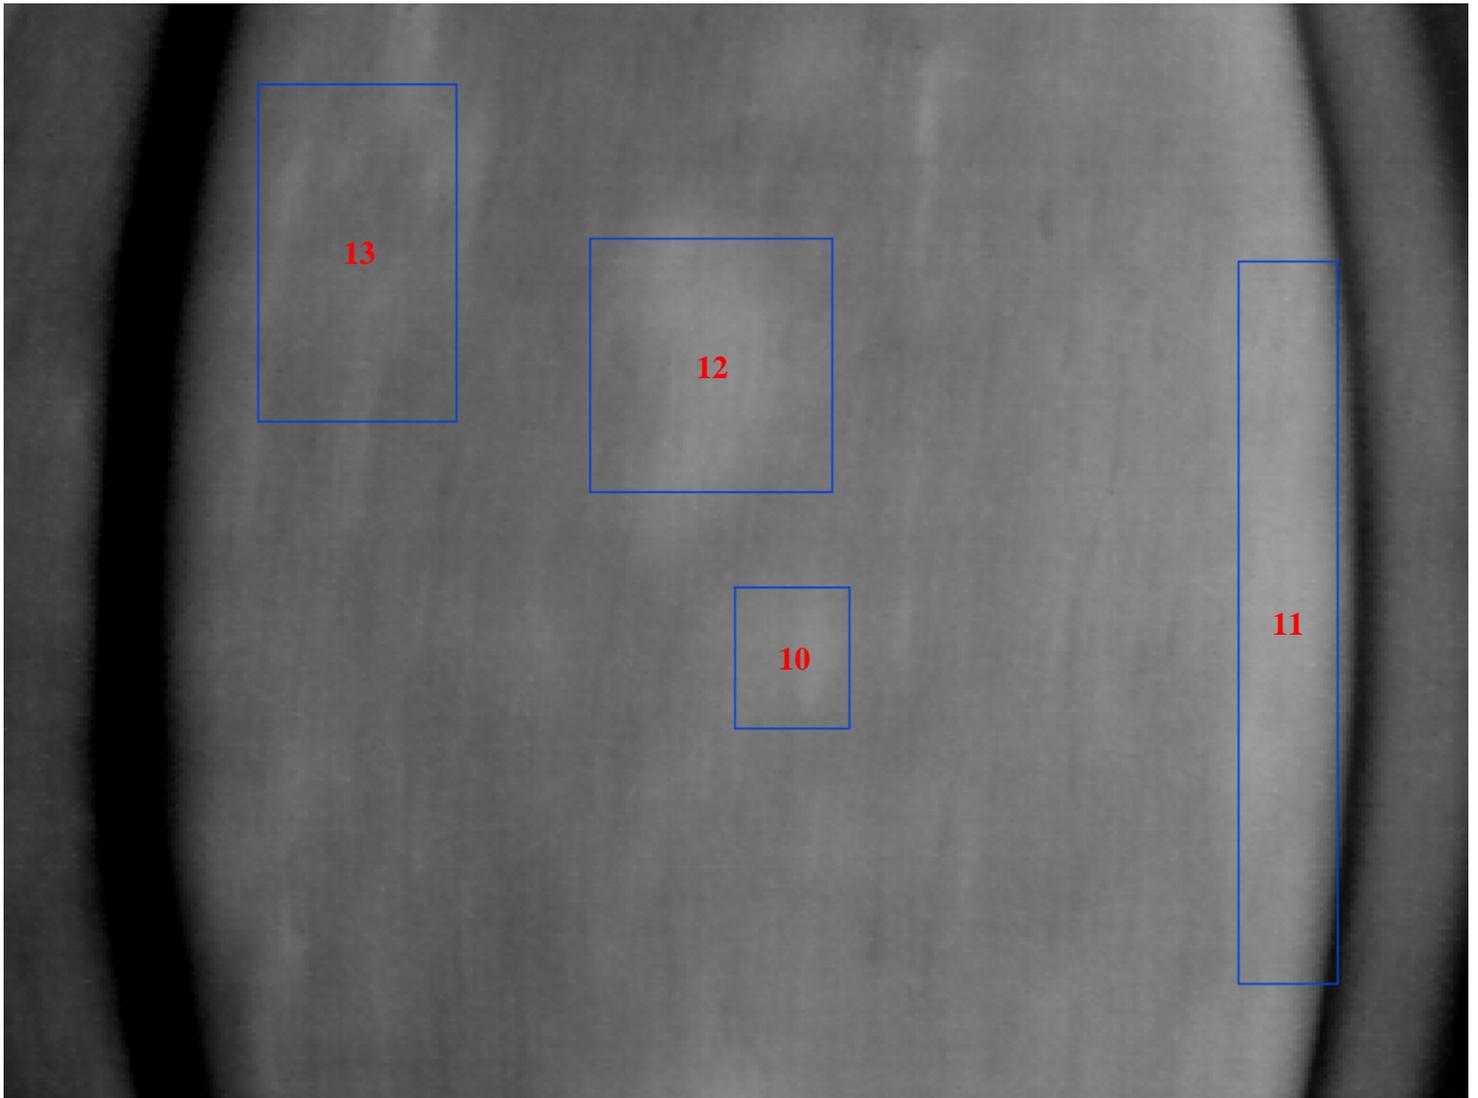
Image Name: 1\_2885000\_57095\_2176.tif

Defect #	10	11	12	13
Feet from Start	28.10	28.44	30.85	31.91
Feet from Right	6.46	1.72	7.24	10.62
Defect Size	1.56 sq ft	6.88 sq ft	5.86 sq ft	6.38 sq ft
Length x Width (ft)	1.34 x 1.11	6.81 x 0.97	2.40 x 2.33	3.19 x 1.91
Type	Delam	Delam	Delam	Delam

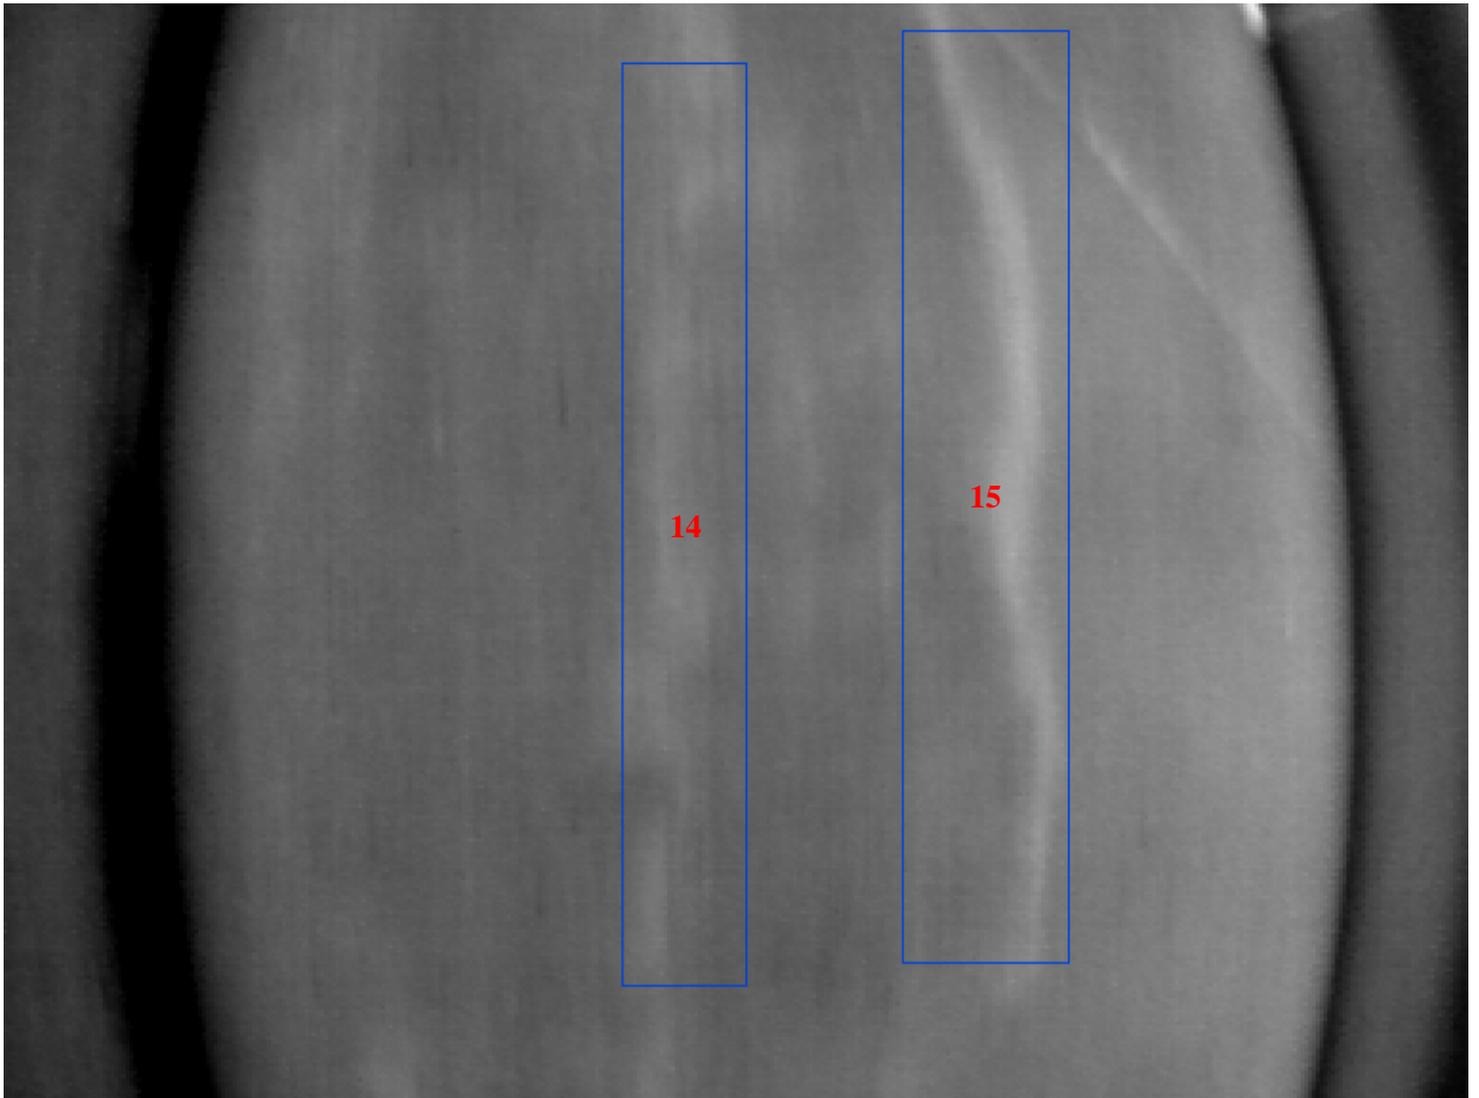
Image Name: 1\_3100000\_57095\_2176.tif

Defect #	14	15
Feet from Start	39.59	39.85
Feet from Right	7.49	4.61
Defect Size	10.94 sq ft	14.73 sq ft
Length x Width (ft)	8.69 x 1.20	8.78 x 1.60
Type	Delam	Delam

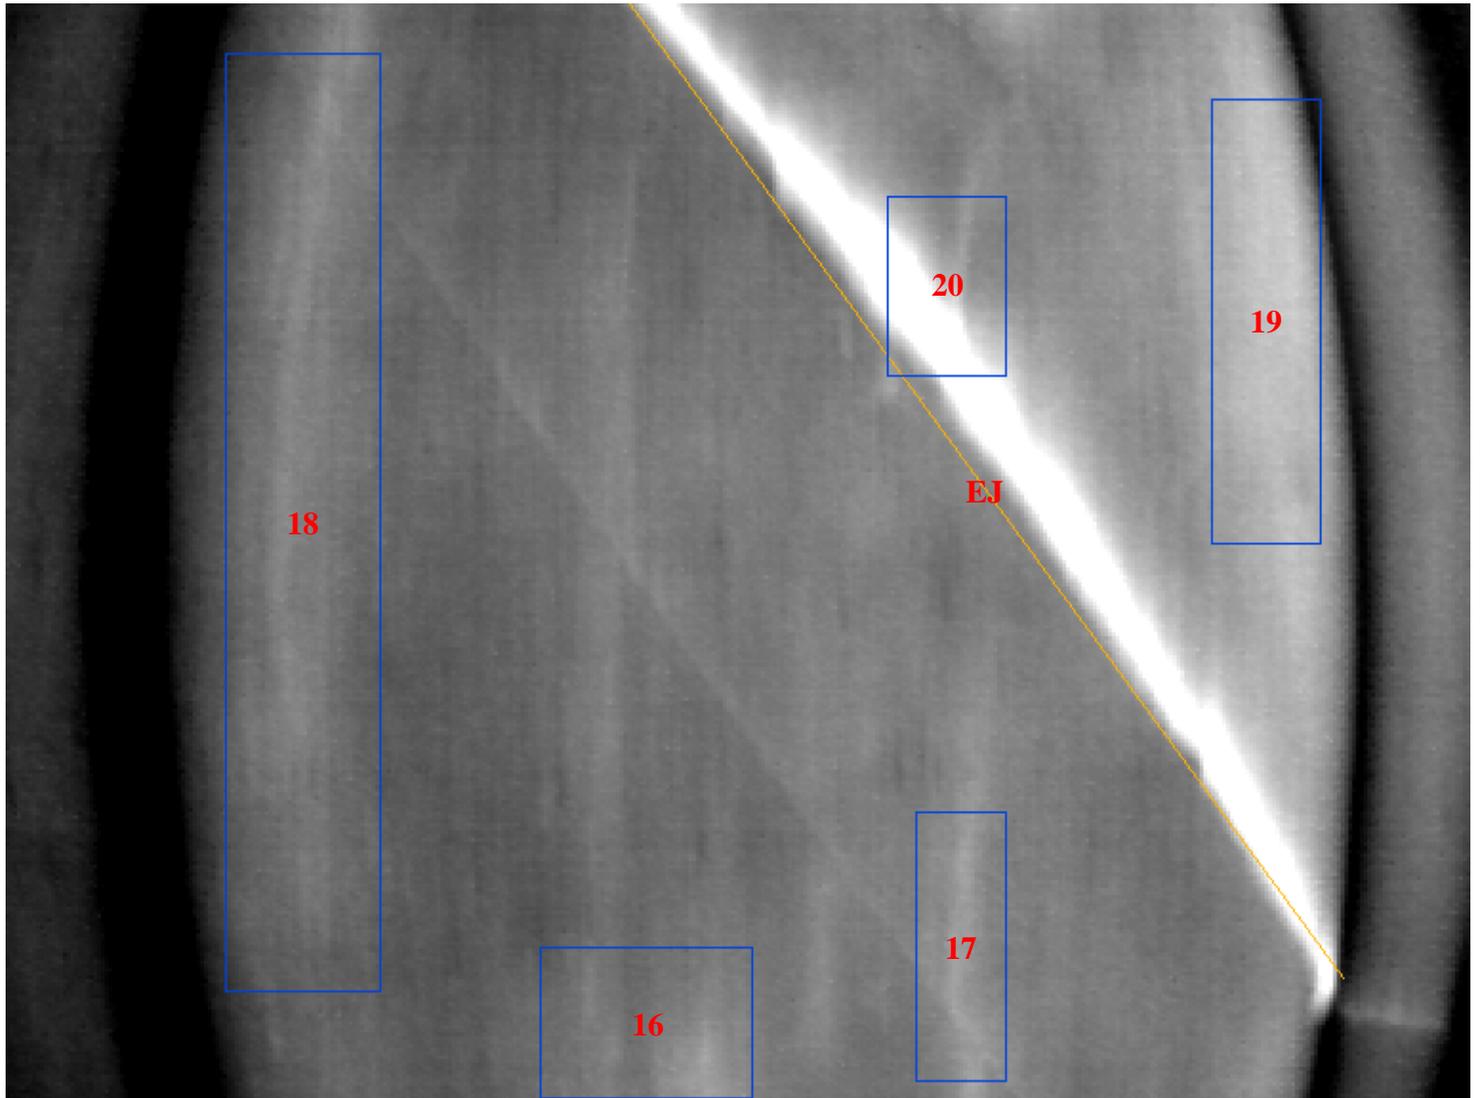
Image Name: 1\_3315000\_57075\_2174.tif

Defect #	16	17	18	EJ	19	20
Feet from Start	45.13	45.85	49.83	50.14	51.72	52.07
Feet from Right	7.88	4.87	11.16	4.63	1.95	5.00
Defect Size	3.06 sq ft	2.33 sq ft	13.81 sq ft	NA	4.64 sq ft	2.04 sq ft
Length x Width (ft)	1.43 x 2.04	2.54 x 0.88	8.83 x 1.49	NA	4.19 x 1.06	1.70 x 1.15
Type	Delam	Delam	Delam	Joint	Delam	Delam

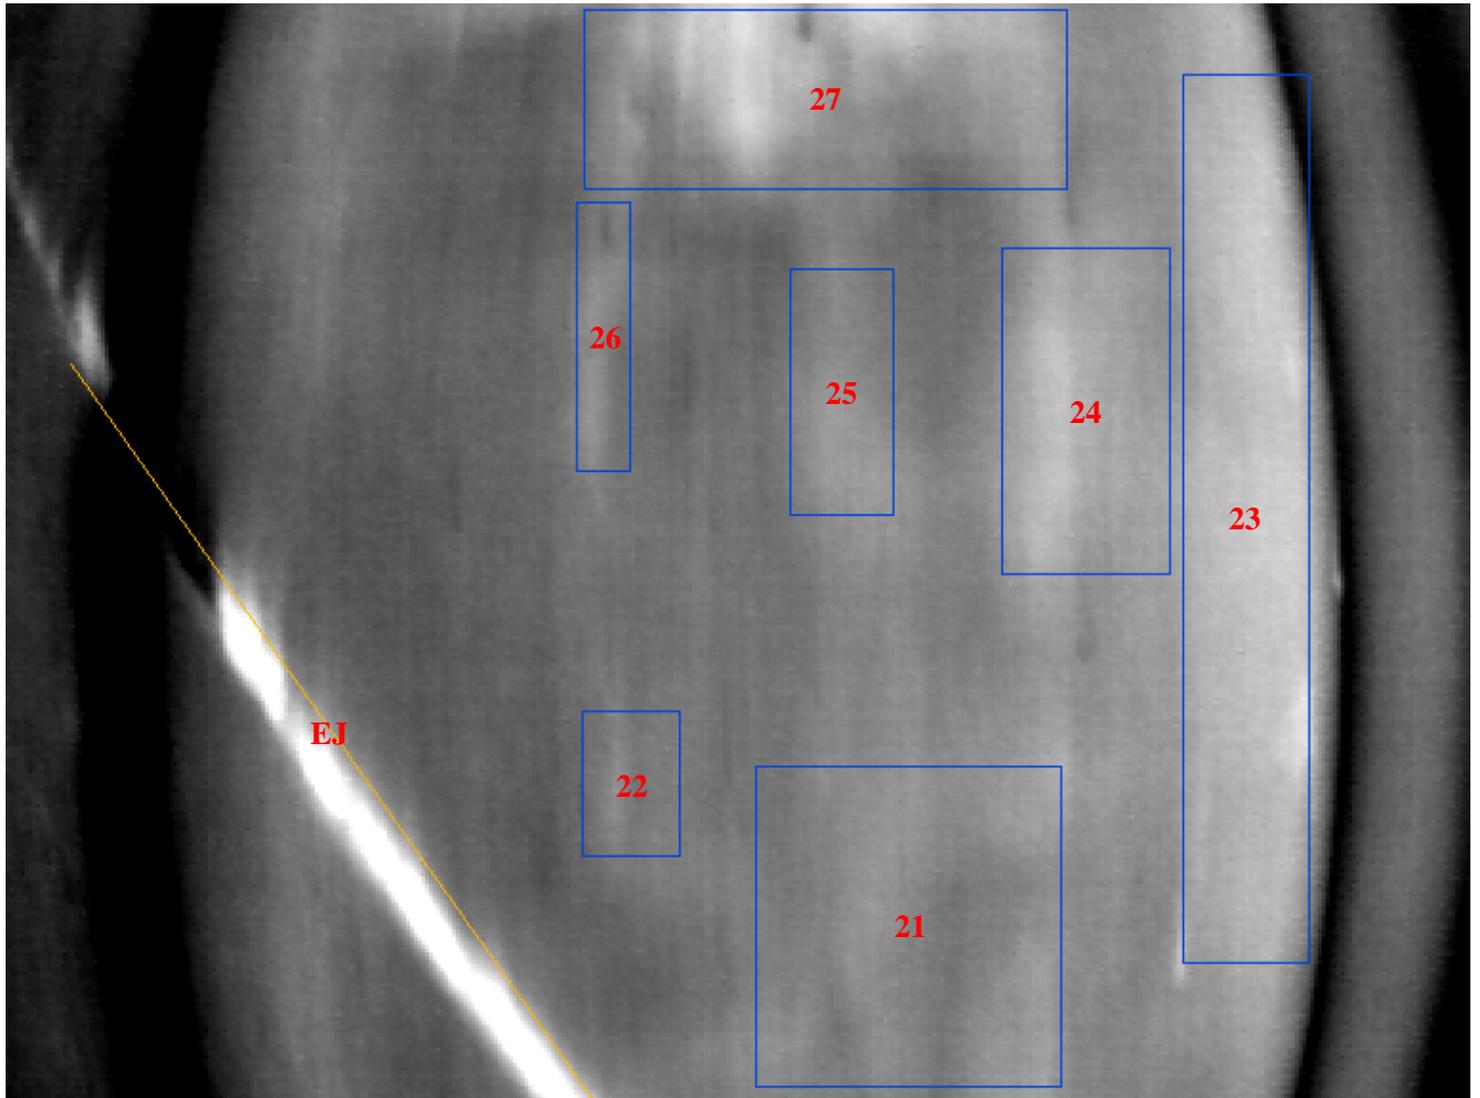
Image Name: 1\_3538000\_57075\_2174.tif

Defect #	21	22	EJ	23	24	25	26	27
Feet from Start	56.66	58.00	58.49	60.47	61.49	61.66	62.18	64.41
Feet from Right	5.37	8.02	10.89	2.14	3.67	6.01	8.29	6.16
Defect Size	9.30 sq ft	1.37 sq ft	NA	10.69 sq ft	5.23 sq ft	2.44 sq ft	1.41 sq ft	8.24 sq ft
Length x Width (ft)	3.03 x 2.93	1.38 x 0.95	NA	8.36 x 1.22	3.08 x 1.62	2.33 x 1.00	2.54 x 0.53	1.70 x 4.63
Type	Delam	Delam	Joint	Delam	Delam	Delam	Delam	Delam

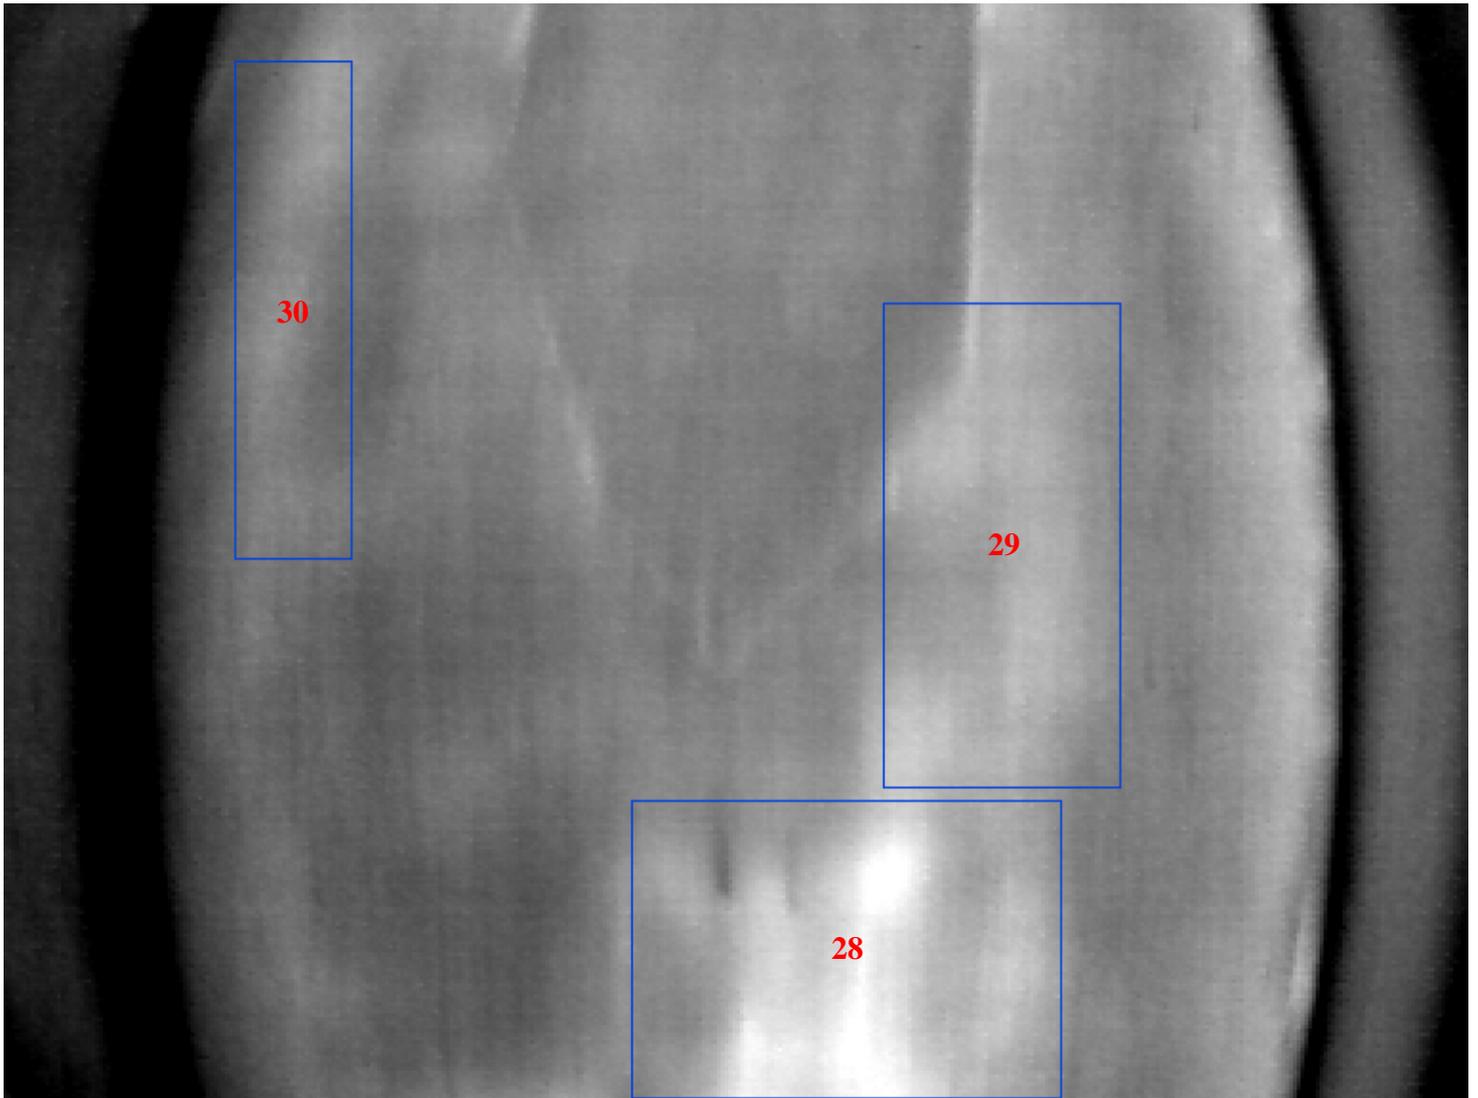
Image Name: 1\_3756000\_57075\_2174.tif

Defect #	28	29	30
Feet from Start	66.79	70.59	72.82
Feet from Right	5.94	4.46	11.23
Defect Size	12.12 sq ft	10.89 sq ft	5.55 sq ft
Length x Width (ft)	2.81 x 4.12	4.57 x 2.28	4.69 x 1.13
Type	Delam	Delam	Delam

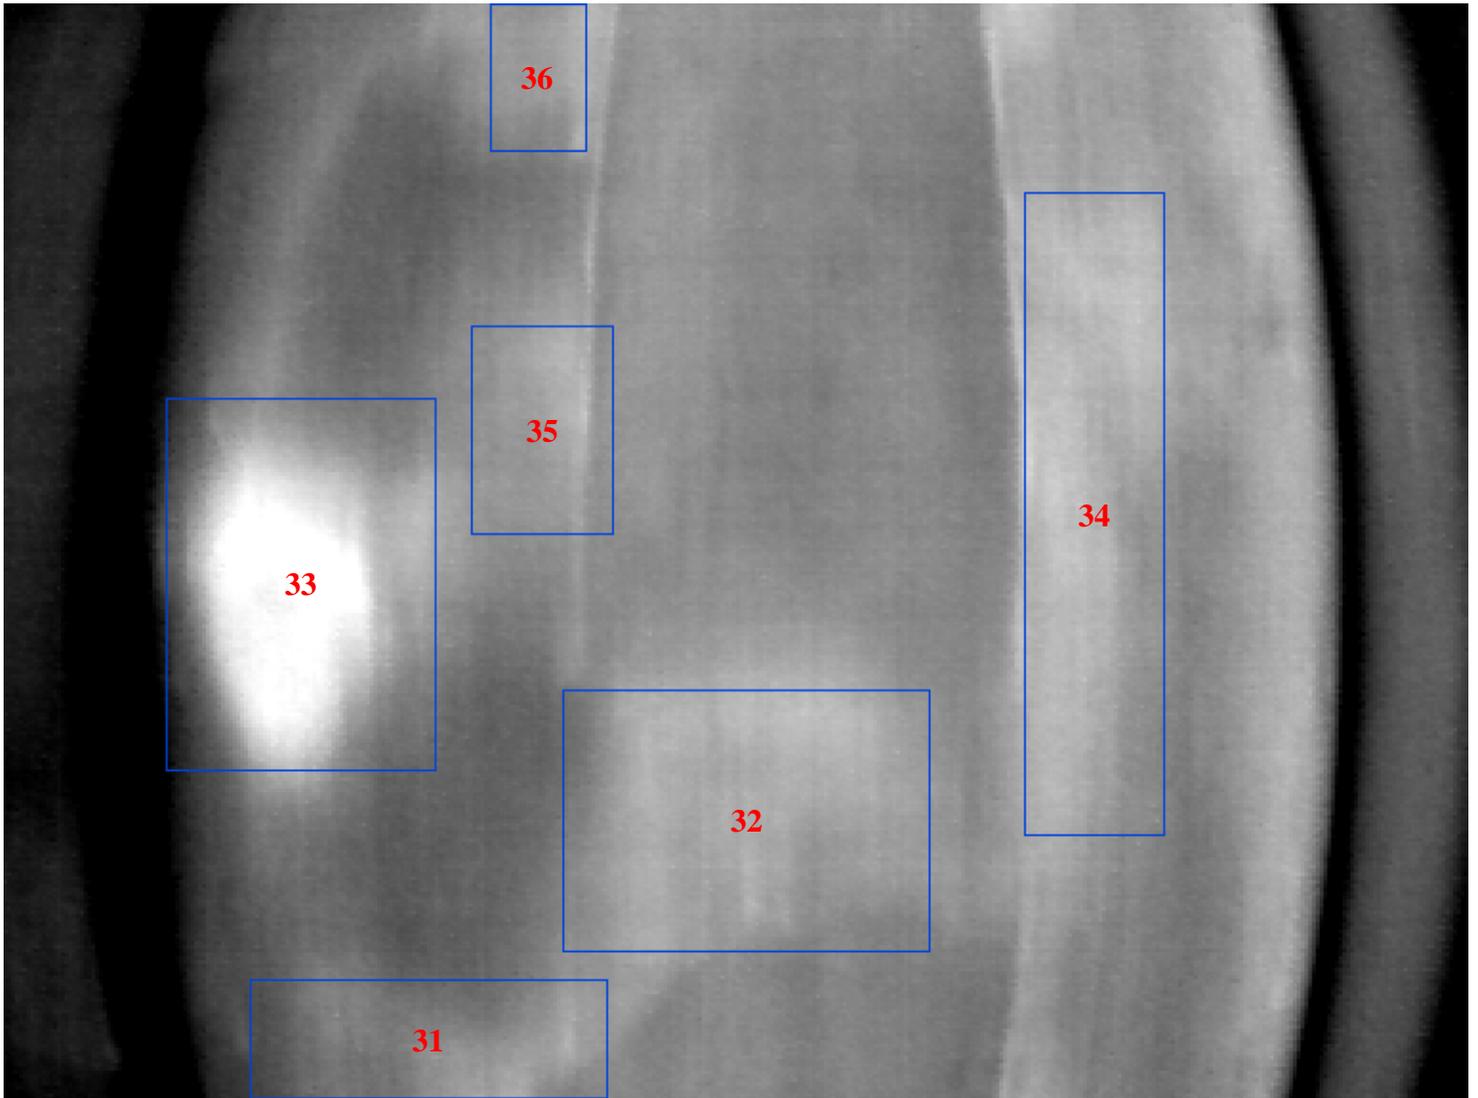
Image Name: 1\_3969000\_57075\_2174.tif

Defect #	31	32	33	34	35	36
Feet from Start	76.08	78.13	80.36	81.02	81.81	85.12
Feet from Right	9.93	6.90	11.16	3.57	8.85	8.89
Defect Size	4.05 sq ft	9.10 sq ft	9.51 sq ft	8.54 sq ft	2.82 sq ft	1.36 sq ft
Length x Width (ft)	1.13 x 3.43	2.47 x 3.52	3.51 x 2.59	6.05 x 1.35	1.97 x 1.37	1.40 x 0.93
Type	Delam	Delam	Delam	Delam	Delam	Delam

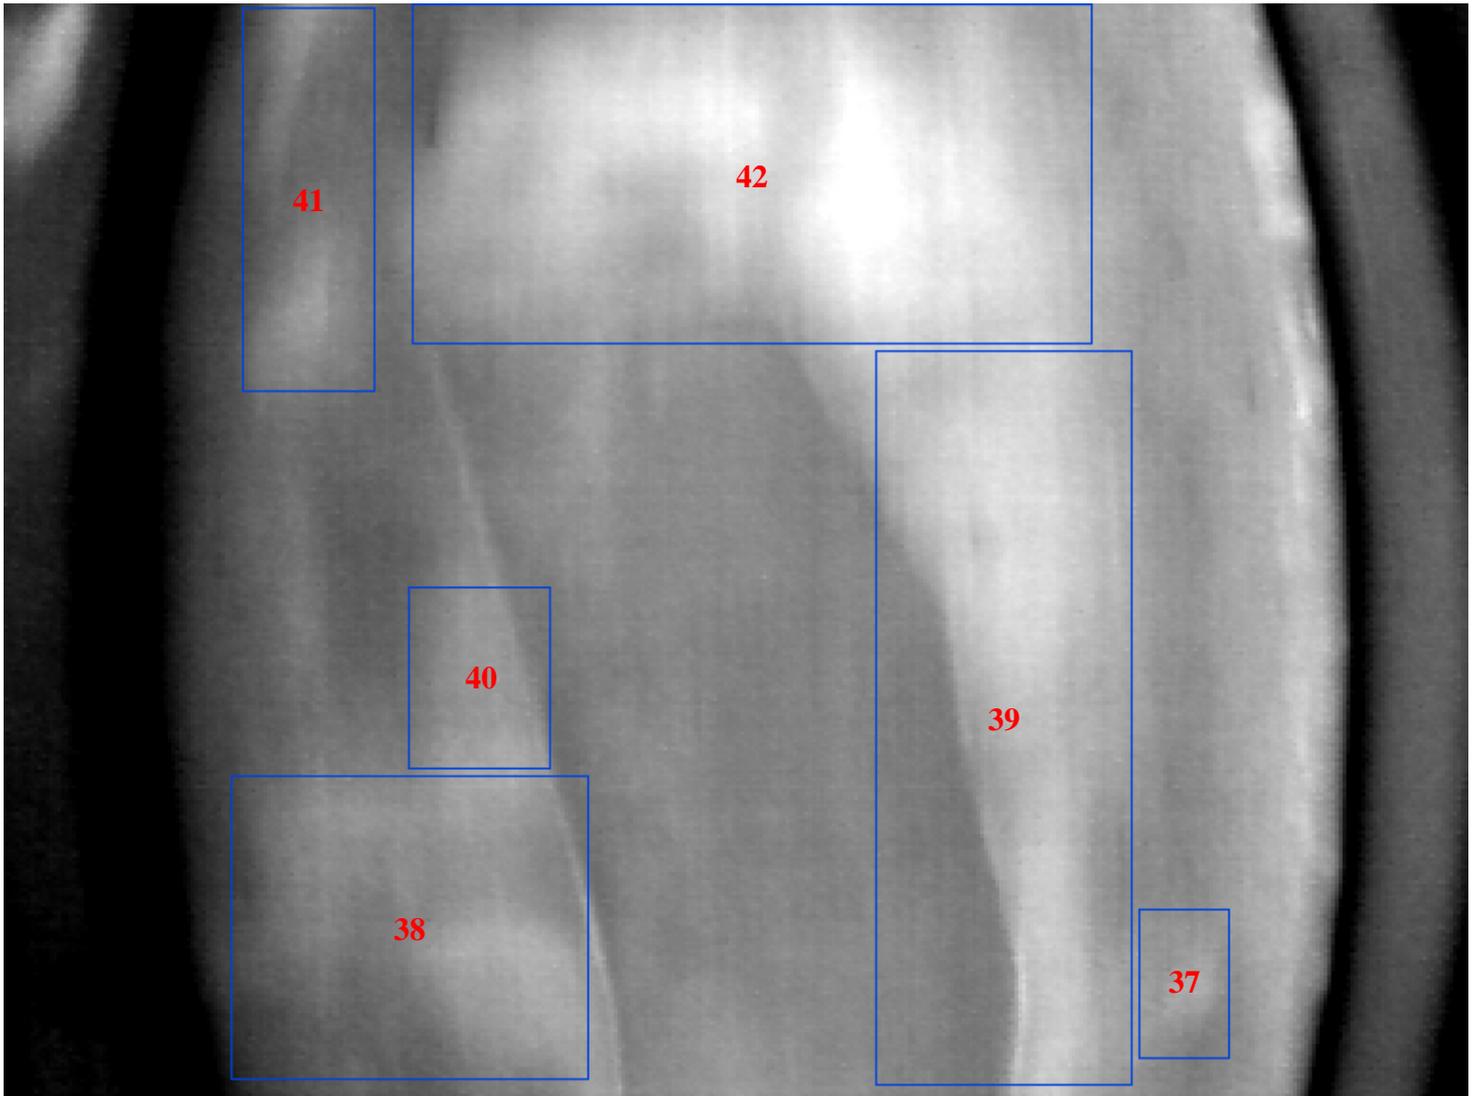
Image Name: 1\_4187000\_57075\_2174.tif

Defect #	37	38	39	40	41	42
Feet from Start	86.97	87.50	89.47	89.86	94.34	94.58
Feet from Right	2.72	10.12	4.44	9.45	11.08	6.85
Defect Size	1.30 sq ft	10.28 sq ft	17.80 sq ft	2.46 sq ft	4.83 sq ft	21.83 sq ft
Length x Width (ft)	1.41 x 0.88	2.87 x 3.43	6.91 x 2.46	1.72 x 1.37	3.62 x 1.28	3.21 x 6.51
Type	Delam	Delam	Delam	Delam	Delam	Delam

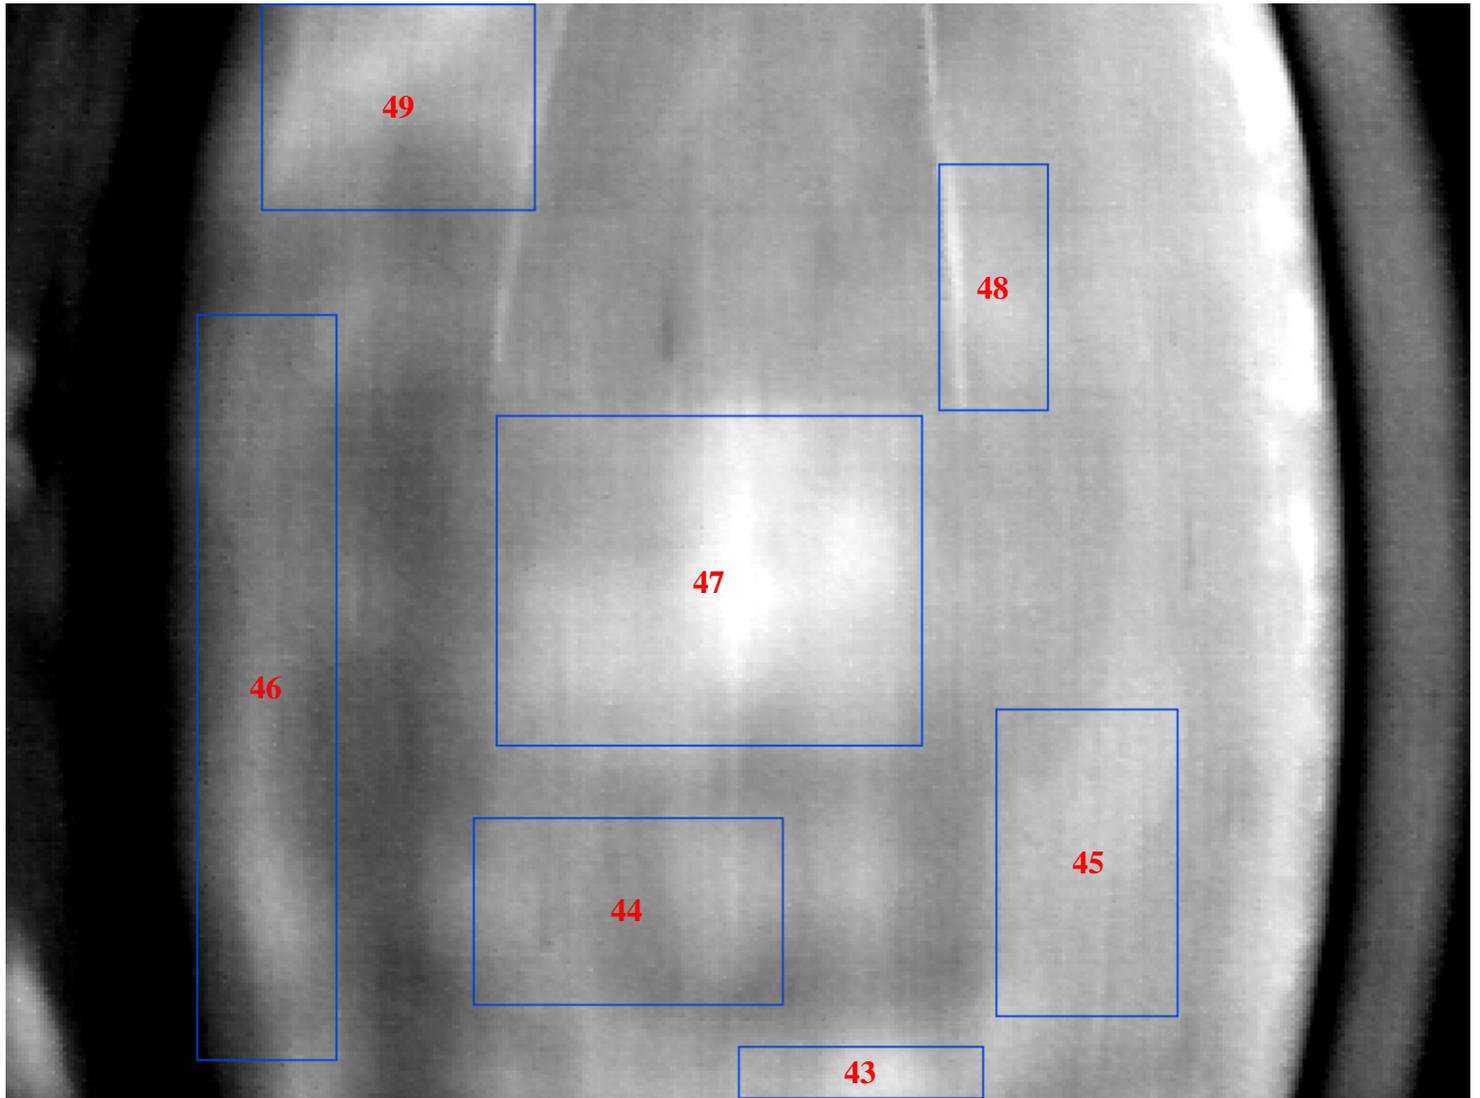
Image Name: 1\_4403000\_57440\_2171.tif

Defect #	43	44	45	46	47	48	49
Feet from Start	96.48	98.01	98.47	100.11	101.10	103.88	105.55
Feet from Right	5.82	8.05	3.66	11.50	7.27	4.56	10.24
Defect Size	1.23 sq ft	5.51 sq ft	5.31 sq ft	9.91 sq ft	13.31 sq ft	2.58 sq ft	5.36 sq ft
Length x Width (ft)	0.50 x 2.35	1.77 x 2.97	2.90 x 1.75	7.02 x 1.35	3.12 x 4.08	2.33 x 1.06	1.95 x 2.63
Type	Delam

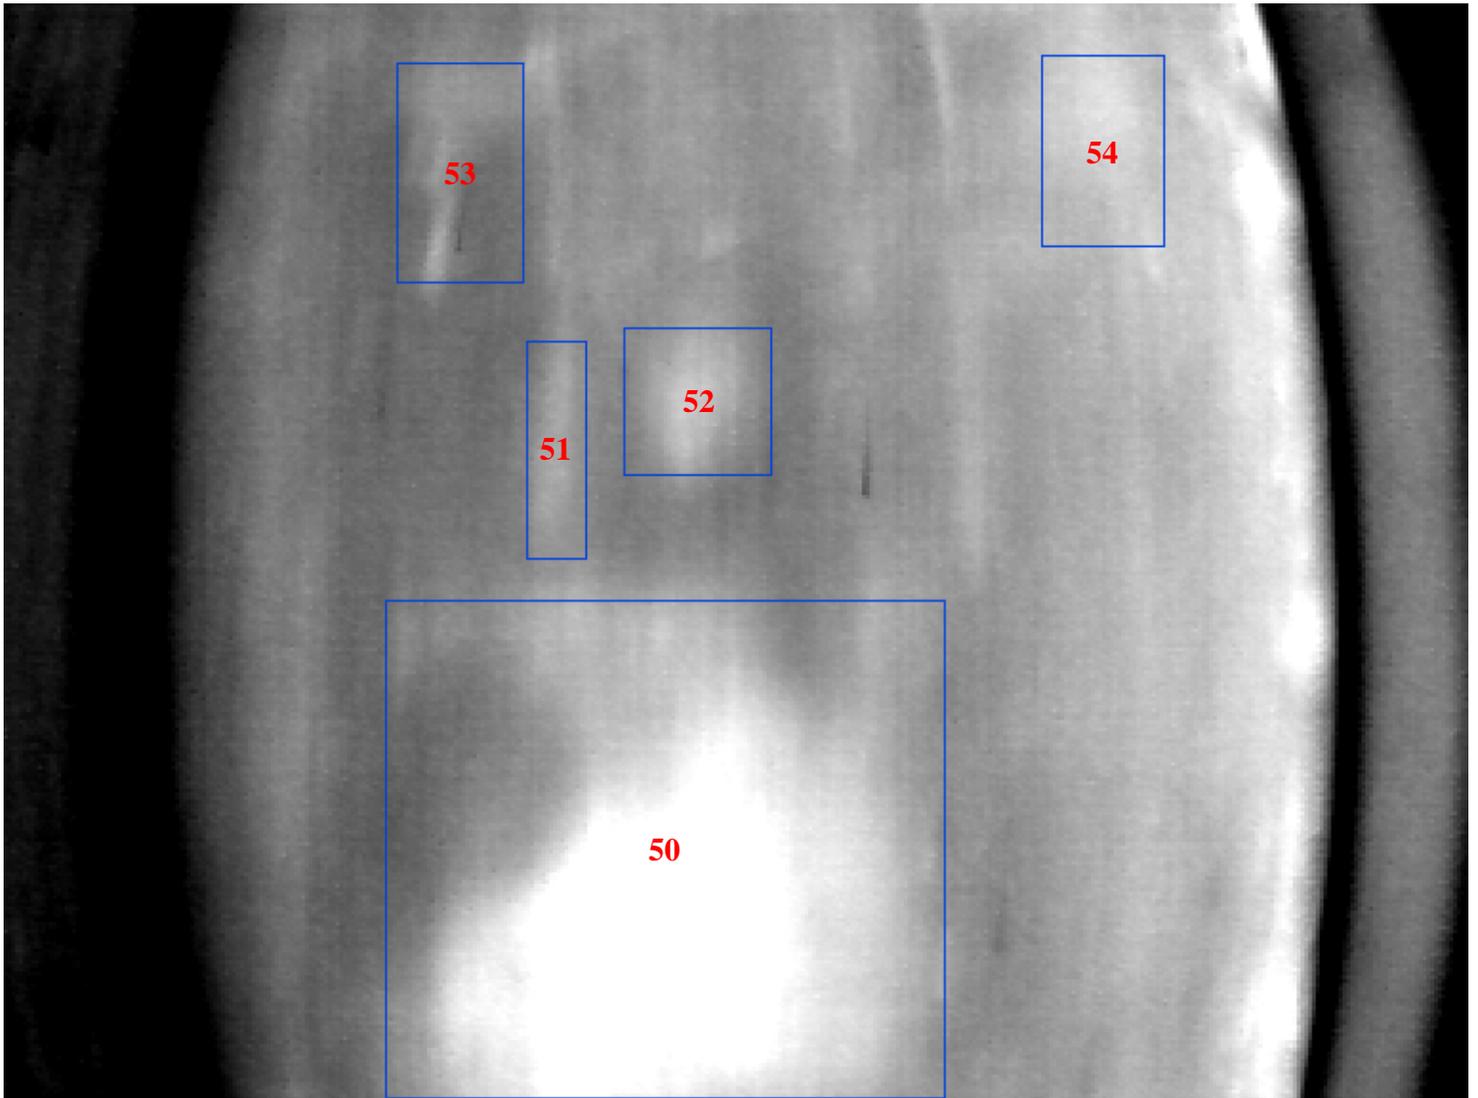
Image Name: 1\_4620000\_57440\_2171.tif

Defect #	50	51	52	53	54
Feet from Start	108.96	112.71	113.17	115.32	115.52
Feet from Right	7.67	8.71	7.36	9.63	3.49
Defect Size	26.31 sq ft	1.26 sq ft	2.08 sq ft	2.66 sq ft	2.24 sq ft
Length x Width (ft)	4.69 x 5.36	2.06 x 0.58	1.40 x 1.42	2.08 x 1.22	1.81 x 1.18
Type	Delam	Delam	Delam	Delam	Delam
