Appendix E – BridgeGuard Maryland Avenue Delamination Report

Bridge Delamination Report

Maryland Ave. over I-96

Freer Road over I-94

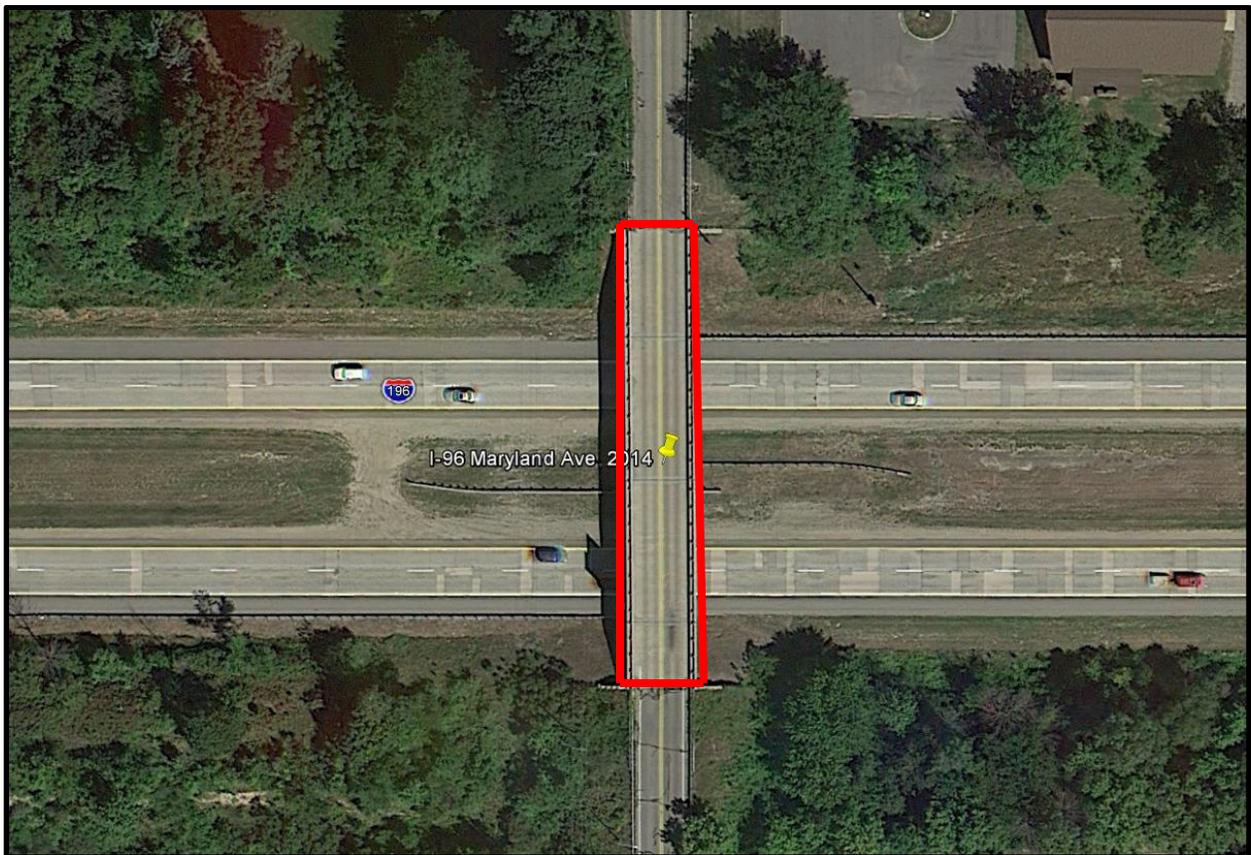
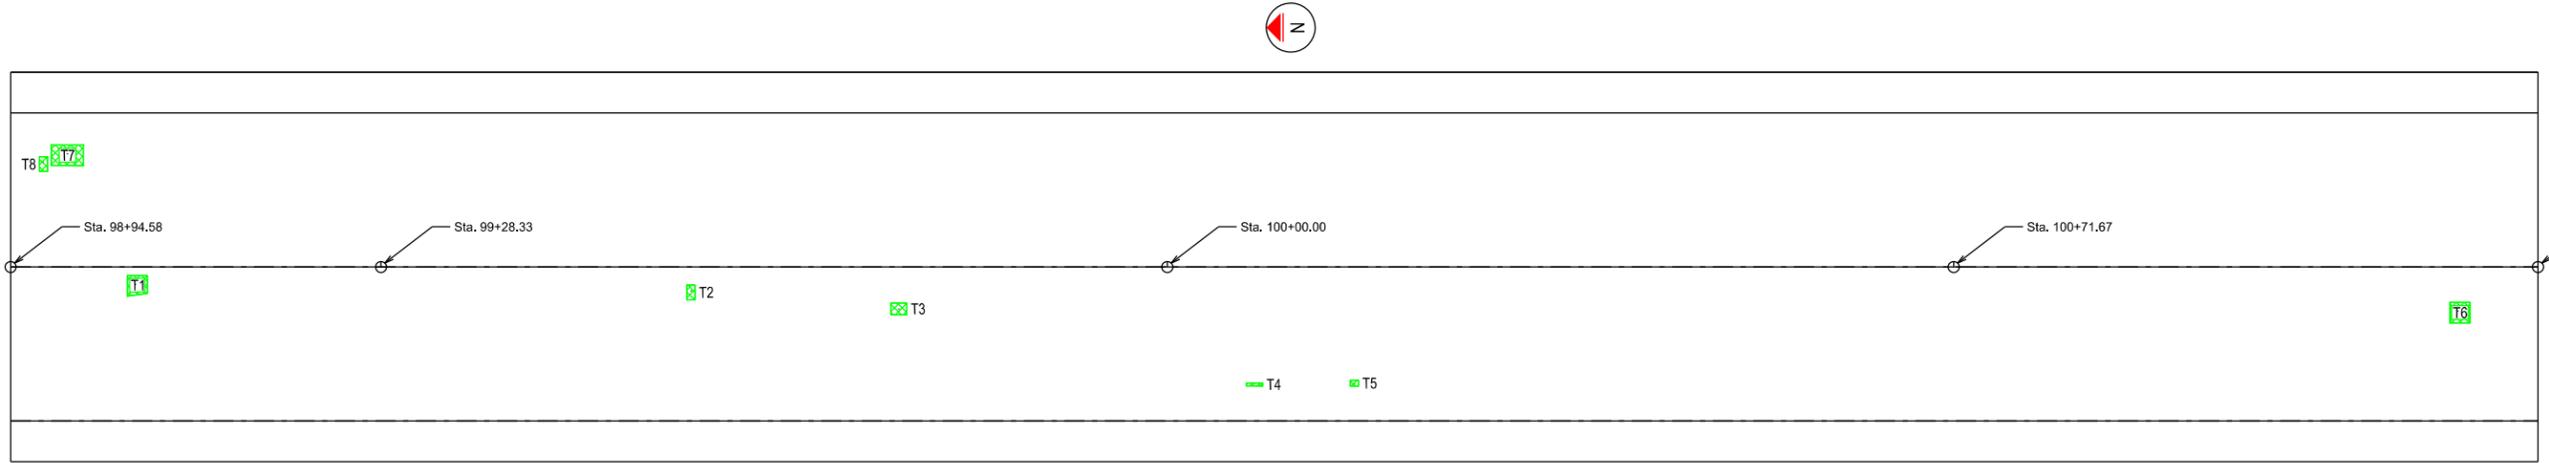
| DRAWN BY | J. STOUT | DRAWING NUMBER 41027-S24-01 |

Maryland Road Summary

| Components | # of Delaminations | Total Element Area (SF) | Delaminated Area (SF) | % Delaminated |
|---|---|---|---|---|
| Deck Top | 8 | 5,520 | 17.6 | 0.32% |
| TOTALS = | 8 | 5,520 | 17.6 | 0.3% |

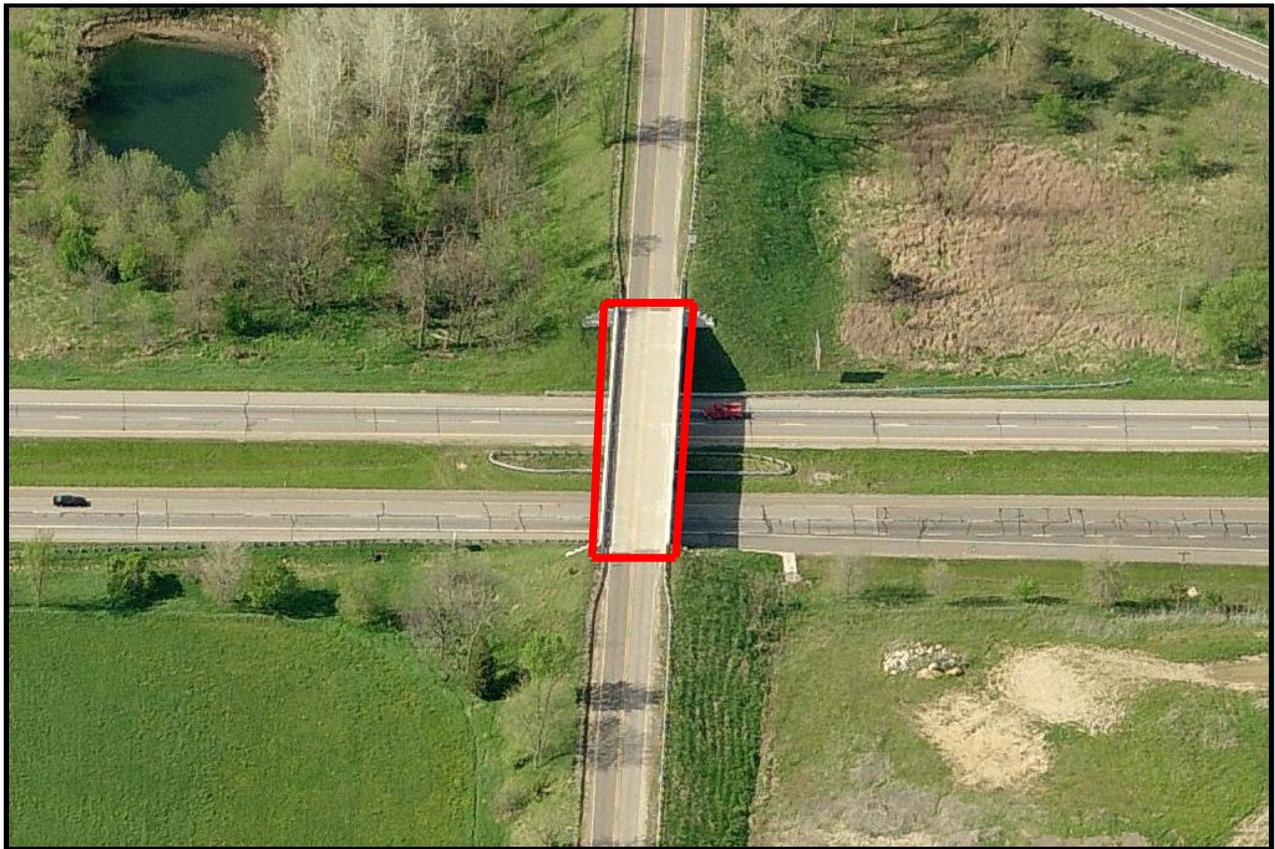
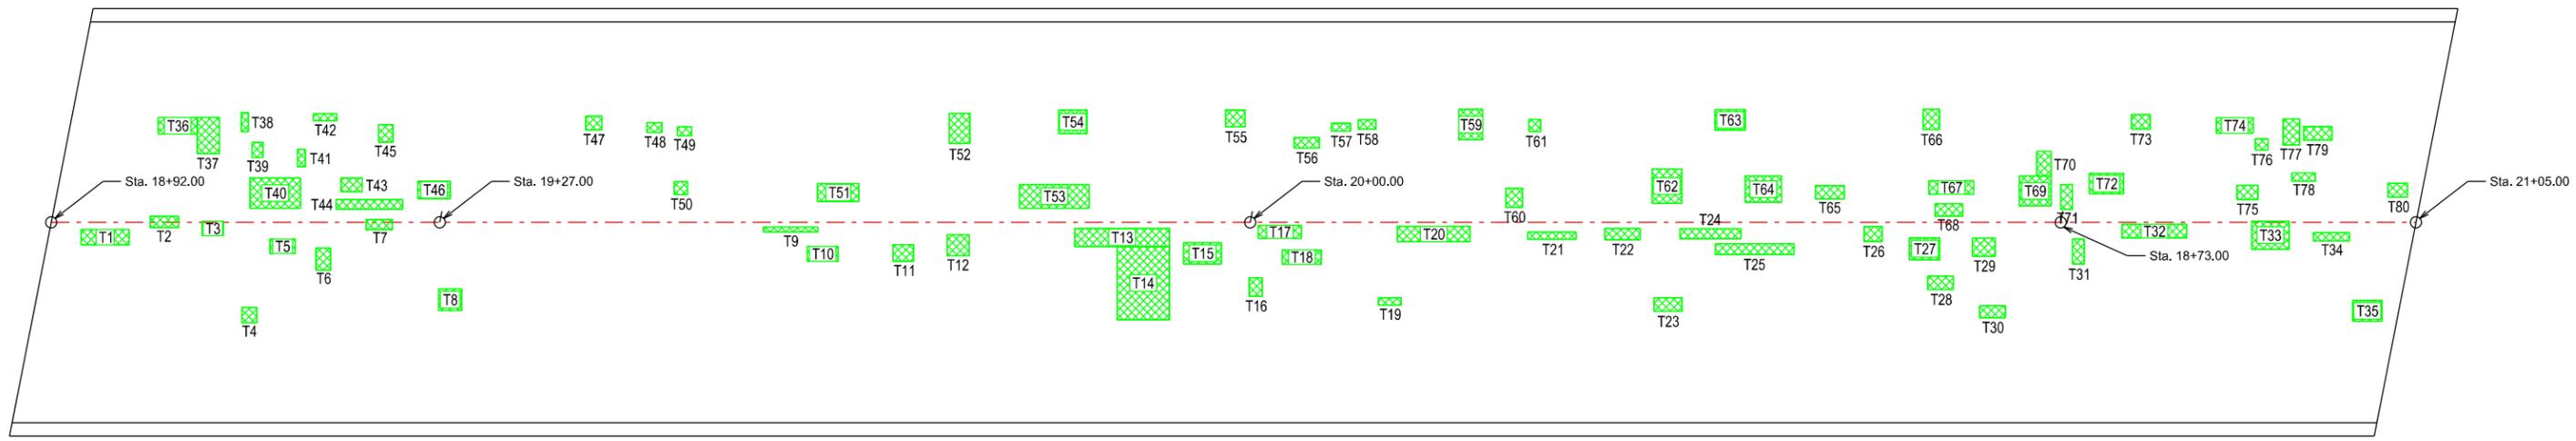
| DRAWN BY | C. STUROS | B | 41027-S24-02 | |

Freer Road Defect Table

| Defect T # | Length | Width | Area (SF) | Station Final | Offset | Notes |
|---|---|---|---|---|---|---|
| Total | | | 342.3 | | | |

| Components | # of Delaminations | Total Element Area (SF) | Delaminated Area (SF) | % Delaminated |
|---|---|---|---|---|
| Deck Top | 80 | 5,112 | 343.0 | 6.71% |

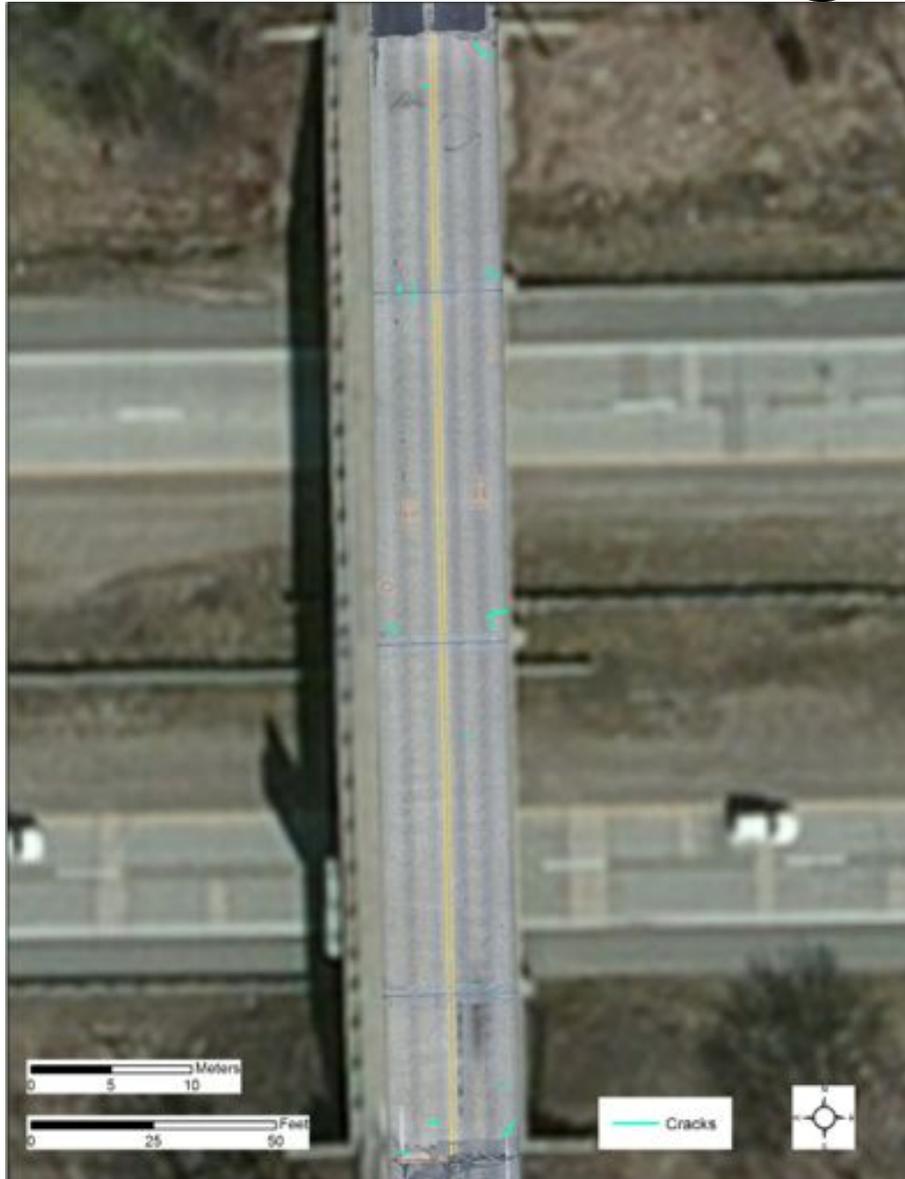
3DOBS High-Res Results

- With imagery resolution of 0.5 mm, cracks down to 1 mm (just over 1/32nd inch) can be mapped.
- Maryland Ave cracks:
 - 35 Cracks were digitized
 - Total crack length – 386.6 in

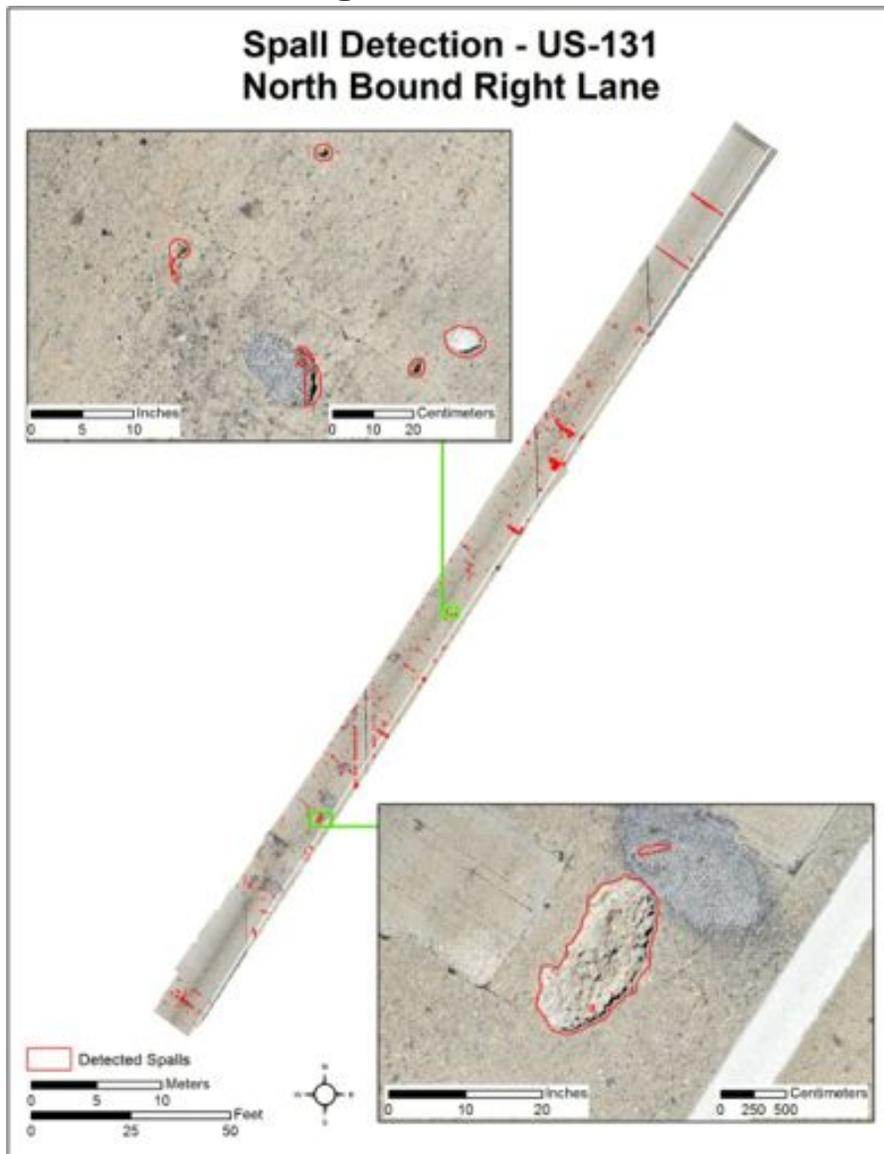
Spall Detection Algorithm

- Able to locate and characterize spalls by area and volume.
- Able to limit the minimum size of spalls detected.
- US-131 NB spall detection results
 - 9.9 ft² spalled
 - 1 % of bridge spalled
