MICHIGAN DEPARTMENT
OF
STATE HIGHWAYS AND TRANSPORTATION

INTERIM GLAREFOIL REPORT

Report TSD 404-78

Engineering Development Unit
Traffic and Safety Division

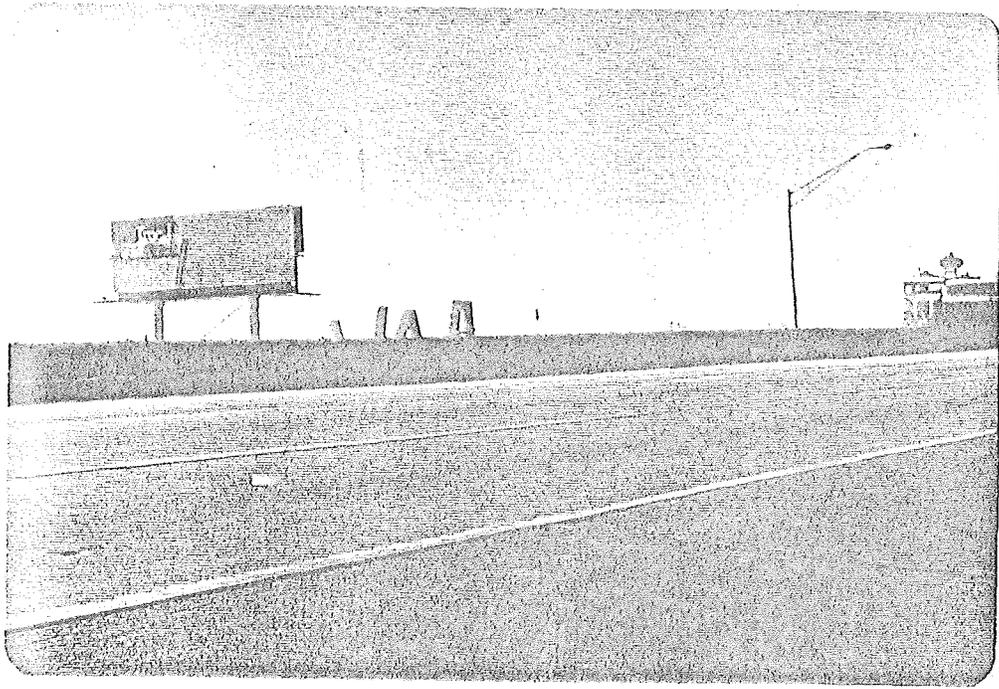
In November of 1977, six months after installation, about 200 units were replaced by the Wayne County Road Commission. On April 9, 1978, about 540 additional foils were missing (see photos). Several panels appeared to have been knocked sideways and others were vibrating in an unstable manner. Another count taken on July 13, 1978, determined about 639 panels were missing and others in conditions as previously stated.

In those areas that the foils are missing but the brackets are in place, it appears that a vehicle climbed the barrier wall and sheared the panel from the bracket by pulling the screw head through the panel; possibly a washer would have reduced the occurrence. In other instances the panel and bracket were both missing (see photos). This seems to be a result of either wind vibration or a vehicle contacting the panel and causing the anchor bolts to break (see photos).

Missing Glarefoils

It is recommended for motorists safety and driving comfort that the concrete glare screen be programmed as soon as possible.

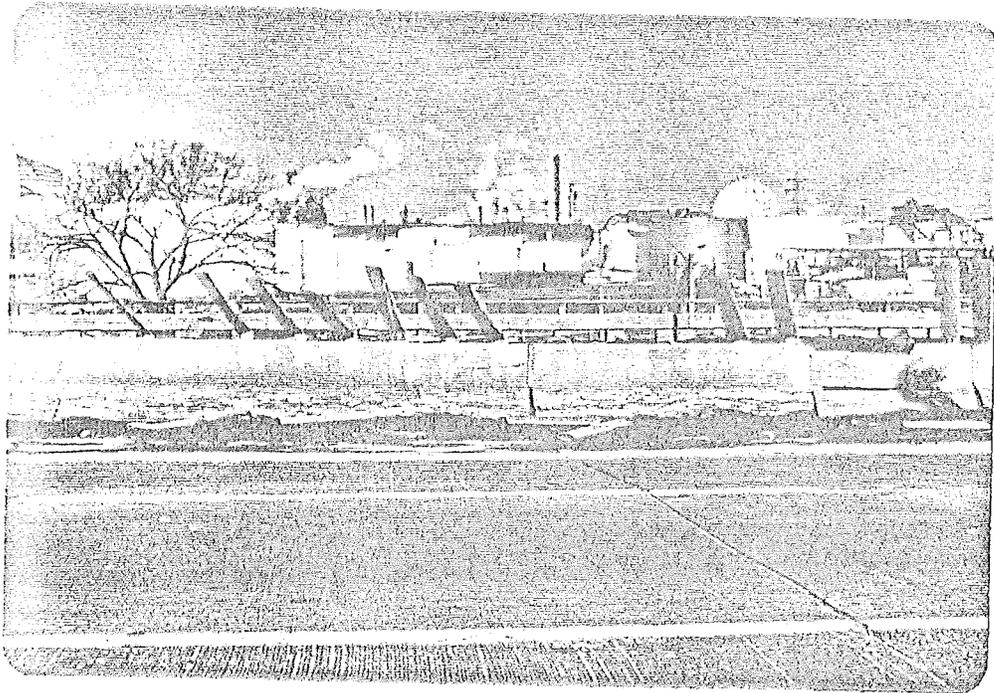
Foils Knocked Sideways

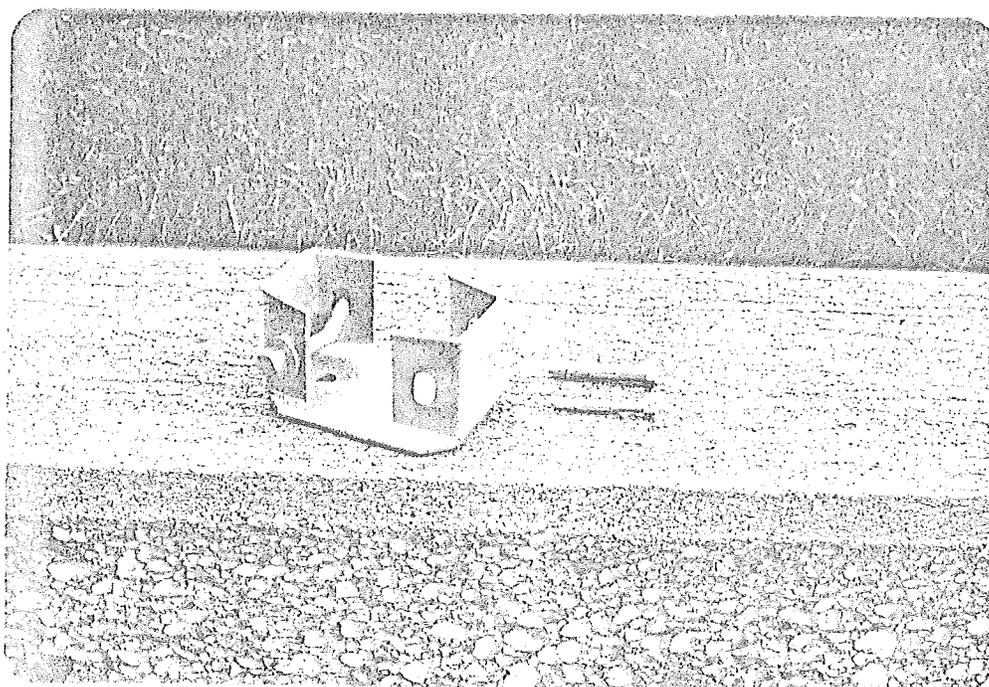
Heavier Bracket and 3/8 inch
Anchor Bolt

In May of 1978, we initiated a request to the Syro Company that they, at their expense, furnish replacement foils (in addition to several units for reserve) with heavier hardware, similar to that being used in at least two other states, and including the larger 3/8-inch diameter anchor bolts to replace the current 1/4-inch diameter bolts (see photos). We have received no reply to that request.
