2015 Communication Meeting

Presented by:
Michigan Public Service
Commission

Significant Incidents

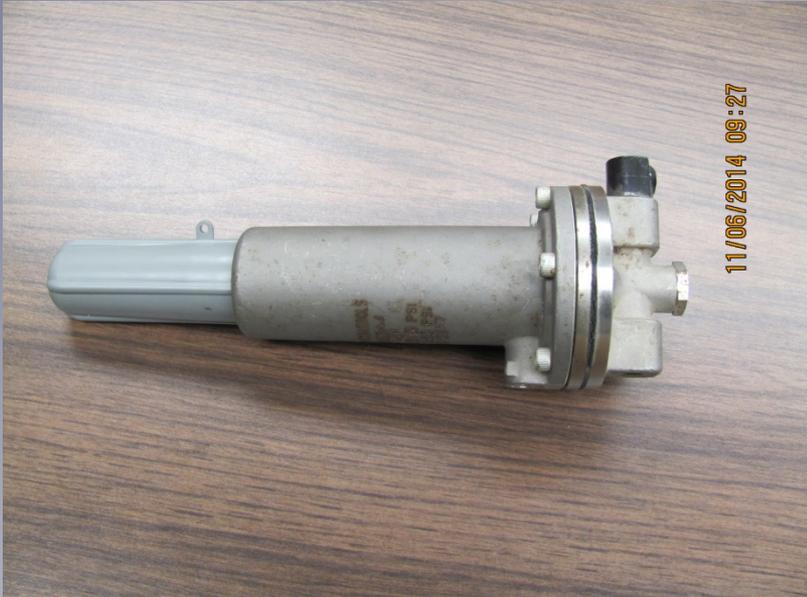
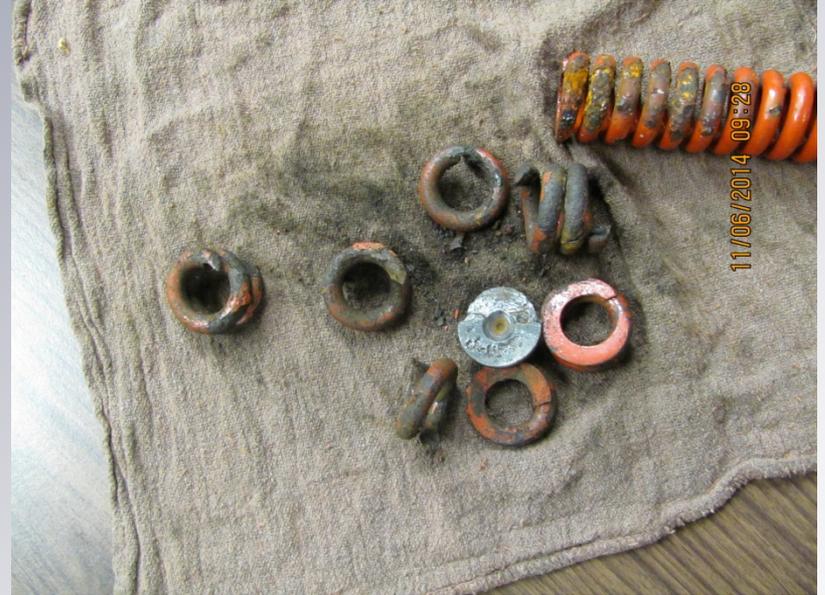
Significant Incident – 261523

- Flame sensor unit triggered compressor station ESD.
- One of four block valves closed and all four blowdown valves opened.
- Three of four block valves failed to close due to frozen pilots.
- 18.4 MMcf gas loss.

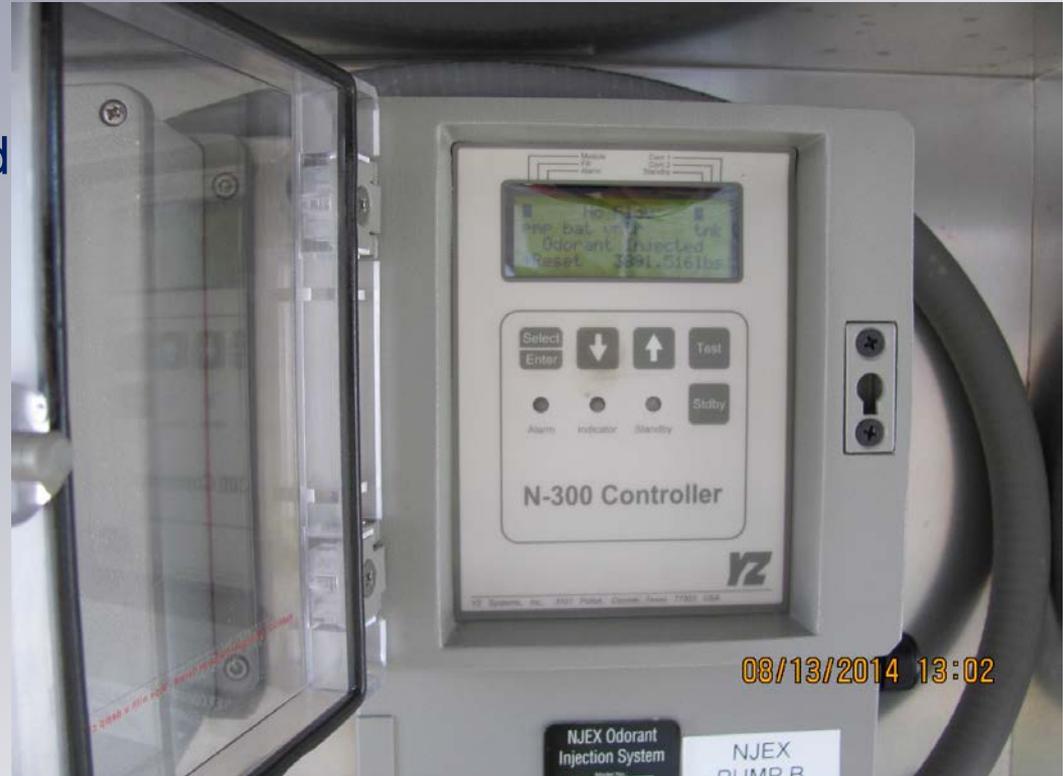
Significant Incident – 289827

- Over-odorization at gate station: NJEX falsely sensed gas flow rate increase from 300 Mcf/hr to 8 MMcf/hr
- 610 leak calls responded to
- Cost: \$87,000

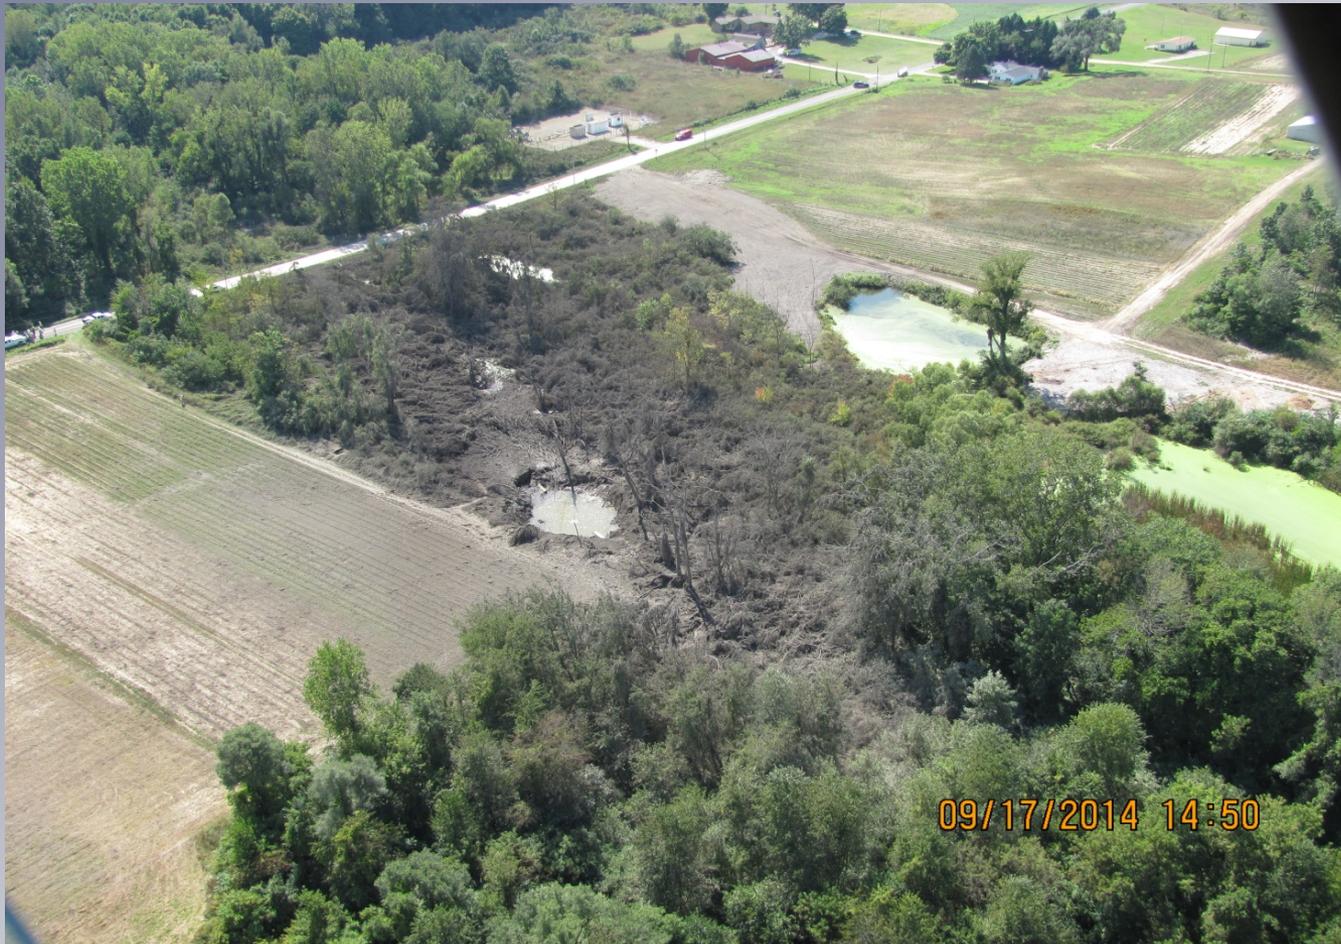
Significant Incident - 295127

- Transmission line rupture following operating pressure increase from approximately 720 to 805 psig.
- 200 evacuated homes
- Pipe characteristics:
 - 22” pipe
 - Coal tar enamel coating
- Origin:
 - 21 feet segment of pipe installed in 1960 (pipeline constructed in 1949)
 - Pipe wall.
 - Saturated wet environment

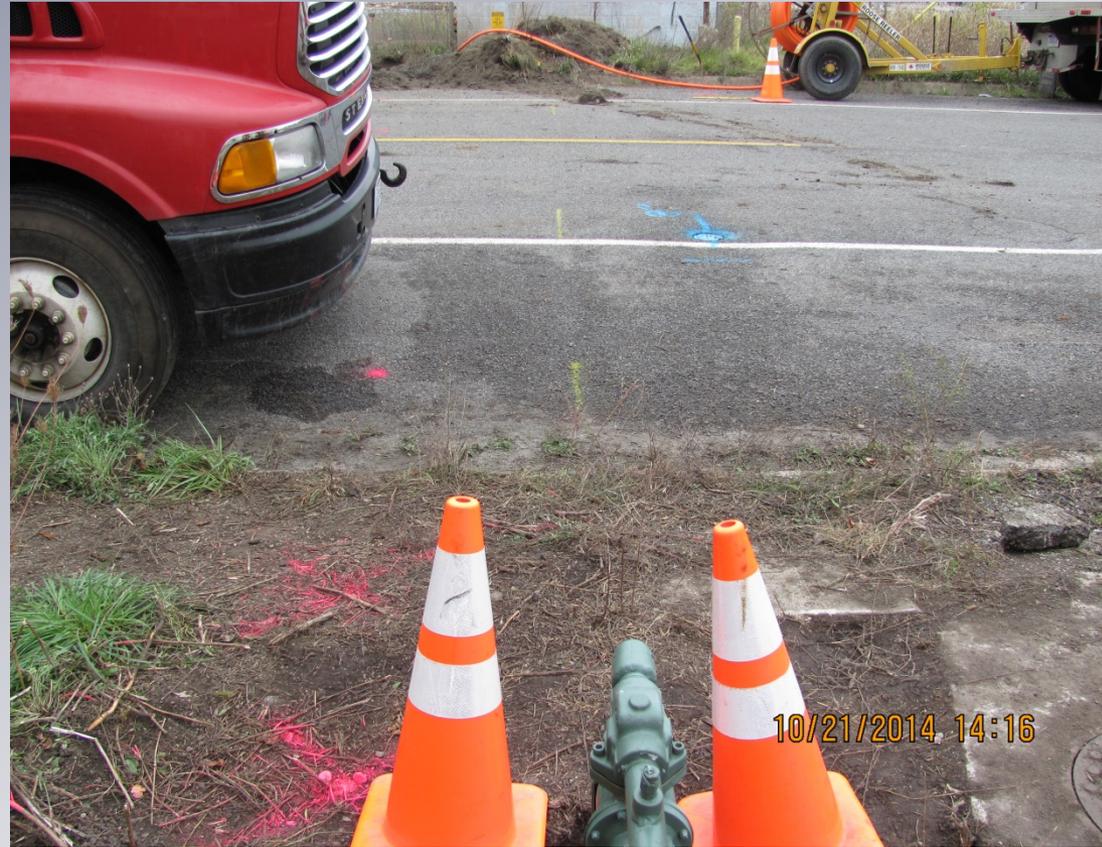
Significant Incident - 301927

- Third-party damage
- Six-inch 200 psig main
- Horizontal directional drill
- Initial isolation failure
- Gas blowing ~29 hours
- 6.4 MMcf gas loss

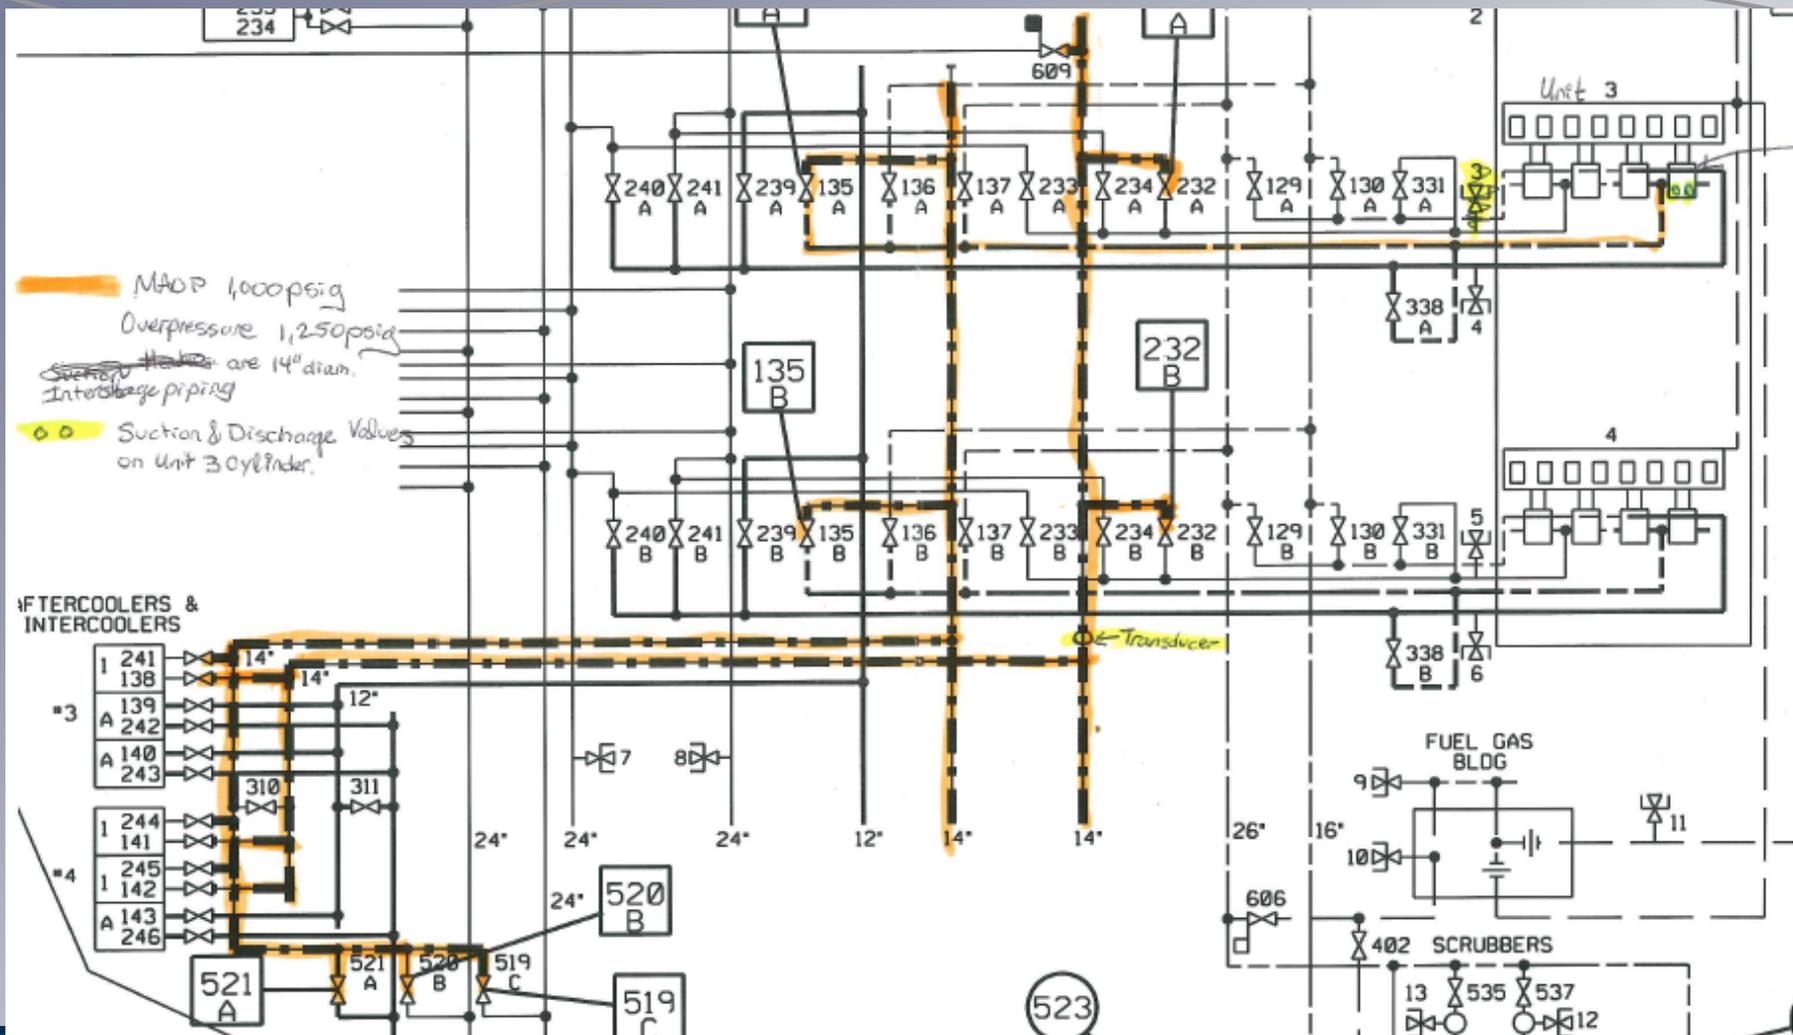
Significant Incident – 300825

SRC. Overpressure at compressor due to equipment failure.

- Five suction and discharge valves on compression cylinder failed due to cracked plates. Causing gas temperatures to spike.
- Mechanic actuated a manual ESD of compressor engine, allowing a backfeed of pressures into the interstage piping.
- No SCADA alarms - Gas Control did not become aware of overpressure because they were not actively monitoring pressures.
- No overpressure protection on the interstage piping to protect it during a manual ESD.
- 900 feet of interstage piping experienced an overpressure of 1225 psig. (1000 psig MAOP)
- Pressures exceeded MAOP for 12-hours.

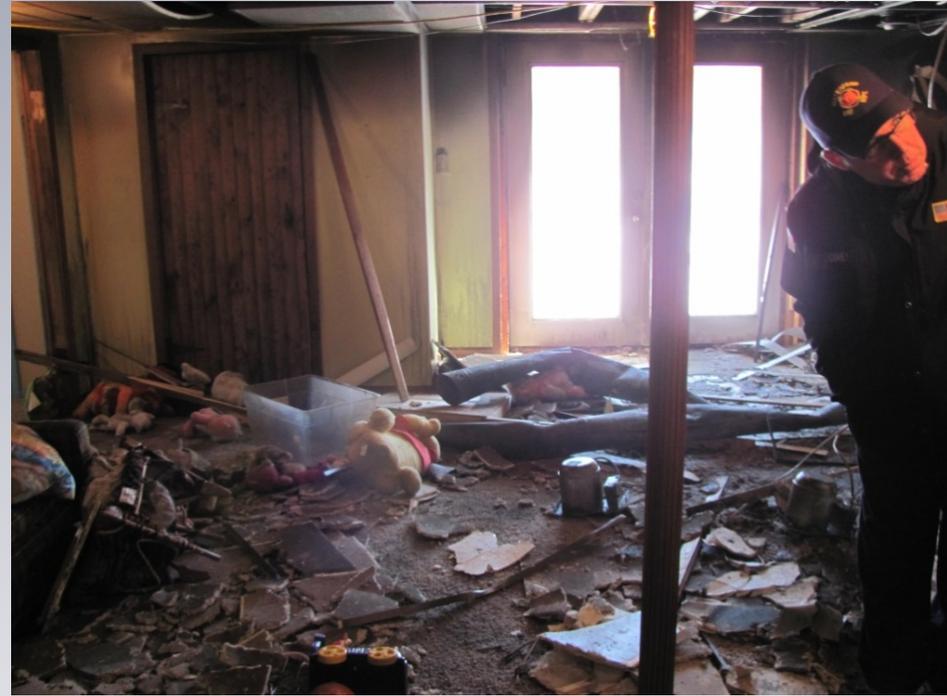
Significant Incident – 268125

- House fire; gas leak found on main 45' from house.
- Fire started in downstairs utility room. Property damages \$112,580.
- After the fire, gas was detected at an exterior building wall and inside the basement.
- Evidence of previous excavation damage to main.

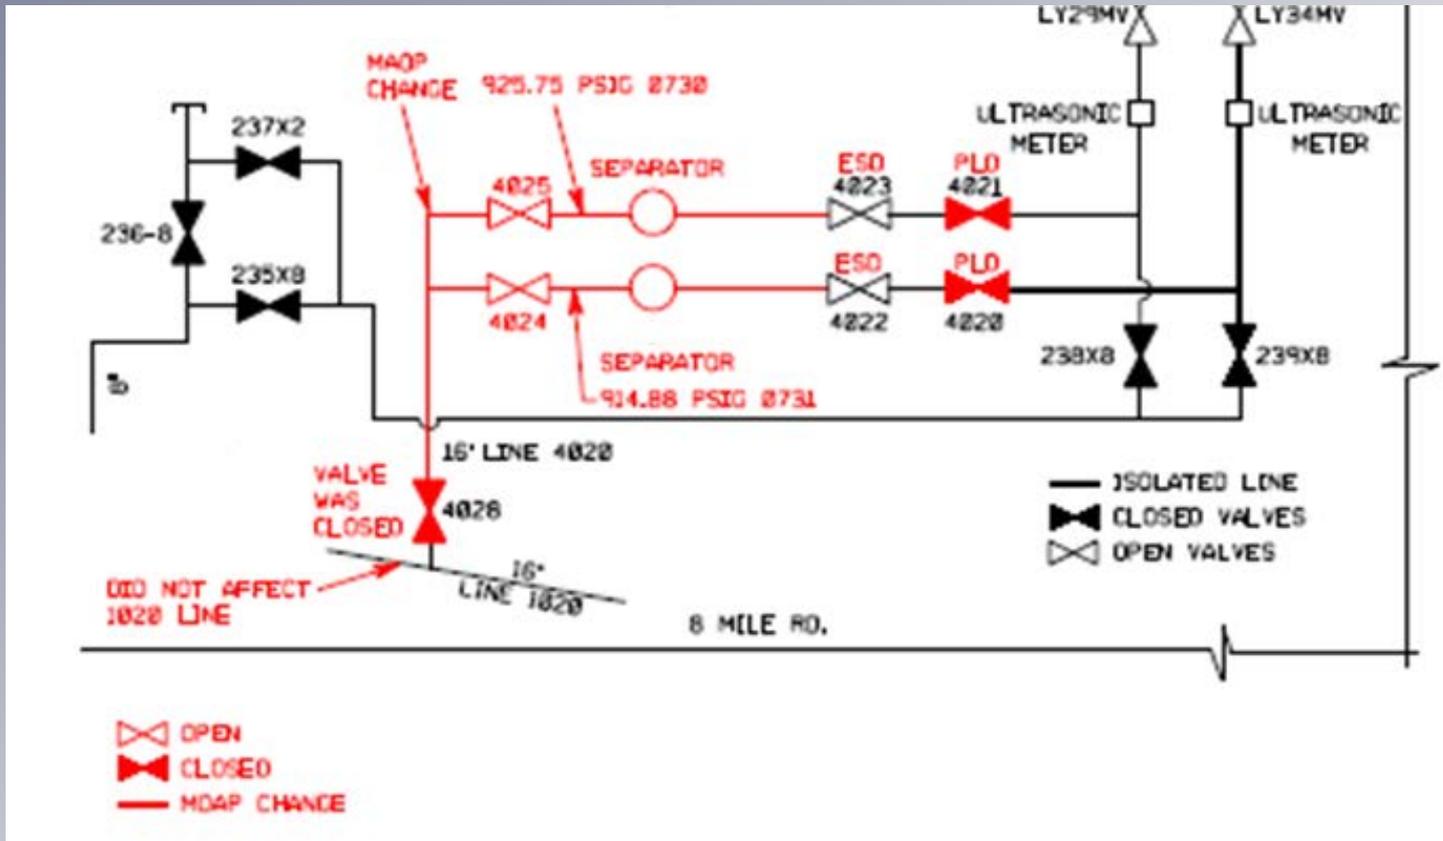
Significant Incident – 264511

- SRC. Overpressure within storage field due to equipment failure.

- Gas Control was gradually opening control valve to withdraw from storage.
- Downstream blockage – Manual valve closed.
- Gas Control interpreted pressure stabilization as line-packing and continued to open control valve.
- Gas Control's 4th command to gradually open the control valve
 - Control valve quickly jerked open and pressures increased near 800 psig MAOP.
- Gas Control recognized the downstream blockage.
 - Sent a command to close the control valve; took 20 minutes to close.
- ESD valve failed to provide OPP due to faulty solenoid.
- 802 feet of storage piping encountered an overpressure for 20 minutes in duration, reaching 925.75 psig.

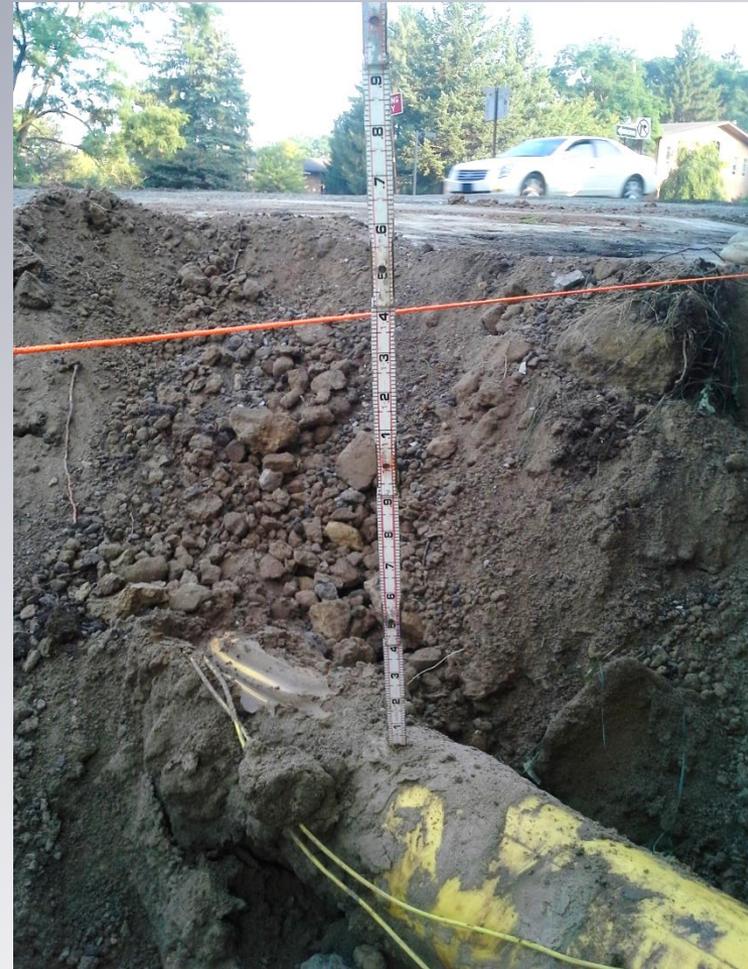
Significant Incident – 289525

- Third-party damage because contractor failed to hand expose.
- Operator's contractor installed the six-inch main two months prior via directional bore.
- Approximately 16" of cover at location of damage.
- 192.327(b) – Main must be installed with at least 24" of cover.

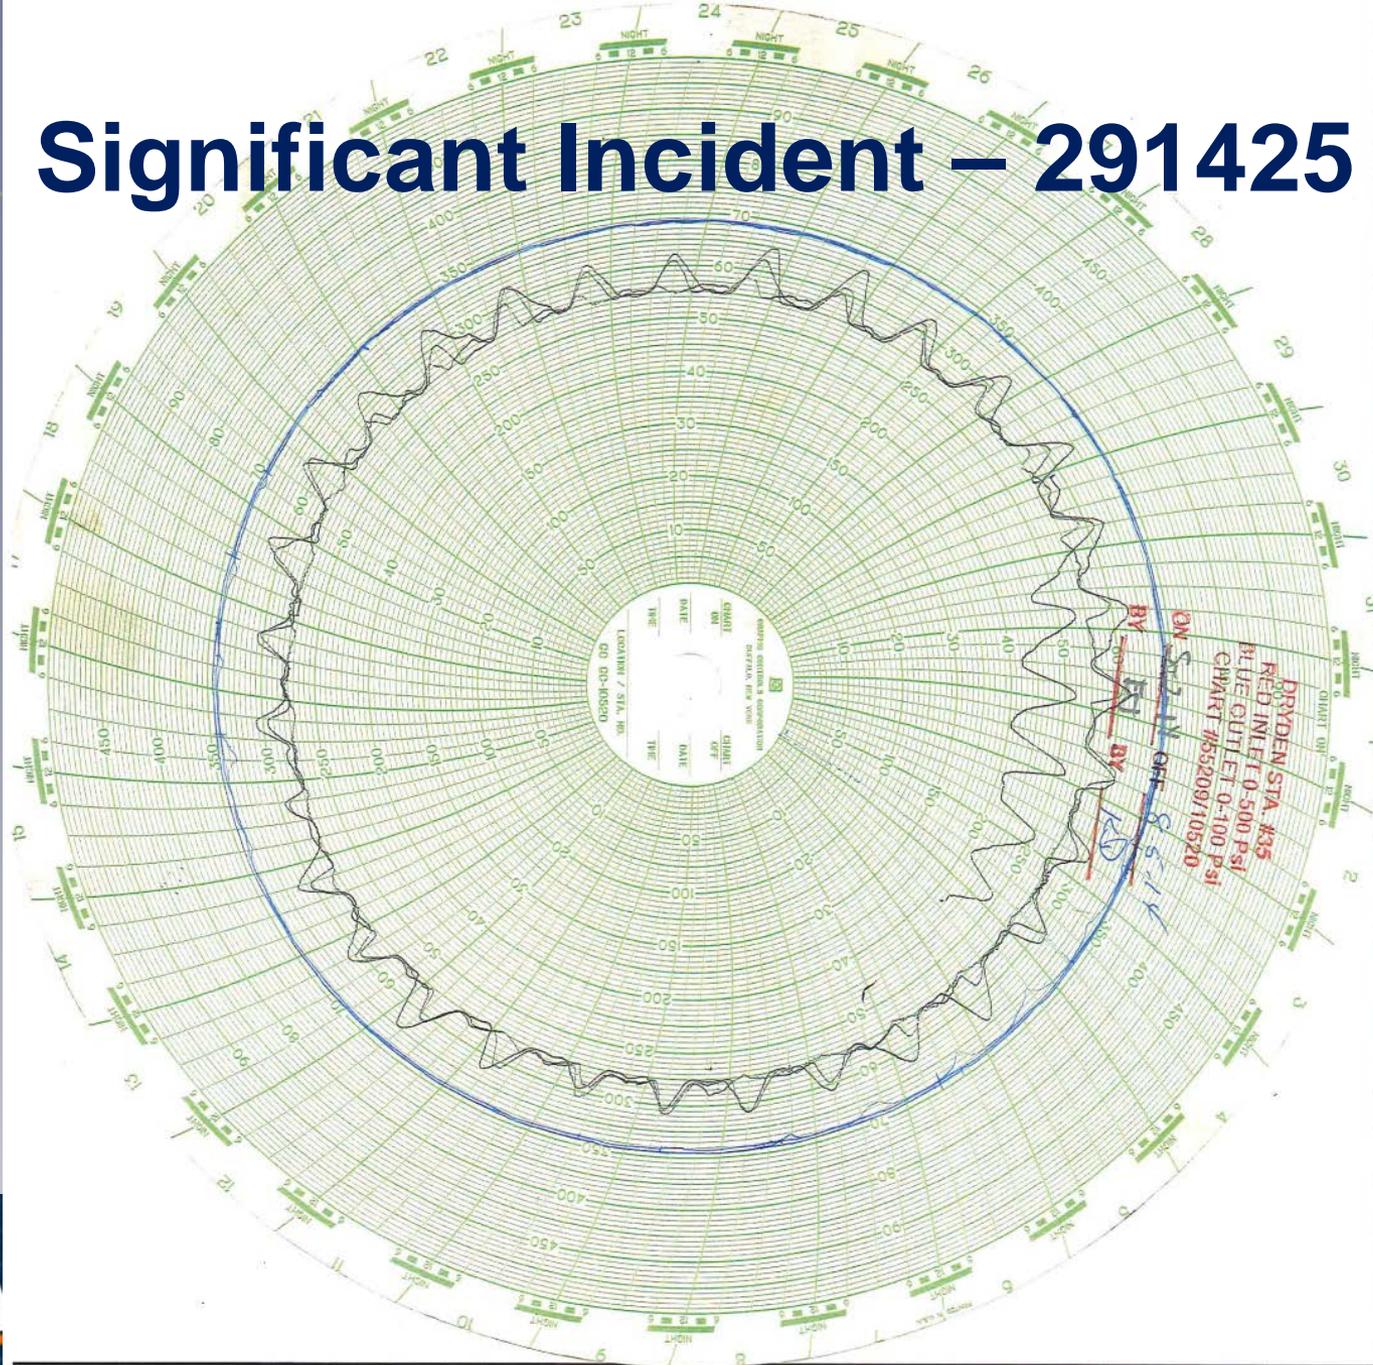
Significant Incident – 291425

- Overpressure caused by a double failure of a regulator and relief at a regulator station.
- Regulator inspection took place 1 week before incident
 - Both regulators failed lock up test.
 - Technician did not make an immediate repair or contact his supervisor.
- The day of the incident, Technician was onsite overhauling regulators. Did not monitor downstream pressures. Left the site.
- Regulator failed due to shavings from a shell-cutter tapping machine.
- Relief valve was isolated. Failed to serve as OPP.
- 67 miles of a four-inch main experienced 96 psig pressures on a 60 psig system; relief valve set point 62 psig.

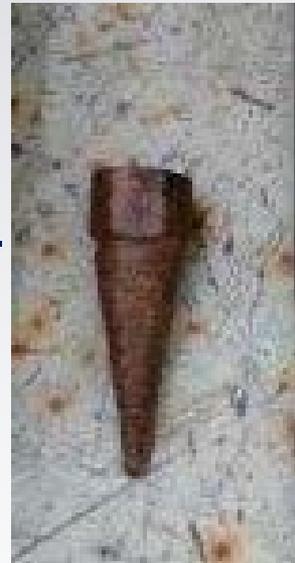
Significant Incident - 271425

- Home explosion. While excavating to pressure test service line, crew broke tee off main. During repair, staff observed:
 - Not monitoring gas and O₂ levels while working with escaping gas.
 - Smoking at top of hole while crew members are repairing leak on main.
 - Not using appropriate primer for hot applied wax.
 - Welded a steel pin without the use of a welding procedure.
 - Used harden hex-head pin. (avoid due to brittle cracking)

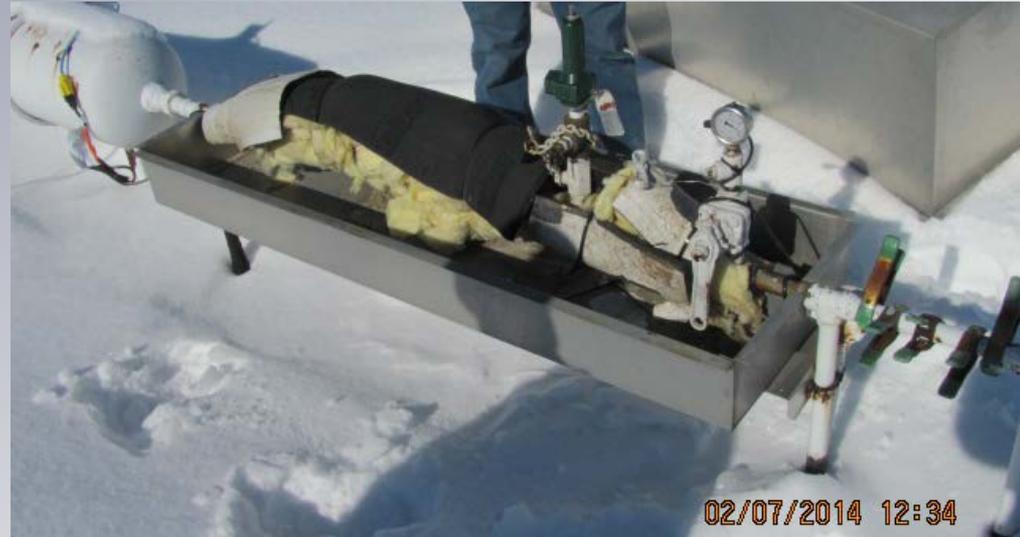
Significant Incident – 263223

- ESD of Compressor Station
- No permanent heat-trace on pilot gas regulator.
- Pilot gas system over-pressured due to frozen regulator.
- Relief activated and then froze open as well.
- Pilot gas pressure bled down to zero psig which triggered the ESD.

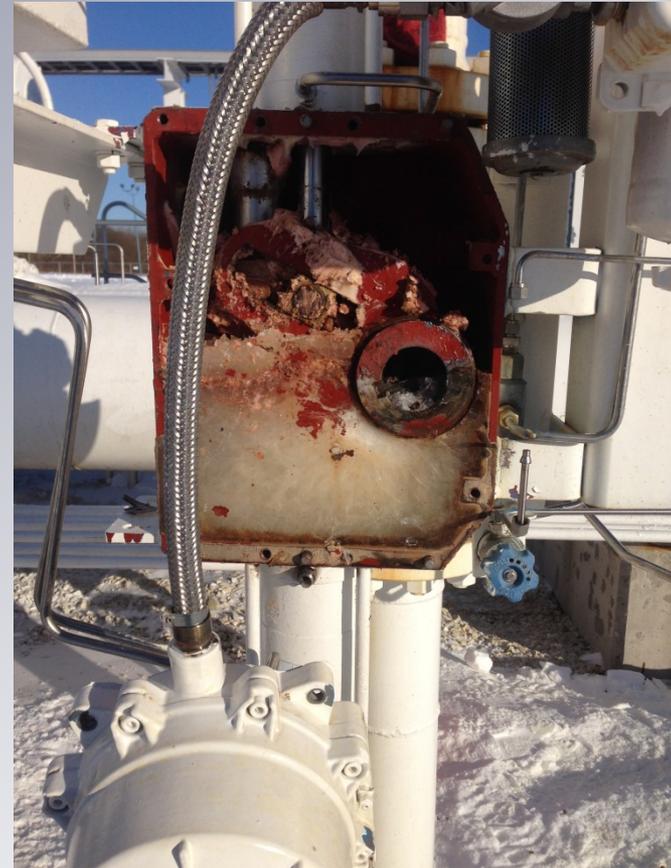
Significant Incident – 263223

- One of two compressor blowdowns activated and vented to atmosphere.
- The other compressor blowdown valve had a frozen pneumatic pilot switch which prevented the blowdown valve from operating.
- The two station blowdown valves activated, but were unable to operate due to the presence of ice in the actuator gear boxes.

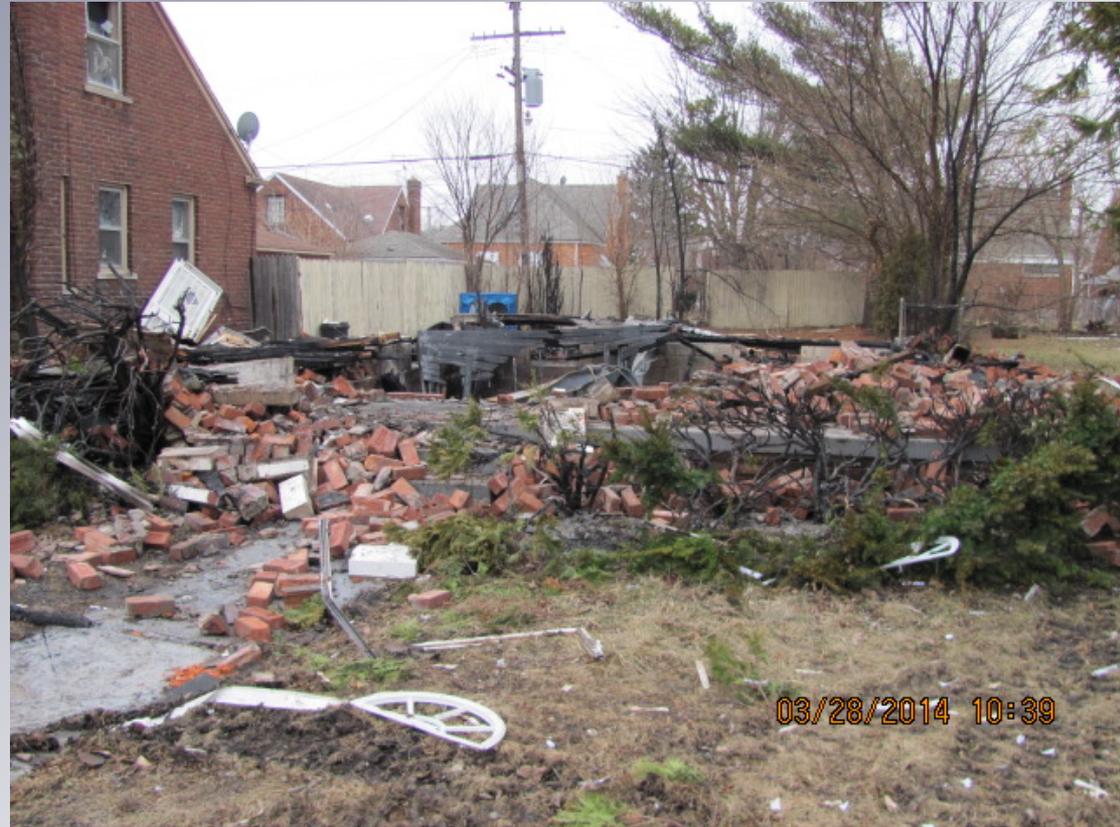
Significant Incident – 272429

- Residential Structure Explosion
- Rental property was vacant and between tenants.
- Structure was illegally occupied and injuries ensued.
- Water heater and furnace were stolen after previous tenants moved out.

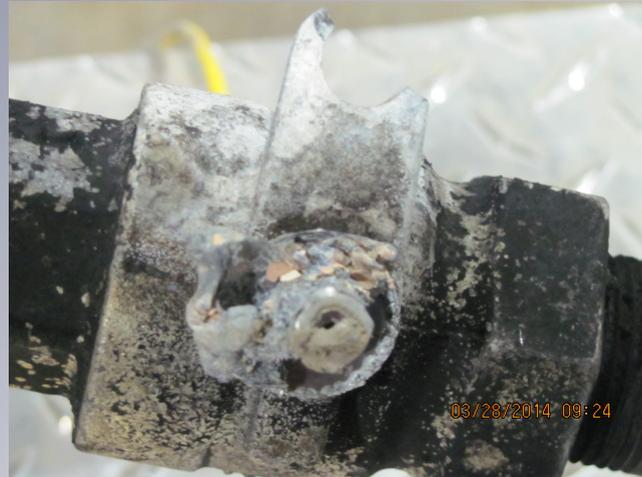
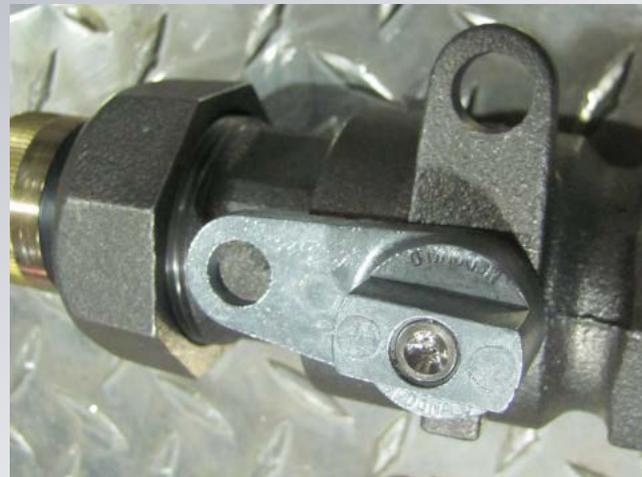
Significant Incident – 272429

- Unknown condition of fuel line.
- Lockwing valve was locked closed after previous tenants moved out.
- Lockwing was found to be broken and in the open position during the incident.
- Incident due to tampering with DOT jurisdictional facilities.

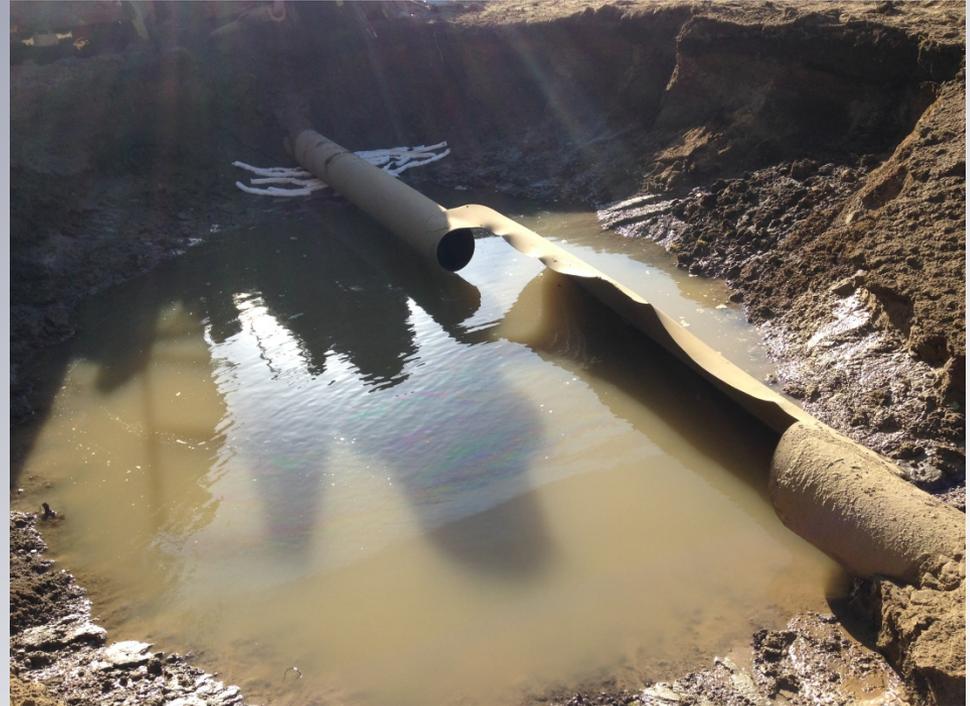
Significant Incident – 281728

- Third-party damage.
- 750 psig 20” transmission.
- Farmer’s contractor was plowing in drain tile 4’ deep.
- Miss Dig was called, but did not wait 3 days to start.
- Control Room isolated with remote control valves within minutes.

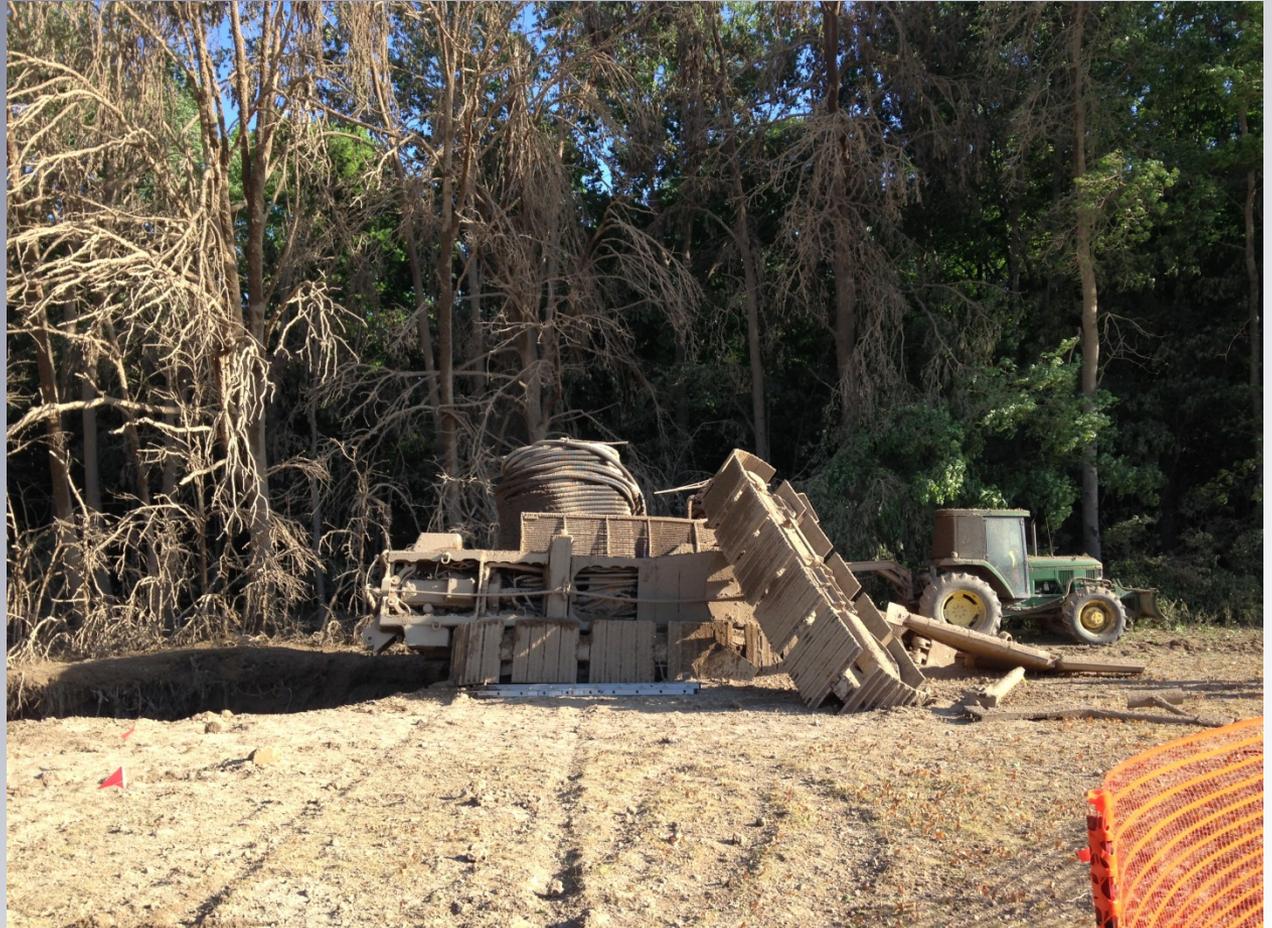
Significant Incident – 281728

- 47,000 lb. tiling machine completely flipped over.

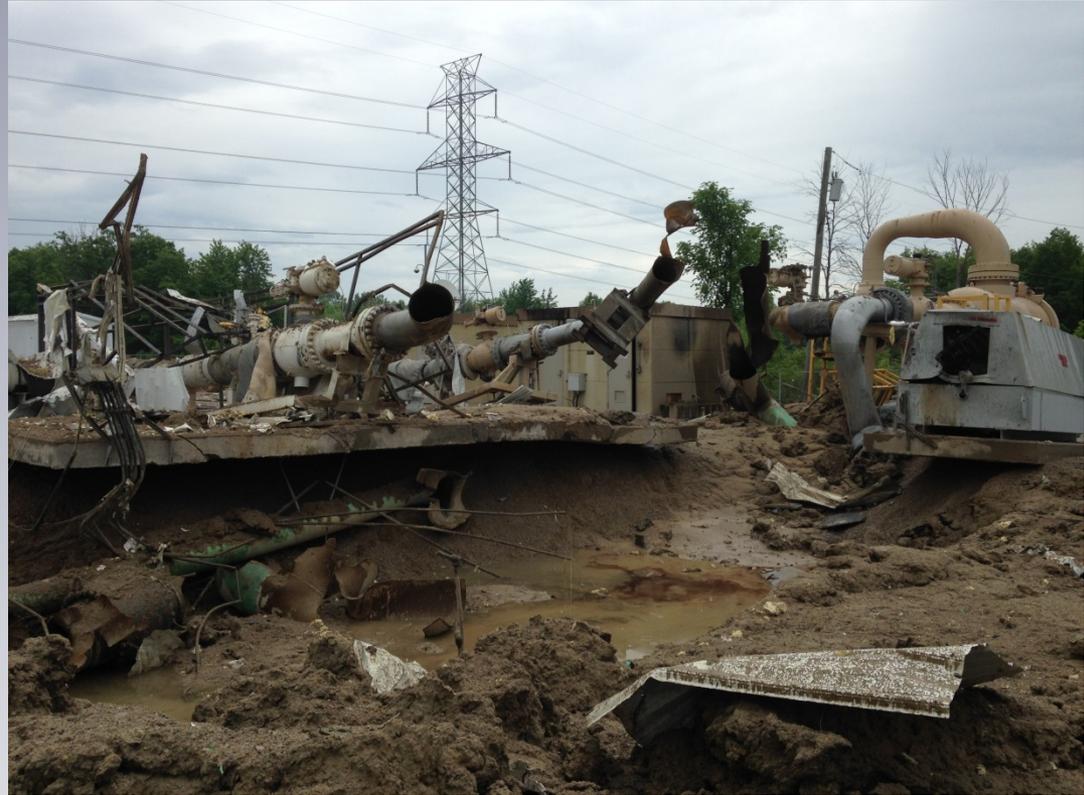
Significant Incident – 282729

- Pipeline rupture.
- 20” transmission within compressor station.
- Operator was purging pipeline after repair of third-party damage.
- Inadequate purging procedure allowed a combustible mixture of gas and air in the pipe.

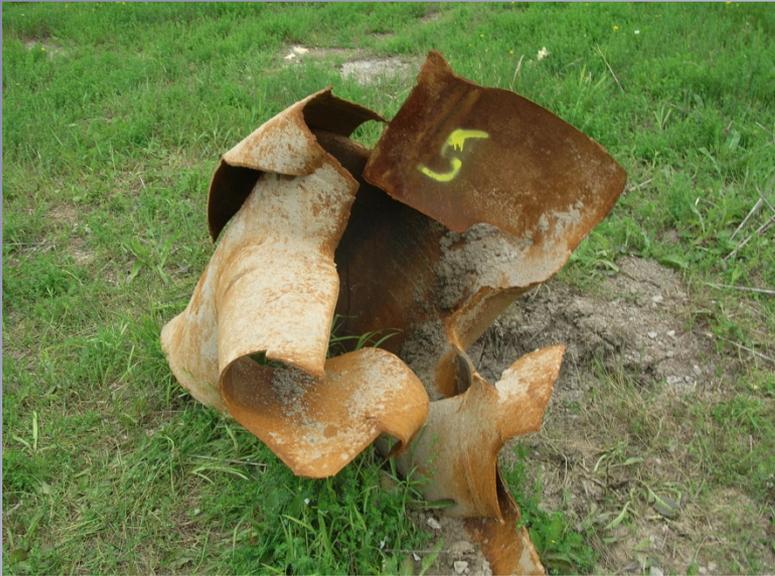
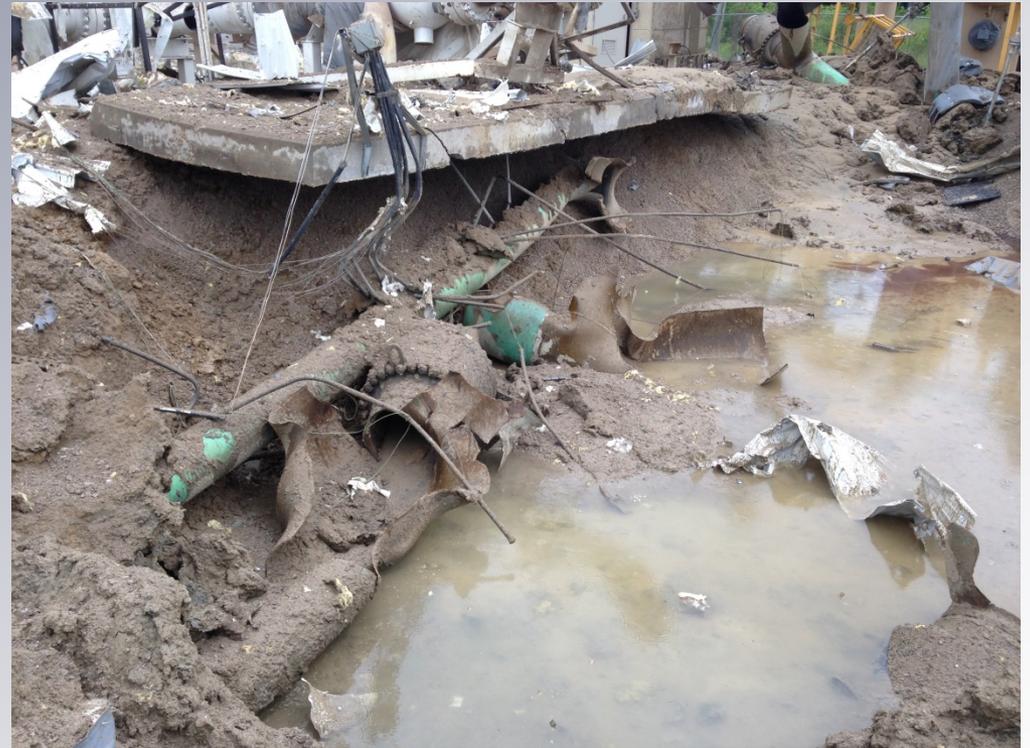
Significant Incident – 282729

- 20” tee found 230’ away.

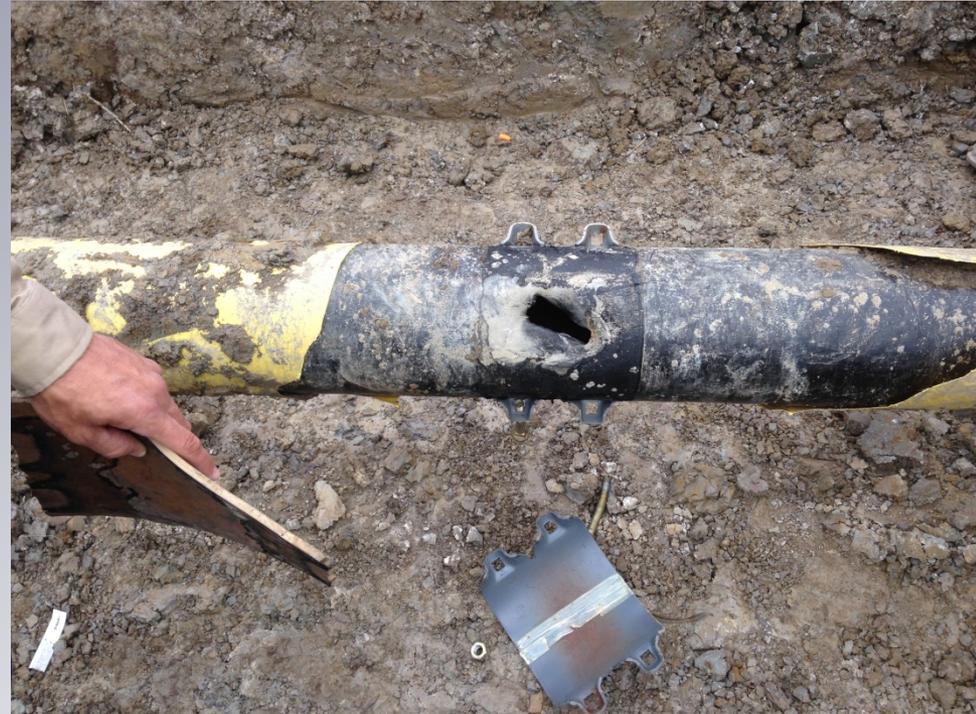
Significant Incident – 282829

- Third-party damage.
- 300 psig eight-inch main.
- Farmer was removing tree stumps with loader bucket.
- Incorrectly identified emergency valve failed to isolate section.
- Gas was blowing for approximately 18 hours.

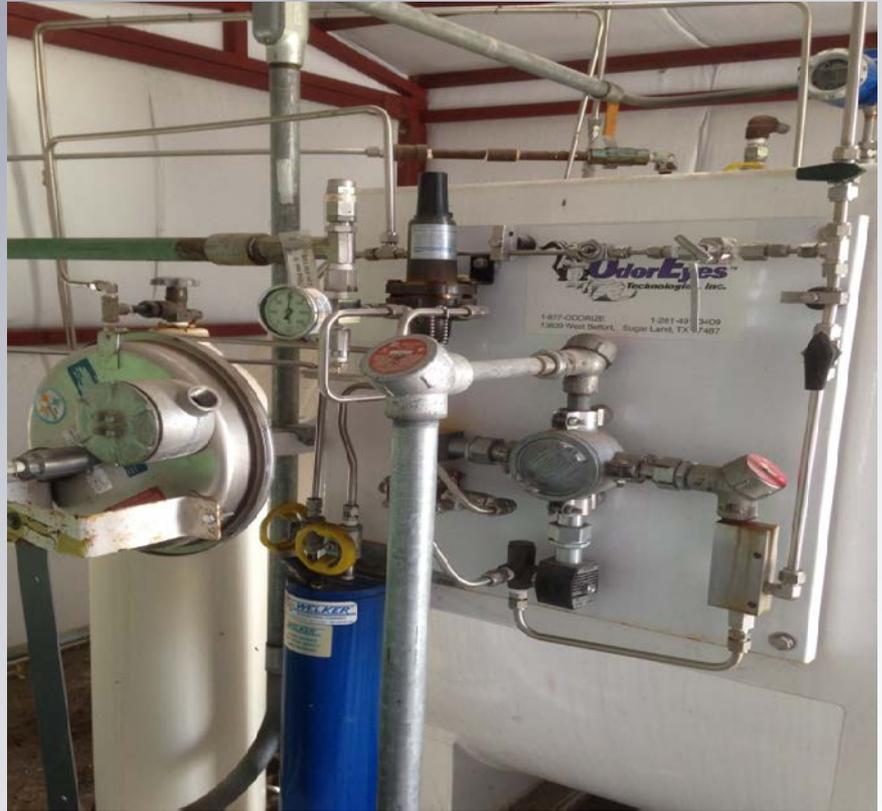
Significant Incident – 289730

- Excessive Odorant & Leakage Complaints
- A simple step in an O/M procedure, on odorization facilities, was omitted; as a result, gas with an extremely high odorant level left an interstate operator and was dispersed across two large distribution systems.
- 900 leakage complaint calls and field follow-ups.

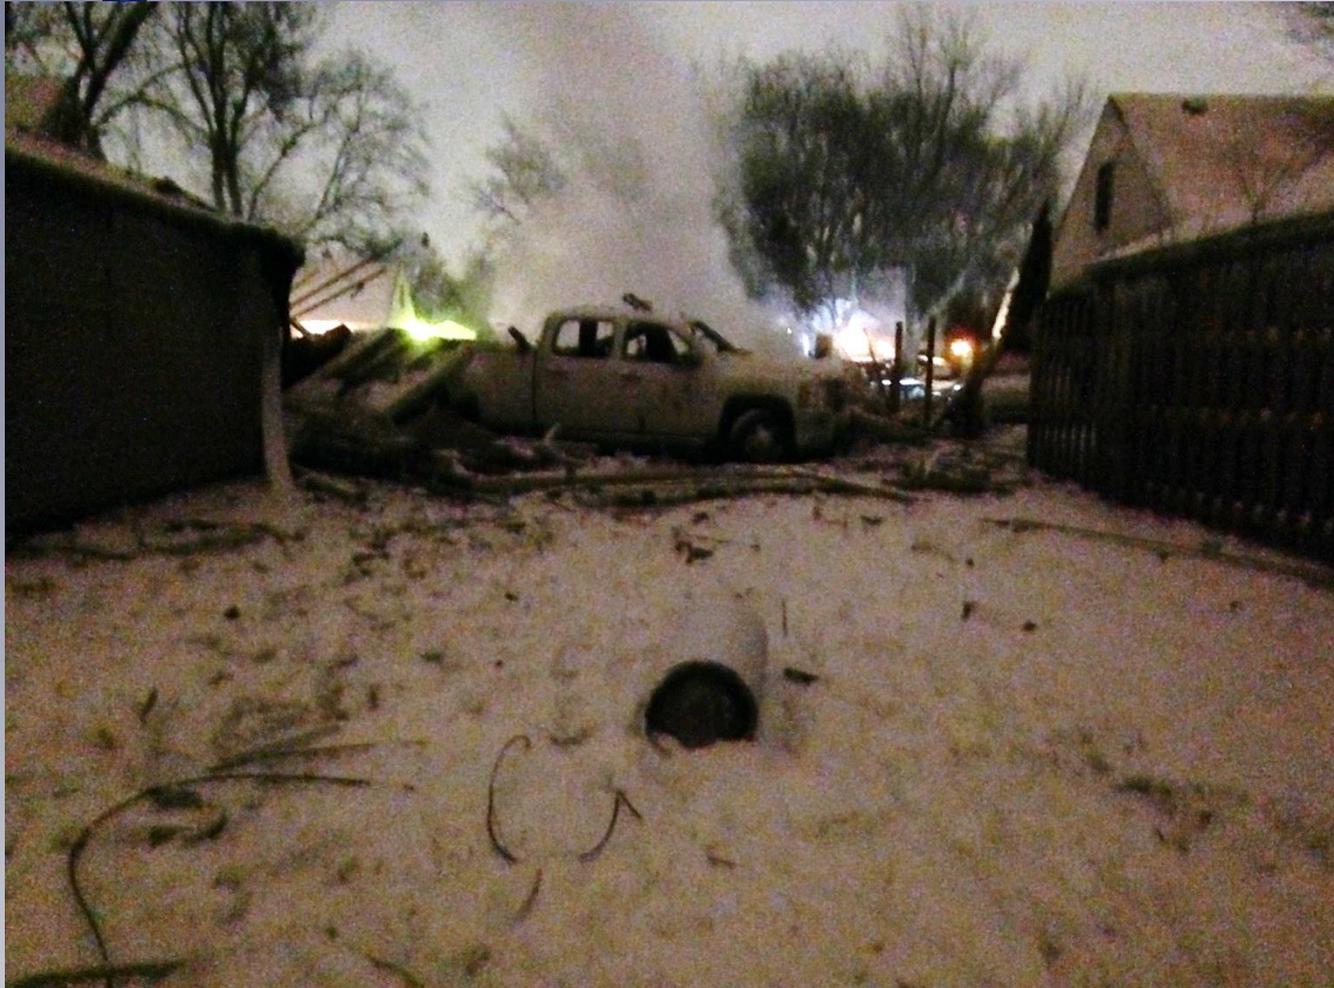
Significant Incident – 308730

- Gas explosion destroyed a house in January.
- The house had an active account/service and an inside meter.
- Tests for gas were conducted and found no leaks; the inside meter was mostly in its original position but partially melted.
- The injured man told investigators that he had dropped a 100-pound tank of propane in the house while moving it on stairs.
- The propane tank was still in the back yard and leaking. The explosion was ruled a result of the propane leak.

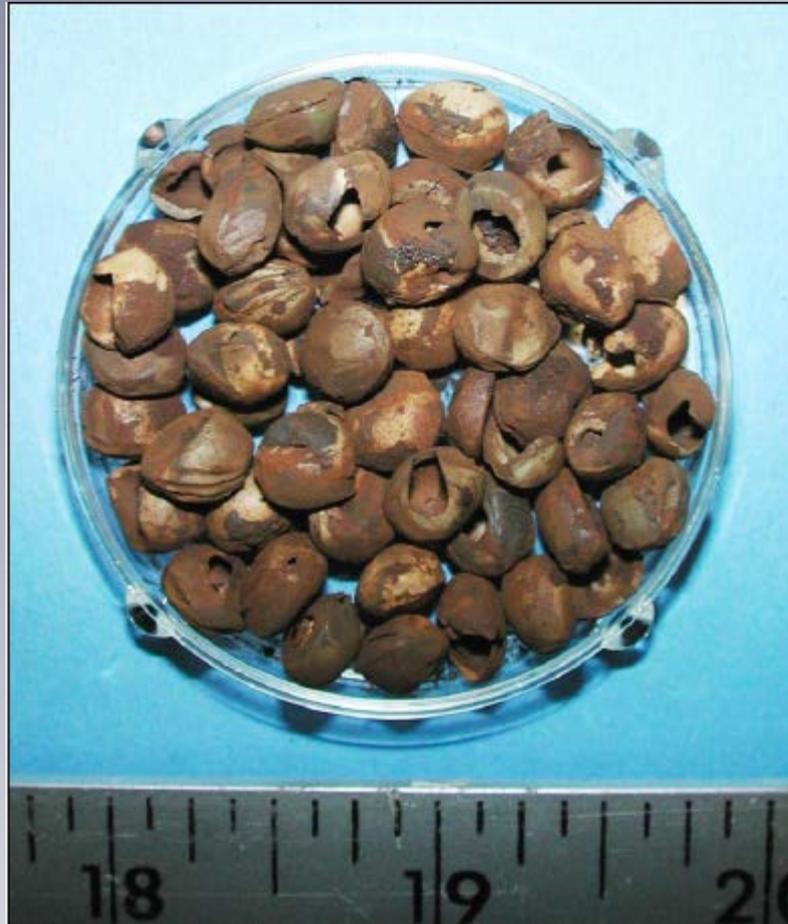
Significant Incident – 263423

- Debris moving through distribution system caused double regulator failure.
- Working-monitor regulator station.
- Caused 139 psig pressure on a 60 psig system.
- 120 miles of distribution main and 7,010 gas services overpressured.
