2015 Communication Meeting

Presented by:
Michigan Public Service
Commission

Significant Incidents

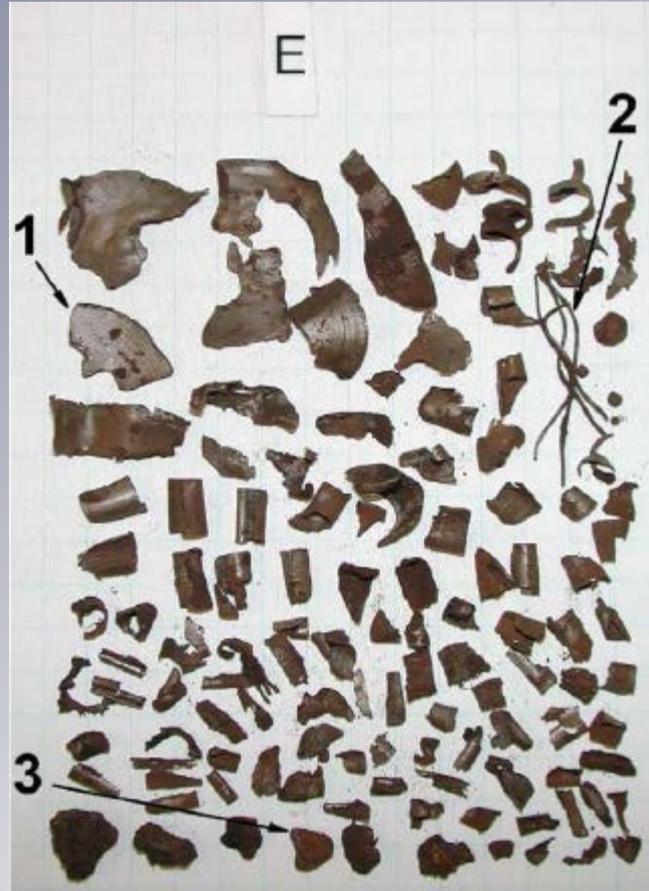
Significant Incident – 263423

- Debris moving through distribution system caused double regulator failure.
- Working-monitor regulator station.
- Caused 139 psig pressure on a 60 psig system.
- 120 miles of distribution main and 7,010 gas services overpressured.

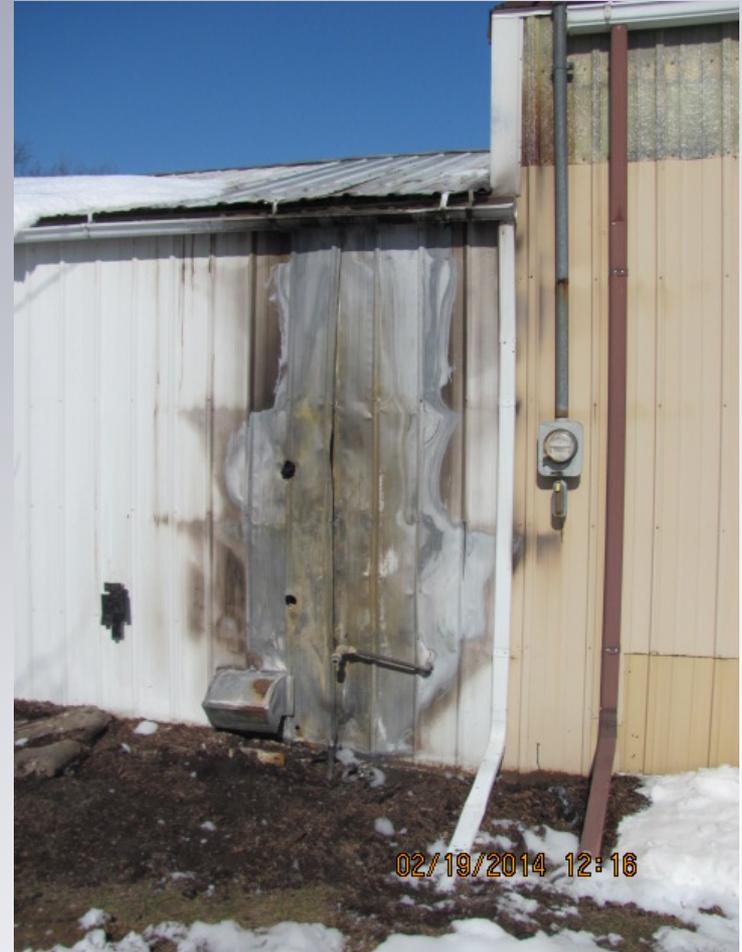
Significant Incident – 265023

- Snow/ice buildup on roof fell onto gas meter, causing a leak which led to ignition.
- Furnace located right inside wall from gas meter.

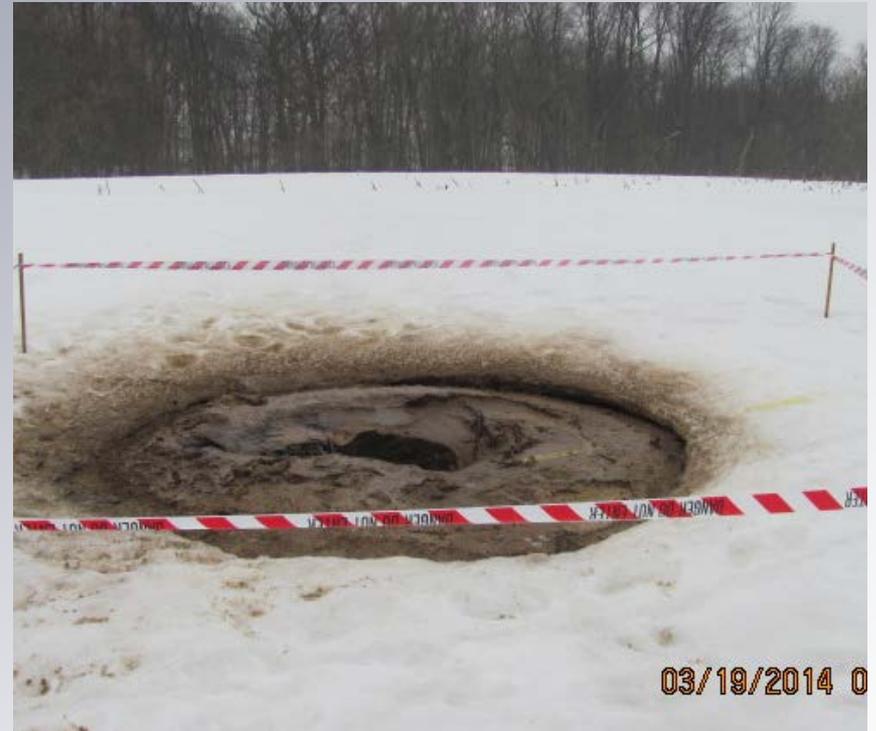
Significant Incident – 271123

- Internal corrosion caused a leak on a storage field girth weld.
- Operating at 417 psig; was operating at 1350 psig 3½ months earlier.

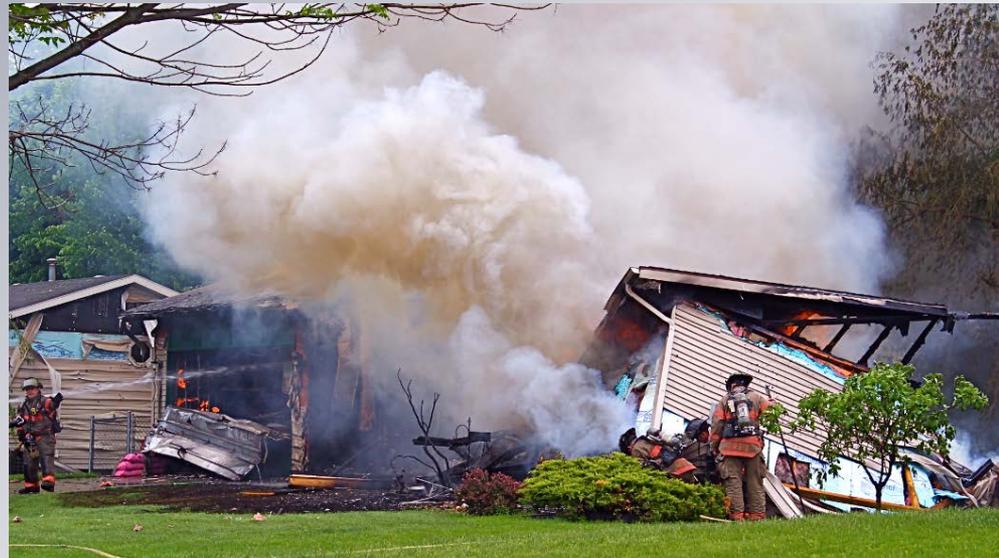
Significant Incident – 280927

- House explosion determined to be non-jurisdictional.
- Fire Department was on-site previous day responding to an odor complaint, cleared the leak with their “nose.”
- Fire Department and public never notified utility.
- No injuries or fatalities.

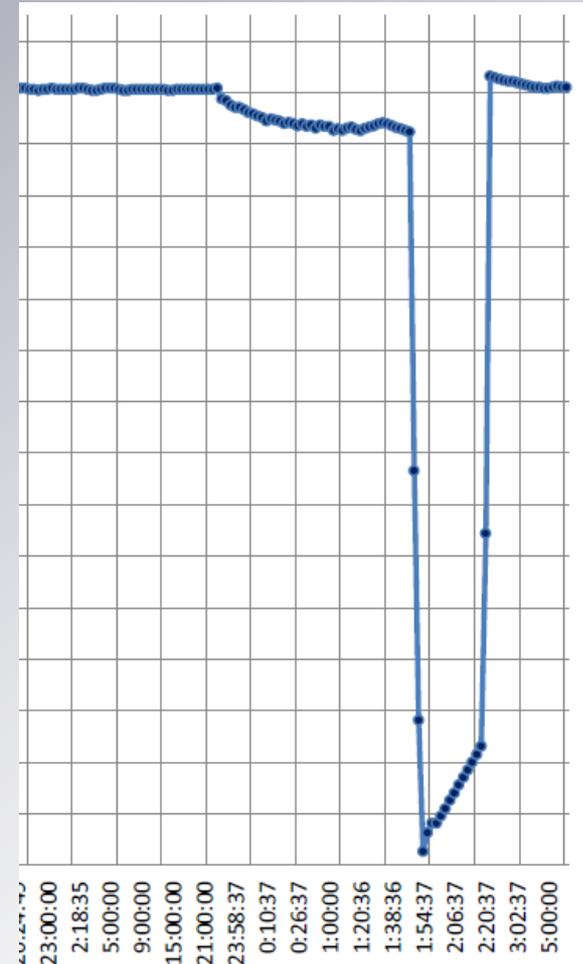
Significant Incidents – 264722

- Operator changed gas flow through route within a station. – Free Flow Conditions.
- Gas passed through several different sized pipe diameters. Pinch point caused ice formation. This combined with cold weather caused a relief valve to open partially.
- Gas release of 15 MMcf.
