2019 Communication Meeting

Michigan Public Service Commission Energy Operations Division

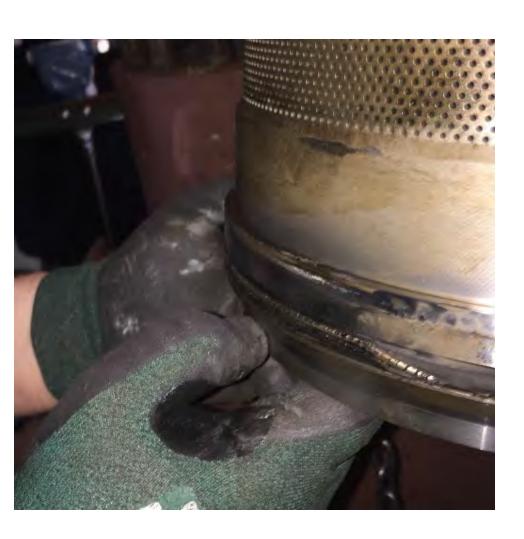
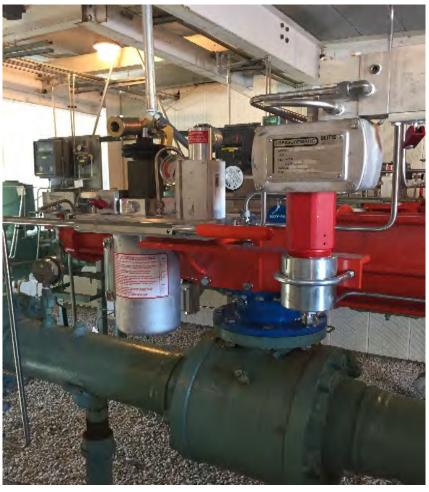
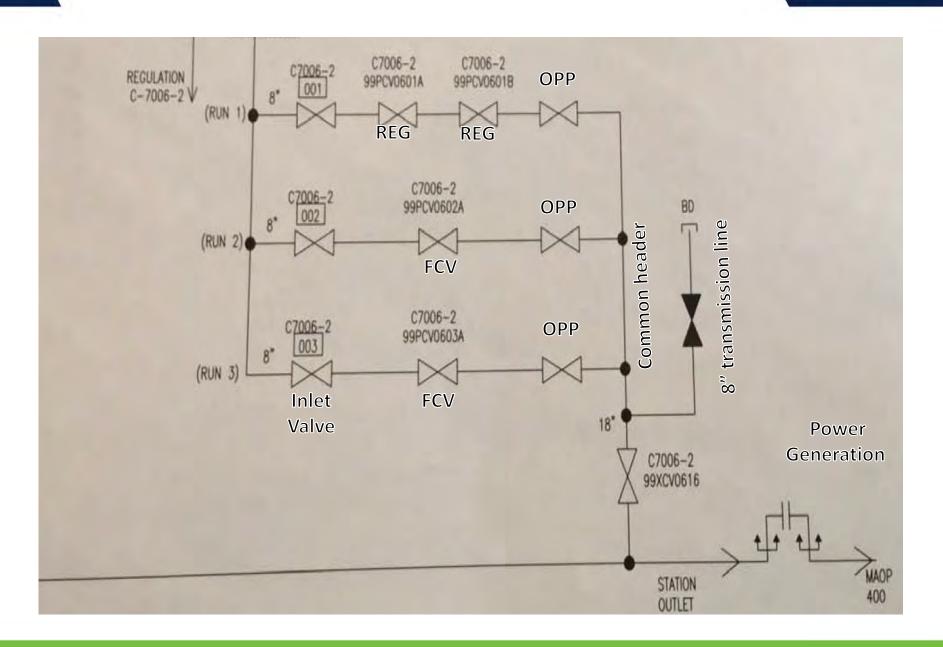
- Type: Overpressure.
- Characteristics:
 - 2.8 miles.
 - Eight-inch steel transmission.
 - Lasted almost six hours.
- Description: Overpressure on one operator caused by backpressure from another operator. 42% exceedance of MAOP.
 Pressure-control valve failure combined with incorrect operations.

Operator #1 Violations:

- 192.603(b): Failure to keep accurate records.
- 192.605(a): Flow control valves and overpressure protection valves not tested prior to being returned to service on the day of incident.
- 192.605(b)(5): Failure to have procedures for cycling gas flow.
- 192.605(c)(1): Failure to have procedures for responding to, investigating, and correcting the cause of an increase in pressure above outside normal operating limits or the operation of any safety device.

- Operator #2 Violations:
 - 192.195(a): Lack of OPP installed at regulating station to protect the station from an MAOP exceedance from Operator #1. No verification that Operator #1 facilities are protecting operator #2 piping.
 - 192.605(c)(1)(ii): Operator #2 was aware of overpressure on Operator #1 pipeline but did not communicate with them for three hours. O&M did not contain procedures for an overpressure when the cause may have been another operator.

- Operator #1 Recommendations:
 - Provide training to ensure individuals performing covered tasks have the necessary knowledge and skills and abilities.
 - Monitor outlet pressures with SCADA alarms or text message notification.
 - Develop AOC procedure to leak survey pipelines that experienced an overpressure.
 - Develop AOC procedure to check variations from normal operation after abnormal operation.
 - Install actuator on existing valve on eight-inch transmission line as redundant OPP.

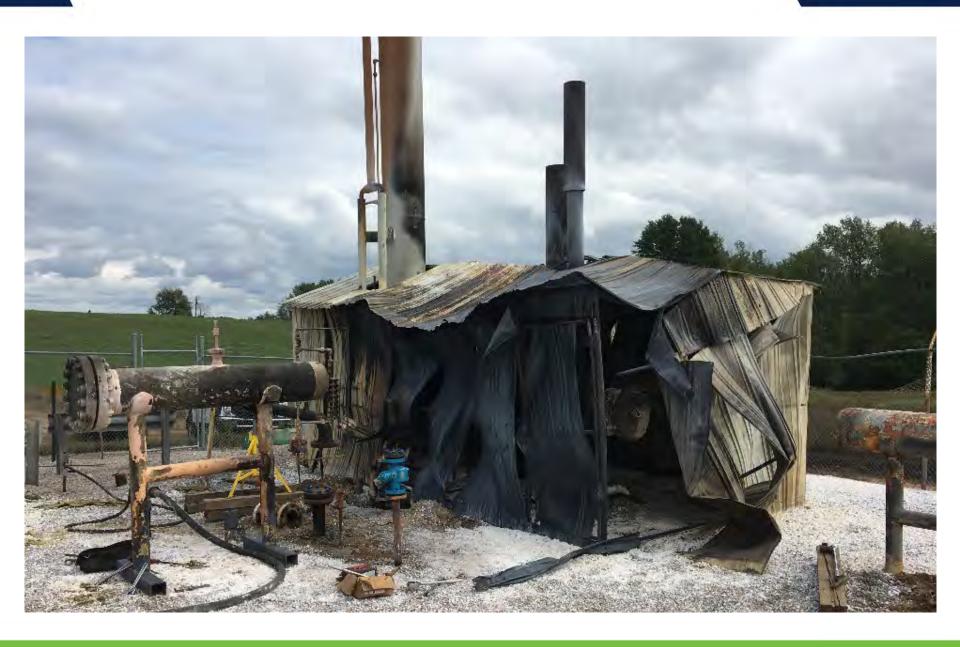
- Type: Natural Force Damage or Equipment Failure.
- Characteristics:
 - Dehydration unit.
 - Damages of \$215,900.
- Description: Still under investigation.
 Dehydration unit was either struck by lightning or overheated because it was left on after the adjacent storage field was shut-in about one month prior.
- Operator Recommendation: Develop procedures to require a dehydration unit to be shut off once the field is at capacity and shut in.

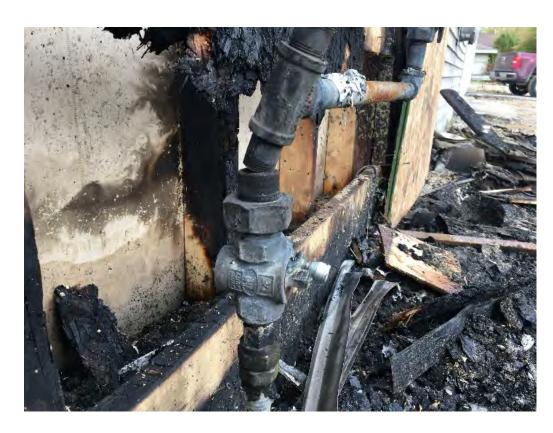
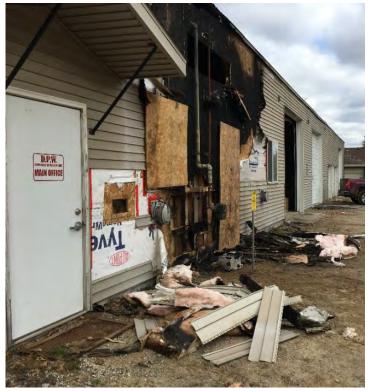
- Type: Other Outside Force.
- Characteristics:
 - Vehicle damage.
 - Damages of \$51,800.
- Description: A vehicle hit a gas meter service riser causing a threaded joint to separate, leading to ignition.
- Operator Violations:
 - 460.20308(d): Meter was not protected from vehicle damage.

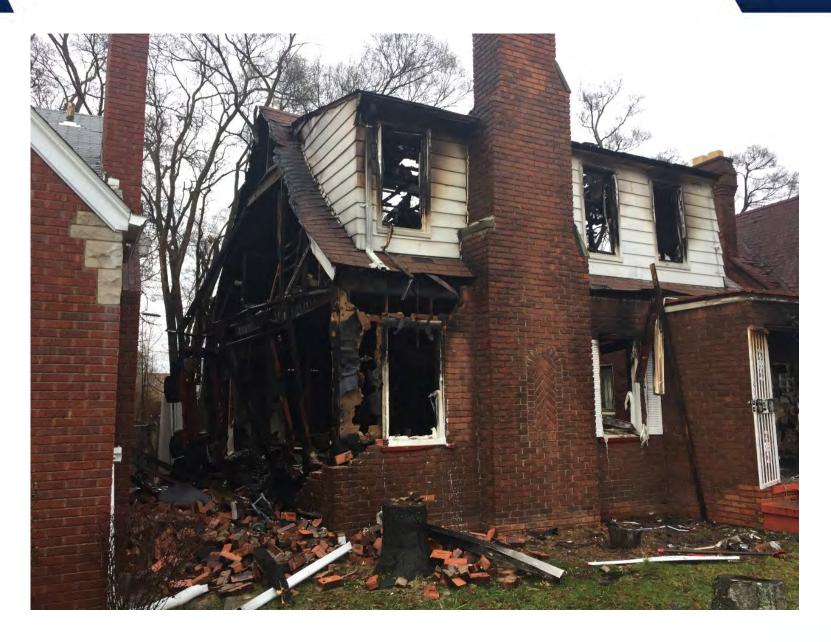
- Type: Non-Jurisdictional.
- Characteristics: Fuel Line.
- Description: House explosion attributed to inside fuel line. Data from AMR meter used to support the determination.

2/16: 4,163.66 2/19: 4,267.00

Operator Violations: None.

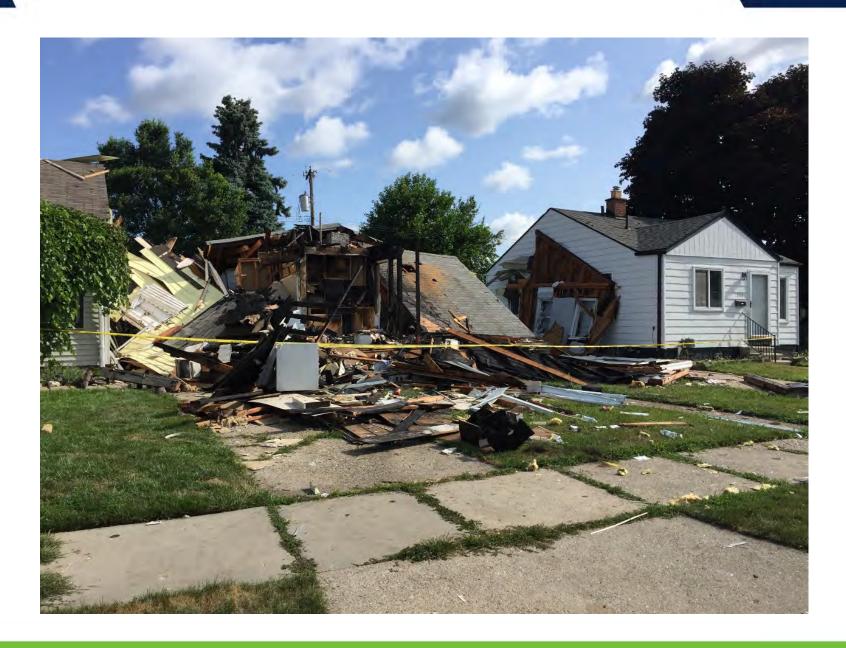
- Type: Non-Jurisdictional.
- Characteristics: Fuel Line.
- Description: House explosion attributed to inside fuel line. Data from AMI meter used to support the determination.

Operator Violations: None.

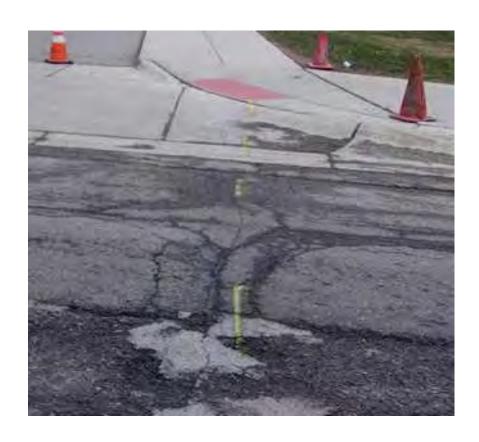
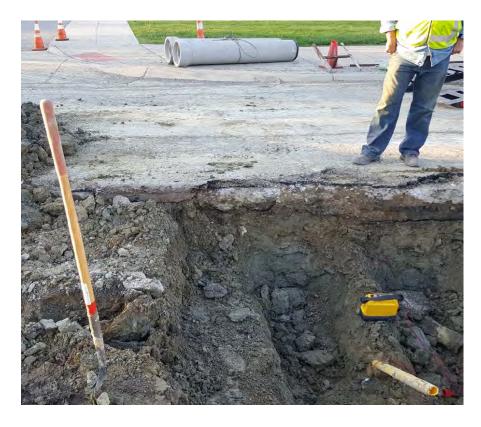
- Type: Third-Party Damage.
- Characteristics: N/A.
- Description: An operator accidently marked a retired service line instead of the live service.
 Contractor hit the live service.
- Operator Violations:
 - 192.614: Failure to mark facilities.

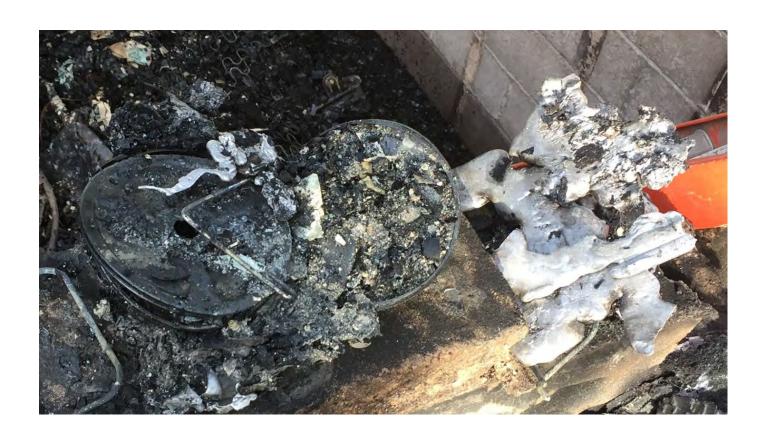
192.481(a): Not having inspected an inside meter since 2013.

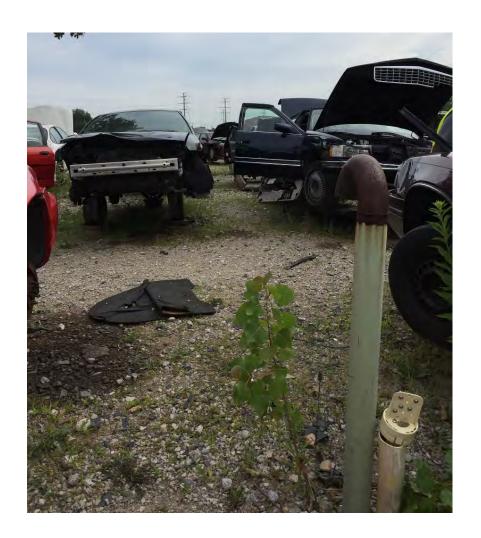
- 192.705(a): Not making required observations on patrols.
- 192.706: Not performing leak surveys in certain areas.

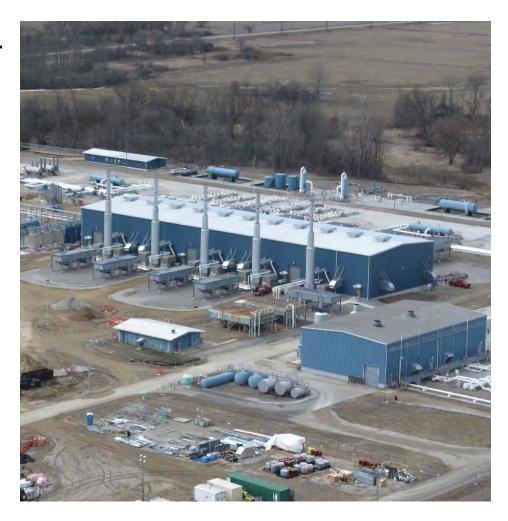
192.905(b)(1): Not considering compressor stations or construction activity in HCA determinations.

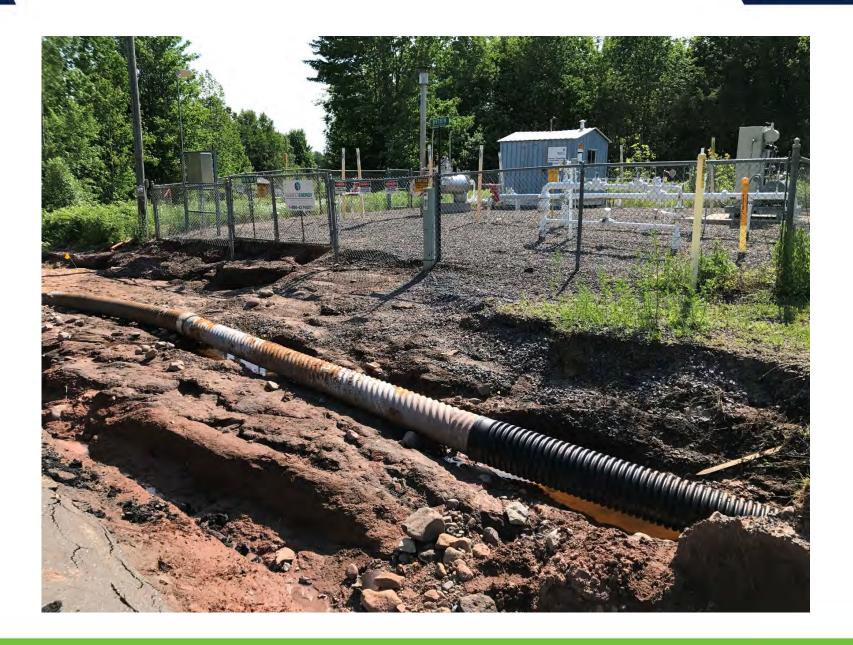
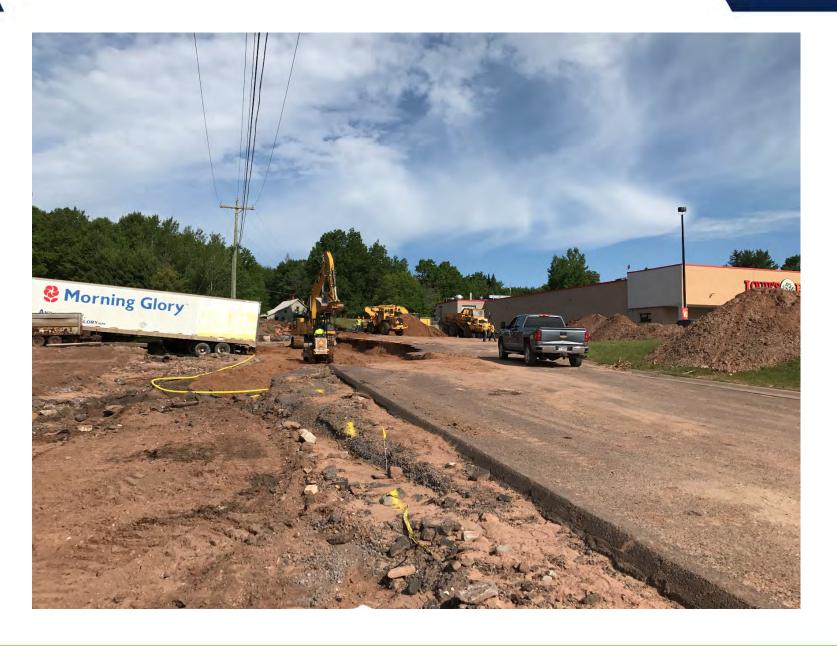
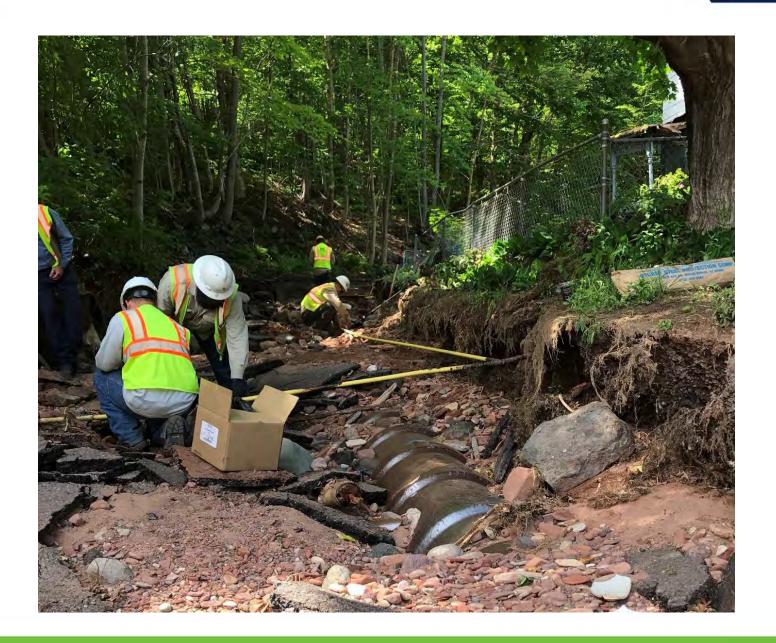
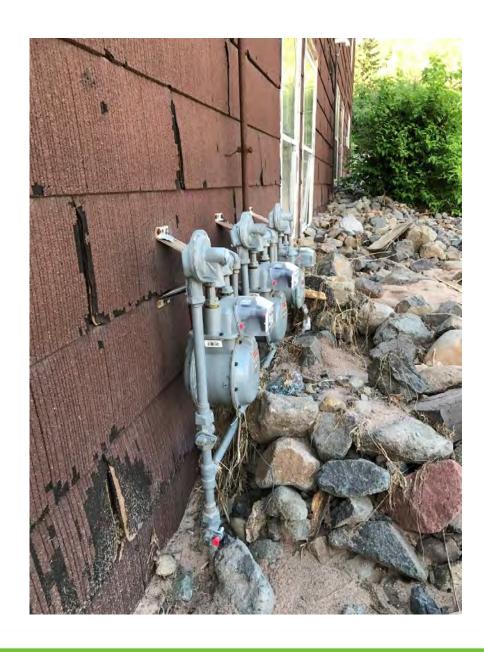
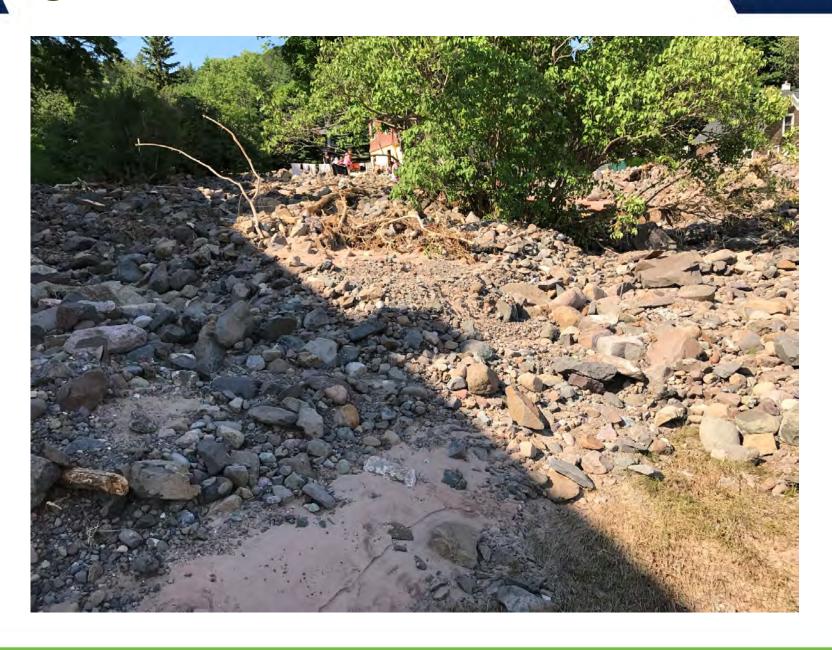
- Type: Natural Force Damage.
- Characteristics:
 - 6.2 inches of rain over six hours.
- Description:
 - 42 areas required response from exposed pipelines varying from ½-inch plastic service to four-inch steel main.

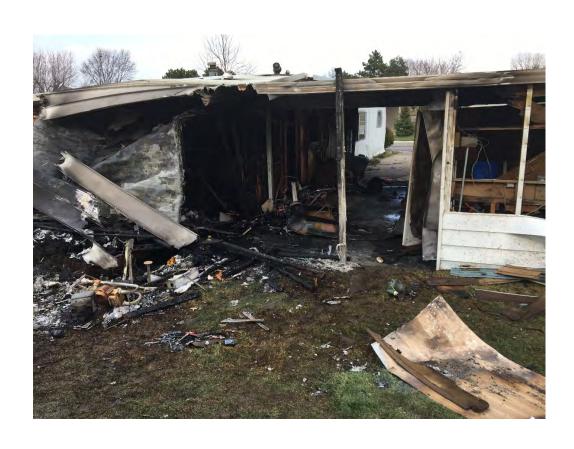
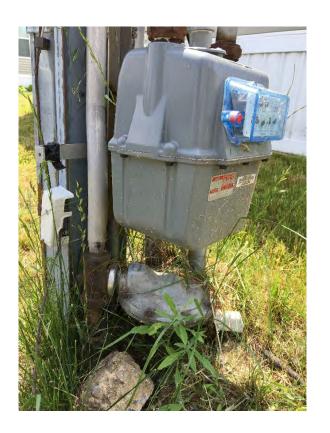
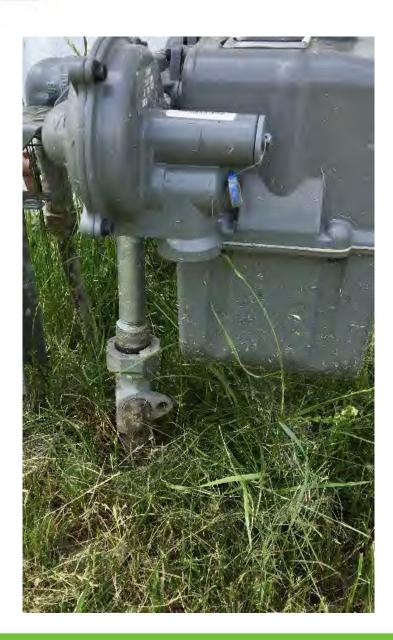
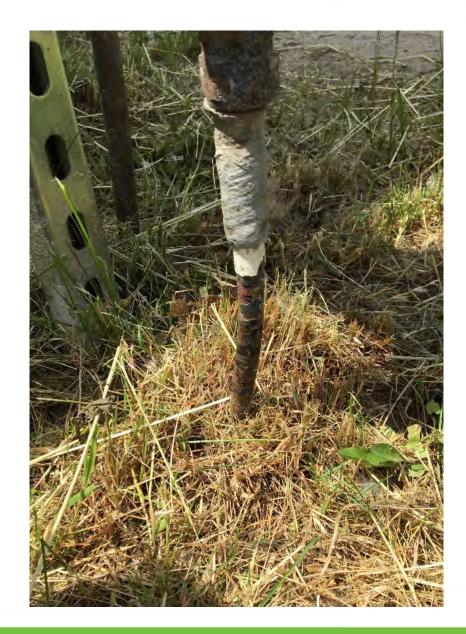
- Type: Incorrect Operations.
- Description:
 - House fire occurred during a scheduled meter replacement.
 - Steel riser broke below the lockwing.
- Operator Violations:
 - 192.355(b)(2): Neighboring service regulator vented directly into the ground.
 - 192.357(a): Neighboring meter supported solely on the riser and customer piping.

- Violations (cont.):
 - 192.481(a): Records showed periods exceeding three years for atmospheric inspections for neighboring residences. Additionally, the damaged house supposedly had atmospheric inspections performed during the mobile leak survey.
 - 192.481(b): Records showed atmospheric conditions as "Good" for five neighboring service risers that were in poor condition.

- Violations (cont.):
 - 192.605(a): Procedures to continuously surveil facilities inadequate for taking appropriate action for the corrosion present on meter assemblies.
 - 192.805(h): Records showed atmospheric conditions good for service risers as "Good." However, risers showed levels of deterioration beyond what should be recognized as good. Additionally, some risers were completely buried up to the lock-wing. These issues were unidentified.

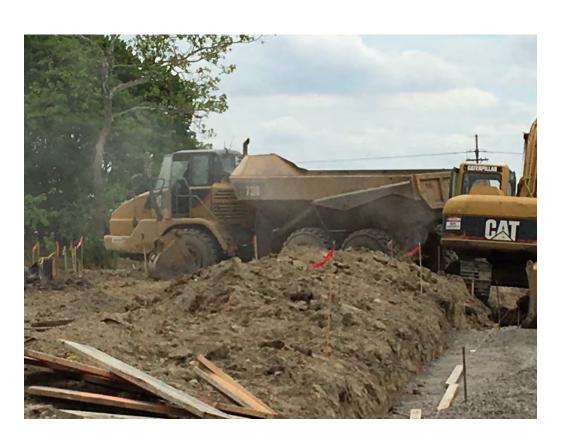
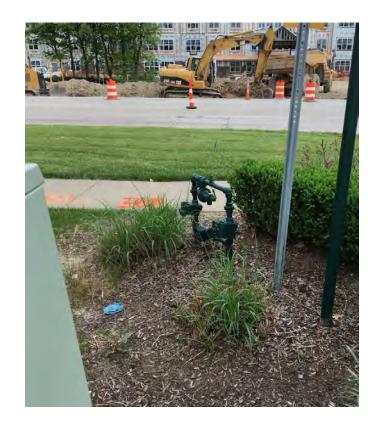
- Type: Third-Party Damage.
- Characteristics:
 - High-pressure service line connected to eight-inch steel distribution main.
- Description:
 - Gas vented for 19.5 hours before main was isolated to complete repair.
- Operator Violations:
 - 192.614(a): Although the excavator was not working under their own one-call ticket, a ticket covering the area was requested by a different contractor and not marked.
 - 192.615(a)(6): Valves were not used to isolate the main and perform repairs, stopple fittings were preferred option. 20 vs 33 customers.

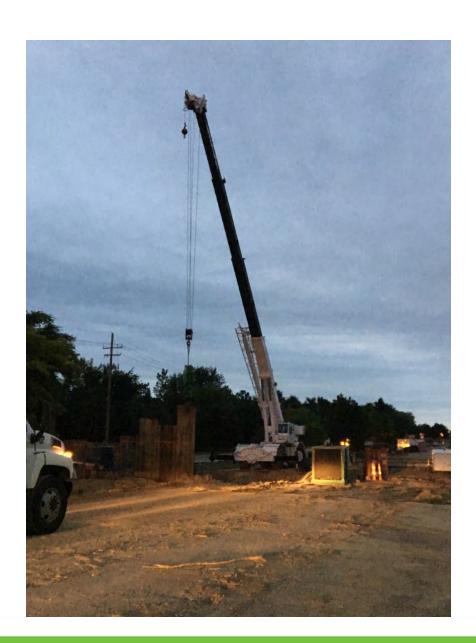
- Type: Third-Party Damage.
- Characteristics:
 - Eight-inch plastic main.
 - 60 psig MAOP.
- Description:
 - Contractor installing shoring for culvert work inside of a road median.
- Operator Violations:
 - Ongoing Investigation.

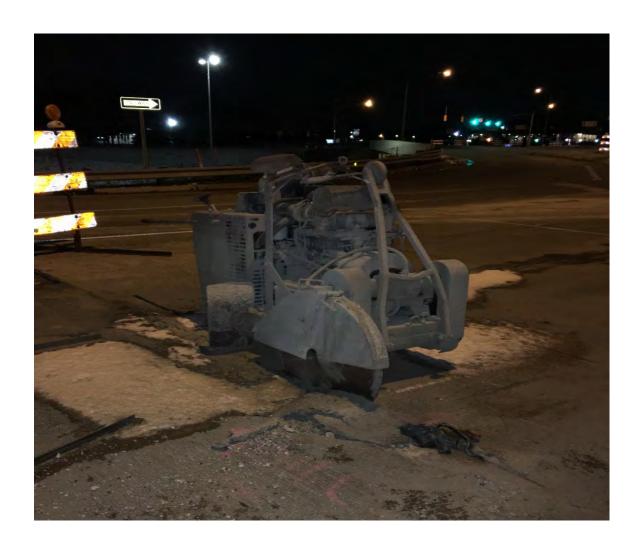
- Type: Third-Party Damage.
- Characteristics:
 - Eight-inch main.
 - 1963 installation.
 - Buried nine-inches deep.
- Description:
 - Contractor was saw-cutting concrete. Pipelines marked, but not noted as shallow. Contractor was cutting to a depth of ten inches.
- Operator Violations:
 - Ongoing Investigation.

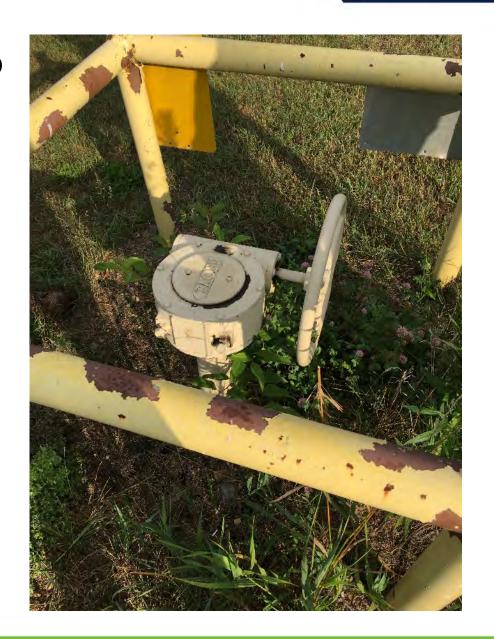
- 192.179(b)(1): Failure to protect valve from tampering.
- 192.225(a):
 - Performed welding with a procedure where the essential variables were out of the scope of the task.
 - Performed welding without any welding procedure.

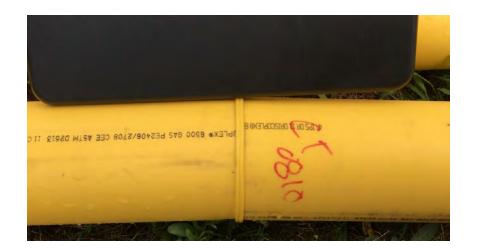
- 192.305: Failed to selfinspect proper fuse alignment.
- 192.505(a): Failure to test lines over 30%
 SMYS to establish
 MAOP. Midway through test the pressure dropped below 1.5x MAOP.

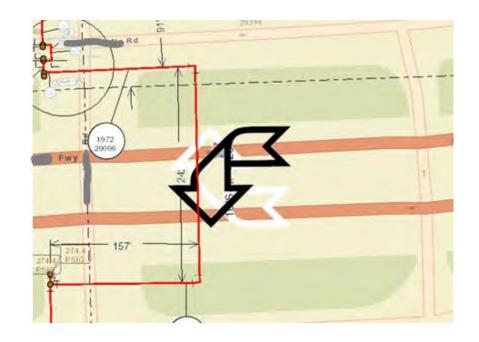
- 192.513(c): Performed pressure tests at 30psig, not the minimum of 50 psig for plastic service lines.
- 192.605(a): Employee
 performed leak survey
 with mobile device over
 a highway overpass,
 which was out of the
 range of the device.

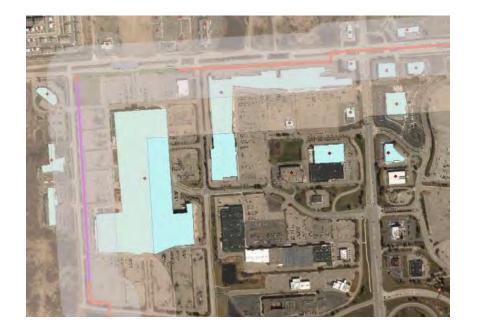
- 192.605(b)(1):
 - Operator's software calculated class location by designating dots in the center of building.
 - Operator's software calculated class location ended at each valve site or line transition without continuing the sliding mile.

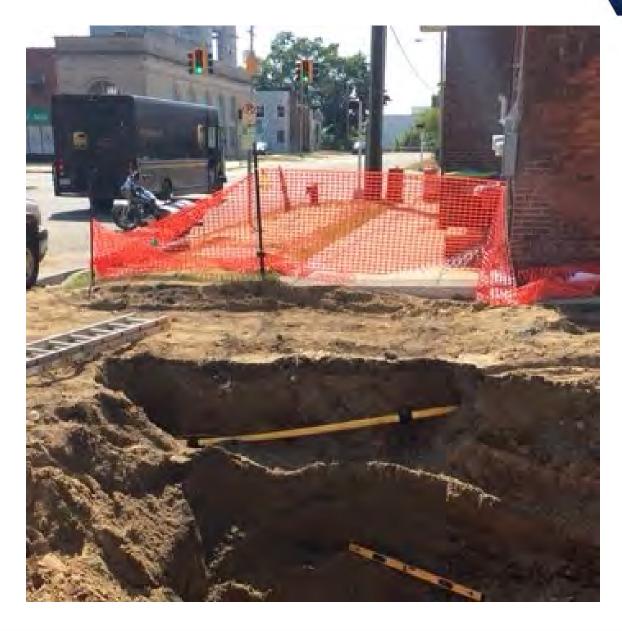
- Type: Third-Party Damage.
- Characteristics:
 - Two-inch plastic main.
- Description: Excavator had hand-exposed the facilities, but re-covered them. No restake request.
- Excavator Violations: MCL 460.725(5): Failure to determine the precise location of facilities before using power tools in the caution zone.

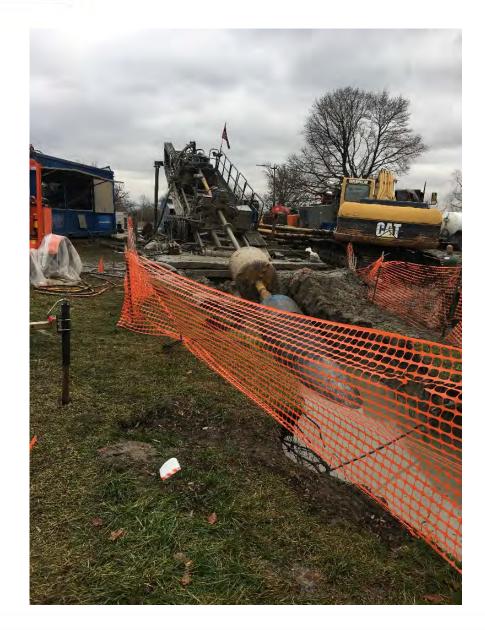
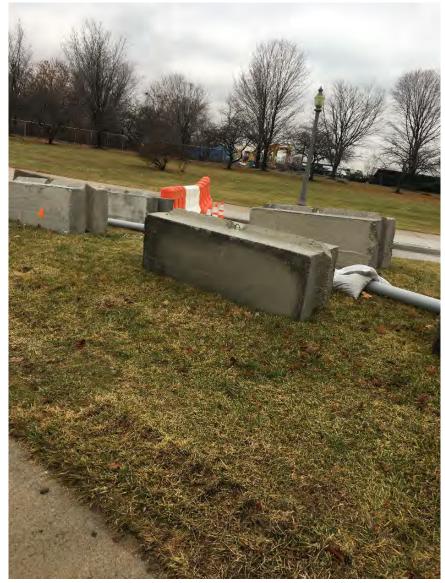
- Type: Third-Party Damage.
- Characteristics:
 - Four-inch steel main.
 - 19 commercial outages.
- Description:
 - Horizontal directional drill punctured a main under a river.
- Operator Violations:
 - Ongoing investigation.

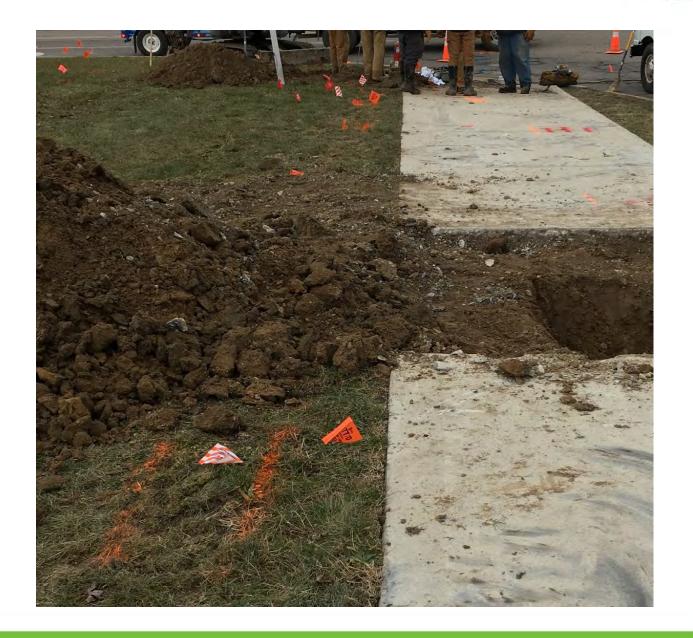
- Type: Third-Party Damage.
- Characteristics:
 - Four-inch plastic main.
- Description:
 - Excavator was digging using an auger under an expired ticket and had not requested a restake.
- Operator Violations:
 - Ongoing investigation.
- Excavator Violations:
 - Ongoing investigation.

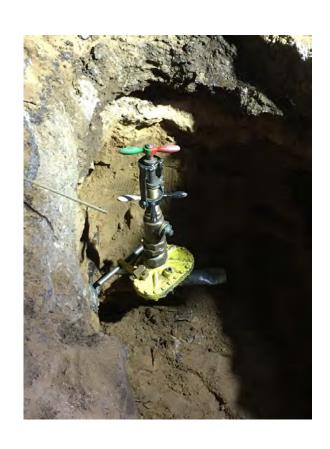
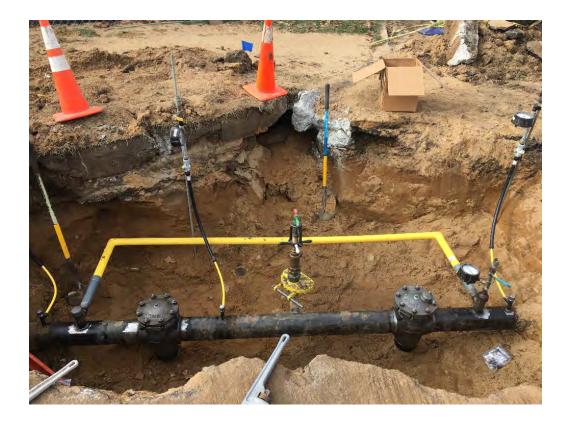
- Type: Third-Party Damage.
- Characteristics:
 - Two-inch steel main.
 - Six-inch steel main.
 - Cost \$40,400.
- Description:
 - Excavator hooked a two-inch steel main pulling it from the ground. Gas blowing for ten hours. Two-inch main connected to six-inch main by a compression coupling.
- Operator Violations: Ongoing Investigation.
