VIAP ASSESSMENT AND MITIGATION IN A COMPLEX SETTING

Case Study Overview

Americhem Sales Corp.

340 North Street, Mason

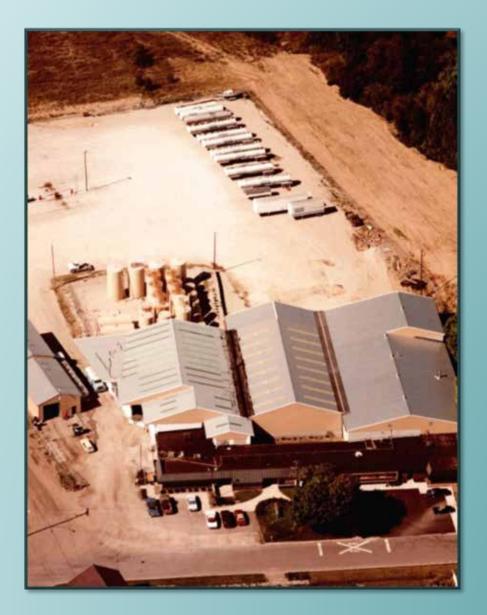
Original Site

- Old tank farm tight to the facility, <u>NO</u> containment and rusted tanks.
- Old fuel island with no containment
- No security

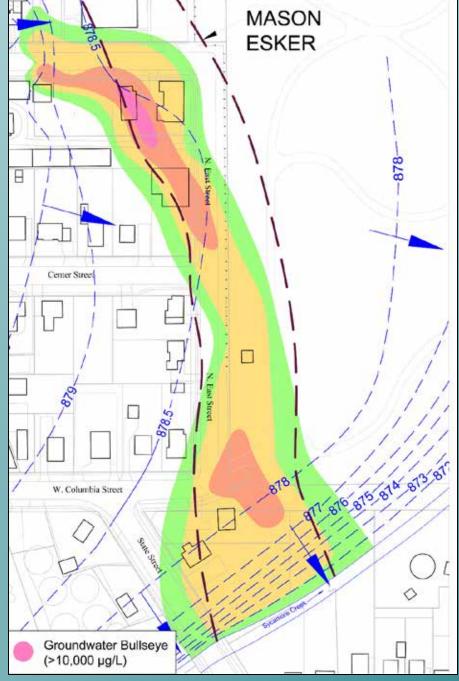
August 2017 Shallow GW - TCE

- Groundwater flow to the east and slow until it reaches Esker
- Flows fast and follows the Esker South
- Does not underflow the Sycamore

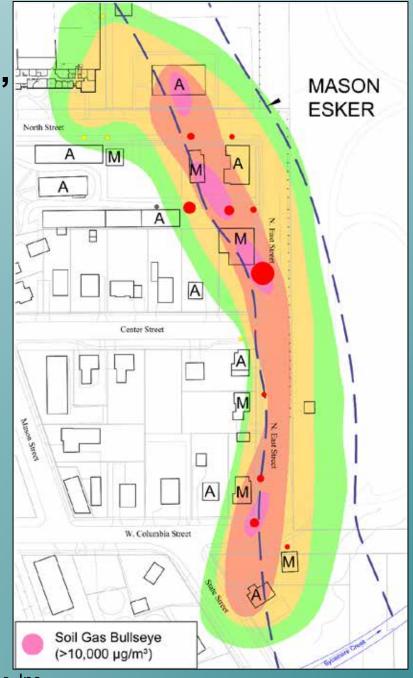
August 2017 Soil Gas - "Early Snapshot"

- All exterior building soil gas, two depth intervals
- TCE > RIASLs and TS RIASLs
- Some homes we expected to Mitigate remained "Assessment"
- Some homes we expected to "Assess" only required Mitigation
- Confounded by second source (Home 3 – furniture restoration)

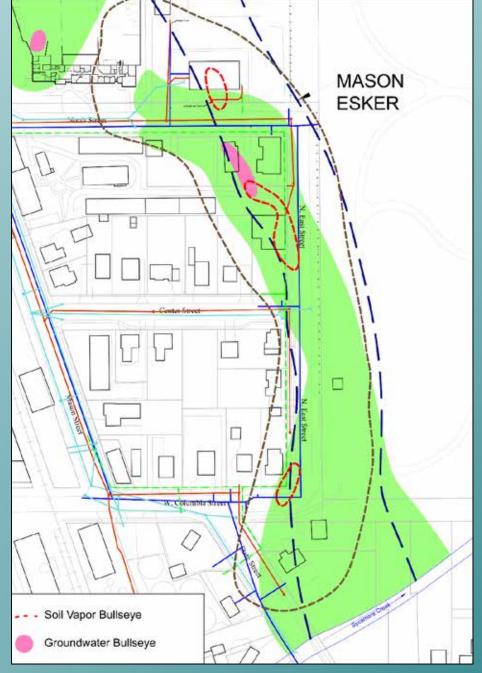
Overlying Soil Gas Plume

"Bullseyes" don't match

Utilities influence transport

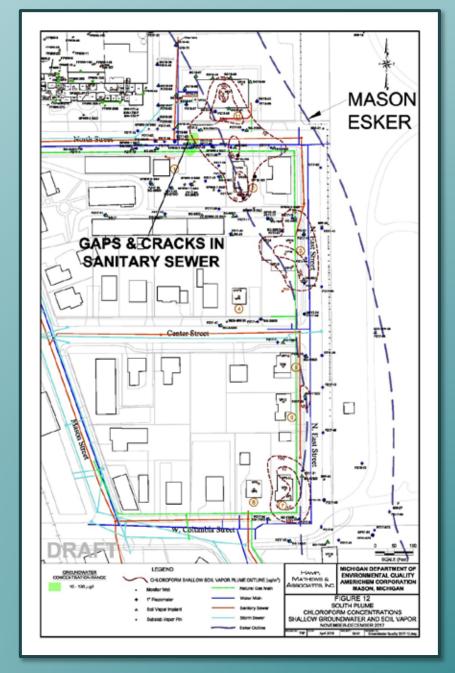
Utilities as Secondary Transport Mechanism

- Chloroform from sewer and water
- Coincident with gaps and cracks
- Utilities capable of transport
