Edenville Dam Inspection Report

Dam Identification No.: 549
Hazard Potential: High
SE ¼ Section : T.17N. – R.01W.
Tobacco Township, Gladwin County, Michigan
Located on Tobacco & Tittabawassee Rivers
Per Part 315, Act 451 of 1994

Date of Inspection: June 2019 to March 2020

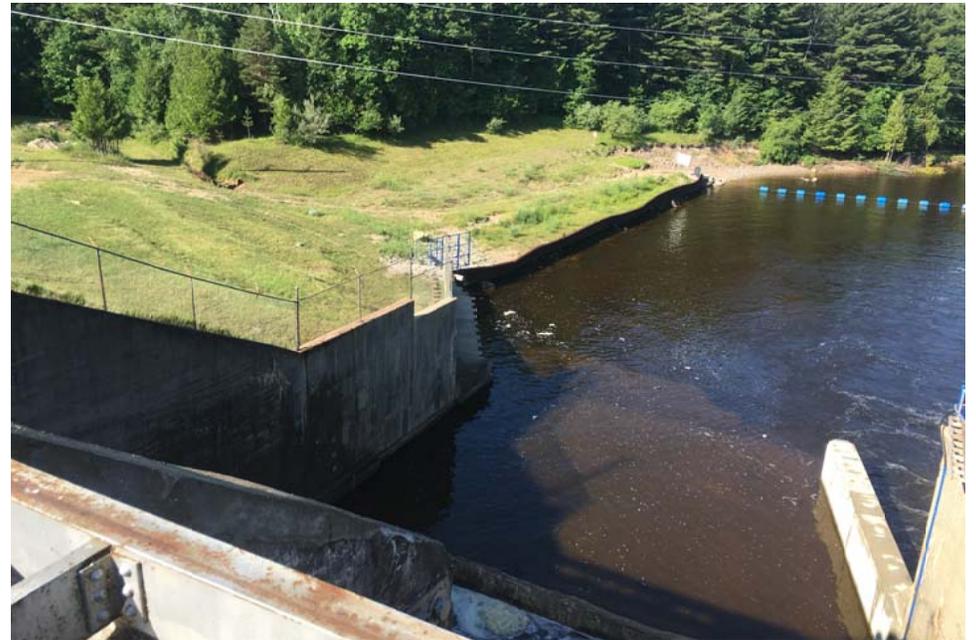
15 - Lower End of Left Training Wall & Sheetpile Retaining Wall in Tailrace - Sheetpile has Failed

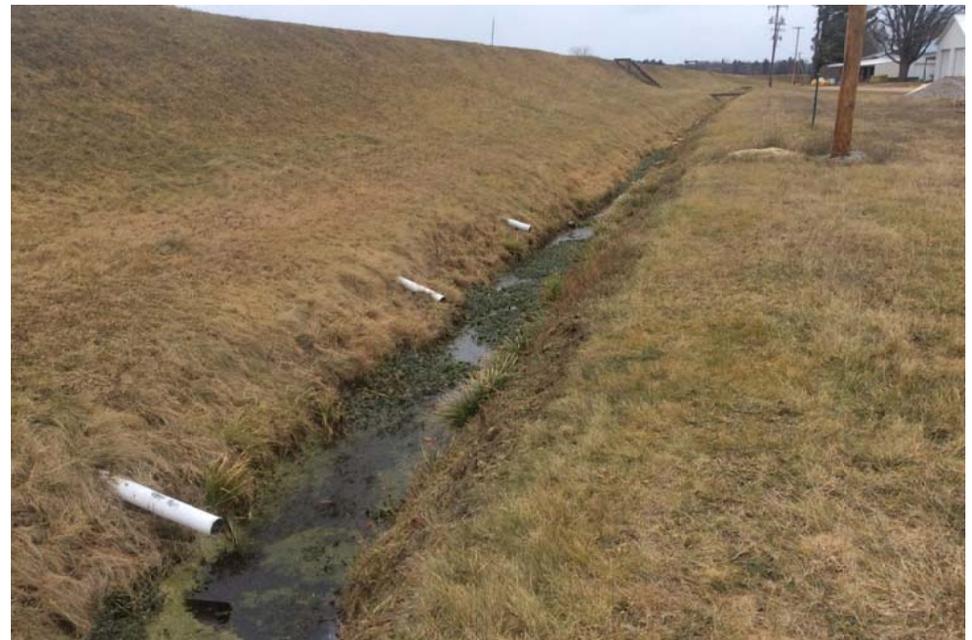
27 - Right Embankment - Broken/Submerged Seepage Tiles, Looking Northeast

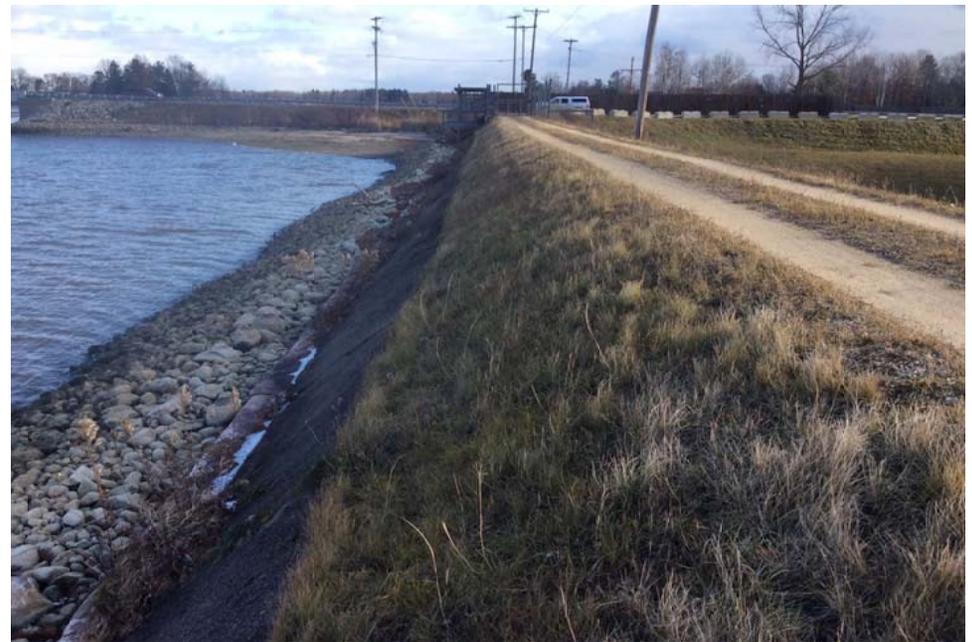
15 - Left Embankment - Erosion at Left Training Wall
