Line 5 Straits

Engineering Assessment

East Leg and Anchor EP-17-1

21 June 2020

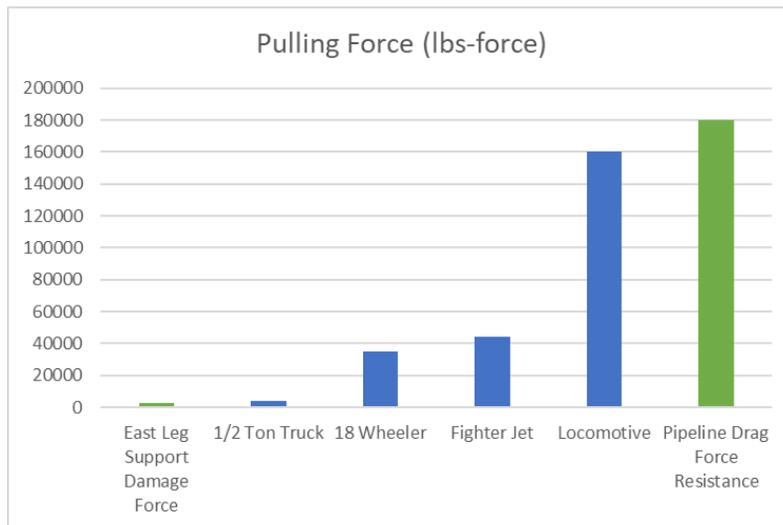
The maximum force on the support anchor would have been due to dragging it in the longitudinal direction (i.e. along the axis of the pipe). The limiting point on the anchor is the slip force of 2600 lbs friction load which occurs at the saddle component and is the interface between the anchor and the pipe. This dragging force equates to less than 0.054 ksi or less than 0.18% specified minimum yield strength (SMYS) of the pipe.

The support anchors are designed to provide stability to the pipeline where spans develop. By design, the anchor supports can de-couple or come apart at various connections in case unplanned forces act upon them. This de-coupling or de-connection occurs at forces far less than the force (700 – 900 kN or 157,366 – 202,328 lbs) needed to cause critical pipeline damage. The resultant movement and damage of the support anchor in this instance demonstrates this design behavior. In other words, an unplanned force that can displace or break apart the anchor is well below the force required to cause critical pipeline damage. For illustration purposes, the pipeline’s resistance (represented as 180,000 lbs) to pulling force relative to the force imparted on the East Leg support is shown in Figure 1 below alongside some pulling force comparators. As shown, the design of the Straits crossing is highly resistant to this type of event.

Figure 1: Comparison of Drag Force that Occurred at the Anchor to Sample Scenarios

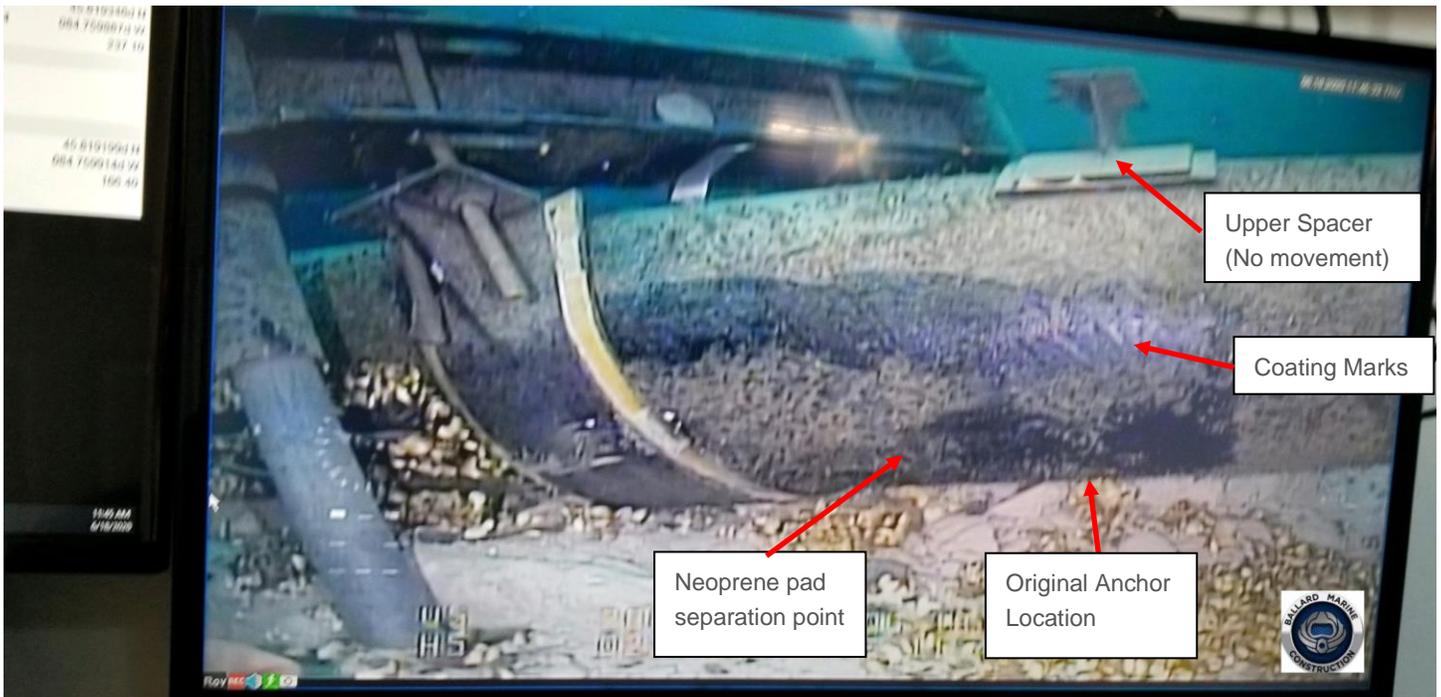
Figure 2: Displaced Anchor looking West

In the first loading scenario, under horizontal out-of-plane load applied to one anchor pile, the anchor and pipe system remain connected until such time as the static friction between the Neoprene pad and pipe coating is exceeded. The assembly of the anchor involves increasing torque on the threaded rod sections until there is approximately 3/16” worth of compression in the 1 1/2” thick 60 durometer Neoprene. This level of compression corresponds to just under 50 ft lbs of torque on each of the 4 threaded rod assemblies. The compressive force between the saddle assembly can then be calculated based on the 8” wide saddle as 13,000 lbs. The static friction coefficient is conservatively estimated at 0.2 based on wet contact face between the Neoprene and the coal tar coating. The resulting required axial force at the pipe to cause initial slip is then calculated to be approximately 11.6 kN or 2600 lbs. Once axial movement is initiated, all preload stored between the three 1/2” Neoprene pads is lost as the upper spacer separates from the cross-beam as shown in Figure 2 above.

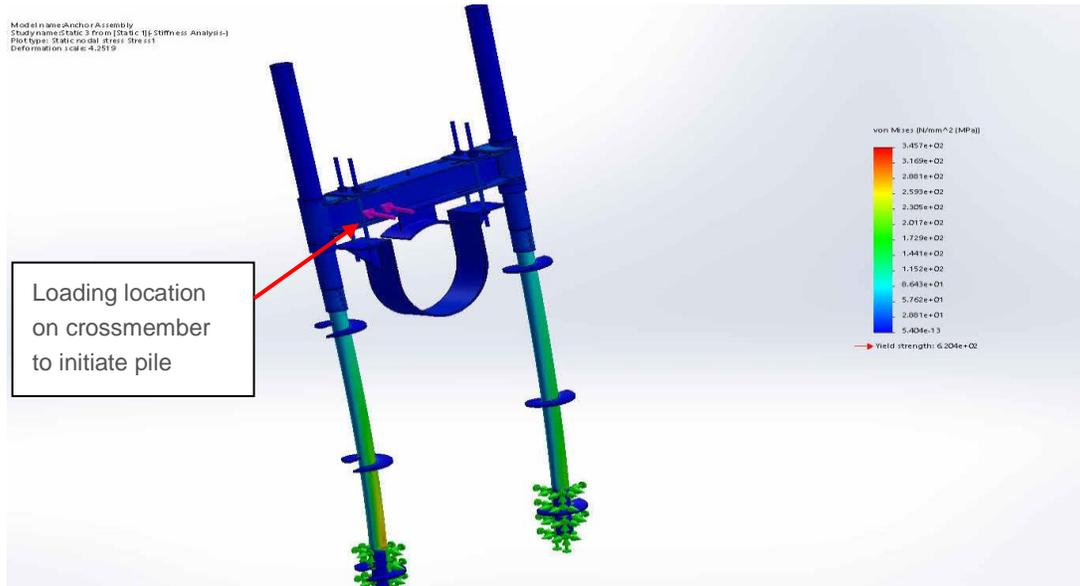
Secondly, the same analysis was repeated with no restraint on the pipe saddle to calculate the maximum load that fails the anchor pile after the anchor assembly is completely detached from the pipe. The maximum applied horizontal load in this scenario is 6.5 kN or 1461 lbs as determined through Finite Element Analysis where loading was increased until pile failure initiation was observed. Once the

yield strength of the pile is reached, there is relatively little increase in load to continue deforming the anchor assembly. The loading condition shown in Figure 3 below has the loading of the cross-member where it meets the East helical screw pile. This loading condition matches the as found deformed shape of the assembly when viewed from above as shown in Figure 4 below. Also, the reduced stresses within the West helical screw pile in Figure 3 support this loading condition.

Figure 3: Required loading to yield the helical anchor

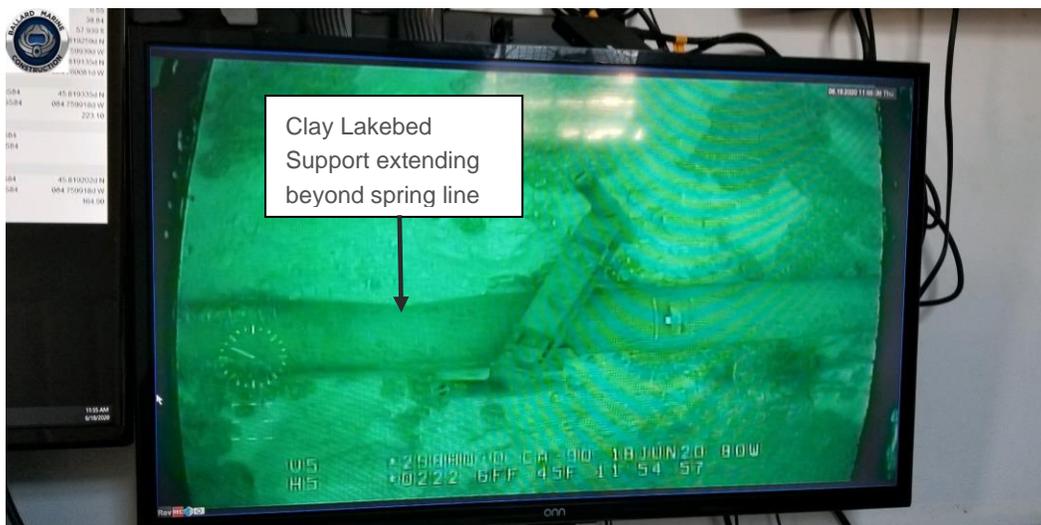
Figure 4: View from above showing the increased deflection within the East helical pile

The pipe is currently sitting on clay material nearby the damaged support anchor as shown in Figure 4 above and Figure 5, below. The clay touchdown serves as a support point and is 66 ft from the next anchor. This new pipe span of 66 ft is shorter than the remediation target of 75 ft, as stipulated within the requirements of the Line 5 Straits Easement Agreement. The 75 ft target provides a 2x safety factor. The 3rd Consent Decree additionally stipulates that locations identified beyond 65 ft span will require assessment and determination for remediation. The damaged anchor is incapable of carrying any measurable pipeline load due to the damaged and mis-aligned 1-inch threaded rods, as well as the gap between the top cross member and the pipeline as shown in Figure 5 below. This indicates that the maximum vertical load that can be imparted to the pipe is limited to the bending load of the failed 1" threaded rods and that the existing damaged anchor does not provide sufficient span management. As such, in order to meet the requirements of the Consent Decree, a replacement anchor will be scheduled for install in the near term once the required permit modifications are approved by both USACE and EGLE.

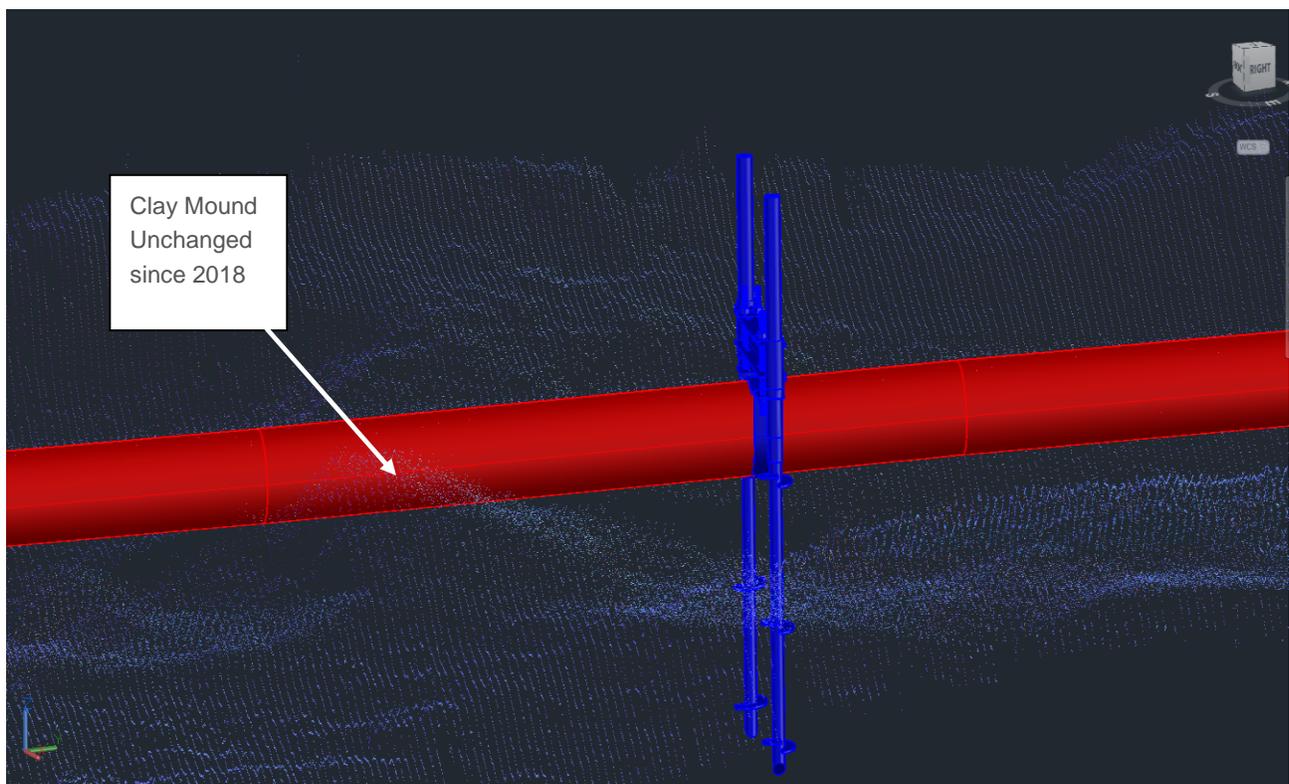
Figure 5: Multibeam bathymetry of EP-17-1 in relation to the adjacent clay mound.

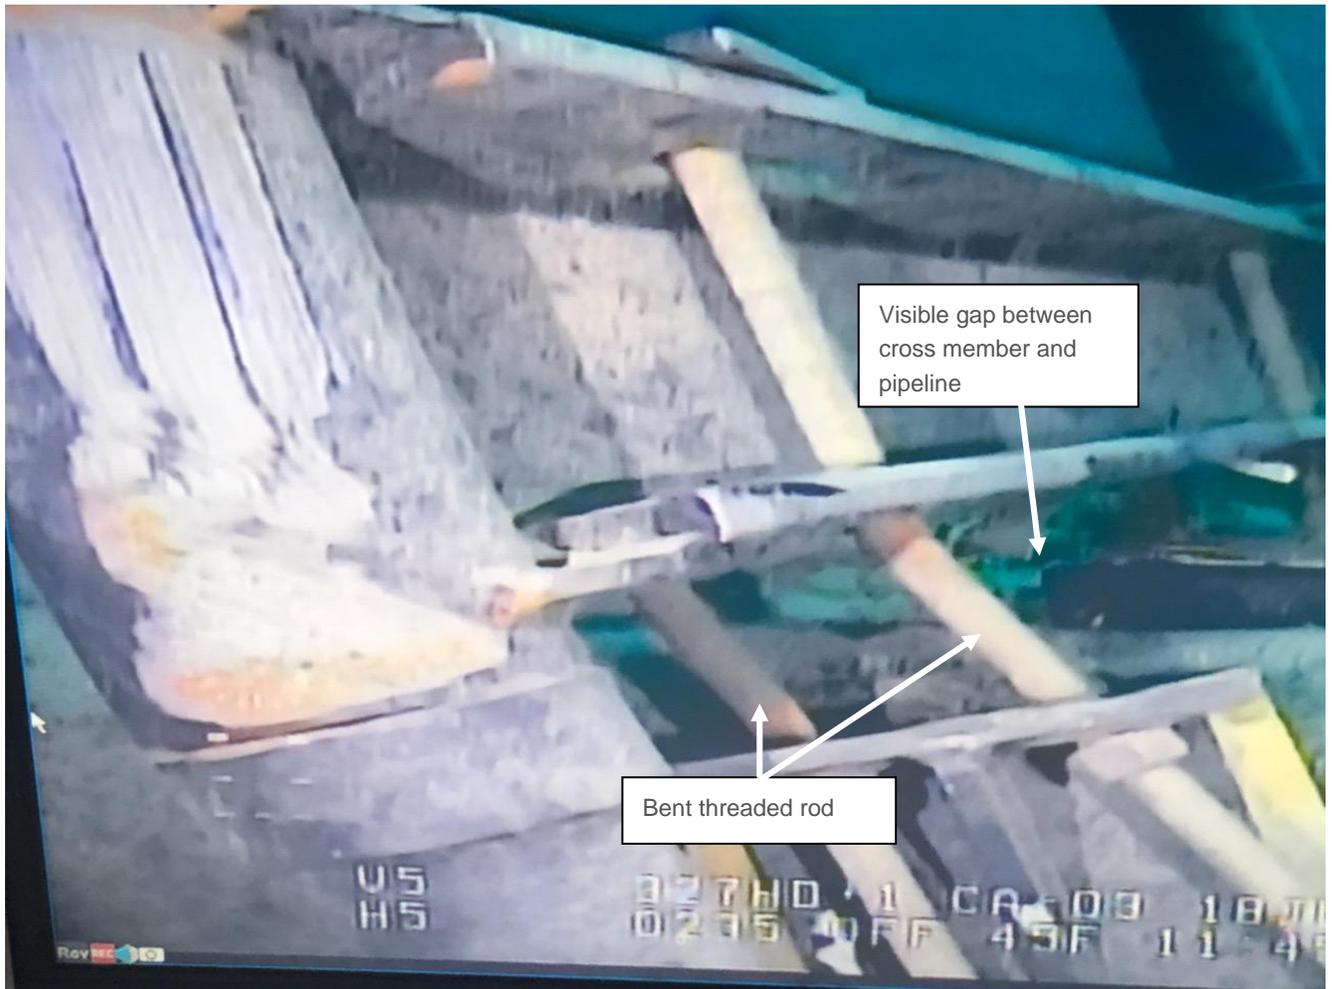
Figure 6: Damaged Threaded Rod Assemblies and Pipeline Gap to Cross Member
