Re: Revised Corrective Measures Implementation Report Submittal  
Former General Electric Apparatus Service Center  
18075 Krause Street, Riverview, Michigan  
MID 050 616 622

# **Corrective Measures Implementation Report**

**Former GE Apparatus Service Center  
18075 Krause Street  
Riverview, Michigan  
MID 050 616 622**

August 2015 (Revised August 2018)

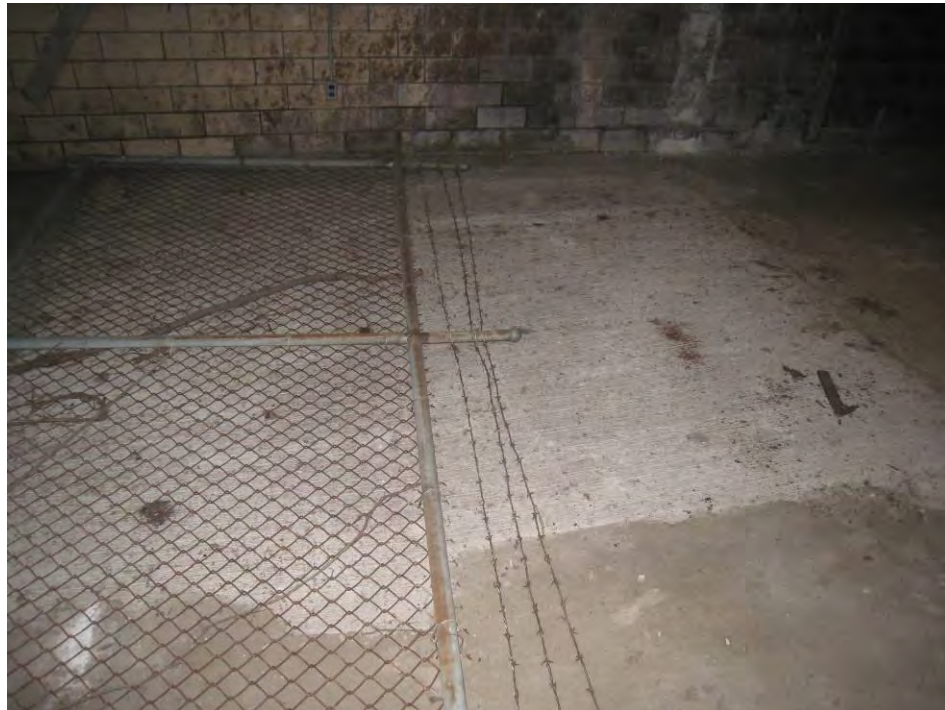
The excavation was backfilled and the concrete floor was replaced. A photograph of the concrete patch is shown below. The concrete floor and patch were removed in 2014 when the building was deconstructed.

**Photo 1 - View towards west of patched concrete floor at former ESCS location on 21 November 2011.**

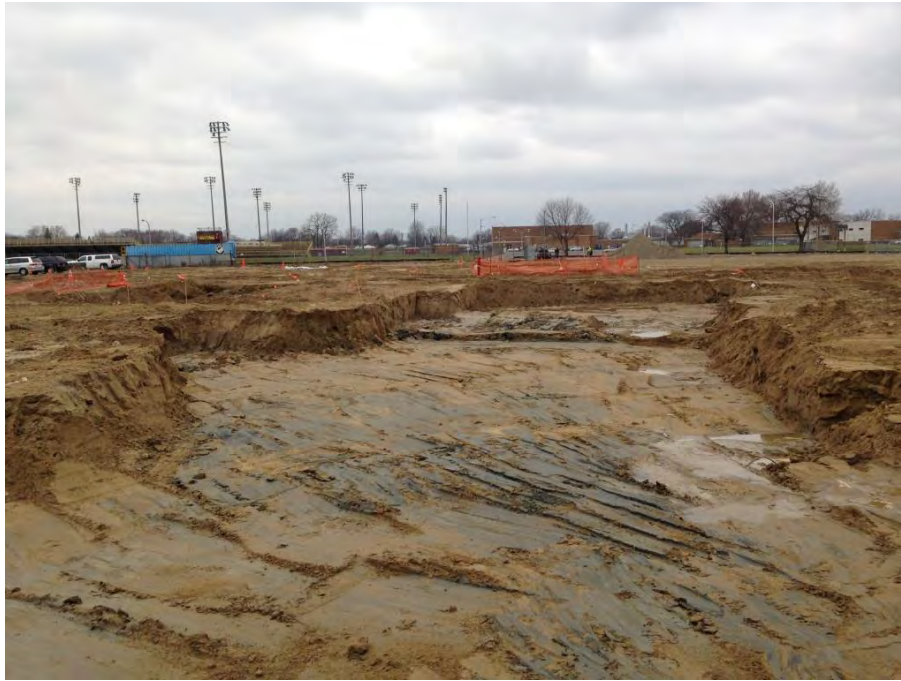
Photo 2 - View towards west of partially completed northern shop area excavation on 9 December 2014. Tan material is structural fill and gray material is underlying native clay. Note that perched water is practically non-existent within the excavation.

As a corrective measure the fill and soils containing VOCs in the northern shop area was excavated to a nominal depth of four feet bgs, a depth that included the concrete floor, the structural fill, and the upper approximately six inches of native clay soil. In the area surrounding boring 154, the excavation was extended to ten feet bgs to remove soil near a support column footer. The final horizontal and vertical dimensions of the VOC excavation area are shown on **Figures 10A** and **10B**, respectively.

The excavated soil was profiled and disposed as F001-listed hazardous waste at Wayne Disposal, in Belleville, MI.

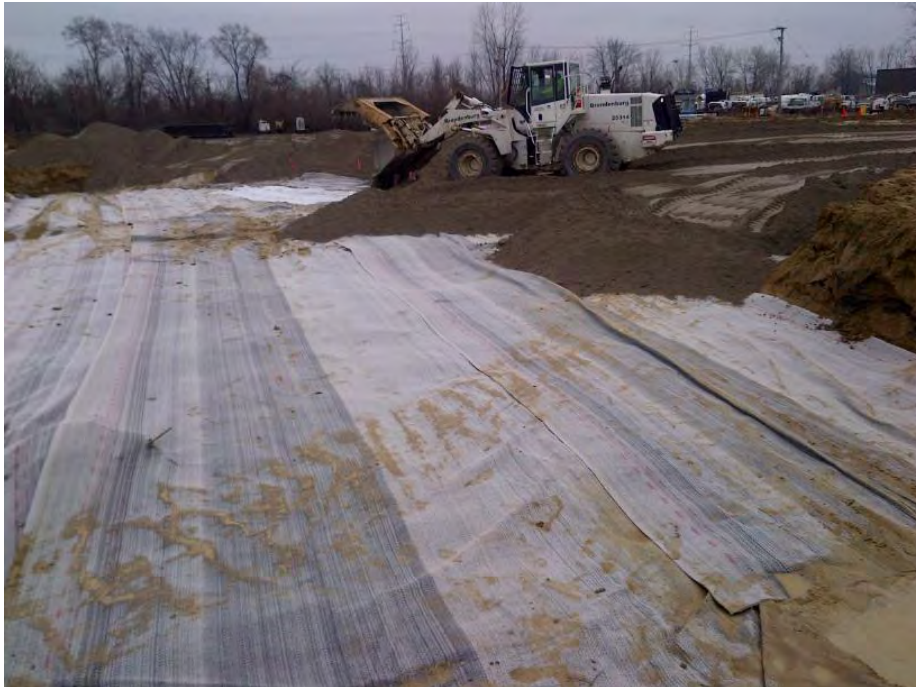
Photo 3 - Bentonite mat being installed in northern shop area excavation on 23 December 2014. Four feet of clean fill is being placed over the top of the mat. View is eastward.

During building deconstruction and soil excavation activities, a Bentomat™ bentonite mat was emplaced at a depth of four feet bgs within

the approximately 5,000 ft<sup>2</sup> portion of the northern shop area as a conservative measure to help manage stormwater that could accumulate in the open excavation. The bentonite mat was not intended to be an engineering control or an “excavation marker” and damage or excavation of the mat would not require any repairs or special handling from a waste disposal perspective.

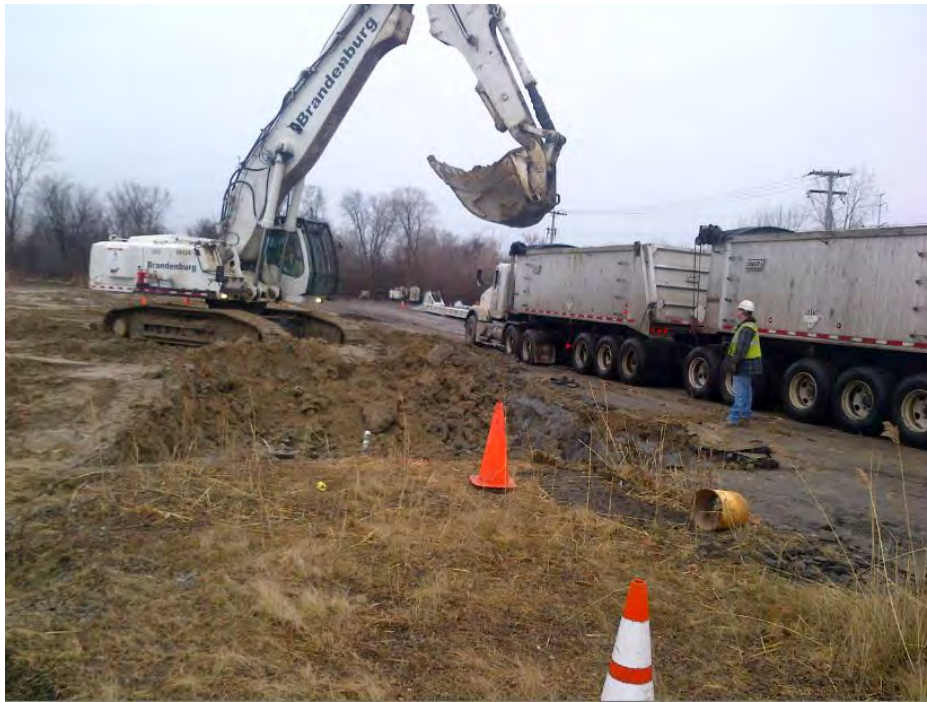
Photo 4 - Initiation of HWSB remedial excavation on 23 December 2014. View is eastward.

As a corrective measure, the VOC-impacted fill and soil beneath the former HWSB and outdoor container storage area was excavated to a nominal depth of four feet bgs, a depth that included the concrete floor or pad, the underlying fill, and approximately one foot of native clay soil. The final horizontal and vertical dimensions of the VOCs excavation area are shown on **Figures 11A** and **11B**, respectively. The excavated soil was profiled and disposed as F001-listed hazardous waste at Wayne Disposal, in Belleville, MI.

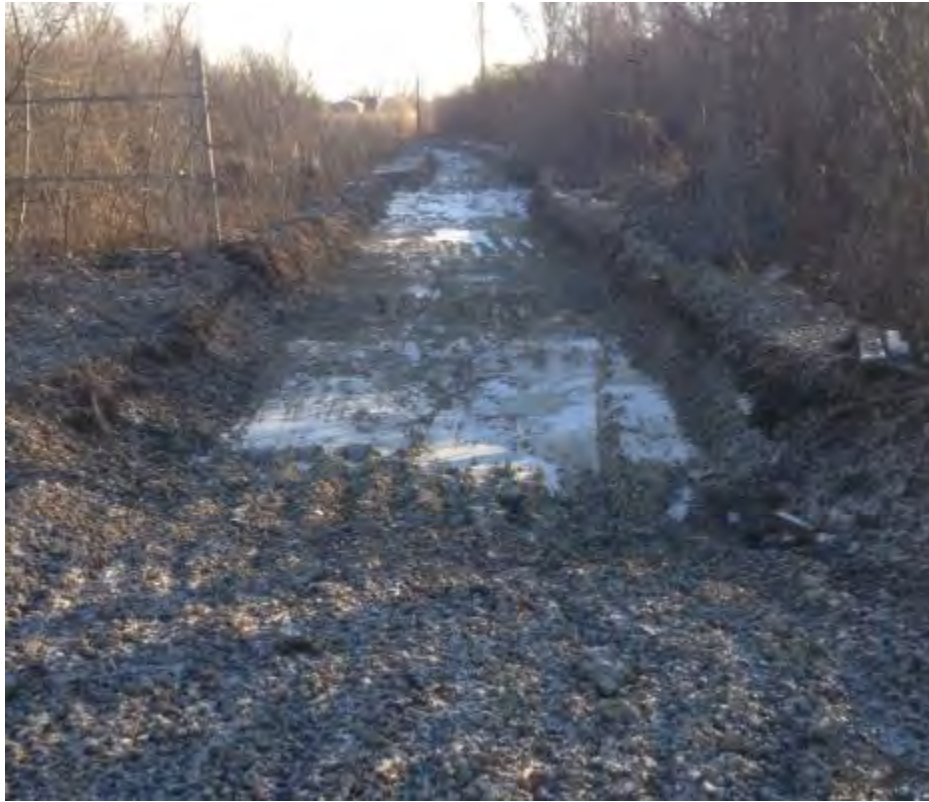
**Photo 5 – View eastward along excavated rail spur on 5 January 2015 prior to restoration.**

Approximately 450 feet of railroad track, rail ties, and ballast were removed from the east end of the former shop building to the eastern property line. Included within the excavated area were the 1986 ballast samples referred to as RTN and RTS on **Figure 4** and in **Table 3** and which contained 4.7 mg/Kg and 7.4 mg/Kg total PCBs, respectively. The 75-foot section of asphalt east of former building was also removed. As shown on **Figure 4**, ballast and soil within a 20-foot strip centered on the railroad track was removed along the 100-foot long stretch beginning 30 feet west and extending to 70 feet east of the perimeter fence. An eight-foot wide strip was excavated from the remaining spur to the eastern property line.

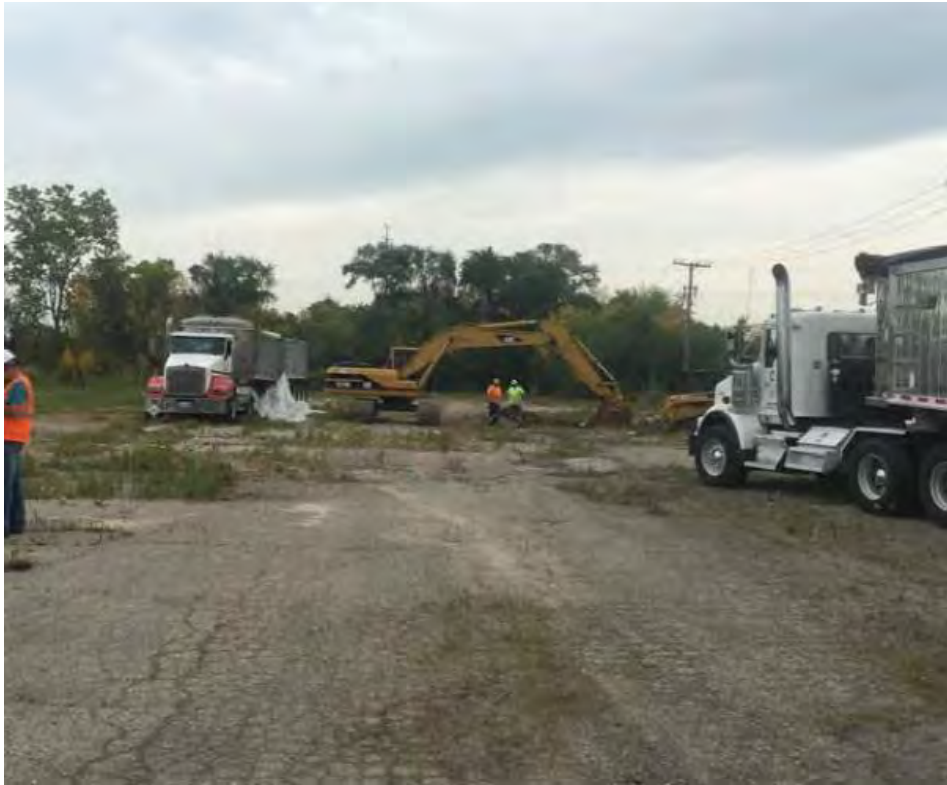
**Photo 6 - View eastward towards ongoing Excavation #1B activities on 19 September 2017.**

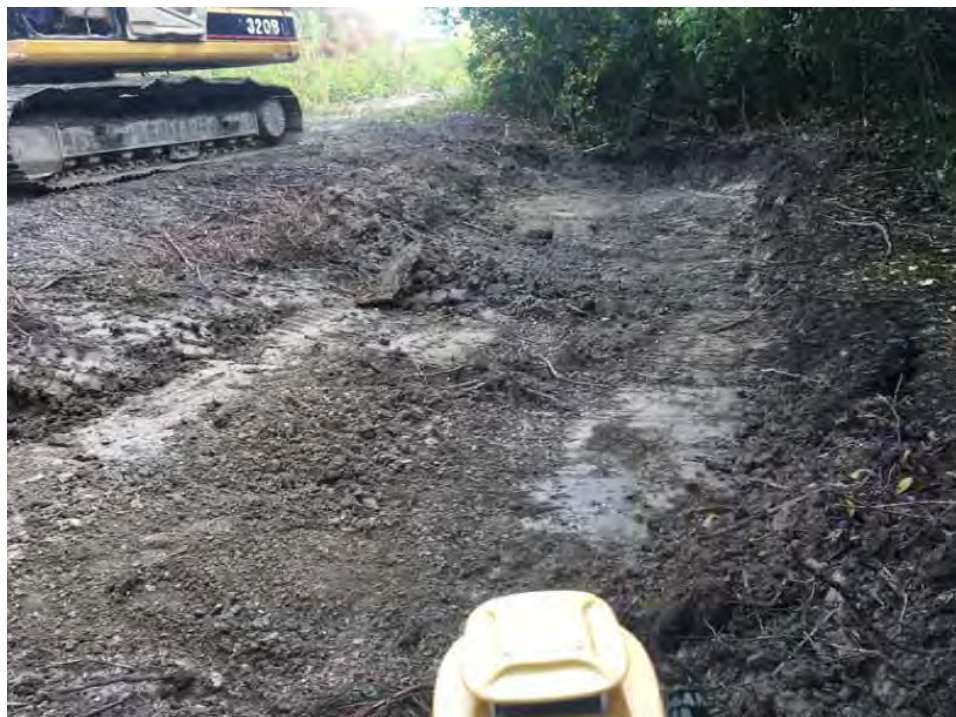
**Photo 7 - View eastward towards ongoing Excavation #7 along south side of the rail spur on 20 September 2017.**
