# CONSTRUCTION REPORT

## MINERAL BUILDING SOURCE REMOVAL TORCH LAKE AREA OF CONCERN HOUGHTON COUNTY, MICHIGAN

August 2021

Project 3293191868

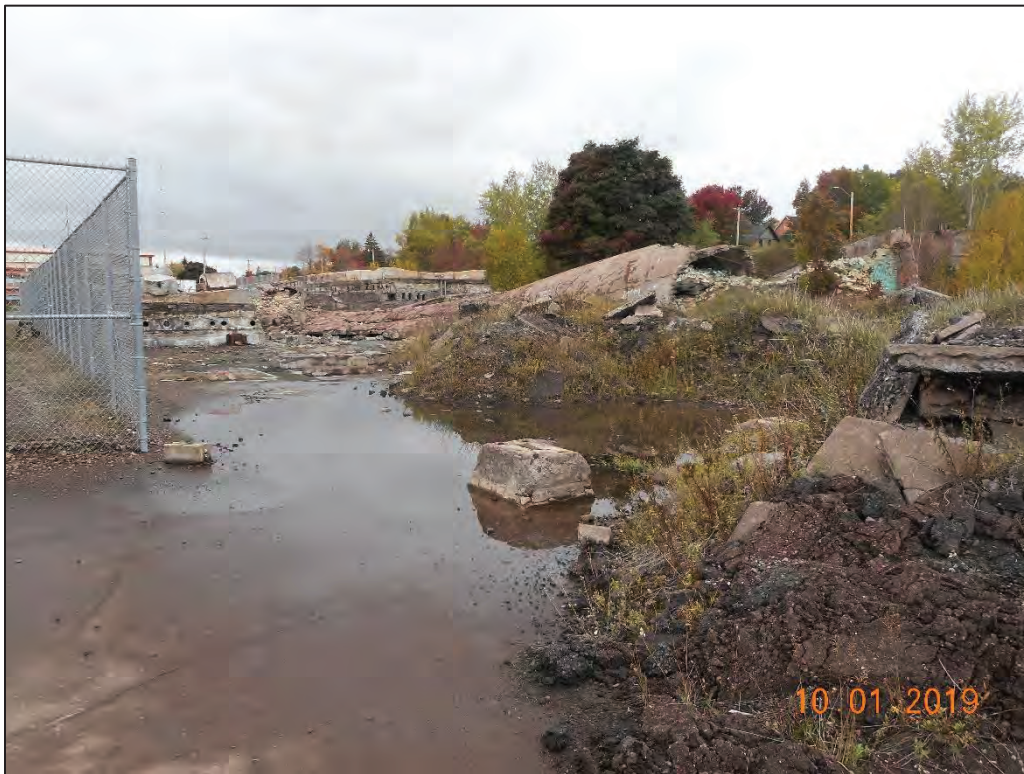
A material with toothpaste like consistency and the color of copper patina was encountered within the bases of the stacks in the Stack Debris area. The material was sampled and analyzed and assumed to be hazardous based on the high concentration of lead. A total of 20.85 tons of hazardous waste was removed from the site and transported to US Ecology in Belville, Michigan for disposal.

**Stack Debris, prior to EnviroBlend® treatment and removal (facing west) 2019**

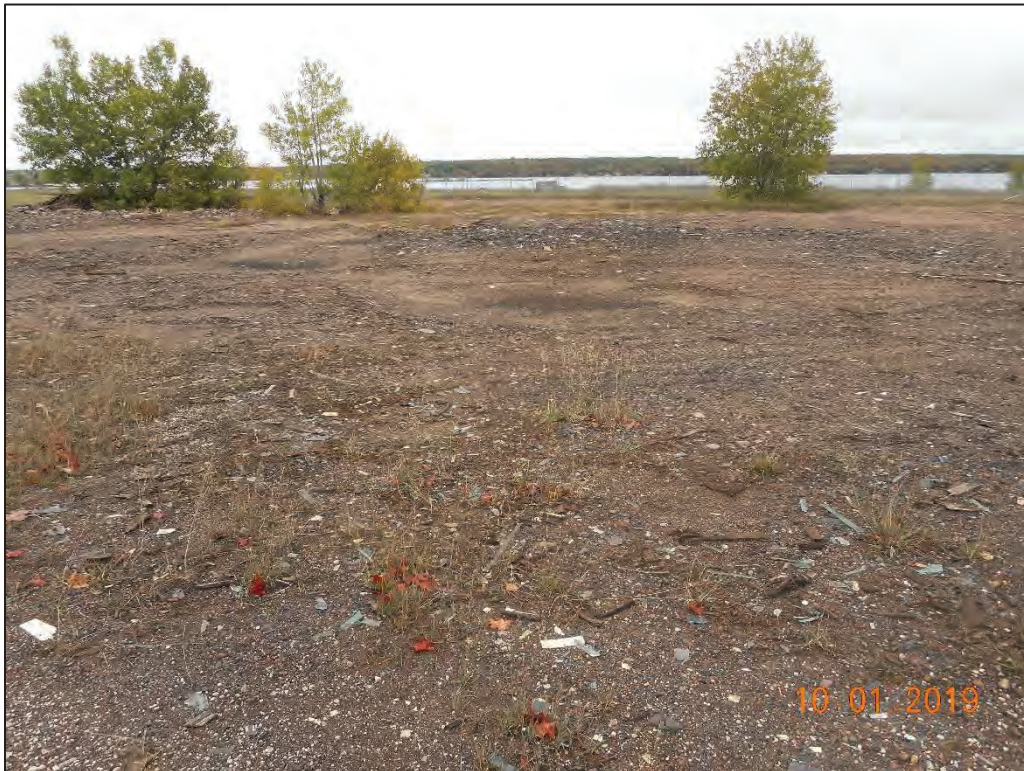
- 4,057 cyd were identified as characteristically hazardous for lead. This included waste piles WP-02, WP-05, WP-10, WP-18, WP-27, WP-28, stack debris, and approximately 831 cubic yards of WP-48. The stack debris accounted for an estimated 2,821 cubic yards of the material. Of these waste piles WP-02, WP-10, WP-18, WP-27 and WP-28 also contained asbestos.

**Waste Pile 48 prior to EnviroBlend® treatment and removal (facing East). 2019**

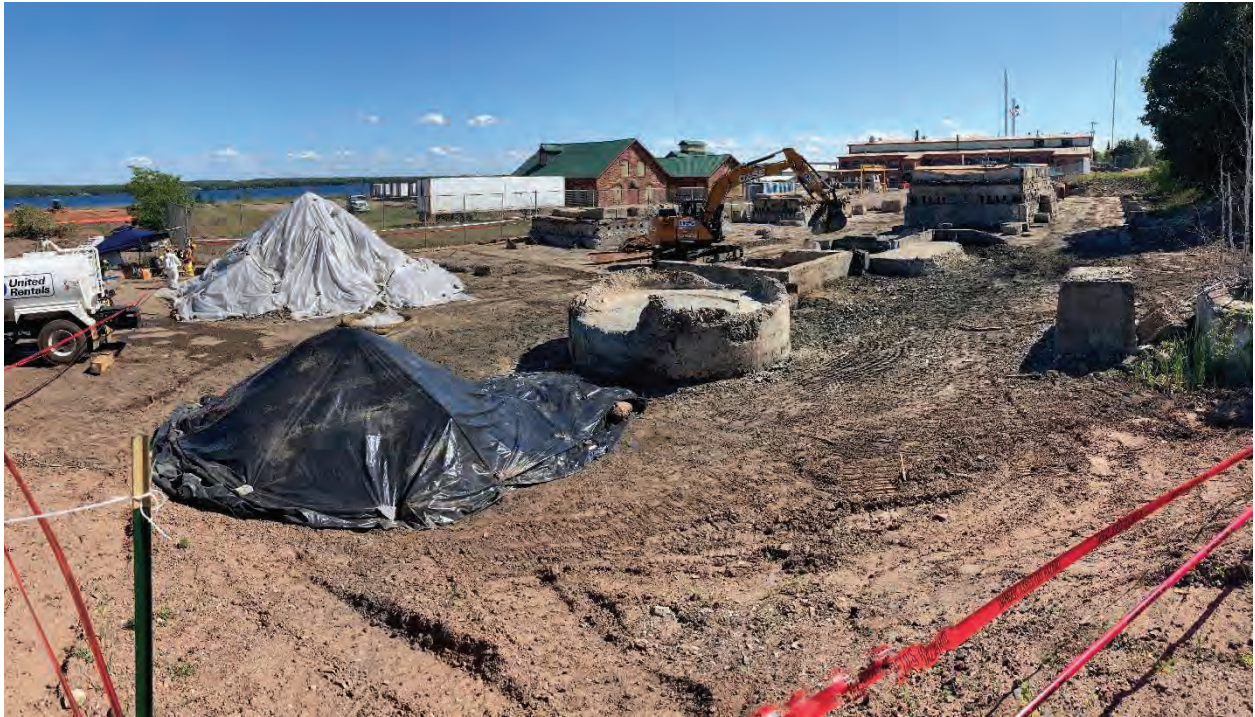
**Hazardous Material from the stack bases has been stockpiled and covered awaiting disposal  
(facing south) 2020**

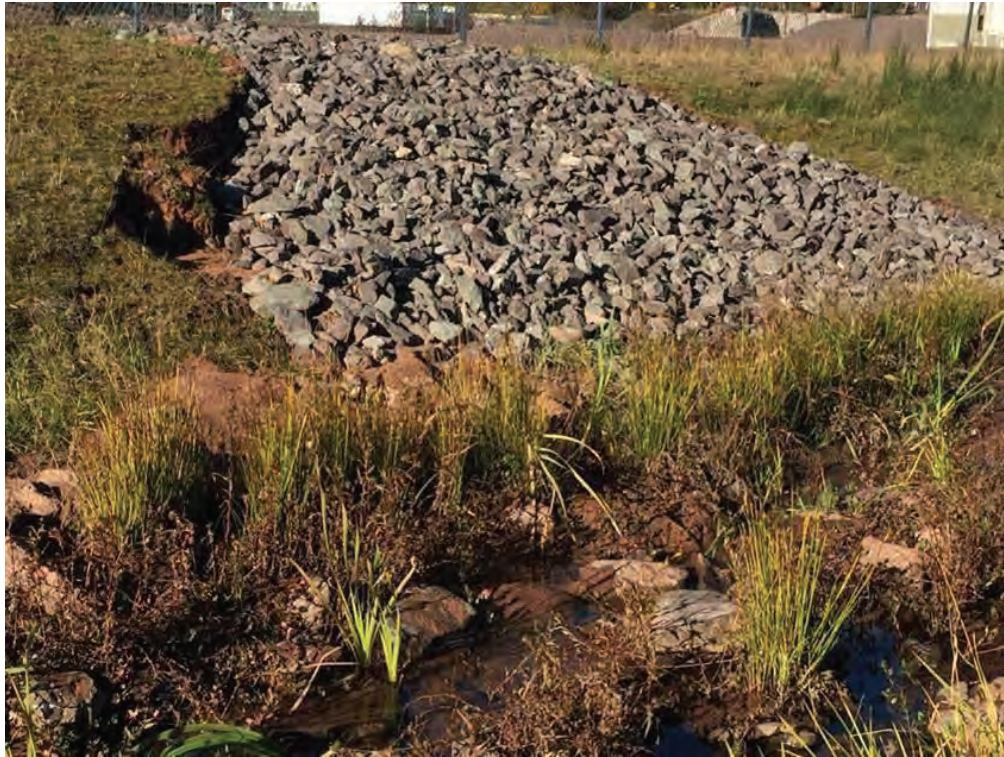
On October 8, 2020, EGLE conducted a site inspection and observed erosion of the cover system near the riprap swale in the east corner of the site. On October 13, 2020, Silver Shore completed repair work by adding fabric along the eroded soil areas and re-grading the riprap.

**Erosion issue documented by EGLE on 10/08/2020 (facing southwest)**

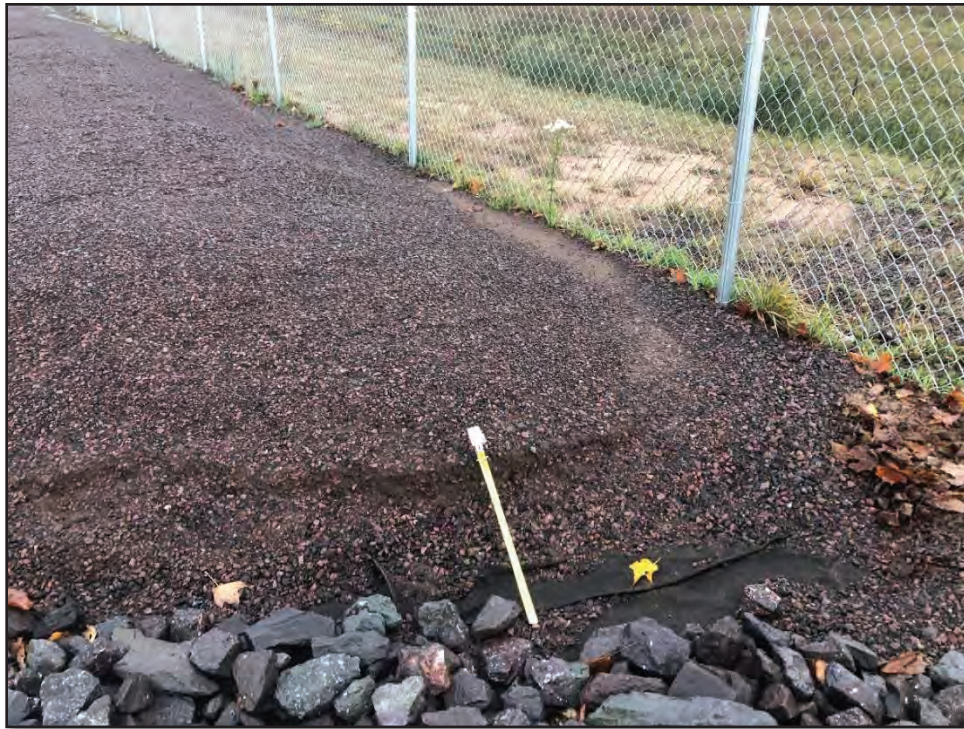
**Erosion issue documented by EGLE on 10/08/2020 (facing north)**

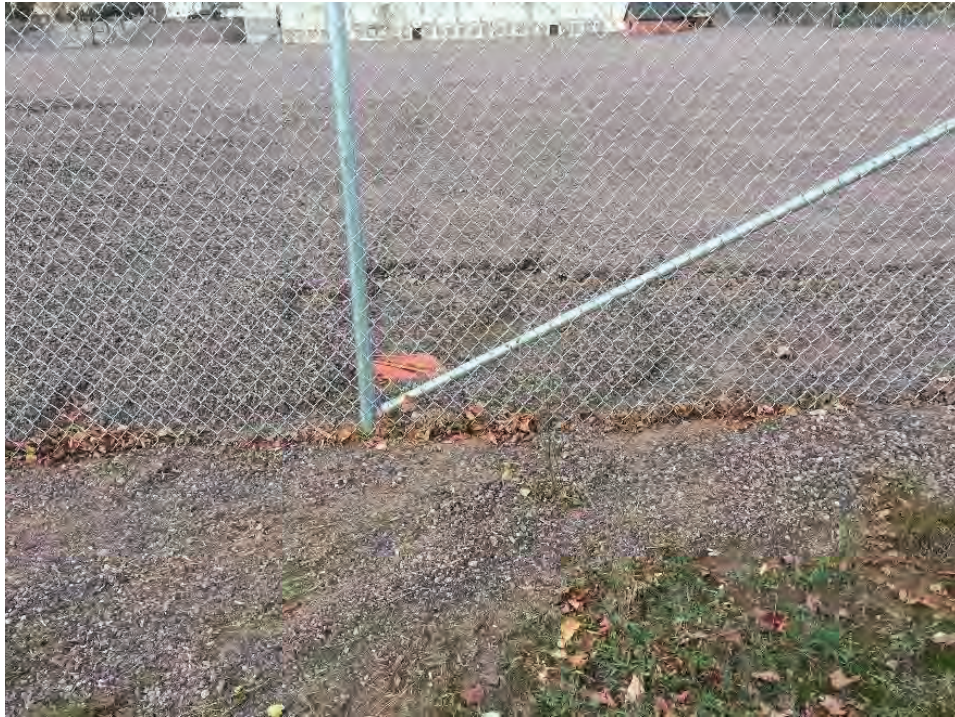
EGLE conducted a follow up inspection on October 20, 2020, and observed erosion of the cover system along the east side of the site, adjacent to USEPA cap. It was noted that eroded soil had entered the ditch. On October 29, 2020, Silver Shore added riprap in the eroded areas and removed the sediment from the ditch.

**Erosion issue documented by EGLE on 10/20/2020 (facing northwest)**
