# **HISTORICAL DATA REVIEW AND COMPILATION TECHNICAL MEMORANDUM ADDENDUM**

ABANDONED MINING WASTES – TORCH LAKE NON-SUPERFUND SITE  
CENTENNIAL MINE  
HOUGHTON COUNTY, MICHIGAN  
SITE ID# 31000096

MARCH 2024

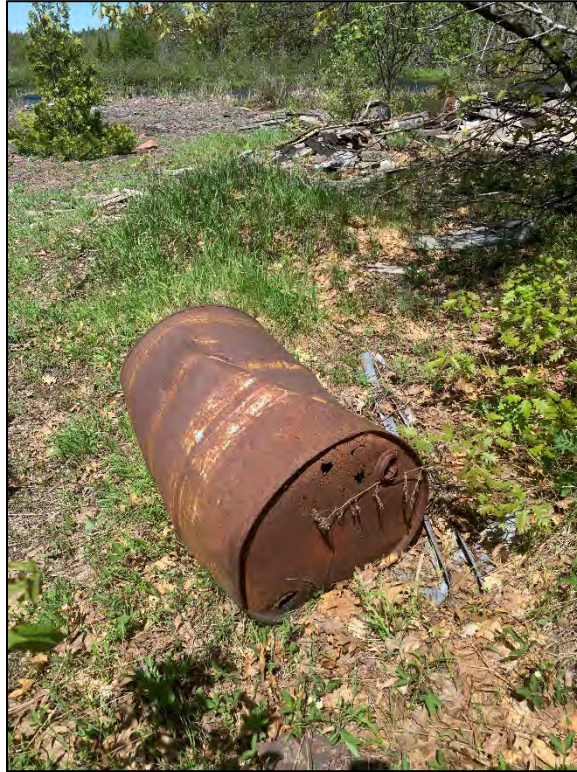
Photo 13: Observation #22

022	55-gal drum on side rusted with holes but could still contain material
023	Hoses, gaskets, and other materials suspect asbestos containing
024	11 Keweenaw copper 55-gal blue poly drums with water and soil in the ones that are open to atmosphere.
025	Approximately 500-gallon ast
026	55-gal drum carcass
027	3 55-gal drum carcasses with sheet metal partially buried. 2 inch steel pipe leading from ditch to drums also.
028	3 inch pipe soft with even spaced 1/2 inch perforations
031	Roof shingle pieces
032	Scrap pieces of white SACM
033	Coal scattered on ground surface
034	Rusty pieces of metal on ground surface- possibly from a drum
035	Remnant structure
036	Intact concrete foundation wall approx. 3.5 feet high and approx. 15 feet long. Stone wall and additional structure remnants located nearby. Located on mounded ground.
037	Possible drum remnant by old stone wall at observation 36.
038	Two pieces of a possible metal container of unknown origin. No contents.

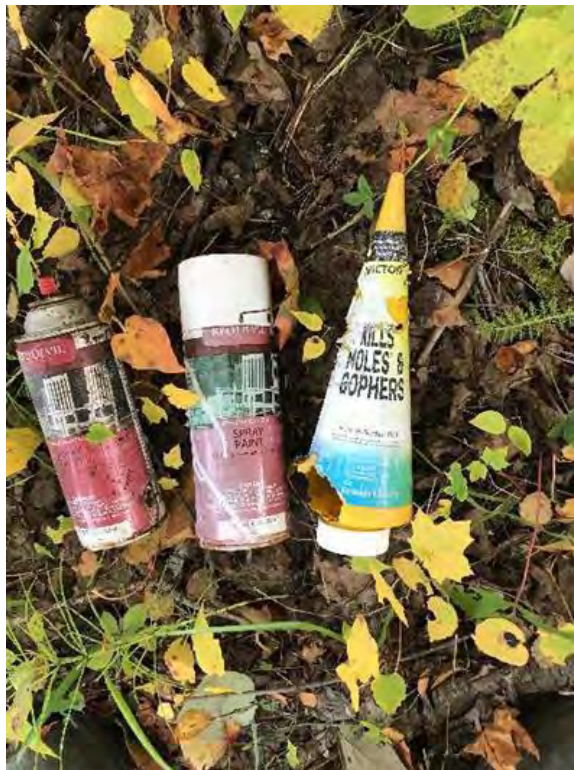
Photo 24: Observation #39

039	2 empty can of spray paint and 1 empty container of mole/gopher killer
040	Estimated 800-900 square feet
041	Pile of poor rock (basalt) approx. 10-15 feet high.
042	Area of ground with apparent tailings, much appears to be covered with vegetation
043	Area of ground with thin cover of tailings at surface
044	Four abandoned tires
045	Tailings area
046	Abandoned oil filter
047	Large area with reddish tailings visible at surface. Portions are under water.
048	Partial drum remnant (empty, rusty, no visible markings); steel pipe sticking out of ground; valve controller on ground, steel pipe in ground. Origins unknown.
049	Rusty steel pipe on ground by rock pile and area of running water. Approximately 10 feet visible. Can't see north end
050	Shingle fragment in road.
051	Debris pile
052	15 abandoned 30 lb 1,1,1,2 tetrafluorethane tanks.
053	Rusted 55-gallon drum carcass.
054	Abanonded metal paint thinner container. Approximately 0.5 gallons.
