**Torch Lake AMW
QMCM Processing Area**

Osceola & Torch Lake Township, Houghton County
T55N R33W Sections 13,14, 23, 24, 26 & 27

**SITE MAP SHOWING 2016
SIDE SCAN SONAR COVERAGE AREA**

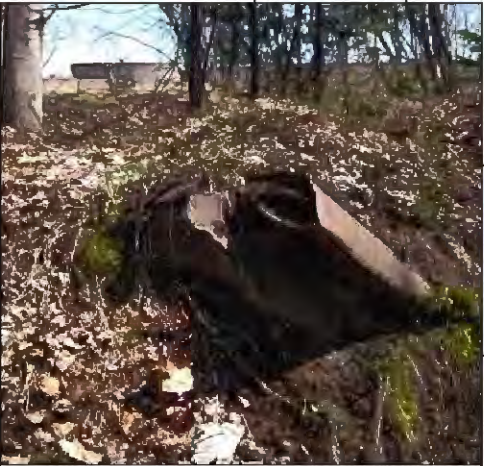
| Check as Appropriate: | | Record Field Measurements: | Provide Written Description Including Condition, Content, and Similar Material Properties: | Document as Applicable: | | | | |
|--|---|---|---|---|---|---|---|--|
| Suspect ACM | | Latitude: 47.13986491N Longitude: 88.46471665W | Drum#22: Rusted drum, buried in hillside, contents unknown | | | | | |

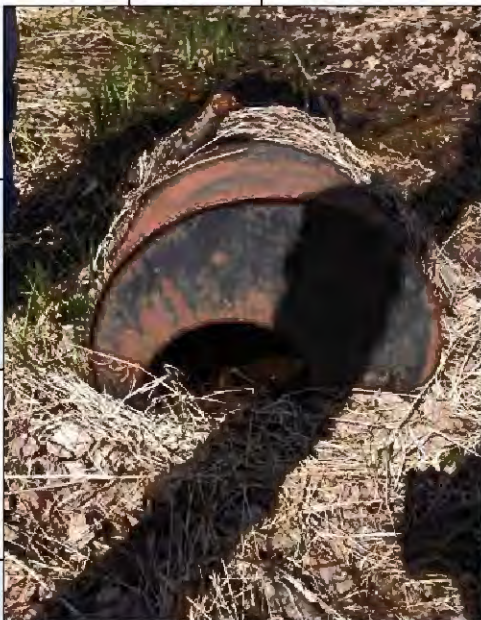
| Record as Appropriate: | | Record Field Measurements: | | Provide Written Description Including Condition, Content, and Similar Material Properties: | Document as Applicable: | | | | |
|---|---|---|---|--|---|--|---|---|---|
| Suspect ACM | | | Latitude: 47.13978937N Longitude: 88.46429651W | Drum#24: Rusted drum, appears to be empty, has black tar mastic on sides | 55 Gal | | | | |

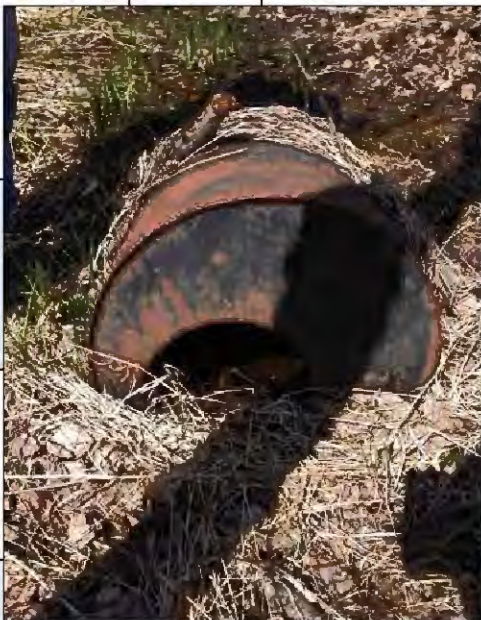
| Record as Appropriate: | | Record Field Measurements: | | Provide Written Description Including Condition, Content, and Similar Material Properties: | Document as Applicable: | | | | |
|---|---|---|---|--|---|--|---|---|---|
| Suspect ACM | | | Latitude: 47.13971273N Longitude: 88.46435615W | Drum#25: Rusted Drum, circular hole on one end, intact bottom, unknown contents | 55 Gal | | | | |

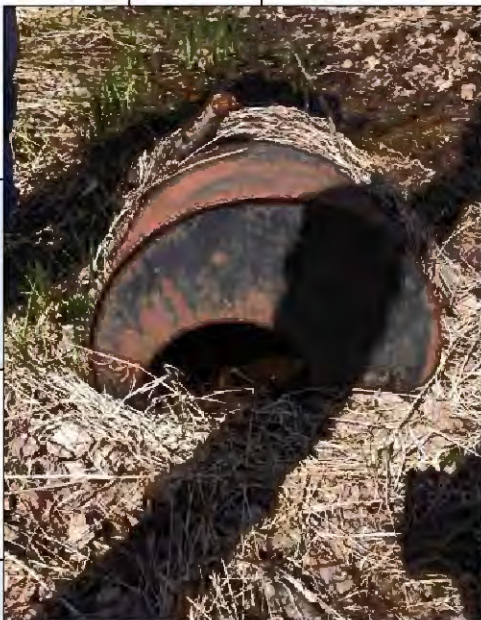
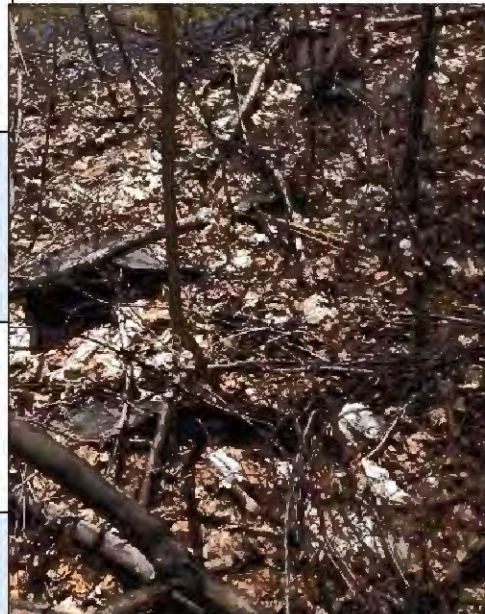
| Record as Appropriate: | | Record Field Measurements: | | Provide Written Description Including Condition, Content, and Similar Material Properties: | Document as Applicable: | | | | |
|---|---|---|---|--|---|--|---|---|---|
| Suspect ACM | | | Latitude: 47.13969077N Longitude: 88.46437048W | Drum#26: Rusted drum, open on one end, intact on other end, unknown contents, if any | 55 Gal | | | | |

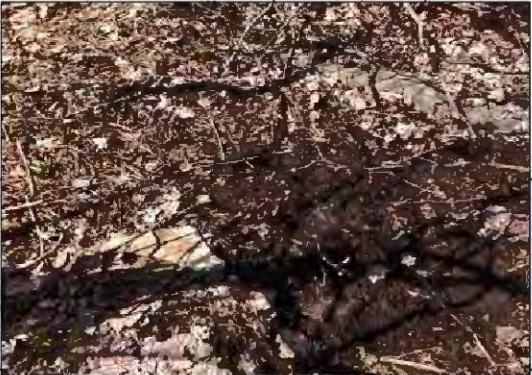
| Check as Appropriate: | | Record Field Measurements: | Provide Written Description Including Condition, Content, and Similar Material Properties: | Document as Applicable: | | | | |
|---|---|---|---|---|---|---|---|--|
| Suspect ACM | ✓ | Latitude: 47.13950995N | SACM#75: Suspect asbestos containing Transite siding, white/gray tile pieces partially buried near 10x10 foot concrete foundation, approximately 3 square feet visible, potentially more buried | | | | | Material sample QMCM-ASBBLK01-052417 collected during targeted inspection activities is representative of the materials identified during reconnaissance activities. |

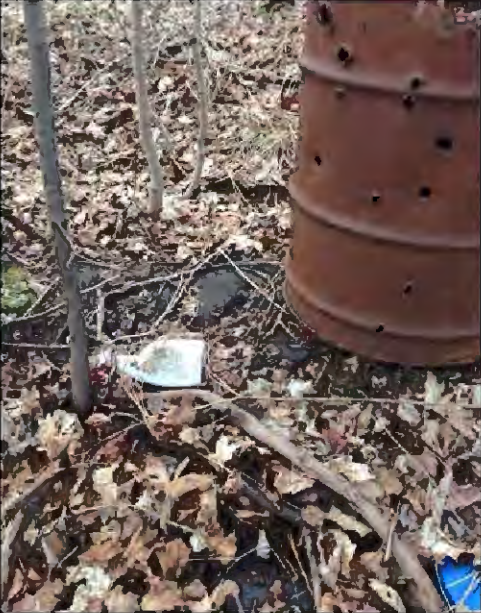
| Check as Appropriate: | | Record Field Measurements: | Provide Written Description Including Condition, Content, and Similar Material Properties: | Document as Applicable: | | | | |
|---|---|---|--|---|---|---|---|--|
| Suspect ACM | ✓ | Latitude: 47.13985488 N Longitude: 88.46600599 W | SACM#82: Black asphaltic roofing material, underneath Drum#41 | 25 SF | | | | Material sample QMCM-ASBBLK51-052517 collected during targeted inspection activities is representative of the materials identified during reconnaissance activities. |

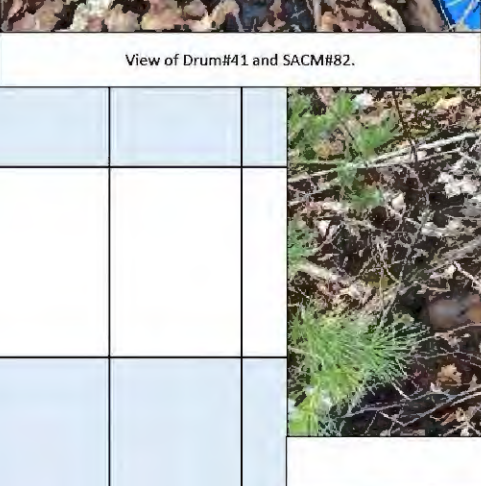
| Check as Appropriate: | | Record Field Measurements: | Provide Written Description Including Condition, Content, and Similar Material Properties: | Document as Applicable: | | | | |
|---|---|---|--|---|---|---|---|--|
| Suspect ACM | | Latitude: 47.13985488 N Longitude: 88.46600599 W | Drum#41: Rusted drum with bullet holes, feels empty, located near ORV trail | 55-Gal | | | | View of Drum#41 and SACM#82. |

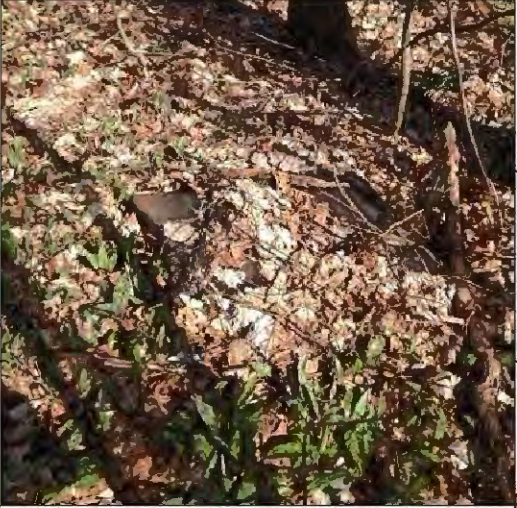
| Check as Appropriate: | | Record Field Measurements: | Provide Written Description Including Condition, Content, and Similar Material Properties: | Document as Applicable: | | | | |
|---|---|---|---|---|---|---|---|--|
| Suspect ACM | | Latitude: 47.13823390 N Longitude: 88.46721466 W | Drum#45: Crushed, empty drum, flattened | | | | | |

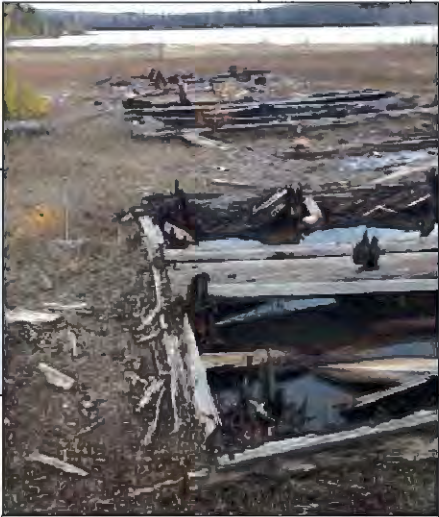
| Check as Appropriate: | | Record Field Measurements: | Provide Written Description Including Condition, Content, and Similar Material Properties: | Document as Applicable: | | | | |
|---|---|---|--|---|---|---|---|--|
| Suspect ACM | ✓ | Latitude: 47.14095346 N Longitude: 88.46098202 W | SACM#61: Black faded, weathered material in strips along wooden boards near pits on edge of capped area, red and white coloring are found along the opposite side, strips are various lengths and are found near each of the wooden pits in the vicinity | | | | | Material sample QMCM-ASBBLK21-052417 collected during targeted inspection activities is representative of the materials identified during reconnaissance activities. |

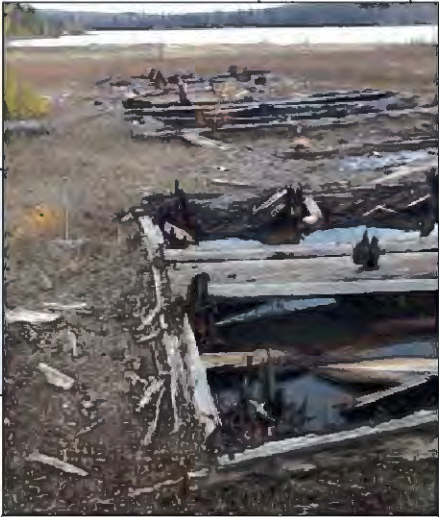
| Check as Appropriate: | | Record Field Measurements: | Provide Written Description Including Condition, Content, and Similar Material Properties: | Document as Applicable: | | | | |
|---|---|---|--|---|---|---|---|--|
| Other: _____ | | Latitude: 47.14078429 N Longitude: 88.46335091 W | SACM#62: Quincy Shore Plant: various suspected asbestos containing materials including: black tar-like roofing material and black roofing material with metallic paint varying in size from small quarter sized bits to larger 4x6 foot sheets attached to wooden boards and corrugated metal sheeting, black gasket material, green shingles, layered rubber coated woven material, 1-inch diameter black solid tubing, 2-inch diameter black wrapped tubing, rubber and woven fabric coated wiring, white imprinted thin paper-like material, potential lumpy white TSI material that appears fibrous (similar to other piles), a concrete area approximately 5x12 feet covered in brown/gray fine grained sandy material with hardened appearance on top (RPM), white paper-like material (potential TSI material, further out on wood debris), and white coated wiring | | | | | Material samples QMCM-ASBBLK13-052417, QMCM-ASBBLK14-052417, QMCM-ASBBLK15-052417, QMCM-ASBBLK16-052417, QMCM-ASBBLK17-052417, QMCM-ASBBLK18-052417, QMCM-ASBBLK19-052417, QMCM-ASBBLK20-052417, and QMCM-RPM02-0"-6" collected during targeted inspection activities are representative of the materials identified during reconnaissance activities. |

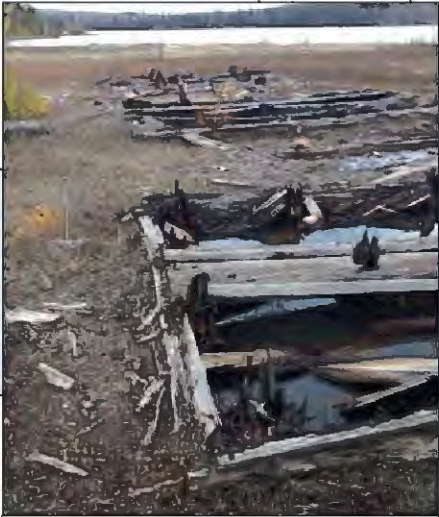
| Check as Appropriate: | | Record Field Measurements: | Provide Written Description Including Condition, Content, and Similar Material Properties: | Document as Applicable: | | | | |
|---|---|---|--|---|---|---|---|--|
| Potential PCB or Mercury Containing Equipment | | Latitude: 47.14036552 N Longitude: 88.46404602W | SACM#63: Concrete slab with the following items: Rubbery roofing material nailed to boards, rubber, black coated wiring, metal rusted coated wiring, various weathered roofing material pieces, and rusted crushed metal paint cans | | | | | |

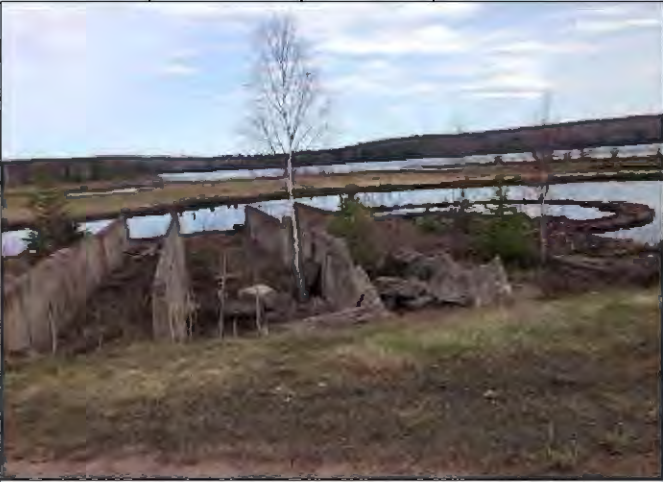
| Check as Appropriate: | | Record Field Measurements: | Provide Written Description Including Condition, Content, and Similar Material Properties: | Document as Applicable: | | | | |
|---|---|---|--|---|---|---|---|--|
| Potentially Abandoned Containers | ✓ | Latitude: 47.14012865N Longitude: 88.46420838W | SACM#64: Concrete circular structure with rebar. Contains wood debris, black roofing material with metallic coating in various sizes and conditions. Also contains automobile tires. | | | | | Material sample QMCM-ASBBLK10-052417 collected during targeted inspection activities is representative of the materials identified during reconnaissance activities. |

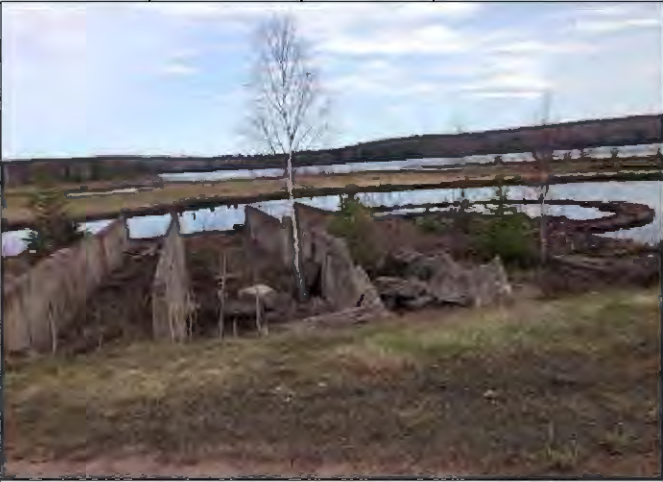
| Check as Appropriate: | | Record Field Measurements: | Provide Written Description Including Condition, Content, and Similar Material Properties: | Document as Applicable: | | | | |
|---|---|---|--|---|---|---|---|--|
| Suspect ACM | ✓ | Latitude: 47.14043893N Longitude: 88.46445164W | SACM#65: Black tar mastic on concrete base, found mostly on left side/corner looking east, appears to have dripped from top of concrete wall, also found on small square concrete base to the south. | | | | | Material sample QMCM-ASBBLK10-052417 collected during targeted inspection activities is representative of the materials identified during reconnaissance activities. |

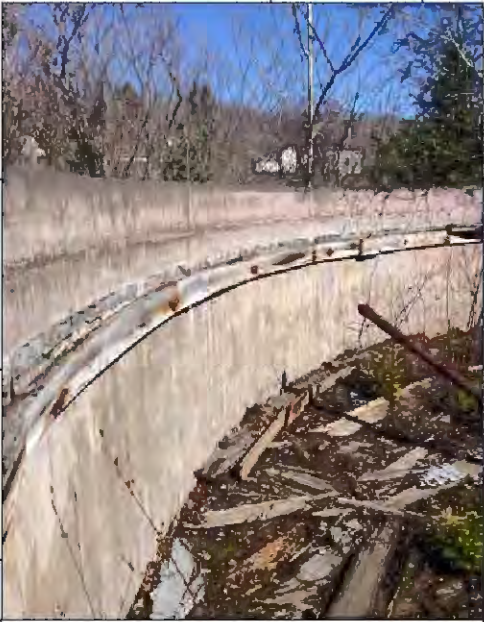
| Check as Appropriate: | | Record Field Measurements: | Provide Written Description Including Condition, Content, and Similar Material Properties: | Document as Applicable: | | | | |
|---|---|---|--|--|---|---|---|--|
| Suspect ACM | ✓ | Latitude: 47.14012865N Longitude: 88.46420838W | Silver felt paper, with some black coloring, found on concrete walls of circular structures, between wooden boards and wall, found in three other circular concrete structures, approximately quantity 130SF. Use the GPS location from SACM#64 for this material. | | | | | Material sample QMCM-ASBBLK07-052417 collected during targeted inspection activities is representative of the materials identified during reconnaissance activities. |

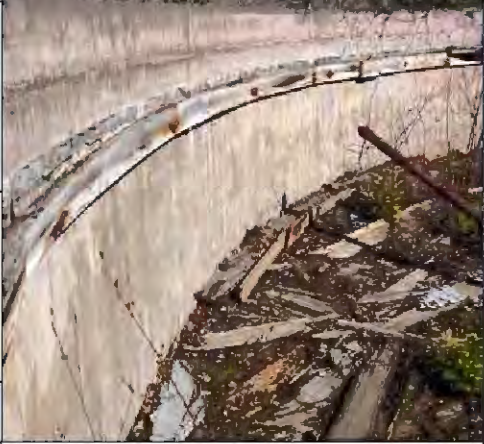
| Check as Appropriate: | | Record Field Measurements: | Provide Written Description Including Condition, Content, and Similar Material Properties: | Document as Applicable: | | | | |
|---|---|---|--|--|---|---|---|--|
| Other: _____ | | Latitude: 47.14043893N Longitude: 88.46445164W | Fibrous string-like piles of material, appears white/gray, weathered, found on concrete floor of Reclamation Plant, also found on ground and on wooden boards between concrete in circular structures. Brown suspect TSI material is observed in the SW circular structure, approximately 2 square feet of material is visible on wooden board, more may be buried within debris. Use the GPS location from SACM#65 for this material. | | | | | Material samples QMCM-ASBBLK08-052417 and QMCM-ASBBLK09-052417 collected during targeted inspection activities are representative of the materials identified during reconnaissance activities. |

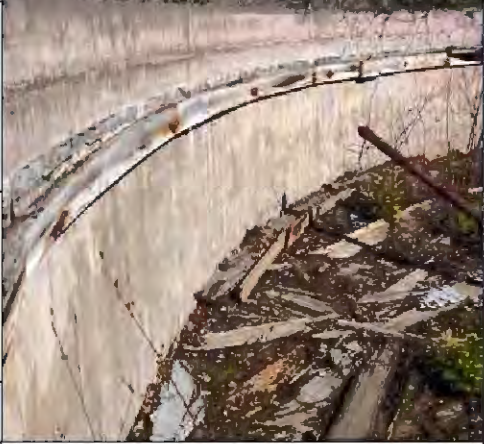
| Check as Appropriate: | | Record Field Measurements: | Provide Written Description Including Condition, Content, and Similar Material Properties: | Document as Applicable: | | | | |
|---|---|---|--|--|---|---|---|--|
| Other: _____ | | Latitude: 47.14058117N Longitude: 88.46437282W | RPM#5: Dark brown/black, greasy, globular and sheet-like material on concrete walls. The material appears to start at the top of the concrete and follows the wall down, forming hardened piles at the bottom. | | | | | Waste Characterization sample QMCM-RPM03-0"-6" collected during targeted inspection activities. |

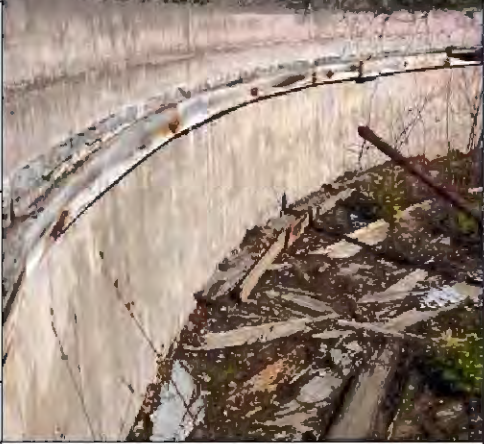
| Check as Appropriate: | | Record Field Measurements: | Provide Written Description Including Condition, Content, and Similar Material Properties: | Document as Applicable: | | | | |
|---|---|---|--|--|---|---|---|--|
| Other: _____ | | Latitude: 47.14058117N Longitude: 88.46437282W | SACM#66: Creamy/white/yellow mastic material on northwest corner of concrete structures near arches, found with RPM#5, black tar mastic on northeast concrete corners | | | | | Material sample QMCM-ASBBLK10-052417 collected during targeted inspection activities is representative of the (black tar mastic) materials identified during reconnaissance activities. Creamy/white/yellow mastic material was determined not to be SACM. |

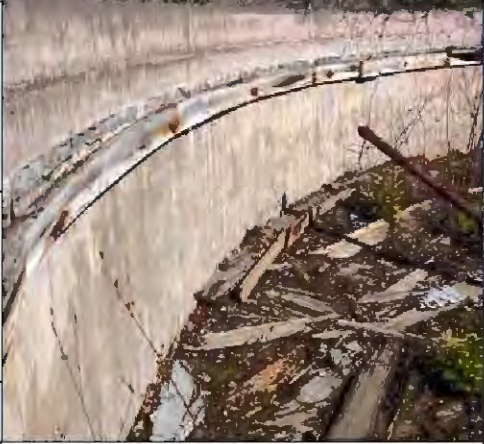
| Check as Appropriate: | | Record Field Measurements: | Provide Written Description Including Condition, Content, and Similar Material Properties: | Document as Applicable: | | | | |
|---|---|---|--|--|---|---|---|--|
| Other: _____ | | Latitude: 47.14075090N Longitude: 88.46425435W | SACM#67: Black hardened rubber material with imprint on one side, found in small pile at north end of concrete structure and scattered south along the concrete remains. | | | | | Material sample QMCM-ASBBLK11-052417 collected during targeted inspection activities is representative of the materials identified during reconnaissance activities. |

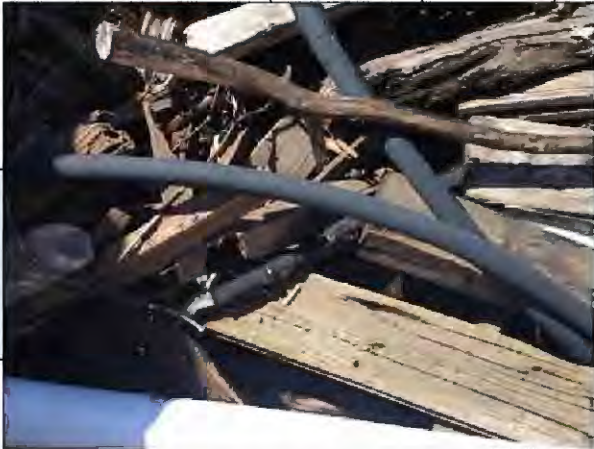
| Check as Appropriate: | | Record Field Measurements: | Provide Written Description Including Condition, Content, and Similar Material Properties: | Document as Applicable: | | | | |
|--|---|---|--|--|---|---|---|--|
| Suspect ACM | ✓ | Latitude: 47.14066270N | SACM#68: Black rubber-coated fabric hydraulic tubing, approximately 2 inches in diameter, weathered, and appears dry rotted. Some tubing appears more deteriorated. Material is found in the concrete pit on the east side of the plant. | | | | | Material sample QMCM-ASBBLK12-052417 collected during targeted inspection activities is representative of the materials identified during reconnaissance activities. |

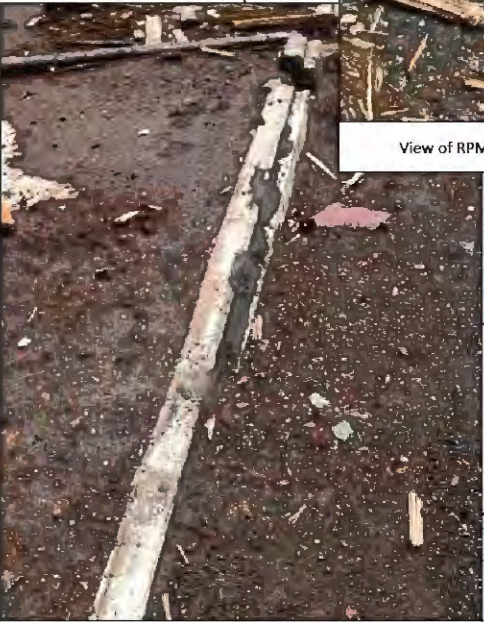
View looking east to SACM#14 on concrete foundation of Stamp Mill No. 2.

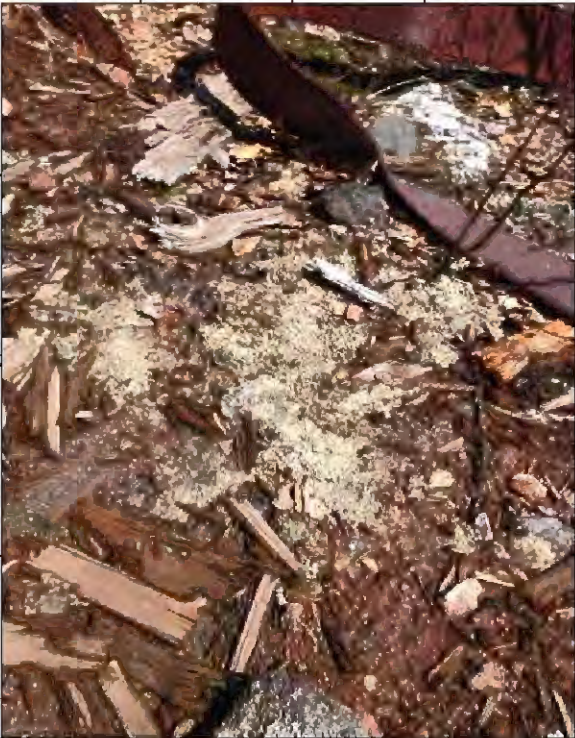
View looking north to SACM#17 on foundation of Stamp Mill No. 2.

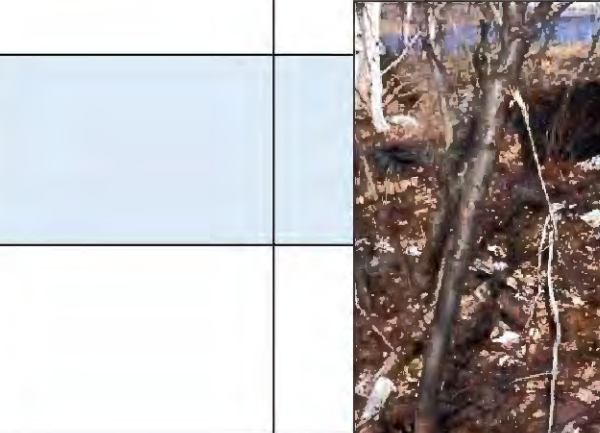
| Check as Appropriate: | | Record Field Measurements: | Provide Written Description Including Condition, Content, and Similar Material Properties: | Document as Applicable: | | | | |
|--|---|---|---|---|---|---|---|---|
| Other: ___ Physical Hazard ___ | ✓ | Latitude: 47.14870808 N Longitude: 88.45726001 W | SACM#38: Red layered paper material in small pieces on former foundation area, appears rough and chipped, area encompasses foundational extent and includes potential Transite tiles, black roofing material, gray layered material (potentially dried paint), and white/gray paper-like layered gasket material | | | | | Material sample QMCM-ASBBLK42-052517, QMCM-ASBBLK43-052517, QMCM-ASBBLK44-052517 collected during targeted inspection activities are representative of the materials identified during reconnaissance activities. |

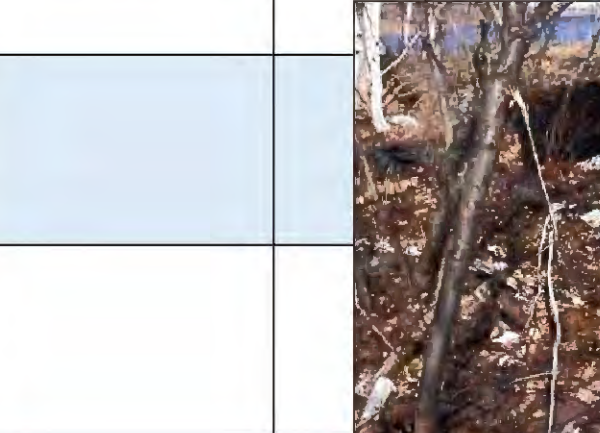
| Check as Appropriate: | | Record Field Measurements: | Provide Written Description Including Condition, Content, and Similar Material Properties: | Document as Applicable: | | | | |
|--|---|---|---|---|---|---|---|---|
| Potential PCB or Mercury Containing Equipment | | Latitude: 47.14857874 N Longitude: 88.45690433 W | SACM#39: Black layered woven fabric material, appears to be weathered, wrapped around brown foam-like material in a bundle, partially buried | | | | | Material sample QMCM-ASBBLK36-052517 collected during targeted inspection activities is representative of the materials identified during reconnaissance activities. |

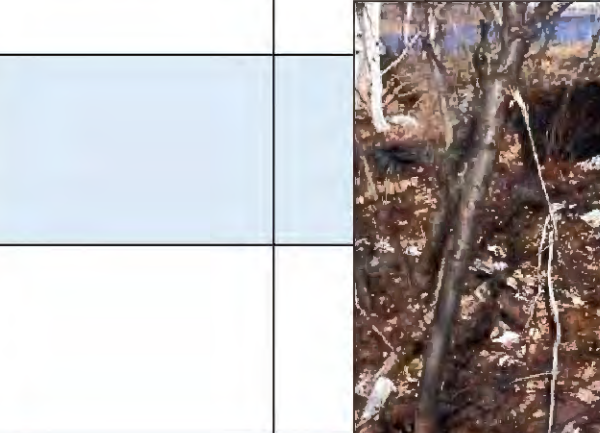
| Check as Appropriate: | | Record Field Measurements: | Provide Written Description Including Condition, Content, and Similar Material Properties: | Document as Applicable: | | | | |
|--|---|---|---|---|---|---|---|---|
| Soil Staining/Stressed Vegetation | | Latitude: 47.14857874 N Longitude: 88.45690433 W | SACM#39: Black layered woven fabric material, appears to be weathered, wrapped around brown foam-like material in a bundle, partially buried | | | | | Material sample QMCM-ASBBLK36-052517 collected during targeted inspection activities is representative of the materials identified during reconnaissance activities. |

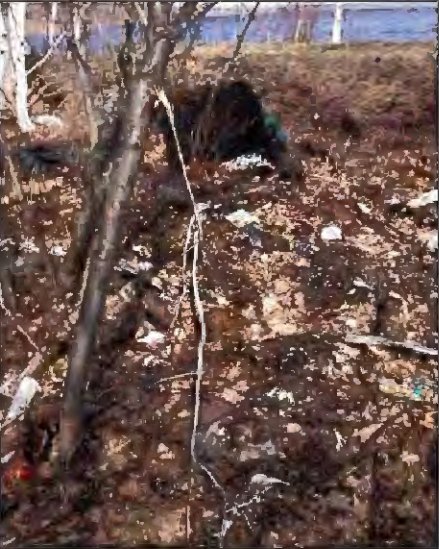
| Check as Appropriate: | | Record Field Measurements: | Provide Written Description Including Condition, Content, and Similar Material Properties: | Document as Applicable: | | | | |
|--|---|---|---|---|---|---|---|---|
| Potentially Abandoned Containers | | Latitude: 47.14857874 N Longitude: 88.45690433 W | Dump Area #1: Residential/Commercial Dump Site, items observed include: car parts, rubber gasket material, floor tile/linoleum, gray woven fabric sheeting (similar in appearance to SACM#39), black weathered roofing material, gray woven metallic painted fabric tubing, rusted metal woven tubing, paint cans (most rusted, crushed, appear to be empty), automobile tires (10 counted, potentially more), large kitchen appliances, black rubber sheeting, black tape wrapped hose, weathered household linoleum, rusted drums and carcasses including the following: 10 drum carcasses, drum pieces, one empty crushed drum, and one 5-gallon empty can | | | | | Material sample QMCM-ASBBLK37-052517, QMCM-ASBBLK38-052517, QMCM-ASBBLK39-052517, QMCM-ASBBLK40-052517, and QMCM-ASBBLK41-052517 collected during targeted inspection activities are representative of the materials identified during reconnaissance activities. |

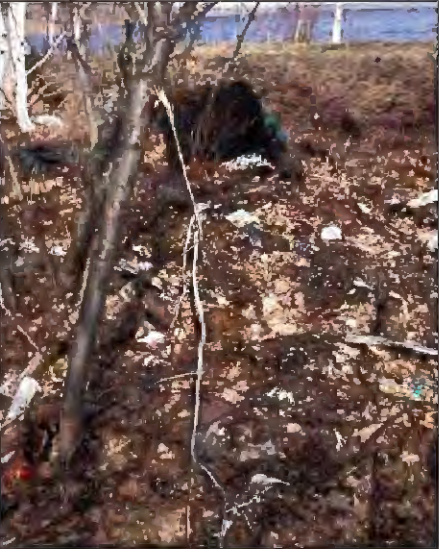
| Check as Appropriate: | | Record Field Measurements: | Provide Written Description Including Condition, Content, and Similar Material Properties: | Document as Applicable: | | | | |
|--|---|---|---|---|---|---|---|---|
| Residual Process Materials | | Latitude: 47.14794143 N Longitude: 88.45760635 W | Dump Area #2: Dump Site, includes mostly buried items including household bottles and containers, wire mesh, black woven fabric material, at least one rusted drum carcass, and sheet metal | | | | | Material sample QMCM-ASBBLK37-052517, QMCM-ASBBLK38-052517, QMCM-ASBBLK39-052517, QMCM-ASBBLK40-052517, and QMCM-ASBBLK41-052517 collected during targeted inspection activities are representative of the materials identified during reconnaissance activities. |

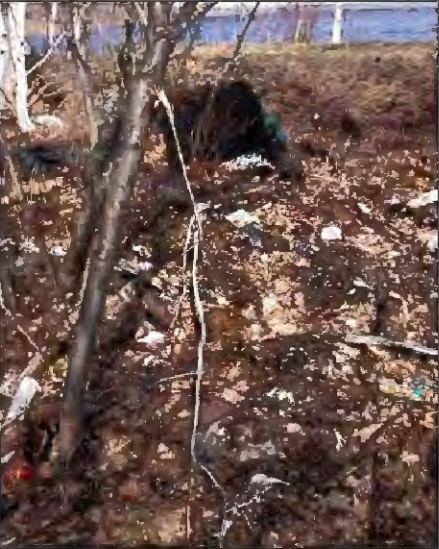
| Check as Appropriate: | | Record Field Measurements: | Provide Written Description Including Condition, Content, and Similar Material Properties: | Document as Applicable: | | | | |
|--|---|---|---|---|---|---|---|---|
| Suspect ACM | | Latitude: 47.14794143 N Longitude: 88.45760635 W | Drum#11: Crushed, rusted drum, partially flattened, appears empty, contents unknown | | | | | Material sample QMCM-ASBBLK37-052517, QMCM-ASBBLK38-052517, QMCM-ASBBLK39-052517, QMCM-ASBBLK40-052517, and QMCM-ASBBLK41-052517 collected during targeted inspection activities are representative of the materials identified during reconnaissance activities. |

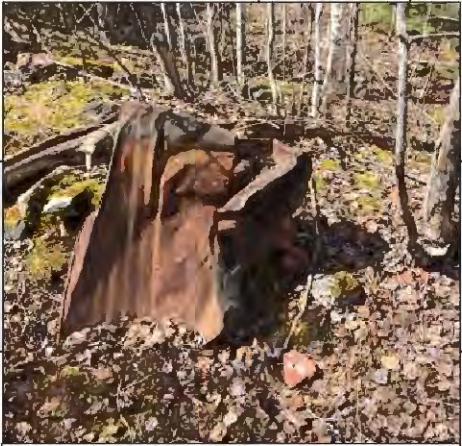
| Check as Appropriate: | | Record Field Measurements: | Provide Written Description Including Condition, Content, and Similar Material Properties: | Document as Applicable: | | | | |
|---|---|---|--|--|---|---|---|--|
| Suspect ACM | | Latitude: 47.14804420 N Longitude: 88.45766746 W | Drum#12: Crushed, rusted drum, flattened, appears empty, contents unknown, located on top of overgrown debris pile | | | | | |

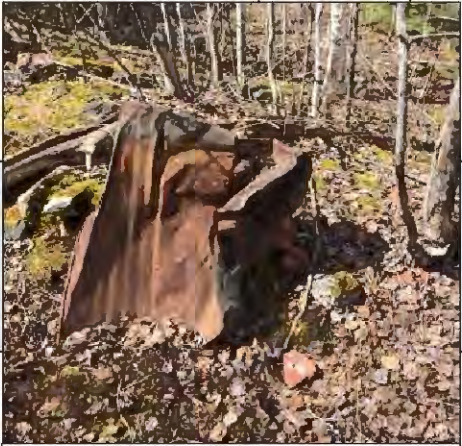
| Check as Appropriate: | | Record Field Measurements: | Provide Written Description Including Condition, Content, and Similar Material Properties: | Document as Applicable: | | | | |
|---|---|---|--|--|---|---|---|--|
| Suspect ACM | | Latitude: 47.14804911 N Longitude: 88.45771026 W | Drum#13: Crushed, rusted drum carcass, contents unknown, if any, located on top of overgrown debris pile | | | | | |

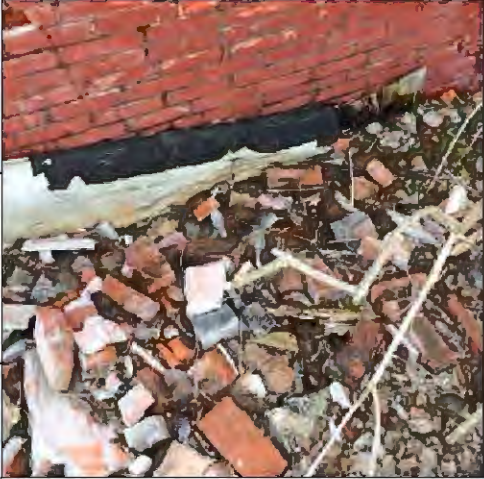
| Check as Appropriate: | | Record Field Measurements: | Provide Written Description Including Condition, Content, and Similar Material Properties: | Document as Applicable: | | | | |
|---|---|---|--|--|---|---|---|--|
| Suspect ACM | ✓ | Latitude: 47.14700700 N Longitude: 88.45803578 W | SACM#42: Black tar paper roofing material, partially buried on railroad grade, similar material is found south toward Torch Lake near wood structural remains | | | | | Material sample QMCM-ASBBLK32-052517 collected during targeted inspection activities is representative of the materials identified during reconnaissance activities. |

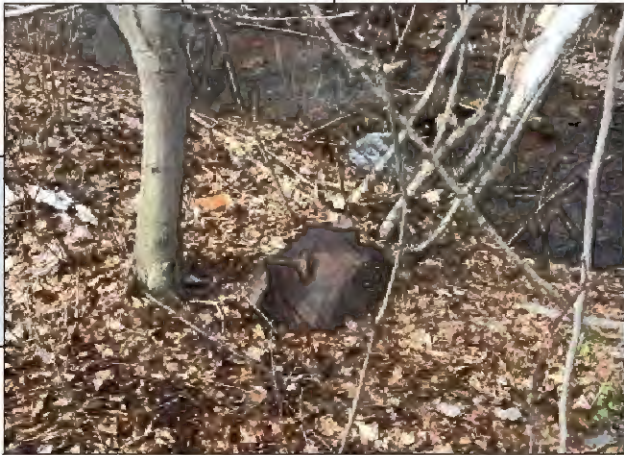
| Check as Appropriate: | | Record Field Measurements: | | Provide Written Description Including Condition, Content, and Similar Material Properties: | Document as Applicable: | | | | | | |
|---|---|---|---|--|---|---|--|--|--|--|--|
| Other: _____ | | Latitude: 47.14711821 N | Drum#14: Crushed drum, partially buried on west side of Quincy Creek Bank | | | | | | | | |

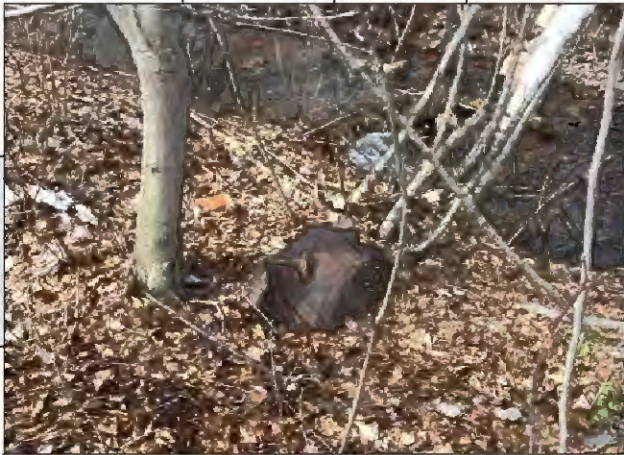
| Check as Appropriate: | | Record Field Measurements: | | Provide Written Description Including Condition, Content, and Similar Material Properties: | Document as Applicable: | | | | | | |
|---|---|---|---|--|---|---|--|--|--|--|--|
| Soil Staining/Stressed Vegetation | | Longitude: 88.45727676 W | Drum#15: Rusted, mangled, drum carcass, partially buried | | | | | | | | |

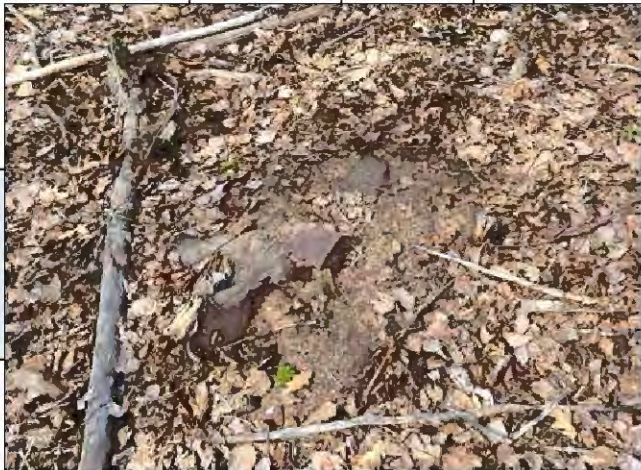
| Check as Appropriate: | | Record Field Measurements: | | Provide Written Description Including Condition, Content, and Similar Material Properties: | Document as Applicable: | | | | |
|---|---|--|---|--|---|---|---|--|--|
| Suspect ACM | ✓ | Latitude: 47.14641487 N Longitude: 88.45837528 W | SACM#47: Pile of white/gray woven material covered/coated in black rubber, approximately 4 inches in width, partially buried | | | | | Material sample QMCM-ASBBLK30-052517 collected during targeted inspection activities is representative of the materials identified during reconnaissance activities. | |

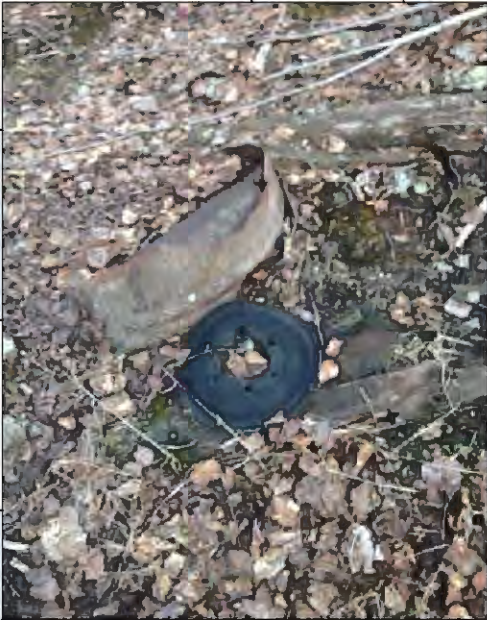
| Check as Appropriate: | | Record Field Measurements: | Provide Written Description Including Condition, Content, and Similar Material Properties: | Document as Applicable: | | | | |
|---|---|---|---|---|---|--|---|---|
| Suspect ACM | ✓ | Latitude: _____ Longitude: _____ | Black wire wrap, appears to be aluminum wire, near northeast shoreline of Coal Dock area, observed and sampled during targeted inspection activities. | | | | | |

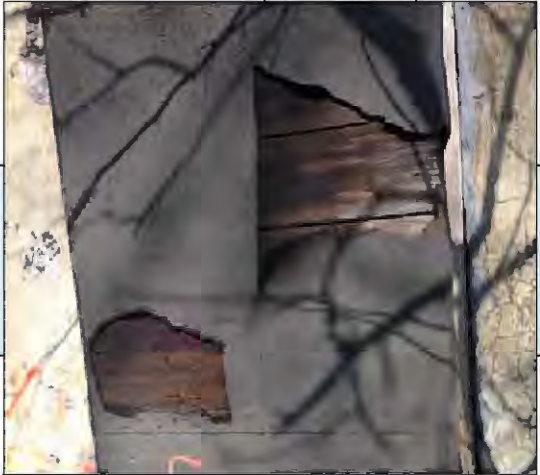
| Check as Appropriate: | | Record Field Measurements: | Provide Written Description Including Condition, Content, and Similar Material Properties: | Document as Applicable: | | | | |
|---|---|---|--|--|---|---|---|---|
| Suspect ACM | ✓ | Latitude: 47.14626304 N Longitude: 88.45848218 W | SACM#50: Gray/black shingle-like roofing material attached to wooden board with nails along approximately 3/4 of the height of the coal bin/silo, approximately 3 feet wide Includes gray/white mastic between wooden boards and the concrete silo walls. | | | | | Material samples QMCM-ASBBLK24-052517 and QMCM-ASBBLK25-052517 collected during targeted inspection activities are representative of the materials identified during reconnaissance activities. |

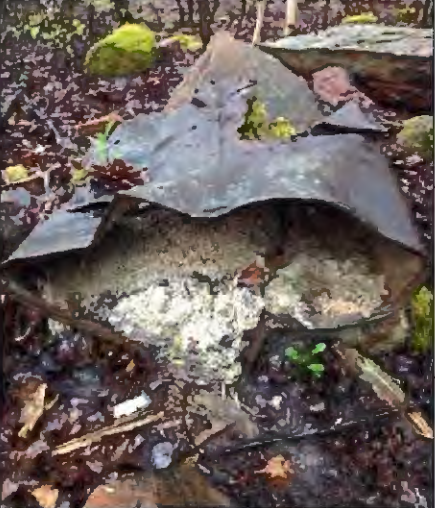
| Check as Appropriate: | | Record Field Measurements: | Provide Written Description Including Condition, Content, and Similar Material Properties: | Document as Applicable: | | | | |
|---|---|---|--|--|---|---|---|---|
| Suspect ACM | ✓ | Latitude: 47.14471045 N Longitude: 88.45981845 W | SACM#54: Black roofing material on shoreline near edge of cap, has metallic coating, appears weathered and in poor condition, material appears to be similar to that on dredge roof in places | | | | | Material sample QMCM-ASBBLK45-052517 collected during targeted inspection activities is representative of the materials identified during reconnaissance activities. |

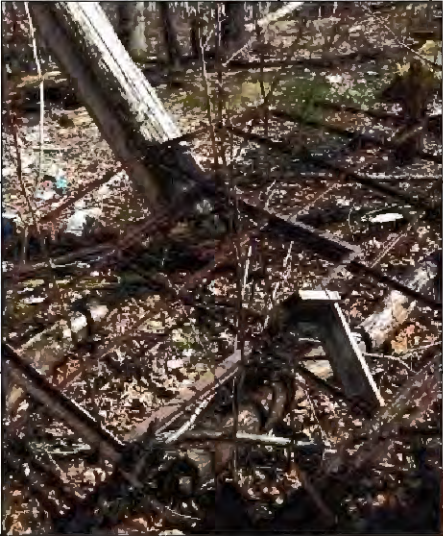
| Check as Appropriate: | | Record Field Measurements: | Provide Written Description Including Condition, Content, and Similar Material Properties: | Document as Applicable: | | | | |
|---|---|---|--|---|---|---|---|--|
| Suspect ACM | ✓ | Latitude: 47.14770860 N | SACM#21: Flat, rectangular sheet of layered material with rusted metal brackets attached, sheet is approximately 18 x 36 inches | | | | | Material sample QMCM-ASBBLK68-052617 collected during targeted inspection activities is representative of the materials identified during reconnaissance activities. |

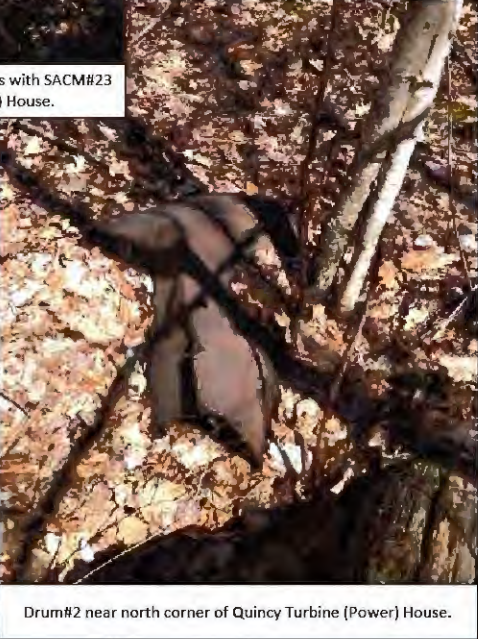
Drum#2 near north corner of Quincy Turbine (Power) House.

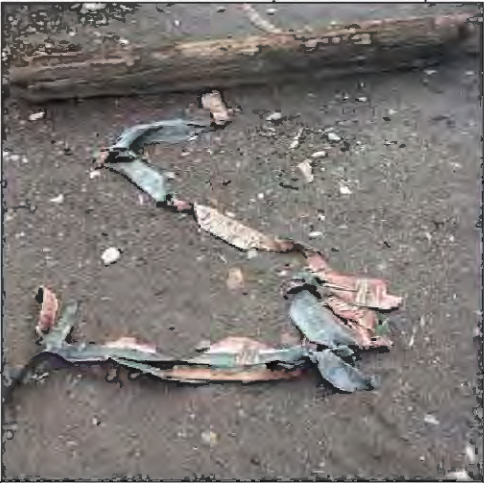
| Check as Appropriate: | | Record Field Measurements: | Provide Written Description Including Condition, Content, and Similar Material Properties: | Document as Applicable: | | | | |
|---|---|---|---|--|---|---|---|--|
| Suspect ACM | ✓ | Latitude: 47.14672952 N Longitude: 88.46053163 W | SACM#30: Length of black and red woven fabric material, approximately 40 feet x 4 inches, shredded and frayed along the edges, surrounded by small pieces of mesh-imprinted material, roofing, and screen | | | | | Material sample QMCM-ASBBLK62-052517 collected during targeted inspection activities is representative of the materials identified during reconnaissance activities. |

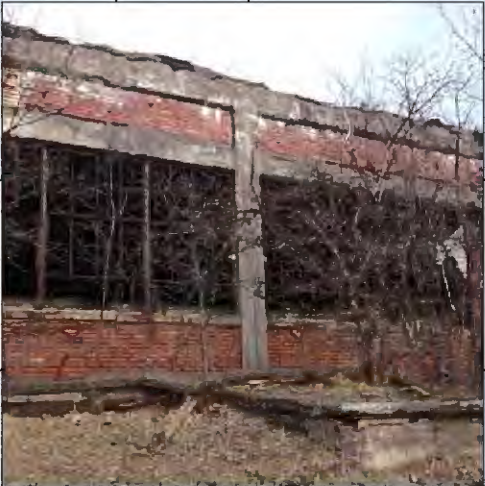
| Check as Appropriate: | | Record Field Measurements: | Provide Written Description Including Condition, Content, and Similar Material Properties: | Document as Applicable: | | | | |
|---|---|---|--|--|---|---|---|--|
| Soil Staining/Stressed Vegetation | | Latitude: 47.14683184 N Longitude: 88.45973366 W | SACM#35: Roofing material along southeast edge of Stamp Mill No. 1 building, adjacent to M-26. Roofing is black, weathered, and similar in appearance to SACM#34. Pieces are scattered on the ground between the building and the roadway in the right of way, additional pieces are found on ground near the south edge of the building near the parking lot. Roofing appears to have come from Stamp Mill No. 1 building | | | | | Material sample QMCM-ASBBLK58-052517 collected during targeted inspection activities is representative of the materials identified during reconnaissance activities. |

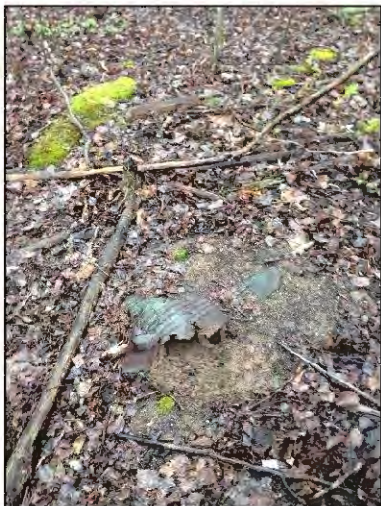
Photo 7: Drum material observed during reconnaissance and sampled as QMCM-DM02-0"-6". Photo taken on 5/17/2017.
