November 29, 2021

Re: Due Care Actions Letter Report
Lake Linden Route trail (a.k.a. Trail No. 3)
Ripley, Houghton County, Michigan

Lake Linden Route (Trail No. 3)
Ripley, Houghton County, Michigan

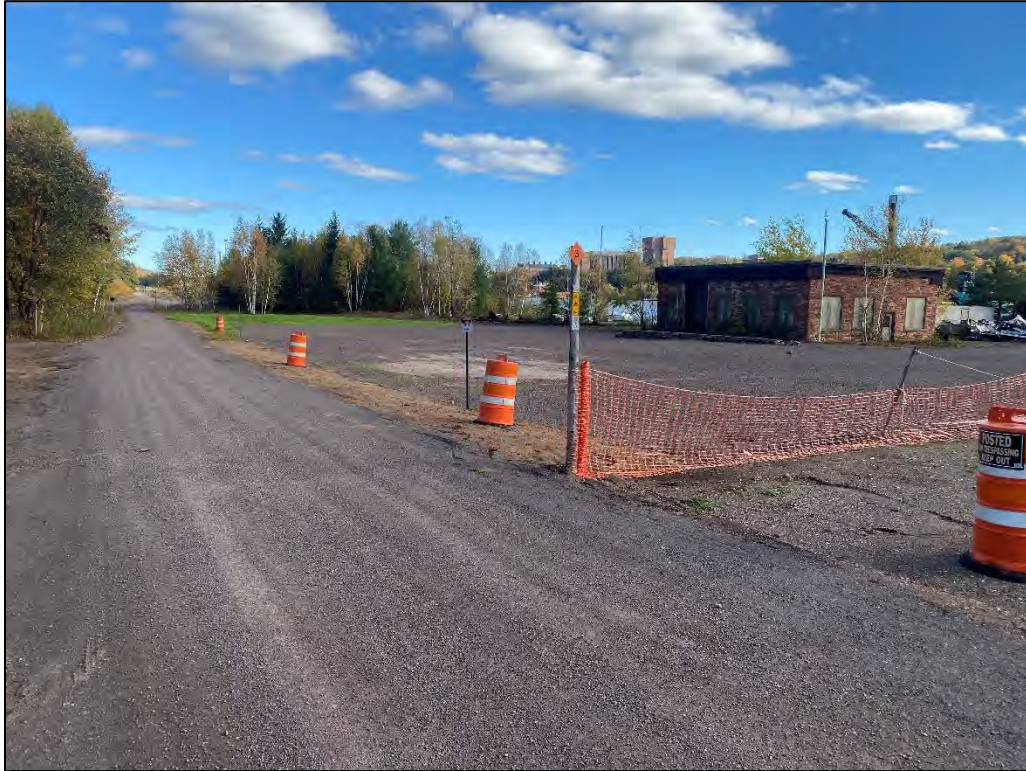
Photo 1: View looking southeast of the designated trail through the Julio Salvage Parcel following MDNR's grading and graveling, and Priority Area 1 following EPA's removal and placement of gravel cover including a vegetated buffer adjacent to the south side of the designated trail.

- The parcel owner removed, staged, and/or transported off site for recycling previously accumulated salvageable materials from near and on the MDNR trail, cleared Priority Areas 1, 2, and 7 of abandoned containers and scrap metal, cleared Priority Areas 1 and 2 of trees, and scrapped surficial debris/soil in Priority Area 7 into piles.

- EPA removed and disposed of off-site soil/waste/mercury and PCB-containing equipment, encapsulated on-site equipment that is asbestos containing, placed a vegetated strip adjacent to the MDNR trail, and placed and graded a gravel or vegetated cover to promote drainage and further mitigate residual direct contact and wind and water erosion concerns near the MDNR trail.

- Following completion of parcel owner and EPA activities, the MDNR graded and graveled the designated trail, and installed fencing and signage directing trail users to stay on the designated trail.

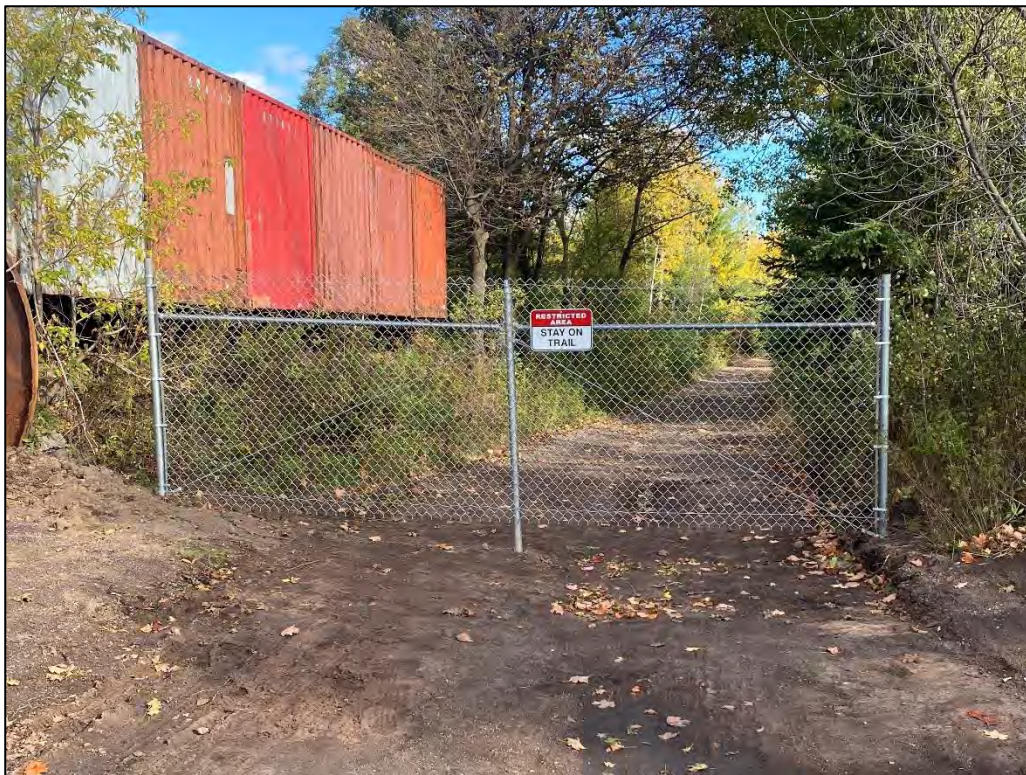
Photo 2: View looking east of the MDNR installed fencing and signage directing users to stay on the designated trail through the Julio Salvage Parcel.

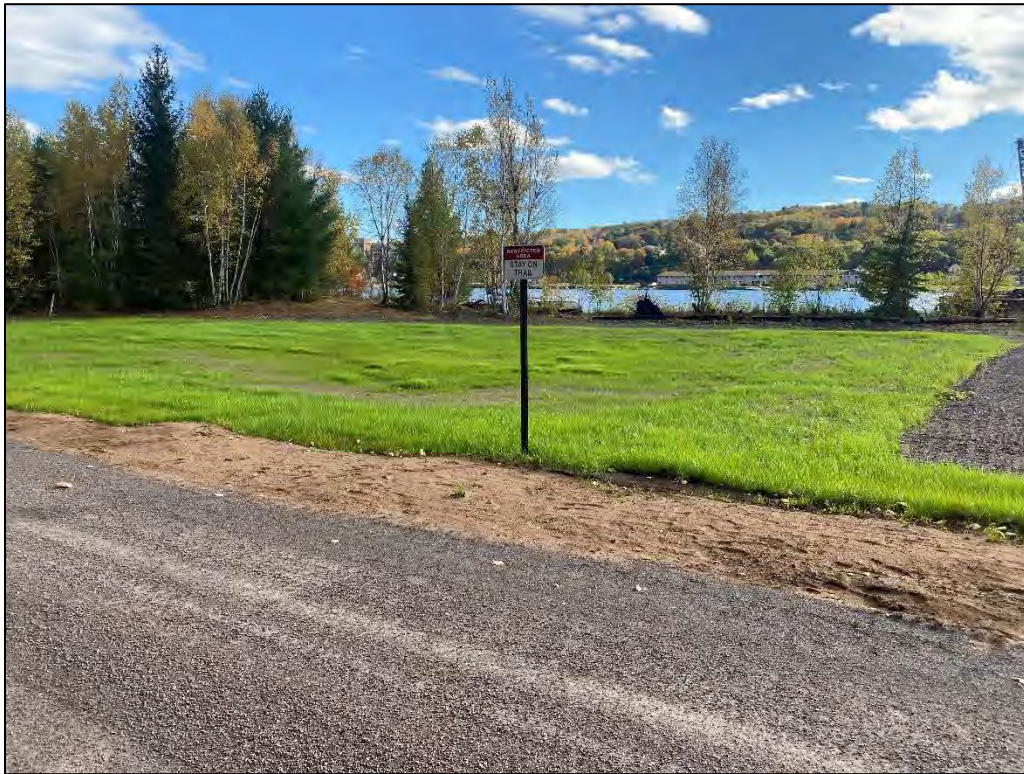
Photo 3: View looking south of MDNR installed signage at the Julio Salvage Parcel directing users to **stay on the designated trail, and Priority Area 2 following EPA's removal and placement of a vegetated cover adjacent to the designated trail.**

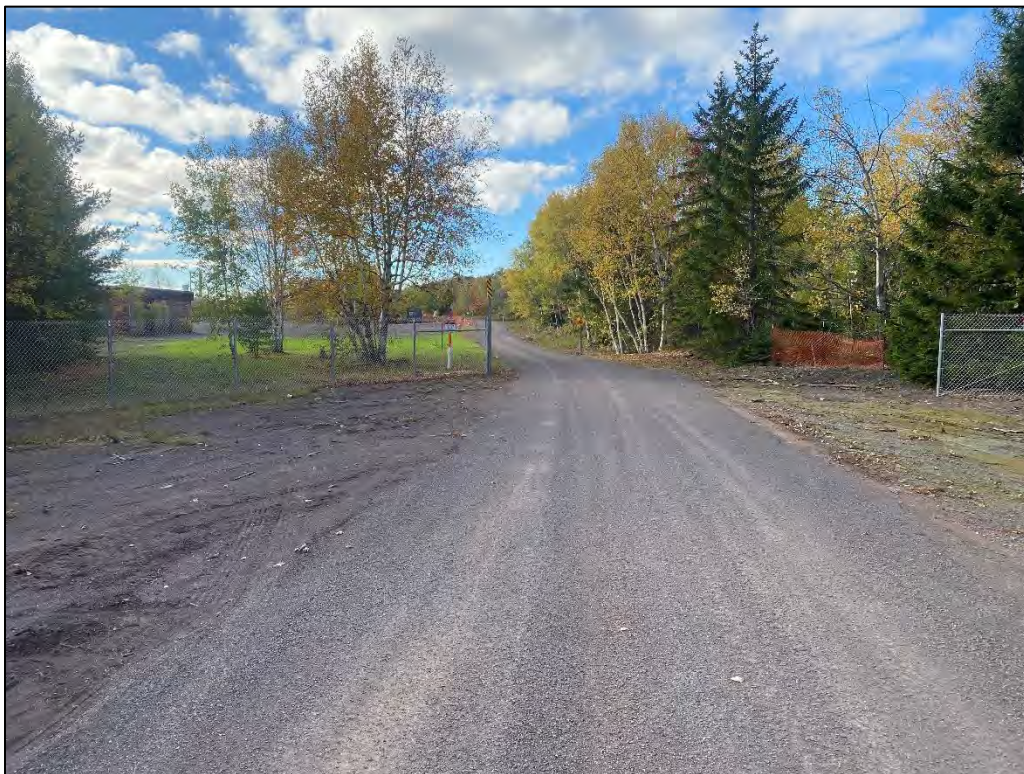
Photo 4: View looking west of the designated trail through the Julio **Salvage Parcel following MDNR's** grading, graveling, and installation of fencing to direct users to stay on the designated trail.

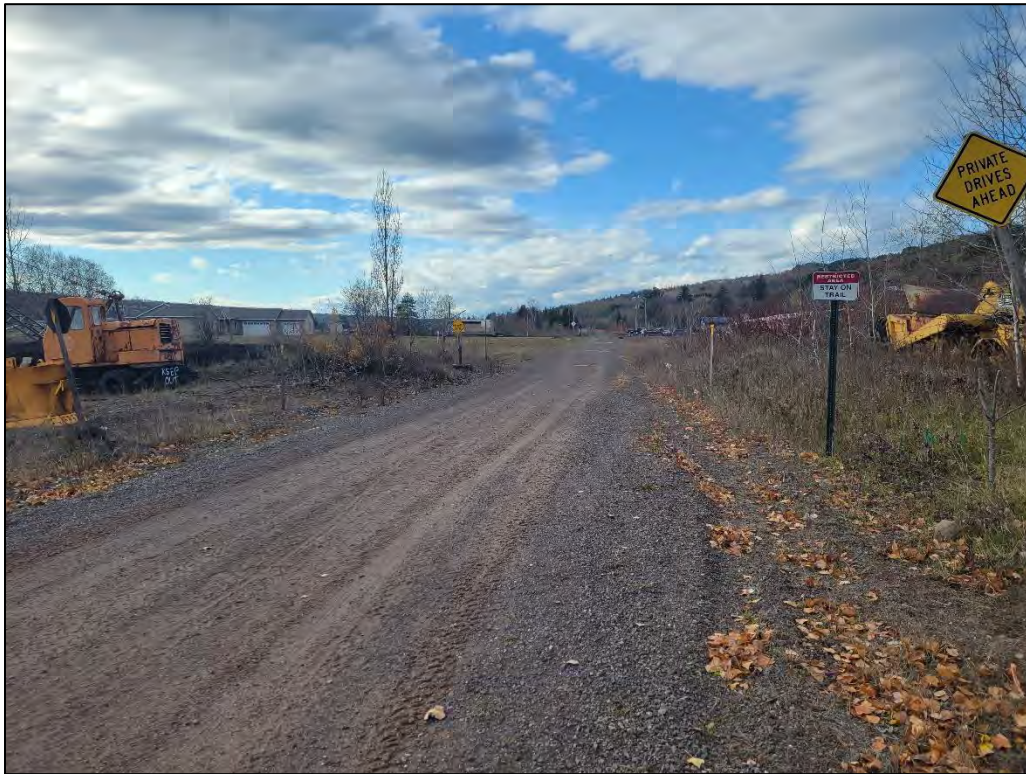
Photo 5: View looking west of the designated trail through the Julio Contracting/Former Standard Oil Company Parcel following MDNR's grading, graveling, and installation of signage directing users to stay on the designated trail.

- The MDNR graded and graveled the designated trail, and installed fencing and signage directing trail users to stay on the designated trail.

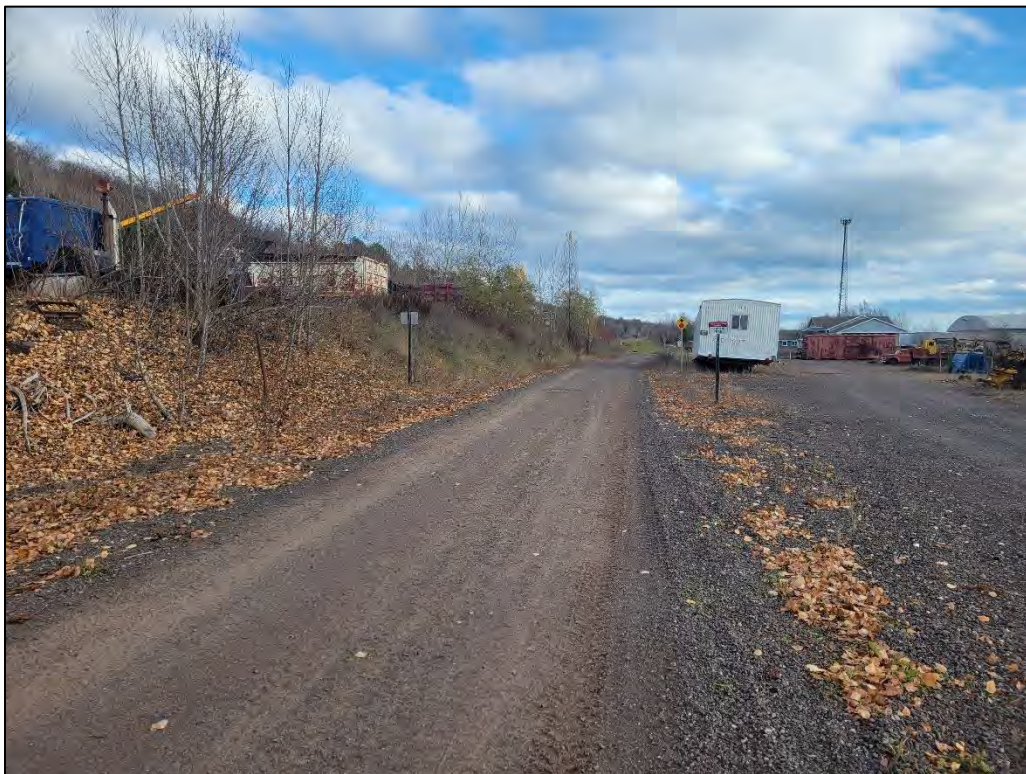
Photo 6: View looking east of the designated trail through the Julio Contracting/Former Standard Oil Company Parcel following MDNR's grading, graveling, and installation of signage directing users to stay on the designated trail.

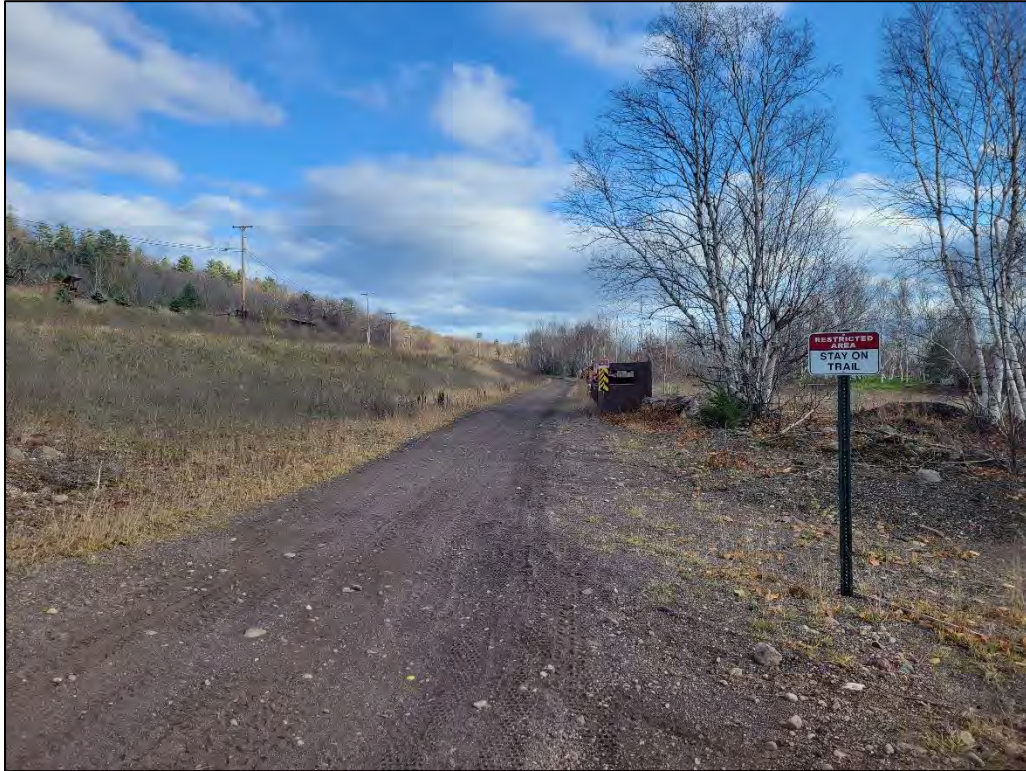
Photo 7: View looking east of the designated trail through Julio Scrap Yard Parcel following MDNR's grading, graveling, and installation of signage directing users to stay on the designated trail.

- The parcel owner removed, staged, and/or transported off site for recycling previously accumulated salvageable materials from near and on the Berm in the northern portion of the parcel.

- EPA placed a vegetated cover over the Berm, removed and disposed off-site PCB-contaminated soils associated with the Tank Car and placed a vegetated cover, and decommissioned the Tank Car.
- Following completion of parcel owner and EPA activities, the MDNR graded and graveled the designated trail, and installed fencing and signage directing trail users to stay on the designated trail.

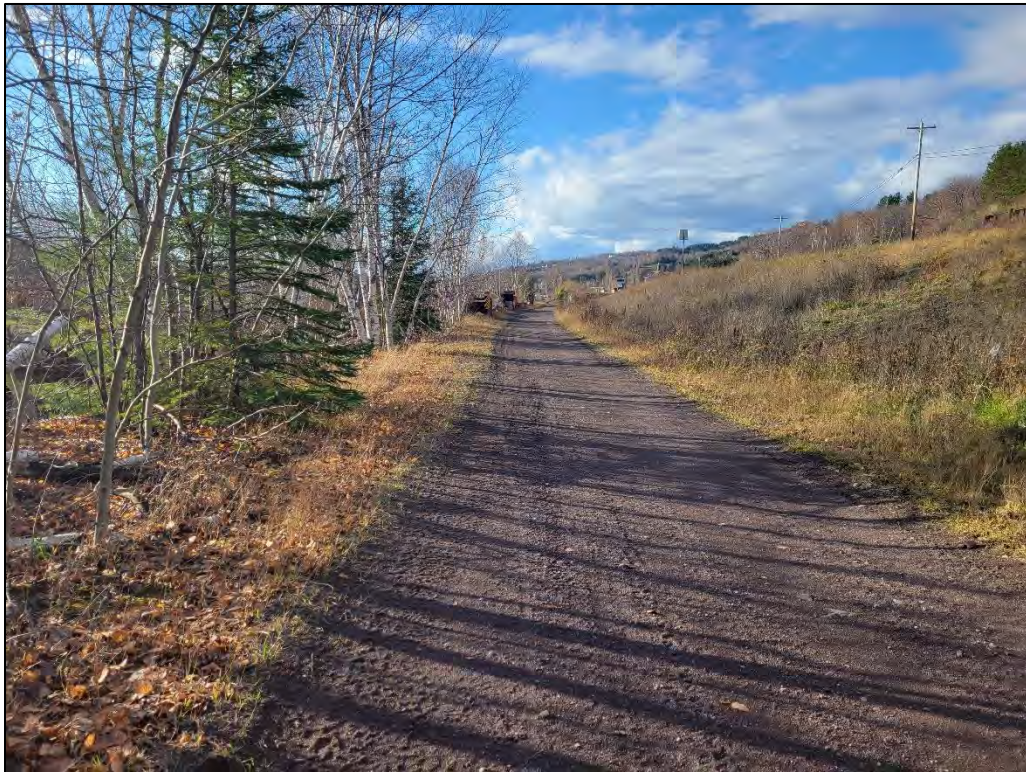
Photo 8: View looking west of the designated trail through Julio Scrap Yard Parcel following MDNR's grading and graveling.
