SUBJECT

Compromised Well OW-16D2 Abandonment
Former Kelsey-Hayes Milford
101 Oak Street
Milford, Michigan
EGLE Facility ID No. 6300095

June 28, 2023

30136112

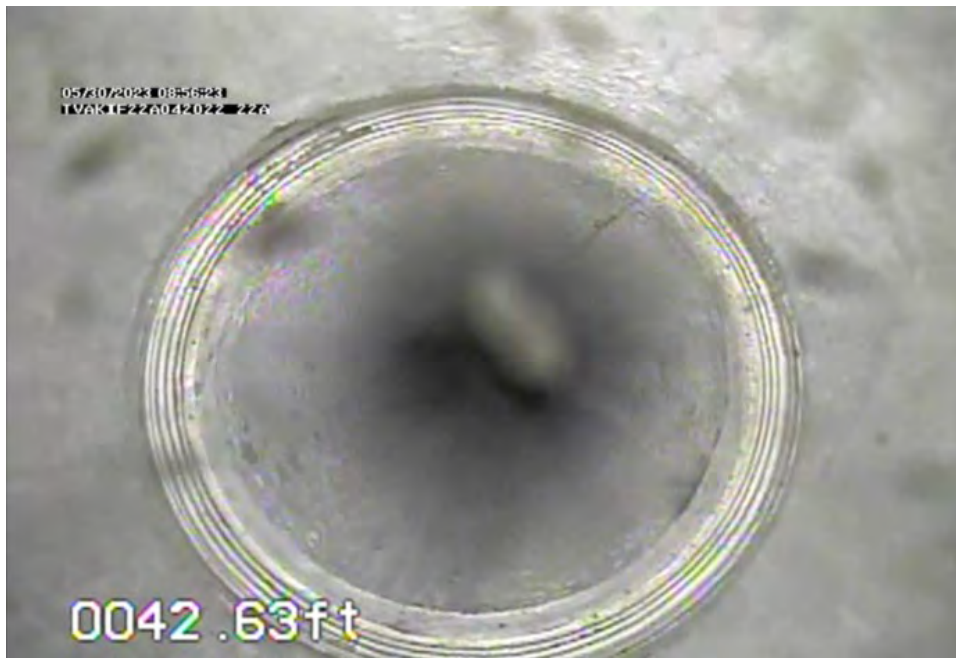
Photograph: 1

OW-16D2 – Well
Survey; Casing
Threads at 42 feet.

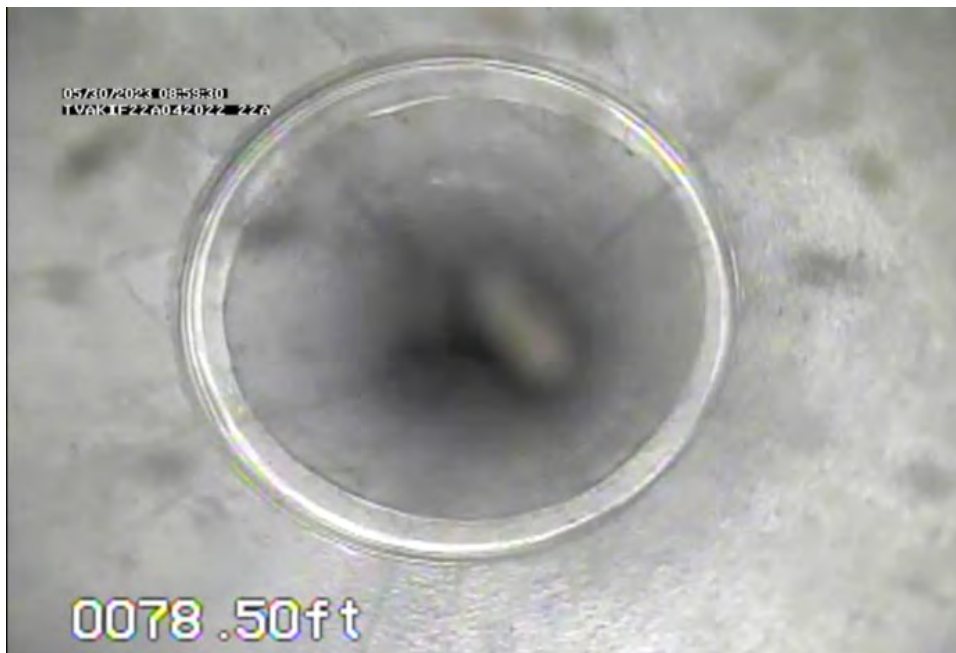
Photograph: 2

OW-16D2 – Well
Survey; Casing
Threads at 78.5 feet.

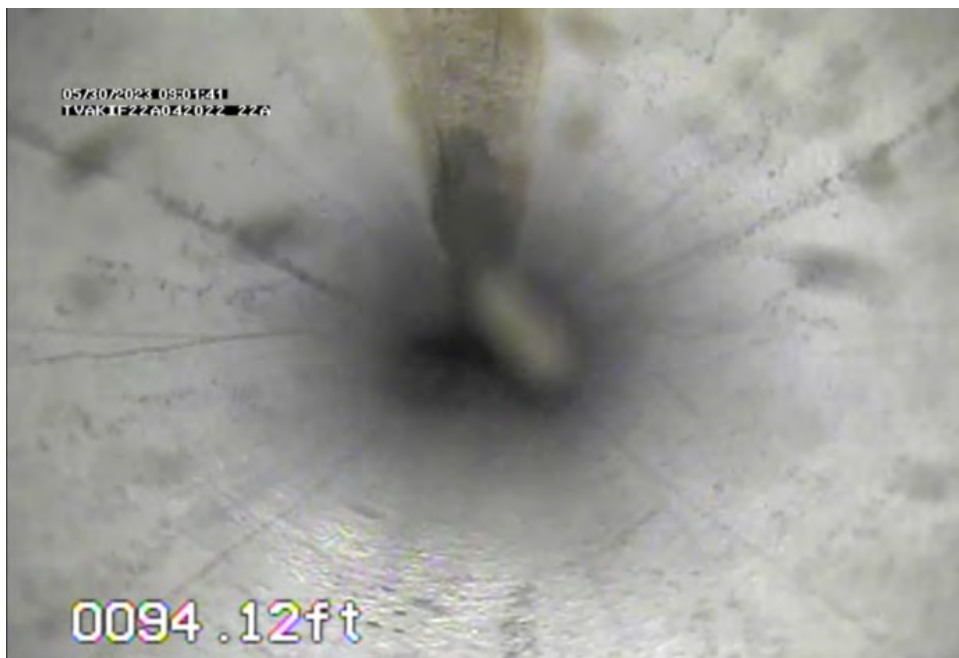
Photograph: 3

OW-16D2 – Well
Survey; Casing
Discoloration at
94 feet.

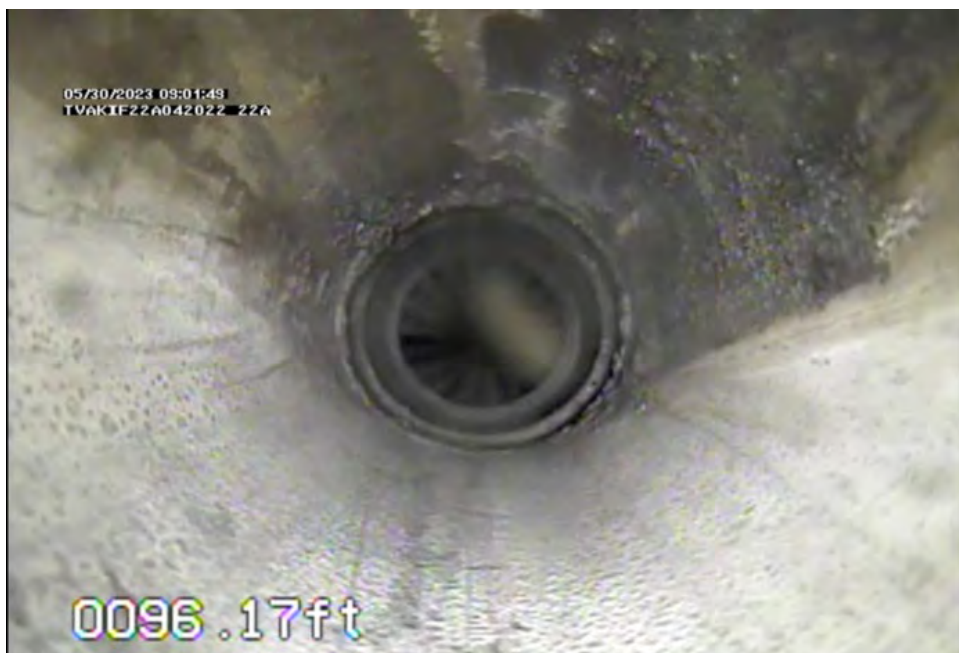
Photograph: 4

OW-16D2 – Well
Survey; Casing
Discoloration at
96 feet.

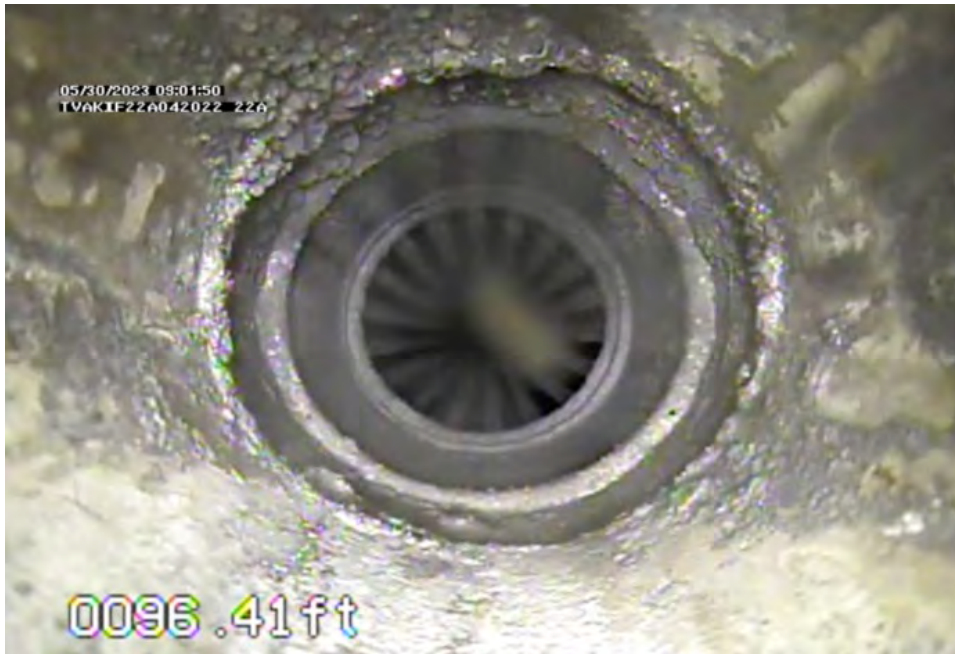
Photograph: 5

The down-hole camera survey was completed to collect additional visual documentation of the condition of the Compromised Well immediately prior to the abandonment. The camera survey was conducted with a Laval SC-350 camera system, which was equipped with an SC-166 water well camera. The camera was lowered into the Compromised Well and the entire length of its casing and screen was recorded. Still images from the video are included in **Attachment 2**. Starting above the screen at approximately 94 feet below ground surface (bgs), the casing exhibits discoloration to approximately 96 feet bgs (Photos 3 and 4) and apparent corrosion at the joint where the casing connects to the screen (Photo 5). The inside of the screen (Photos 6 through 10) shows

OW-16D2 – Well
Survey; Top of Well
Screen at 96.5 feet.

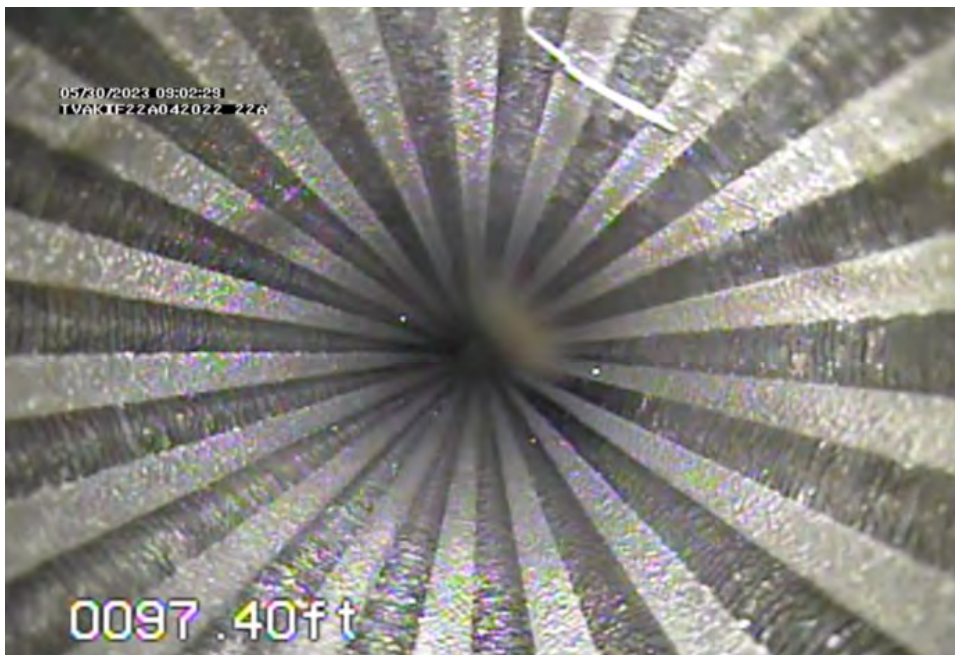
Photograph: 6

evidence of material build-up. An irregular pattern of material accumulation can also be seen at the bottom of the Compromised Well in Photo 10. Significant turbidity was observed on the video when raising and lowering the camera within the screen.

OW-16D2 – Well
Survey; Well Screen at
97.5 feet.

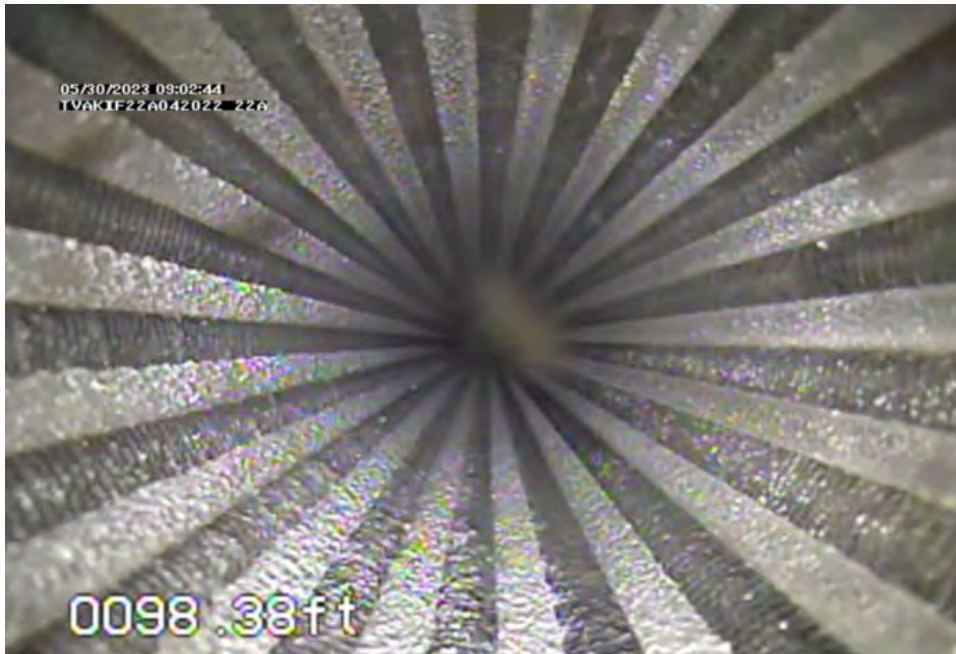
Photograph: 7

OW-16D2 – Well
Survey; Well Screen
at 98 feet.

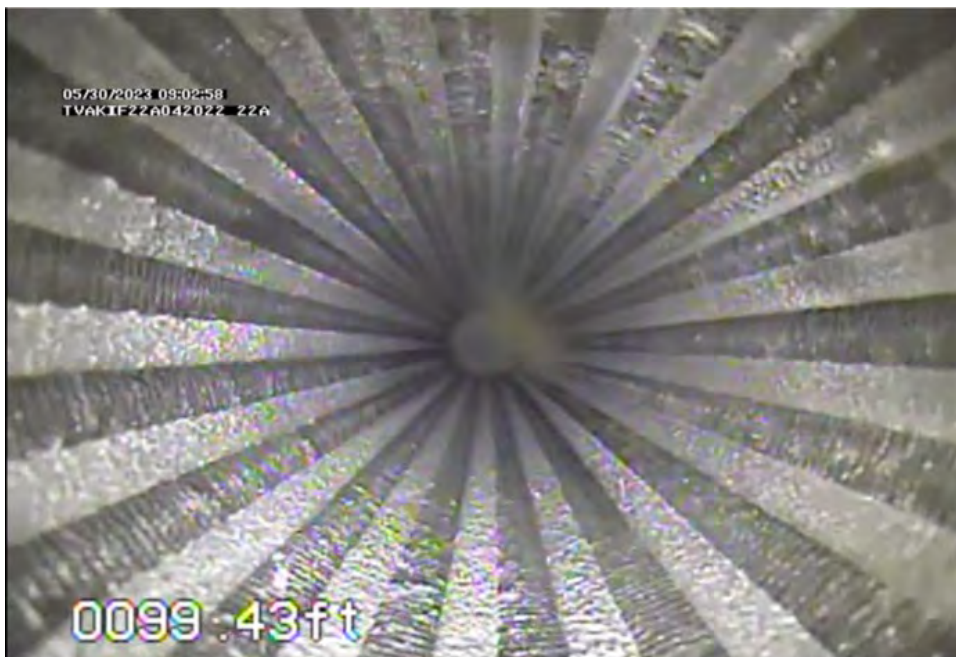
Photograph: 8

OW-16D2 – Well
Survey; Well Screen at
99.5 feet.

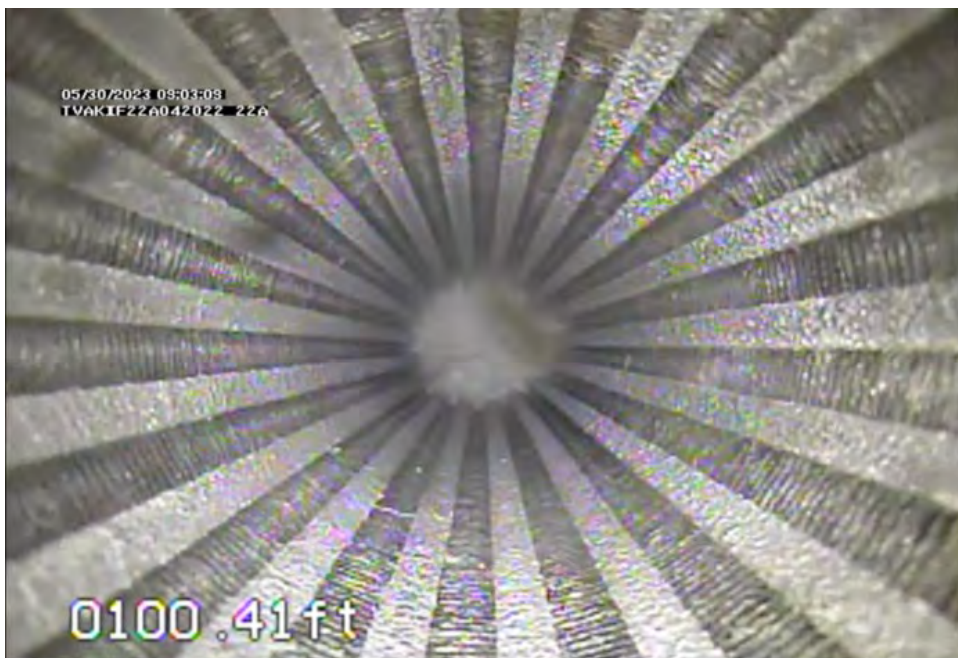
Photograph: 9

OW-16D2 – Well
Survey; Well Screen at
100.5 feet.

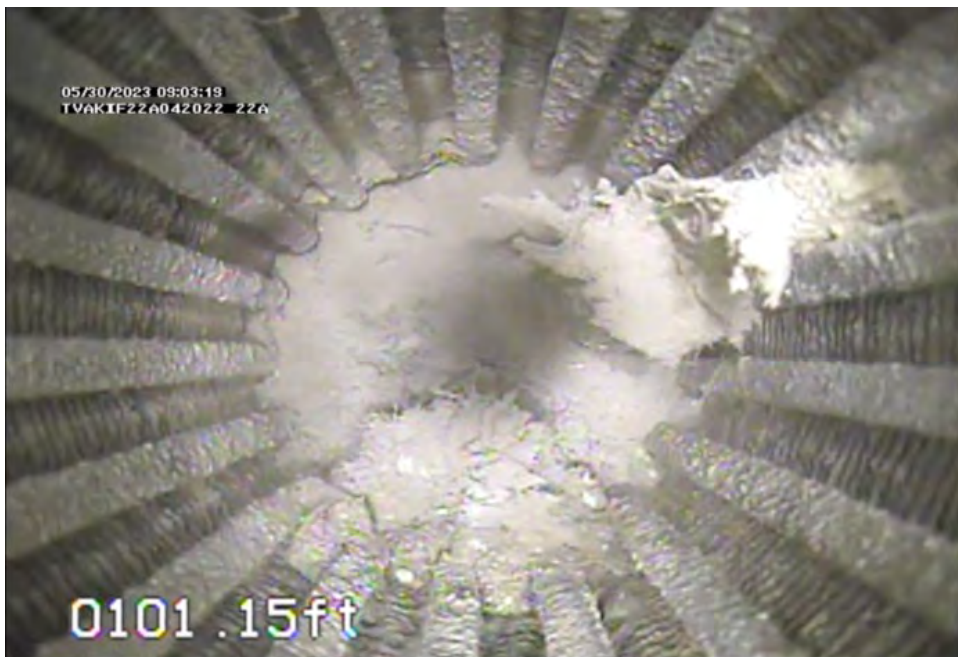
Photograph: 10

OW-16D2 – Well
Survey; Bottom of Well
Screen.

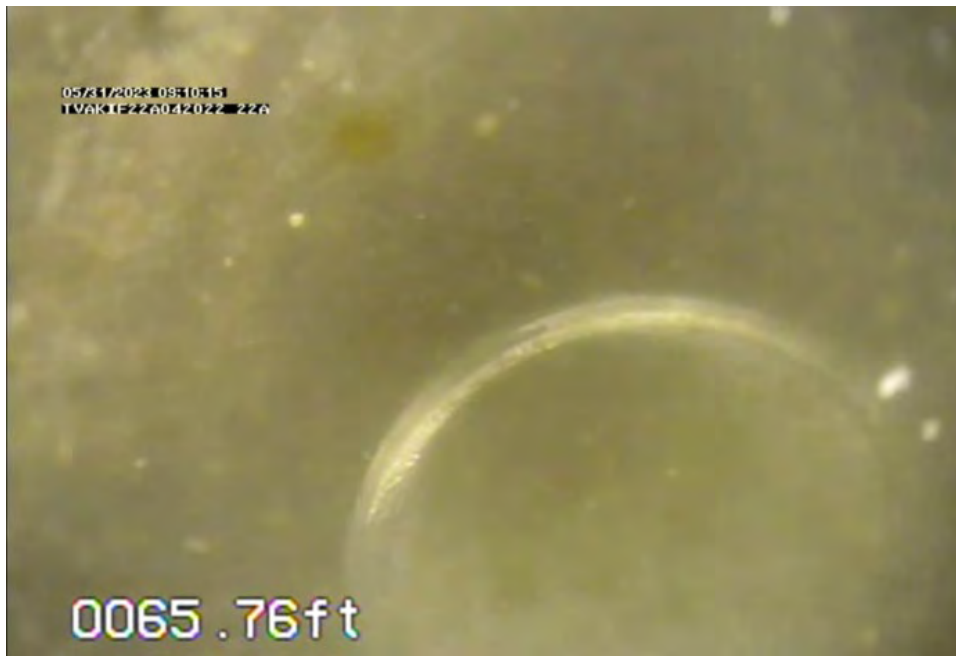
Photograph: 11

A camera survey confirmed the top of the casing at 65 feet bgs (Photos 11 and 12 in **Attachment 2**). Cascade used new pipe with a threaded coupling to attempt to connect to the top of the casing. After lowering the additional new pipe into the hole and carefully attempting to thread onto the casing, the driller pulled on the pipe to lift the Compromised Well out of the borehole, but the threaded pipe disconnected and the Compromised Well remained in the ground.

OW-16D2 – Well
Survey; Disconnected
Well Casing after Over
Drilling.

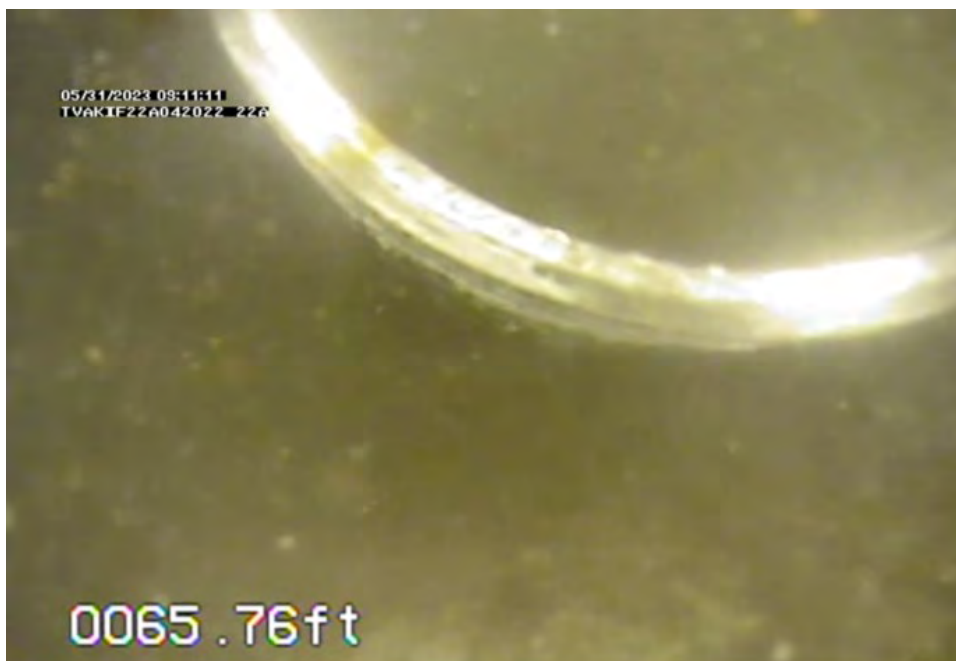
Photograph: 12

OW-16D2 – Well
Survey; Disconnected
Well Casing after Over
Drilling.

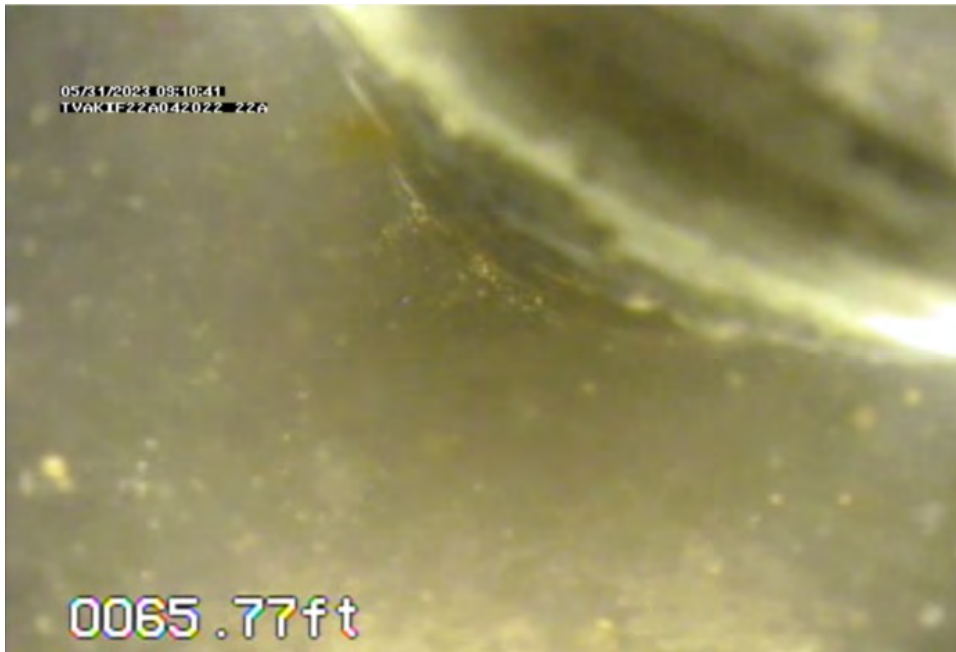
Photograph: 13

OW-16D2 – Well
Survey; Disconnected
Well Casing after Over
Drilling.

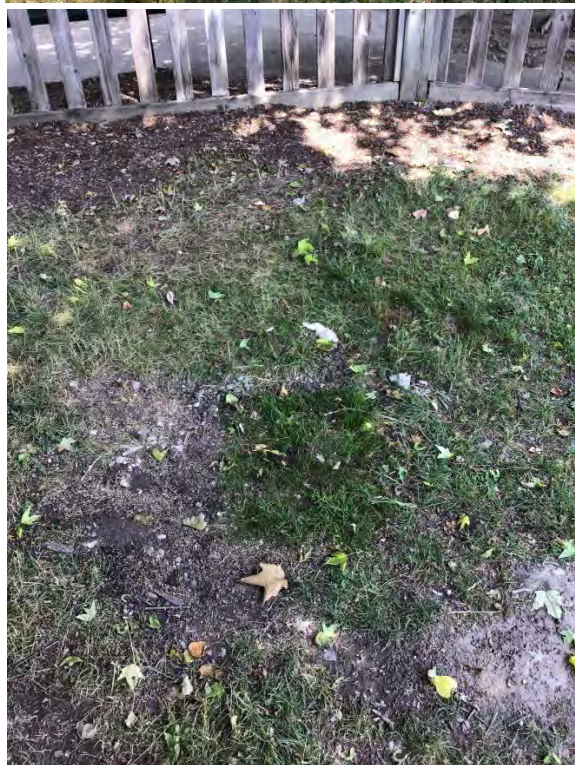
Photograph: 14

On June 13, 2023, Arcadis returned to the location of the former Compromised Well to inspect ground conditions. Photo 14 in **Attachment 3** shows no further settling occurred at the location and that grass is covering the site where the pad had been. The abandonment of the Compromised Well has been completed in accordance with the Work Plan. The Cascade well abandonment log is included in **Attachment 4**.

OW-16D2 –Former
Well Location 2 Weeks
after Abandonment.
