Title: Dead River Stream Restoration

Problem: In May 2003 the Silver Lake fuse plug on the Dead River in Marquette County failed, damaging local homes, roads, bridges, dams and dikes, and utility service to local residents; destabilized 4 miles of stream channel; and caused an estimated \$100 million to total damages.

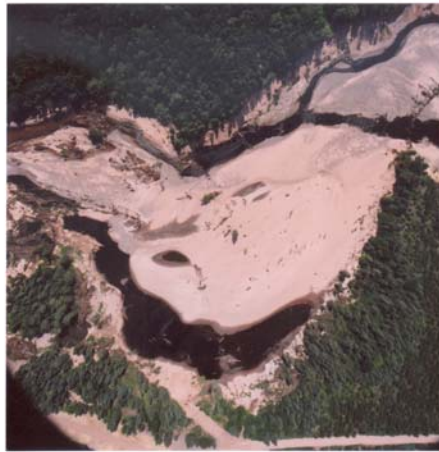
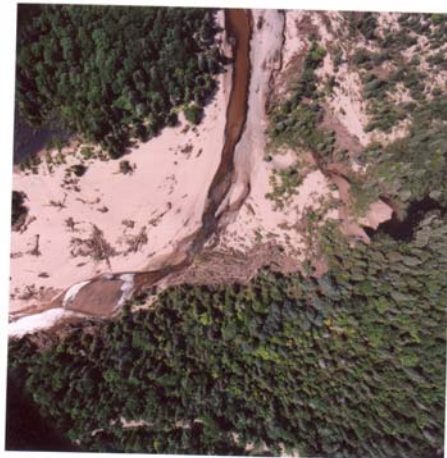
- Mobilized approximately 1 million cubic yards of sediment and debris, equivalent to a 500-year precipitation event, which destabilized approximately 4 miles of river channel and deposited up to 2 meters of sediment on the floodplain (Figures 1 and 2).

Figure 1. Aerial photographs of sediment deposition in the floodplain 2 months after the dam failed.

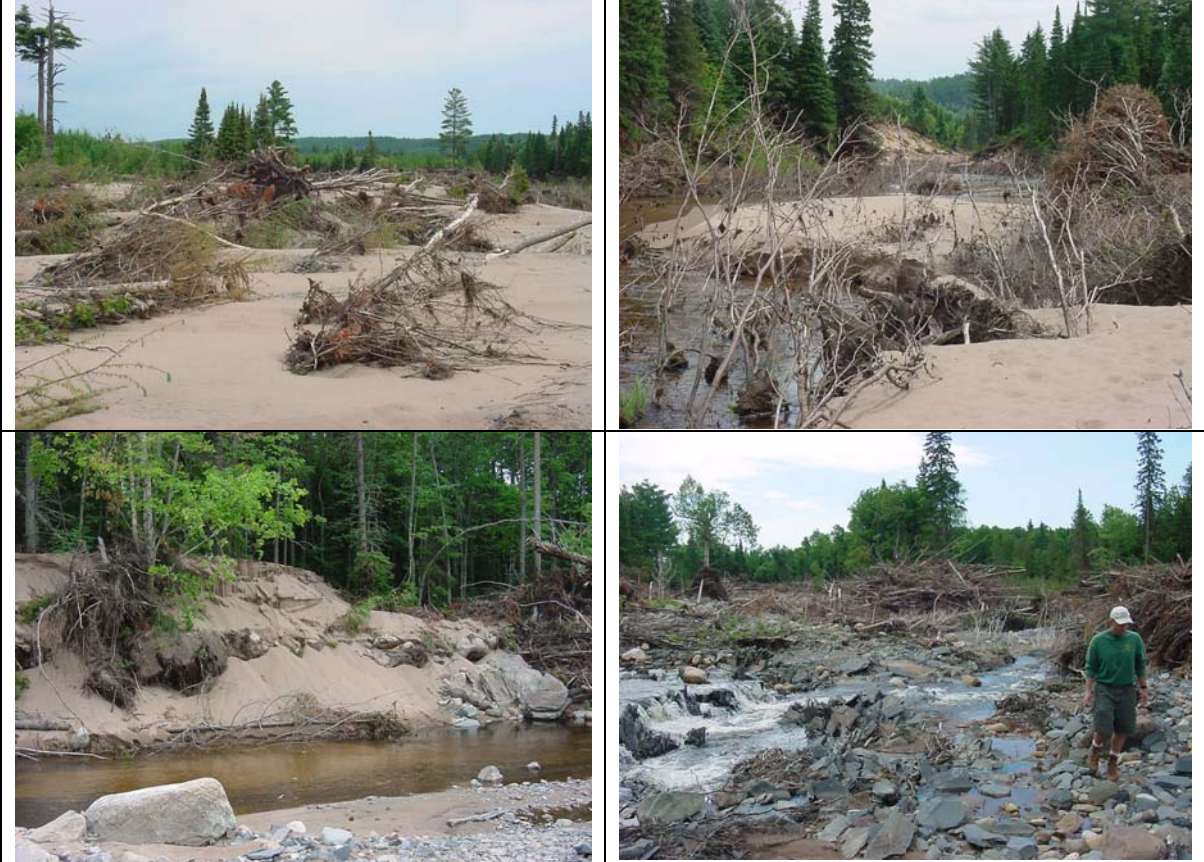
Figure 2. Photographs of the impacted reach 2 months after the dam failed.

Riparian zone, showing downed vegetation, excessive sediment deposition, and a channel scoured to bedrock

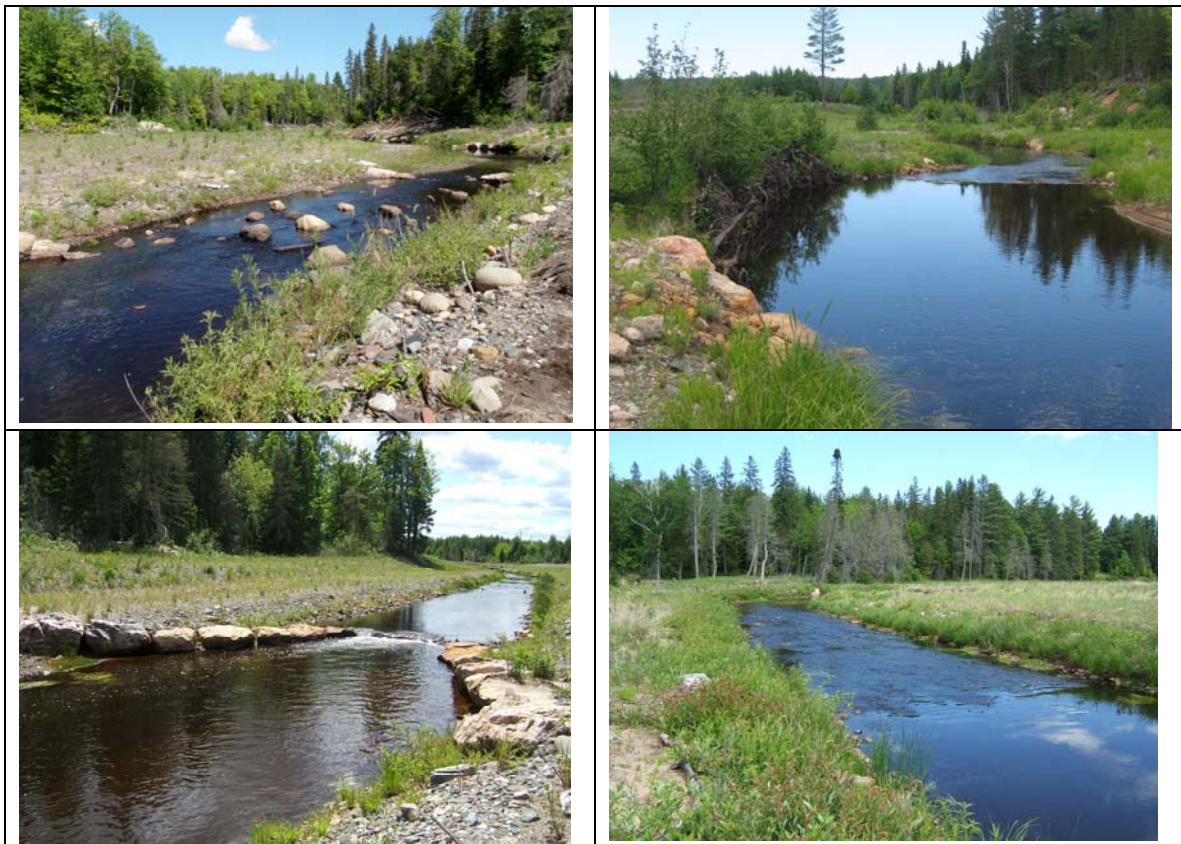
- The riparian and wetland plantings are surviving.
- The designed channel is generally stable.
- The instream structures are providing the intended bank stabilization and stream bed grade control (Figure 3).
- Pools at the edges of constructed riffles and cross-vanes are becoming larger and deeper.

Figure 3. Photographs of the impacted reach 7 years after the dam failed, including some of the instream stabilization structures. Note the regenerating floodplain vegetation.

Between 2003 and 2009 the dam's owner, the Upper Peninsula Power Company (UPPCO), restored a total of 4 miles of river channel and reestablished riparian vegetation and wetlands along the river corridor. The channel restoration combined the principles of natural channel design to create a stable channel configuration that will transport its water and sediment loads with the installation of instream grade control and bank stabilization structures (cross-vanes, J-hooks, W-weirs, riffles, and rootwads) to provide short-term channel stability until vegetation fully establishes to provide long-term stability.
