Benton Harbor Area Schools

Facilities Assessment November 4, 2016

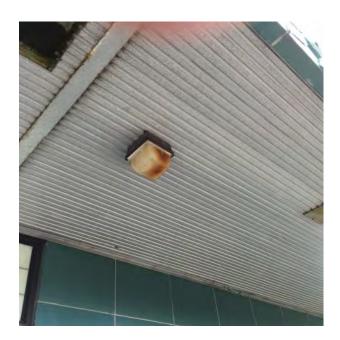
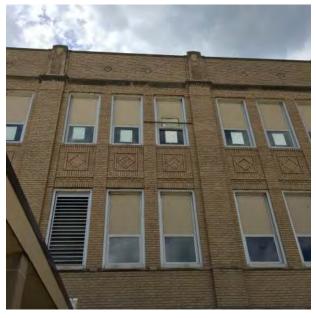
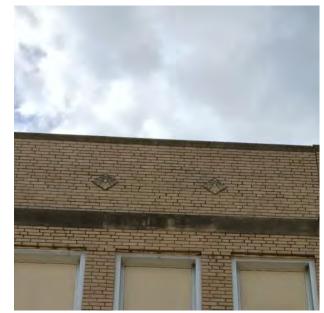
- Gymnasium entry canopy replace lights and heaters
- 3rd Story brick needs maintenance and minor tuck pointing

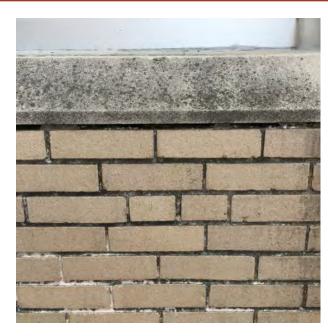
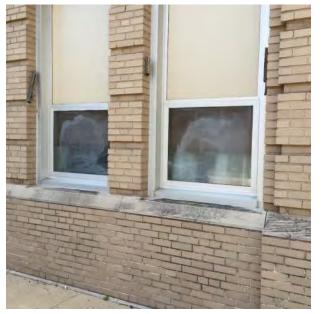
- Tuck point brick beneath sills, clean and repair sills
- Many broken seals at exterior glazing

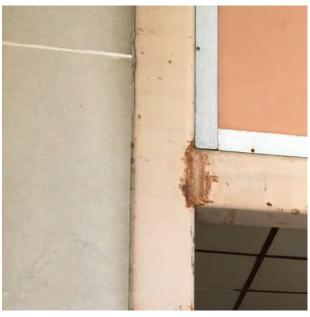
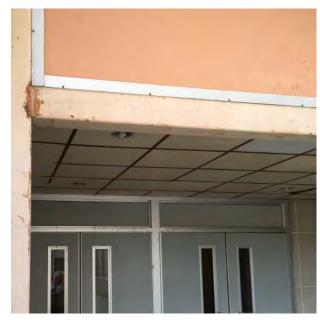
- Single pane glazing should be replaced with insulated units
- Limestone panels need to be cleaned and sealed
- Entrance steel framing showing signs of rust, prep and repaint
- Entrance soffit/ceiling grid is rusting. Replace system

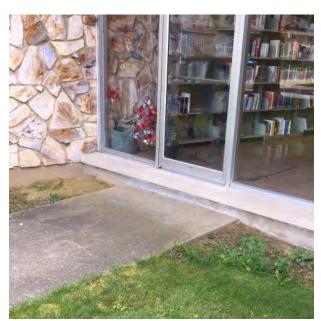
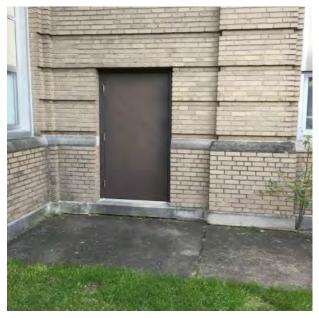
- East and west library stoops and emergency exit door walkway do not meet ADA egress requirements. Bring elevation up to floor level.
- Repaint exit door and frame

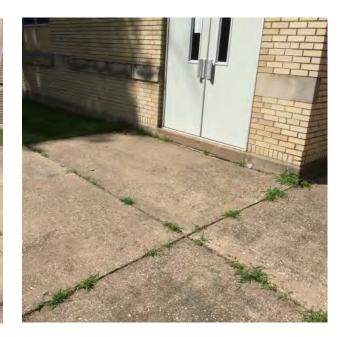
- Exit door has no landing install per code.
- Replace all frames and glazing at south 1950's addition.
- Prep & repaint all lintels; caulk joints.

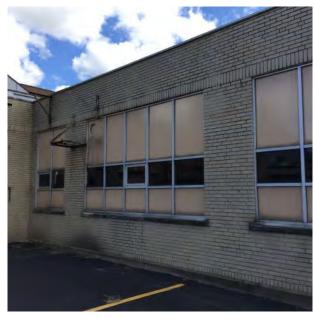
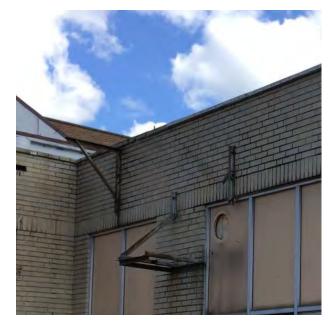
- Limestone sills missing joint caulk and need cleaning.
- Tuck point masonry and repaint.
- Remove miscellaneous steel and patch.

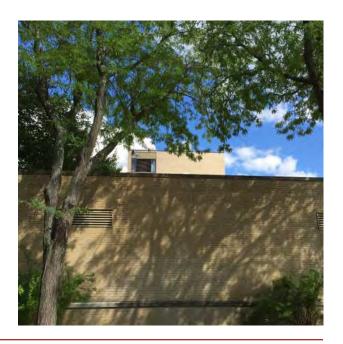
Cafeteria wing:

- Repaint standing seam metal roofs.
- Replace damaged glazing
- Limb up trees or remove

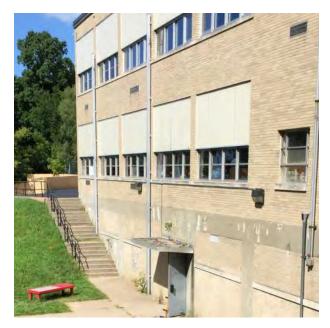
- Level concrete pads at courtyard to eliminate trip hazards
- West elevation windows need replacement in 2-5 years

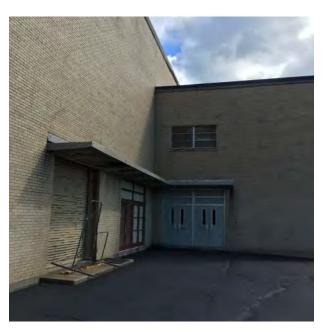
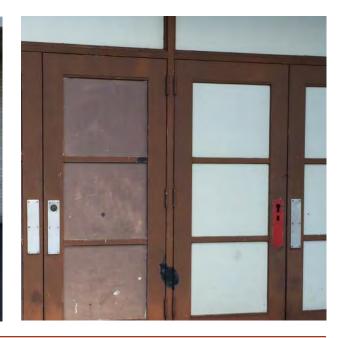
- Clean and tuck point brick as needed
- Repair canopy and add sloped roofing & gutter for handling runoff
- Replace panels and patch stone at stairwell by Gym

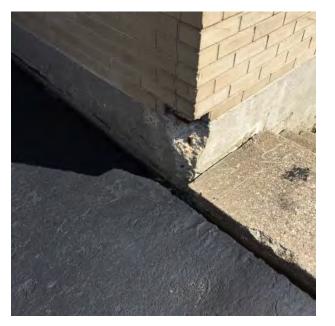
- Repair damaged concrete below brick
- Replace scupper and downspout at North Gym wall

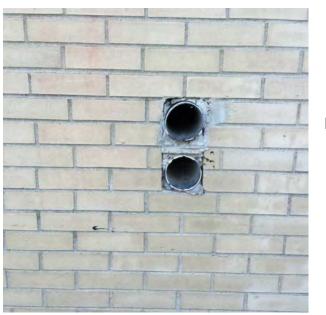
North Gym Wall:

- New vent covers and cages
- Seal penetrations

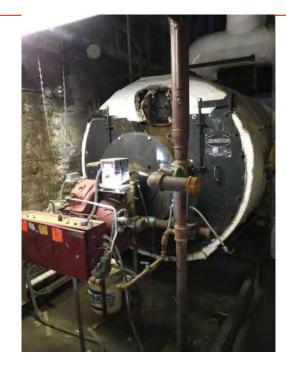
(1) Johnston Steam Boiler, 3,450lbs/hr and (2) Johnston Steam Boilers 10,350 lbs/hr (1955)	Boiler Room	Entire Facility	С	1955	25	61	0	A steam heating system is very inefficient compared to today's hot water systems. The boiler breeching has corroded at chimney connection and resulting holes leak exhaust fumes into boiler room. Steam is hard to control due to constant high temperature (227F). Energy losses are high due to boiler design, uninsulated hot surfaces, no damper on combustion air louver and typical steam trap blow-thru.	Replace entire steam boiler system with high efficiency hot water condensing boilers, vent/comb air ducts, pumps, HW piping, controls and classroom CUVs. Include new hot water pumps, boiler room piping/insulation, hydronic tanks/devices, etc Asbestos abatement in pipe insulation is also needed for this work.	\$755,000	I
Steam / condensate piping system	Boiler Room, pipe tunnels, inside CUV cabinets	Entire Facility	С	1955	25	61	0	Pipe leakage is common with 5psi (227F) steam systems due to corrosion at fittings, heat loss is high where insulation is missing and from uninsulated hot surfaces (valves, steam traps, condensate tanks, etc) . Steam traps require annual inspection and repair to minimize blow-thru loss. Hot water systems operate with supply temperatures between 100F to 180F making heat loss lower and controllability higher.	Replace steam/condensate piping systems with hot water piping/insulation outside boiler room throughout the building. Asbestos abatement in pipe insulation is also needed for this work.	\$490,000	I

- Combustion Air Louver wide open
- Boiler breeching at chimney leaking fumes

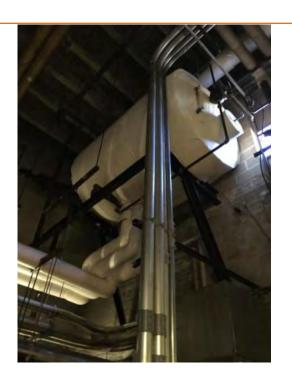
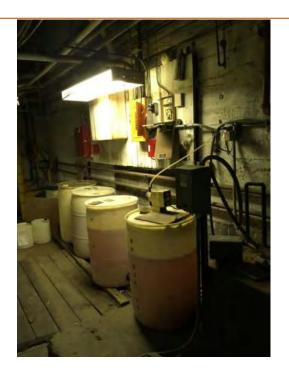
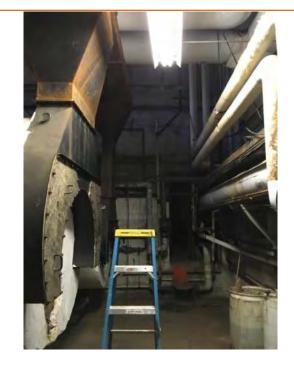
- Condensate Return Tank in good condition
- Chemical treatment for steam system
- Boiler breeching is uninsulated (energy loss)

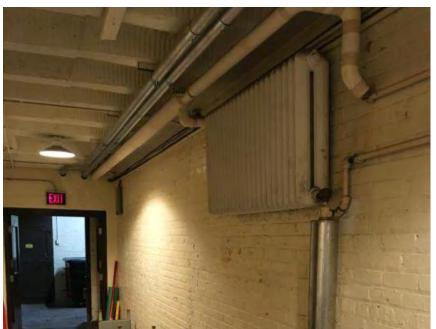
- Radiator at corridor
- City water line with many patches

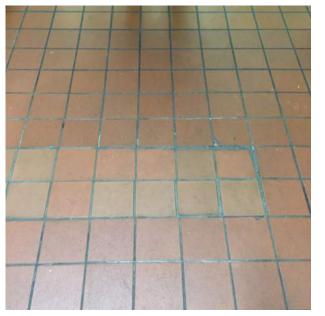
27 Cooking Kitchen - ceiling & flooring repairs needed

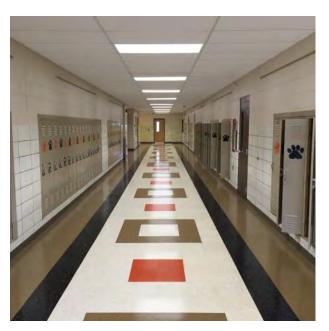
251 Corridor - structural cracks

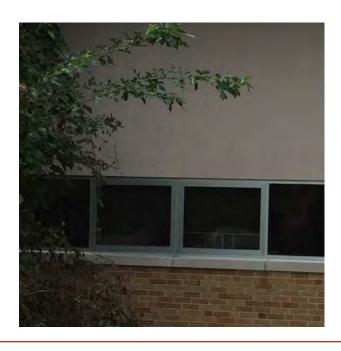
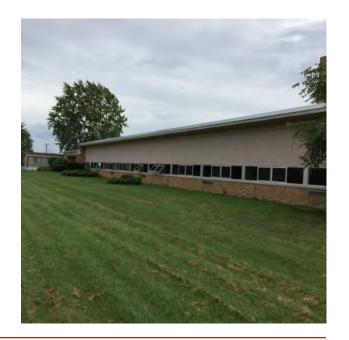
- Typical stone sill condition at North Elevation - seal joints
- EIFS finish to be recoated in 3-5 years

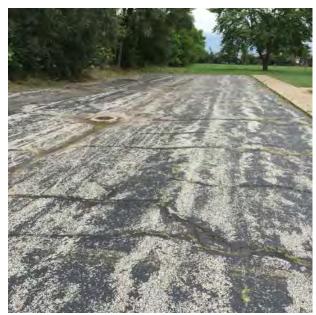
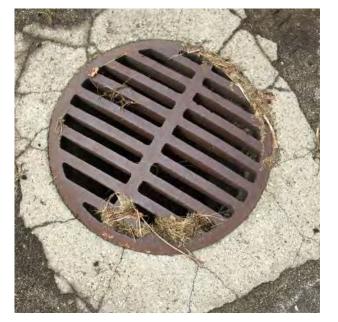
- North Parking lot condition.
- Sidewalk North entrance does not meet ADA - needs replacement

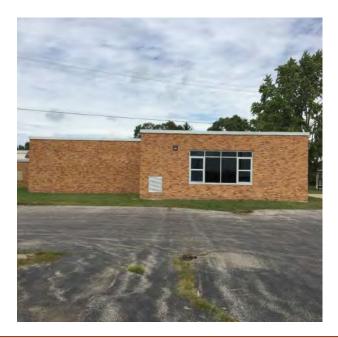
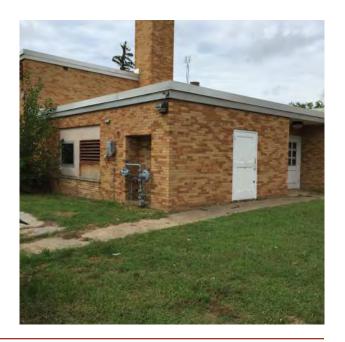
- Good brick condition at addition area
- Replace service doors.

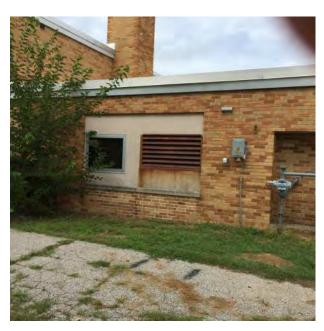
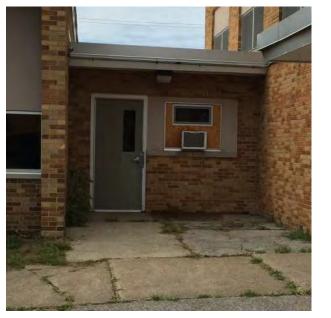
- Replace louver and recoat EIFS
- Paint entry door, install EIFS over plywood panel
- Recoat EIFS over gym clerestory windows

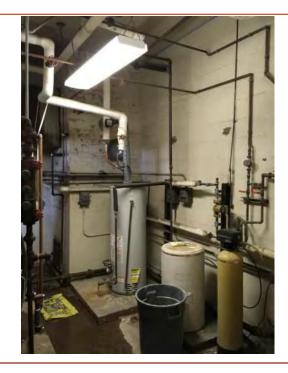
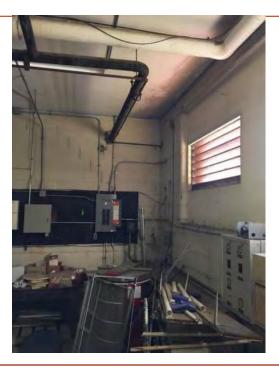
- 1955 Steam Boiler
- 2011 Gas Water Heater and Water Softener
- Combustion Air Louver no damper

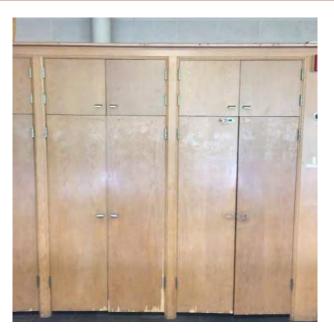
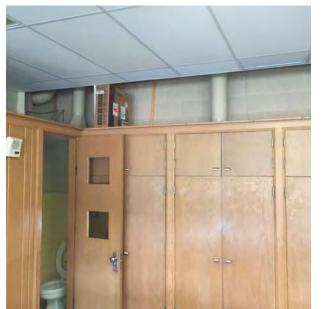
Typical condition of cabinets and doors at South Wing classrooms
