BENTON HARBOR AREA SCHOOLS

2017 Facility Assessment

GMBae Project #5-4061

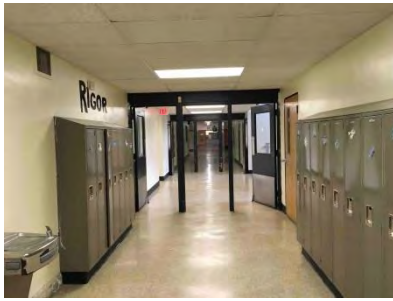
- This is a non sprinklered building
- Illuminated exit signs are lacking
- Door hardware is a mix of lever and knobsets with panic devices at corridor exiting doors – knobs are non-compliant

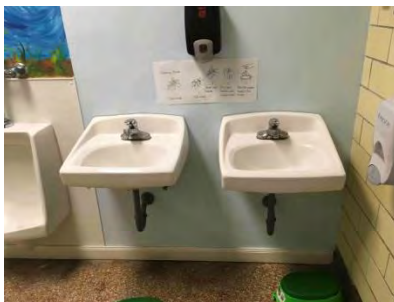
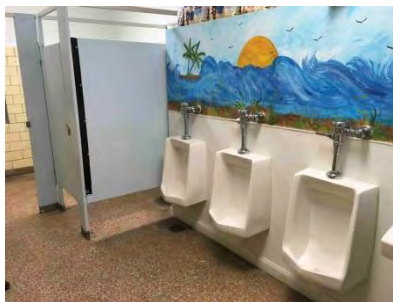
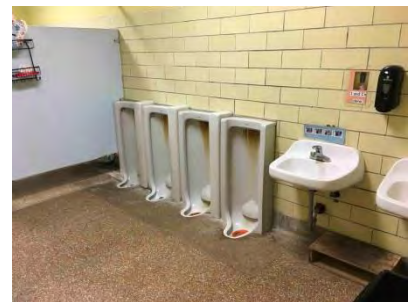
- Most fixtures appear to be in average condition and in need of some repair/replacement

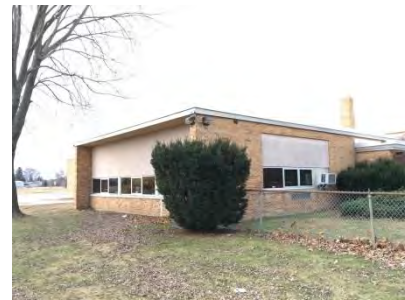
- Masonry block exterior walls with brick veneer and sand stone at main entry. Sandstone is in good condition
- There are some cracking in the brick joints in need of repair
- EIFS panels located above awning windows have some discoloration and minor repairs are required
- Control joints and the perimeter window sealants need to be replaced
- The top portion of the brick chimney stack is deteriorated and repairs are needed
- Aluminum double pane awning type are in good condition
- Exterior window sills need to be tuck pointed to seal voids and to minimize water infiltration
- Doors are aluminum in good condition

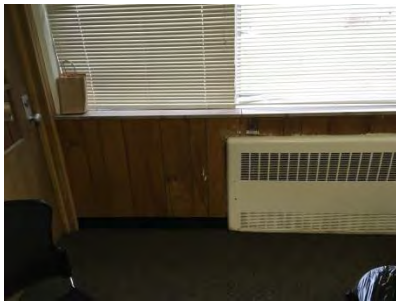
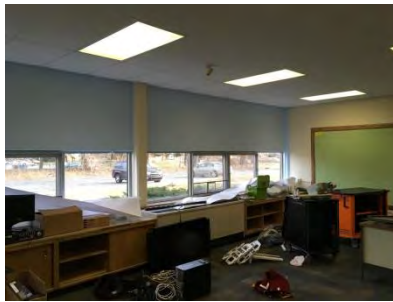
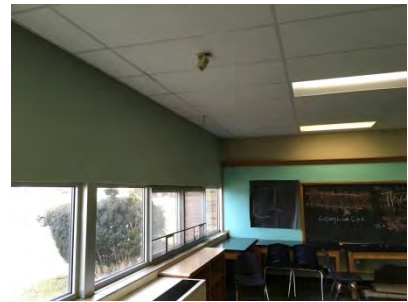
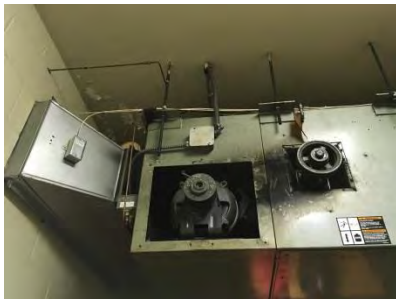
- Nesbitt horizontal unit ventilators installed in 1999 are in average condition and near end of service life.
- New addition includes vertical unit ventilators with A/C and hot water heat.
- Gymnasium heating and vent unit, not running

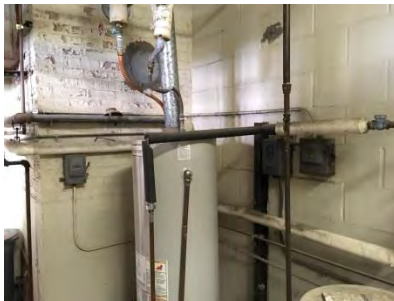
- Domestic water heater in good condition.
- Plumbing piping is routed thru tunnels and assumed to be original to the building. Original study noted multiple patches and that piping is in poor condition.

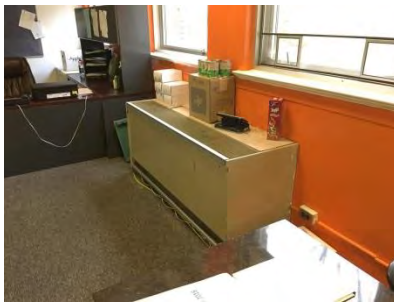
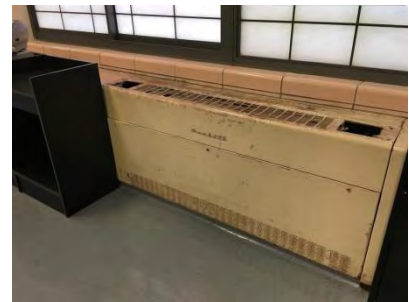
- Library is conditioned only by Nesbitt horizontal unit ventilators that are old and need to be replaced.
- Main office area served by radiator that is not controlled well and was found to be very hot
- Cafeteria served by rooftop unit, condition and age is unknown
- Gymnasium served by two rooftop units, ages are unknown
- Most first floor classrooms have old horizontal unit ventilators that need to be replaced. Some have newer Trane vertical unit ventilators that are in good condition.
- Second floor contains mix of new and updated vertical unit ventilators and a handful of old, original horizontal unit ventilators that should be replaced
- Science renovation spaces in good condition with newer Aeon RTU and lab exhaust fans.

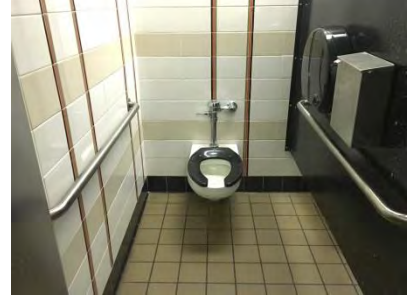
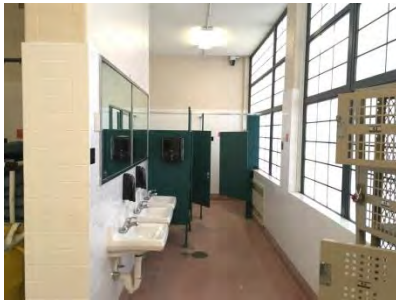
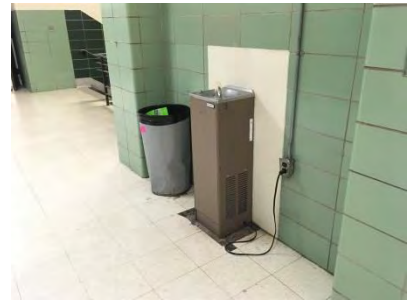
- Plumbing fixtures are in fair condition with some needing to be replaced.
- Lower level locker rooms are in good condition with new and upgraded fixtures.

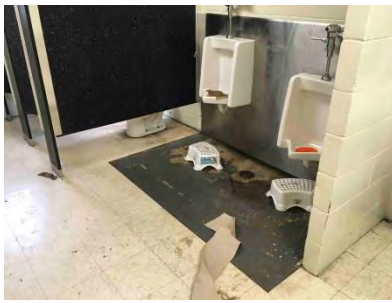
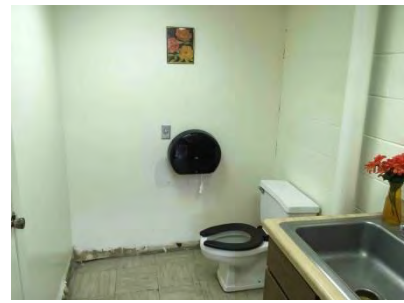
- Toilet rooms and fixtures are not barrier free accessible

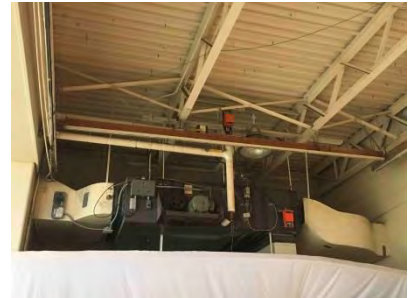
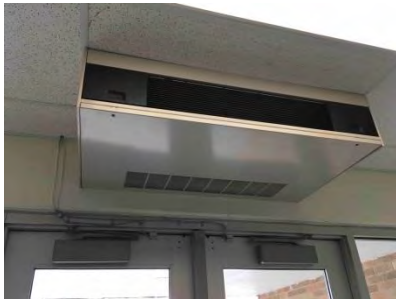
- Trane horizontal unit ventilators installed in 1997 are in average condition.
- Gymnasium has heating and ventilation unit that is old and past its service life.
- Handful of misc. window air conditioners that are 20+ years old and should be removed.

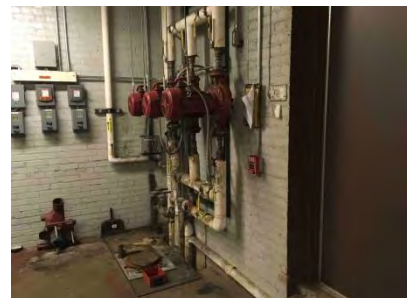
- (1) Johnston heating hot water boiler, 5120 lbs./hr. capacity (not steam), installed in 1994 and is in fair condition. Boiler is nearing end of expected usable life and should be considered for replacement in 3-7 years.
- Pumps/piping in the boiler room are leaking and should be repaired/replaced.

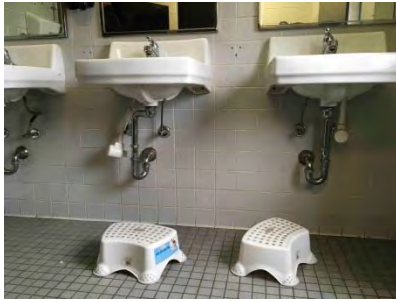
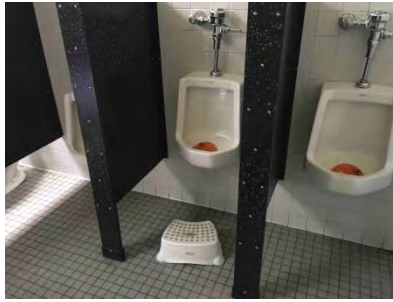
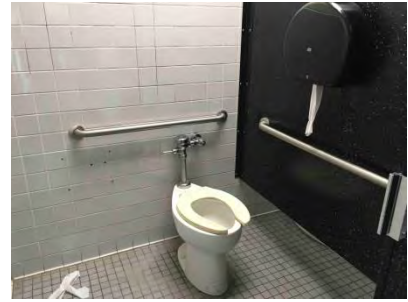
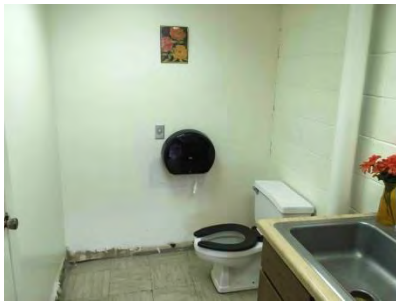
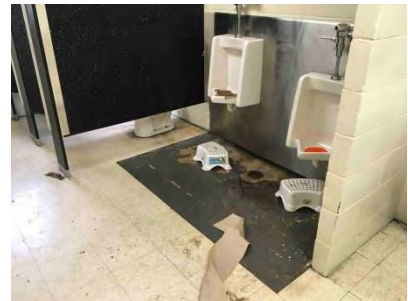
- One bathroom has upgraded fixtures, other bathroom fixtures in fair condition and may need replacing.

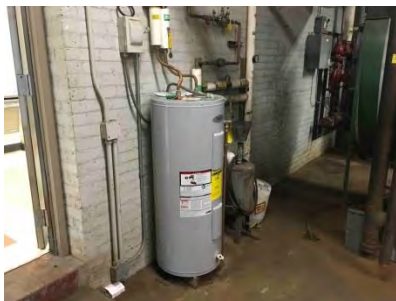
- Plumbing piping is routed thru tunnels and assumed to be original to building.
- Multiple existing electric water heaters. Appear to be in operable condition, but may consider replacing with gas water heaters to reduce operating costs.

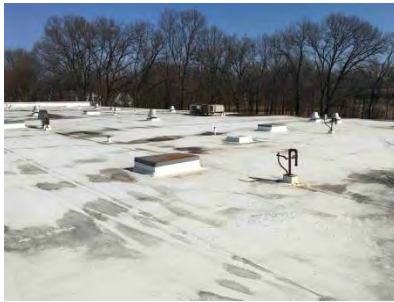
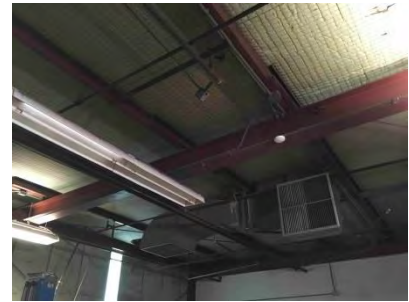
- Maintenance shop has ductwork from previously used RTU's, all RTU's curbs are capped and ductwork is abandoned. Maintenance area has minimal ventilation and exhaust. If vehicles are operated indoors current codes require much more ventilation and specialized exhaust.
- (1) RTU installed in 2010 serves front office area and is in average condition.
- Remainders of spaces are served by ceiling hung hot water unit heaters.

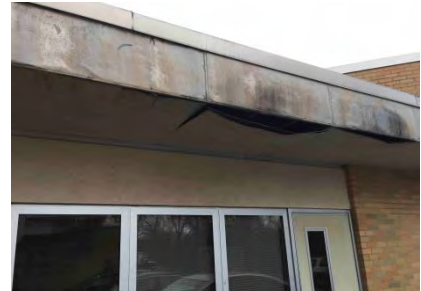
- Exposed concrete and brick in good condition with some repairs needed at concrete support columns
- There are areas with stress cracks in the brick veneer that need repaired
- Aluminum curtain wall system with awning style operable windows. All glass is double pane in good condition
- Main entry doors are FRP installed in aluminum frames and are in good condition. However some of the door hardware is damaged and should be replaced
- Soffit areas are in poor condition with repairs being needed
- Hollow metal doors and frames are rusted through and are in very poor condition

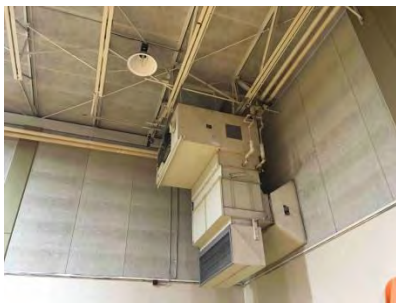
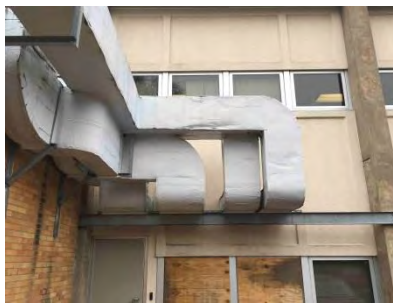
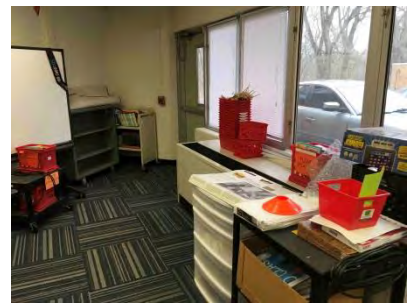
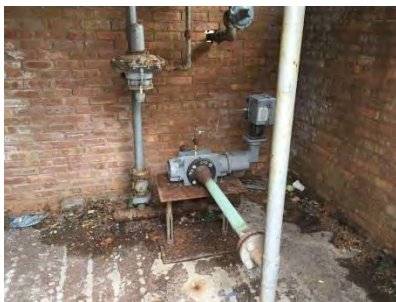
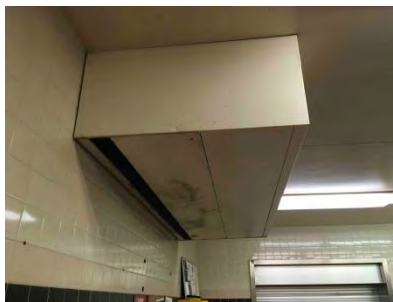
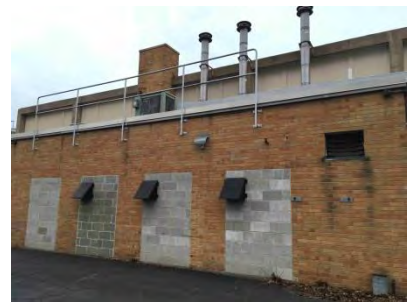
- Separate Packaged RTU's serve Media Center, Technology Room and Server Room. Units appear to be near the end of their service life.
- Gas meter and piping external to building in poor condition, very corroded.
- Gymnasium heating and ventilation unit is beyond expected usable life.
- Trane horizontal unit ventilators are in average condition and near end of service life.
- Kitchen exhaust fan and make up air unit are near end of service life.

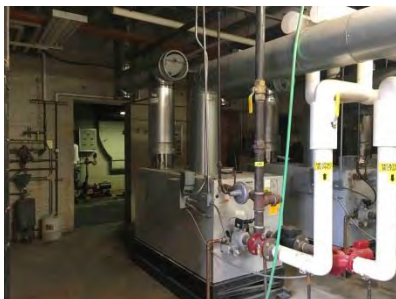
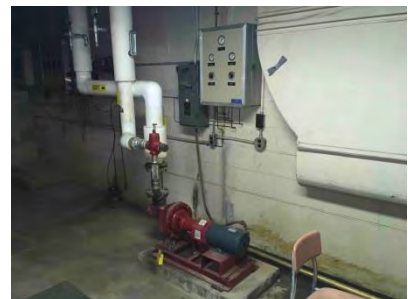
- (3) Lochinvar Copper-Fin heating hot water boilers, 1440 MBH input each, installed in 2000. The boilers appear to be in relatively good condition.
- Heating hot water piping insulation in good condition, some hot water pumps are newer.

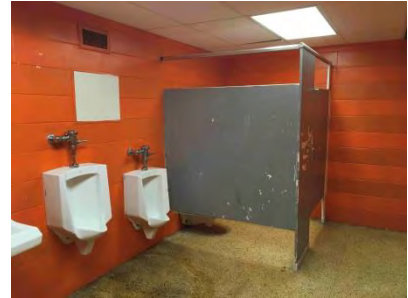
- Bathroom plumbing fixtures are in poor condition and may need to be replaced.

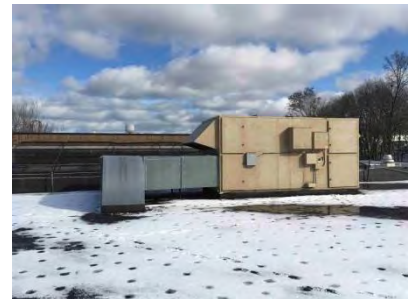
- (1) Trane rooftop mounted DX heating and cooling units, appear to be old and beyond service life.
- Rooftop mounted ductwork is rusted and degrading.
- (1) American Energy Exchange heat recovery rooftop unit appears to be in average condition and newer than Trane unit.
- (1) small Trane RTU installed 2015 in good condition.
- Some horizontal unit ventilators that appear to be in poor condition.

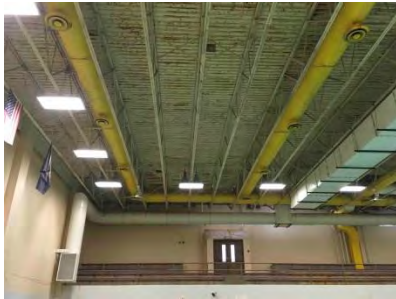
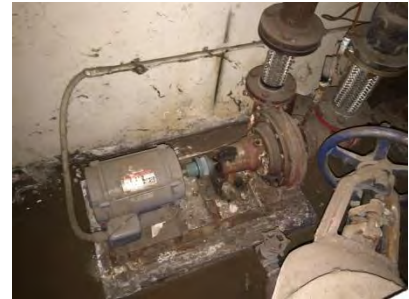
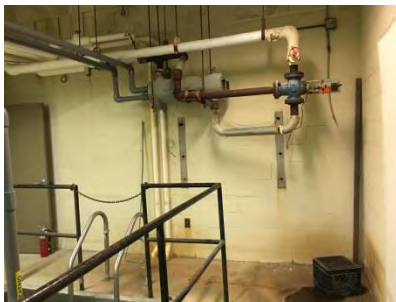
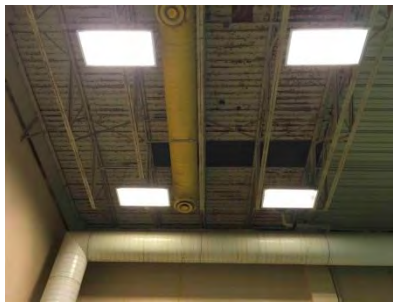
- Duct cable supports are rusted and need to be replaced
- Ductwork shows some signs of corrosion but generally acceptable
- Dehumidification is needed to protect building structure from rust
- Hot water heat exchanger piping, insulation and control valve need to be replaced
- New sump pump needed for pool

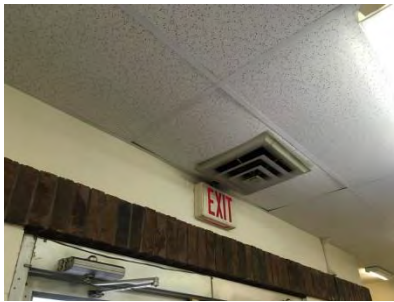
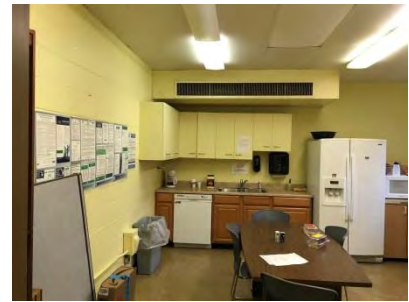
- Front entrance has old and dirty diffusers served by unknown equipment, likely FCU above ceiling or an RTU.
- Unit ventilators appear original to building and due for replacement. The unit ventilators location and sizing is not adequate for current building layout and usage.
- Building ventilation is inadequate. Some office spaces have little or no airflow.
- Kitchen area has large cabinet unit heater and old exhaust hood. Kitchen smells very strong.

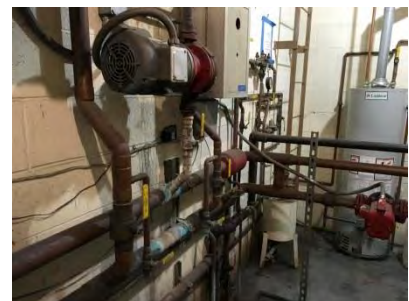
- (1) Lochinvar Heating Hot Water Boiler, 745 MBH capacity, installed in 1994.
- Boiler room piping appears in good condition, no insulation on piping in boiler room.
- Some pump casings are very rusted and old.
- There is a sign for asbestos in the boiler room.

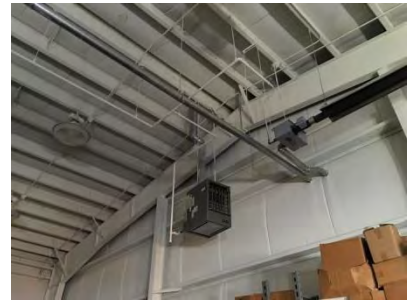
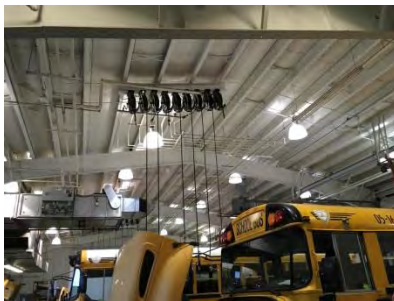
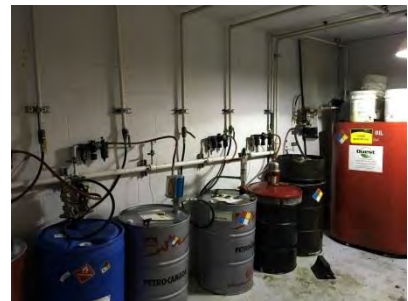
- Bus garage systems appear to be in good condition including vehicle exhaust system, makeup air units with energy recovery and hose reels.
- RTU on grade serves office area installed in 2003 and may be due for replacement in the near future.
