UNOCCUPIED BUILDINGS

2017 Facility Assessment

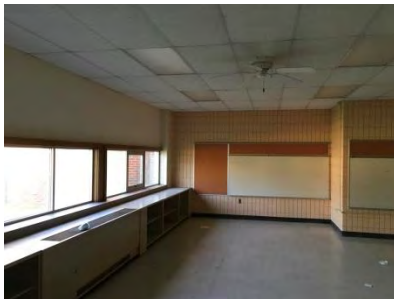
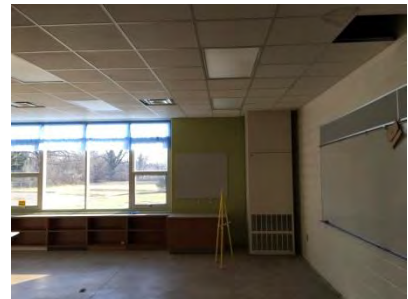
Building Systems

- Gym has a Heating and Vent unit with new smoke detectors. Unit is old, but externally appears in good condition.
- Misc. Fin Tube at perimeter walls
- Most classrooms have Trane horizontal unit ventilators (old) that have their front panels removed, and are beyond expected service life.
- Heating distribution piping routed thru tunnels, assumed to be original to building.
- Newer 2 classroom addition with Vertical Unit Ventilators in good condition.

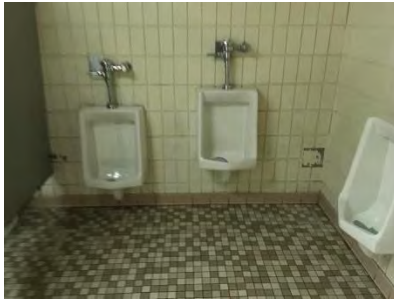
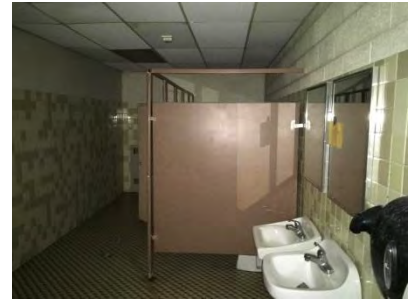
Plumbing Fixtures

- Bathroom fixtures in general appear to be average condition. Some flush valves are missing.

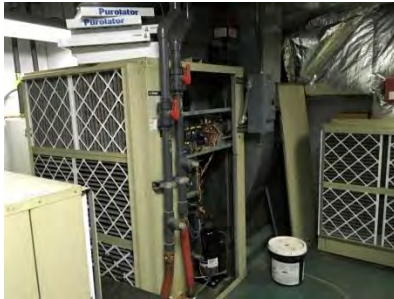
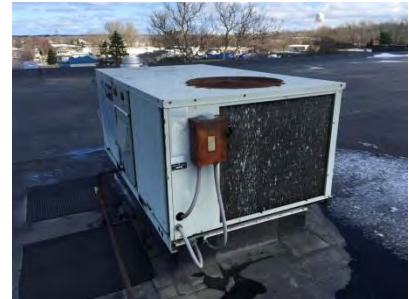
Building Systems

- Perimeter fin tube in average condition.
- (1) Trane RTU appears old and due for replacement.
- (1) Trane RTU mounted on grade, installed in 2002 and near end of service life.
- Several Trane furnace units appear to be in average condition, mechanical room is used as return air plenum for units

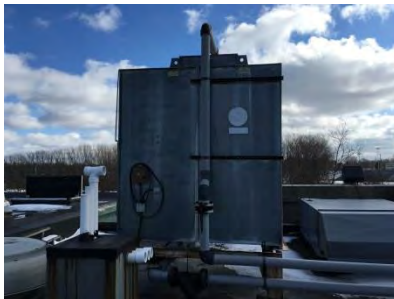
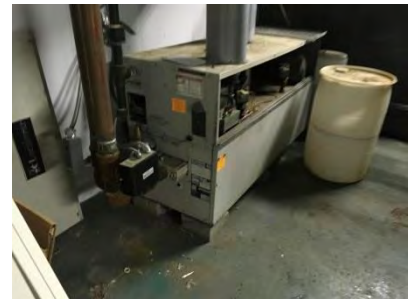
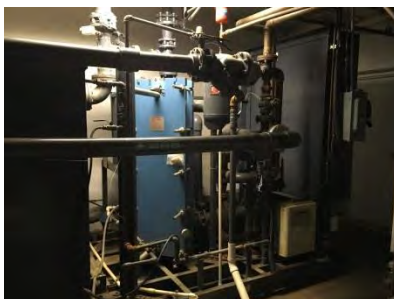
Central Plant Systems

- (1) Lochinvar heating hot water boiler, 750 MBH capacity, installed in 1991. Boiler is near end of service life.
- Systecon packaged chilled water skid with heat exchanger and pumps. Appears to be in average condition, piping is uninsulated.
- (1) Roof mounted BAC cooling tower appears old and near end of service life.

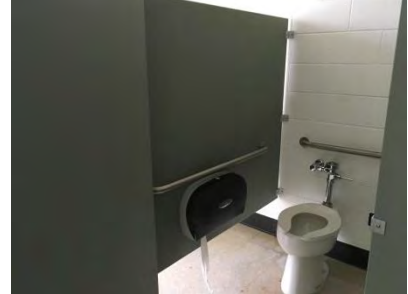
Plumbing Fixtures

- Most fixtures appear to be in average condition and in need of some repair.

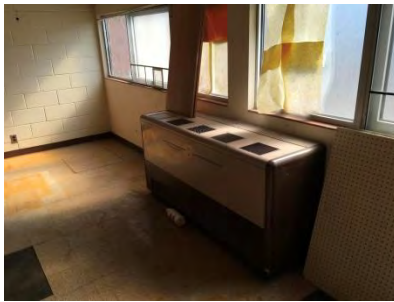
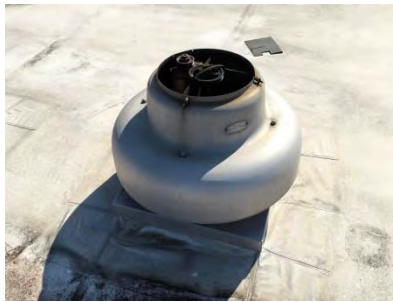
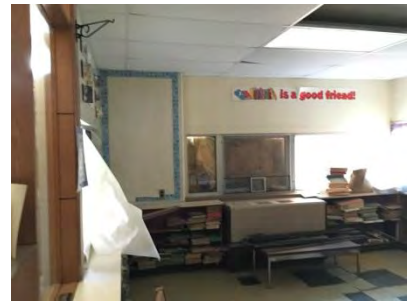
Building Systems

- Classrooms have horizontal unit ventilators that appear to be original, very old and poor condition. They are well beyond expected service life.
- Gym has fin tube up high along the windows
- (3) Existing rooftop exhaust fans, all need to be replaced.

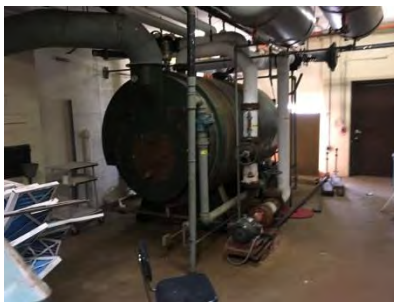
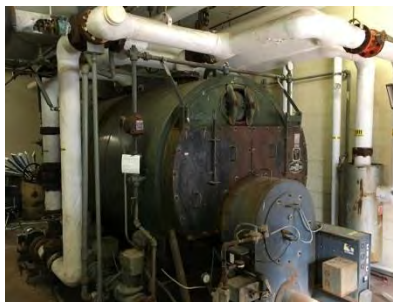
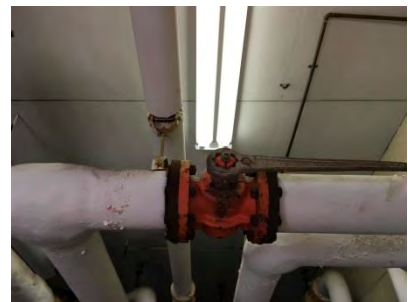
Central Plant Systems

- Boiler room has piping disconnected and missing.
- (1) Johnstone heating hot water boiler, 4,000 MBH capacity installed in 1971 and needs to be replaced.
- Heating distribution piping routed thru tunnels, assumed to be original to building.
- Piping and insulation is in average condition, many valves rusty.

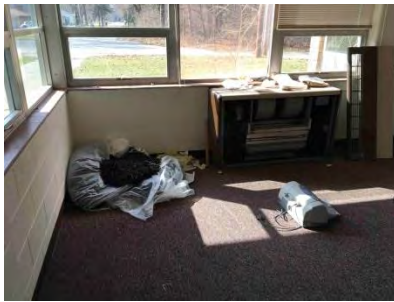
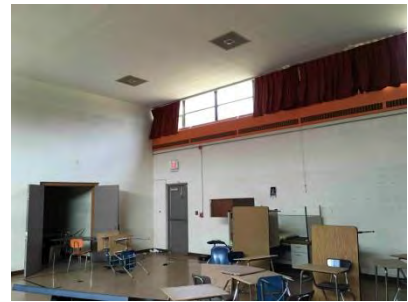
Building Systems

- Original horizontal unit ventilators in poor condition and well beyond expected service life. Units need to be replaced.
- Trane RTU installed in 2006 for office area, 2.5 Tons. Unit is near end of expected service life.
- Fin tube high along gym wall windows
- (4) Rooftop exhaust fans from 2006 and older.

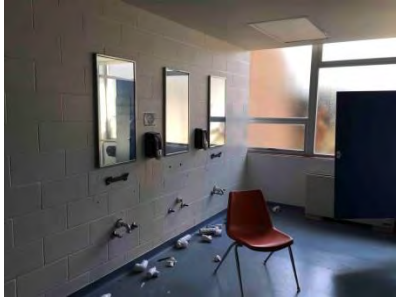
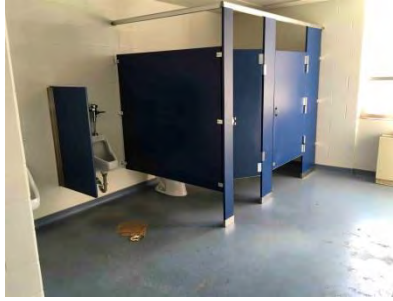
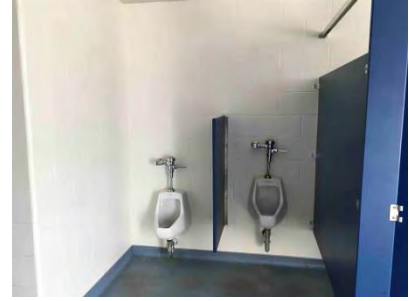
- Some bathroom fixtures removed and missing.
- Some fixtures newer and in good condition.
- Some flush valves removed and missing.

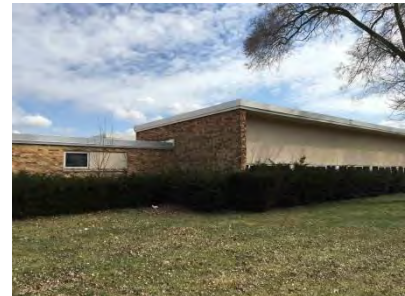
Building Envelope Assessment

- Masonry block exterior walls with brick veneer and sand stone at main entry. Sandstone is in good condition
- The bushes and vines along the front of the building are quite overgrown
- Brick exterior with EIFS infill panels above windows.
- EIFS panels are in need of some repair and recoated due to heavy staining
- Sealants at control joints and the perimeter of the windows need to be replaced
- The top portion of the brick chimney stack is deteriorated and repairs are needed
- Many windows are covered with plywood due to broken glass
- Doors are aluminum in good condition

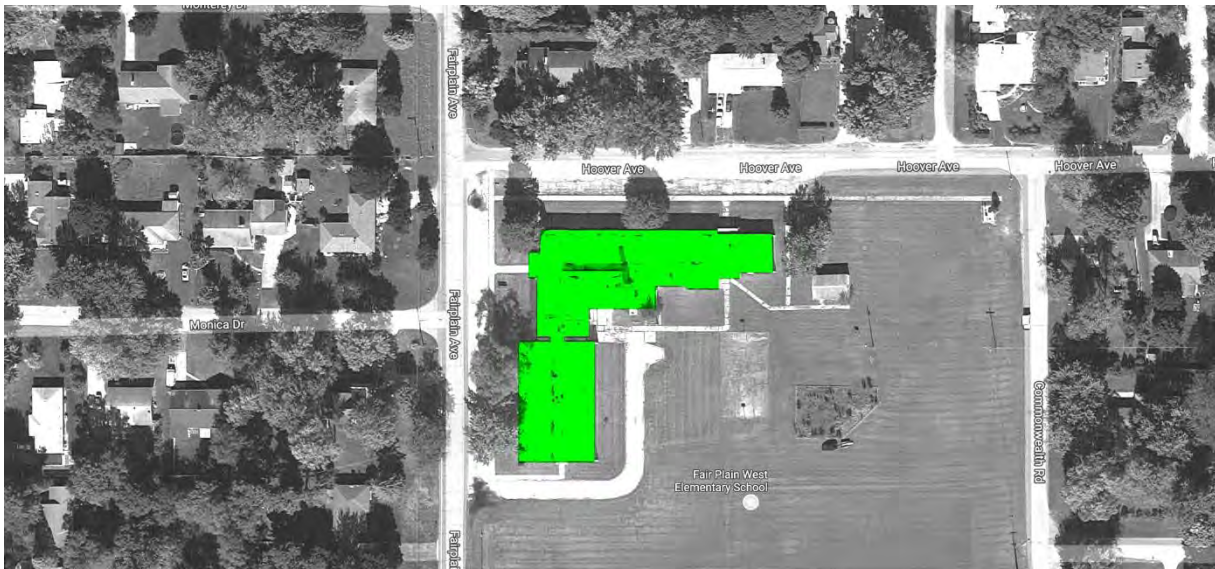
Roof Conditions & Anticipated Service Life Plan

- Approximate roof area of 27,500 SF
- Duro-Last white TPO membrane
- 2003 – 4,346 SF
- 2004 – 27,056 SF

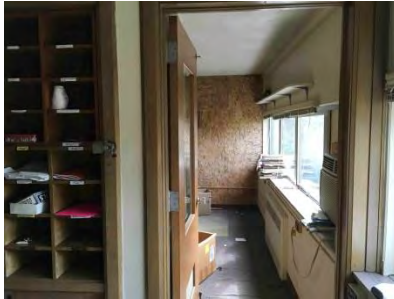
Building Systems

- Old horizontal unit ventilators that appear original to building are in poor condition and should be replaced.
- Gymnasium has old vertical heat/vent unit that is due to be replaced.

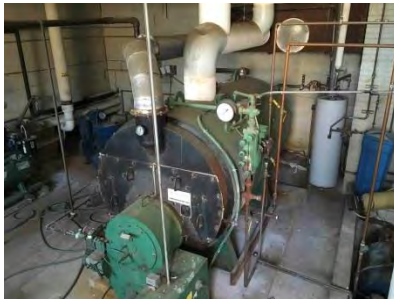
Central Plant Systems

- (1) Johnston steam boiler, 2,024 lbs/hr capacity, installed in 1986. Boiler is near end of service life.
- Steam distribution piping routed thru tunnels, assumed to be original to building.

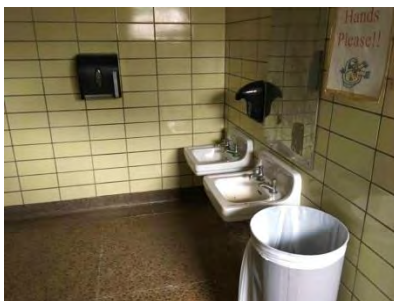
Plumbing Fixtures

- Most fixtures appear to be in poor condition and in need of some repair.

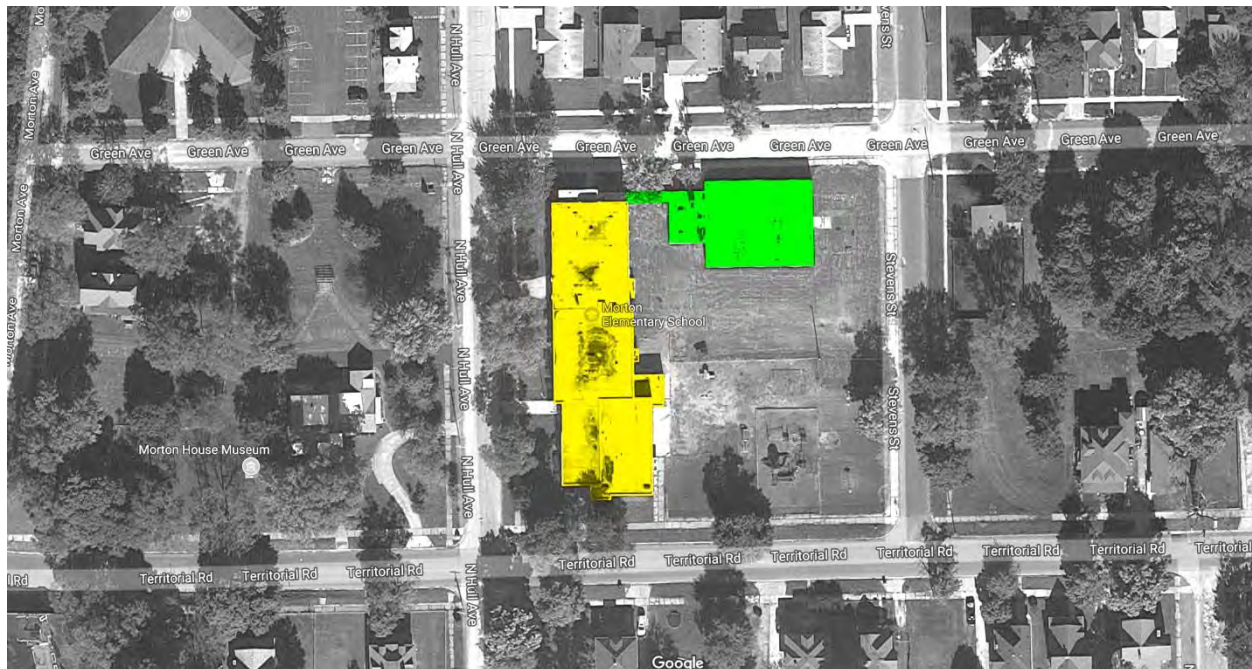
Roof Conditions & Anticipated Service Life Plan

- Approximately 23,000 SF
- Duro-Last white TPO membrane
- Approximately 8,000 SF installed in 2008

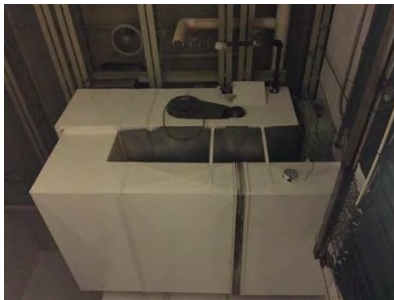
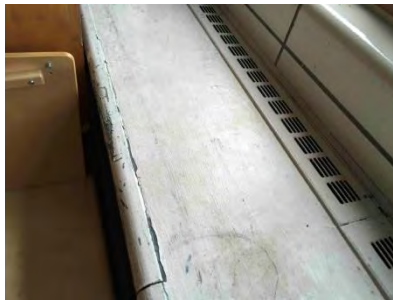
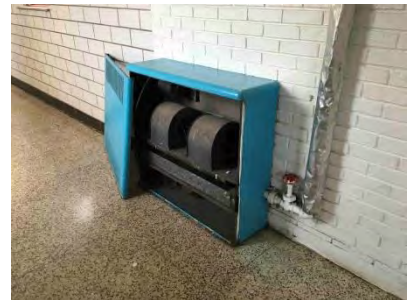
Building Systems

- Original horizontal unit ventilators are well beyond expected service life. Need to be replaced.
- Heating and ventilation units serve gymnasium are old and beyond expected service life.
- Steam radiators in stairwells and bathrooms

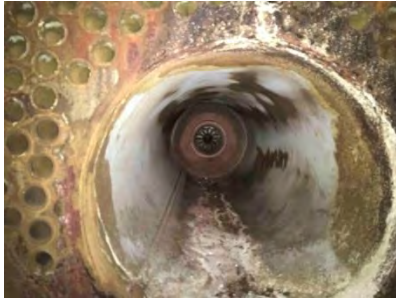
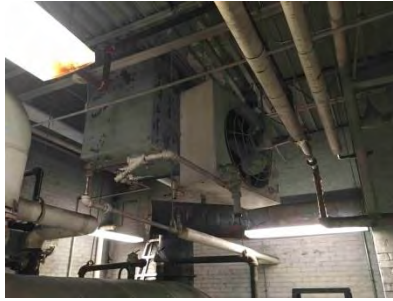
- Old basement boiler room appears to be abandoned.
- Current boiler room contains (1) Johnston steam boiler, that has front casing removed. Boiler tubes are visible and exposed. Boiler appears to serve a steam heating system with piping routed thru tunnels.
- Boiler has certificate of inspection from October 2016.
- Steam distribution piping routed thru tunnels, assumed to be original to building.

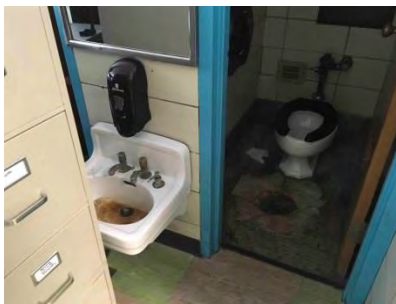
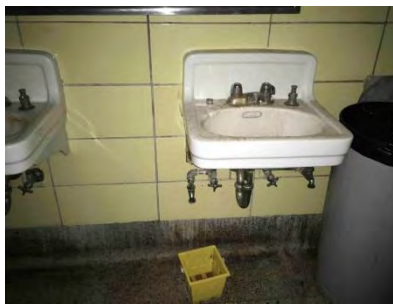
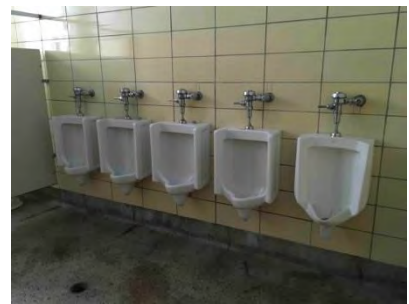
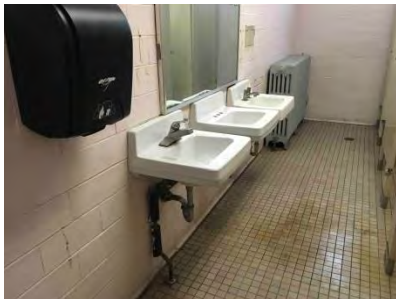
Plumbing Fixtures

- Bathroom fixtures old, in poor condition and need to be replaced.
- Some fixtures removed and missing.

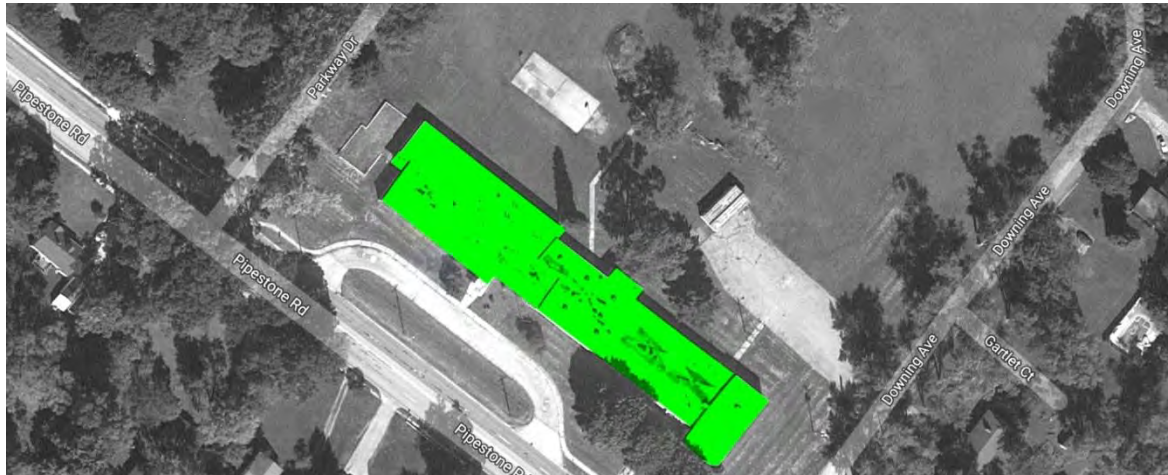
Roof Conditions & Anticipated Service Life Plan

- Approximately 25,000 SF total roof area
- Dura-Last white TPO membrane installed in 2007

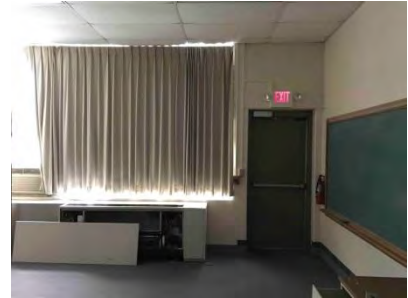
Building Systems

- Old horizontal unit ventilators, not original. Most front panels removed, some missing. Units need to be replaced.
- Large cabinet unit heaters serve the Gym.

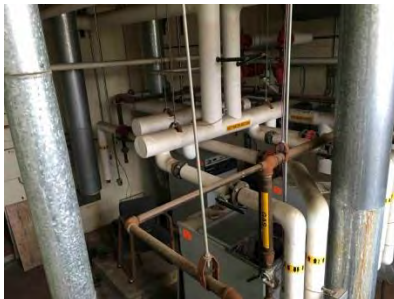
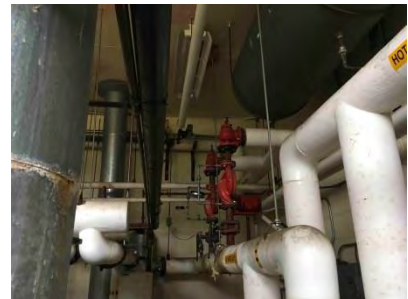
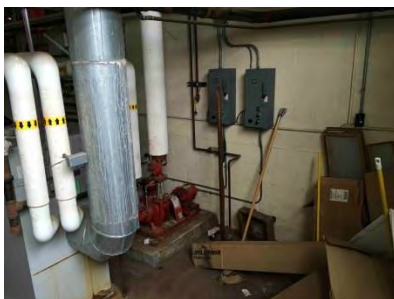
Central Plant Systems

- Original boiler room appears to be abandoned and heating piping in tunnels no longer used.
- Current boiler room includes (3) Lochinvar Powerfin heating hot water boilers, 750 MBH input, installed 1994.
- Appears that (1) boiler was removed, there is room and piping for (4) boilers.
- All heating hot water piping and insulation is new (1994?) and routed overhead thru classrooms with pipe drops down to horizontal unit ventilators and new valves.
- Piping and insulation in boiler room is in good condition, many valves are newer.

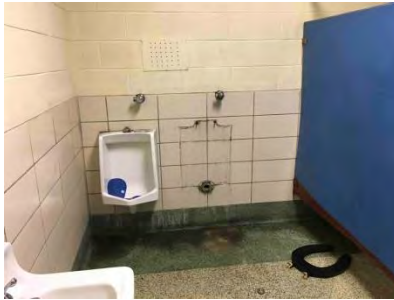
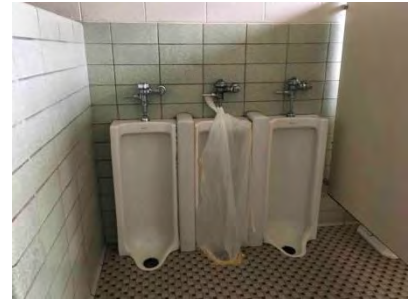
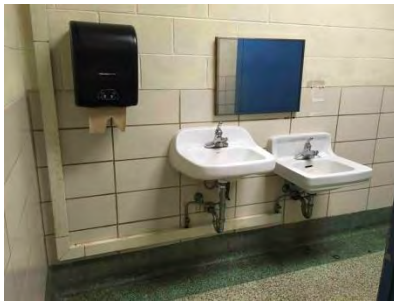
Plumbing Fixtures

- Bathroom fixtures are old and need to be replaced. Some have been removed and are missing. Some flush valves removed/missing.

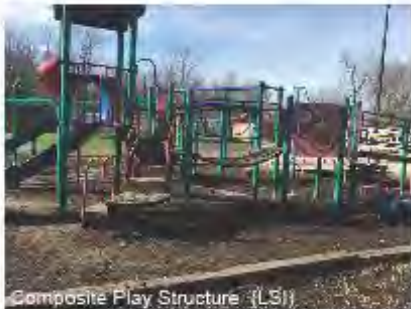
Composite Play Structure (LS)

ASTM F 1487, 4.1.1 Rusted Metal, Chipped Paint
ASTM F 1487, 9.2.1 Use Zone (less than 6'-0")
ASTM F 1487, 10.1.4 Accessibility (tripping)
ASTM F 1487, 13.1 Maintenance (broken equipment)
ASTM F 1487, 13.2.1 Maintenance - Play Surfacing

General Findings: Insufficient safety surfacing. Provide and maintain safety surfacing to proper depth. Consider underdrainage to alleviate wet areas. Touch up paint all areas of chipped or worn paint. Adjust border near transfer point/stair and block climber to achieve 6'-0" use zone.

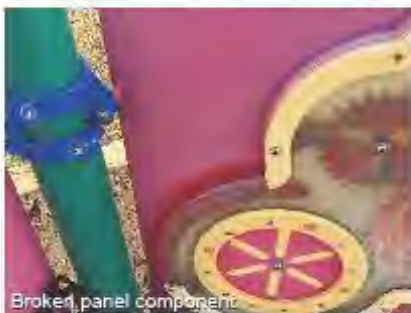
Broken panel component

ASTM F 1487, 13.1 Maintenance (broken equipment)

Recommendations: Monitor equipment for any sharp edges, replace when budget allows.

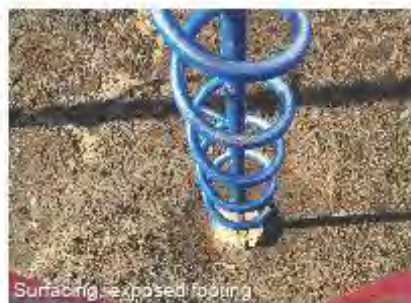
Surfacing: exposed footing

ASTM F 1487, 13.2.1 Maintenance - Play Surfacing

Recommendations: Inadequate surfacing on entire playground. Several areas of exposed concrete footing. Provide and maintain safety surfacing to proper depth.

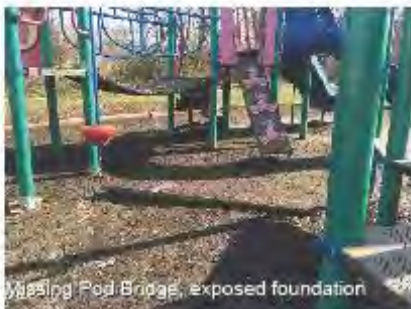
Wobbling Pod Bridge, exposed foundation

ASTM F 1487, 10.1.4 Accessibility (tripping)
ASTM F 1487, 13.1 Maintenance (broken equipment)
ASTM F 1487, 13.2.1 Maintenance - Play Surfacing

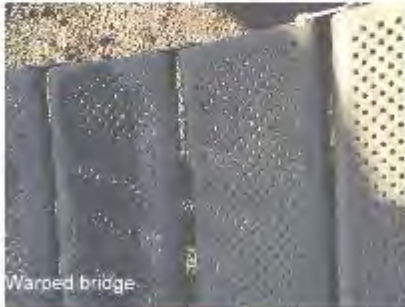
ASTM F 1487, 13.1 Maintenance (warped equipment)

Recommendations: Monitor equipment for increased gaps to avoid tripping and crush/shear, replace when budget allows.

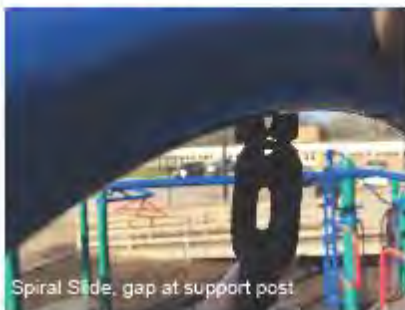
AASIM F 1487, 13.1 Maintenance (wearing equipment)

Recommendations: Monitor equipment for chain wear, replace when budget allows.

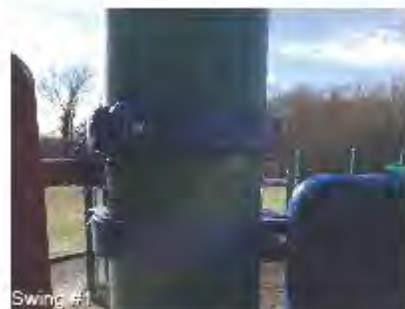
ASTM F 1487, 12.1 Structural Integrity

Recommendations: Consult manufacturer on missing collar pins and replace as needed.

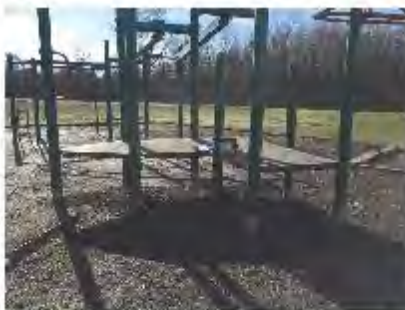
ASTM F 1487 7.1 Accessible Routes to play

ASTM F 1487, 13.1 Maintenance (broken equipment)

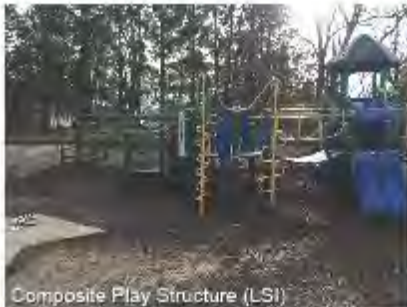
ASTM F 1487, 4.1.1 Rusted Metal , Chipped Paint
ASTM F 1487, 6.3 Protrusions
ASTM F 1487, 10.1.4 Accessibility (tripping, exposed rock/concrete)
ASTM F 1487, 13.1 Maintenance (broken equipment)
ASTM F 1487, 13.2.1 Maintenance - Play Surfacing

General Findings: Insufficient safety surfacing. Provide and maintain safety surfacing to proper depth. Touch up paint all areas of chipped or worn paint. Replace all rusted hardware that appears to serve a structural purpose or may cause injury due to rough or sharp edges. Replace all missing hand hold panels or missing barriers. Adjust safety surface depth at slide discharge points to bring the height from discharge to appropriate heights. Cut off any protruding bolts to less than 2 threads. Replace damaged equipment.

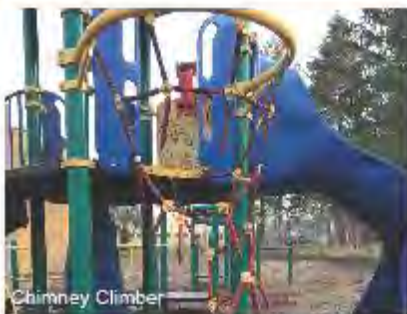
ASTM F 1487, 13.1 Maintenance (broken equipment)

Recommendations: Install temporary barrier to prohibit access until climber can be replaced.

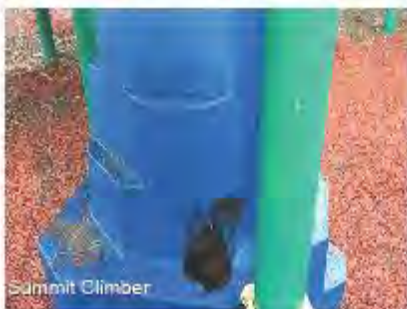
ASTM F 1487, 13.1 Maintenance (broken equipment)

Recommendations: Remove debris from hole to prevent bees and other nuisances until climber can be replaced.

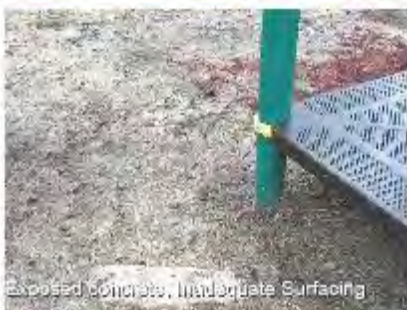
ASTM F 1487, 13.2.1 Maintenance - Play Surfacing

Recommendations: Provide and maintain safety surfacing to proper depth. Consideration should be given to the excavation and removal of debris/rock within play use zones.

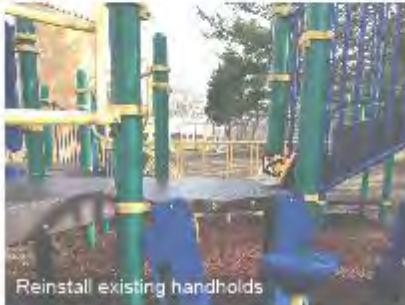
ASTM F 1487, 7.4.2 Transition from access to platform
ASTM F 1487, 7.5.5.2 Maximum clear opening

Recommendations: Reinstall existing handhold panels.

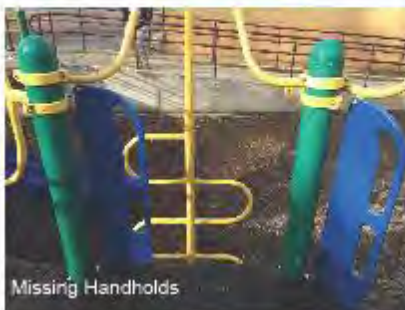
ASTM F 1487, 7.4.2 Transition from access to platform
ASTM F 1487, 7.5.5.2 Maximum clear opening

Recommendations: Replace missing handhold panel.

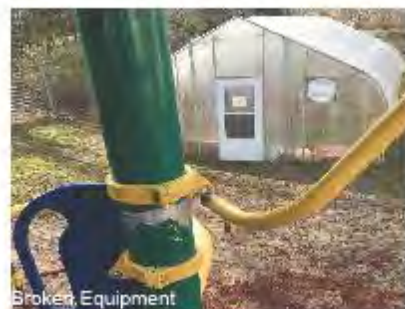
ASTM F 1487, 13.1 Maintenance (broken equipment)

Recommendations: Install temporary barrier to prohibit access until climber can be replaced.

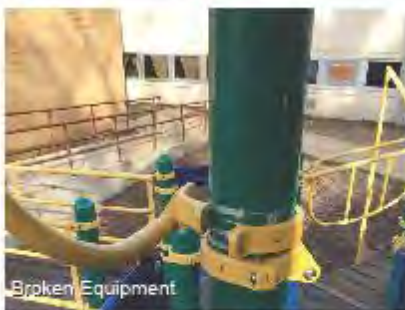
ASTM F 1487, 13.1 Maintenance (broken equipment)

Recommendations: Install temporary barrier to prohibit access until climber can be replaced.

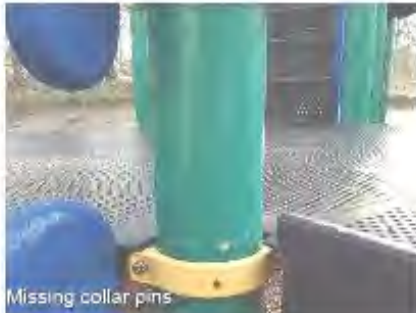
Missing collar pins

ASTM F 1487, 12.1 Structural Integrity

Recommendations: Consult manufacturer on missing collar pins and replace as needed.

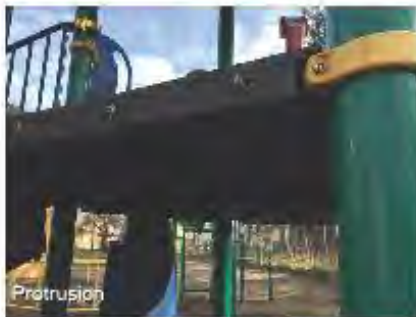
Protrusion

ASTM F 1487, 6.3 Protrusions

ASTM F 1487, 6.4.4 Entanglement

Recommendations: Exposed bolts are protrusions and entanglement hazards. Replace washer and cut bolt end down with no more than 2+ threads exposed.

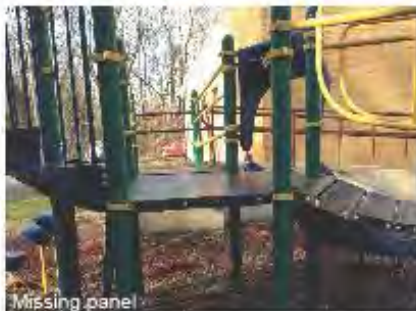
Missing panel

ASTM F 1487, 7.4.4.1 Inadequate barrier
