BROWNELL STEM ACADEMY

Outlet Sampling and Plumbing Assessment Recommendations

6302 Oxley Drive, Flint, Michigan 48504

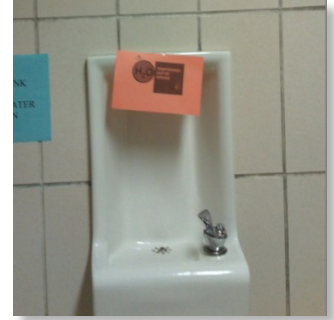
Outlet: Bubblers Drinking Fountain (DW001)

Location: North Hallway, across from Classroom 12
Results: P1=64 parts per billion, P2=4 parts per billion
F01=2 parts per billion, F02=non-detect

These results suggest the highest contribution of lead may be from the bubbler itself. This bubbler fixture is made of chrome plated brass with a brass connection on the underside of the unit. The connection piping to the unit also contains some brass components, including brass fittings and a brass valve.

Replacement of this bubbler tap and its connection plumbing with lead free materials will significantly reduce lead exposure at this location. If replacement is not currently feasible, sample results indicate that flushing this tap for three minutes following periods of stagnation is likely to reduce lead concentrations and lead exposure.

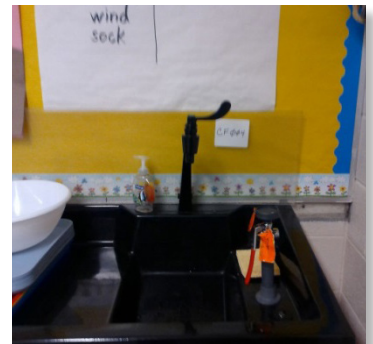
Outlet: Laboratory Sink Faucet, Right (CF004)

Location: Classroom 17, west wall
Results: P1=56 parts per billion, P2=29 parts per billion,
F01=7 parts per billion, F02=3 parts per billion

These results suggest the highest contribution of lead may be from the faucet and its connecting plumbing. This faucet appears to be constructed of coated brass. Connecting plumbing for this faucet was not accessible, but should be checked for additional lead containing components, including brass fittings and a brass valve.

Replacement of this faucet and its connection plumbing with lead free materials will significantly reduce lead exposure at this location. If replacement is not currently feasible, sample results indicate that flushing this tap for three minutes following periods of stagnation is likely to reduce lead concentrations and lead exposure.

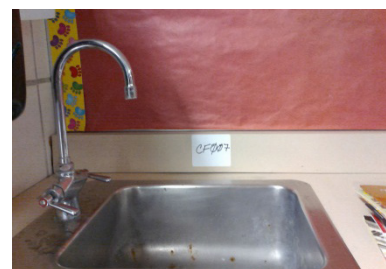
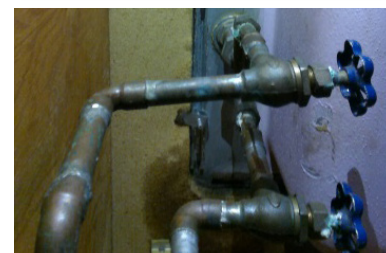
Outlet: Sink Faucet, Left (CF007)

Location: Classroom 26, south wall

Results: P1=164 parts per billion, P2=166 parts per billion,
F01=15 parts per billion, F02=1 part per billion

These results suggest the highest contribution of lead may be from the faucet and its connecting plumbing. The base of this faucet is chrome plated brass, and has a brass connection on the underside of the sink. Hot and cold water lines connect to this faucet with a brass mixer fitting under the sink. Connecting plumbing in the cabinet under the sink is copper piping with lead solder and contains additional brass components and brass shutoff valves.

Copper results for samples P1 and P2 at this location were also at levels above which the DEQ recommends school facilities take action. Copper results suggest these same brass components are contributing to this condition.

Replacement of this faucet and its connection plumbing with lead free materials will significantly reduce lead and copper exposure at this location. If replacement is not currently feasible, sample results indicate that flushing this tap for three minutes following periods of stagnation is likely to reduce lead concentrations and lead exposure.

This faucet also has an aerator/screen at the outlet. If the faucet is not replaced, the aerator/screen should be removed, inspected for particulate accumulations, scrubbed clean, and reinstalled. If particulates are found, the aerator/screen should be periodically checked and cleaned.

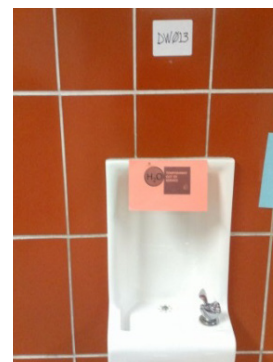
Outlet: Bubbler Drinking Fountain, Left (DW013)

Location: West Wing South Hallway, between Classrooms 1 and 2

Results: P1=27 parts per billion, P2=15 parts per billion,
F01=8 parts per billion, F02=2 parts per billion

These results suggest the highest contribution of lead may be from the bubbler itself. This bubbler fixture is made of chrome plated brass with a brass connection on the underside of the unit. The connection piping to the unit also contains some brass components, including brass fittings and a brass valve.

Replacement of this bubbler tap and its connection plumbing with lead-free materials will significantly reduce lead exposure at this location. If replacement is not currently feasible, sample results indicate that flushing this tap for three minutes following periods of stagnation is likely to reduce lead concentrations and lead exposure.

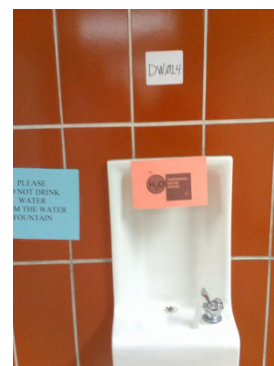
Outlet: Bubbler Drinking Fountain, Right (DW014)

Location: West Wing South Hallway, between Classrooms 1 and 2

Results: P1=16 parts per billion, P2=3 parts per billion,
F01=2 parts per billion, F02=1 part per billion

These results suggest the highest contribution of lead may be from the bubbler itself. This bubbler fixture is made of chrome plated brass with a brass connection on the underside of the unit. The connection piping to the unit also contains some brass components, including brass fittings and a brass valve.

Replacement of this bubbler tap and its connection plumbing with lead-free materials will significantly reduce lead exposure at this location. If replacement is not currently feasible, sample results indicate that flushing this tap for three minutes following periods of stagnation is likely to reduce lead concentrations and lead exposure.

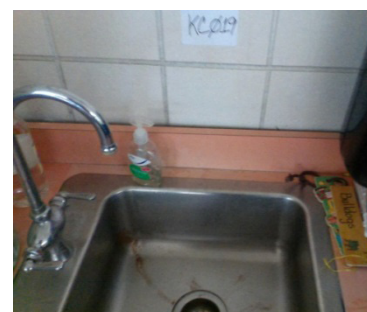
Outlet: Sink Faucet (KC019)

Location: Classroom 4, east wall

Results: P1=16 parts per billion, P2=10 parts per billion,
F01=non-detect, F02=non-detect

These results suggest the highest contribution of lead may be from the faucet and its connecting plumbing. The base of this faucet is chrome plated brass. Connecting plumbing for this faucet should be checked for additional lead containing components, including brass fittings and brass valves.

Replacement of this faucet and its connection plumbing with lead-free materials will significantly reduce lead exposure at this location. If replacement is not currently feasible, sample results indicate that flushing this tap for three minutes following periods of stagnation is likely to reduce lead concentrations and lead exposure.
