# HOLMES STEM ACADEMY

Outlet Sampling and Plumbing Assessment Recommendations

6602 Oxley Drive, Flint, Michigan 48504

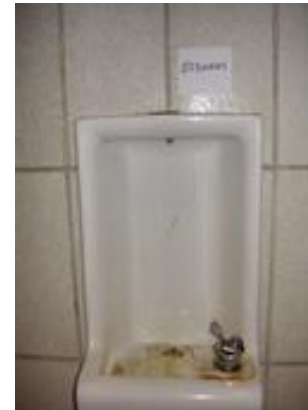
### Outlet: Bubbler Fountain (01DW001)

Location: Boys Locker Room, North Wall

Results: P1= 17 parts per billion, P2= 12 parts per billion  
F01= 5 parts per billion, F02=5 parts per billion

These results suggest the highest contribution of lead may be from the bubbler itself. The bubbler is chrome-plated brass. The connecting piping to the unit also contains some brass components, including brass fittings and a brass valve.

Replacement of this bubbler and its connecting plumbing with lead-free materials will significantly reduce lead exposure at this location. If replacement is not currently feasible, sample results indicate that flushing this tap for three minutes following periods of stagnation is likely to reduce lead concentrations and lead exposure.

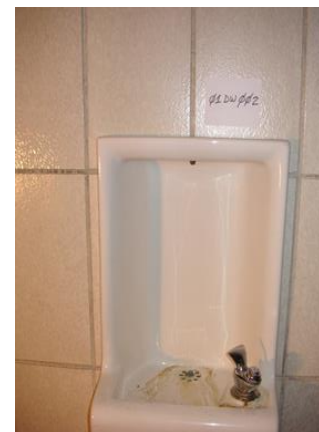
### Outlet: Bubbler Fountain (01DW002)

Location: Girls Locker Room, South Wall

Results: P1= 18 parts per billion, P2=9 parts per billion  
F01=9 parts per billion, F02=4 parts per billion

These results suggest the highest contribution of lead may be from the bubbler itself. The bubbler is chrome-plated brass. The connecting piping to the unit also contains some brass components, including brass fittings and a brass valve.

Replacement of this bubbler and its connecting plumbing with lead-free materials will significantly reduce lead exposure at this location. If replacement is not currently feasible, sample results indicate that flushing this tap for three minutes following periods of stagnation is likely to reduce lead concentrations and lead exposure.

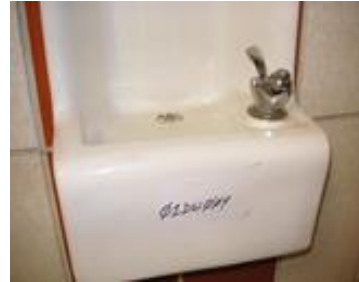
**Outlet: Bubbler Fountain (01DW004)**

Location: Hallway Across from Girls Locker Room, West Side

Results: P1=16 parts per billion, P2=4 parts per billion,  
F01=3 parts per billion, F02=2 parts per billion

These results suggest the highest contribution of lead may be from the bubbler itself. The bubbler is chrome-plated brass. The connecting piping to the unit also contains some brass components, including brass fittings and a brass valve.

Replacement of this bubbler and its connecting plumbing with lead-free materials will significantly reduce lead exposure at this location. If replacement is not currently feasible, sample results indicate that flushing this tap for three minutes following periods of stagnation is likely to reduce lead concentrations and lead exposure.

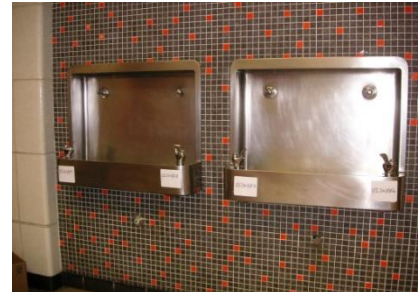
**Outlet: Bubbler Fountains (01DW006, 01DW007, 01DW008, 01DW009)**

Location: Cafeteria, South Wall

Results: P1= 22 parts per billion, P2=20 parts per billion  
F01=5 parts per billion, F02=4 parts per billion

Results: P1=15 parts per billion, P2=5 parts per billion  
F01=4 parts per billion, F02=4 parts per billion

Results: P1=47 parts per billion, P2=8 parts per billion  
F01=6 parts per billion, F02=17 parts per billion

Results: P1=22 parts per billion, P2=16 parts per billion  
F01=13 parts per billion, F02=8 parts per billion

These results suggest that while the highest contribution of lead may be from the bubblers themselves, sample F02 for bubbler 01DW008 shows additional sources of lead deeper within the supply plumbing. The bubblers are all constructed of chrome-plated brass. Connecting plumbing contains brass connections, brass fittings, brass shut-off valves, and copper piping with lead solder.

Replacement of these bubblers and their connecting plumbing will significantly reduce lead exposure at this location. Further investigation of the supply plumbing in this area is also recommended. If investigation

and replacement is not currently feasible, **SHUT OFF THESE BUBBLER FOUNTAINS AND DO NOT USE FOR DRINKING OR COOKING.**

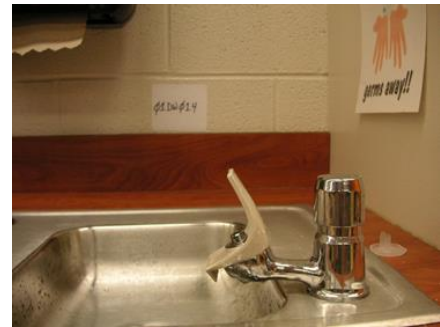
**Outlet: Bubbler Fountain (01DW014)**

Location: Room B109, West Wall

Results: P1=18 parts per billion, P2=2 parts per billion  
F01=non-detect, F02=non-detect

These results suggest the highest contribution of lead may be from the bubbler itself. The bubbler is constructed of chrome-plated brass, with a brass connection on the underside of the sink. The connecting piping to the unit also contains some brass fittings.

Replacement of this bubbler with lead-free materials will significantly reduce lead exposure at this location. If replacement is not currently feasible, sample results indicate that flushing this tap for three minutes following periods of stagnation is likely to reduce lead concentrations and lead exposure.

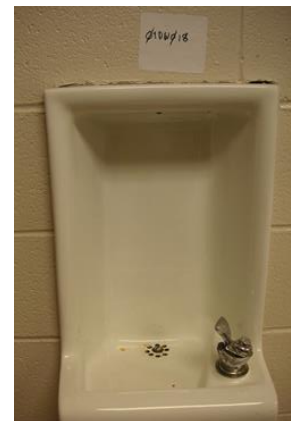
**Outlet: Bubbler Fountain (01DW018)**

Location: Room B102, North Side of Room

Results: P1=59 parts per billion, P2=35 parts per billion  
F01=20 parts per billion, F02=4 parts per billion

These results suggest the highest contribution of lead may be from the bubbler itself. The bubbler is chrome-plated brass. The connecting piping to the unit also contains some brass components, including brass fittings and a brass valve.

Replacement of this bubbler and its connecting plumbing with lead-free materials will significantly reduce lead exposure at this location. If replacement is not currently feasible, sample results indicate that flushing this tap for three minutes following periods of stagnation is likely to reduce lead concentrations and lead exposure.

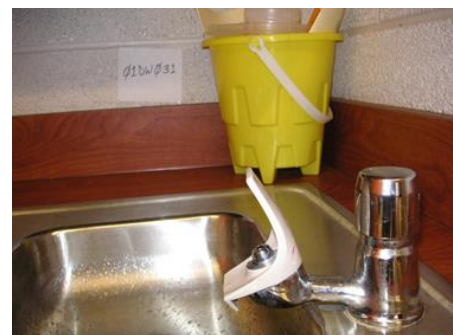
**Outlet: Bubbler Fountain (01DW31)**

Location: Community Room, West Wall

Results: P1=19 parts per billion, P2=77 parts per billion  
F01=4 parts per billion, F02=3 parts per billion

These results suggest the highest contribution of lead may be from the bubbler and its connecting plumbing. The bubbler is constructed of chrome-plated brass and has a brass connection on the underside of the sink.

Replacement of this bubbler and its connecting plumbing with lead-free materials will significantly reduce lead exposure at this location. If replacement is not currently feasible, sample results indicate that flushing this tap for three minutes following periods of stagnation is likely to reduce lead concentrations and lead exposure.

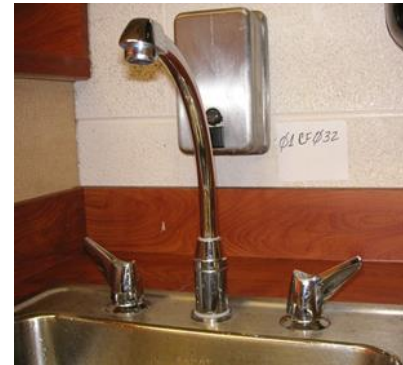
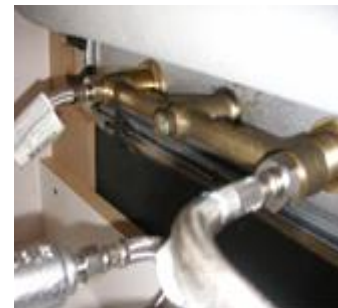
**Outlet: Classroom Faucet (01CF32)**

Location: Community Room, West Wall  
Results: P1=34 parts per billion, P2=15 parts per billion  
F01=4 parts per billion, F02=4 parts per billion

These results suggest the highest contribution of lead may be from the faucet and its connecting plumbing. This faucet is an Elkay model that contains a brass mixer fitting on the underside of the sink to connect hot and cold water lines.

Replacement of this faucet and its connecting plumbing with lead-free materials will significantly reduce lead exposure at this location. If replacement is not currently feasible, sample results indicate that flushing this tap for three minutes following periods of stagnation is likely to reduce lead concentrations and lead exposure.

This faucet also has an aerator/screen at the outlet. If the faucet is not replaced, the aerator/screen should be removed, inspected for particulate accumulations, scrubbed clean, and reinstalled. If particulates are found, the aerator/screen should be periodically checked and cleaned.

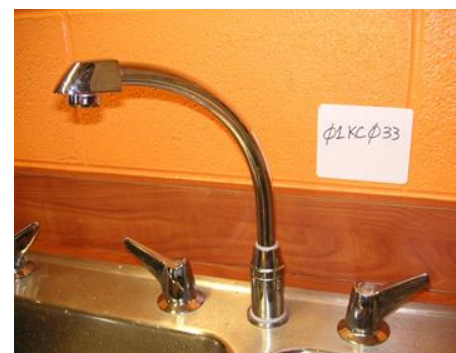
**Outlet: Kitchen Faucet (01KC033)**

Location: Community Room, South Wall  
Results: P1= 700 parts per billion, P2=181 parts per billion  
F01=10 parts per billion, F02=2 parts per billion

These results suggest the highest contribution of lead may be from the faucet and its connecting plumbing. This faucet is an Elkay model, with a brass mixer fitting on the underside of the sink to connect hot and cold water lines.

Copper results for sample P2 at this location were also at levels above which the DEQ recommends school facilities take action. Copper results suggest these same brass components are contributing to this condition.

Replacement of this faucet and its connection plumbing with lead-free materials will significantly reduce lead and copper exposure at this location. If replacement is not currently feasible, sample results indicate

that flushing this tap for three minutes following periods of stagnation is likely to reduce lead concentrations and lead exposure.

This faucet also has an aerator/screen at the outlet. If the faucet is not replaced, the aerator/screen should be removed, inspected for particulate accumulations, scrubbed clean, and reinstalled. If particulates are found, the aerator/screen should be periodically checked and cleaned.

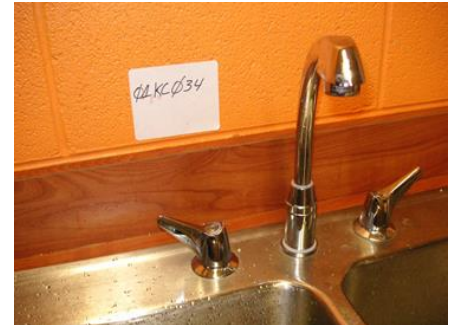
#### **Outlet: Kitchen Faucet (01KC34)**

Location: Community Room, South Wall  
Results: P1=21 parts per billion, P2=10 parts per billion  
F01=3 parts per billion, F02=1 part per billion

These results suggest the highest contribution of lead may be from the faucet and its connecting plumbing. This faucet is an Elkay model, with a brass mixer fitting on the underside of the sink to connect hot and cold water lines.

Replacement of this faucet and its connecting plumbing with lead-free materials will significantly reduce lead exposure at this location. If replacement is not currently feasible, sample results indicate that flushing this tap for three minutes following periods of stagnation is likely to reduce lead concentrations and lead exposure.

This faucet also has an aerator/screen at the outlet. If the faucet is not replaced, the aerator/screen should be removed, inspected for particulate accumulations, scrubbed clean, and reinstalled. If particulates are found, the aerator/screen should be periodically checked and cleaned.

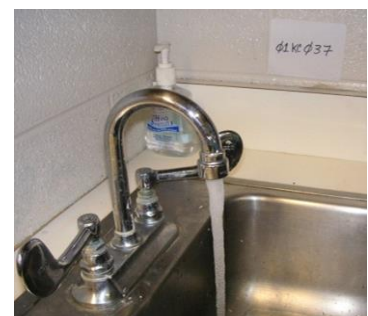
#### **Outlet: Kitchen Faucet (01KC037)**

Location: Supply Room, North of Community Room, East Wall  
Results: P1= 32 parts per billion, P2=31 parts per billion  
F01=8 parts per billion, F02=2 parts per billion

These results suggest the highest contribution of lead may be from the faucet and its connecting plumbing. The connecting piping to the unit also contains some brass components.

Replacement of this faucet and its connecting plumbing with lead-free materials will significantly reduce lead exposure at this location. If replacement is not currently feasible, sample results indicate that flushing this tap for three minutes following periods of stagnation is likely to reduce lead concentrations and lead exposure.

This faucet also has an aerator/screen at the outlet. If the faucet is not replaced, the aerator/screen should be removed, inspected for particulate accumulations, scrubbed clean, and reinstalled. If particulates are found, the aerator/screen should be periodically checked and cleaned.

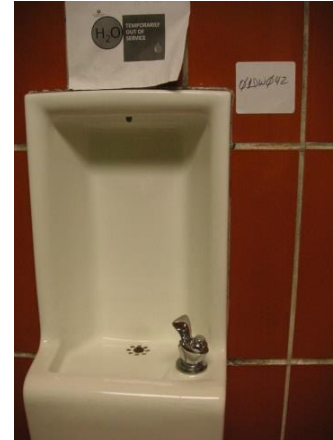
### **Outlet: Bubbler Fountain (01DW042)**

Location: Off of Green Hall, next to Boys Restroom  
Results: P1=24 parts per billion, P2=17 parts per billion  
F01=4 parts per billion, F02=3 parts per billion

These results suggest the highest contribution of lead may be from the bubbler itself. The bubbler is chrome-plated brass. The connecting piping to the unit also contains some brass components, including brass fittings and a brass valve.

Replacement of this bubbler and its connecting plumbing with lead-free materials will significantly reduce lead exposure at this location. If replacement is not currently feasible, sample results indicate that flushing this tap for three minutes following periods of stagnation is likely to reduce lead concentrations and lead exposure.

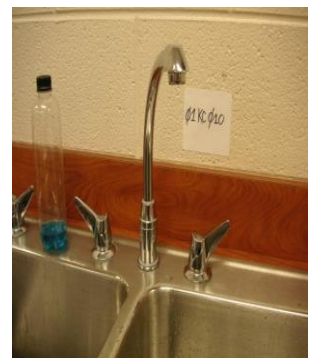
### **Outlet: Kitchen Faucet (01KC010)**

Location: Room B110, East Wall  
Results: P1=0.16 parts per million, P2=1.32 parts per million  
F01=0.09 parts per million, F02=0.07 parts per million

These results suggest the highest contribution of copper may be from the faucet and its connecting plumbing. This faucet is an Elkay model that contains a brass mixer fitting on the underside of the sink to connect hot and cold water lines. Copper results suggest these brass components are contributing to this condition.

Replacement of this faucet and its connecting plumbing is recommended and will reduce copper exposure at this location. If replacement is not currently feasible, sample results indicate that flushing this tap for

three minutes following periods of stagnation is likely to reduce copper concentrations and copper exposure.

This faucet also has an aerator/screen at the outlet. If the faucet is not replaced, the aerator/screen should be removed, inspected for particulate accumulations, scrubbed clean, and reinstalled. If particulates are found, the aerator/screen should be periodically checked and cleaned.

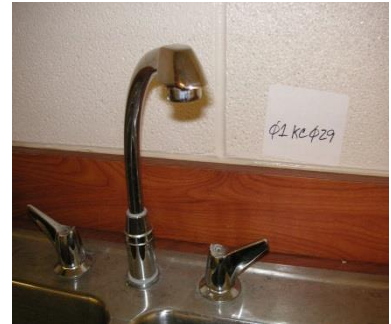
### **Outlet: Kitchen Faucet (01KC029)**

Location: Room B114, East Wall

Results: P1=0.13 parts per million, P2=1.66 parts per million

F01=0.10 parts per million, F02=non-detect

These results suggest the highest contribution of copper may be from the faucet and its connecting plumbing. This faucet is an Elkay model, with a brass mixer fitting on the underside of the sink to connect hot and cold water lines. Copper results suggest these brass components are contributing to this condition.

Replacement of this faucet and its connecting plumbing is recommended and will reduce copper exposure at this location. If replacement is not currently feasible, sample results indicate that flushing this tap for three minutes following periods of stagnation is likely to reduce copper concentrations and copper exposure.

This faucet also has an aerator/screen at the outlet. If the faucet is not replaced, the aerator/screen should be removed, inspected for particulate accumulations, scrubbed clean, and reinstalled. If particulates are found, the aerator/screen should be periodically checked and cleaned.
