EISENHOWER ELEMENTARY SCHOOL

Outlet Sampling and Plumbing Assessment Recommendations

1235 Pershing Street, Flint, Michigan 48503

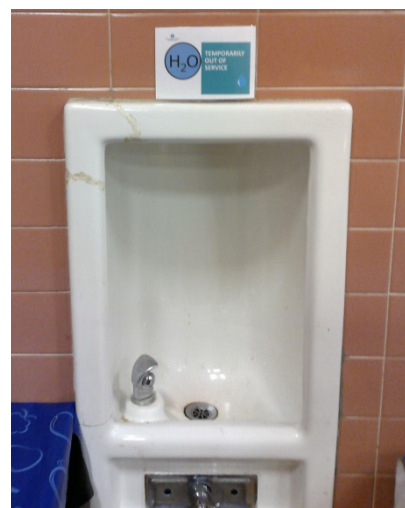
Outlet: Bubbler Drinking Fountain (01DW001)

Location: West corner, Gymnasium Multipurpose Room

Results: P1=32 parts per billion, P2=6 parts per billion
F01=5 parts per billion, F02=3 parts per billion

These results suggest the highest contribution of lead may be from the bubbler itself. This bubbler fixture is made of chrome plated brass and is believed to have a brass valve. The connection piping with the unit may also contain some brass components.

Replacement of this bubbler tap and its connection plumbing with lead-free materials will significantly reduce lead exposure at this location. If replacement is not currently feasible, sample results indicate that flushing this tap for 3 minutes following periods of stagnation is likely to reduce lead concentrations and lead exposure.

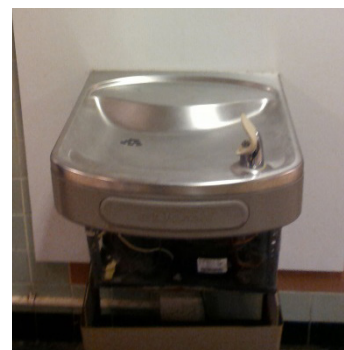
Outlet: Water Cooler Fountain (01WC002)

Location: Hallway between Gym and Auditorium, northeast side

Results: P1=17 parts per billion, P2=17 parts per billion

F01=12 parts per billion, F02=3 parts per billion

These results suggest the highest contribution of lead may be from the water cooler unit. The water cooler is an Elkay model LKEZFS8. This model contains some brass components. Connecting plumbing to the cooler unit may also contain brass components.

Replacement of the entire unit is recommended and will significantly reduce lead exposure at this location. If replacement is not currently feasible, sample results indicate that flushing this tap for 3 minutes following periods of stagnation is likely to reduce lead concentrations and lead exposure.

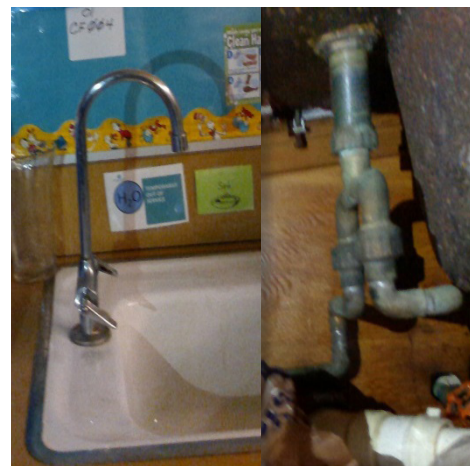
Outlet: Sink Faucet (01CF004)

Location: Classroom 109, northwest wall

Results: P1=17 parts per billion, P2=10 parts per billion

F01=1 part per billion, F02=2 parts per billion

These results suggest the highest contribution of lead may be from the faucet and its connecting plumbing. The base of this faucet is chrome plated brass, and has a brass connection on the underside of the sink. Hot and cold water lines connect to this faucet with a brass mixer fitting under the sink. Connecting plumbing in the cabinet under the sink may also contain additional brass components.

Replacement of this faucet and its connection plumbing with lead free materials will significantly reduce lead exposure at this location. If replacement is not currently feasible, sample results indicate that flushing this tap for 3 minutes following periods of stagnation is likely to reduce lead concentrations and lead exposure.

This faucet also has an aerator/screen at the outlet. If the faucet is not replaced, the aerator/screen should be removed, inspected for particulate accumulations, scrubbed clean, and reinstalled. If particulates are found, the aerator/screen should be periodically checked and cleaned.

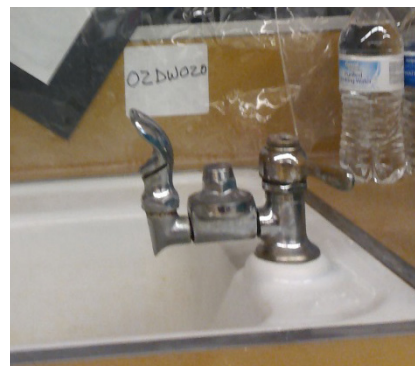
Outlet: Bubbler Fountain (02DW020)

Location: Classroom 201, southeast wall

Results: P1=37 parts per billion, P2=24 parts per billion

F01=2 parts per billion, F02=non-detect

These results suggest the highest contribution of lead may be from the bubbler and its connecting plumbing. This bubbler fixture is made of chrome plated brass and has a brass connector on the underside of the sink. The bubbler also has a chrome plated brass flow regulator installed between the operating valve and the outlet. The connecting plumbing is copper with lead solder and includes a brass shut off valve.

Replacement of this bubbler tap and its connection plumbing with lead-free materials will significantly reduce lead exposure at this location. If replacement is not currently feasible, sample results indicate that flushing this tap for 3 minutes following periods of stagnation is likely to reduce lead concentrations and lead exposure.

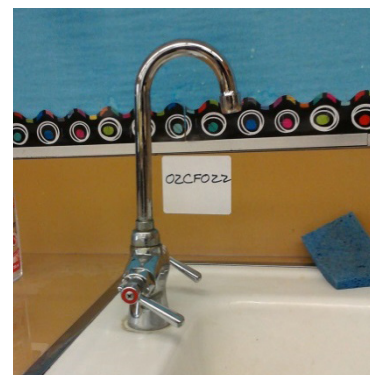
Outlet: Sink Faucet (02CF022)

Location: Classroom 202, northwest wall

Results: P1=7 parts per billion, P2=24 parts per billion

F01=2 parts per billion, F02=1 part per billion

These results suggest the highest contribution of lead may be from the faucet and its connecting plumbing. The base of this faucet is chrome plated brass, and has a brass connection on the underside of the sink. Connecting plumbing in the cabinet under the sink is made up of brass connectors; copper piping with lead solder and brass shut off valves.

Replacement of this faucet and its connection plumbing with lead free materials will significantly reduce lead exposure at this location. If replacement is not currently feasible, sample results indicate that flushing this tap for 3 minutes following periods of stagnation is likely to reduce lead concentrations and lead exposure.

This faucet also has an aerator/screen at the outlet. If the faucet is not replaced, the aerator/screen should be removed, inspected for particulate accumulations, scrubbed clean, and reinstalled. If particulates are found, the aerator/screen should be periodically checked and cleaned.

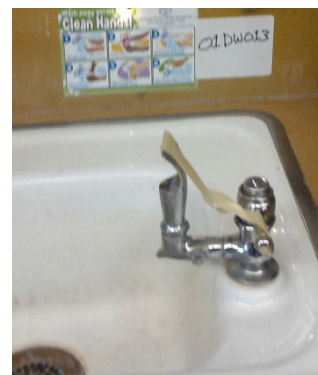
Outlet: Bubbler Fountain (01DW013)

Location: Classroom 104, southwest wall

Results: P1=43 parts per billion, P2=106 parts per billion

F01=3 parts per billion, F02=2 parts per billion

These results suggest the highest contribution of lead may be from the bubbler and its connecting plumbing. This bubbler fixture is made of chrome plated brass and has a brass connector on the underside of the sink. Connecting plumbing in the cabinet under the sink is made up of brass connectors; copper piping with lead solder, and a brass shut off valve.

Replacement of this bubbler tap and its connection plumbing with lead free materials will significantly reduce lead exposure at this location. If replacement is not currently feasible, sample results indicate that flushing this tap for 3 minutes following periods of stagnation is likely to reduce lead concentrations and lead exposure.

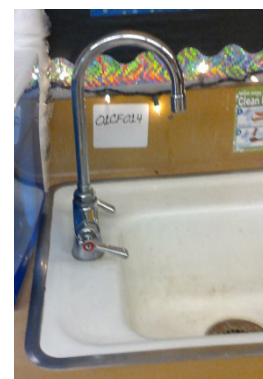
Outlet: Sink Faucet (01CF014)

Location: Classroom 104, southwest wall

Results: P1=36 parts per billion, P2=36 parts per billion

F01=2 parts per billion, F02=1 part per billion

These results suggest the highest contribution of lead may be from the faucet and its connecting plumbing. The base of this faucet is chrome plated brass, and has a brass connection on the underside of the sink. Connecting plumbing in the cabinet under the sink is made up of brass connectors; copper piping with lead solder and brass shut off valves.

Replacement of this faucet and its connection plumbing with lead free materials will significantly reduce lead exposure at this location. If replacement is not currently feasible, sample results indicate that flushing this tap for 3 minutes following periods of stagnation is likely to reduce lead concentrations and lead exposure.

This faucet also has an aerator/screen at the outlet. If the faucet is not replaced, the aerator/screen should be removed, inspected for particulate accumulations, scrubbed clean, and reinstalled. If particulates are found, the aerator/screen should be periodically checked and cleaned.

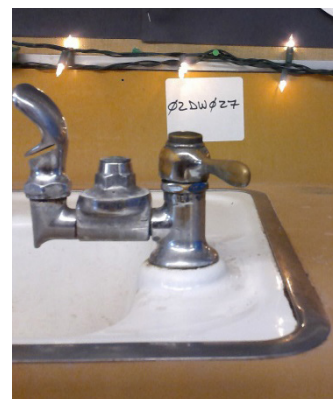
Outlet: Bubbler Fountain (02DW027)

Location: Classroom 204, southwest wall

Results: P1=18 parts per billion, P2=8 parts per billion

F01=2 parts per billion, F02=1 part per billion

These results suggest the highest contribution of lead may be from the bubbler and its connecting plumbing. This bubbler fixture is made of chrome plated brass and has a brass connector on the underside of the sink. The bubbler also has a chrome plated brass flow regulator installed between the operating valve and the outlet. The connecting plumbing is copper with lead solder and includes a brass shut off valve.

Replacement of this bubbler tap and its connection plumbing with lead free materials will significantly reduce lead exposure at this location. If replacement is not currently feasible, sample results indicate that flushing this tap for 3 minutes following periods of stagnation is likely to reduce lead concentrations and lead exposure.

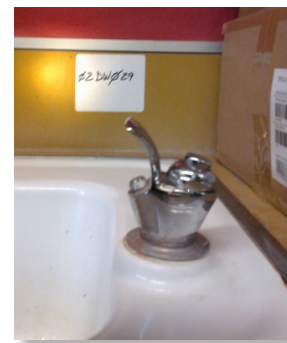
Outlet: Bubbler Fountain (02DW029)

Location: Classroom 205, northeast wall

Results: P1=39 parts per billion, P2=14 parts per billion

F01=11 parts per billion, F02=1 part per billion

These results suggest the highest contribution of lead may be from the bubbler and its connecting plumbing. This bubbler fixture is made of chrome plated brass and has a brass connector on the underside of the sink. Connecting plumbing in the cabinet under the sink is made up of brass connectors and copper piping with lead solder.

Replacement of this bubbler tap and its connection plumbing with lead free materials will significantly reduce lead exposure at this location. If replacement is not currently feasible, sample results indicate that flushing this tap for 3 minutes following periods of stagnation is likely to reduce lead concentrations and lead exposure.

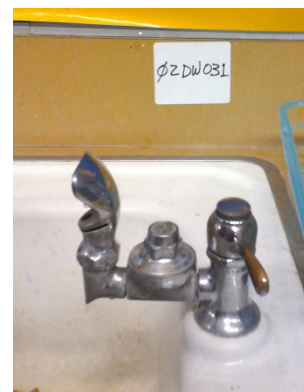
Outlet: Bubbler Fountain (02DW031)

Location: Classroom 206, southwest wall

Results: P1=84 parts per billion, P2=7 parts per billion

F01=1 part per billion, F02=non-detect

These results suggest the highest contribution of lead may be from the bubbler and its connecting plumbing. This bubbler fixture is made of chrome plated brass and has a brass connector on the underside of the sink. The bubbler also has a chrome plated brass flow regulator installed between the operating valve and the outlet. Connecting plumbing in the cabinet under the sink should be checked for brass components and copper piping with lead solder.

Replacement of this bubbler tap and its connection plumbing with lead free materials will significantly reduce lead exposure at this location. If replacement is not currently feasible, sample results indicate that flushing this tap for 3 minutes following periods of stagnation is likely to reduce lead concentrations and lead exposure.

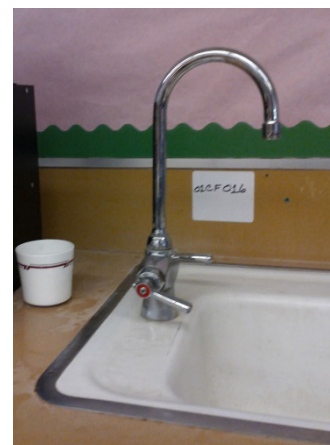
Outlet: Sink Faucet (01CF016)

Location: Classroom 106, northeast wall

Results: P1=402 parts per billion, P2=61 parts per billion

F01=4 parts per billion, F02=1 part per billion

These results suggest the highest contribution of lead may be from the faucet and its connecting plumbing. The base of this faucet is chrome plated brass, and has a brass connection on the underside of the sink. Connecting plumbing in the cabinet under the sink is partly made up of brass connectors; copper piping with lead solder, and brass shut off valves.

Replacement of this faucet and its connection plumbing with lead free materials will significantly reduce lead exposure at this location. If replacement is not currently feasible, sample results indicate that flushing this tap for 3 minutes following periods of stagnation is likely to reduce lead concentrations and lead exposure.

This faucet also has an aerator/screen at the outlet. If the faucet is not replaced, the aerator/screen should be removed, inspected for particulate accumulations, scrubbed clean, and reinstalled. If particulates are found, the aerator/screen should be periodically checked and cleaned.

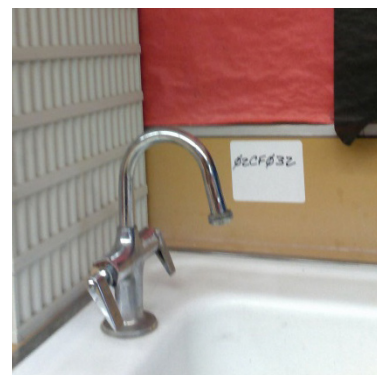
Outlet: Sink Faucet (02CF032)

Location: Classroom 207, northeast wall

Results: P1=21 parts per billion, P2=23 parts per billion

F01=5 parts per billion, F02=1 part per billion

These results suggest the highest contribution of lead may be from the faucet and its connecting plumbing. The base of this faucet is chrome plated brass, and has a brass connection on the underside of the sink. Connecting plumbing in the cabinet under the sink is partly made up of brass connectors; copper piping with lead solder, and brass shut off valves.

Replacement of this faucet and its connection plumbing with lead free materials will significantly reduce lead exposure at this location. If replacement is not currently feasible, sample results indicate that flushing this tap for 3 minutes following periods of stagnation is likely to reduce lead concentrations and lead exposure.

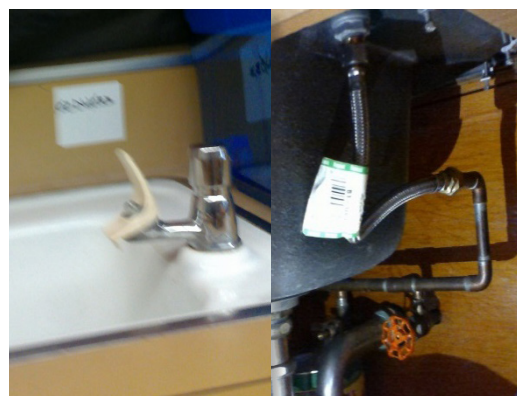
Outlet: Bubbler Fountain (02DW033)

Location: Classroom 207, northeast wall

Results: P1=20 parts per billion, P2=4 parts per billion

F01=3 parts per billion, F02=3 parts per billion

These results suggest the highest contribution of lead may be from the bubbler and its connecting plumbing. Parts of this bubbler fixture are made of brass and it has a brass connector on the underside of the sink. Connecting plumbing in the cabinet under the sink is partly made up of brass connectors; copper piping with lead solder, and a brass shut off valve.

Replacement of this bubbler tap and its connection plumbing with lead free materials will significantly reduce lead exposure at this location. If replacement is not currently feasible, sample results indicate that flushing this tap for 3 minutes following periods of stagnation is likely to reduce lead concentrations and lead exposure.

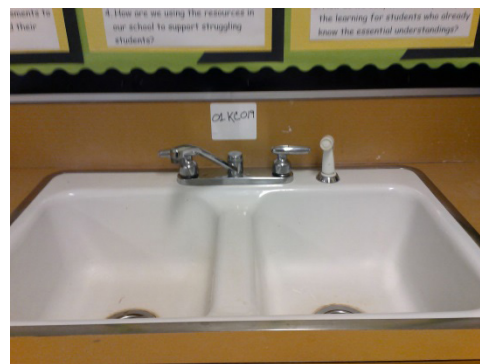
Outlet: Kitchen Faucet (01KC019)

Location: Room 108, southwest wall

Results: P1=17 parts per billion, P2=5 parts per billion
F01=4 parts per billion, F02=1 part per billion

These results suggest the highest contribution of lead may be from the faucet and its connecting plumbing. This fixture appears to be a Delta two handled faucet. This model faucet typically has a brass tube in its deck body and may contain some additional brass components. Connecting plumbing in the cabinet under the sink should be checked for brass components and copper piping with lead solder.

Replacement of this faucet and its connection plumbing with lead free materials will significantly reduce lead exposure at this location. If replacement is not currently feasible, sample results indicate that flushing this tap for 3 minutes following periods of stagnation is likely to reduce lead concentrations and lead exposure.

This faucet also has an aerator/screen at the outlet. If the faucet is not replaced, the aerator/screen should be removed, inspected for particulate accumulations, scrubbed clean, and reinstalled. If particulates are found, the aerator/screen should be periodically checked and cleaned.

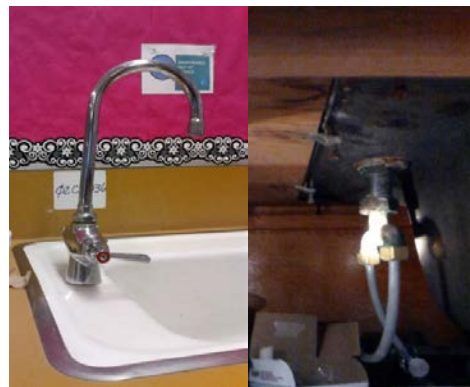
Outlet: Sink Faucet (02CF036)

Location: Classroom 209, southwest wall

Results: P1=7 parts per billion, P2=21 parts per billion
F01=5 parts per billion, F02=1 part per billion

These results suggest the highest contribution of lead may be from the faucet and its connecting plumbing. The base of this faucet is chrome plated brass, and has a brass connection on the underside of the sink. Hot and cold water lines connect to this faucet with a brass mixer fitting under the sink. Connecting plumbing in the cabinet under the sink may also contain additional brass connectors and copper plumbing with lead solder.

Replacement of this faucet and its connection plumbing with lead free materials will significantly reduce lead exposure at this location. If replacement is not currently feasible, sample results indicate that flushing this tap for 3 minutes following periods of stagnation is likely to reduce lead concentrations and lead exposure.

This faucet also has an aerator/screen at the outlet. If the faucet is not replaced, the aerator/screen should be removed, inspected for particulate accumulations, scrubbed clean, and reinstalled. If particulates are found, the aerator/screen should be periodically checked and cleaned.

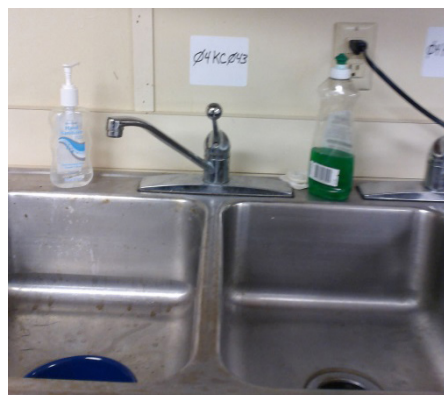
Outlet: Kitchen Faucet, Left (04KC043)

Location: Outbuilding Unit 2 DHHS Office

Results: P1=17 parts per billion, P2=3 parts per billion
F01=2 parts per billion, F02=3 parts per billion

These results suggest the highest contribution of lead may be from the faucet and its connecting plumbing. The faucet is a Delta 400. This model faucet valve has brass components. This style faucet also has a mixing valve that may allow mixing of hot and cold water. Connecting plumbing in the cabinet under the sink may also contain brass components.

Replacement of this faucet and its connection plumbing with lead free materials will significantly reduce lead exposure at this location. If replacement is not currently feasible, sample results indicate that flushing this tap for 3 minutes following periods of stagnation is likely to reduce lead concentrations and lead exposure.

This faucet also has an aerator/screen at the outlet. If the faucet is not replaced, the aerator/screen should be removed, inspected for particulate accumulations, scrubbed clean, and reinstalled. If particulates are found, the aerator/screen should be periodically checked and cleaned.

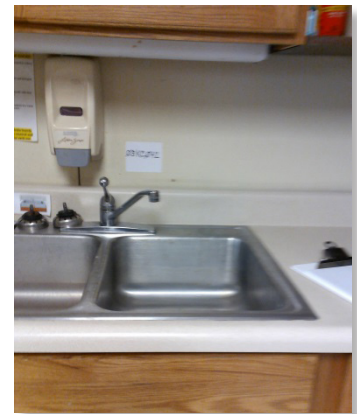
Outlet: Kitchen Faucet, Left (03KC041)

Location: Outbuilding Unit 1, Proposed Preschool

Results: P1=0.33 parts per million, P2=1.84 parts per million
F01=1.07 parts per million, F02=1.12 parts per million

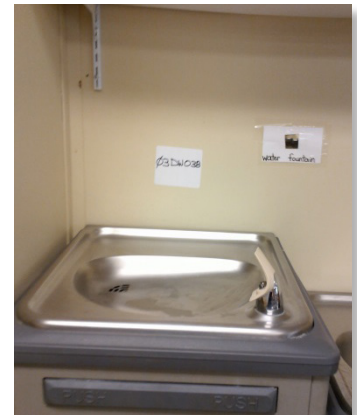
Outlet: Water Cooler, Left (03DW038)

Location: Outbuilding Unit 1, Proposed Preschool

Results: P1=2.77 parts per million, P2=1.37 parts per million
F01=1.2 parts per million, F02=1.03 parts per million
