2020 Communication Meeting

Michigan Public Service Commission
Energy Operations Division

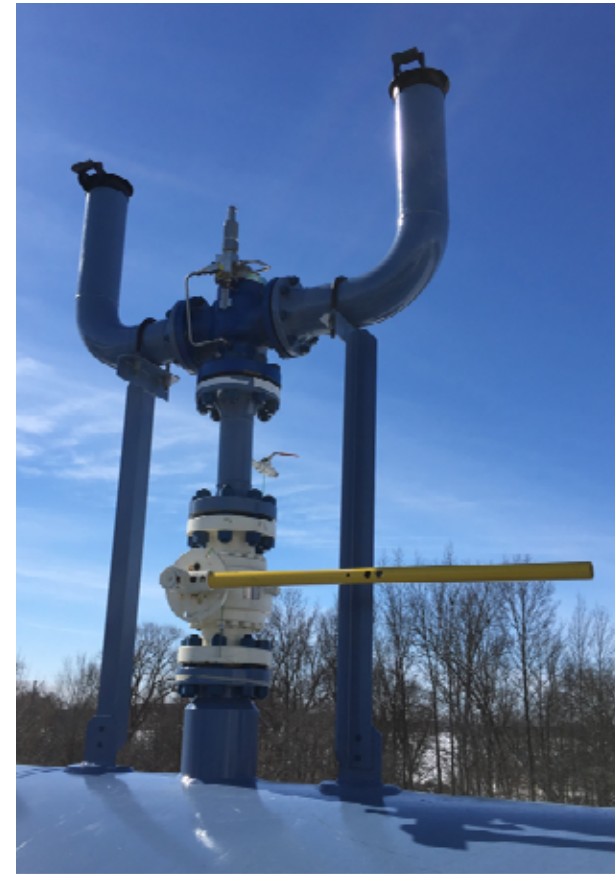
Significant Incident – 3105

- Type: Equipment Failure
- Characteristics:
 - Venting Slug Catcher Relief
 - 4” modulating relief valve manufactured by Anderson Greenwood.
 - Placed into service on January 10, 2019.
- Description:
 - External temperatures and moisture content of the natural gas caused internal components of the relief valve to freeze
 - Freezing caused the valve to actuate below its set pressure.
 - Heat trace and insulation was installed per manufacturer’s recommendation.

- Recommend Operator refrain from placing equipment that has failed back into service prior to determining the cause of failure.
- Recommend Operator refrain from isolating pressure relief valves on equipment even if the operating pressure is below the equipment's MAOP, unless a lock-out tag-out procedure is developed that encompasses all equipment that could cause the operating pressure to exceed the MAOP.
- Recommend Operator conduct a system-wide investigation for similar configurations where heat trace and insulation may be needed to prevent freezing of a pilot and conduct necessary enhancements.
- Recommend Operator provide training to Gas System Planning on how to calculate gas loss.

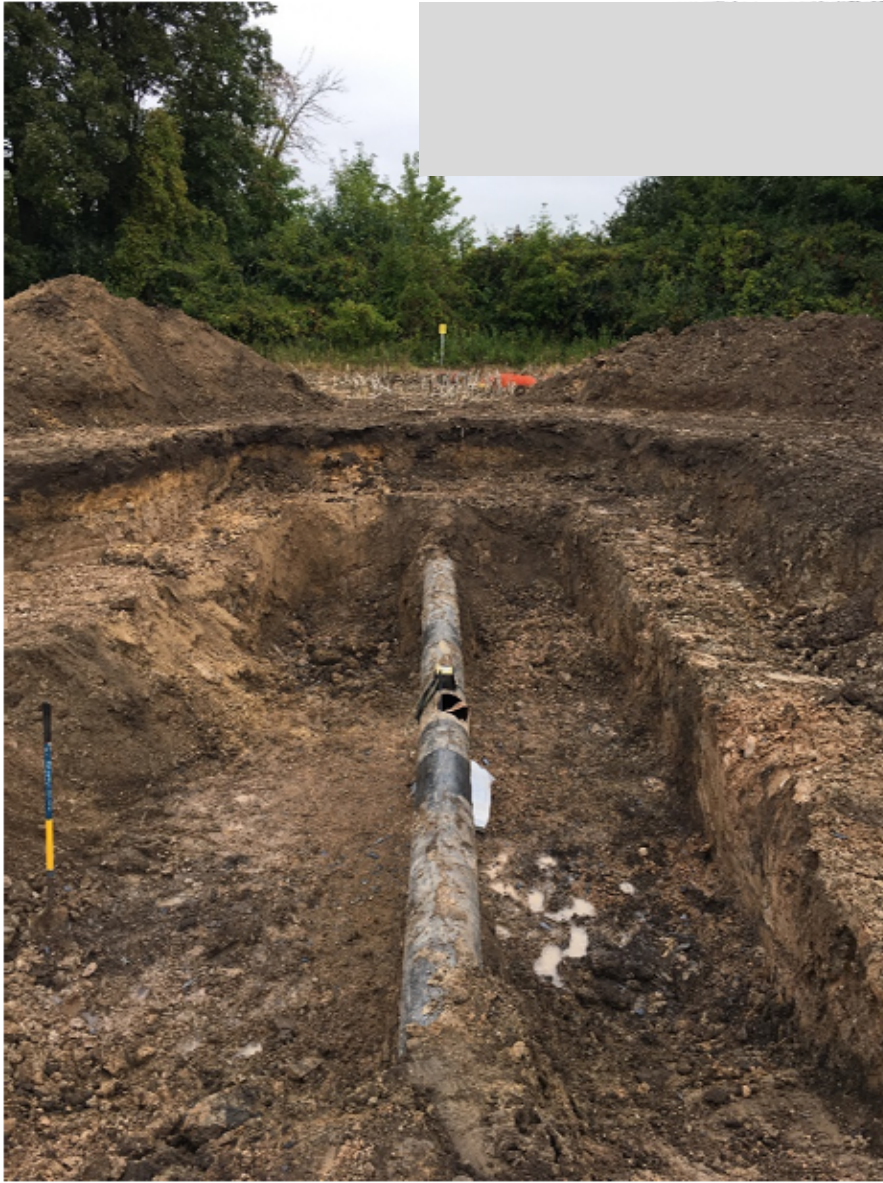
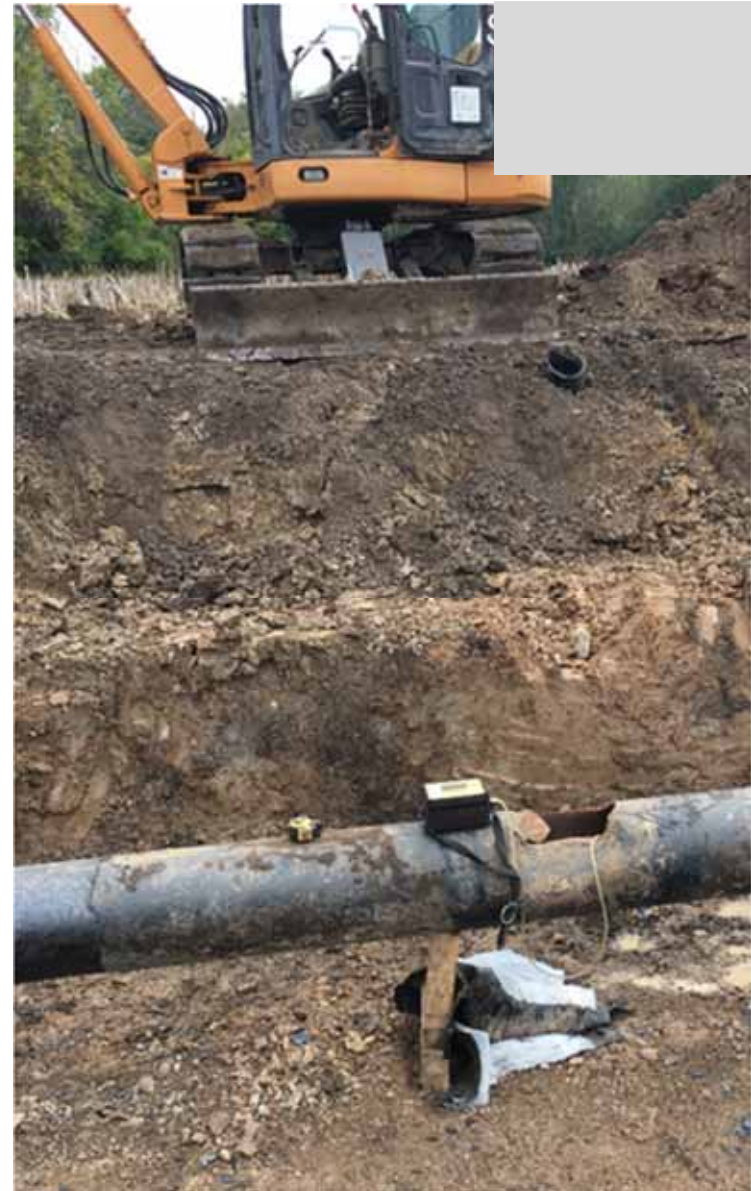
Significant Incident – 3632

- Type:
 - Third-party Damage
- Characteristics:
 - 12-inch steel main installed in 1942.
- Description:
 - Excavator working under expired one-call ticket at time of damage.
 - Excavator believed there were no gas facilities present because operator's staking contractor previously cleared the distribution gas facilities associated with expired ticket.
 - Misunderstanding based on a conversation between the excavator and staking contractor.

- **Violations:**
 - 192.614 (a): Failure to provide temporary marking of buried pipelines in the area of excavation activity before, as far as practical, the activity begins. Operator's staking contractor cleared gas distribution facilities and posed a "No-Conflict" positive response.

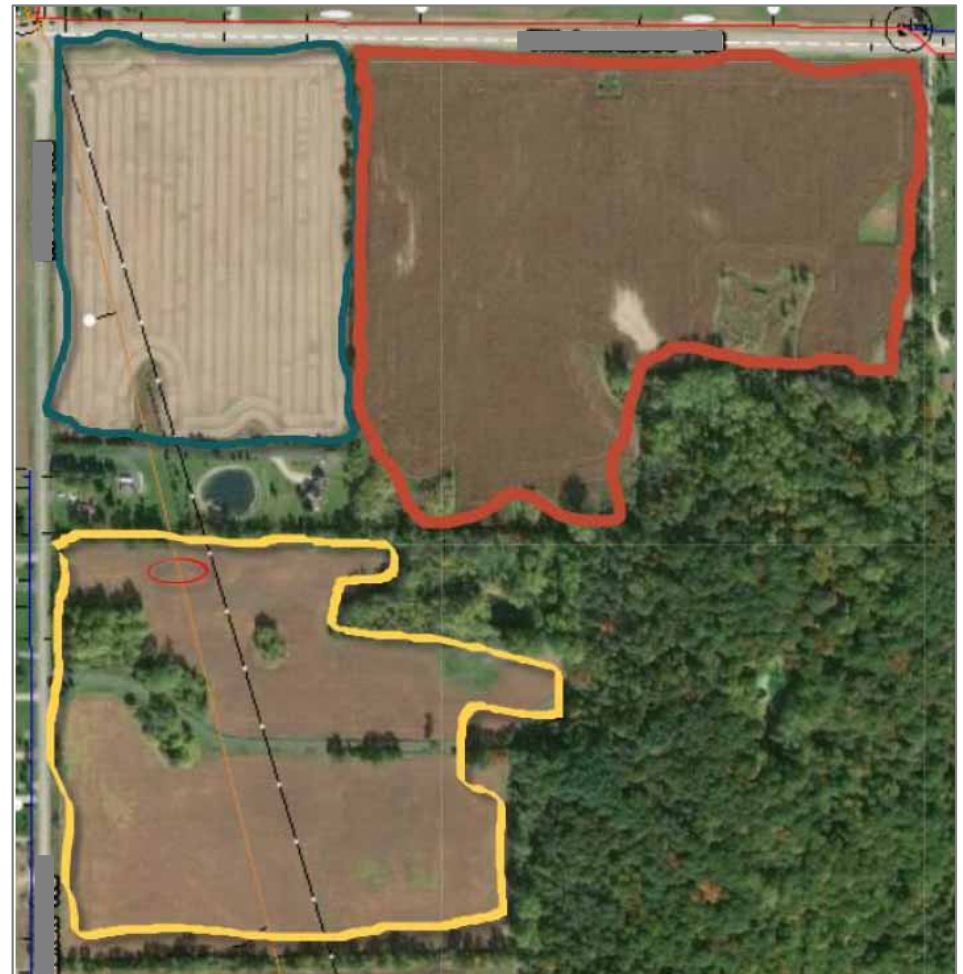
Significant Incident – 3632

Staker notes: Spoke to [excavator] at 10:28am 7-19-19 he doesn't need entire square marked he needs the field e of Hackett that isn't planted marked.

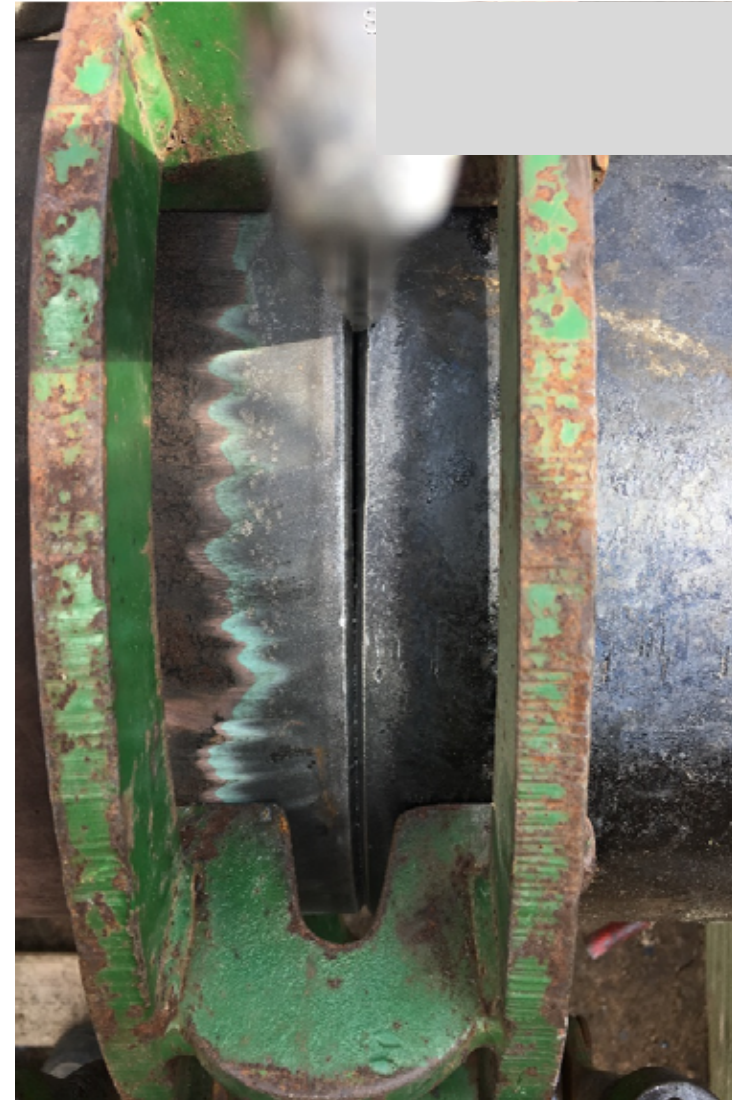
Significant Incident – 3632

- 192.235: Failure to preserve the alignment that provides the most favorable condition for depositing the root bead. Contractor welders did not maintain a minimum of 1/16-inch root opening per welding procedure.
- 192.241(a)(1) - Failure to ensure that the welding is performed in accordance with the welding procedure. CWI failed to recognize that the welders did not maintain a minimum of 1/16-inch root opening prior to depositing the root bead.

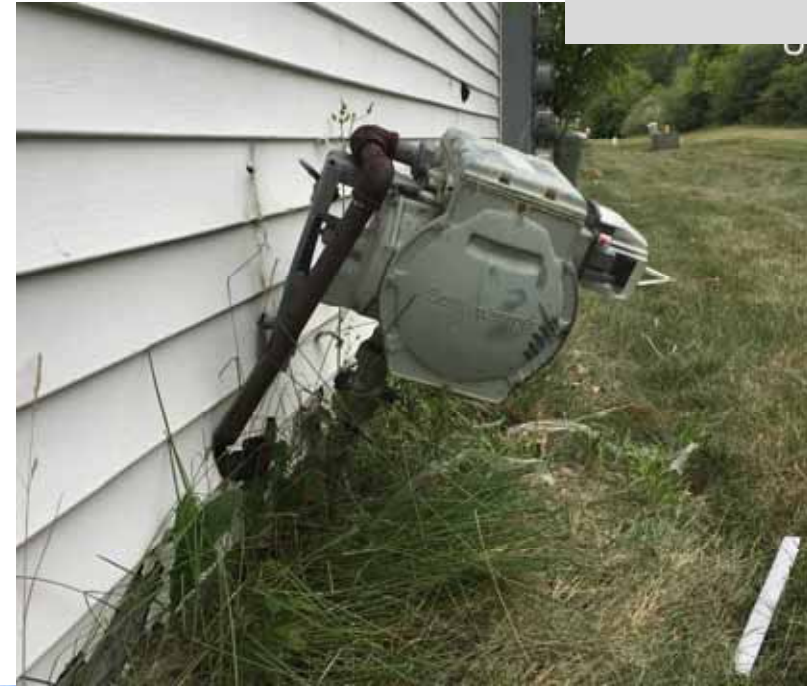
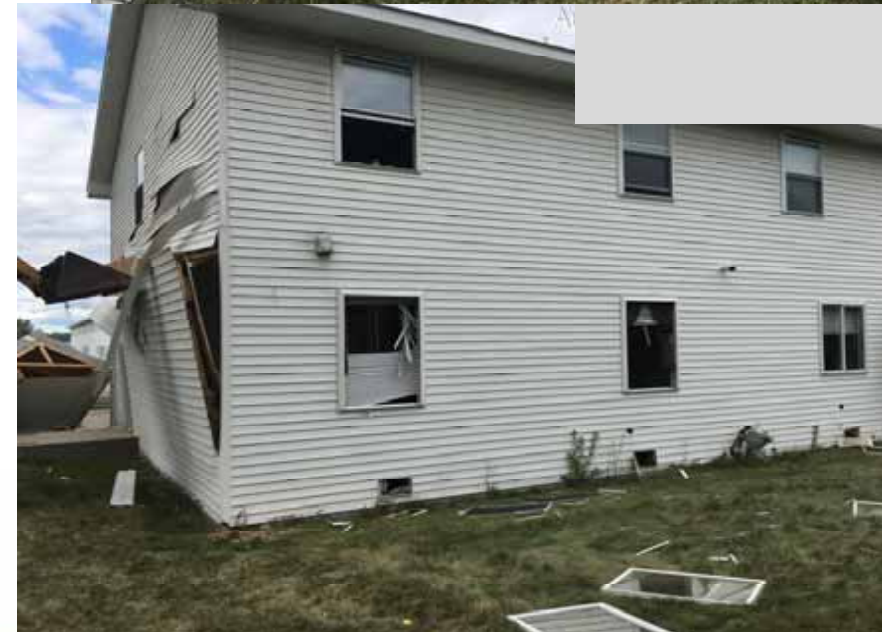
Significant Incident – 3652

- Type:
 - Apartment explosion
- Description:
 - Outside force damage caused by a lawnmower.
 - Mower driver claimed he did not know he hit meter and therefore did not notify operator.
 - Downstream fuel line separated causing gas to migrate into apartment.
 - Meter data indicates explosion occurred approximately 2 hours after damage.

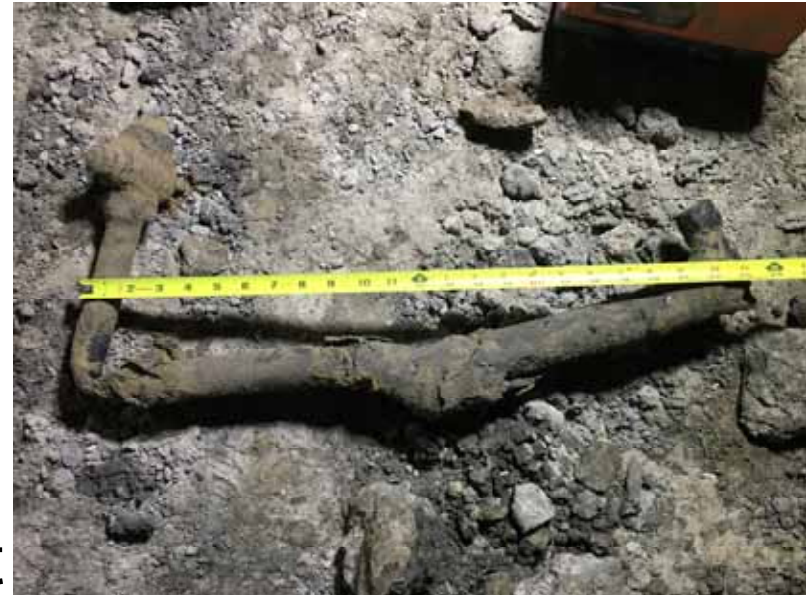
Significant Incident – 3824

- Type:
 - Third-party Damage
- Characteristics:
 - 3' long service stub connected to a 6" steel main.
- Description:
 - Maps and records indicate that service was cut and plugged at the main in 1990.
 - Excavator had a valid one-call ticket but did not call in a restake request when marking were destroyed.

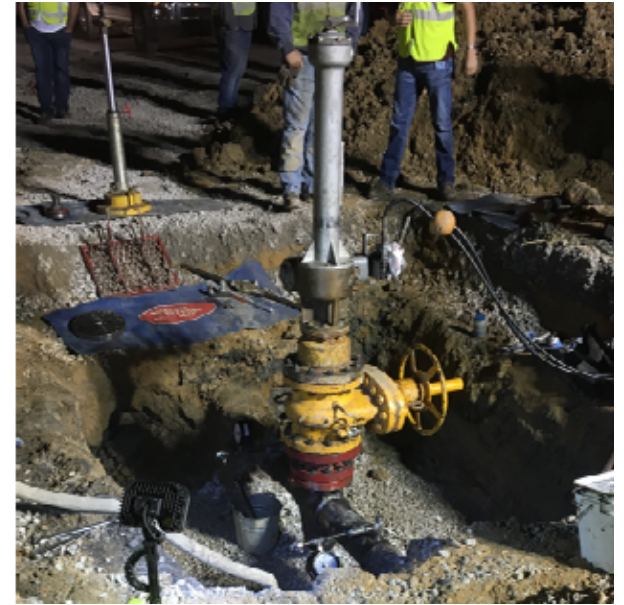
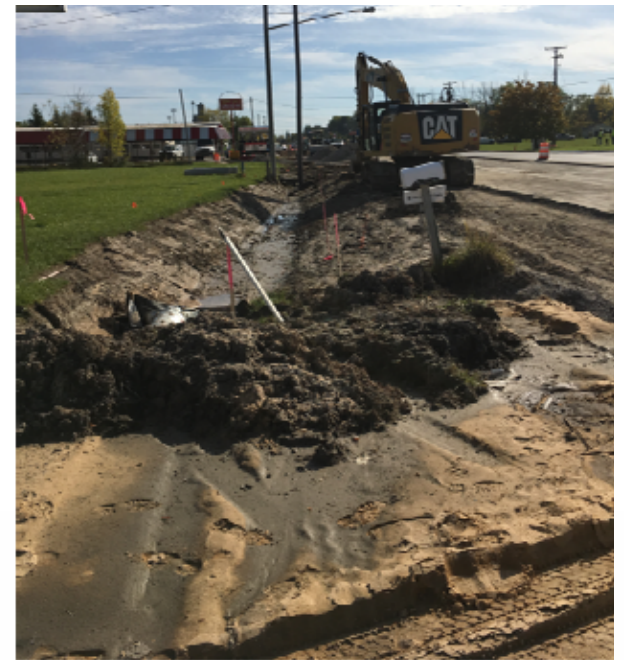
Significant Incident – 3824

- Violations:
 - 192.225(a) – Failure to follow welding procedure. Outside of the amperage range for in-service welds.
 - 192.614(a) – Inaccurate maps and records.
 - MCL 460.725(7) – Failure to provide notification to the notification system when facility markings are destroyed or covered by excavation or blasting activity.

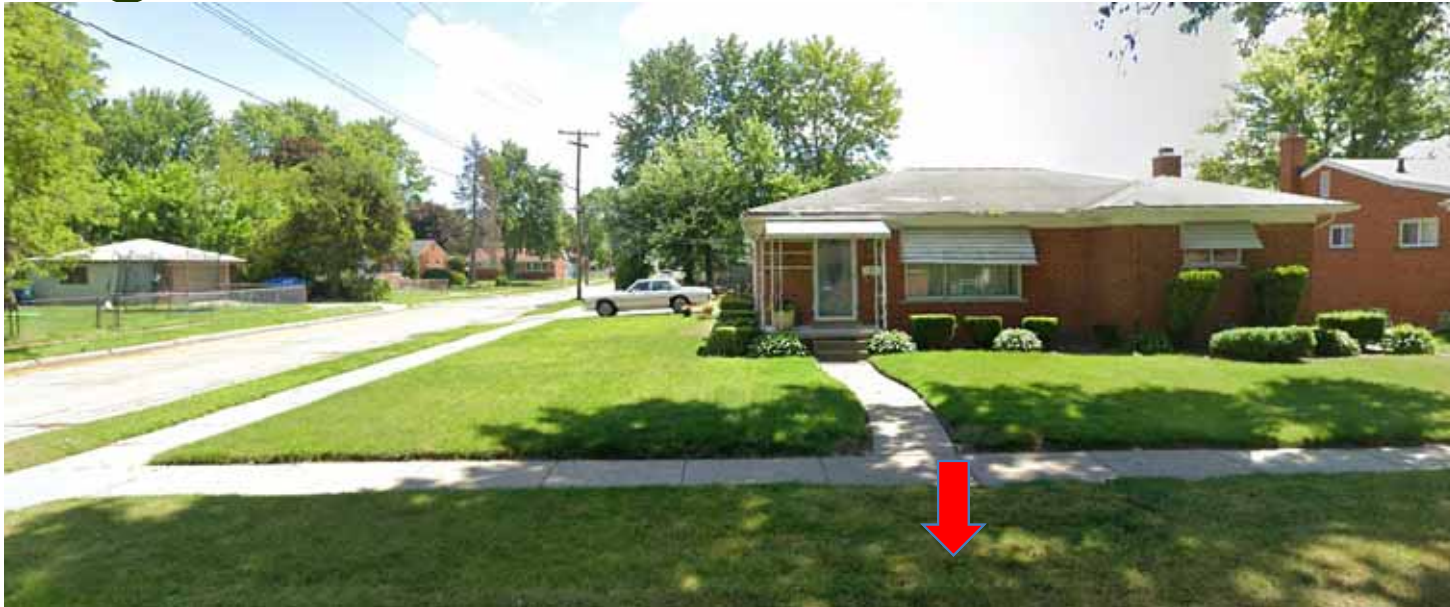
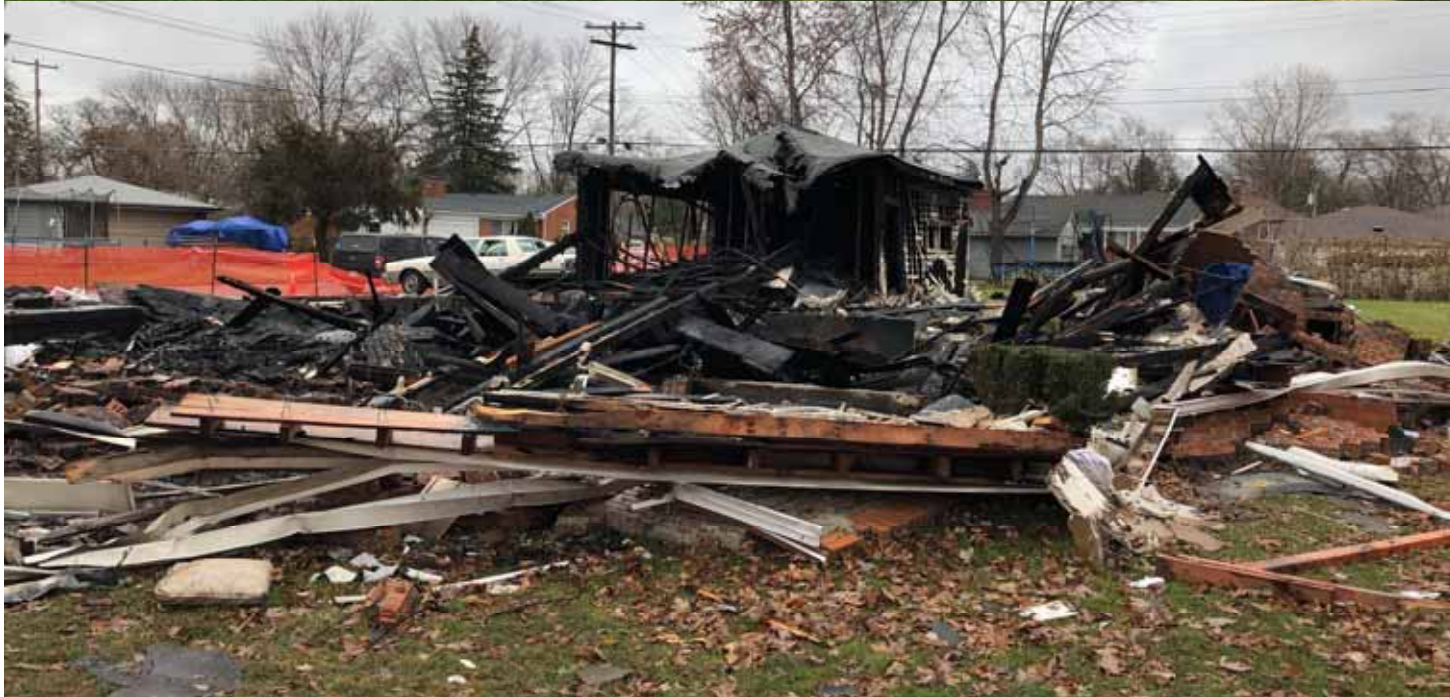
Significant Incident – 3979

- Type:
 - House Explosion
- Characteristics:
 - 2" steel main and 3/4" steel service installed 1959.
 - Plastic riser installed 2008 after meter was moved outside.
- Description:
 - No gas reads obtained on the day of the explosion.
 - Corrosion leak on the main discovered 2 days following the explosion. Gas spread extended 19' from house that exploded.
 - Ongoing investigation.

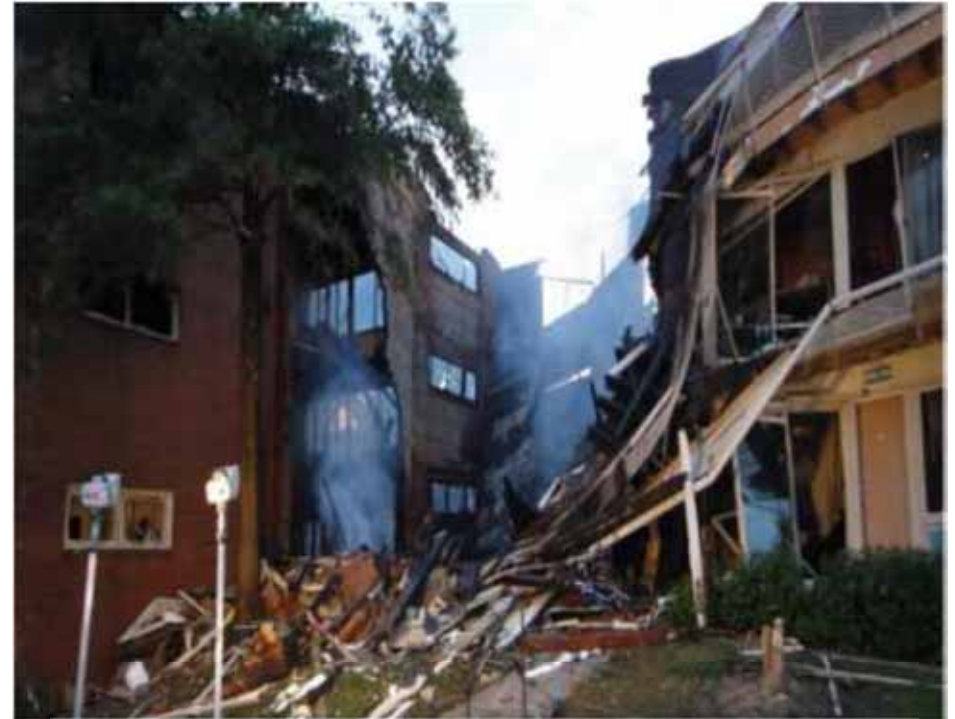
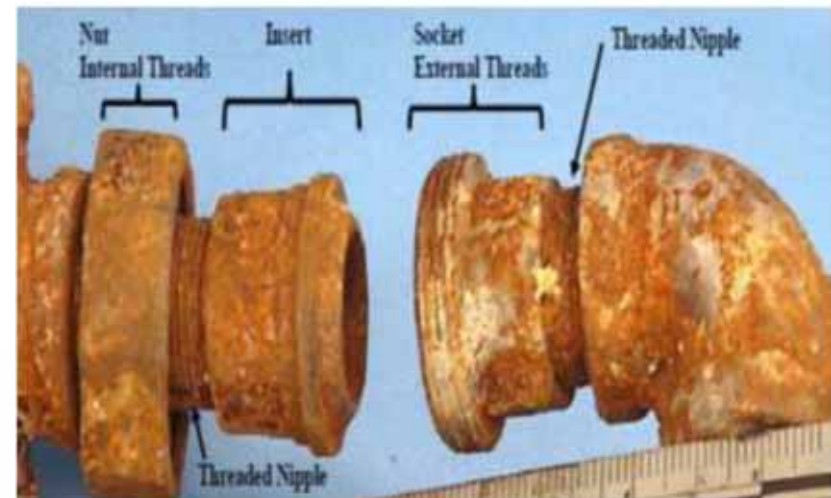
Silver Springs, Maryland Incident

- Explosion/fire at apartment complex in 2016.
- 14 units collapsed.
- 7 fatalities and 68 injuries.
- Inside meters.
- Mercury regulator.
- Cause: Unthreaded union in the vent line that allowed gas to accumulate in meter room.

- NTSB Recommendations:
 - Require that all new service regulators be installed outside occupied structures.
 - Require existing interior service regulators be relocated outside occupied structures whenever the gas service line, meter, or regulator is replaced. In addition, multifamily structures should be prioritized over single-family dwellings.
 - Identify mercury service regulators and expedite replacement that prioritizes multifamily dwellings with inside meters.
 - Technicians should verify integrity of vent lines following testing of indoor service regulators.
 - Require methane detection systems for all types of residential occupancies with gas service. This includes installation, maintenance, placement, and testing.

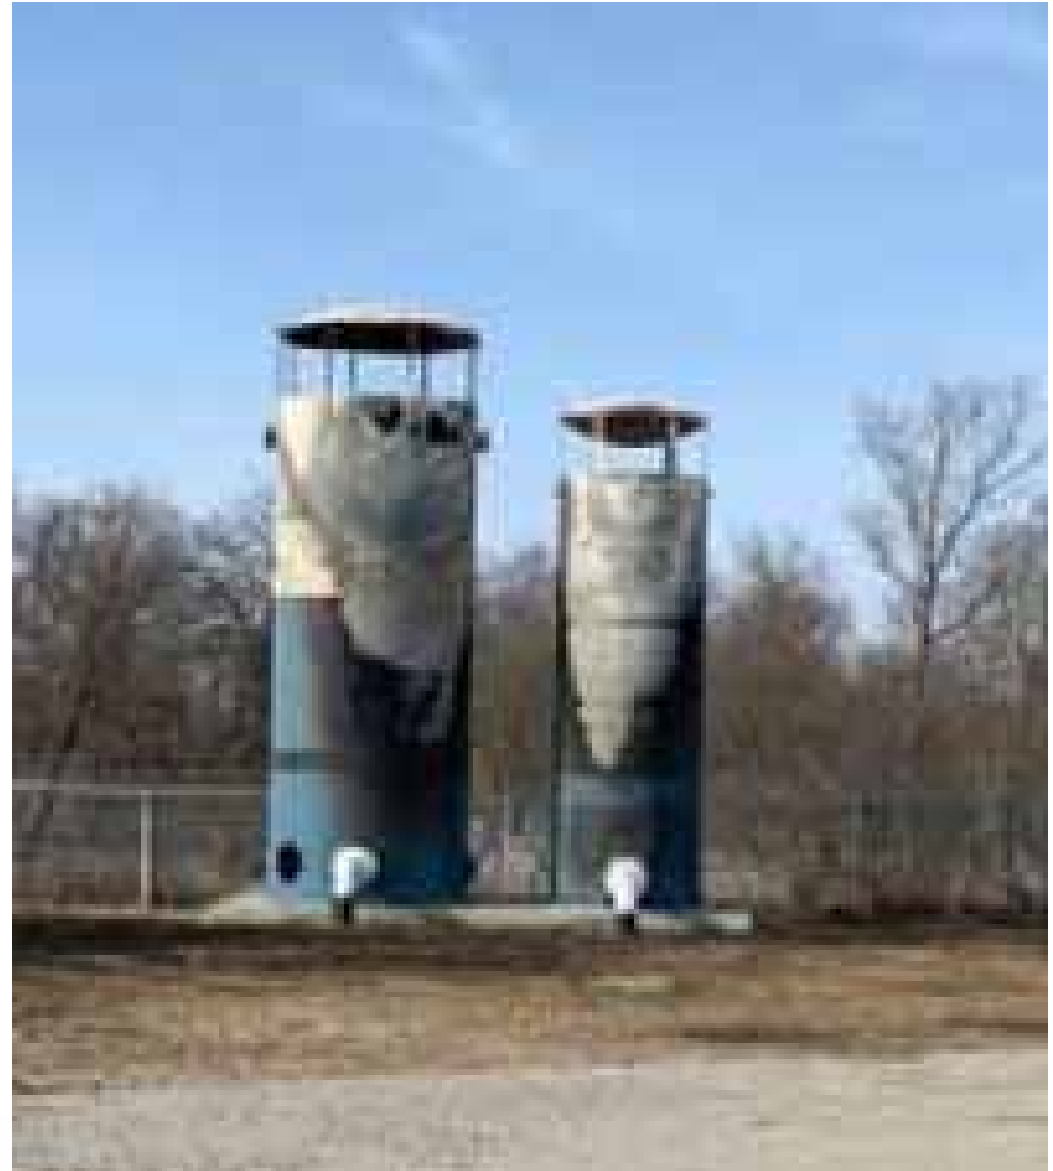
Significant Incident – 478629

- Compressor station blowdown fire.
- Emergency Shut-Down of Plant 3 allowed gas plume to contact Plant 2 thermal oxidizer, igniting.
- Operator identified fire and activated ESD for Plants 1 and 2, adding additional fuel to the fire at the blowdown silencers.

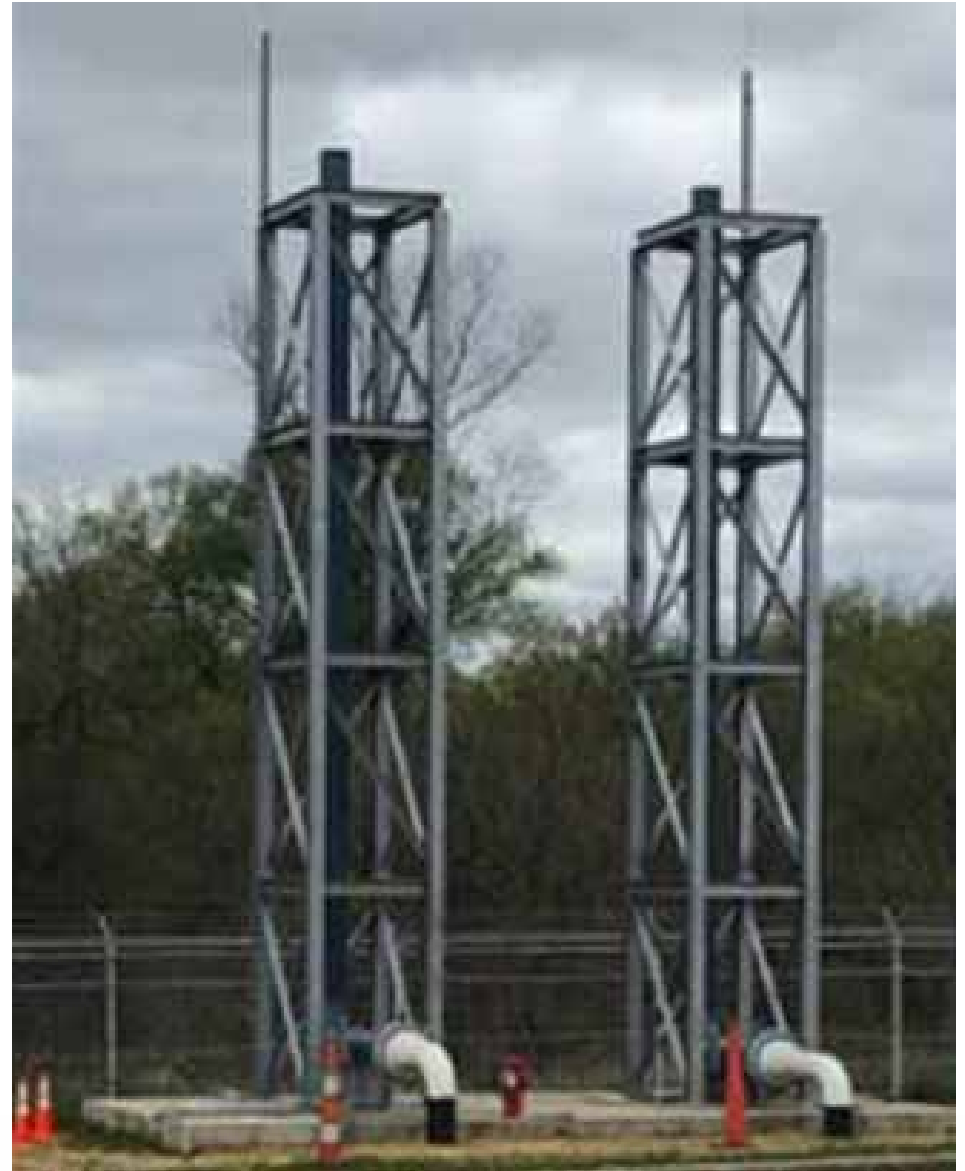
Significant Incident — 478629

- Cause of initial Plant 3 ESD:
 - Grounding issue interfering with the communication system.
- Solution:
 - Move the grounding systems further apart.

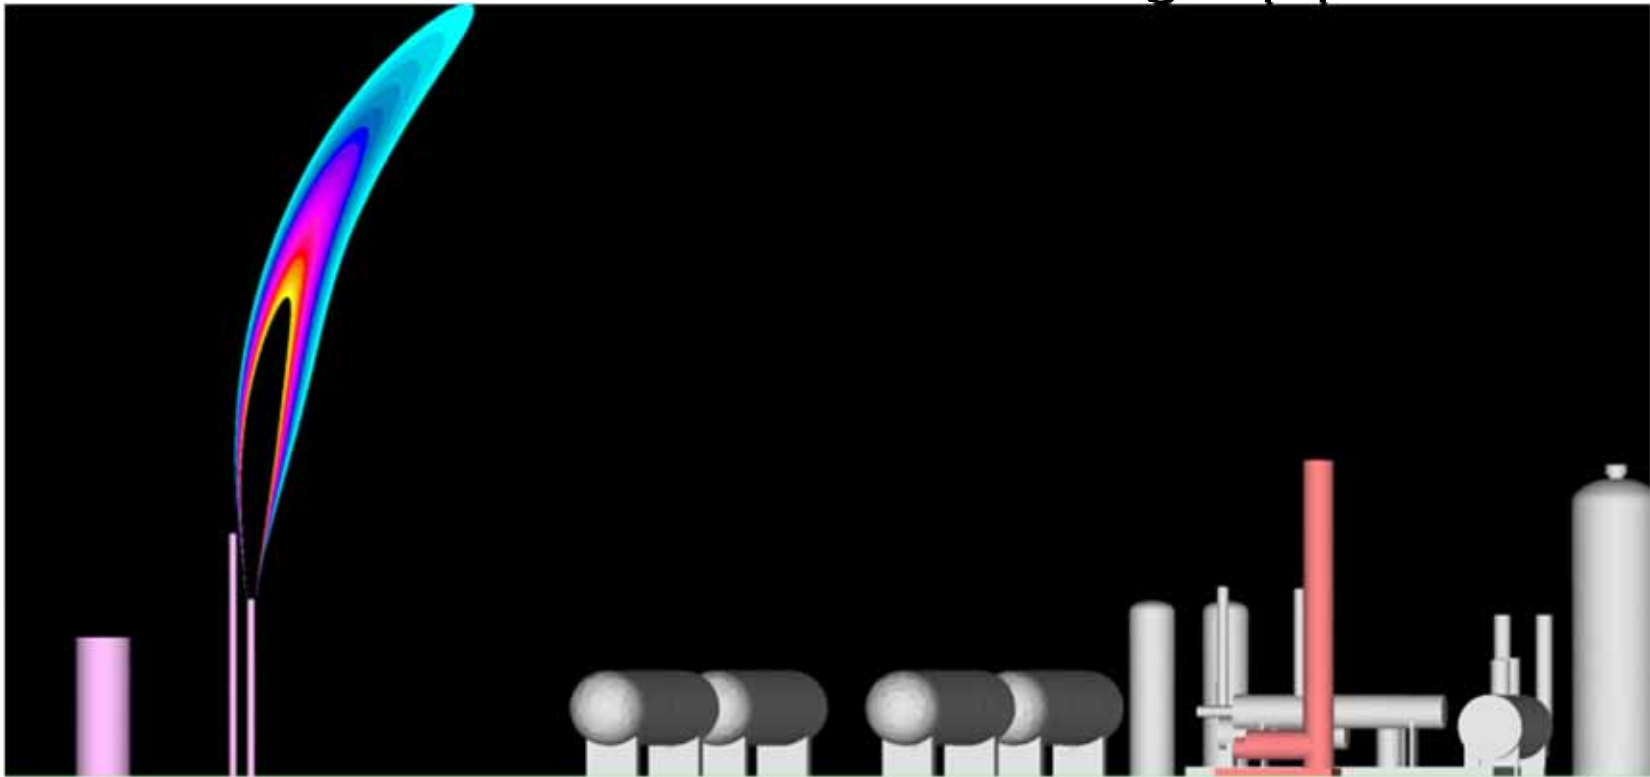
Significant Incident – 478629

- Cause of ignition:
 - Low velocity of gas discharge from blowdown silencer in conjunction with a close proximity to the thermal oxidizer.
- Solution:
 - Remove the silencers and install straight pipe blowdowns.

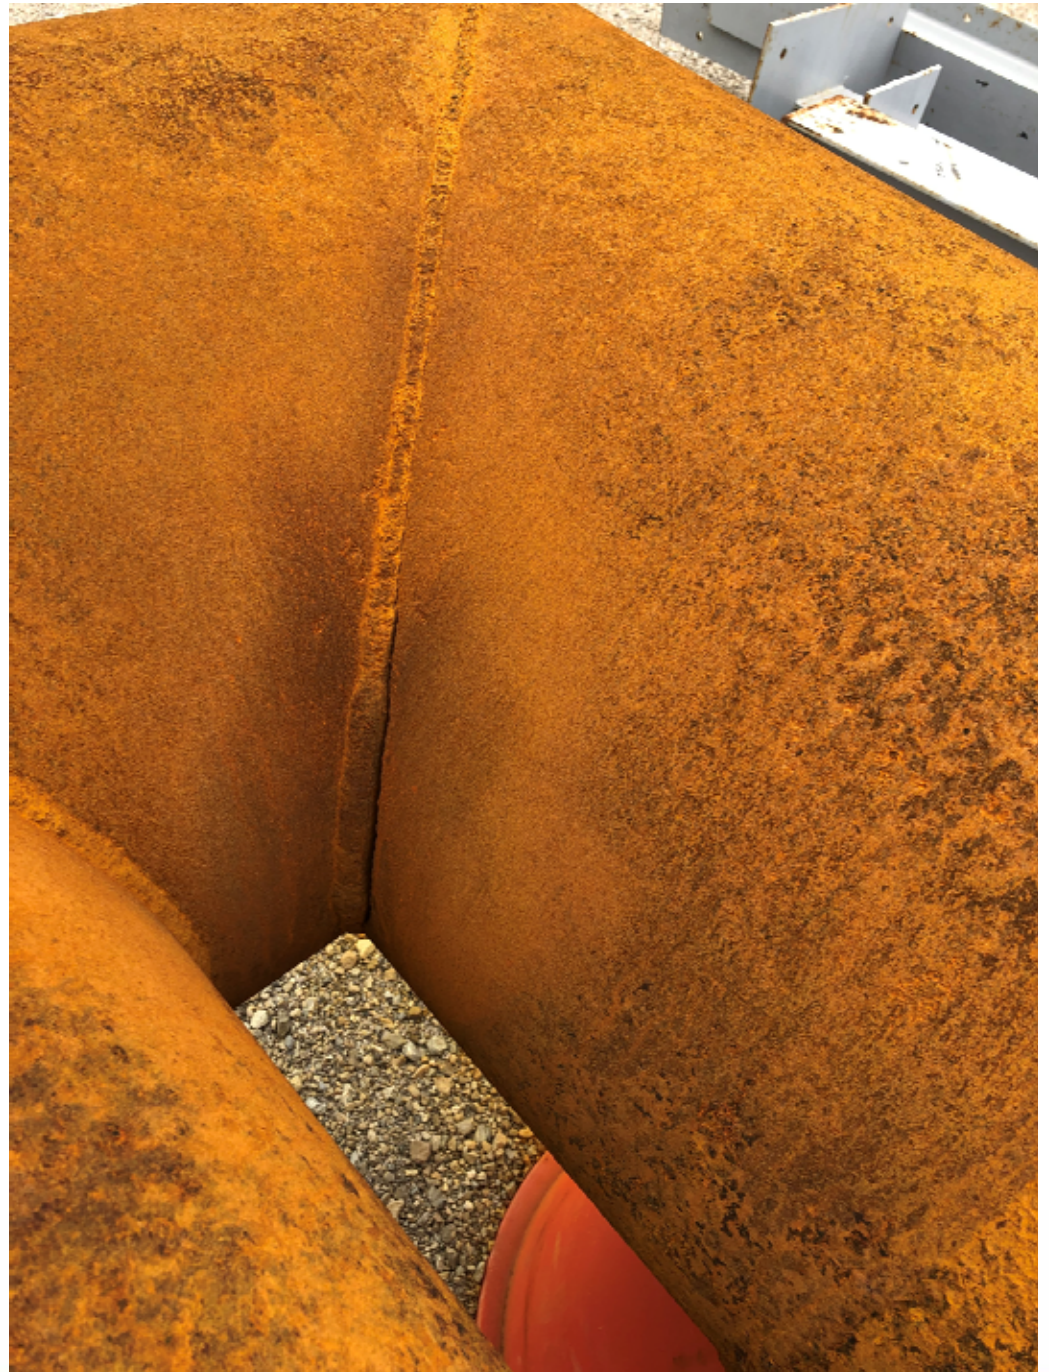
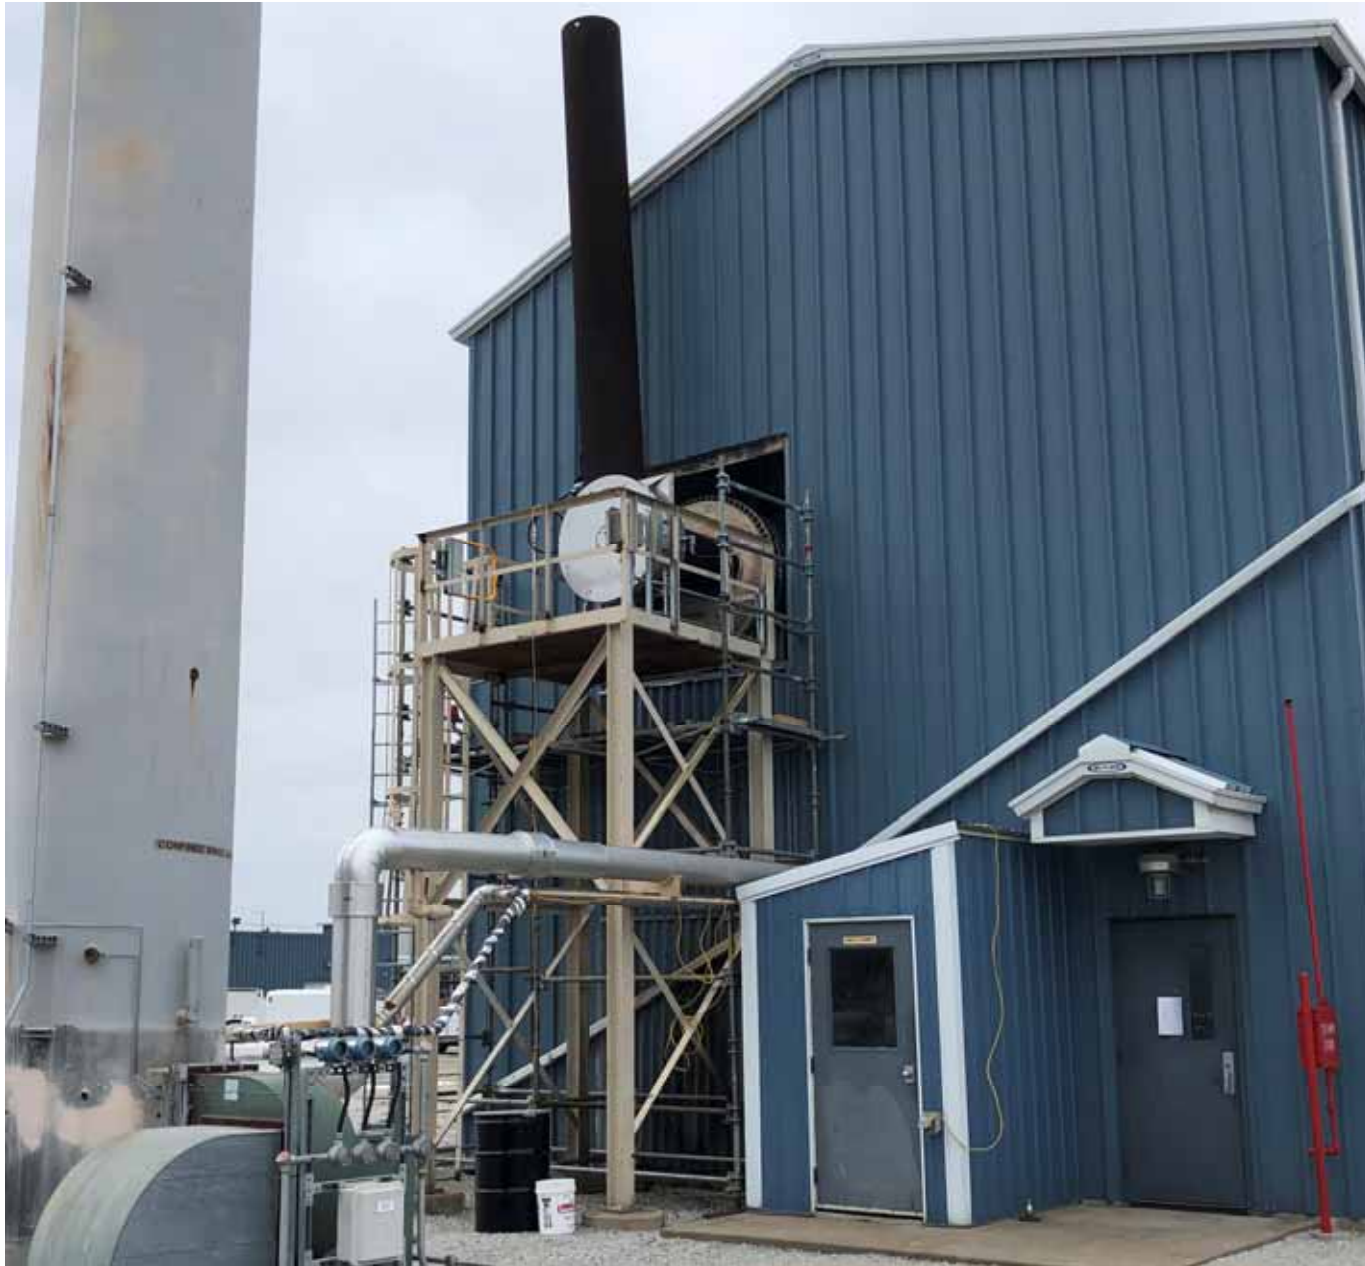
Significant Incident – 4052

- Compressor station dehy fire.
- Glycol reboiler fire-tube miter weld crack.
- Glycol entered fire tube and leaked out of end burner box and ignited.
- Still under investigation.

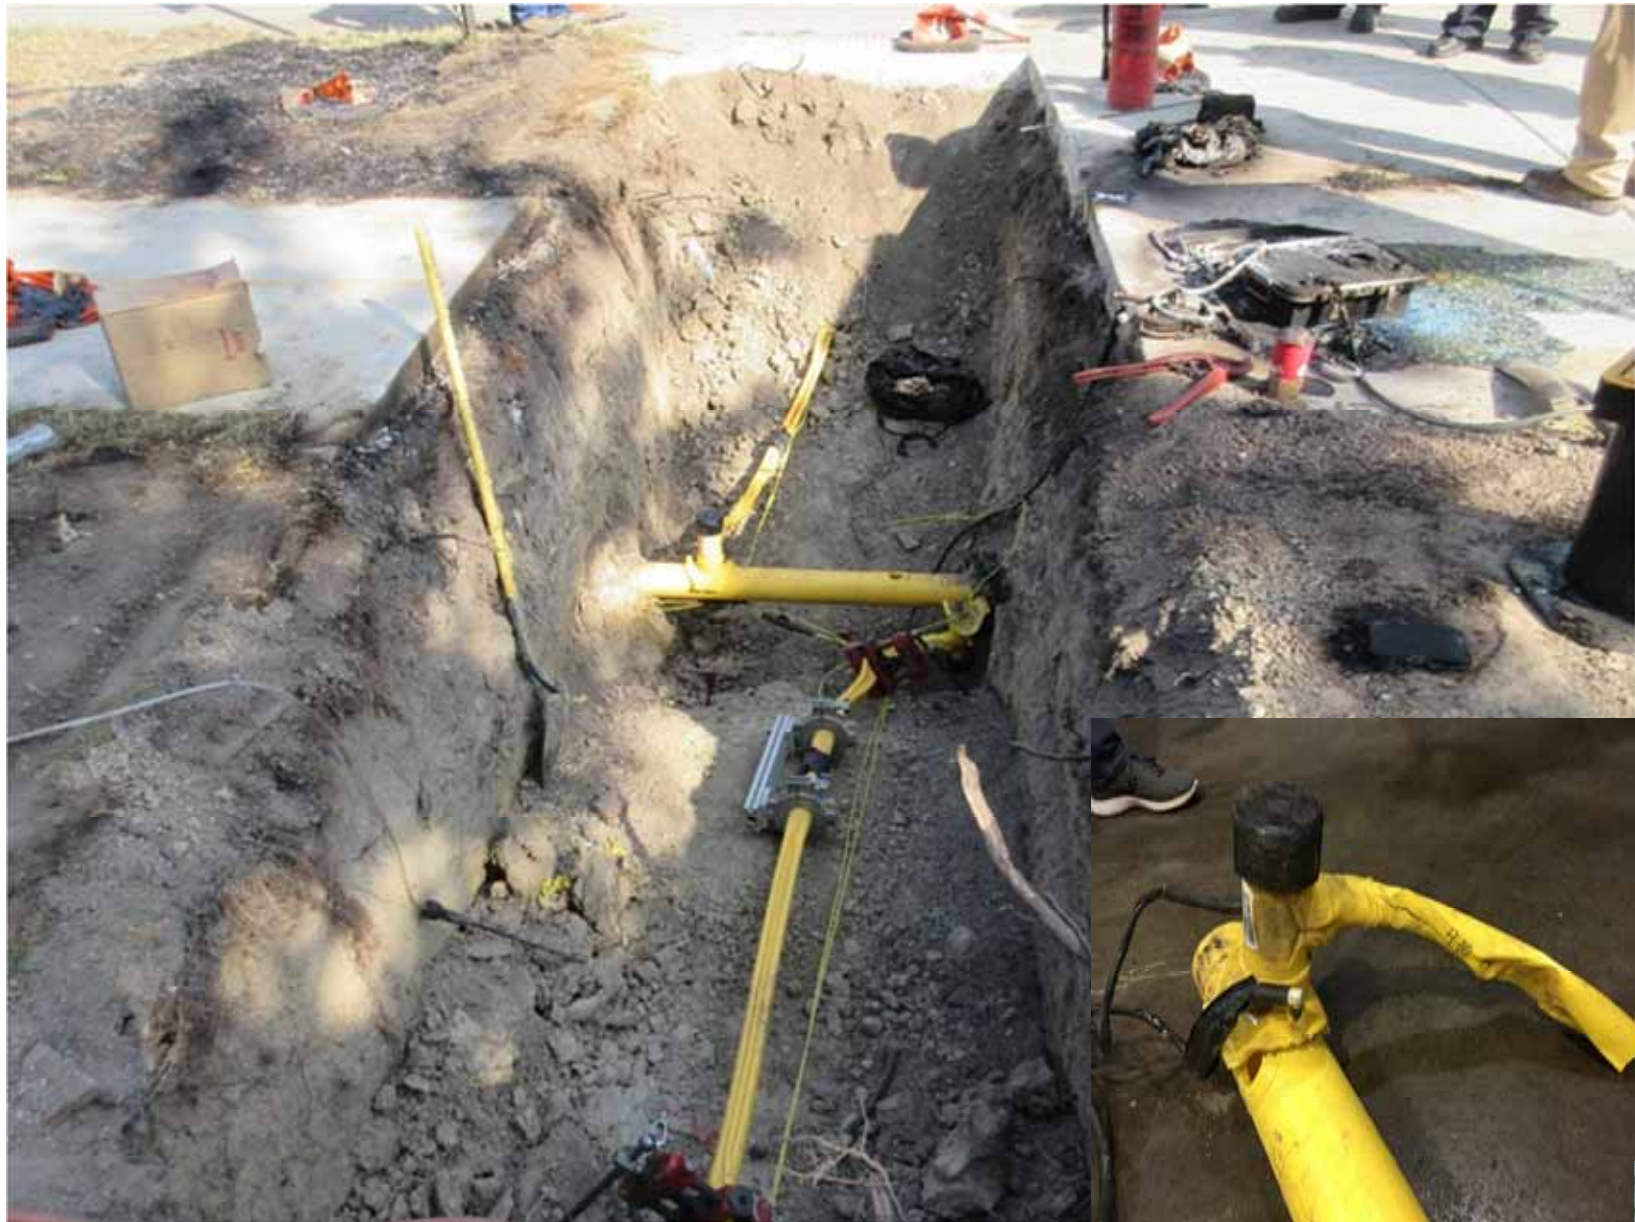
Significant Incident – Case 3622

- Description:
 - Fuser prepared to complete a 2-inch coupling electrofusion, but mistakenly connected the fuse leads to a previously completed electrofusion tee that was already tapped and operating at 60 psig.
 - Pipe, fittings, tools, accessories and fusing equipment were destroyed.
 - No Injuries.
- Violations:
 - 192.273(b): Failure to make each joint in accordance with written procedures that have been proven by test or experience to produce strong gastight joints.
