2020 Communication Meeting

Michigan Public Service Commission
Energy Operations Division

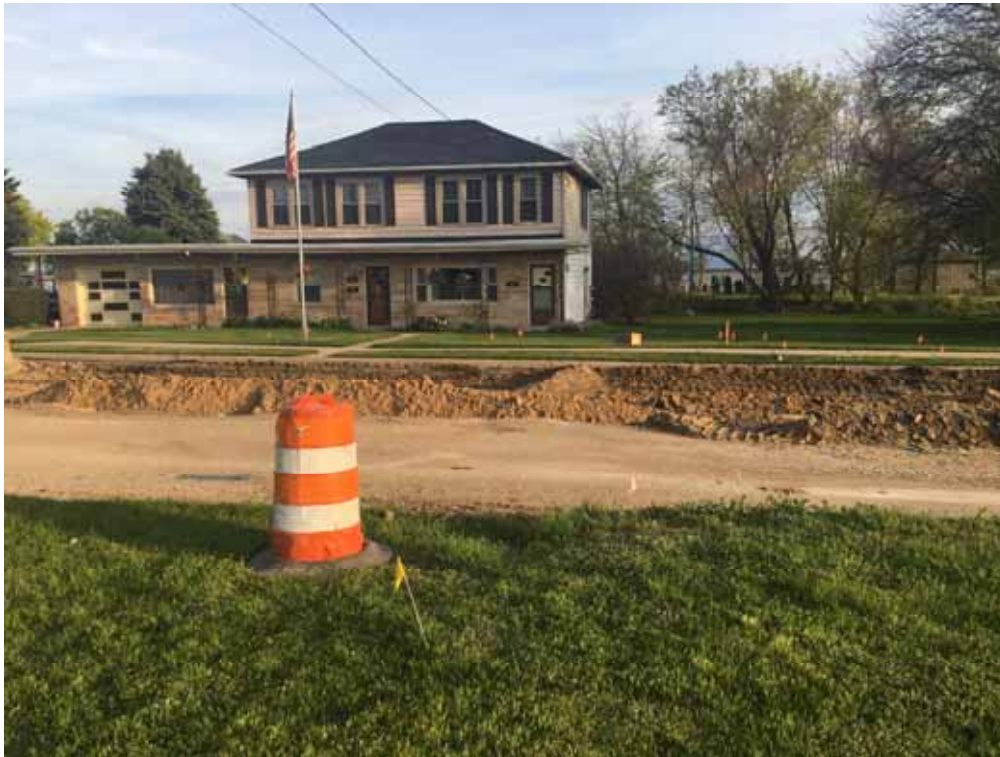
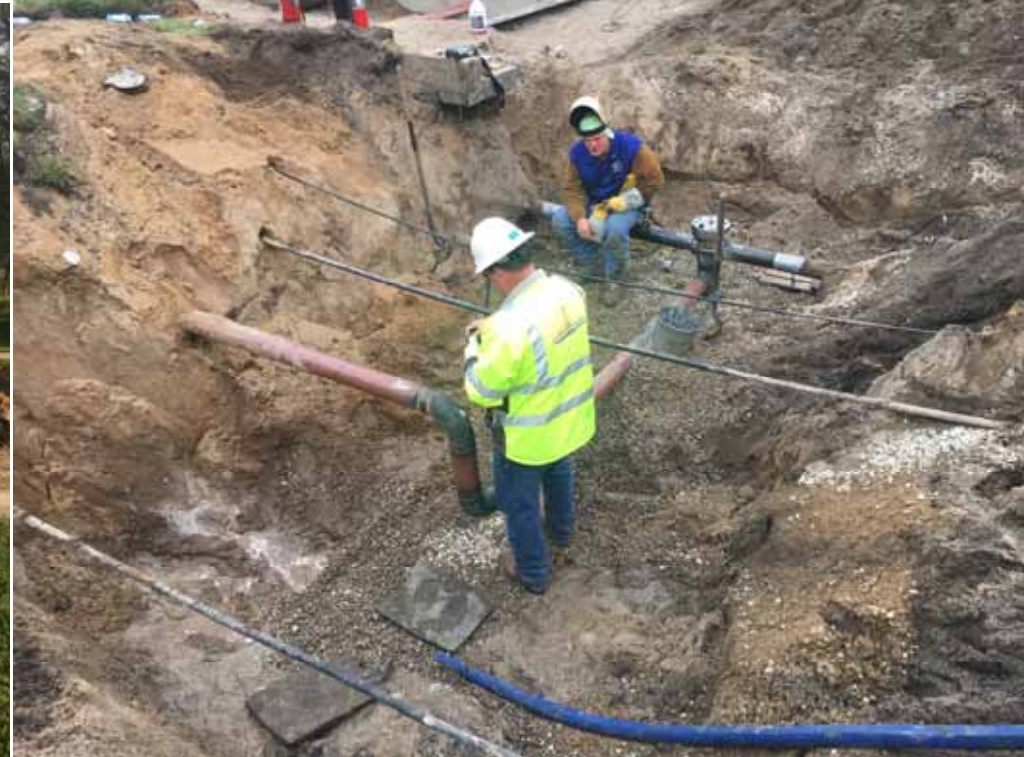
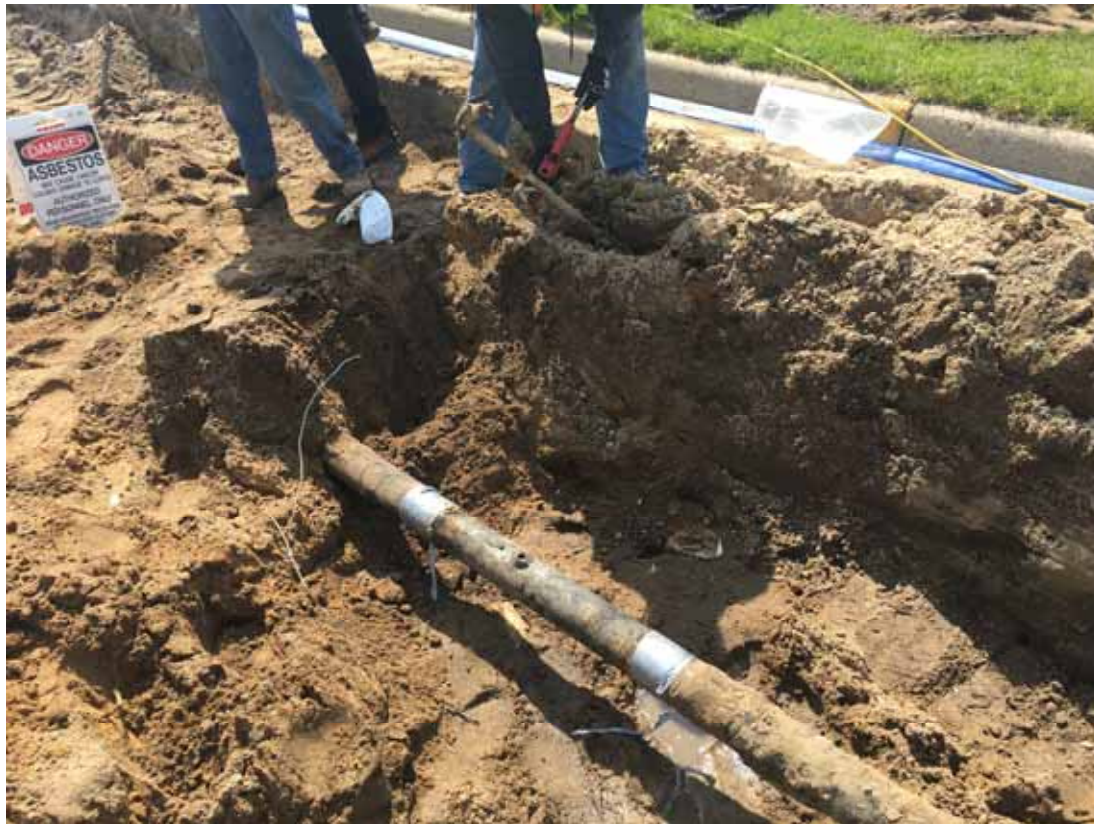
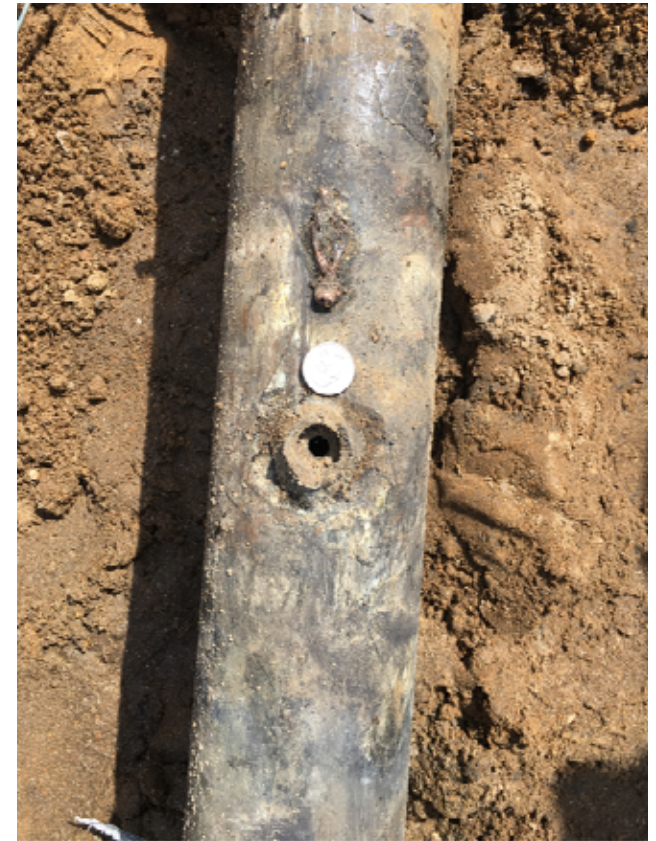
Significant Incident – 3306/3565

- Type:
 - Third Party Damage
- Characteristics:
 - 4” High Pressure Distribution
 - 1-way feed
 - 10 outages (40 hours)
 - \$79k in Property Damages, 1.773MMcf gas lost.
- Description:
 - Excavator nearly completed storm/sanitary sewer construction. While performing final grading with bulldozer, broke service tee off main.
 - Repaired by constructing permanent bypass.

- Violations:
 - 460.725(5): The excavator failed to establish the precise location of facilities in the caution zone prior to using power equipment.
- Key Takeaways:
 - A minor incident became a costly and potentially dangerous incident on a high-pressure system.
 - A small error by an inexperienced equipment operator resulted in a significant incident in terms of costs and potential customer impact.

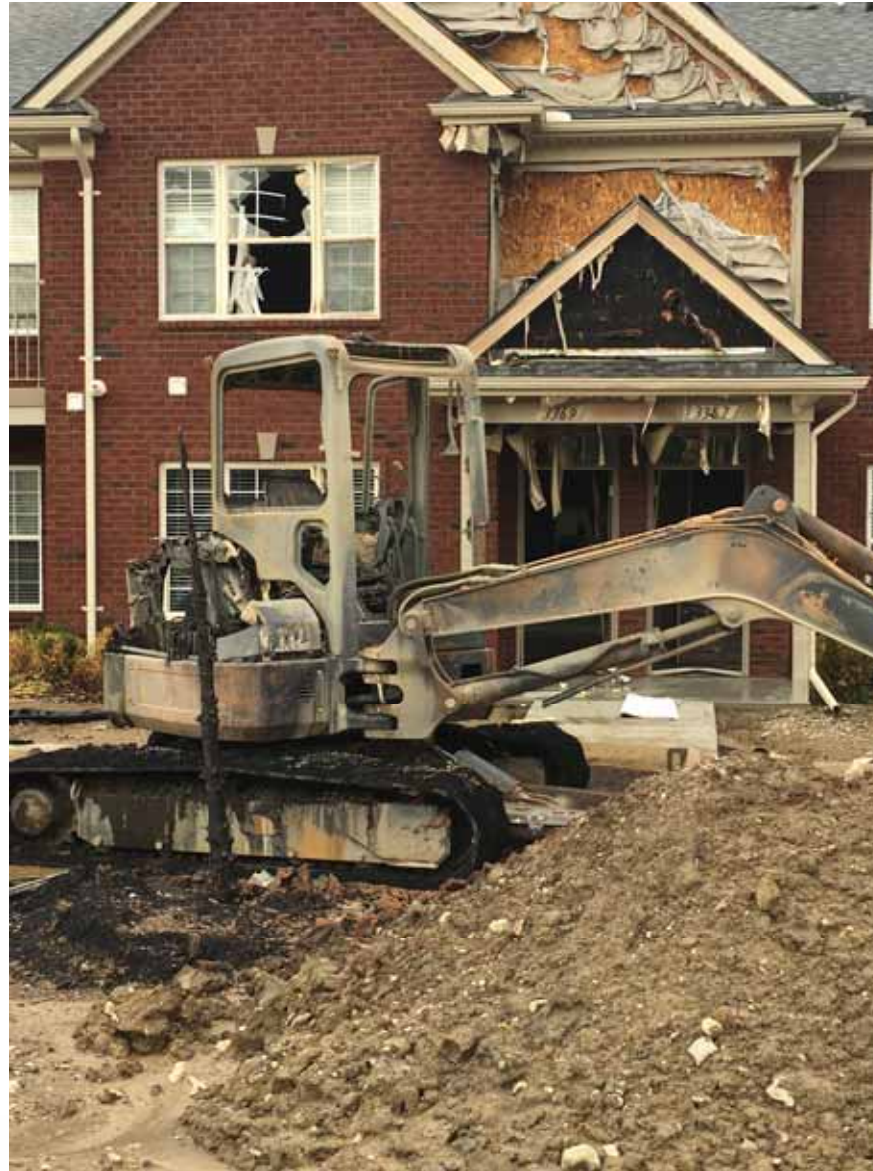
Significant Incident – 3314

- Type:
 - First Party Damage with Ignition
- Characteristics:
 - 2” PE Main
 - \$120,203 in Damages
- Description:
 - Distribution crew hit main during pipe lowering project. While attempting to expose the damage, crew contacted an electric service line located in joint trench, causing ignition and injury.

- Violations:
 - 192.605(a) – Failure to have a gas detector present at squeeze off point, prior to cutting into the pipe to cap it. After Staff inquired if there was a gas detector nearby, Operator's technician had to retrieve one from their truck.
 - 192.751(a) - Operator of the backhoe continued to operate the equipment in the presence of blowing gas, ultimately resulting in their injury after the operator damaged an electrical conductor sharing the same trench as the distribution main.

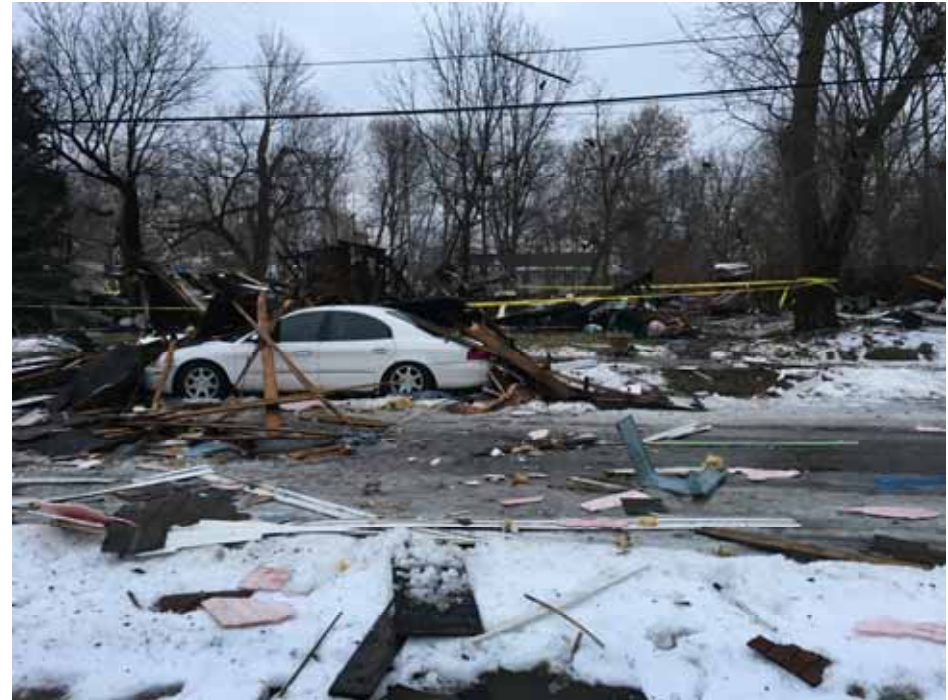
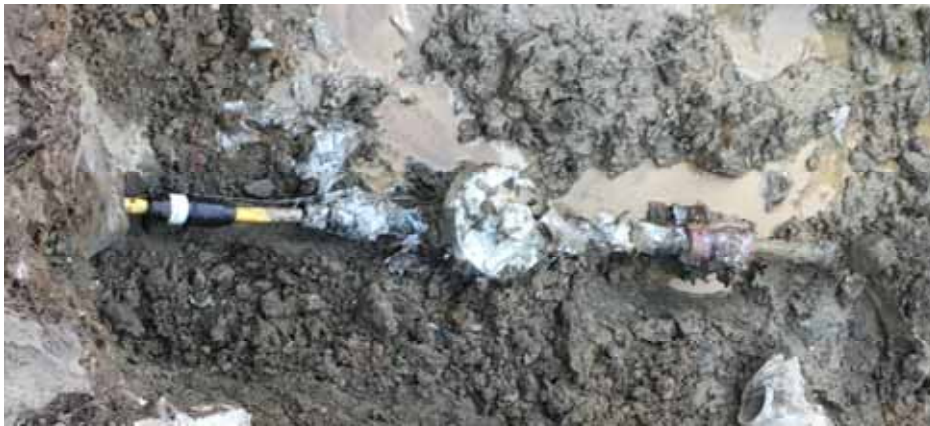
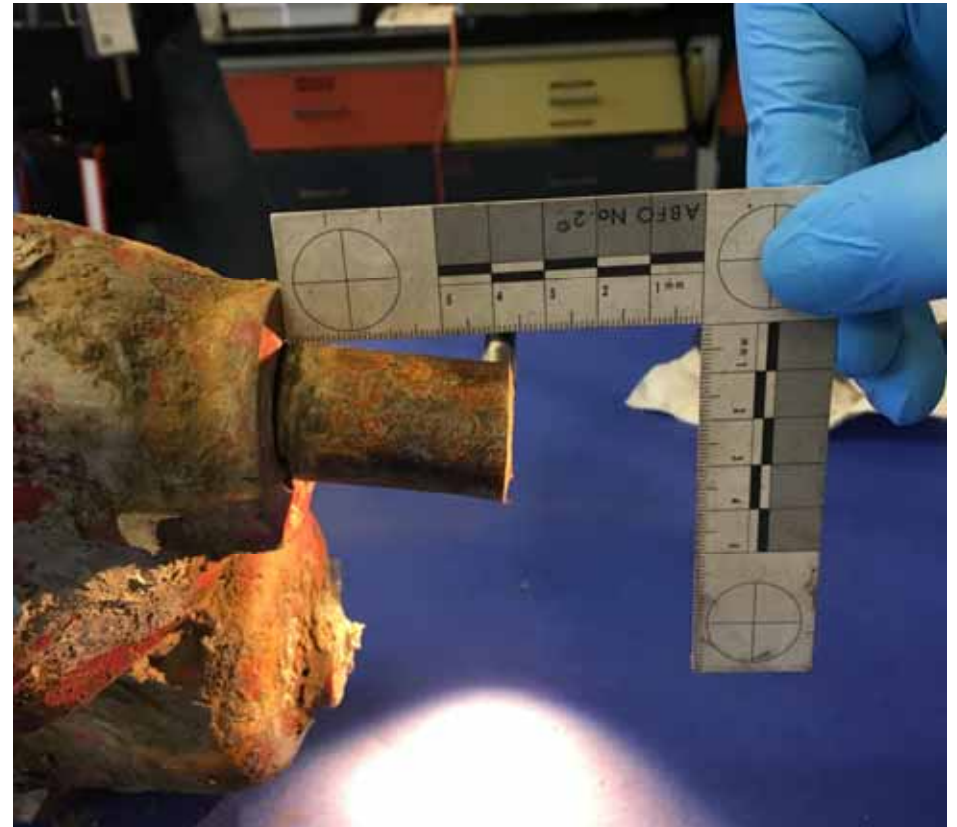
Significant Incident – 3093

- Description:
 - Gas in sanitary sewer and migrated into several houses.
 - When gas shut off at buried regulator, all gas readings dissipated in the sewers.
 - Resident injured.

- Violations:
 - 192.605(a): Employee did not complete required documentation to demonstrate that the gas migration boundaries were determined.
 - 192.605(a): Employee responding to the original leak call did not have access to the current service line map.

- Recommendations:
 - Recommend operator consider in their DIMP plan if there is a threat associated with buried regulators.
 - Recommend operator reevaluate the applicability of using a drag tube in frost conditions to establish underground gas migration.
 - Recommend elevating leak response procedures when multiple leaks are in a single area with a known leak.

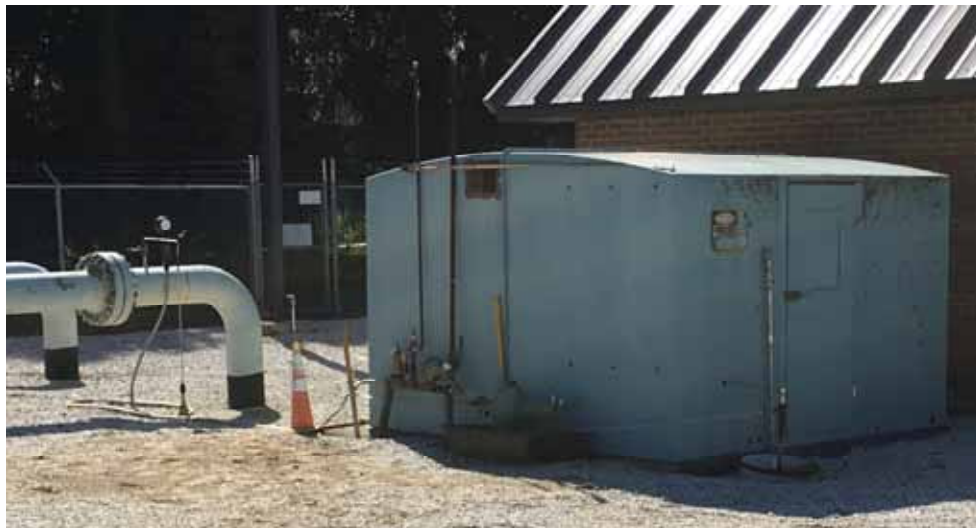
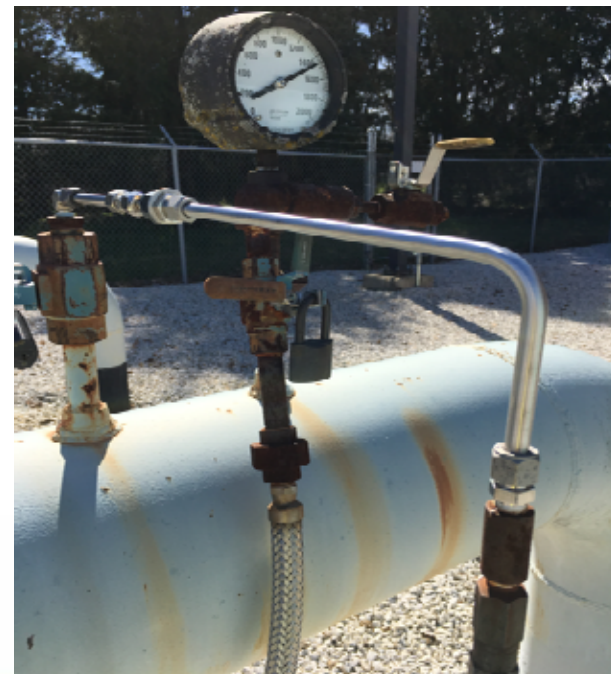
- 192.53(c): Failure to qualify materials for pipe and components in accordance with the applicable requirements of subpart B.
 - A stainless-steel braided hose was connected from a meter run to a temporary methanol pump was unable to demonstrate the braided hose was qualified.

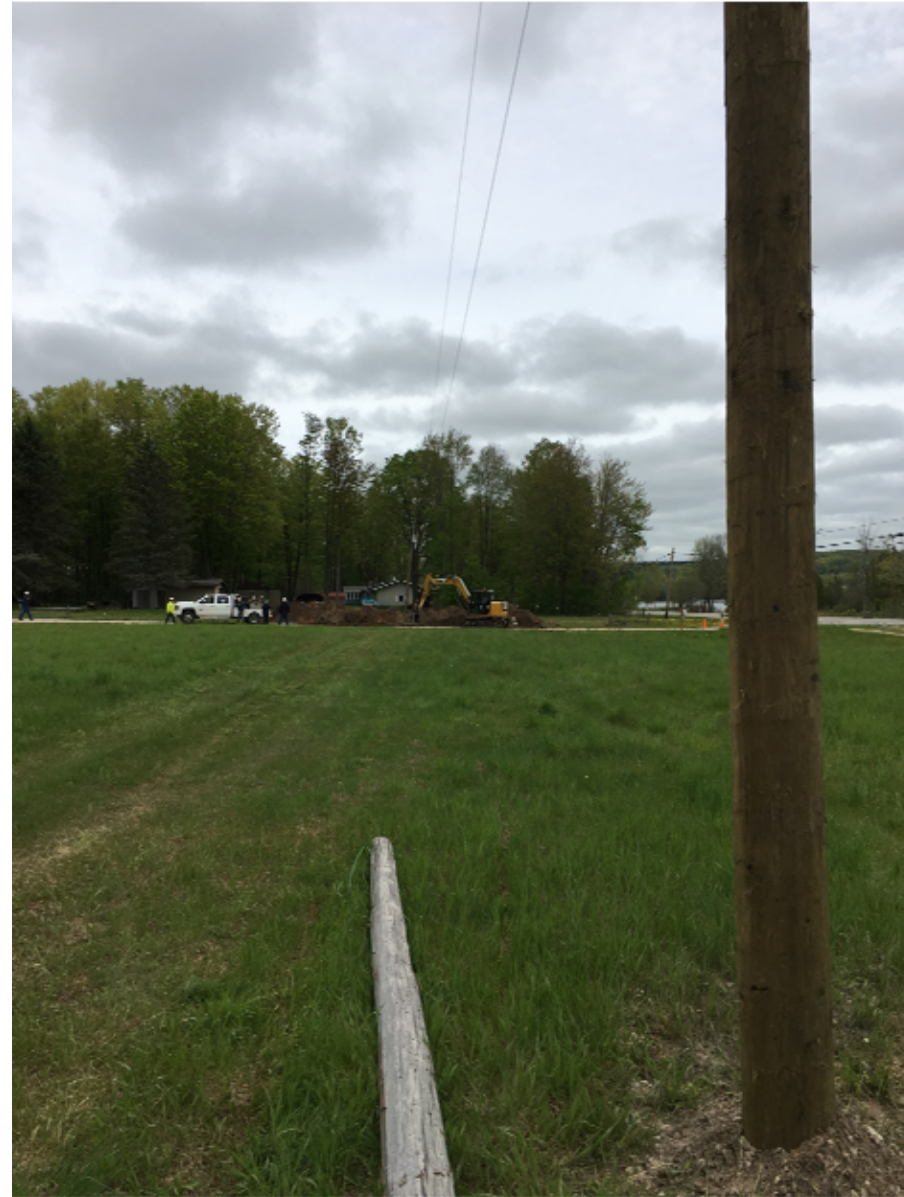
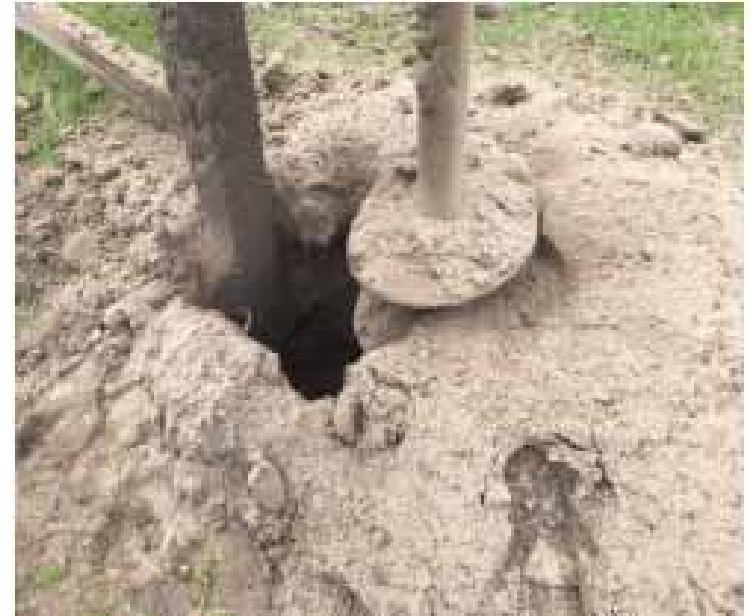
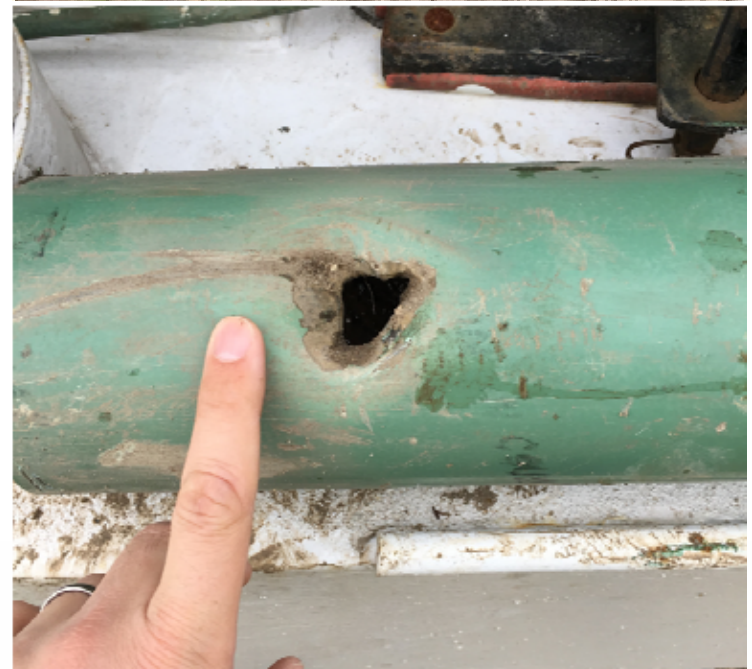
Significant Incident – 3342

- Type:
 - Third-party damage
- Characteristics:
 - 4" Steel Sales Line
 - ~1200 PSI
- Description:
 - Excavator was installing new power poles and had valid Miss Dig Ticket. Excavator requested and had a joint meet with Gas Operator staking contractor at project site.
 - Staking Contractor cleared ticket.

- Description (Continued):
 - Excavator struck and punctured pipeline while auguring for new power pole.
 - Immediate shutdown response by Gas Operator due to staffed compressor station near project site.
 - No injuries or ignition.

- Violations:
 - 192.614 (a): Failure to provide temporary marking of buried pipelines in the area of excavation activity before, as far as practical, the activity begins. Operators Staking Contractor did not fully investigate the extent of the project before clearing the request.

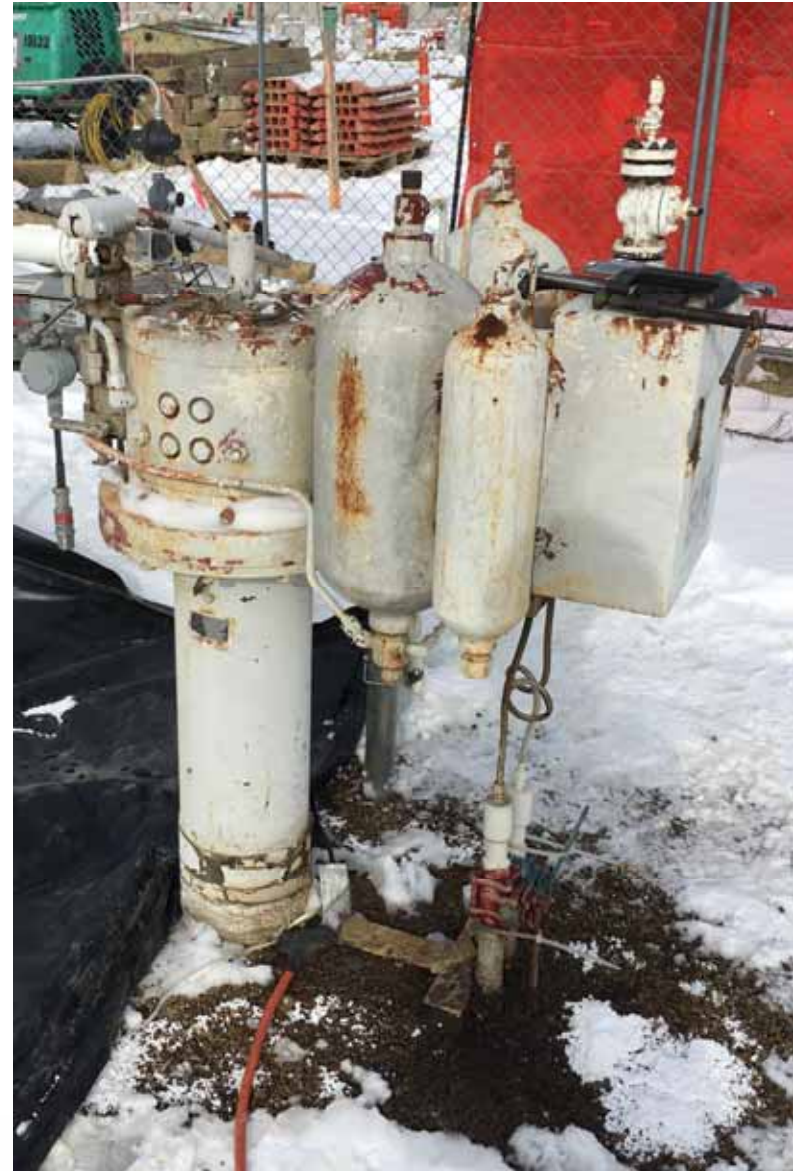
Significant Incident – 477834

- Type:
 - Compressor Emergency Shut-Down
- Characteristics:
 - Compressor Station Pilot Gas System
 - Gas Loss of 32.5 MMcf
- Description:
 - Catalytic heater failed, allowing regulator on pilot gas system to freeze.
 - Slow leaks on pilot gas system caused pressure drop, simulating activation of ESD system, causing blowdown valves to activate.
 - While attempting to restore facility, a blowdown valve stuck open and could not be closed by the responding technician.

- Technician pulled ESD to stop gas flow, and one of the isolation valves failed to close.
- Recommend operator repair leaks on the pilot gas system.
- Recommend operator repair catalytic heaters or replace with equipment better-suited for the operating conditions.

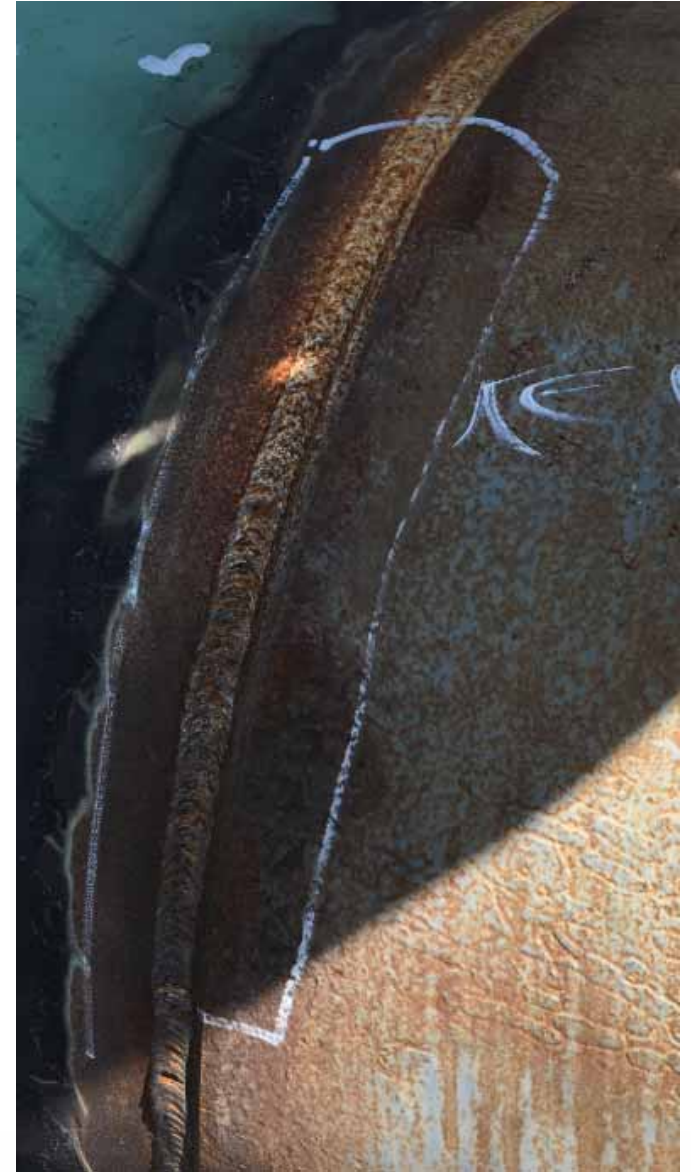
- 192.303: Failure to follow construction procedures during an isolation procedure causing outage to 197 customers.
- 192.303: Failure to follow API 1104 as required in construction procedures. Section 7.8.2 of API 1104 does not allow the crown surface to fall below the outside surface of the pipe.

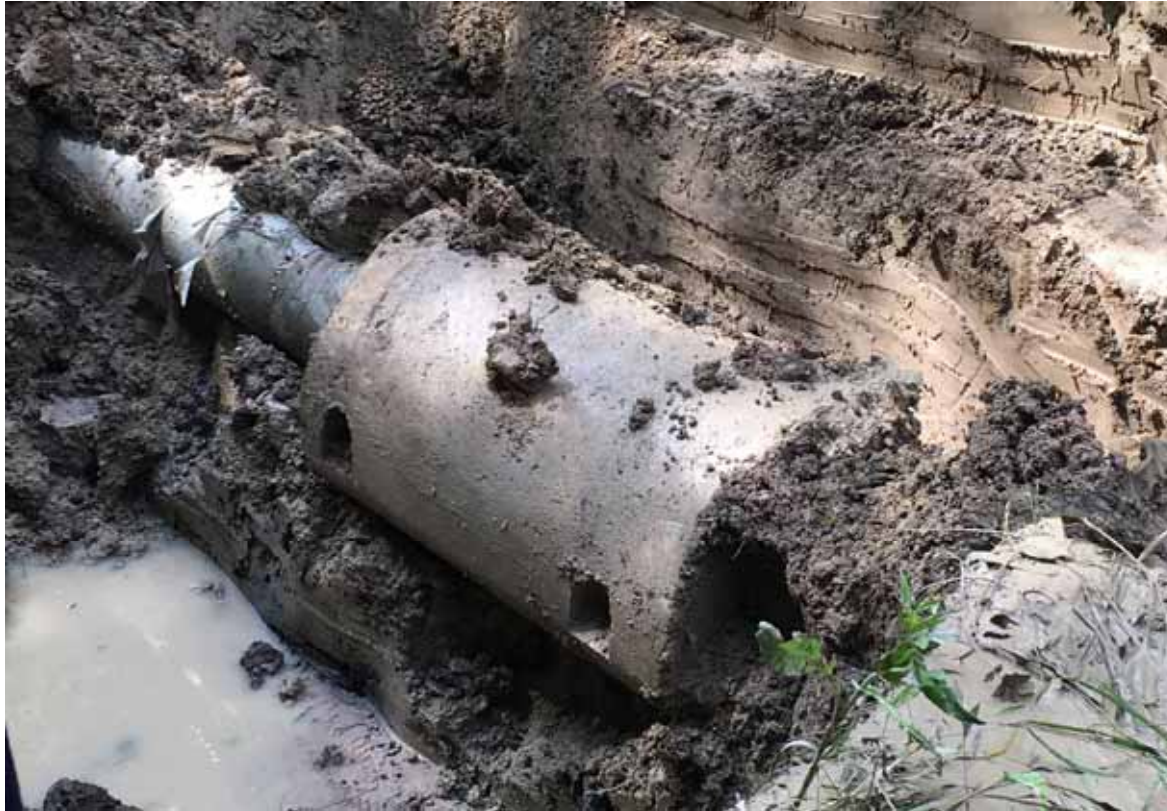
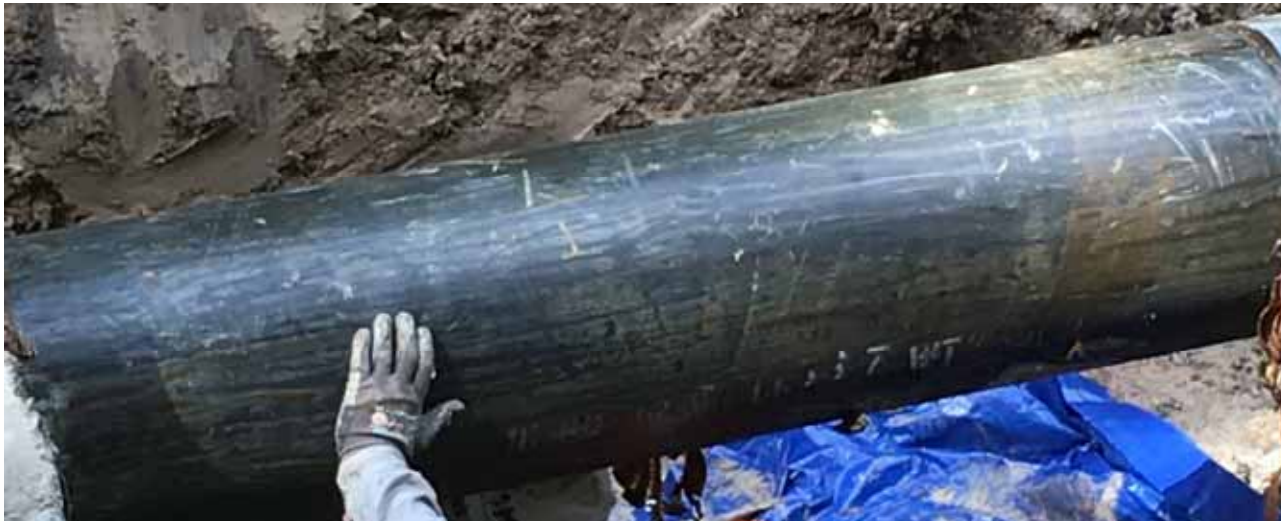
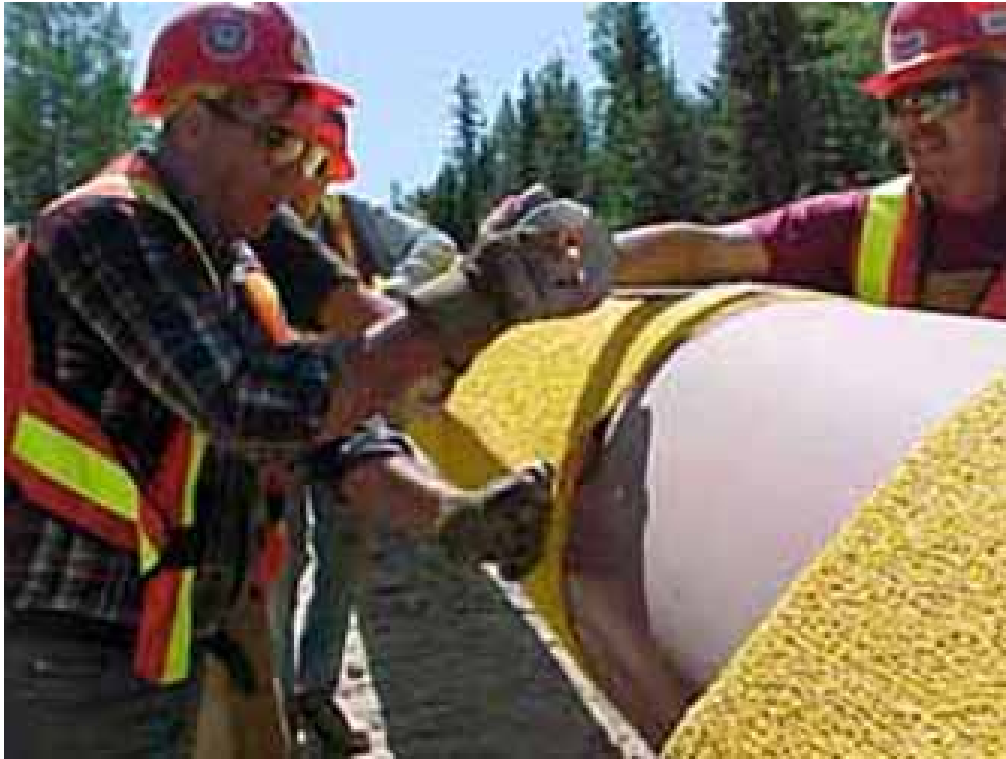
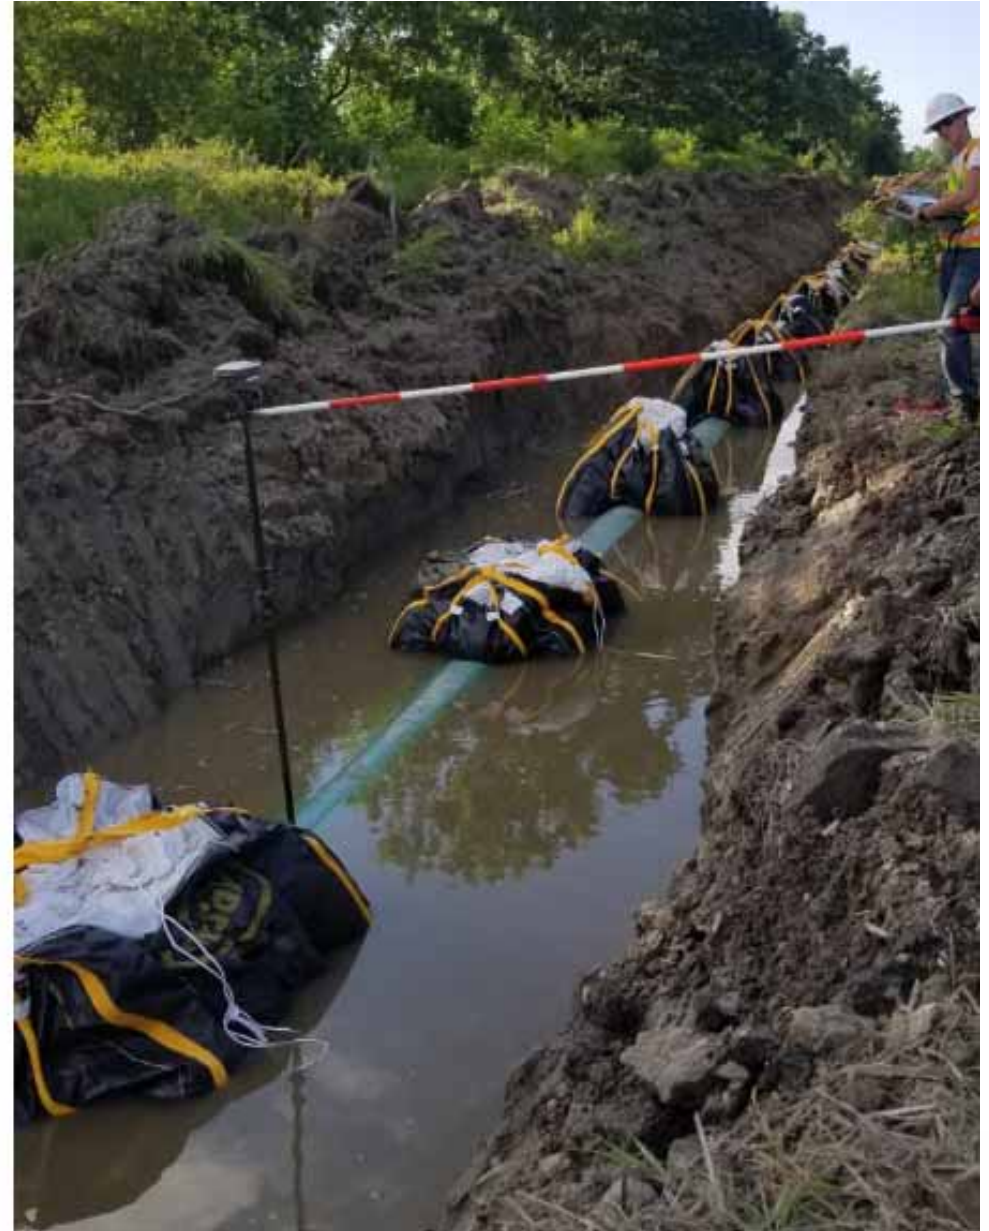
Significant Incident – 3484

- Type:
 - Transmission Leak
- Characteristics:
 - 16” line installed in 1968.
 - MAOP 913 psig, OP 495 psig at incident
 - 3.5 days from discovery to normal operation
- Description:
 - Leak located at creek crossing under 6’ of water.
 - External corrosion leak located under concrete swamp weight. Coating damage and disbondment.

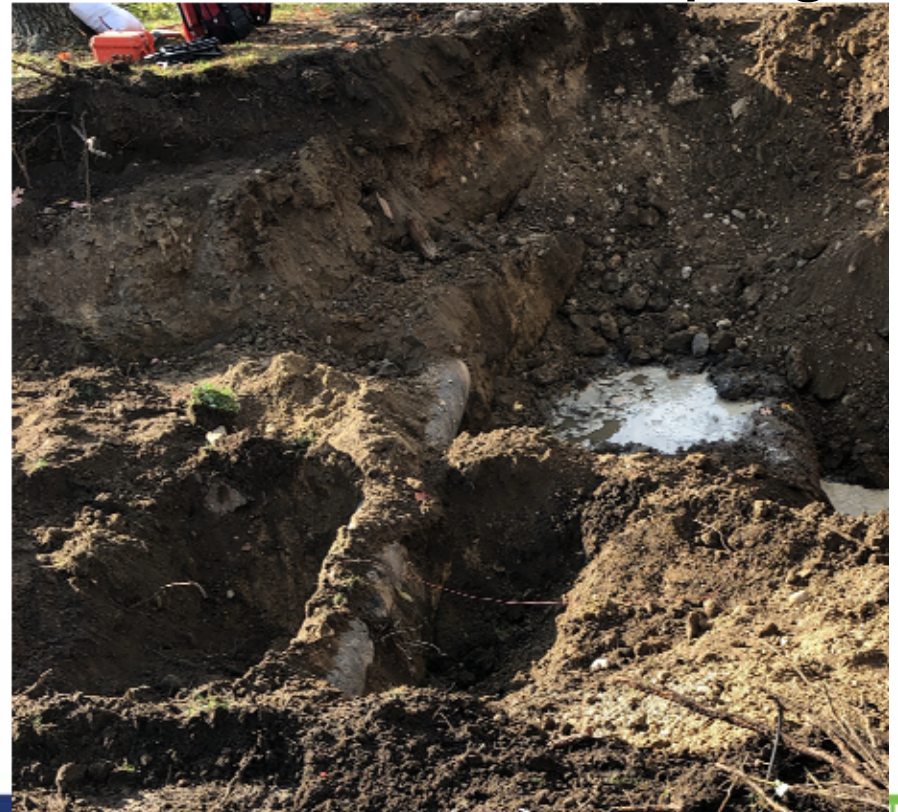
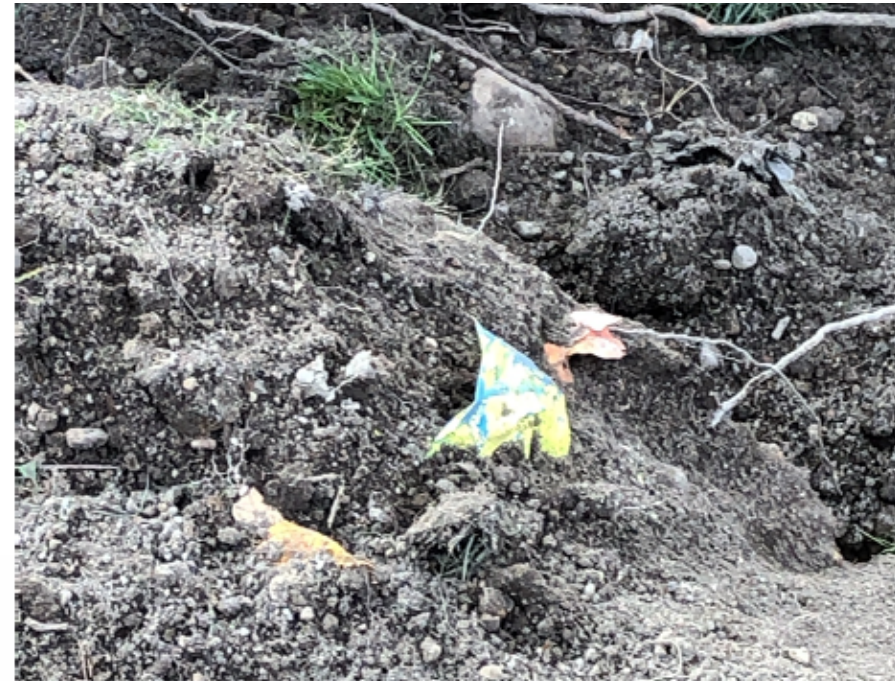
Significant Incident – 3914

- Type:
 - Third Party Damage
- Characteristics:
 - Service tee pulled from 12” main, OP 100 psig
- Description:
 - Main was marked, service was not
 - Temporary plug welded in and PLICO installed for permanent repair.

- Violations:
 - 192.614 – Failure to carry out a written program to prevent damage to pipelines from excavation activities.
- Warning:
 - MCL 460.725(9) - Failure to provide additional notice and failure to stop excavation when there is visible evidence of a facility with no marks visible.

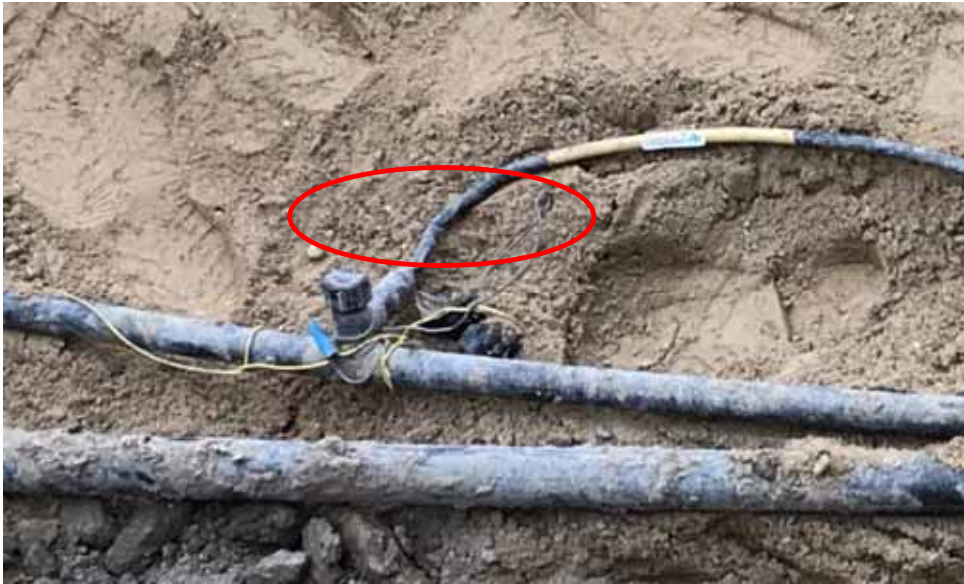
Location of cut by contractor

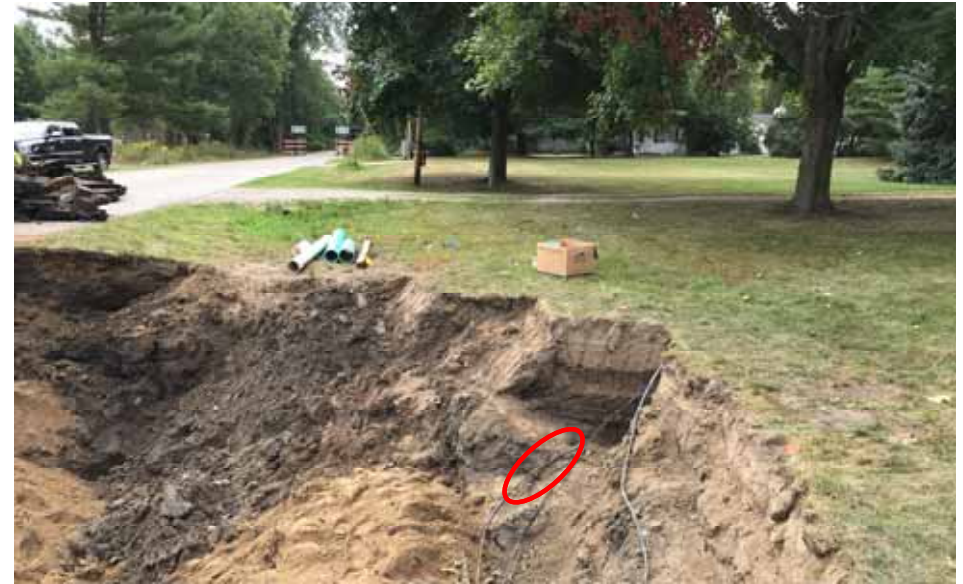
End of damaged service

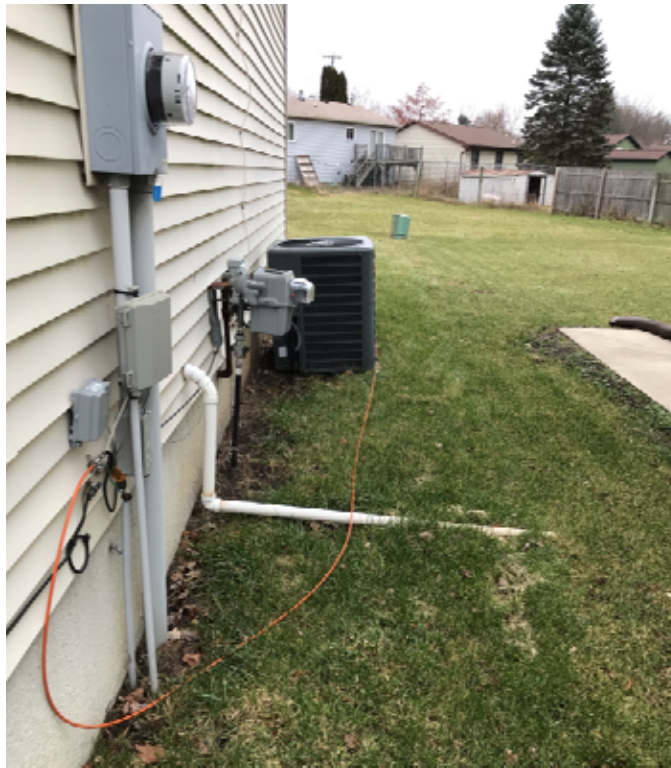
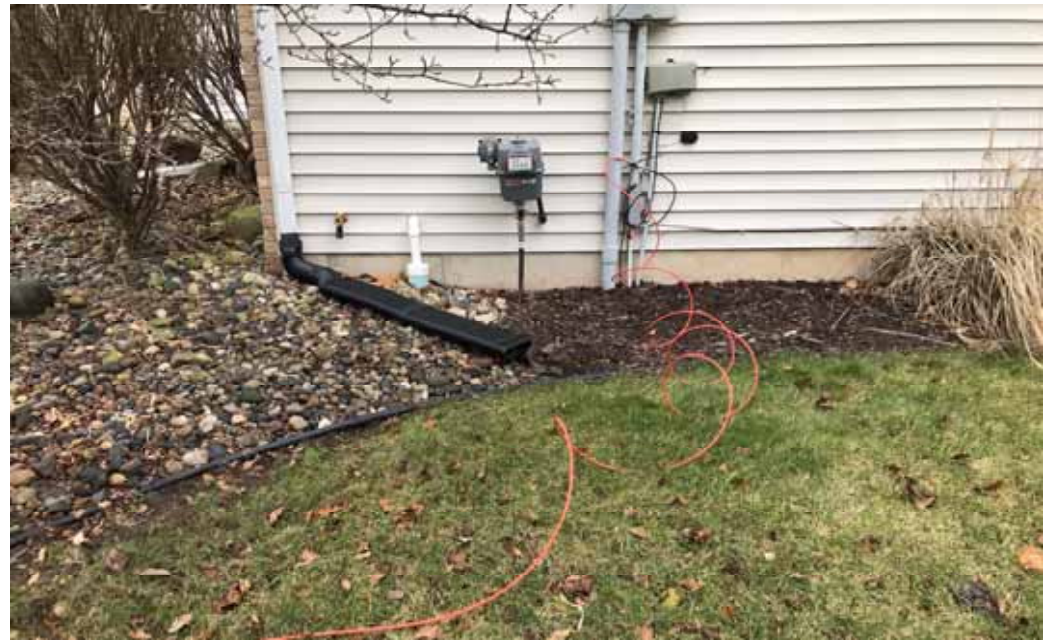
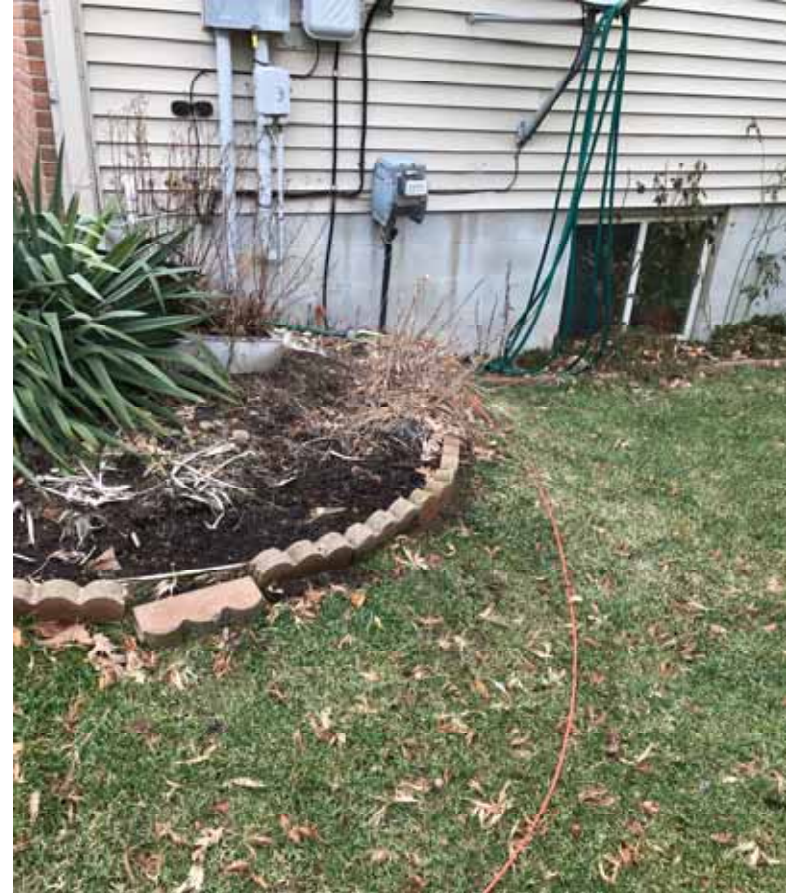
Significant Incident – 4081

- Type:
 - PA 174 Inspection
- Characteristics:
 - Gas Service line
- Description:
 - Gas operator marking 001 (no conflict) when facilities are near an excavation area
- Violations:
 - Ongoing investigation

- Related issues
 - Excavator boring telecom cables without positive response on a consistent basis
 - Operator responding with 001 (no conflict), but including pictures of bored cables near their facilities

- Operator Violations:
 - MCL 460.727(1) – Failure to respond to a ticket by the start date and time for the excavation or blasting by marking facilities in the area of the proposed excavation or blasting in a manner that permits the excavator to employ soft excavation to establish the precise location of the facilities.
