2022 Communication Meeting

Michigan Public Service Commission
Energy Operations Division

Gas Safety Program Updates

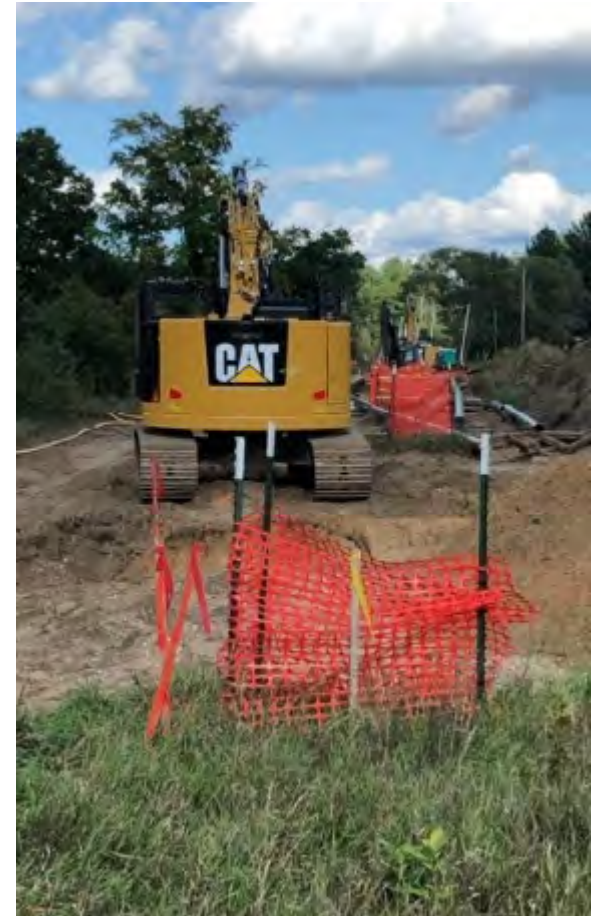
Significant Incident – 6352/6670

- 2nd Party Damage
- Characteristics
 - 6" Plastic Main
 - \$26,300 damages
- Description
 - New pipeline was being installed parallel to existing distribution main.
 - Excavator operator attempted to clean up bench of excavation to stabilize slope.
 - Bucket struck and hooked onto main, causing tear.
 - Had spotter during initial excavation, but did not have one at moment of damage.
 - Utilities were marked and physically located every ~50'.
 - MCL 460.725(5) – Failure to expose all marked facilities in the caution zone by soft excavation.

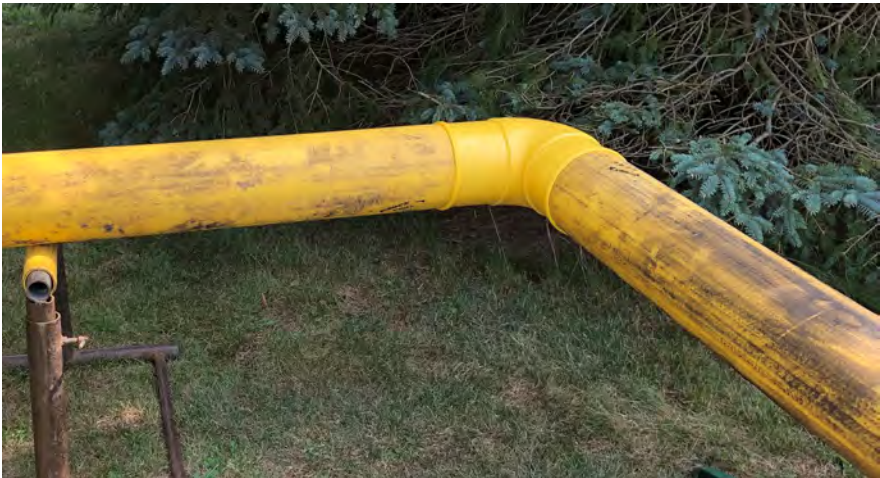
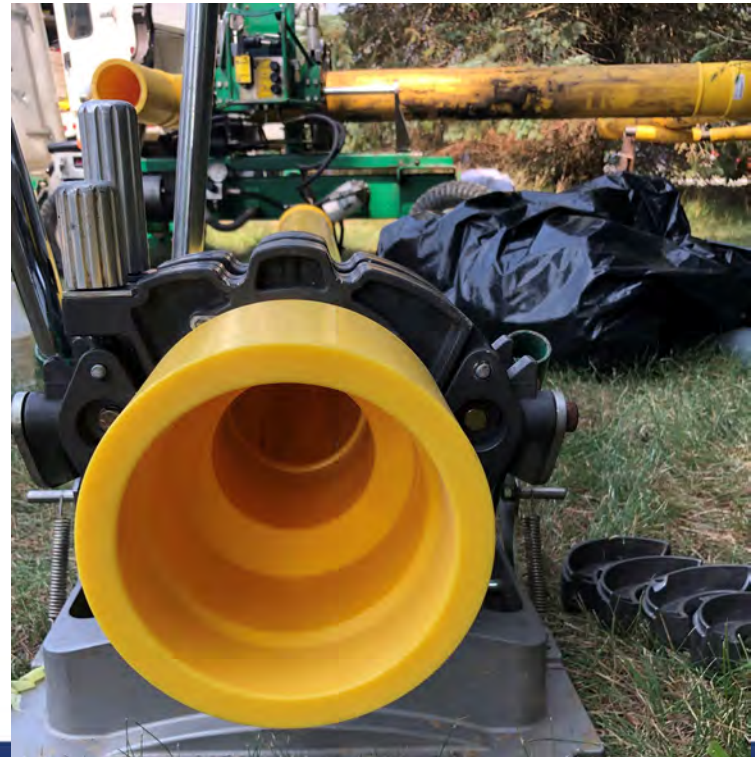
- 192.273(b)– Failure to make each joint in accordance with written procedures that have been proven by test or experience to produce strong gastight joints.

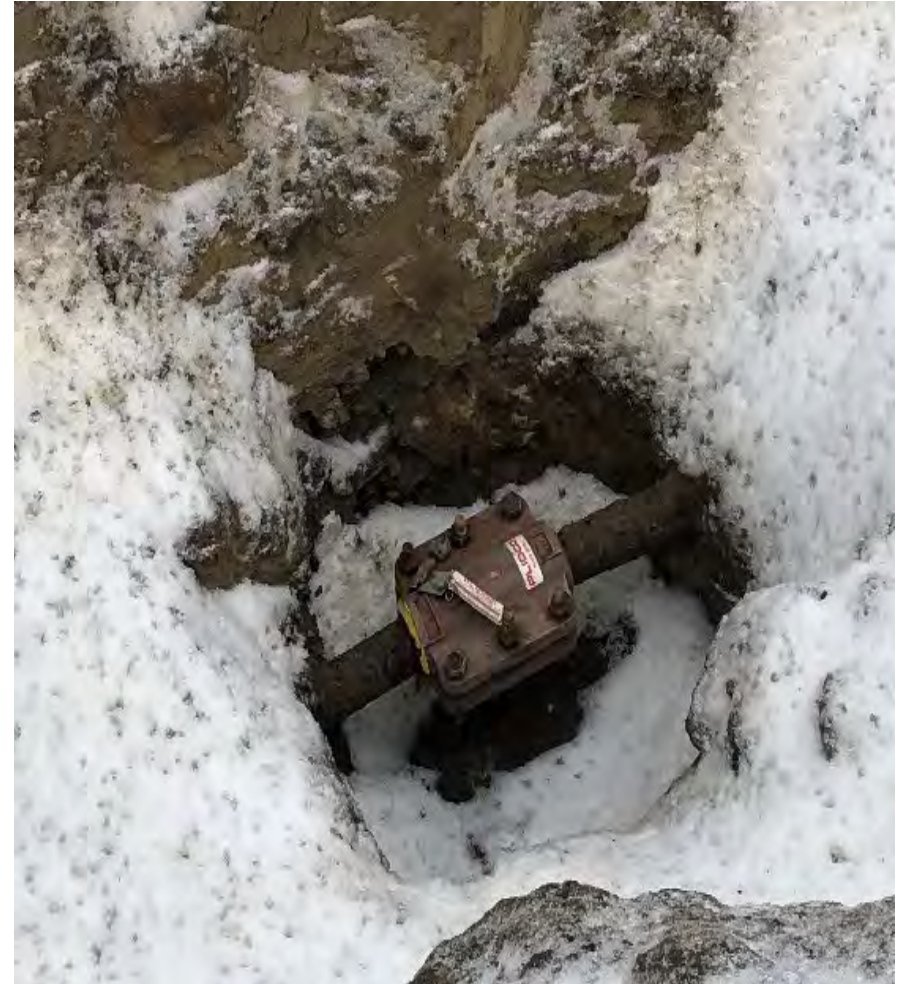
Significant Incident – 5669

- Distribution Leak
- Characteristics
 - 2" steel distribution main.
 - \$126,698.
- Description
 - Initial leak repaired with clamp.
 - Several other leaks found, main partially replaced.
 - Recommendations.

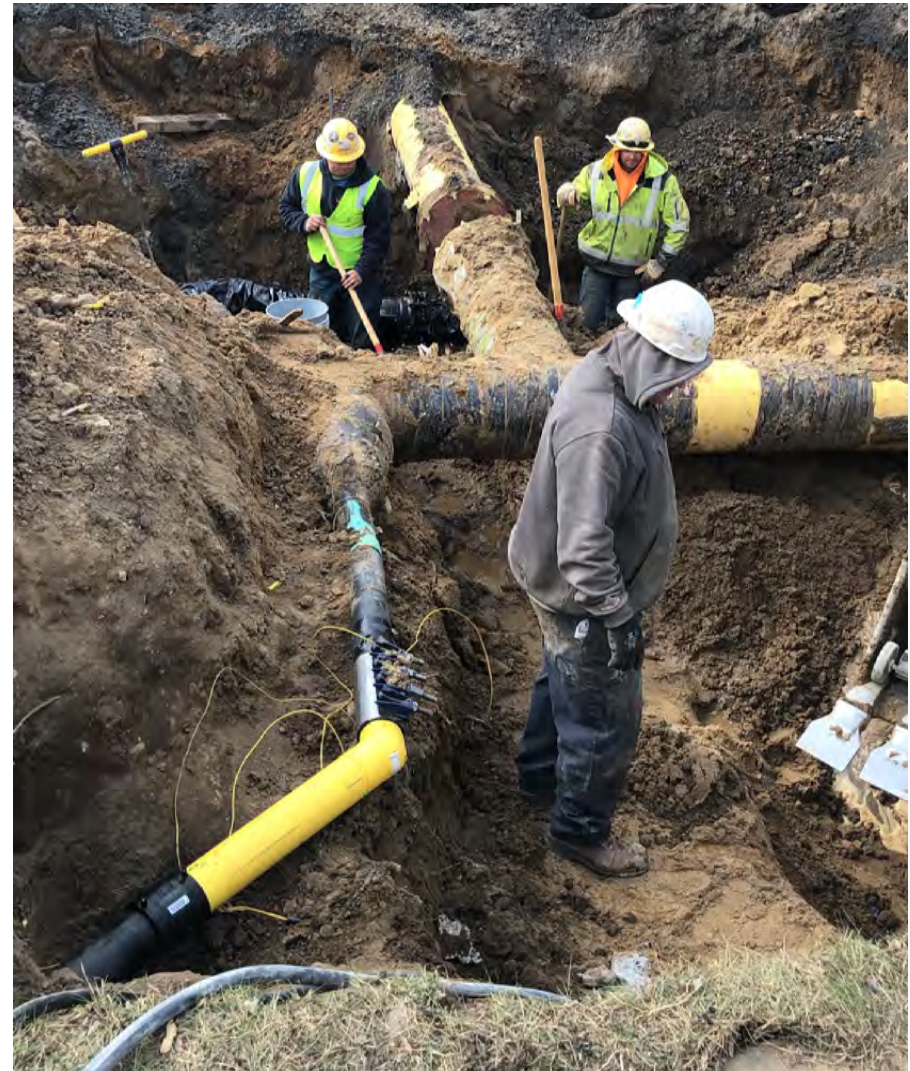
Significant Incident – 5819

- Third Party Damage
- Characteristics
 - 4" steel distribution main
 - Low pressure
- Description
 - Staking error, main not marked.
 - Violations:
192.614(c)(5) – Failure to provide temporary marking of buried pipelines.

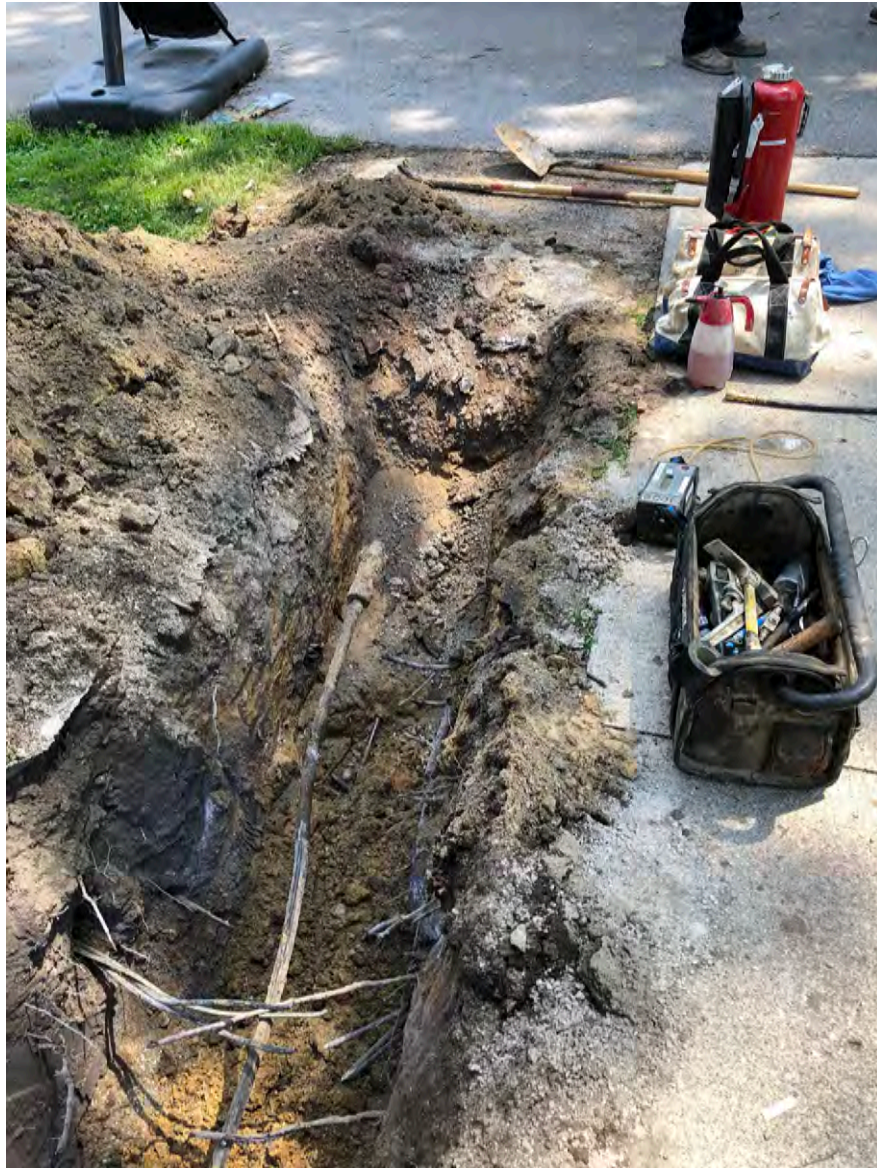
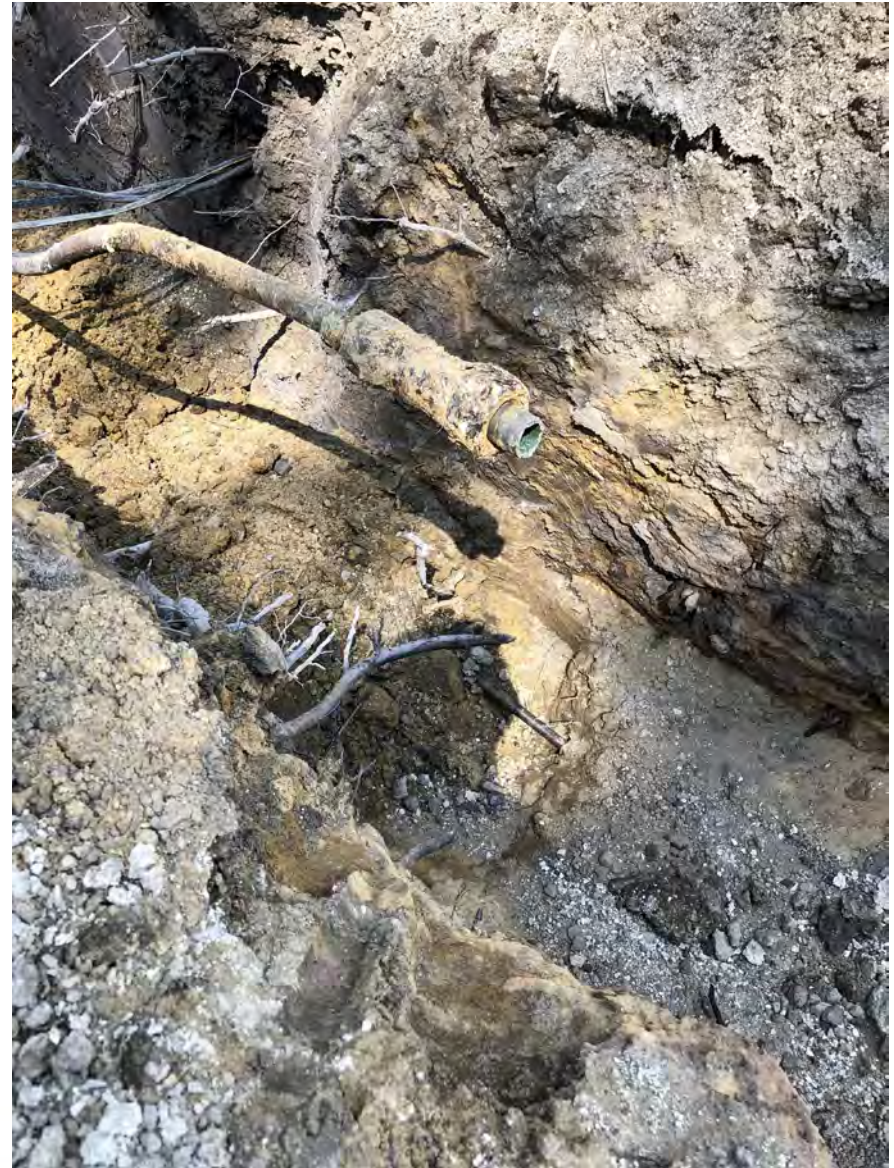
Significant Incident – 6211 (Cont.)

- First Party Damage: release, ignition & injury
- Characteristics
 - Suburban steel distribution, 10 psig main/service
 - MMO & service renewal for a single-family house
 - Gas worker is burned & hospitalized overnight
- Description
 - Service severed near main by back-hoe bucket
 - E-power lines too; co-worker 700' away
 - Ongoing Investigation

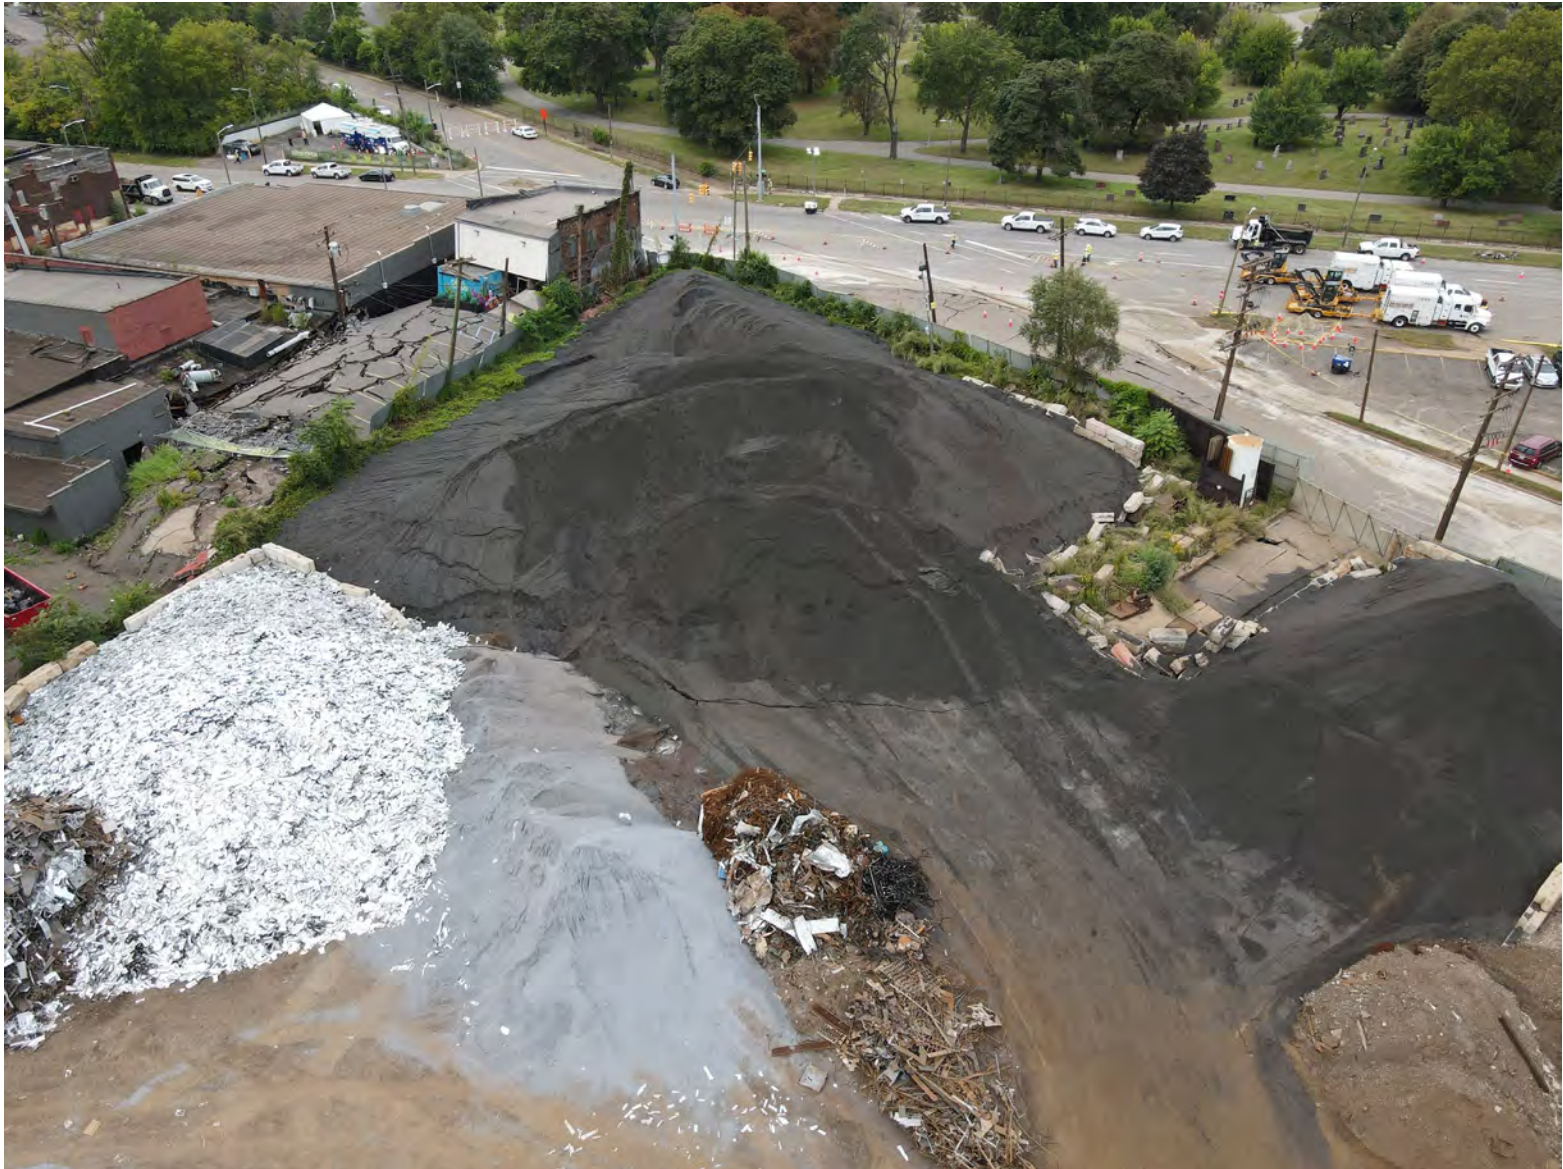
Significant Incident – 6377 (Cont.)

- Outside Force Damage, near-by gravitational surface loads cause ground upheaval
- Characteristics
 - Urban steel, cast iron & plastic distribution lines
 - MAOP's of 2, 10, 99 & 145 psig in the area
 - Leaks occur & damages cost \$2,000,000
- Description
 - Metal scrap yard particle piles overloaded subgrade soft clays; adjacent building & road ROW upheaved; several utilities impacted
 - Ongoing Investigation

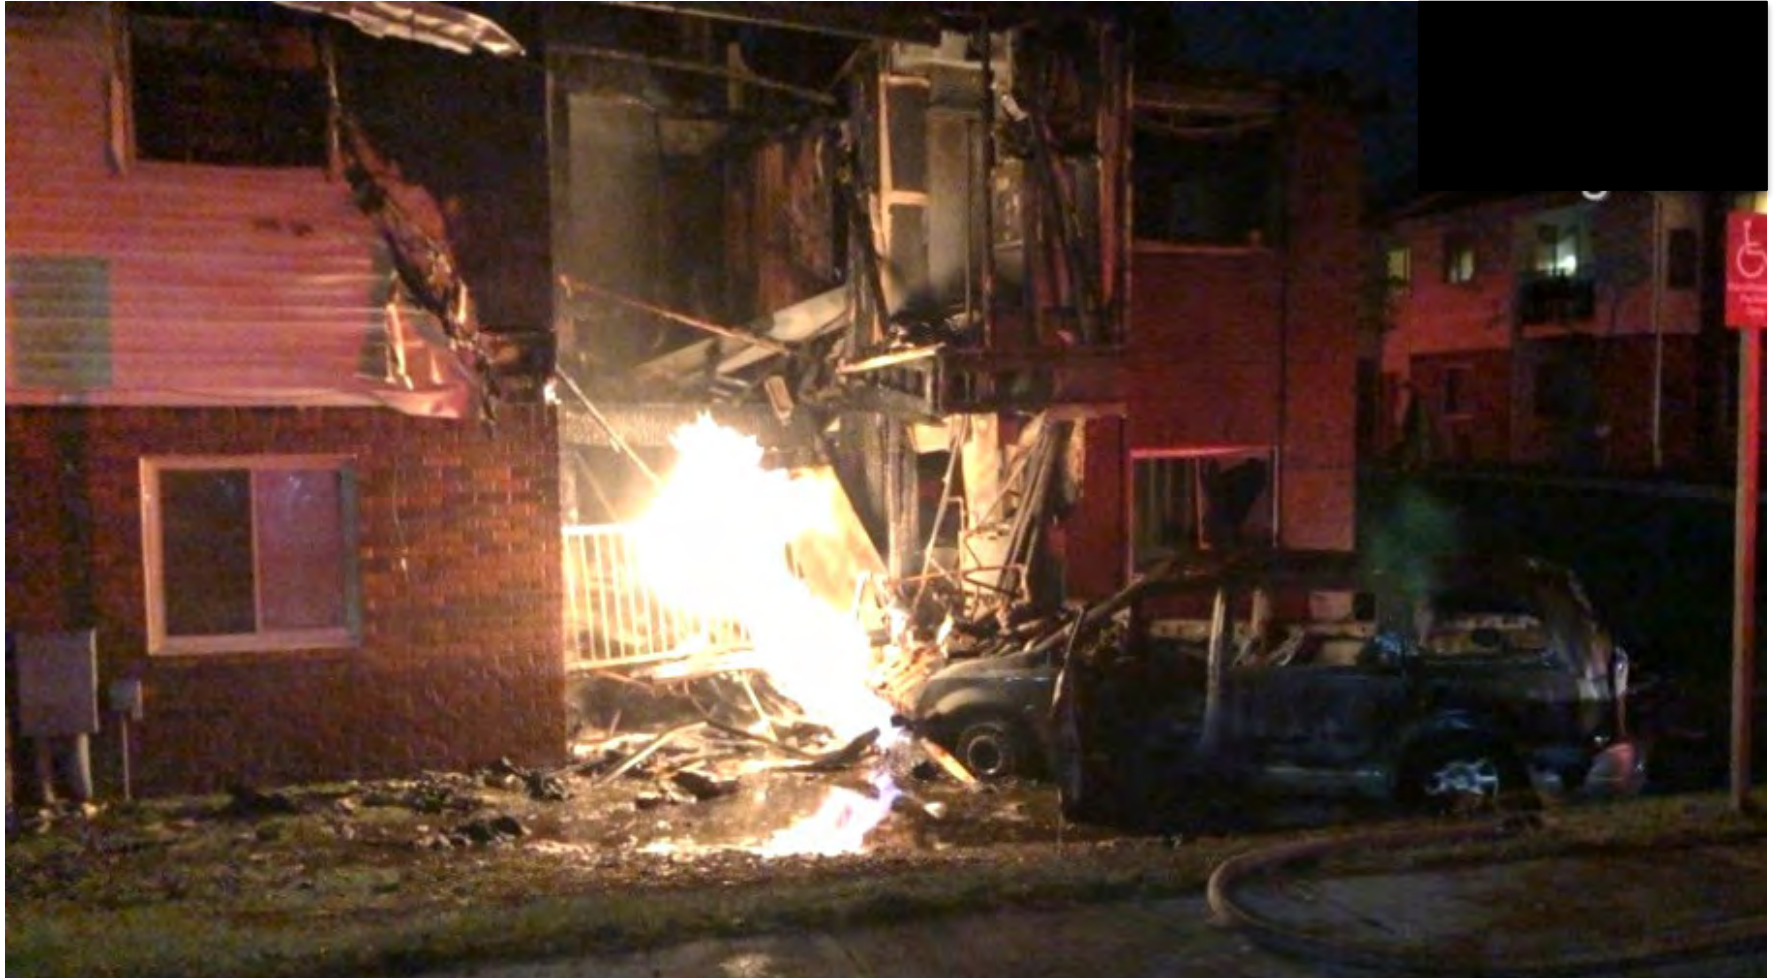
Significant Incident – 5848 (Cont.)

- Apartment Fire due to vehicle damage
- Characteristics
 - 3” plastic service & meter bank installed in 1977
 - 10 psig MAOP
- Description
 - Vehicle left parking lot and drove ~50’ down embankment prior to hitting meter bank.
 - 1 fatality.
 - Gas ignited causing fire damage to 5 units.
 - 22 evacuations.
 - Gas blew for 5 hours and 27 min.
 - R 460.20501(2)(a) – Inaccurate maps. Distribution map did not show 2-way feed.

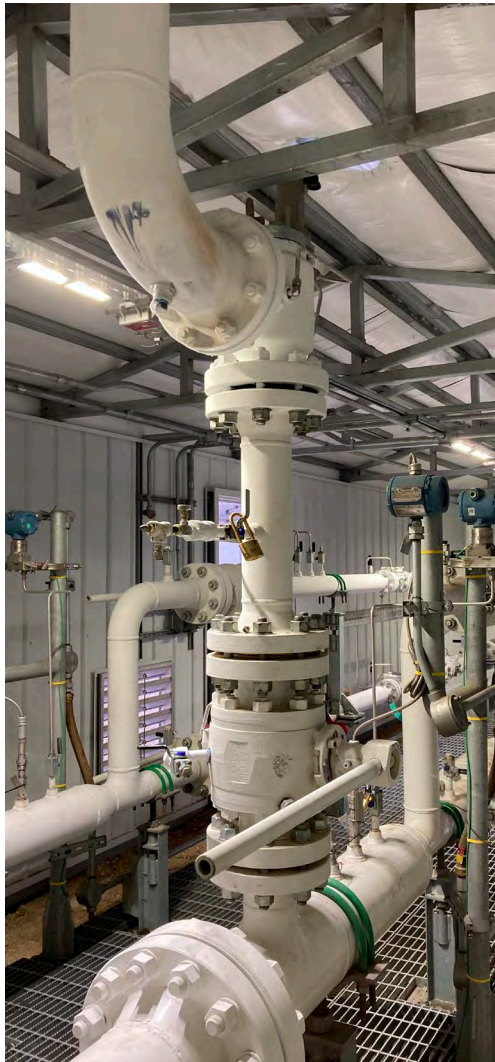
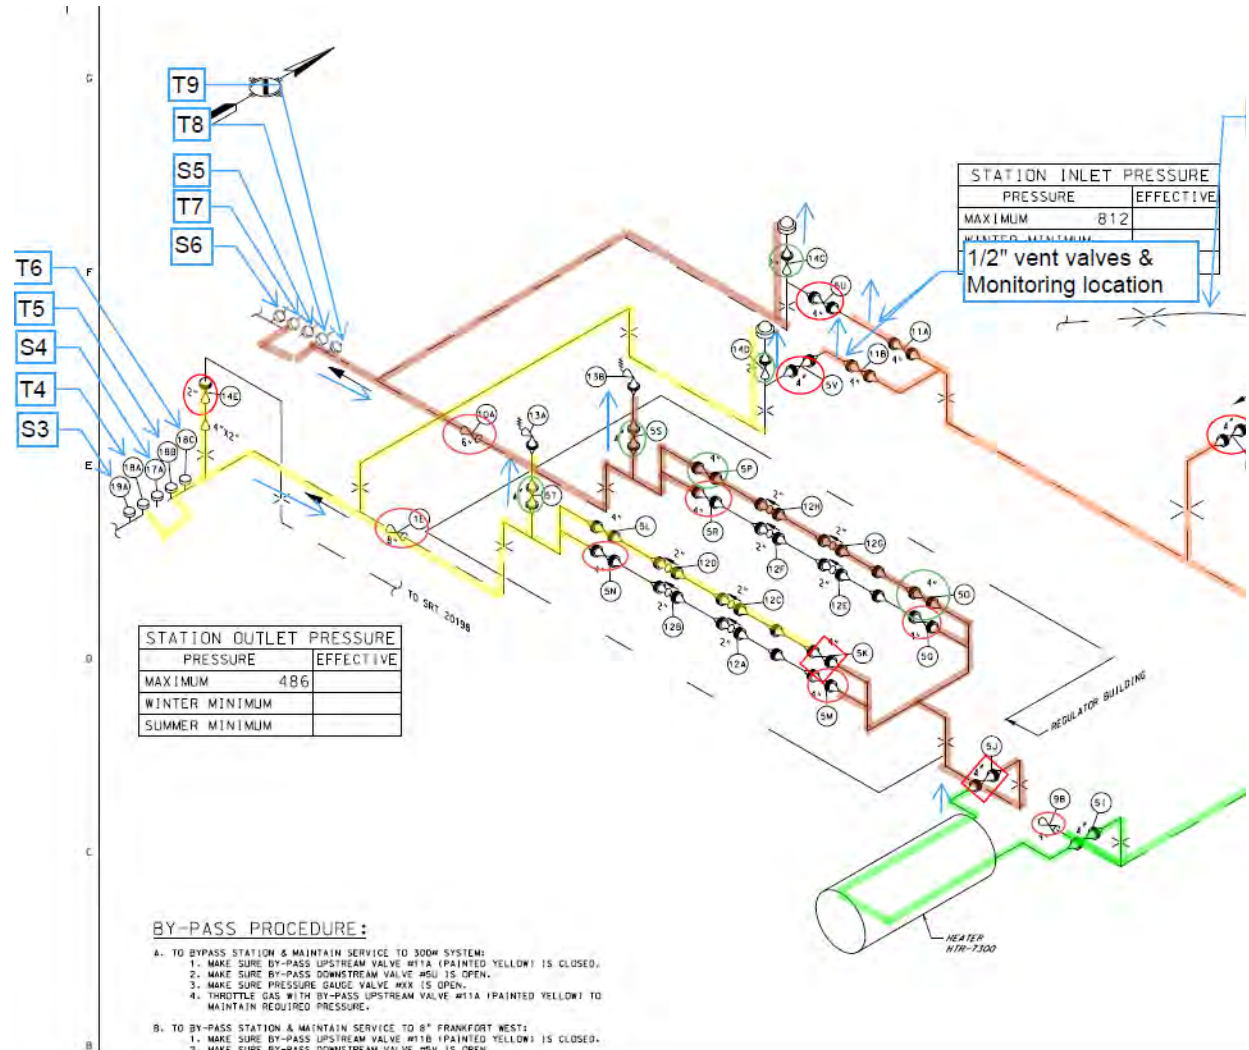
Significant Incident – 6487 (Cont.)

- Venting Relief Valve
- Characteristics
 - Existing 8" transmission line (812 psig MAOP) to be derated to a distribution main (486 psig MAOP).
 - 2021 newly constructed Regulating Station with RV set at 507 psig to protect the derated 8" distribution main.
- Description
 - Line returned to service prior to deration occurring.
 - RV was not isolated. 8.83 Mmcf gas loss
 - Ongoing investigation

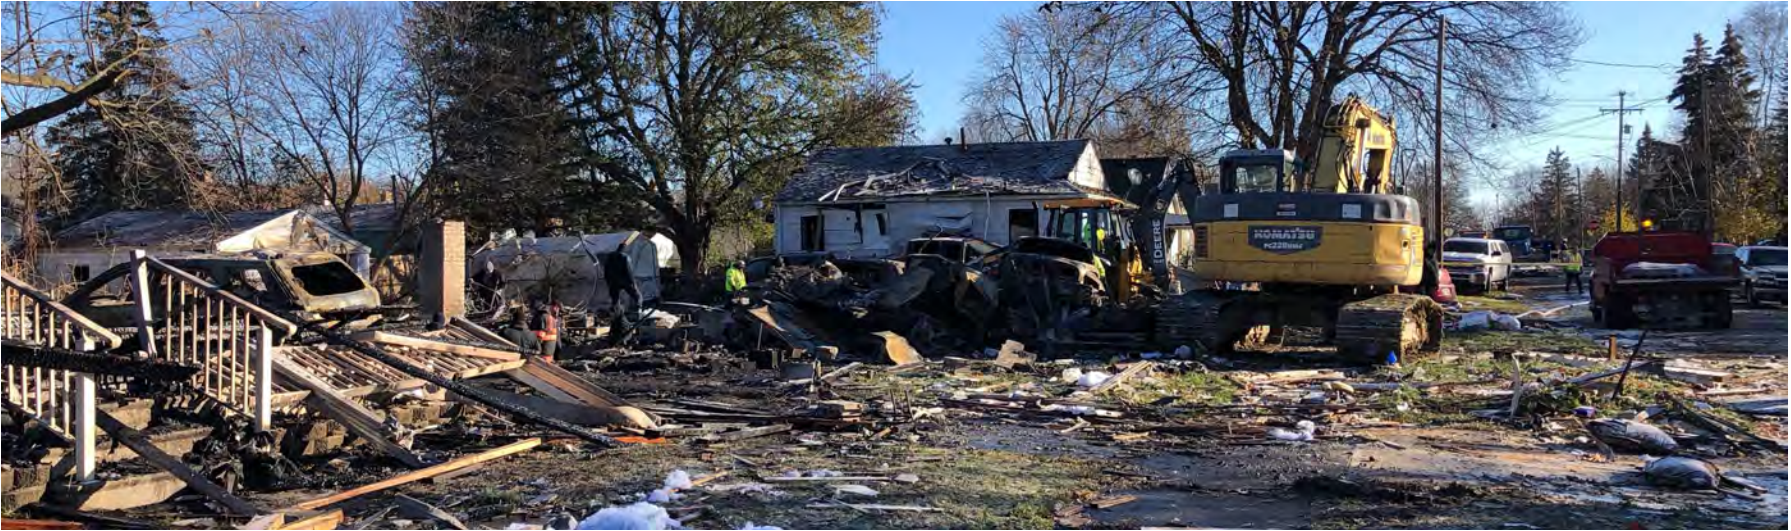
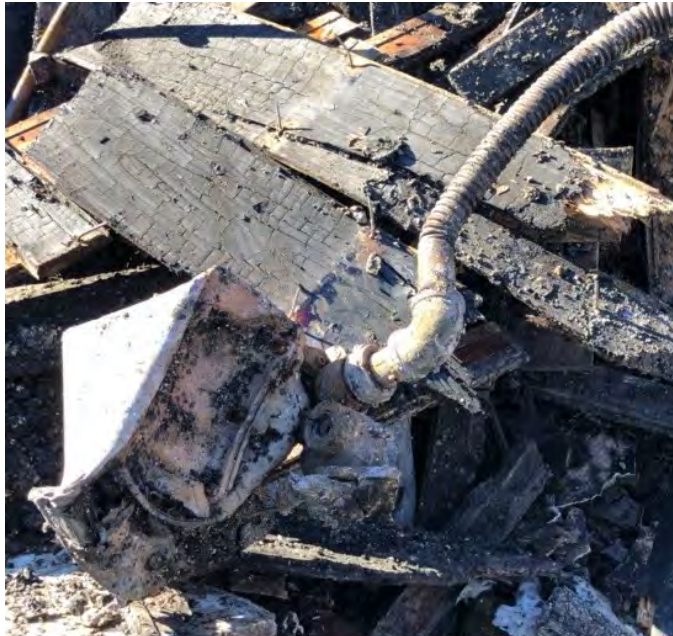
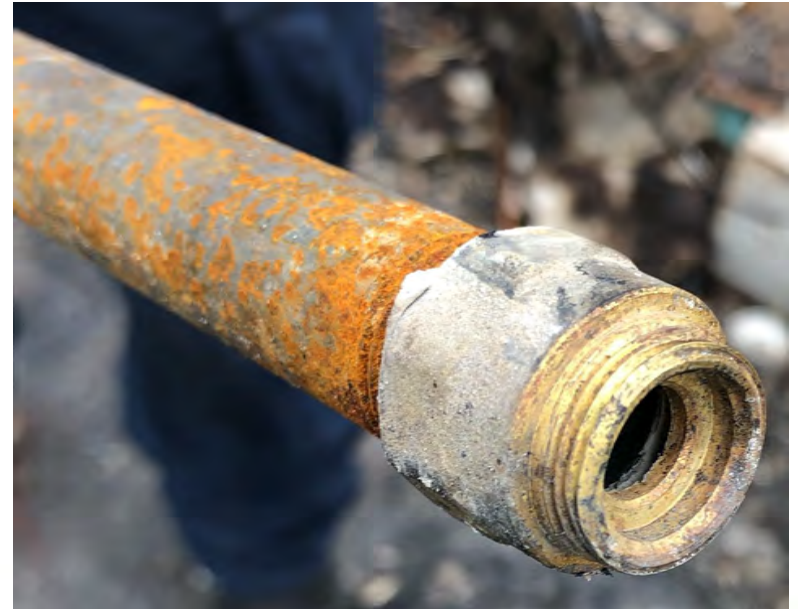
Significant Incident – 6541 (Cont.)

- House explosion with secondary ignition
- Characteristics
 - 1979 1” plastic service
 - \$256,184 damages
 - 2 fatalities & 1 injury
 - 36 houses damaged, including 2 nearby fires
 - 25 outages
- Description
 - Unthreaded fuel line discovered near furnace.
 - Ongoing investigation

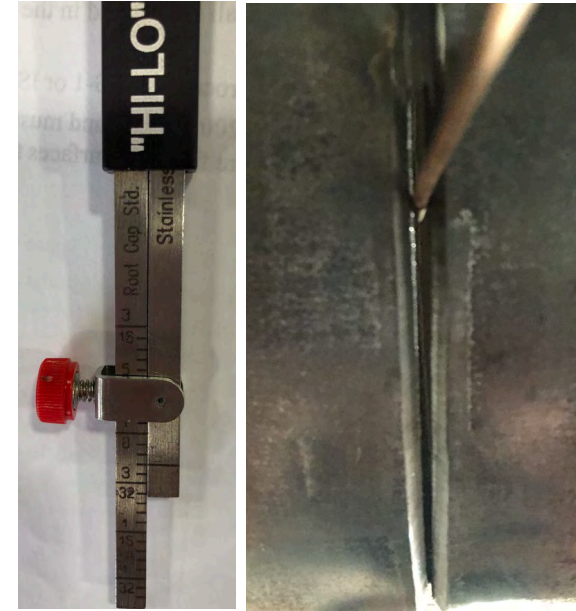
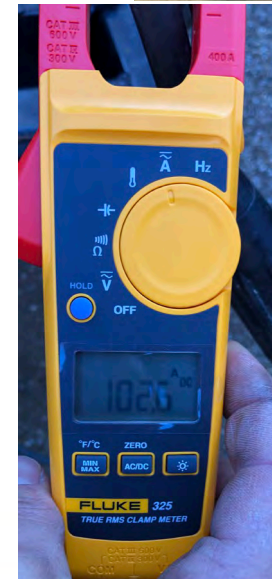
- 192.227(a) – Failure to qualify welders in accordance with API 1104. Welder's amps below range specified and root opening too large.
- 192.241(a)(1) – CWI did not enforce the WPS.
- 192.225(b) – Failure to follow WPS. Welder used wrong size electrode.

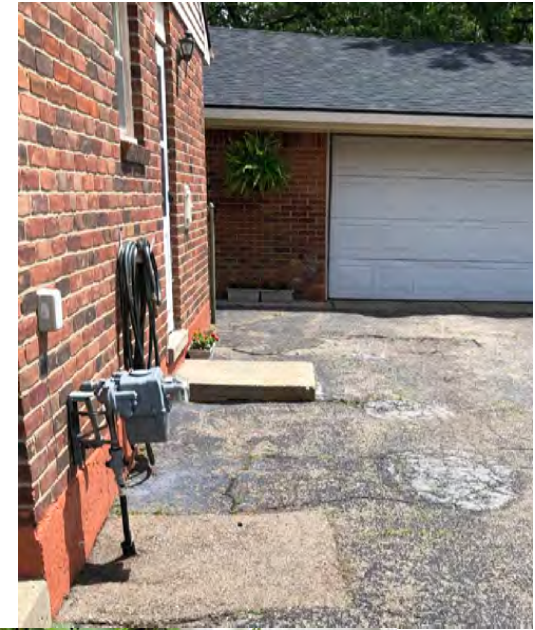
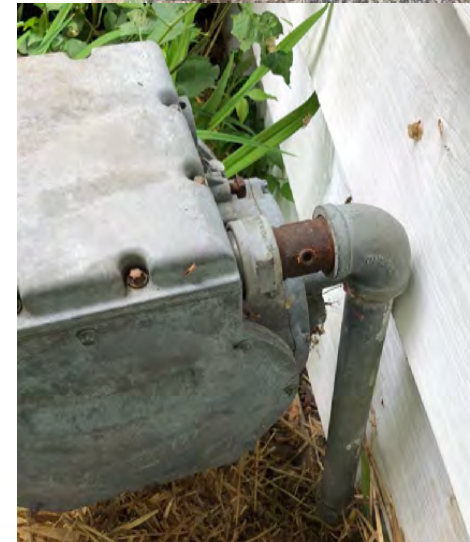
Leak Survey Observations:

- R 460.20308(c) – Failure to identify lack of meter support.
- R 460.20308(d) – Failure to identify lack of meter protection.
- 192.723(b)(2) – Missing leak survey frequency due to inaccurate mapping.
