Distribution Incident History

October 8, 2019

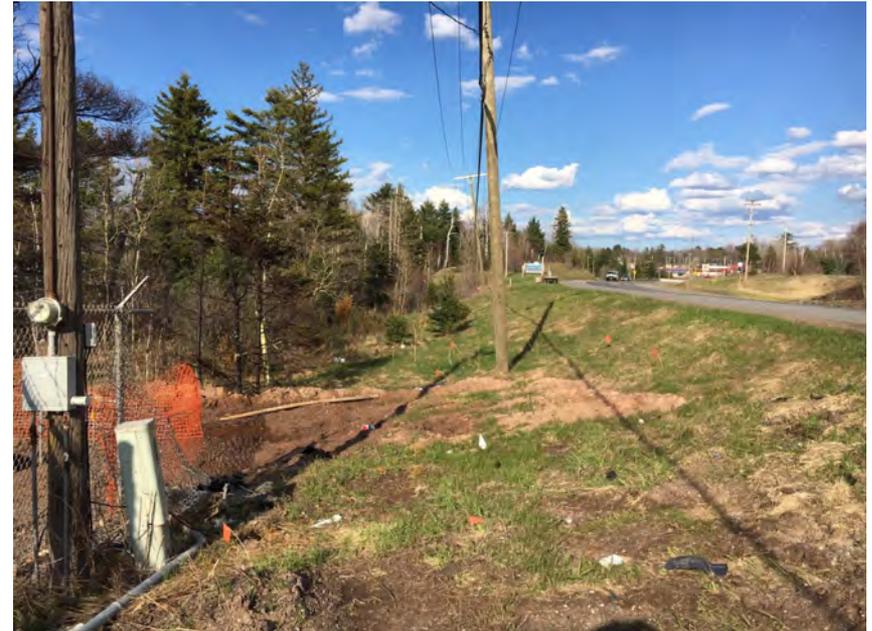
2016 Incident – 381330

- Vehicle exits road and strikes an above ground regulator station, escaping gas ignites.
- Driver was fatigued; injured, but not hospitalized.
- 1,193 customers lost, \$500,800 in damages.
- 38 hours between the incident and completing the first attempt on relights.
- 192.317(b): Not protecting gas facilities from outside force.

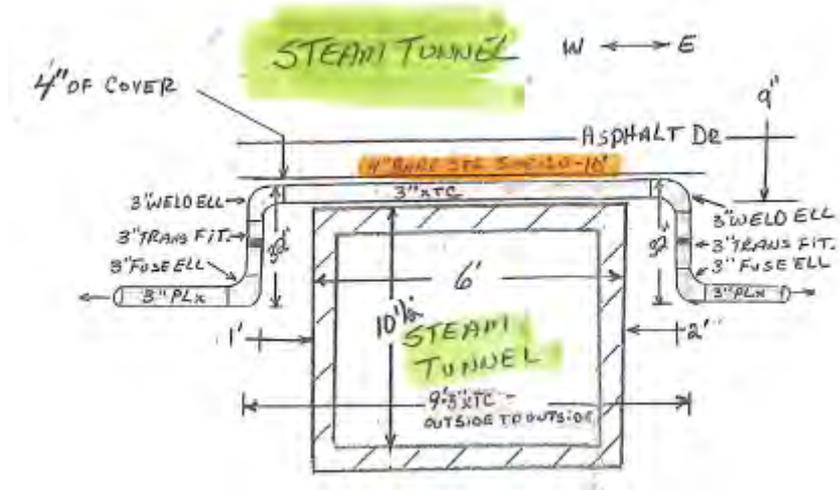
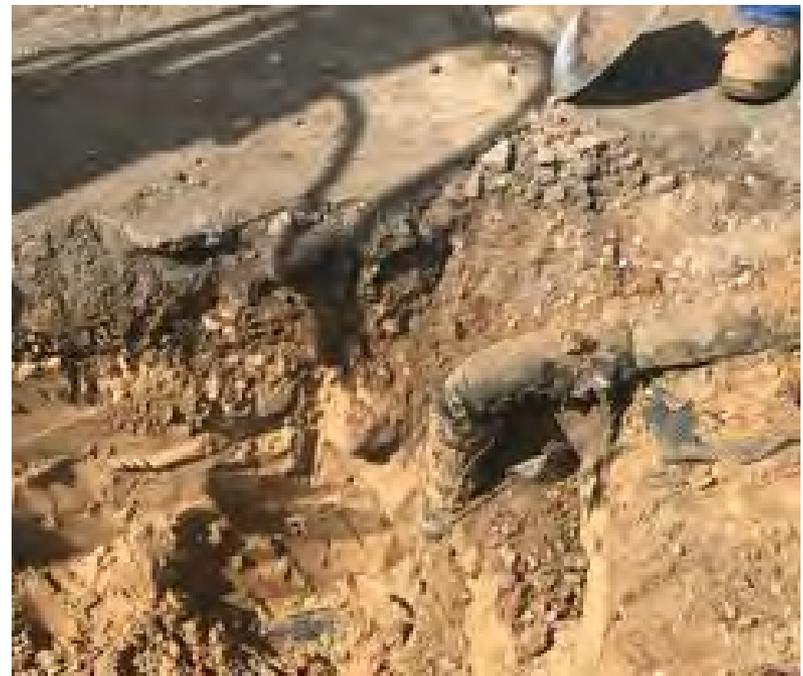
2017 Incident – 411427

- Excavator cut through a 3-inch gas service with an asphalt saw to remove sidewalk.
- Gas service line was marked but was less than 1-foot deep at damage location.
- Rule 460.725(5): Failure to expose the marked facility in the caution zone by soft excavation prior to using power equipment.

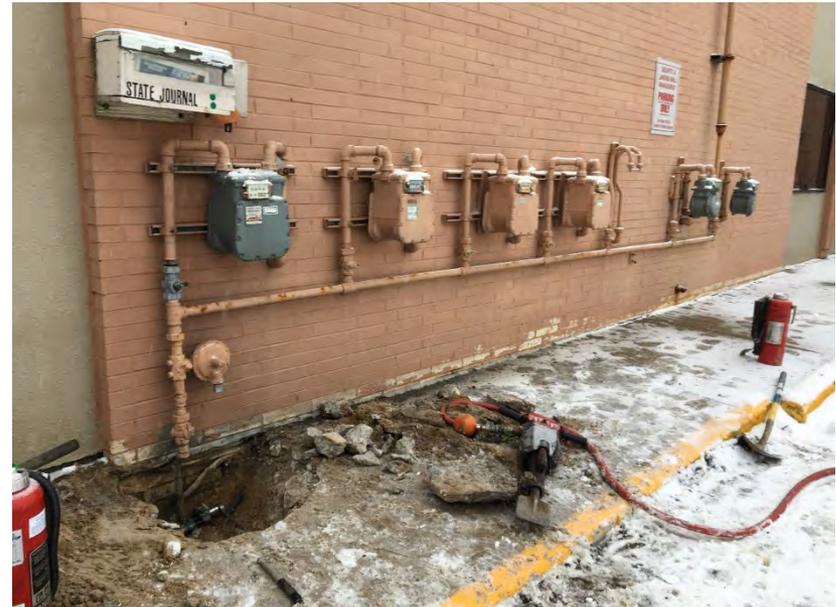
2017 Incident – 401625

- Snowplow hit mall meter bank.
- Meter bank was not protected from vehicular damage.
- Similar incident occurred in 2013, where operator recommended that mall management install meter protection.
- Rule 460.20308(d): Failure to install a meter and service regulator in a readily accessible location and protect the meter and regulator from corrosion and other damage.

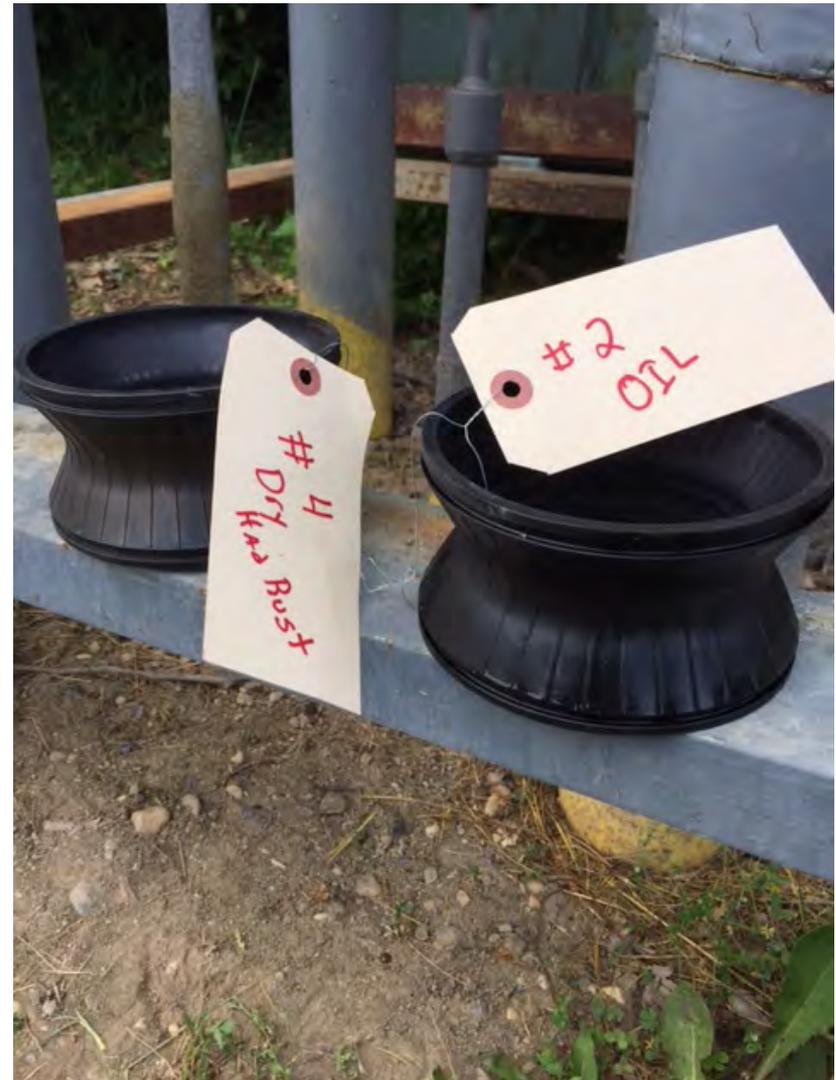
2017 Incident – 416425

- Distribution overpressure due to working-monitor regulator failure.
- History of oil accumulation.
- Recommend operator ensure procedures are in place to promptly dispatch personnel and consider drive time when dispatching emergency personal to report to an emergency.
- 2 hour, 35 minute delay in dispatching, technician lived 1 hour away from the site.

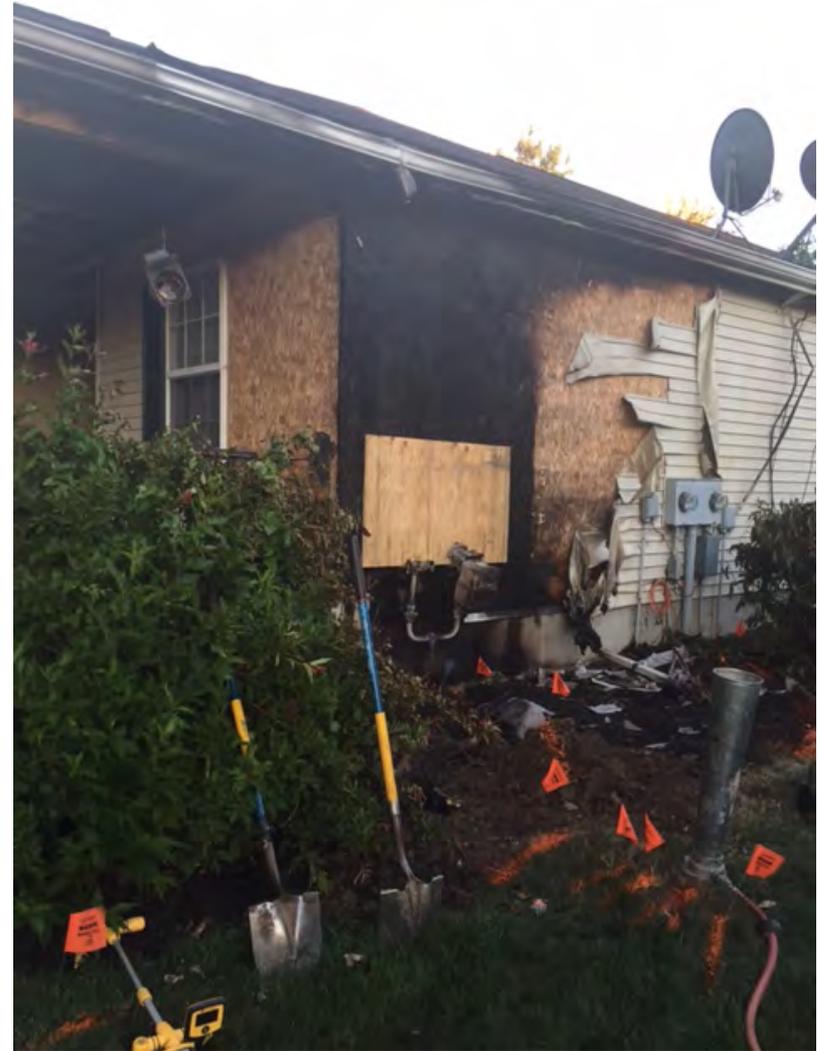
2017 Incident – 421825

- House fire.
- Discarded cigarette ignited landscaping which spread to meter.
- 2 injuries.
- Recommend operator leak test service lines at operating pressure and not pressure test above the maximum allowable operating pressure.

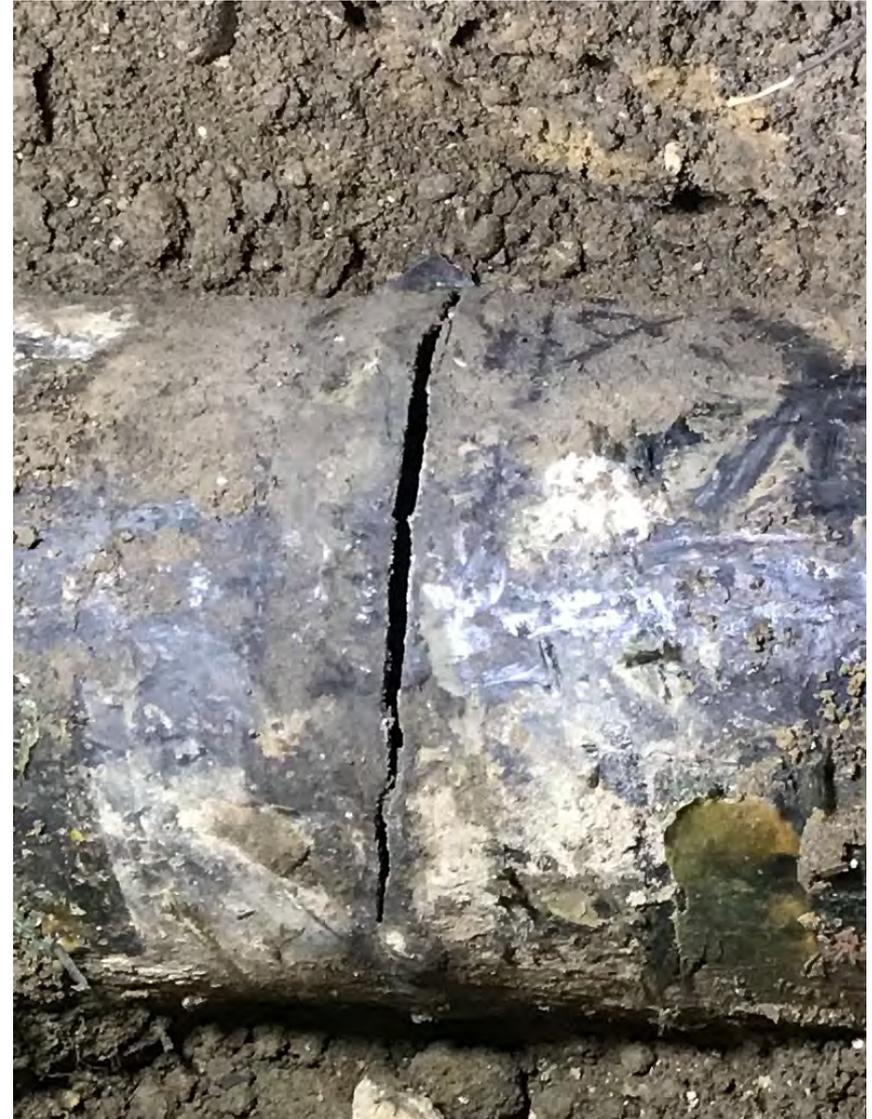
2017 Incident – 433825

- Girth weld failure due to surface loading from heavy equipment.
- 8-inch steel installed in 1950.
- Girth weld had defects such as lack of penetration and significant misalignment.
- Recommend operator examine nearby girth welds to verify integrity and perform more frequent leak surveys until all nearby girth welds are examined or the main replaced.

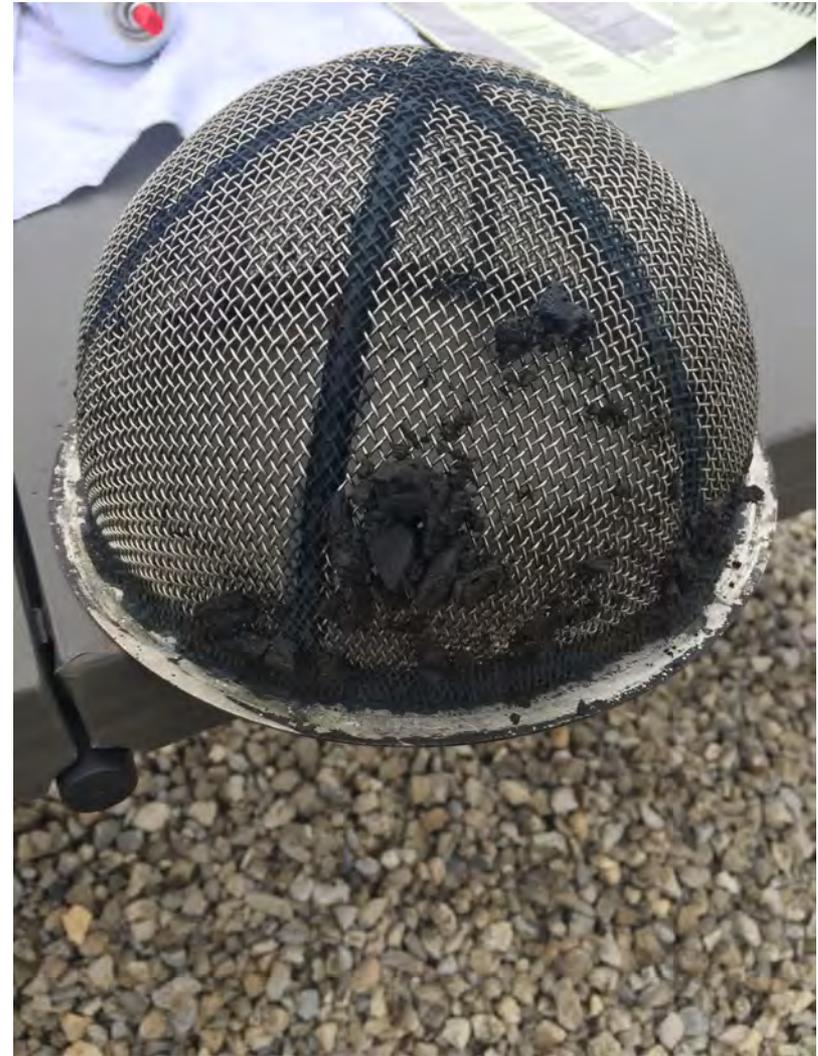
2017 Incident – 435525

- Distribution overpressure. Primary regulator failed due to grease and debris.
- Relief vented for over 5 hrs.
- 12 MMcf gas loss.
- 3 hour and 43-minute delay in responding (vehicle wouldn't start).
- Recommend operator dispatch a second technician if conditions impede the arrival of the first technician.

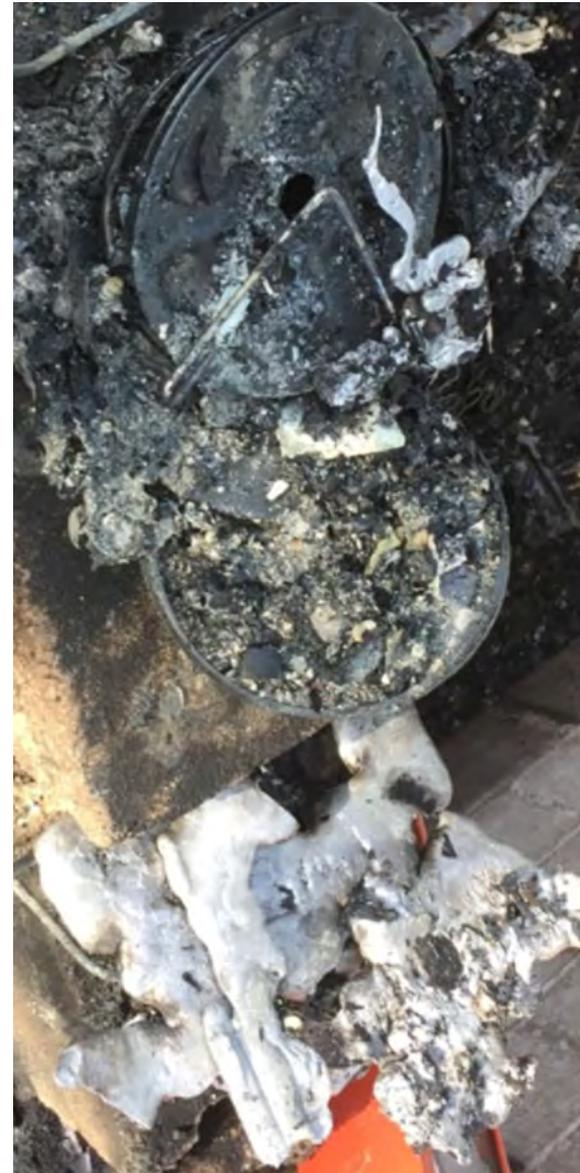
2017 Incident – 428429

- Residential house explosion and fire.
- Cause of explosion undetermined.
- Inside meter destroyed by fire.
- Cannot rule out jurisdictional gas involvement.
- 192.481(a): Failure to conduct atmospheric corrosion inspection on inside meter. No record of inspection could be produced.

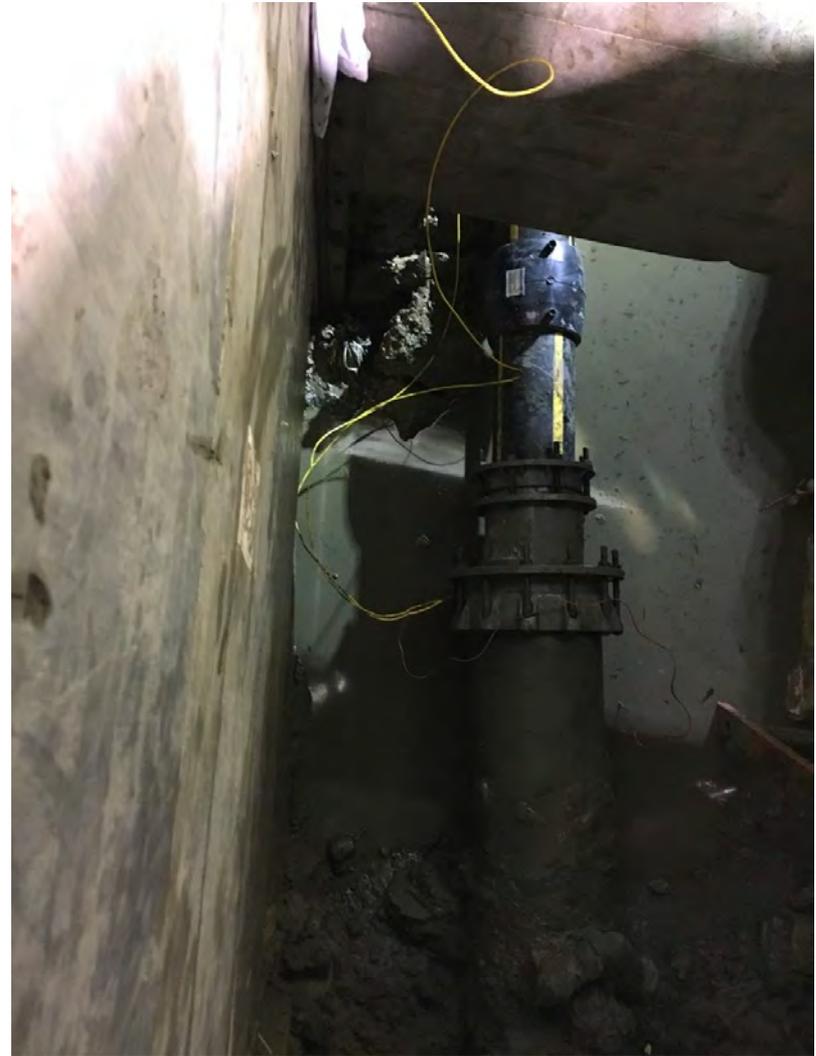
2017 Incident – 392930

- Third-party crossbore damage.
- Excavator installing communication lines across the road when the 8-inch bore head punctured the gas main.
- 12-inch cast iron main installed in 1901.
- \$164,180 damages.
- 192.614(a): Gas main was not marked at location of damage.
- 192.614(a): Locator failed to document on-going coordination with excavator while on-site.

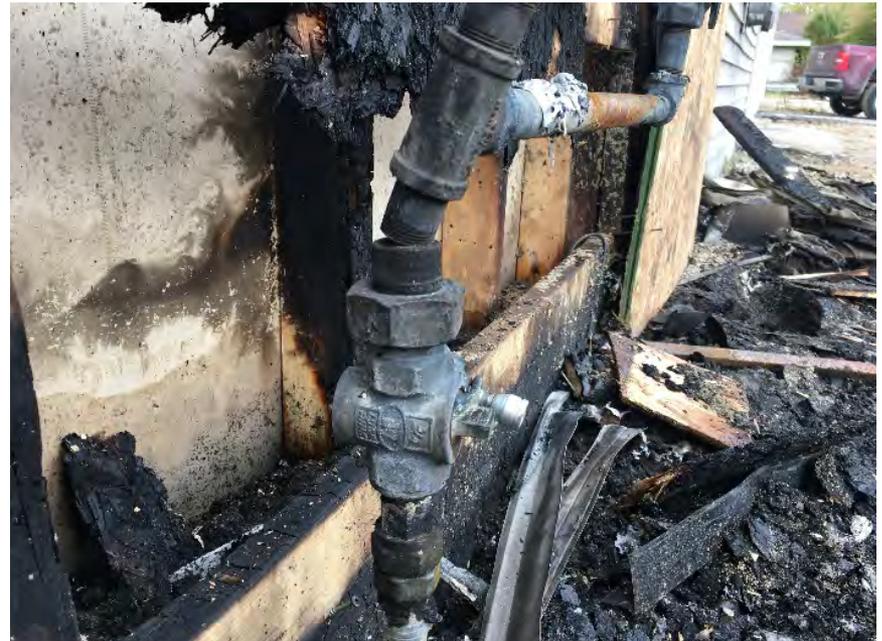
2018 Incident – 473025

- A vehicle hit a gas meter service riser causing a threaded joint to separate, leading to ignition.
- Damages of \$51,800.
- 460.20308(d): Meter was not protected from vehicle damage.

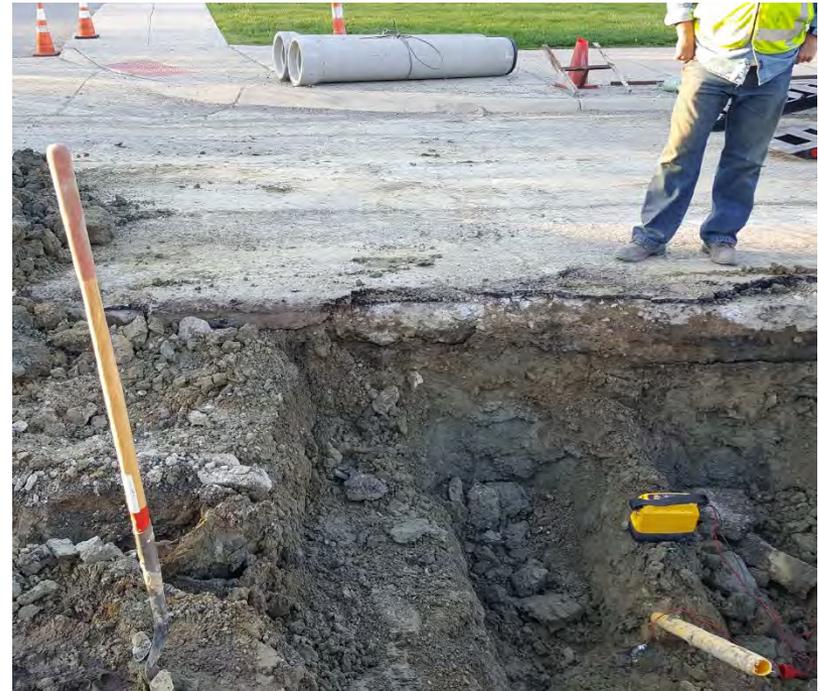
2018 Incident – 451929

- An operator accidentally marked a retired service line instead of the live service. Contractor hit the live service.
- 192.614(a): Failure to mark facilities. Markings inaccurate by approximately 5-feet.

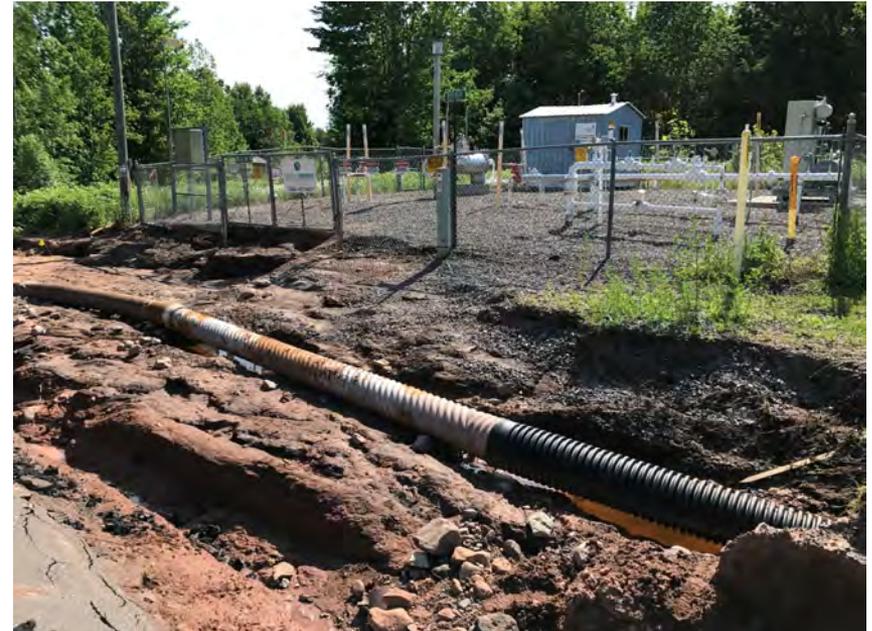
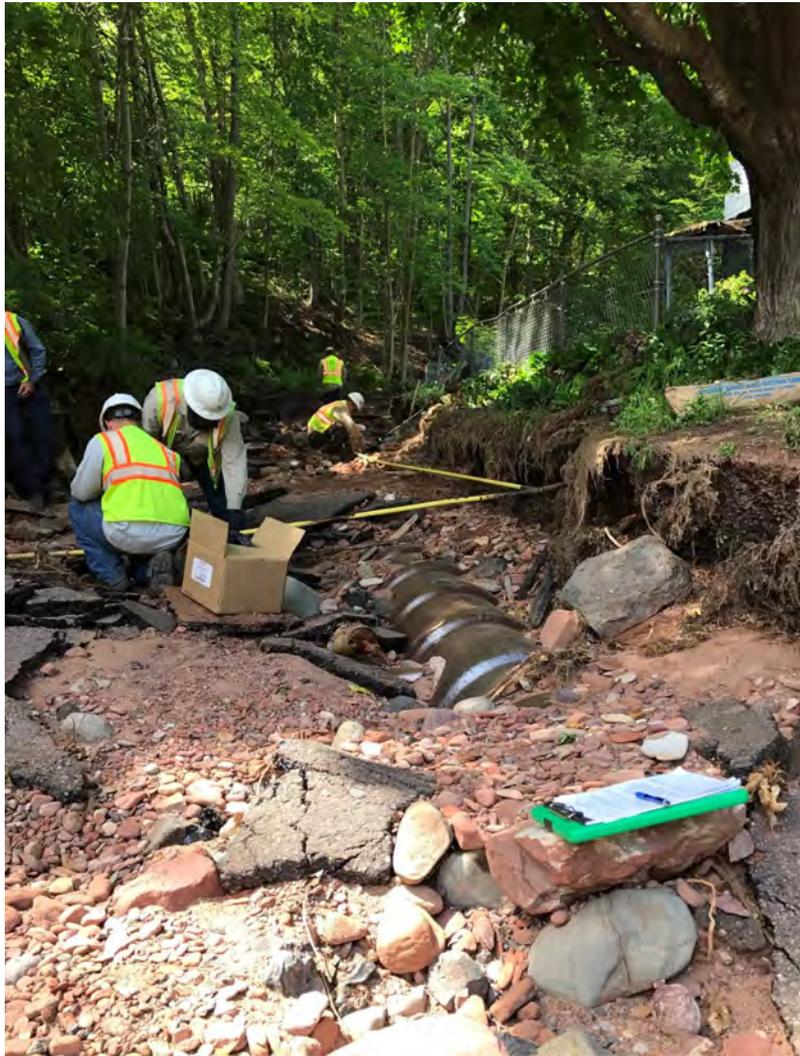
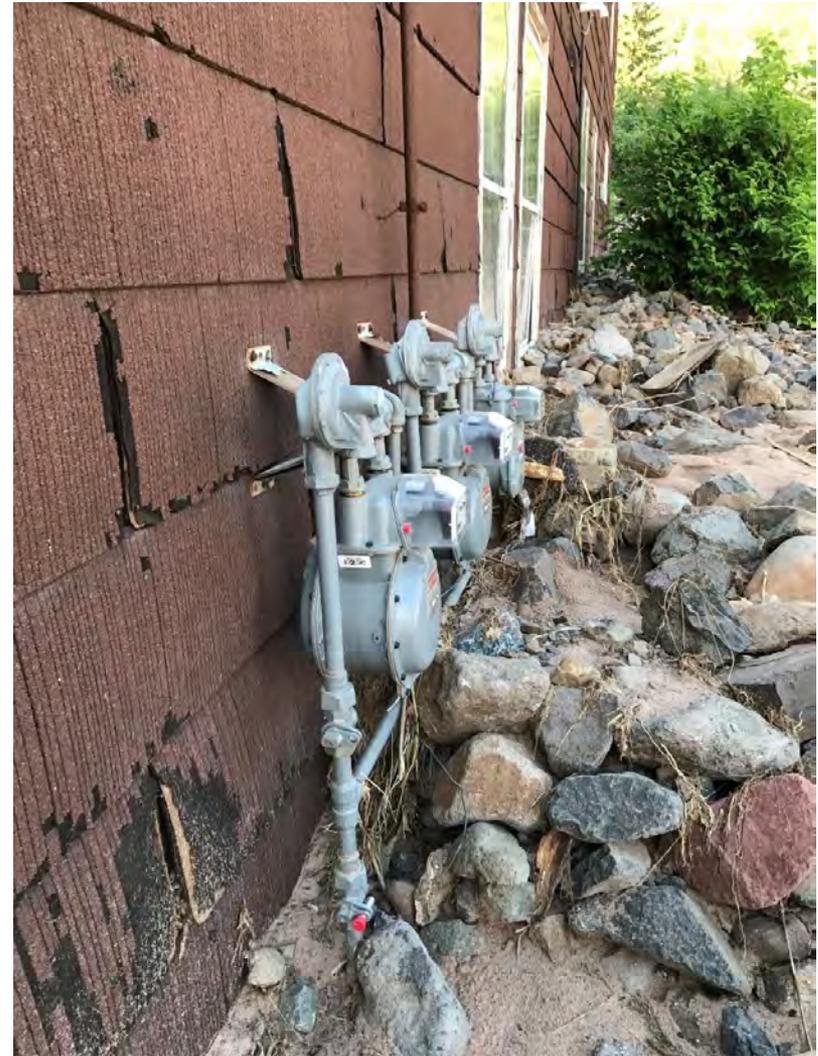
2018 Incident – 333330

- 6.2-inches of rain over six hours.
- 42 areas required response from exposed pipelines varying from ½-inch plastic service to four-inch steel main.

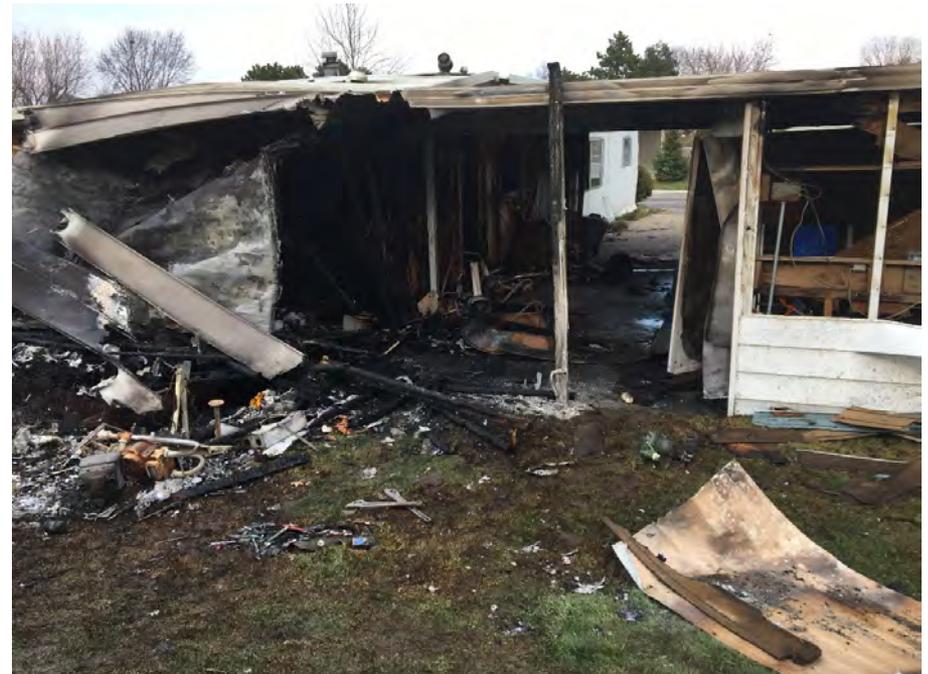
2018 Incident – 451041

- House fire.
- Incorrect operations during scheduled meter replacement.
- Technician placed too much stress upon the connected riser, causing the steel riser to break below the lockwing.
- Escaping gas ignited.

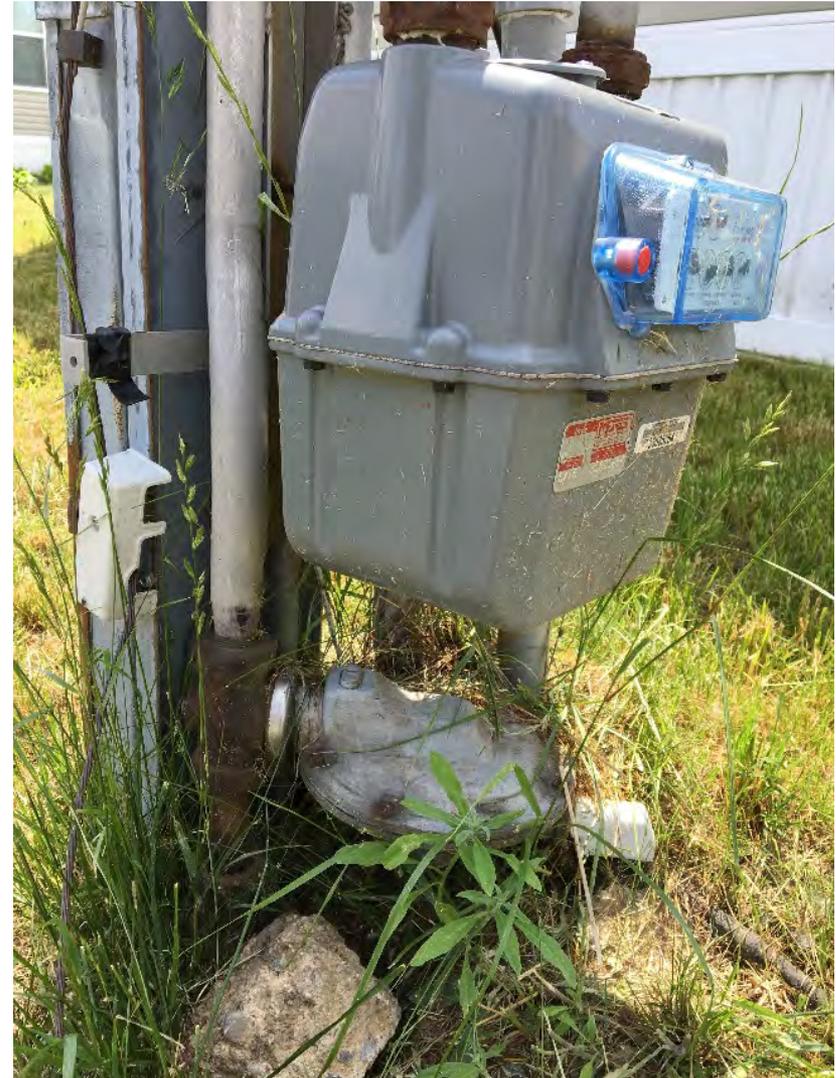
2018 Incident – 451041 Cont.

- 192.355(b)(2): Neighboring service regulator vented directly into the ground.
- 192.357(a): Neighboring meter supported solely on the riser and customer piping.
- 192.481(a): Records showed periods exceeding three years for atmospheric inspections for neighboring residences.
- 192.481(b): Records showed atmospheric conditions as “Good” for five neighboring service risers in poor condition.

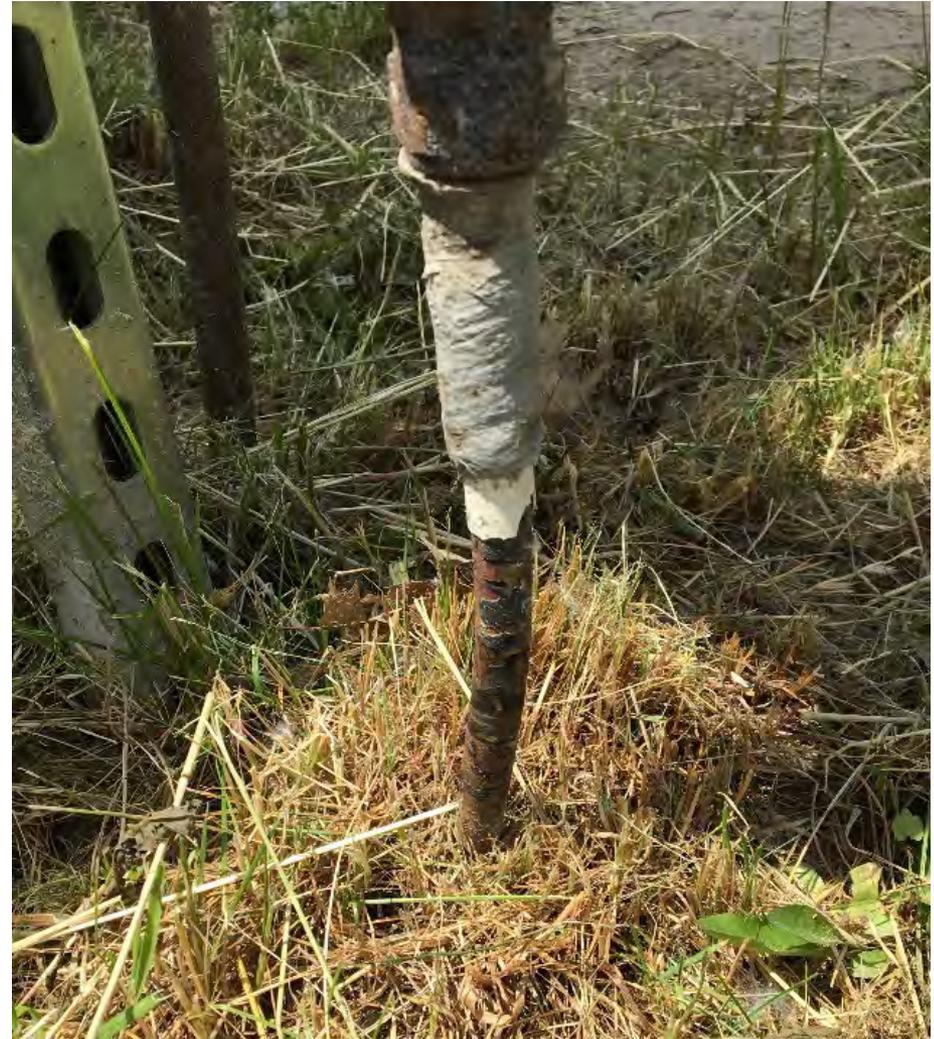
2018 Incident – 451041 Cont...

- 192.605(a): Procedures were inadequate for continuing surveillance of its facilities for taking appropriate action for the corrosion present on meter assemblies.
- 192.805(h): Records showed atmospheric conditions good for service risers as “Good.” However, risers showed levels of deterioration beyond what should be recognized as good.

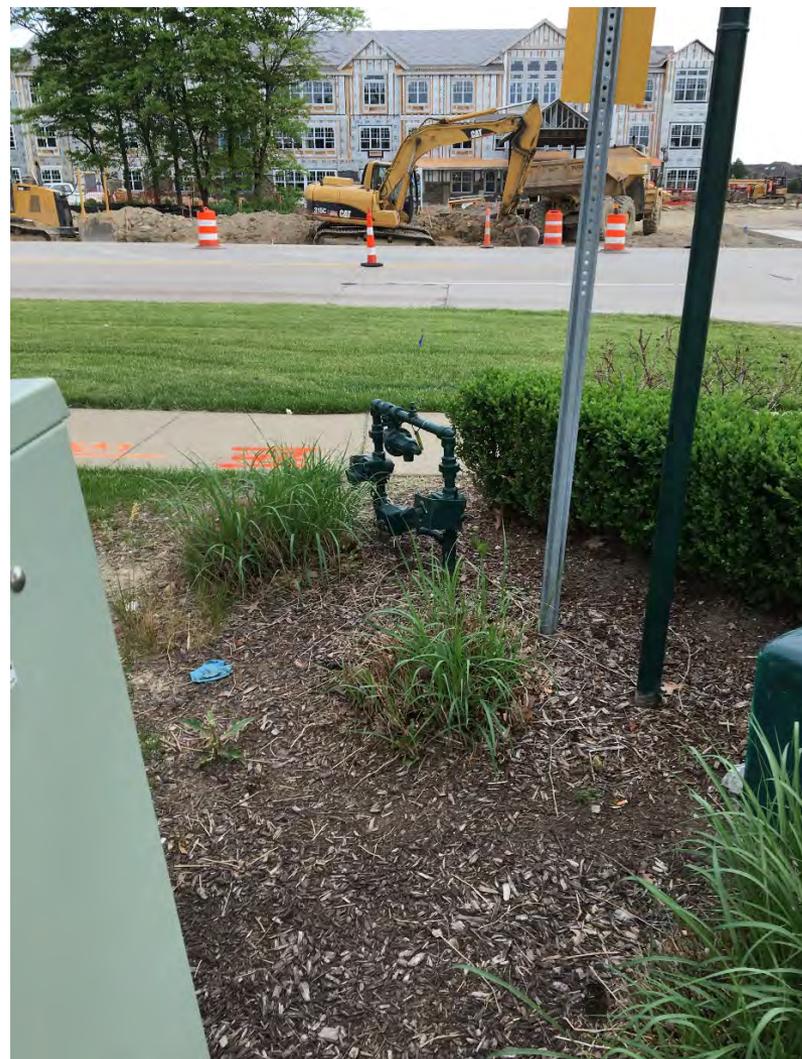
2018 Incident – 456741

- Damaged 1-inch service line off 8-inch steel main operating at 309 psig.
- Excavator also cracked the weld that attached service tee to main as a result of the damage.
- Gas vented for 19.5 hours before main was isolated to complete repair.

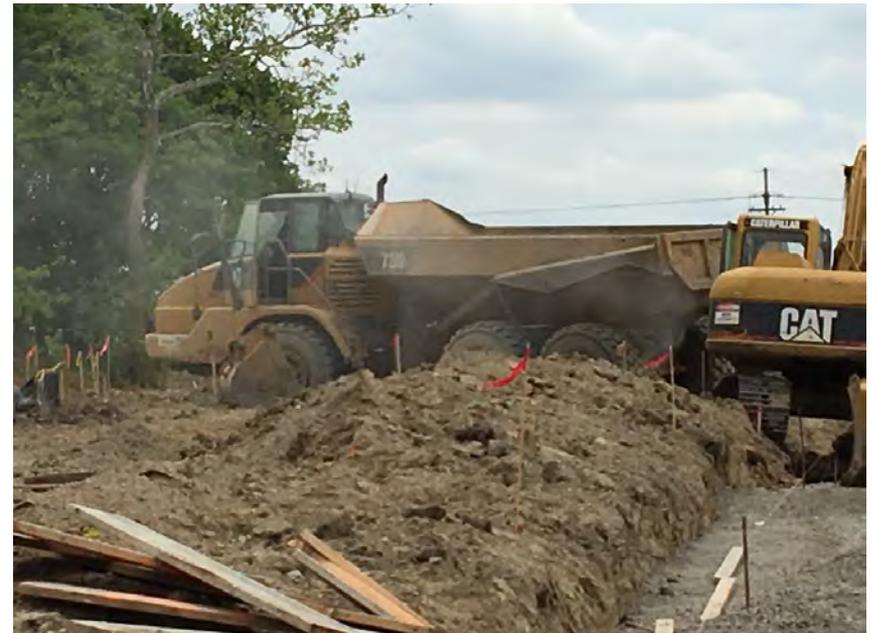
2018 Incident – 456741 Cont.

- 192.614(a): Although the excavator was not working under their own one-call ticket, a ticket covering the area was requested by a different contractor and not marked.
- 192.615(a)(6): Valves were not used to isolate the main and perform repairs, stopple fittings were preferred option. 20 vs 33 customers.
- MCL 460.725(1): Excavator did not have own MISS DIG ticket.

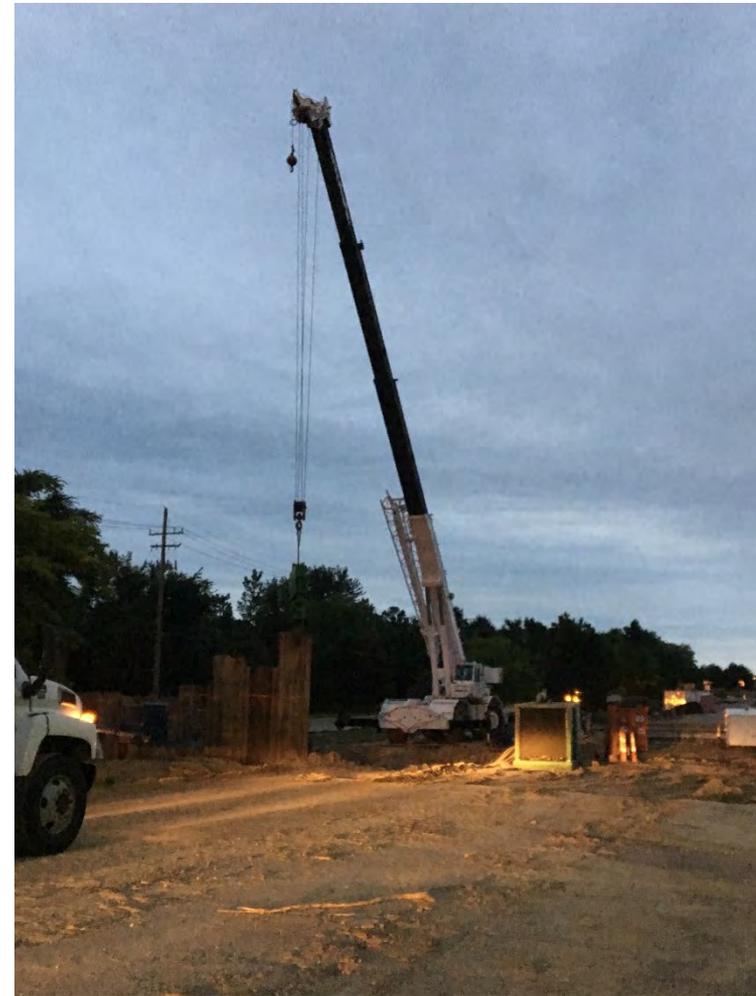
2018 Incident – 460041

- Contractor installing shoring for culvert work inside of a road median damaged 8-inch plastic.
- Staking was accurate.
- Gas blew for 12 hours while waiting for equipment to be obtained to squeeze-off plastic.
- 192.614(a)(4): Failure to have personnel, equipment, tools, and materials as needed at the scene of an emergency.
- MCL 460.725(5) – Excavator failed to hand expose.

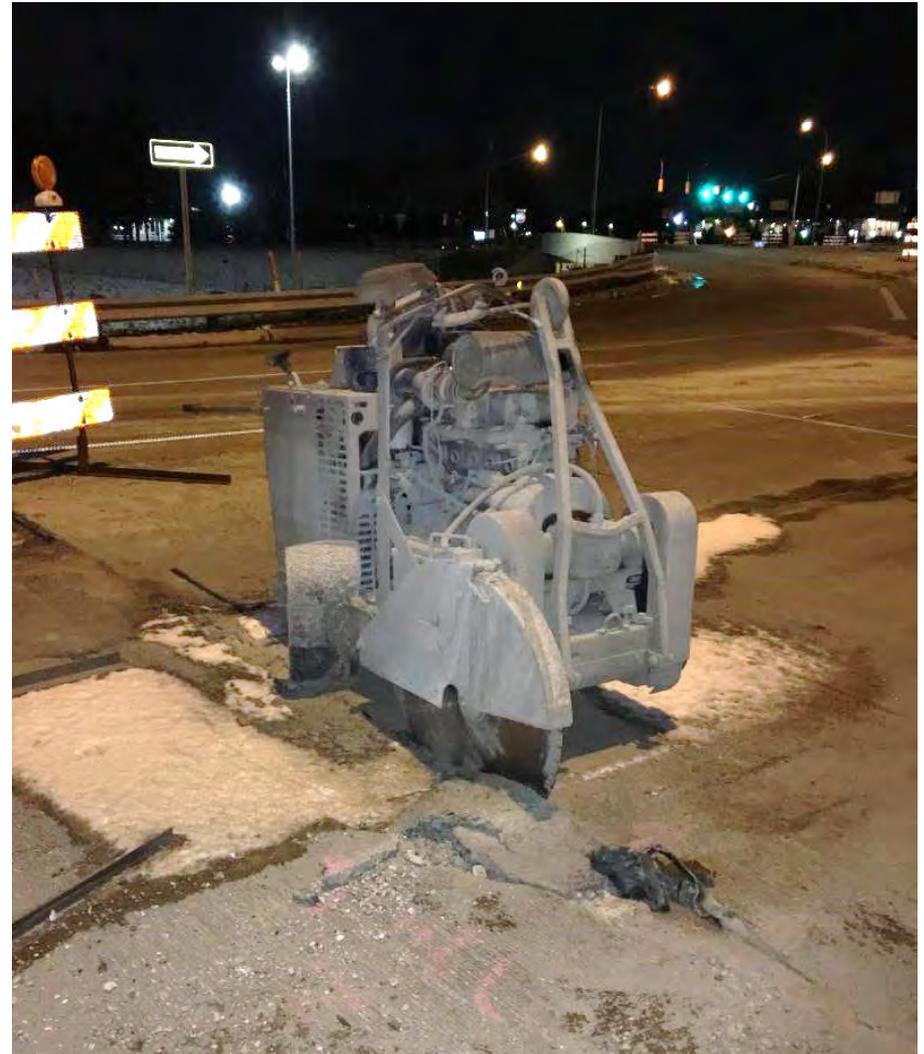
2018 Incident – 475241

- Contractor saw-cutting hit 8-inch steel main installed in 1963 that was only 9-inches deep.
- Staking was accurate but main was not noted as shallow.
- Gas main was parallel and underneath a hard surface. Excavator failed to consult with operator to reach an agreement on how to protect the facility.
- MCL 460.725(1) - Excavator working under an expired locate request (21 day life).

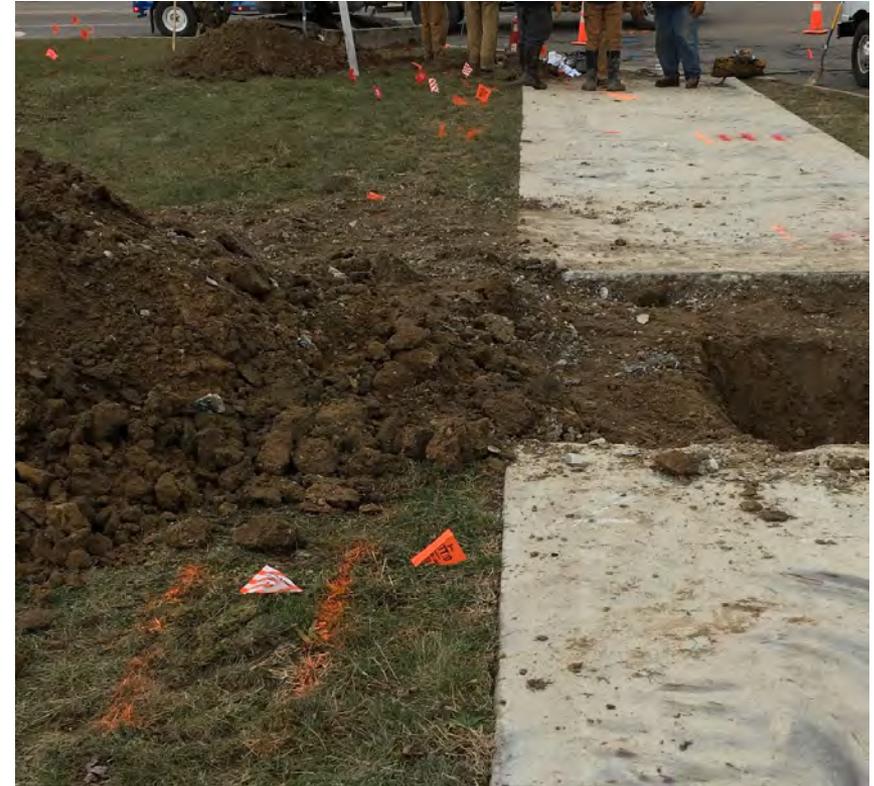
2018 Incident – 476043

- Excavator using an auger under an expired ticket had not requested a restake and hit a 4-inch plastic main.
- 192.614(a): Failure to mark gas facility. Staker posted “Additional Locating Needed” on the dig start date but failed to ever mark the gas main.
- MCL 460.725(1): Failure to provide a dig notice to the notification system not more than 14 calendar days before the start of any blasting or excavation.

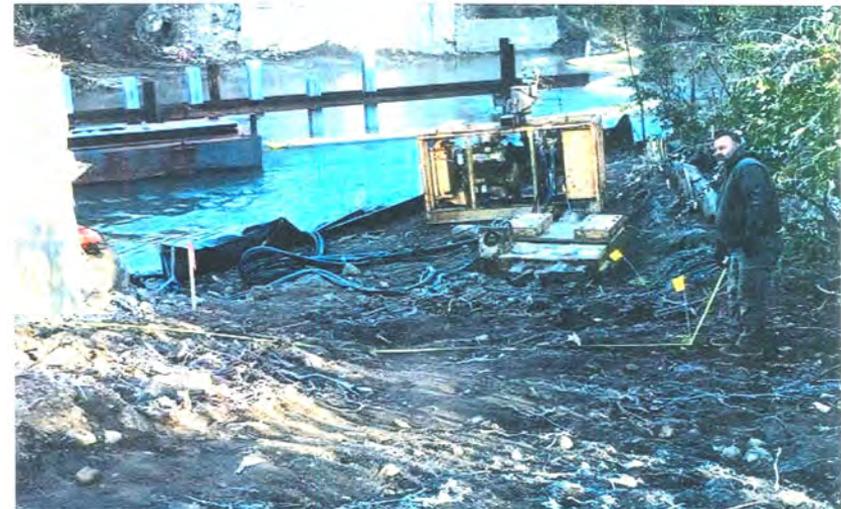
2018 Incident – 473634

- Contractor installing new bridge footings hit a 6-inch plastic main operating at 45 psig.
- \$165,000 damages.
- Two-way feed located in Huron River.
- Recommend operator incorporate the Common Ground Alliance’s Best Practices 4.20 entitled “Locating and Marking in Navigable Waterways” into their damage prevention practice.

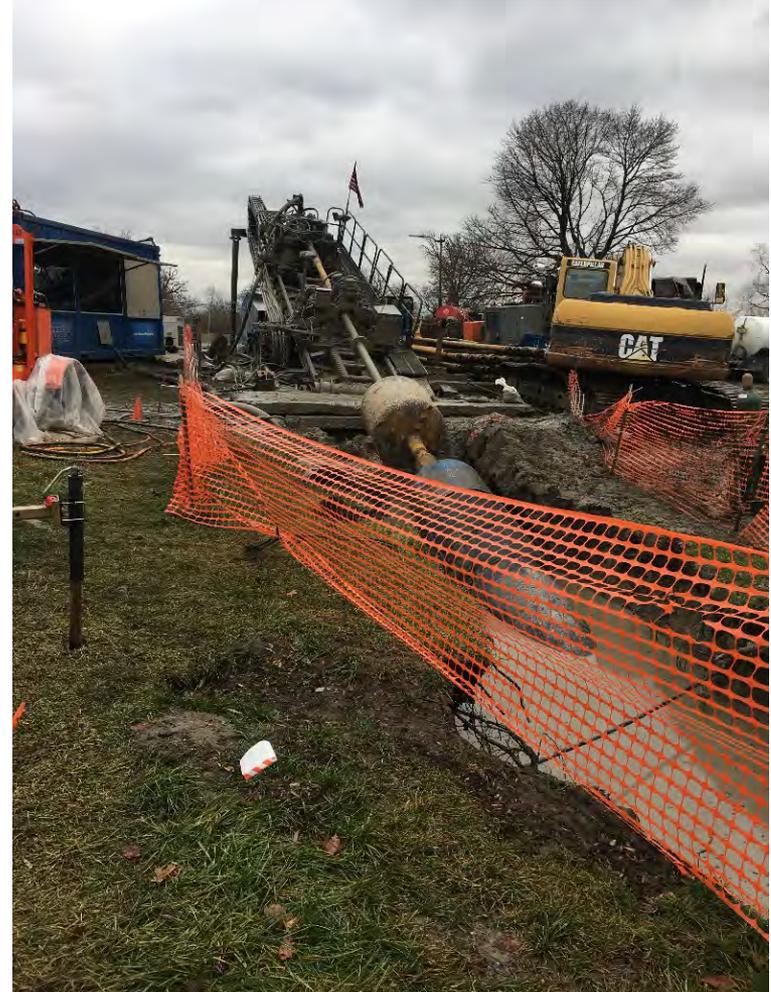
2018 Incident – 475429

- Third-Party Damage.
- 4-inch steel main one-way feed to an island.
- 19 commercial outages.
- Excavator was installing 34-inch conduit between a bridge and existing gas main.
- Horizontal directional drill punctured main under a river while reaming.
- Temporary 3-inch plastic main with a 5-inch PVC sleeving was installed to restore gas to the island.

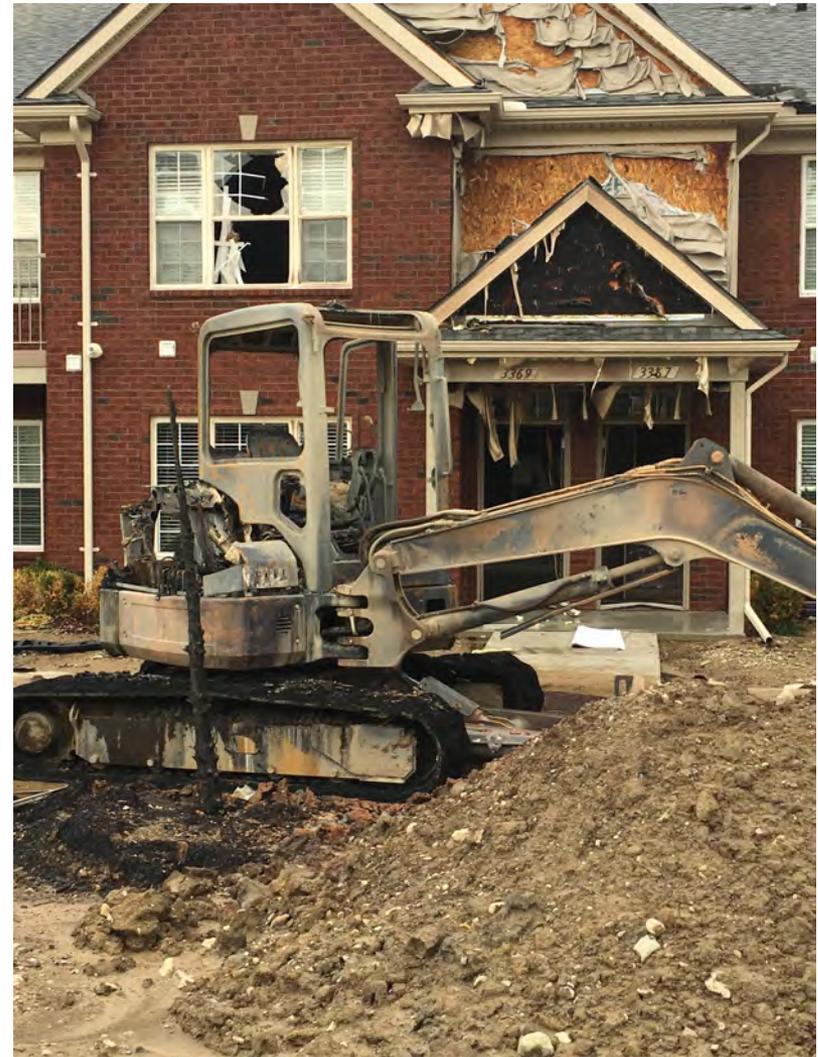
2019 Incident – 3314

- First-party damage with ignition.
- Distribution crew hit 2-inch plastic main during pipe lowering project.
- While attempting to expose the damaged main, crew contacted an electric service line located in joint trench, causing ignition and injury.
- \$120,203 damages.

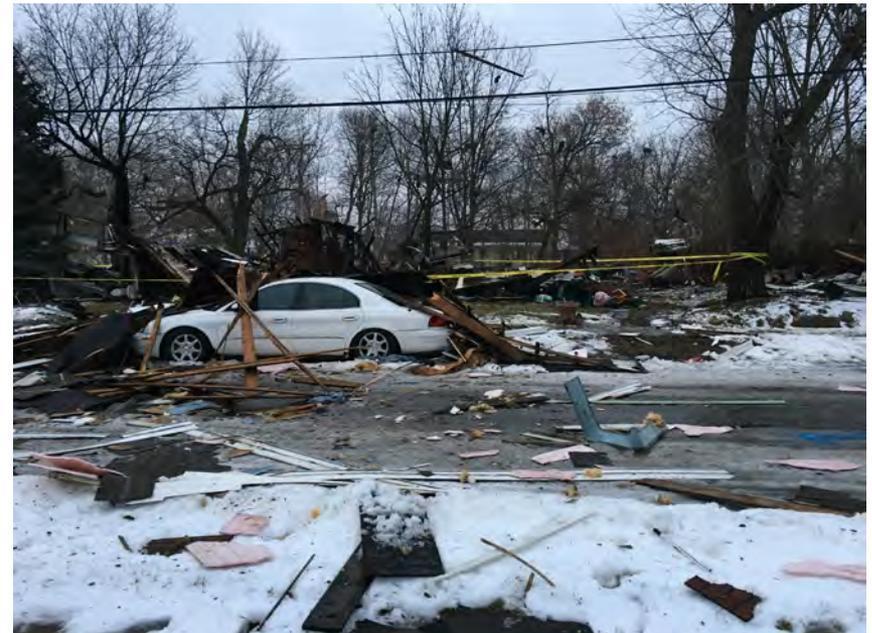
2019 Incident – 3093

- House explosion with fire.
- Gas leak nearby on service line at a connection to a buried regulator operating at 265 psig.
- Operator employee onsite investigating the gas leak one block away.
- Gas in sanitary sewer and migrated into several houses.
- When gas shut off at buried regulator, all gas readings dissipated in the sewers.
- Resident injured.
- \$93,067 damages.

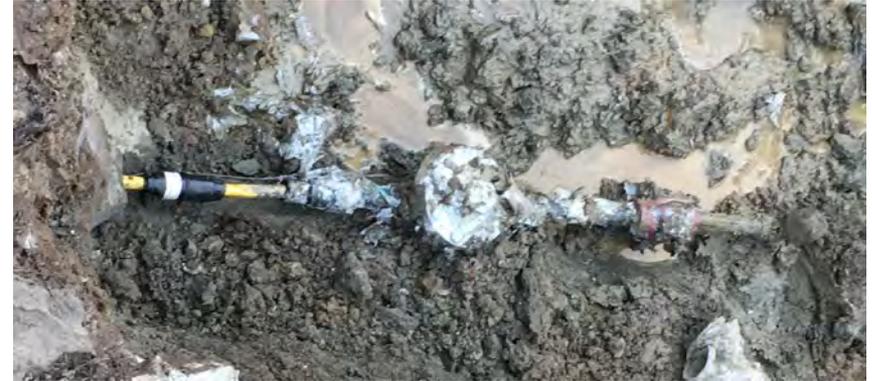
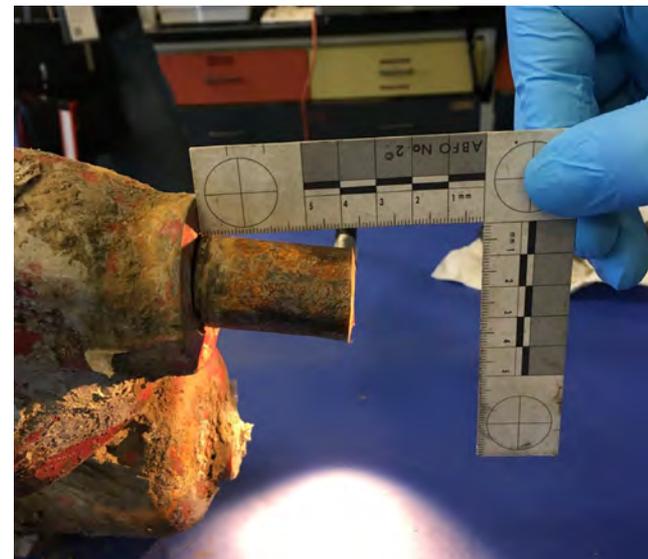
2019 Incident – 3093 Cont.

- 192.605(a): Employee did not complete required documentation to demonstrate that the gas migration boundaries were determined.
- 192.605(a): Employee responding to the original leak call did not have access to the current service line map.
- Recommend operator reevaluate the applicability of using a drag tube in frost conditions to establish underground gas migration.
