Distribution Incident History

October 8, 2019

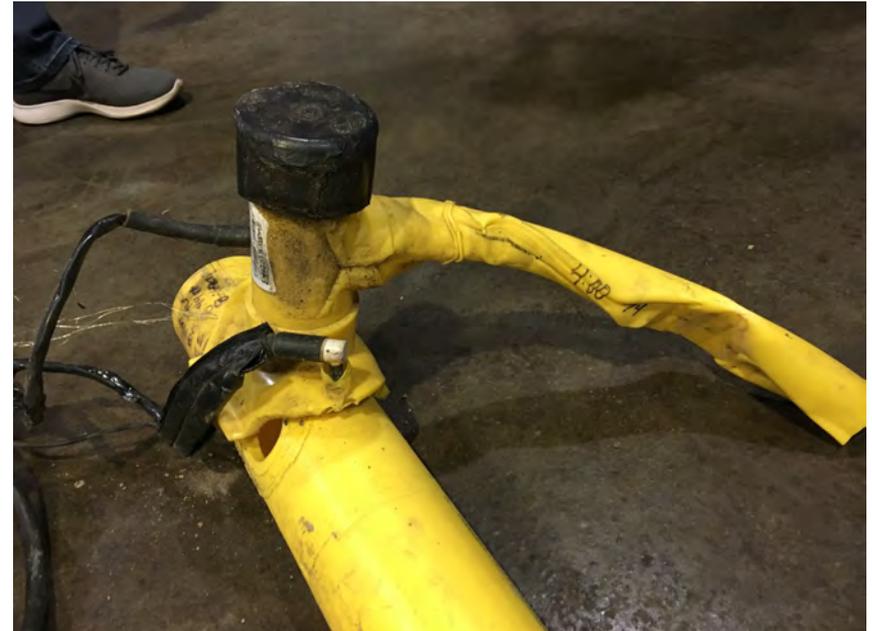
2019 Incident – 3622

- Accidental ignition due to operator error.
- Operator's contractor working on making a tie-in as part of a main replacement project.
- Fuser prepared to complete a 2-inch coupling electrofusion, but mistakenly connected the fuse leads to a previously completed electrofusion tee that was already tapped and operating at 60 psig.
- Several seconds into the fuse, gas released and ignited.
- No injuries.

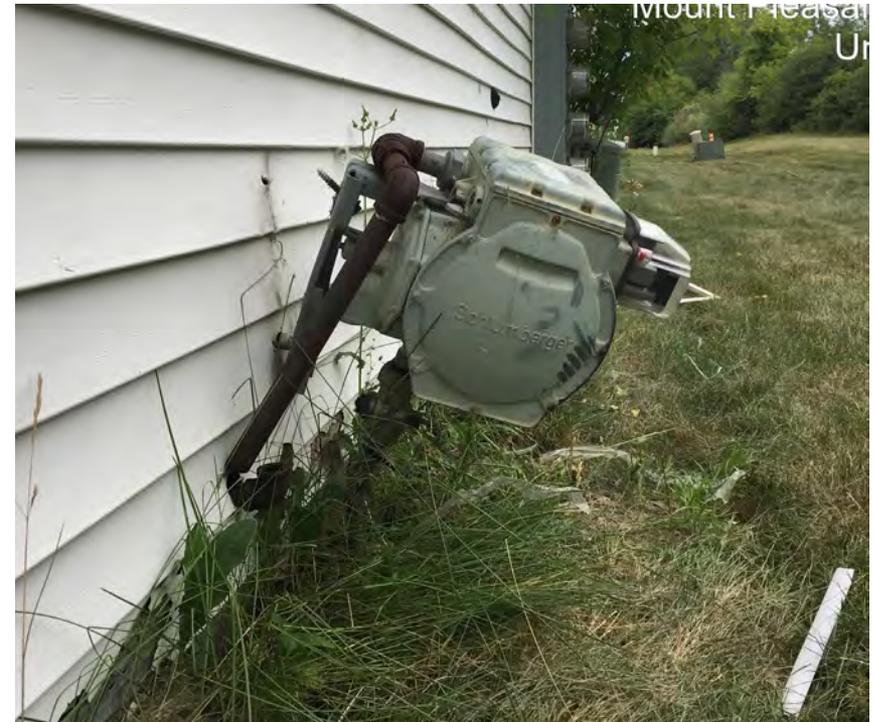
2019 Incident – 3652

- Apartment explosion.
- Mowing company hit gas meter. Driver claimed he did not know he hit meter.
- Downstream fuel line separated and gas migrated into apartment.
- Explosion occurred.
- PHMSA reportable because impact to a regulated piece of equipment caused a failure in a nonregulated pipe which then caused an explosion.
