# Transmission Incident History

October 8, 2019

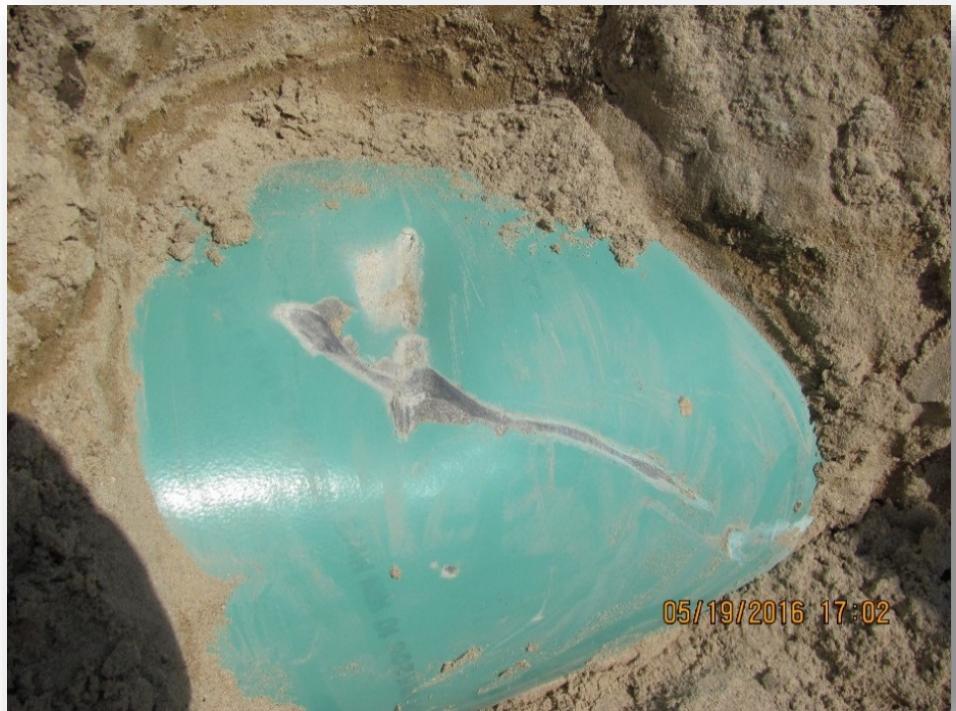
# 2016 Incident – 371227

- Transmission line damage during construction of parallel line.
- Two contractor crews called in one-call tickets.
- Neither ticket covered the scope of the damage area.
- 10-inch steel, 0.250 wall, 976 psig MAOP.
- No fatalities, injuries, or release.
- MCL 460.725(1): Damage location was not within the scope of a one-call ticket.

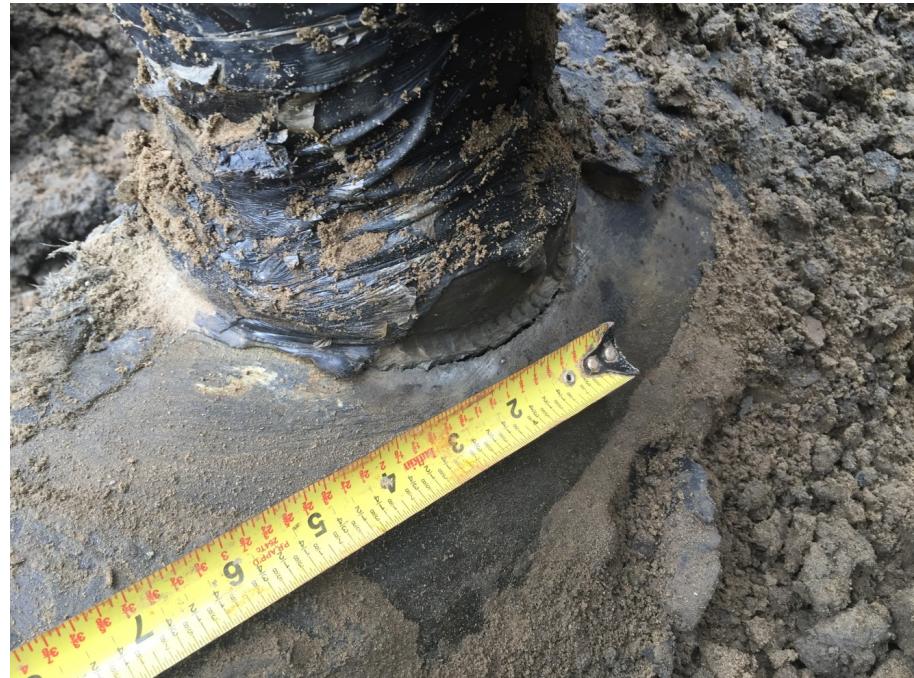
# 2016 Incident – 387129

- Second-party damage during integrity dig.
- 4-inch welded tee on 10-inch pipeline was hit by excavator and cracked.
- 4-inch tee and associated piping was not shown on maps.
- Gas blew over 24 hours.  
Isolated via stopple and an existing valve.
- 192.614(a): Failure to hand expose the gas line within the caution zone prior to using power equipment.

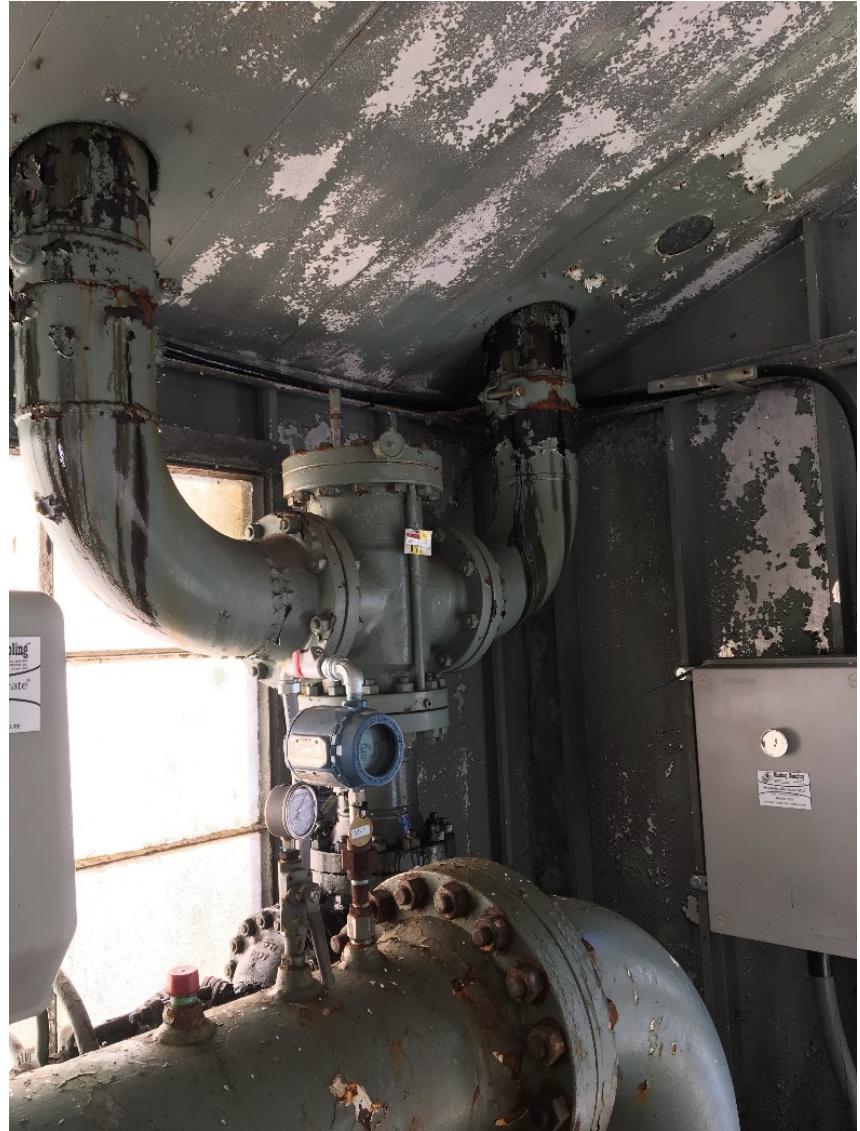
# 2017 Incident - 428725

- Transmission overpressure in a regulating station.
- Pressures reached 500 psig between regulator and relief. MAOP 400 psig.
- Primary regulator failed due to hydrocarbons in the gas stream.
- The relief valve functioned as designed, protecting the downstream transmission line from an overpressure.
- \$123,800 damages from environmental cleanup.

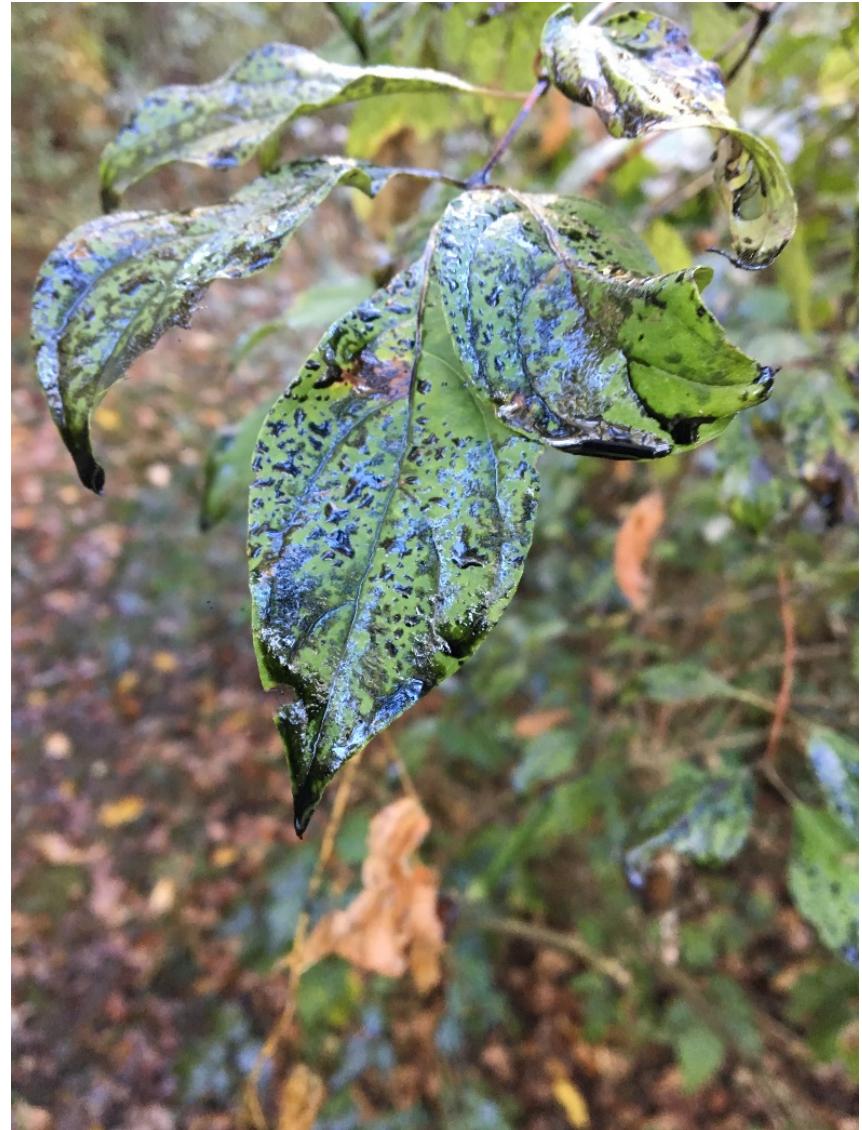
# 2017 Incident – 428725 Cont.

- Recommend review procedures regarding monitoring liquid levels at separators. Inlet and outlet separators discovered full of liquids.
- Potential Source #1: Inadequate free-liquid capture at underground storage fields.
- Potential Source #2: Failure to adequately recover liquids from pigging operations. 1,800 gallons of cleaning liquids not recovered during pigging operation 5 months prior.

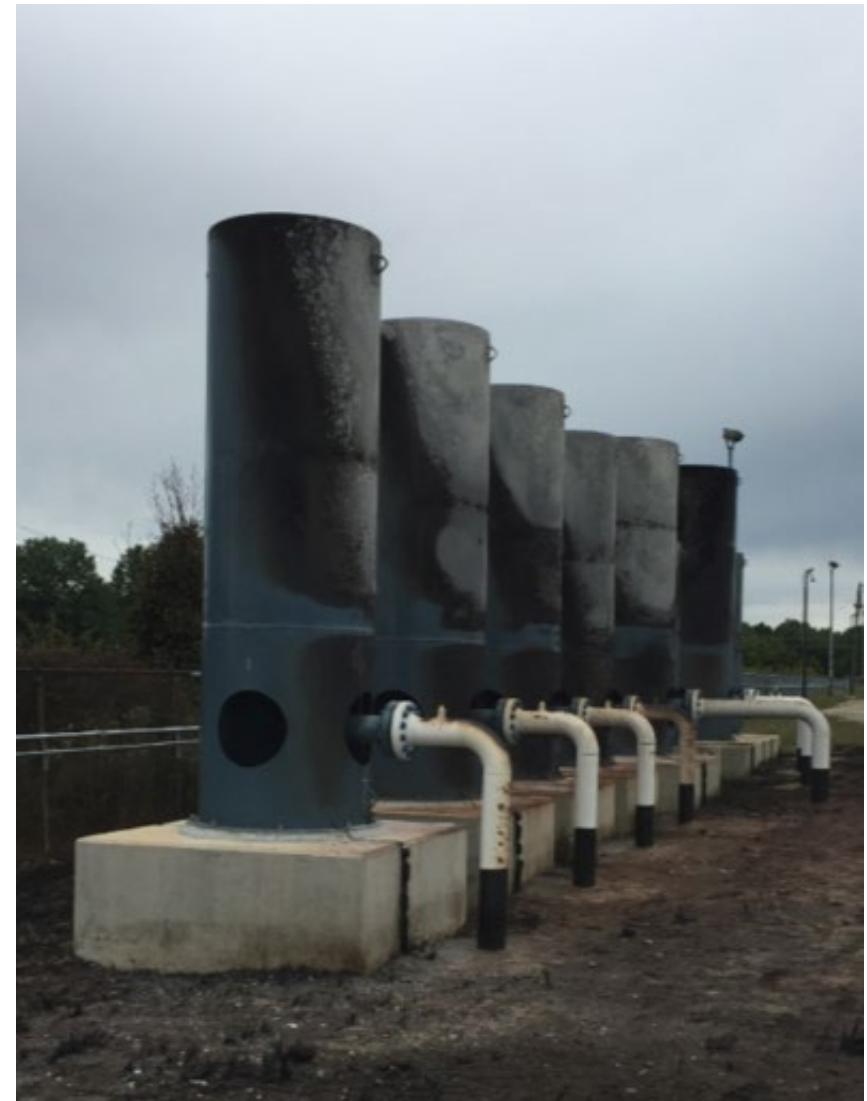
# 2017 Incident – 424729

- Compressor blowdown fire.
- New compressor plant was being commissioned when one compressor unit shut down and vented to the blowdown stack.
- Ignition occurred at outlet of blowdown silencer due to electrostatic discharge from entrained water droplets or debris within venting system.
- \$429,430 damages.
- 1.417 MMcf gas loss.

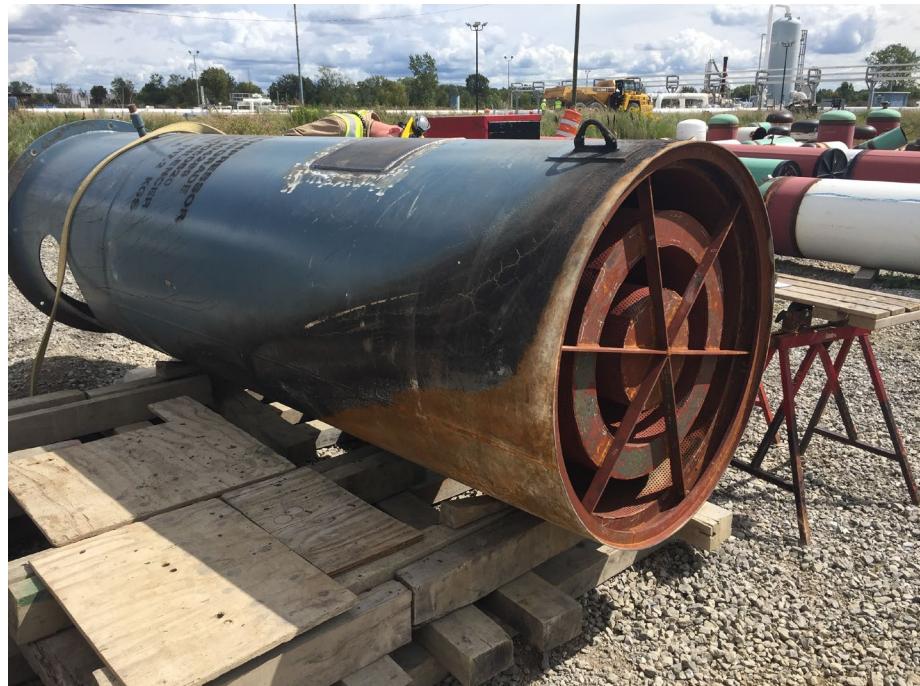
# 2017 Incident – 424729 Cont.

- Blowdown silencer not designed to prevent rainwater and debris from entering the top and collecting in the bottom.
- Design of blowdown silencer allowed for turbulent flow.
- No process for inspecting and draining blowdown silencers. The drain line was plugged at the bottom of the silencer.

- Operator and manufacture of the blowdown silencer did not have a process for reviewing the design for the potential of static discharge.
- Manufacturer of the blowdown silencer did not provide preventative maintenance recommendations.
- Recommend operator provide their root cause analysis report and their third-party expert's report to the blowdown silencer manufacturer.

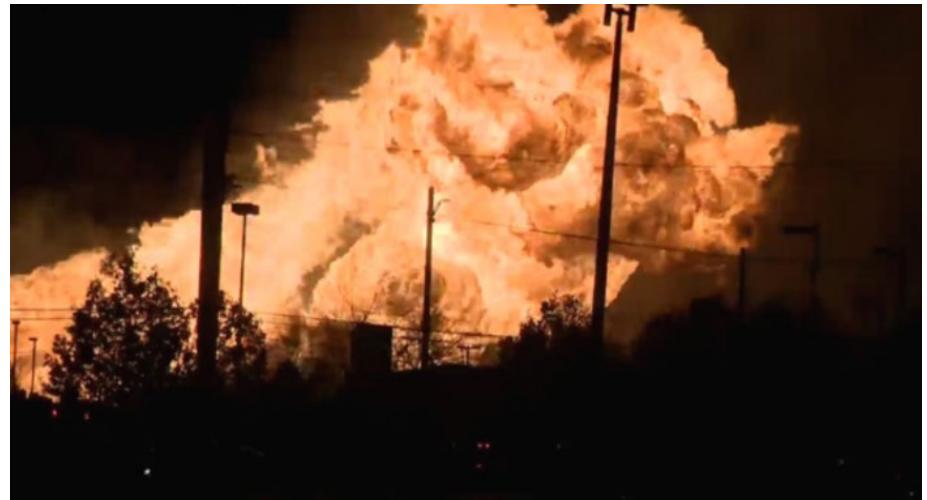
# 2017 Incident – 432829

- Transmission pipeline rupture and ignition.
- Constructed in wetland muck deposit in 1951.
- External stress due to soil burden placed over the pipeline.
- Pipeline segment had a history of stresses induced by changes in elevation profile attributed to buoyancy and excessive filling.
- \$6,267,710 damages.
- 344 MMcf gas loss.

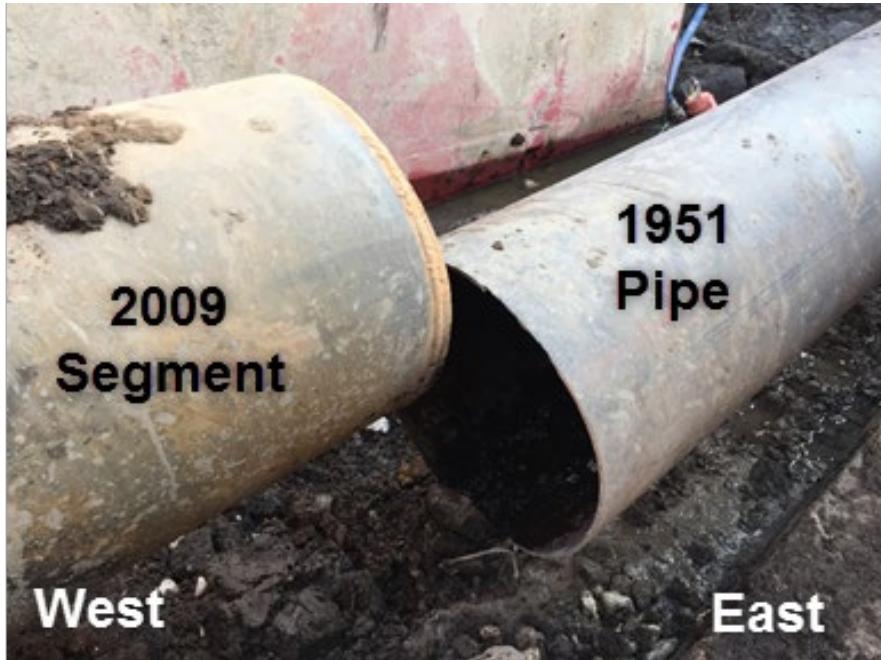
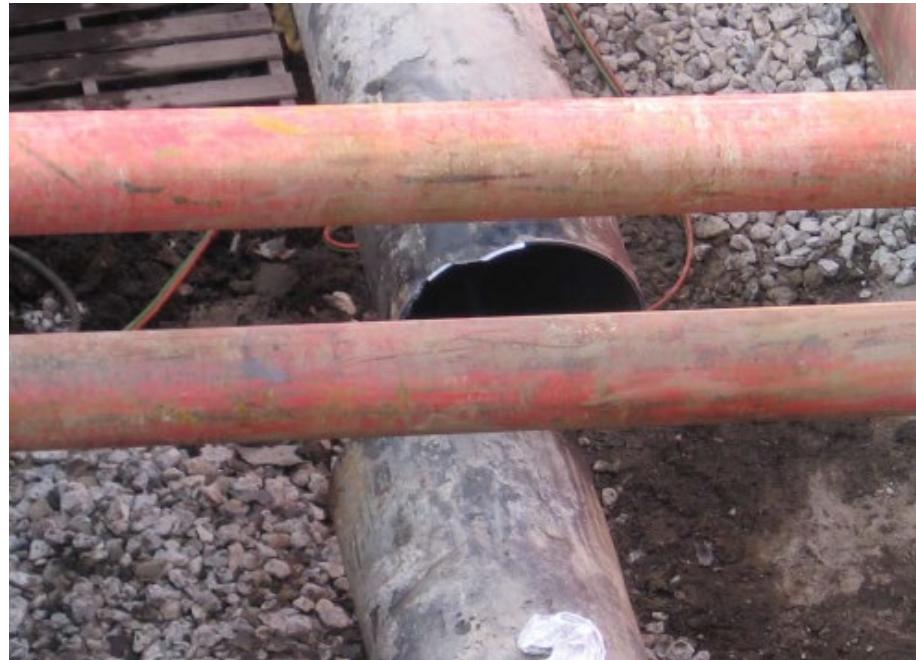
# 2017 Incident – 432829 Cont.

- 192.225(a): Girth weld defects present from 2009 integrity cut-out. This weld was not in compliance with API 1104 and should not have passed visual or radiographic inspection.
  - Incomplete fusion (IF), Incomplete fusion due to cold lap (IFD), and Porosity. The IF at the outer diameter served as a stress riser and the failure initiation point.
  - 2009 segment was not tapered on the inside wall to match with the thinner-walled 1951 pipe. The lack of taper was not in compliance with ASME B31.8.
  - Significant offset (up to 0.155 inches) between the 2009 segment and the 1951 pipe at the failed girth weld location. This is indicative of inadequate fit-up prior to starting the welding.
  - The failed girth weld was made with the connecting pipe ends already placed under stress to achieve fit-up.

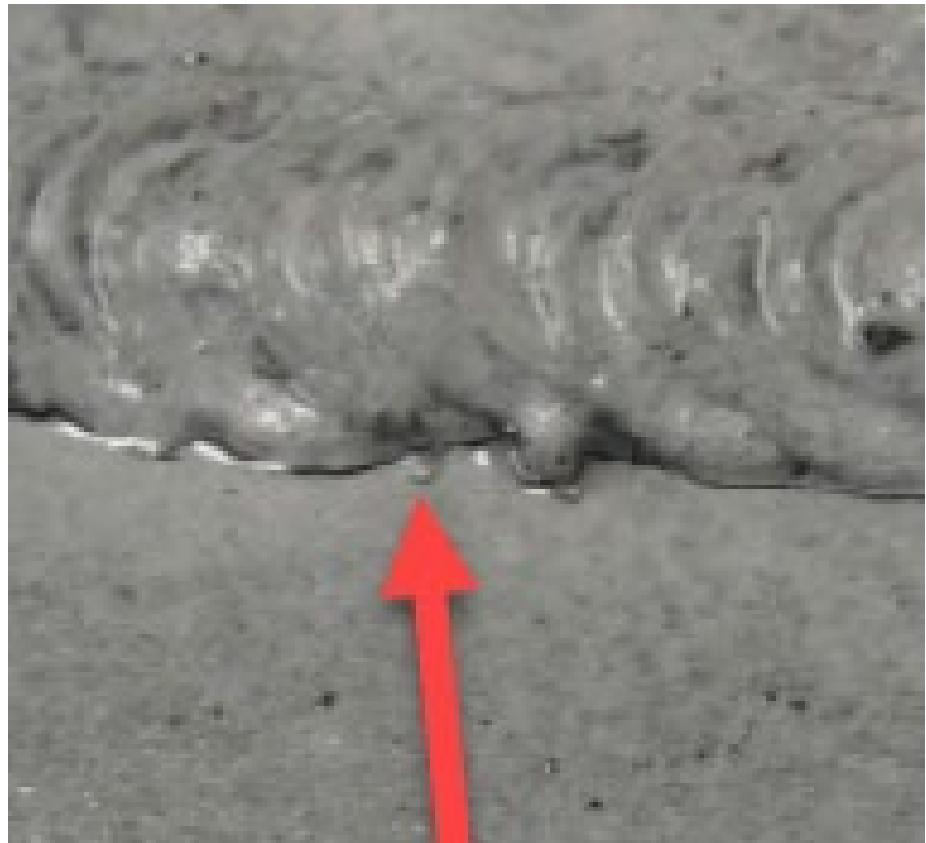
# 2017 Incident – 407141

- Leak discovered in an HCA as line brought back into service.
- Gas pressure reached 650 psig on a line with MAOP of 1000 psig.
- Crack discovered on a tie-in weld.
- Also located failures at numerous “tie-in” welds.
- Welder, weld inspector, and NDT technician exhibited poor performance despite current qualifications.

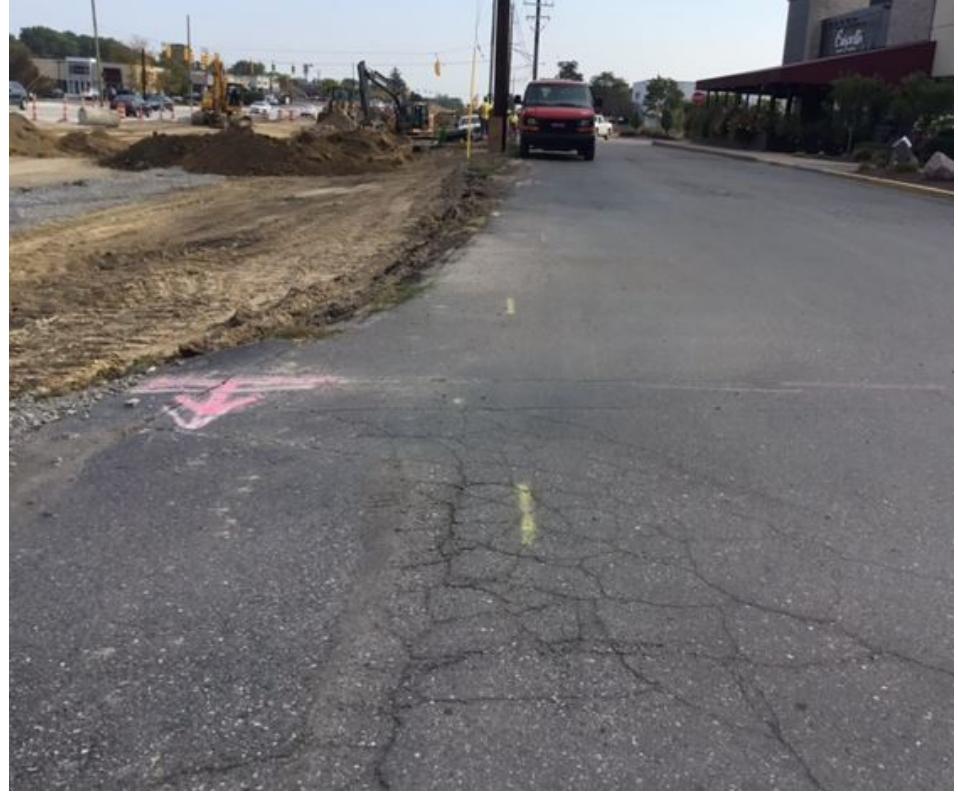
# 2017 Incident – 432341

- Third-party damage on a 12-inch transmission line operated by distribution.
- \$105,918 damages.
- Poor communication between operator and locator facilitated lack of understanding between active and inactive facilities.

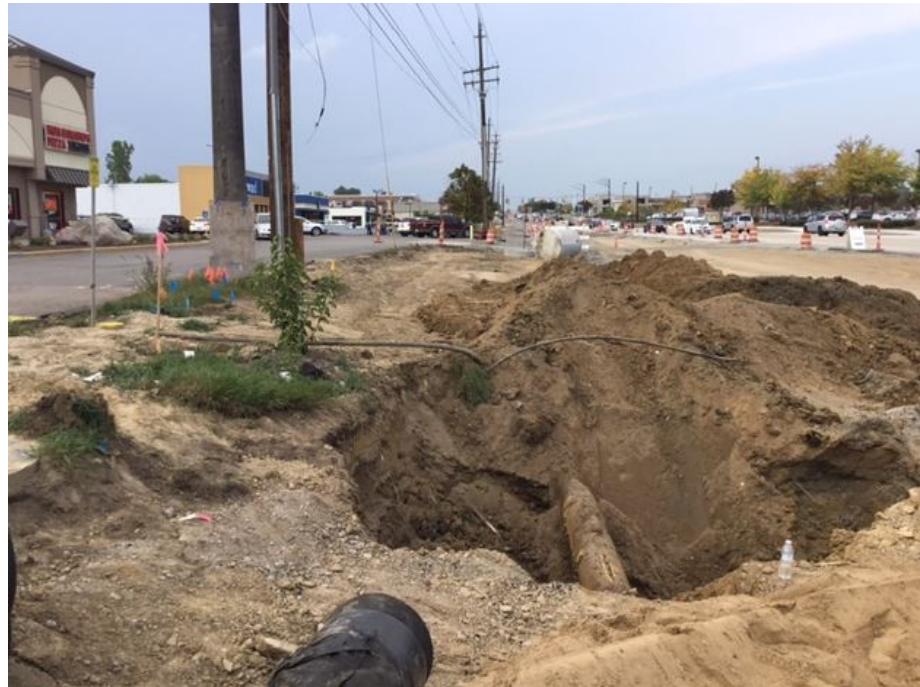
# 2017 Incident – 432341 Cont.

- 460.20503(1)(b): Late reporting. Reported an incident to the MPSC and PHMSA 50 days after the date of the incident.
- 192.614(a): Staking not accurate. Active pipeline was more than 10-feet away from line that was marked.

- Recommend operator adopt the Michigan Damage Prevention Board Best Practice entitled “Abandoned/Idle Facilities,” and provide sufficient information to excavators regarding the characteristics and location of abandoned facilities, up to and including staking abandoned facilities where necessary to avoid confusion.
- Recommend operator provide additional information in the ticket management system that includes, where applicable, information regarding the presence and location of abandoned facilities and photographic evidence of the staking that was conducted.
- 192.935(d)(2): Recommend operator personnel be on-site whenever there is work occurring around its transmission facilities, regardless of whether or not the facility has been exposed.

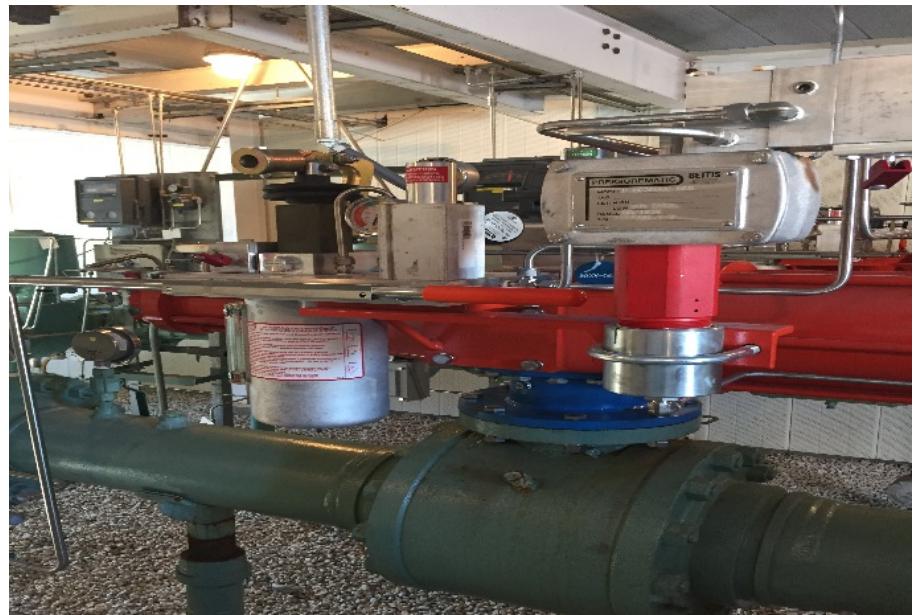
# 2018 Incident – 436025

- Overpressure on one operator caused by backpressure from another operator. 42% exceedance of MAOP. Pressure-control valve failure combined with incorrect operations.
- 2.8 miles.
- 8-inch steel transmission.
- Lasted almost 6 hours.

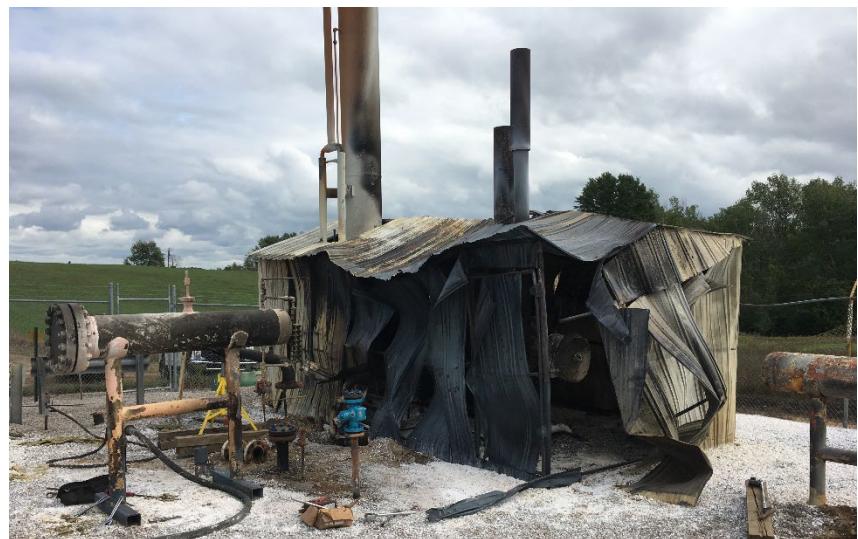
# 2018 Incident – 467425

- Dehydration fire at storage field on glycol reboiler manufactured by Smith Industries and installed in 1982.
- Dehydration unit's controller caused the fuel train regulator to continue to feed fuel to the burner, causing the diethylene glycol to boil over and ignite.
- Dehydration unit remained in the withdrawal cycle mode when field was shut in.

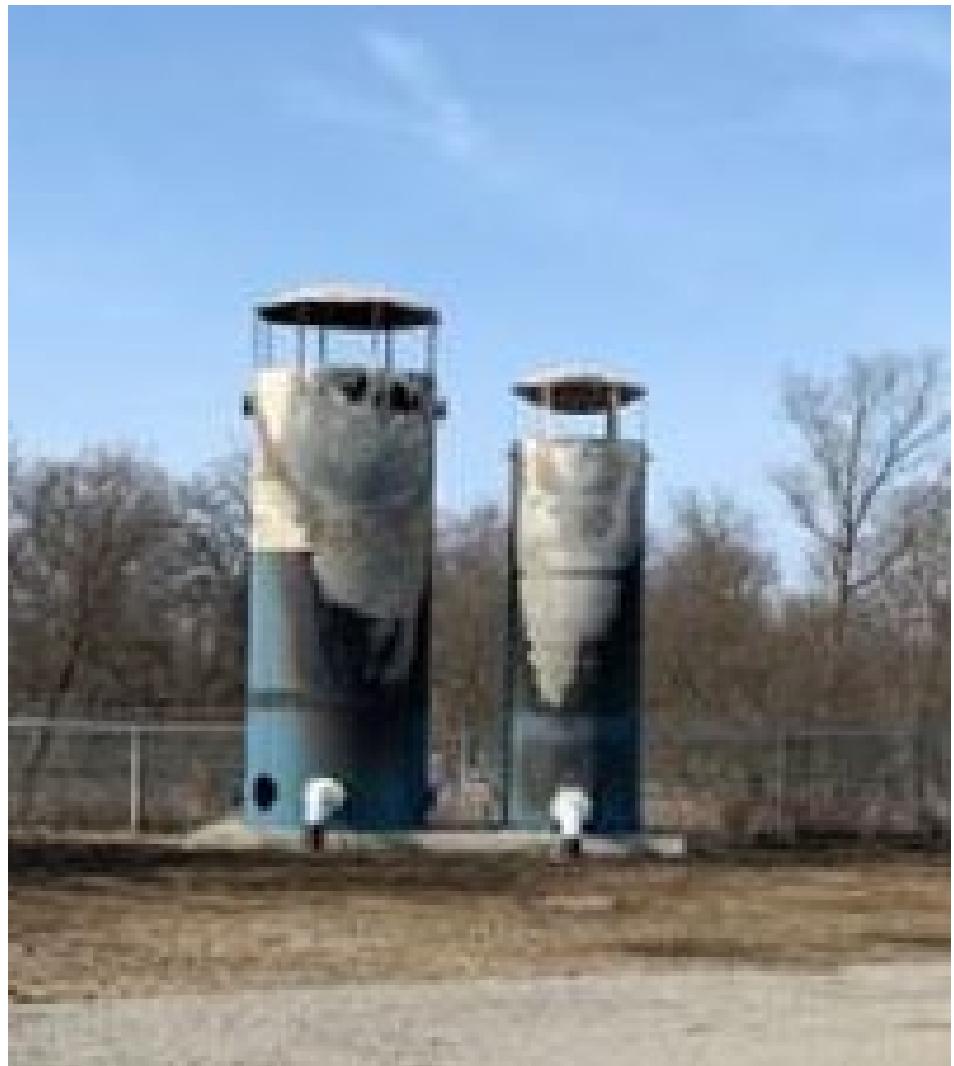
# 2019 Incident – 478629

- Compressor station blowdown fire.
- Emergency Shut-Down of Plant 3 allowed gas plume to contact Plant 2 thermal oxidizer, igniting.
- Operator identified fire and activated ESD for Plants 1 and 2, adding additional fuel to the fire at the blowdown silencers.

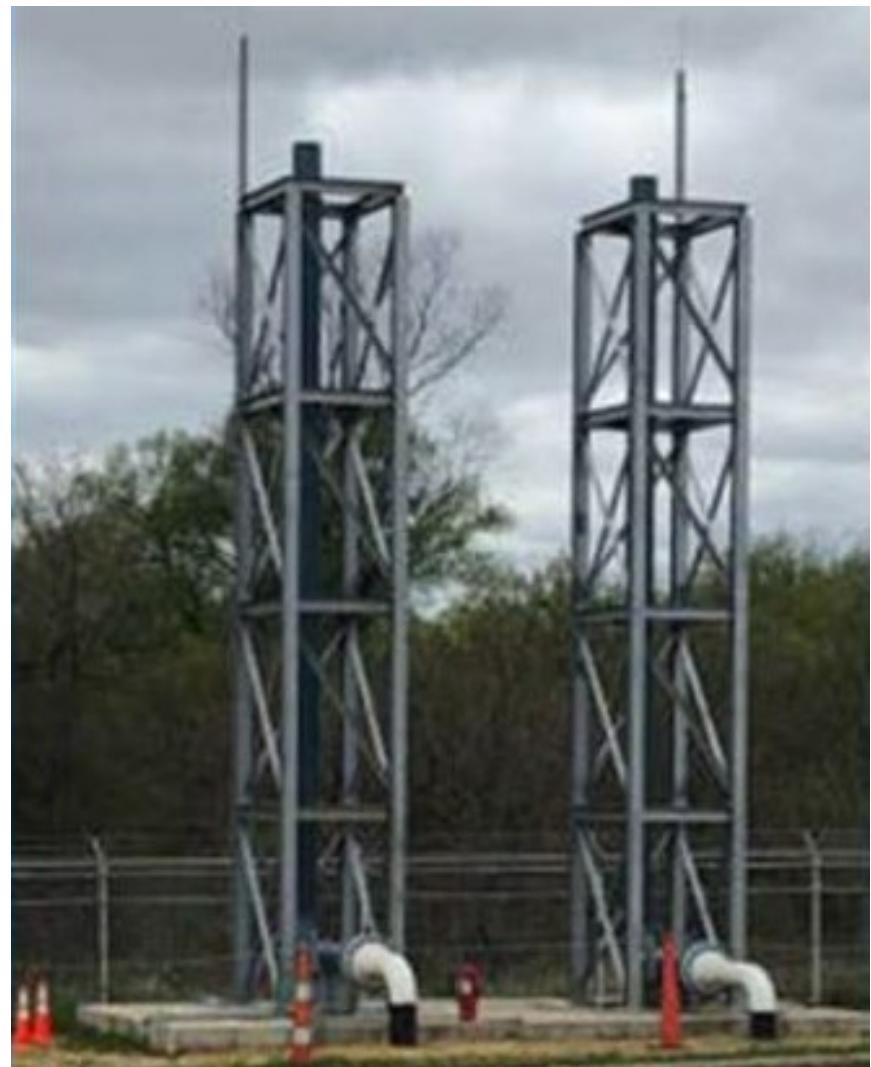
# 2019 Incident – 478629 Cont.

- Cause of initial Plant 3 ESD:  
Grounding issue interfering  
with the communication  
system.
  - Solution: Move the  
grounding systems further  
apart.

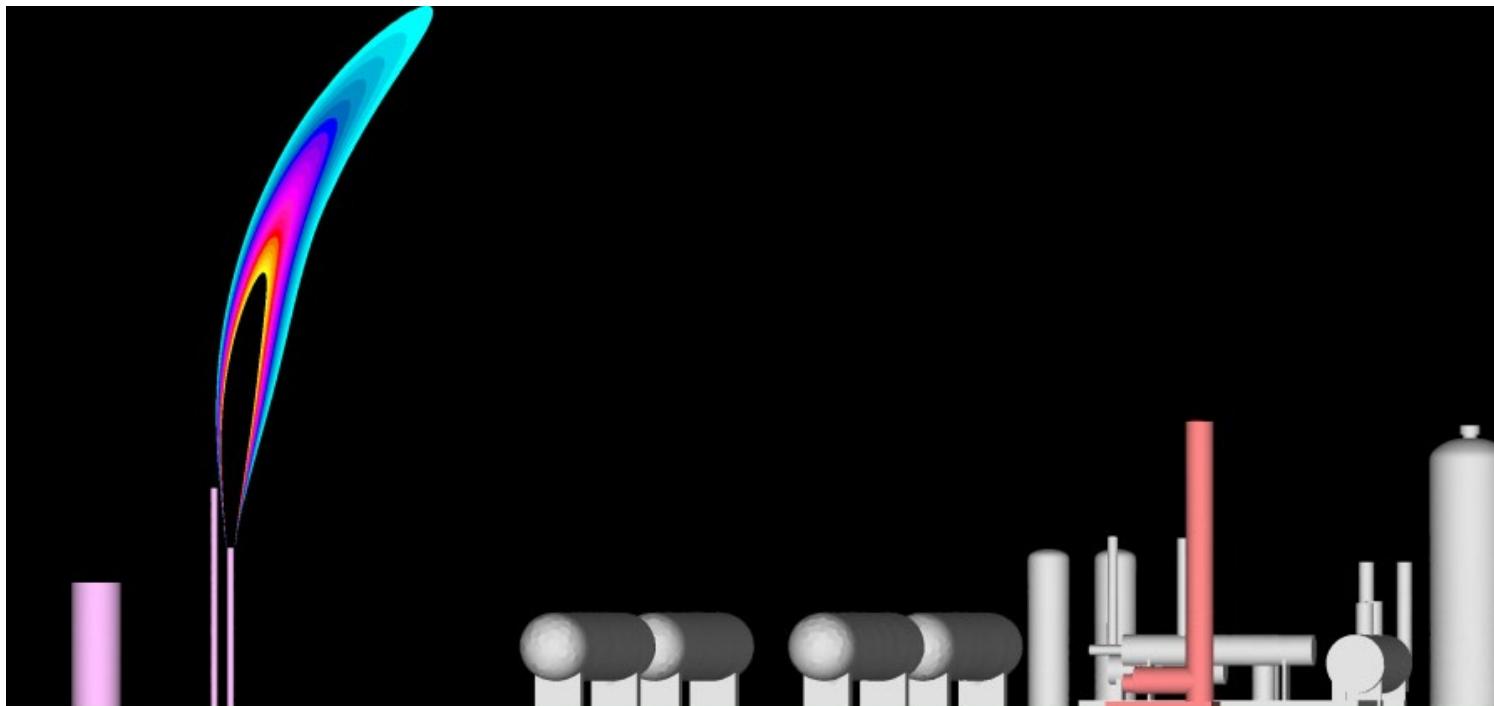
# 2019 Incident – 478629 Cont.

- Cause of ignition: Low velocity of gas discharge from blowdown silencer in conjunction with a close proximity to the thermal oxidizer.
  - Solution: Remove the silencers and install straight pipe blowdowns.

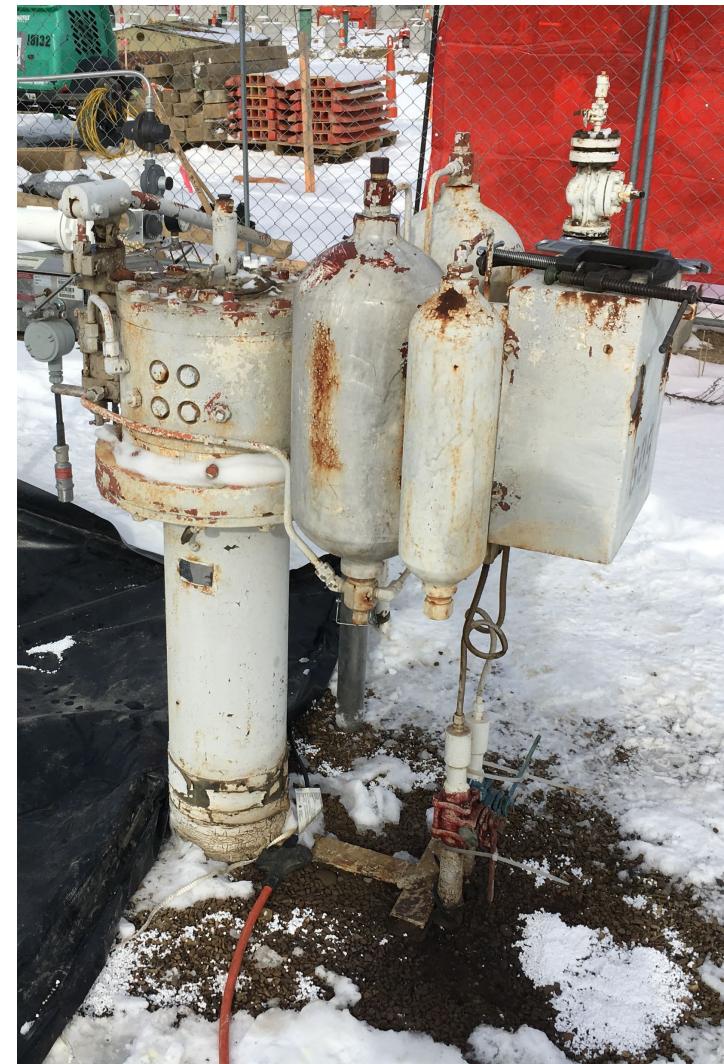
# 2019 Incident – 477834 Cont.

- Technician pulled ESD to stop gas flow, and one of the isolation valves failed to close.
- Gas loss of 32.5 MMcf.
- Recommend operator repair leaks on the pilot gas system to eliminate gas loss leading to false activation of the ESD system.
- Recommend operator repair catalytic heaters or replace with equipment better-suited for the operating conditions.

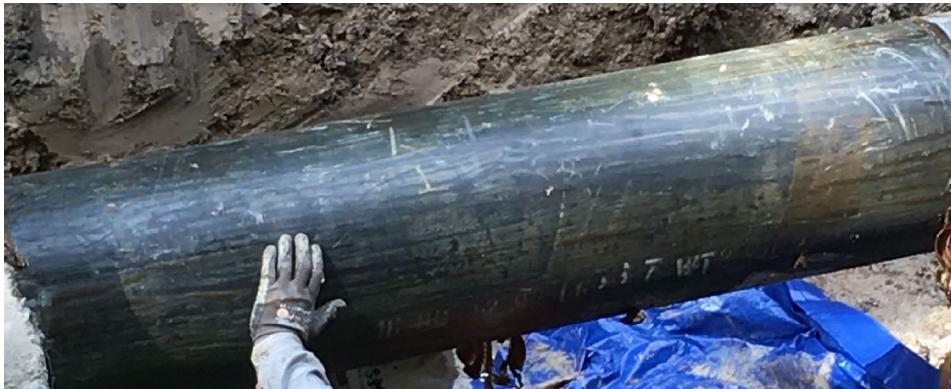
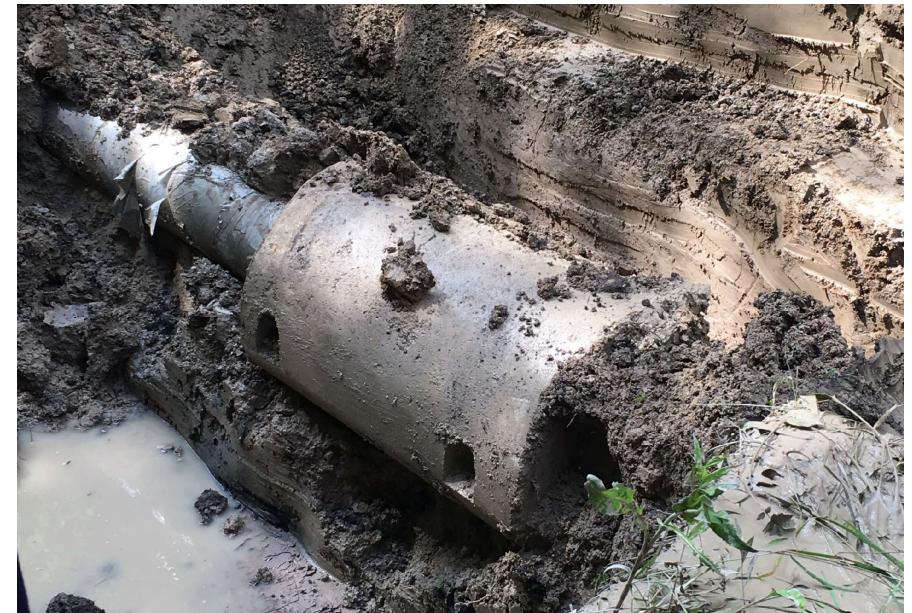
# 2019 Incident – 3484

- Transmission line leak.
- Leak located at creek crossing under 6' of water.
- External corrosion leak located under concrete swamp weight. Coating damage and disbondment.
- 16" Line installed in 1968.
- OP 495 psig. MAOP 913 psig.
- 2.186 Mmcf gas loss.
