Welcome to the Post Rover World

Presented by Jeff Puckett, P.E.
Michigan Pipeline Safety Conference
October 9, 2019

Rover Pipeline Project

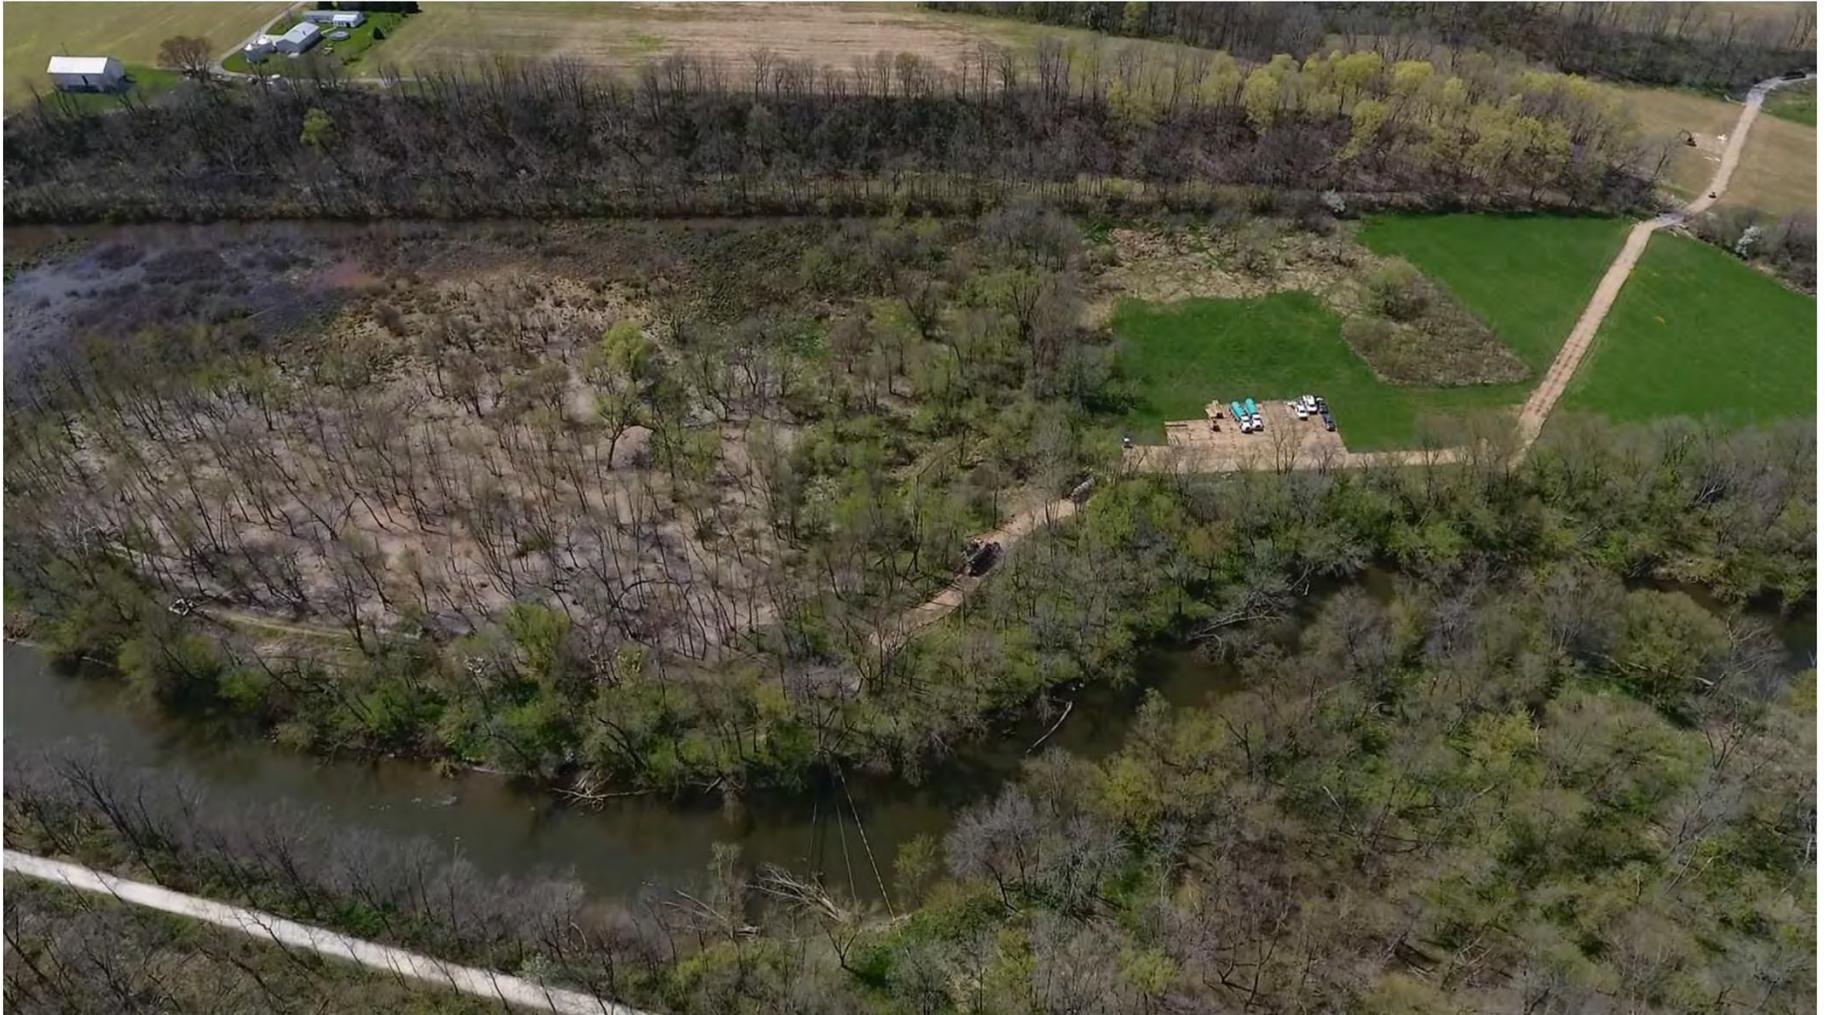
What Went Wrong?

- While there were numerous permit violations and inadvertent returns on the project, one specific inadvertent return was a game changer
- On April 13, 2017, an inadvertent return with an estimated volume of 2,000,000 gallons covering 6.5 acres was discovered in a wetland on the west side of the Tuscarawas River (Line A crossing)
- HDD operations at the Tuscarawas River crossing were immediately suspended so the drilling fluid could be cleaned up
- On May 10, 2017, FERC issued an order prohibiting Rover from starting HDD operations at locations where drilling had not commenced
- On May 15, 2017 at the direction of FERC, Rover solicited proposals for a comprehensive third-party review to:
 - Evaluate the incident at the Tuscarawas River crossing and determine its cause
 - Recommend measures that will minimize the potential for future incidents

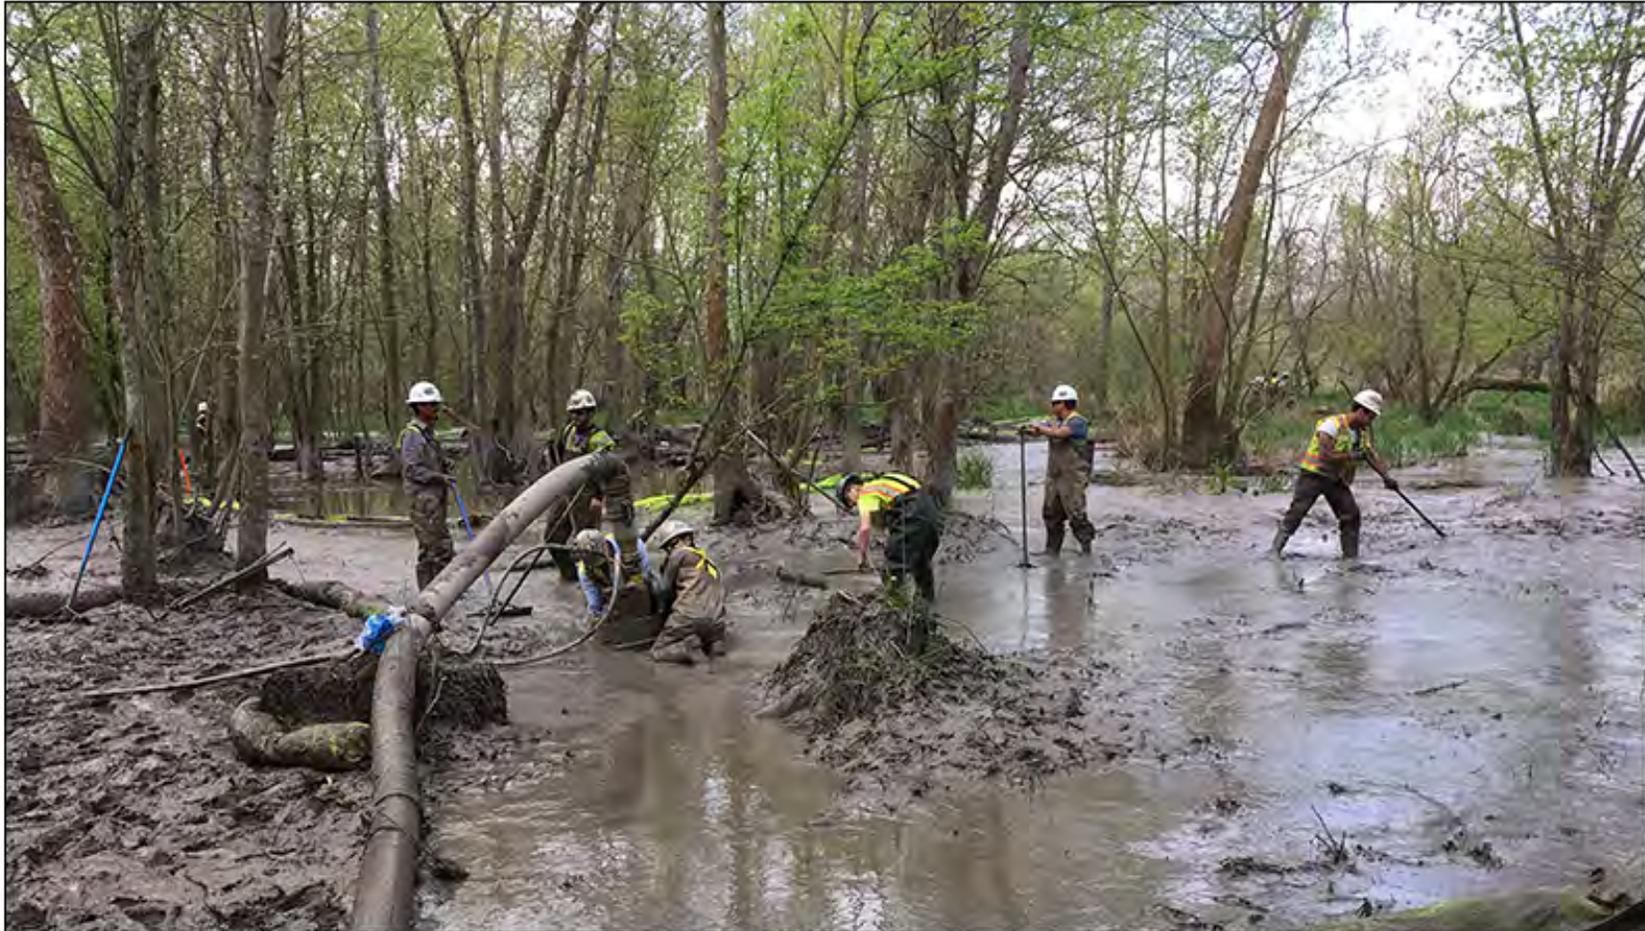
Note: Taken April 27 at site of Rover Tuscarawas HDD spill in Stark County, OH.

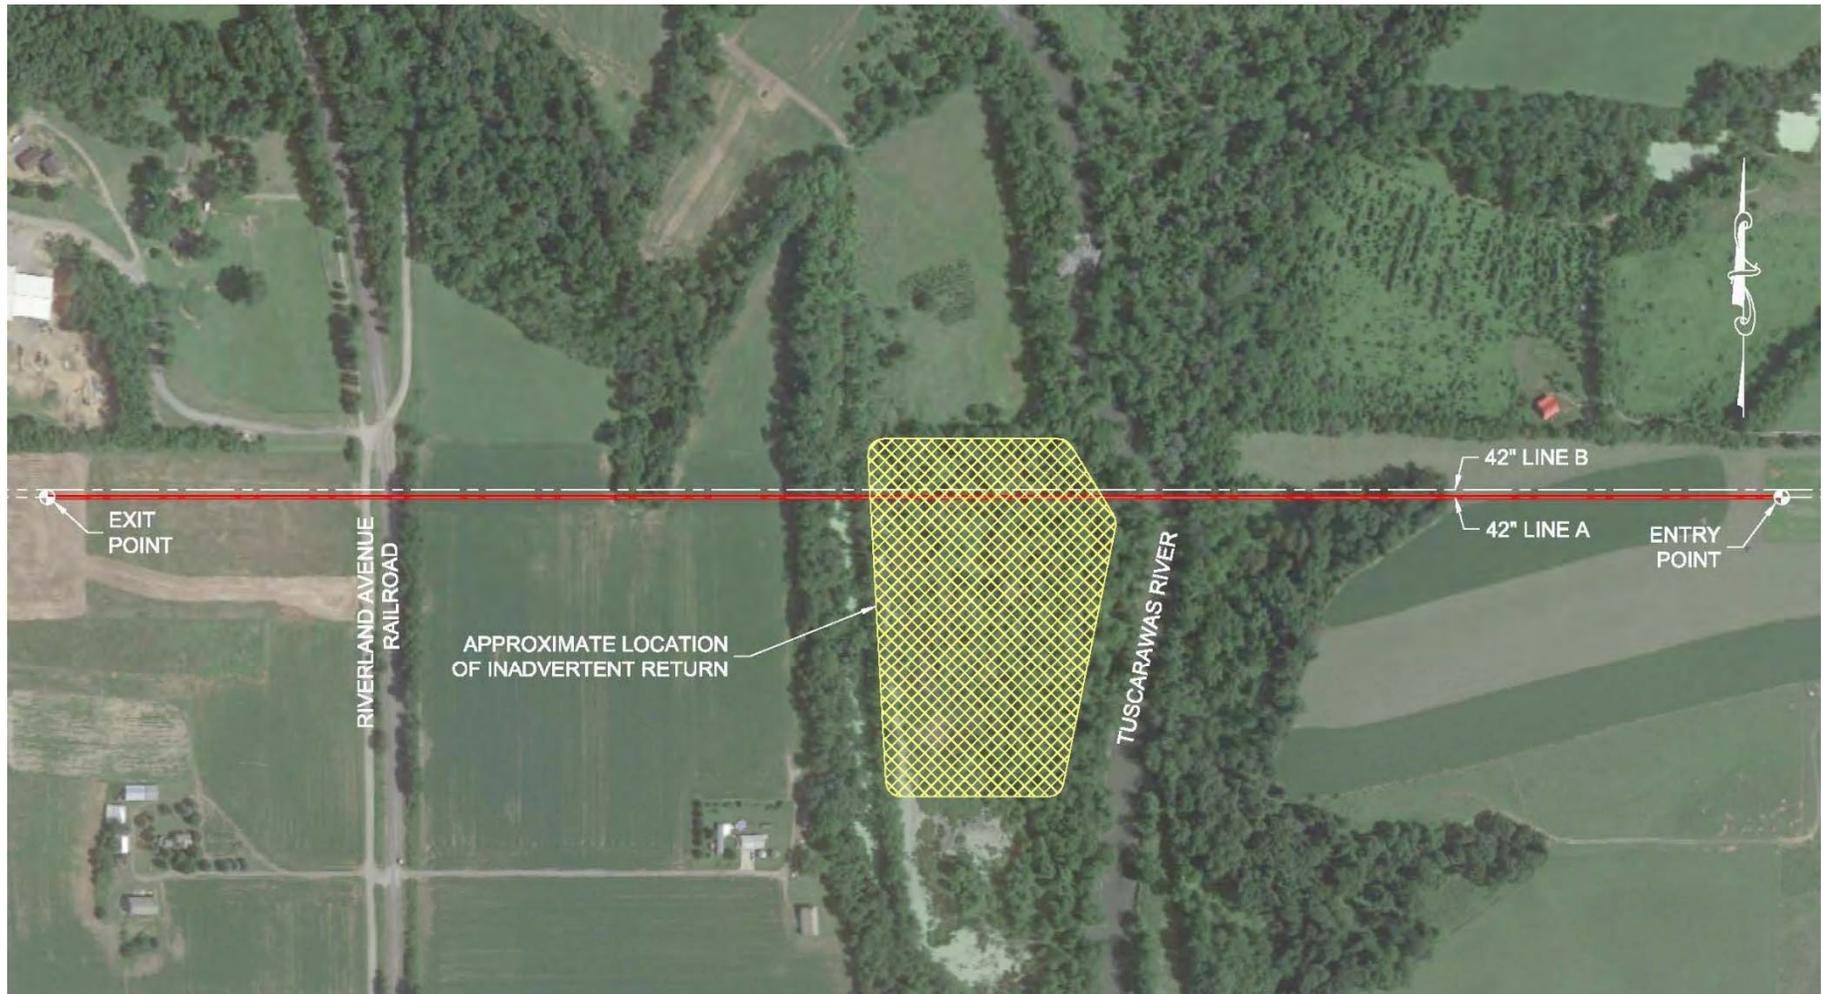
Tuscarawas River (Line A) Plan View

- 42-inch diameter HDD crossing in Stark County, Ohio
- Horizontal drilled length 4,616 feet
- Crosses a broad river valley encompassing the Tuscarawas River and adjacent wetlands, as well as a road and a railroad
- The HDD design provided approximately 49' of cover beneath the river and 61' of cover beneath the wetland to the west of the river
- Subsurface conditions consisted of sand, silt, and clay with occasional gravel overlying sedimentary bedrock (primarily shale & siltstone with some sandstone and limestone)
- Bedrock falls off sharply in the middle of the crossing forming a deep, V-shaped trough filled with unconsolidated sediments
- The design was generally in accordance with HDD industry standards, except that it passed out of bedrock, into unconsolidated soils, and back into bedrock again

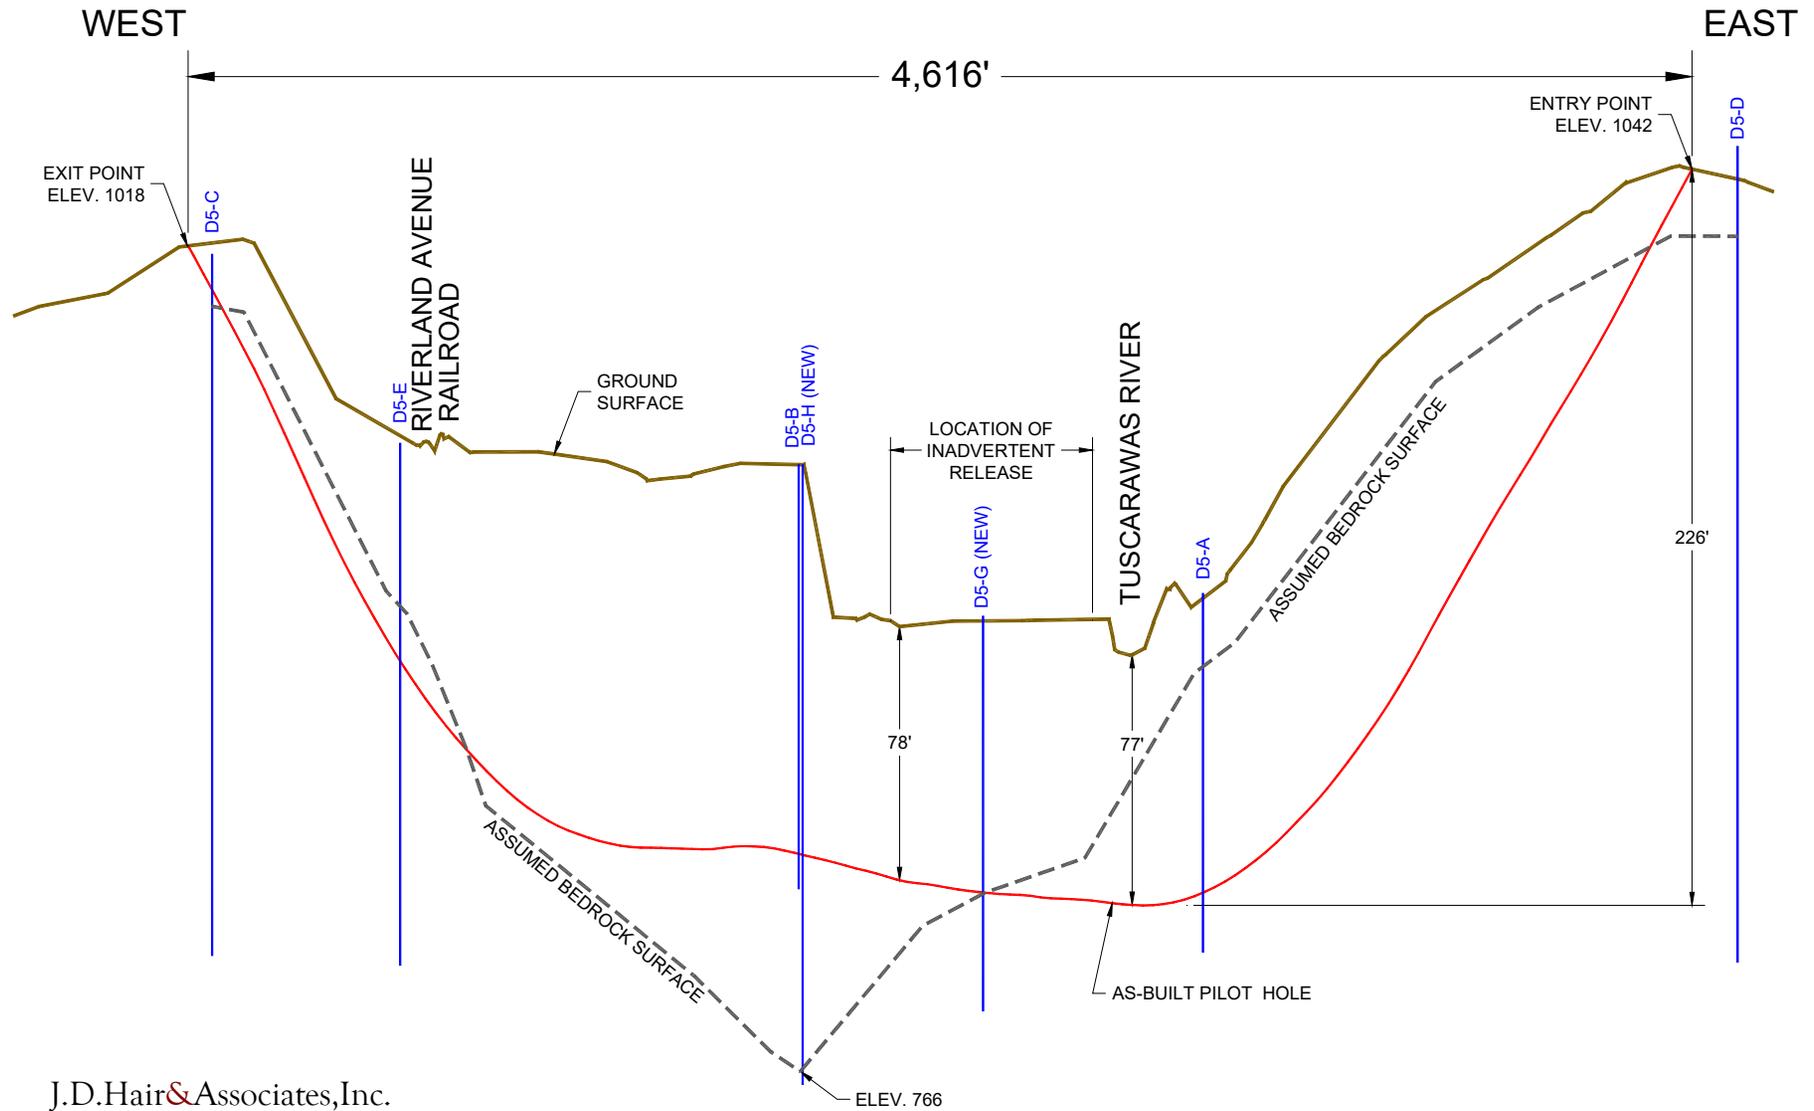
Tuscarawas River (Line A) Profile

- Weak overburden soils beneath the wetland area resulted in a much lower confining pressure than expected (revealed by an exploratory boring conducted after the inadvertent return occurred).
- Annular pressure increases resulting from the HDD contractor's remedial actions to reduce high torque caused by reactive clay/shale
 - The increased pumping rate caused a rapid increase in the height of the drilling fluid column in the hole (increased hydrostatic head)
 - If the hole had become plugged by cuttings at a point west of the river, a sudden increase in drilling fluid flow would have pressurized the zone beneath the wetland
- Failure to use appropriate drilling fluid additives to counteract reactive clay/shale, eliminate bit balling, and reduce rotary torque
 - ❖ Note that the use of such additives appears to have been prohibited by governing agencies
