**Enbridge Energy, Limited Partnership
Enbridge Line 5 - Straits of Mackinac**

**Coating Inspections, Findings and Repairs
from Activities Completed in 2017**

**Anchor Inspection Work Plan:
Interim Report**

Submitted: January 16, 2018

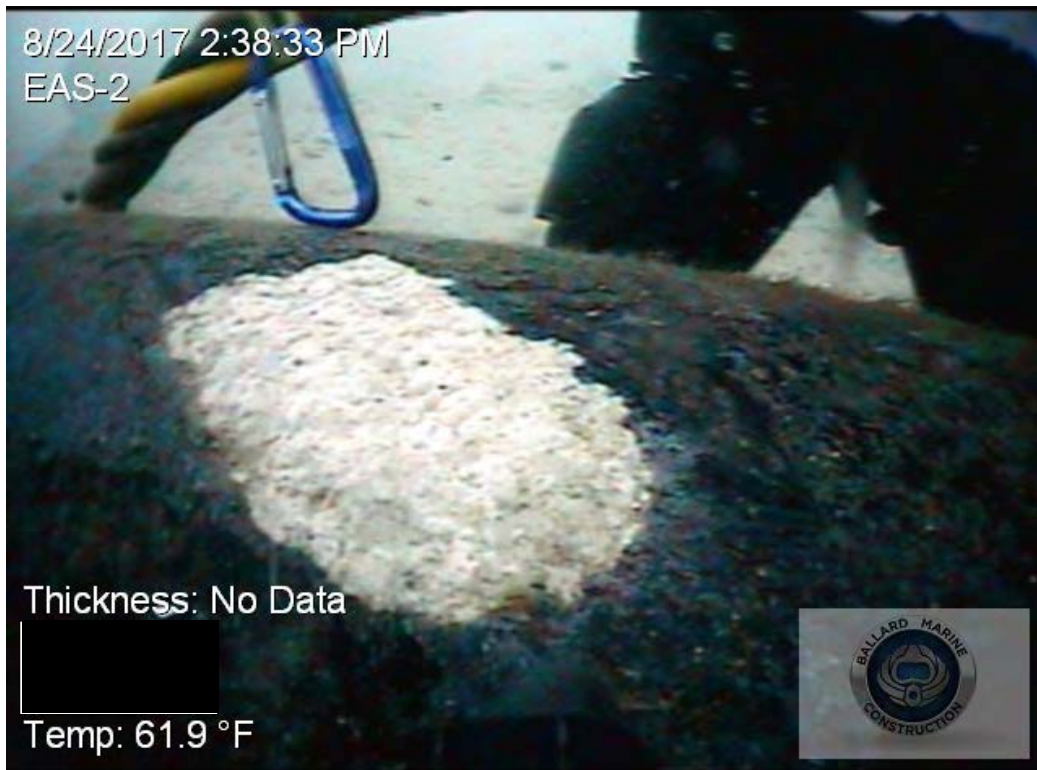
Figure 1: Photograph showing a calcareous deposit at EAS-2

Note: The average thickness of the calcareous deposit and adjacent enamel coating was 0.12 and 0.13 inches, respectively.

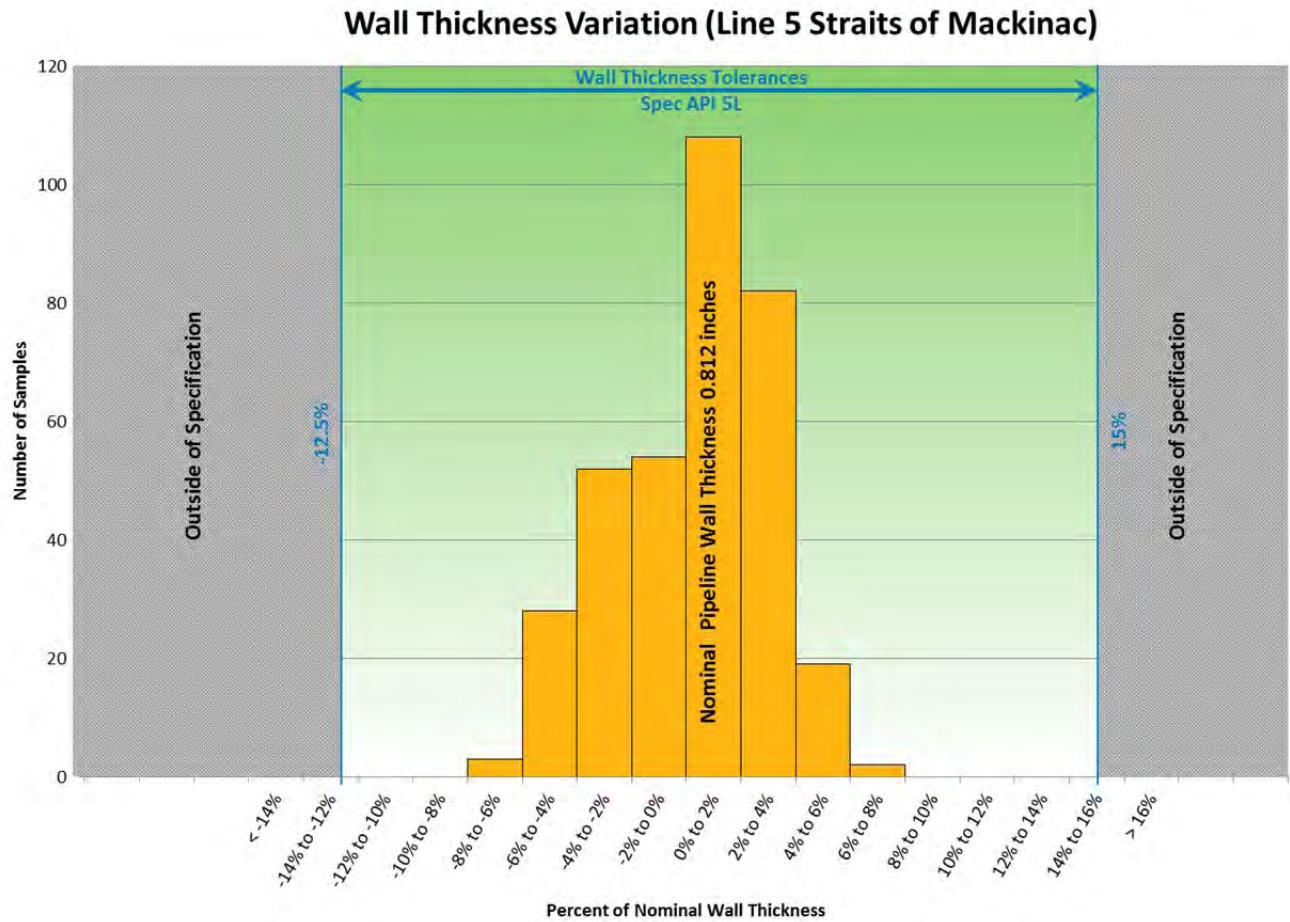
Figure 2: Pipe wall thickness distribution at coating repair locations.
