# Diver Inspection Form for L5 Straits of Mackinac

Date:	09/30/17	Diver:	Troy Baskett, Maurice Unger, Chad Cantrell, George Palmer
AFE / W.O.#:	20011702	Company Rep / Inspector:	[REDACTED]
Pipe Support Anchor:	E-1 (E-74A/E-74B South)	Water Depth (ft):	[REDACTED]
Longitude:	[REDACTED]	Latitude:	[REDACTED]

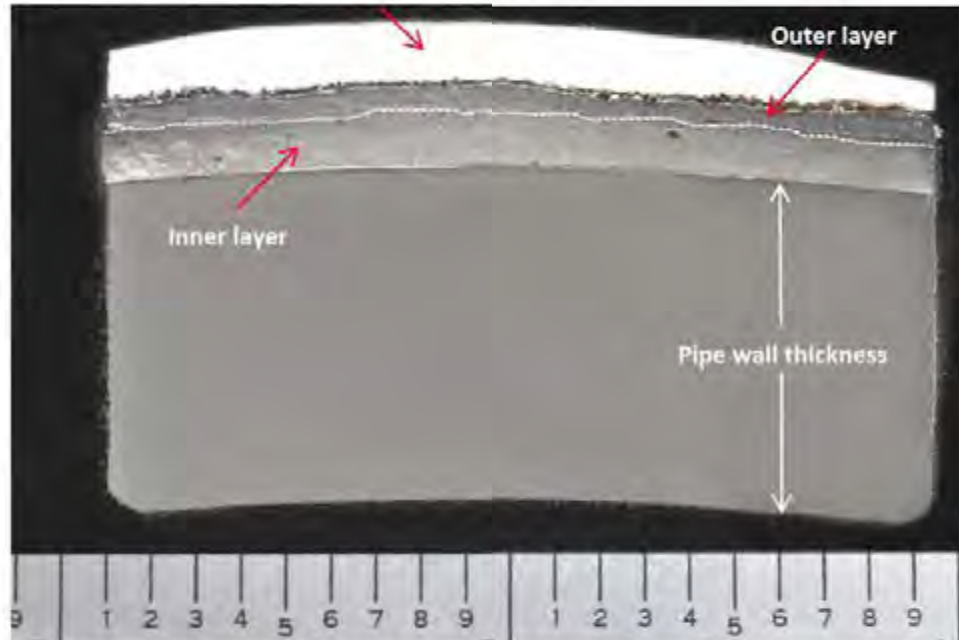
Figure 3: Metallographic cross-section through original coating. Dashed line indicates approximate boundary between inner and outer layers of coating. Numbered scale divisions are 0.1".

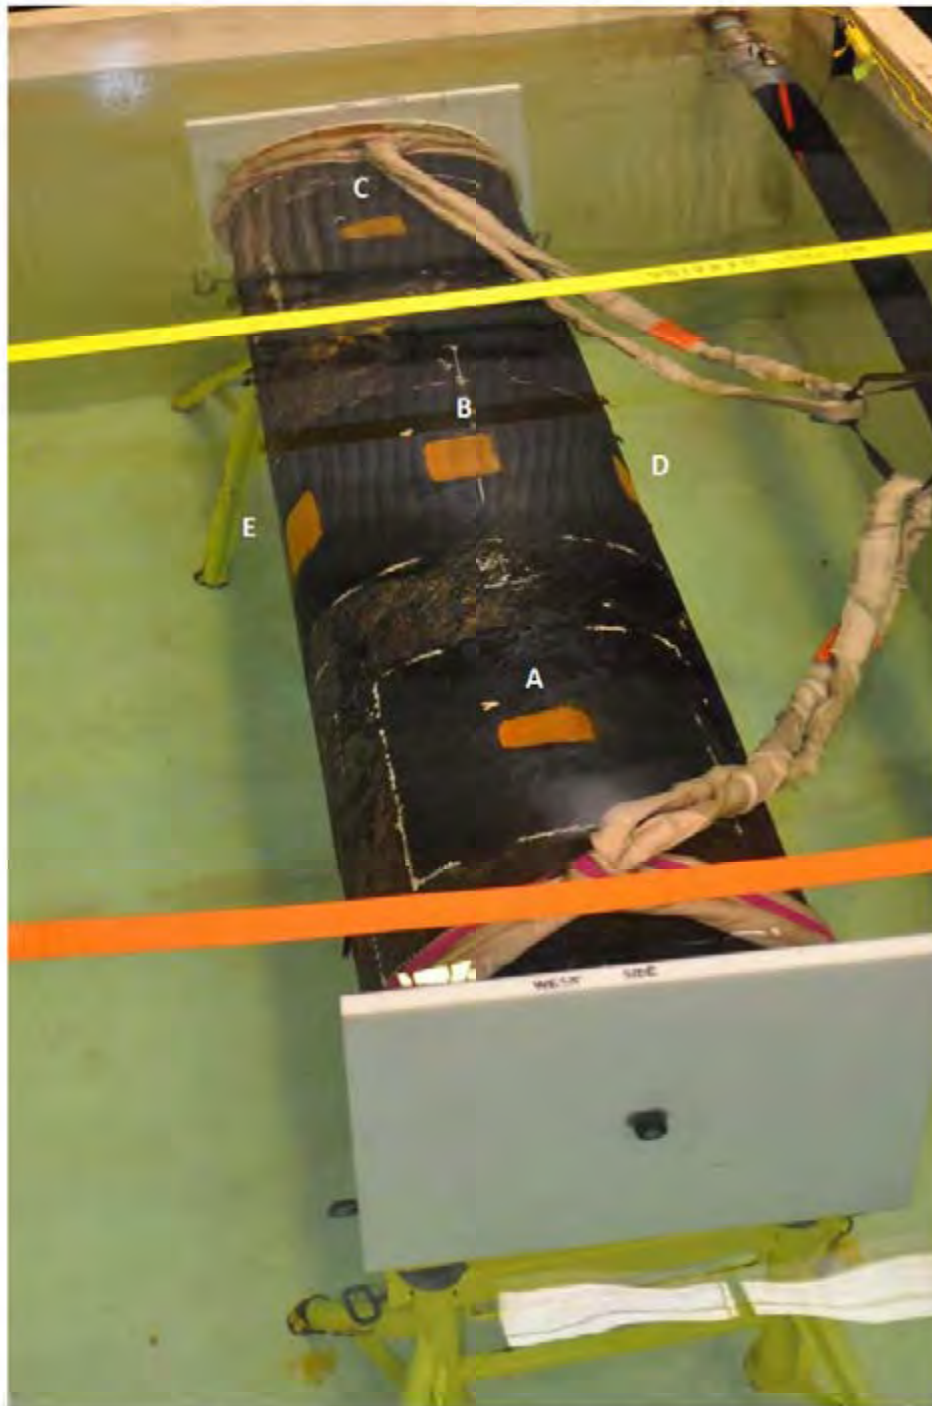
Figure 11: Photograph showing 20" pipe in 40°F water prior to application of epoxy repairs. Repair areas are labeled per Table 1 and Figure 10. Flash rust on exposed areas was removed prior to repair.

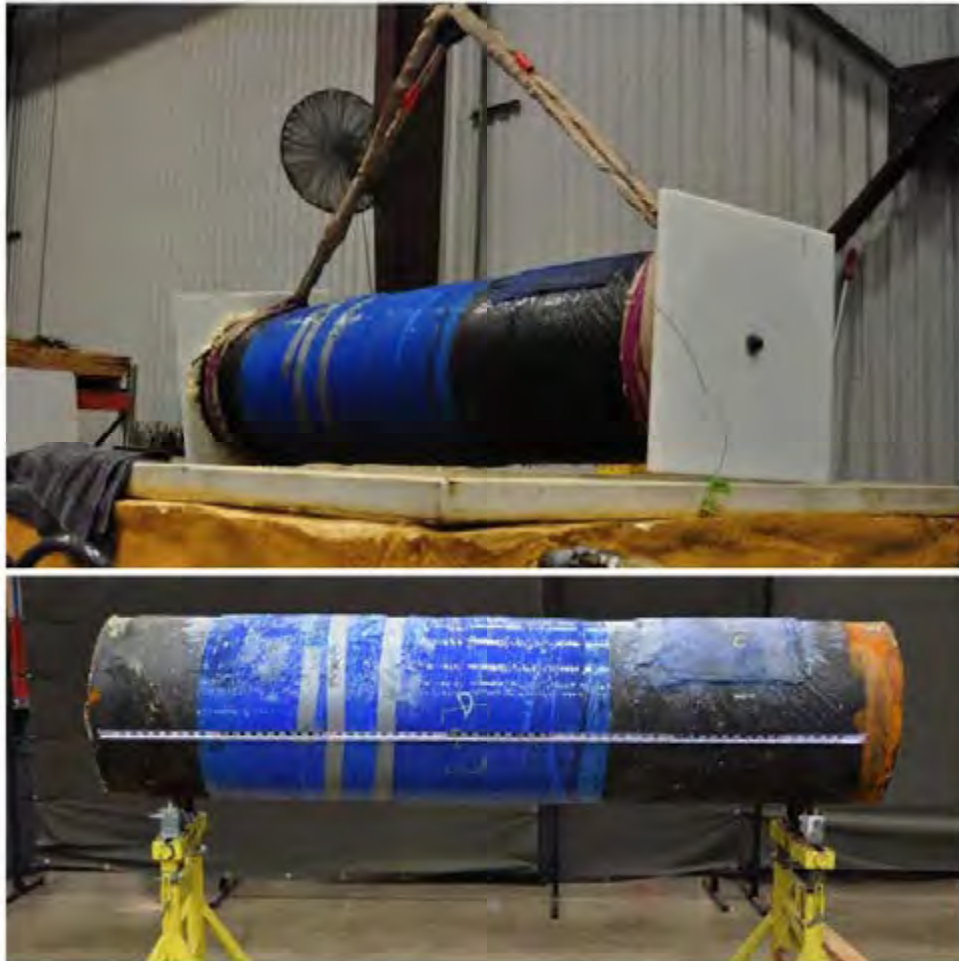
Figure 17: (a) Photograph of 20" pipe sample after removal from water bath; (b) photograph showing stricture still applied to Areas “A” and “B/D/E.” Area “C” (patch repair with no stricture) is on right end. Numbered scale divisions are 0.1 feet.

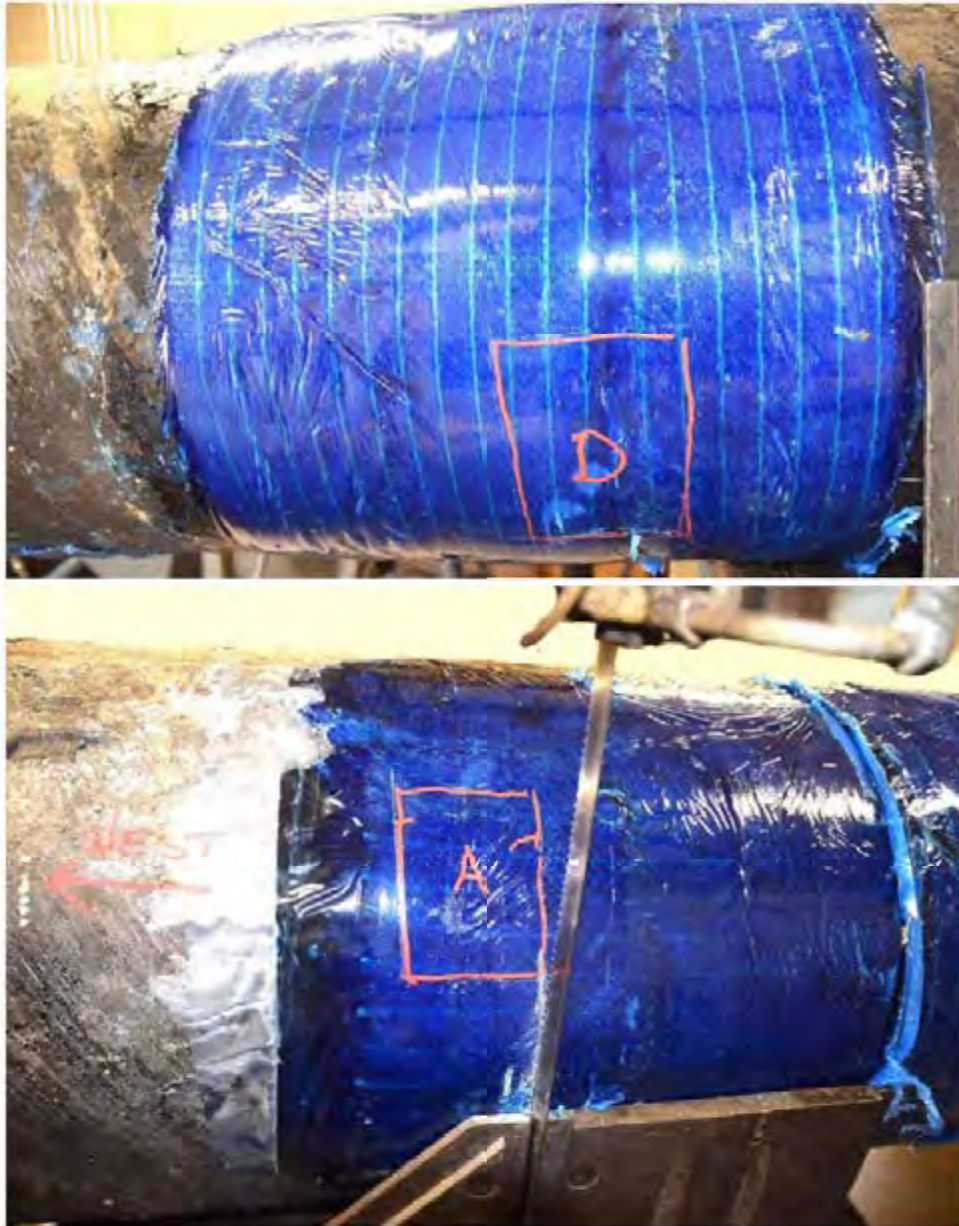
Figure 18: Full circumferential repair (Areas "B/D/E") is shown in upper photograph after stricture was removed.  
Patch repair Area "A" is shown in lower photograph after stricture was removed.

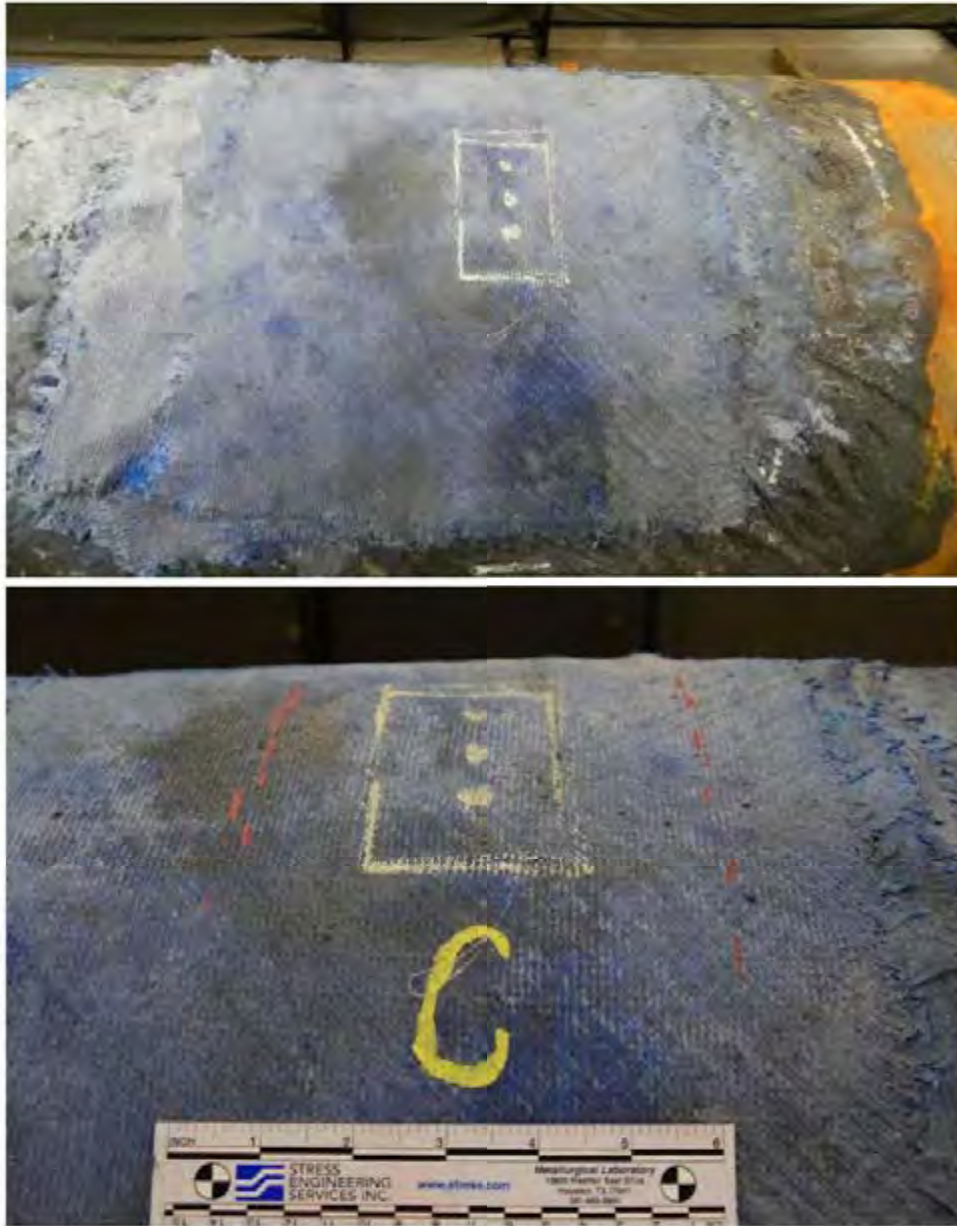
Figure 19: Photographs showing patch repair at Area "C" where no stricture was applied.

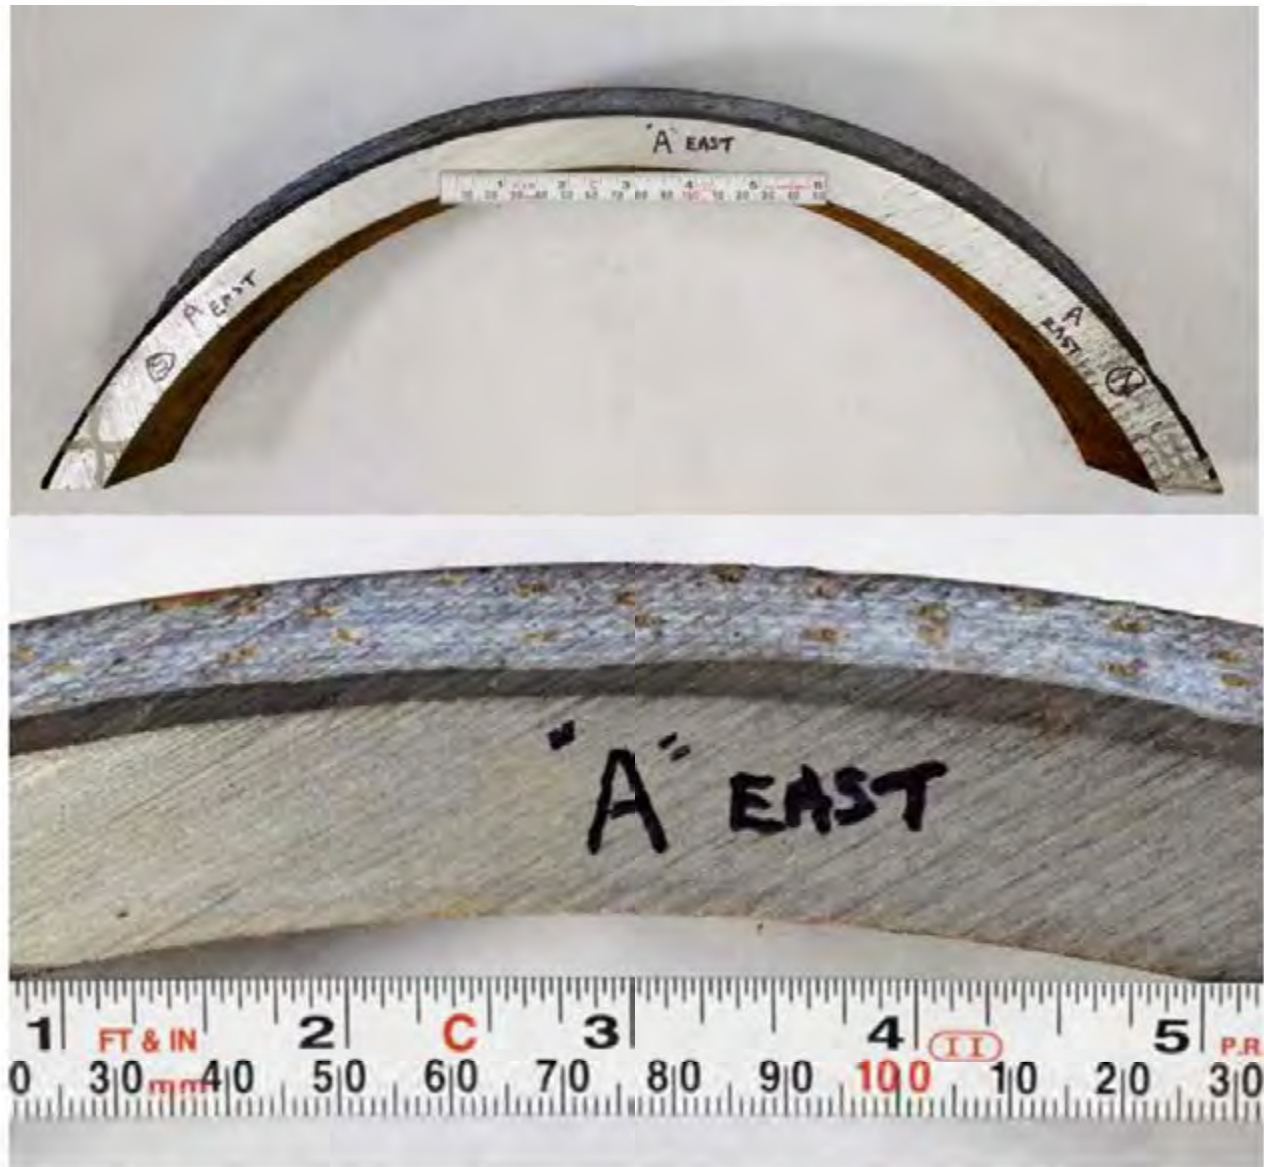
Figure 20: Photographs of rough cut cross-section through repair Area "A" (a patch repair with stricture banding).

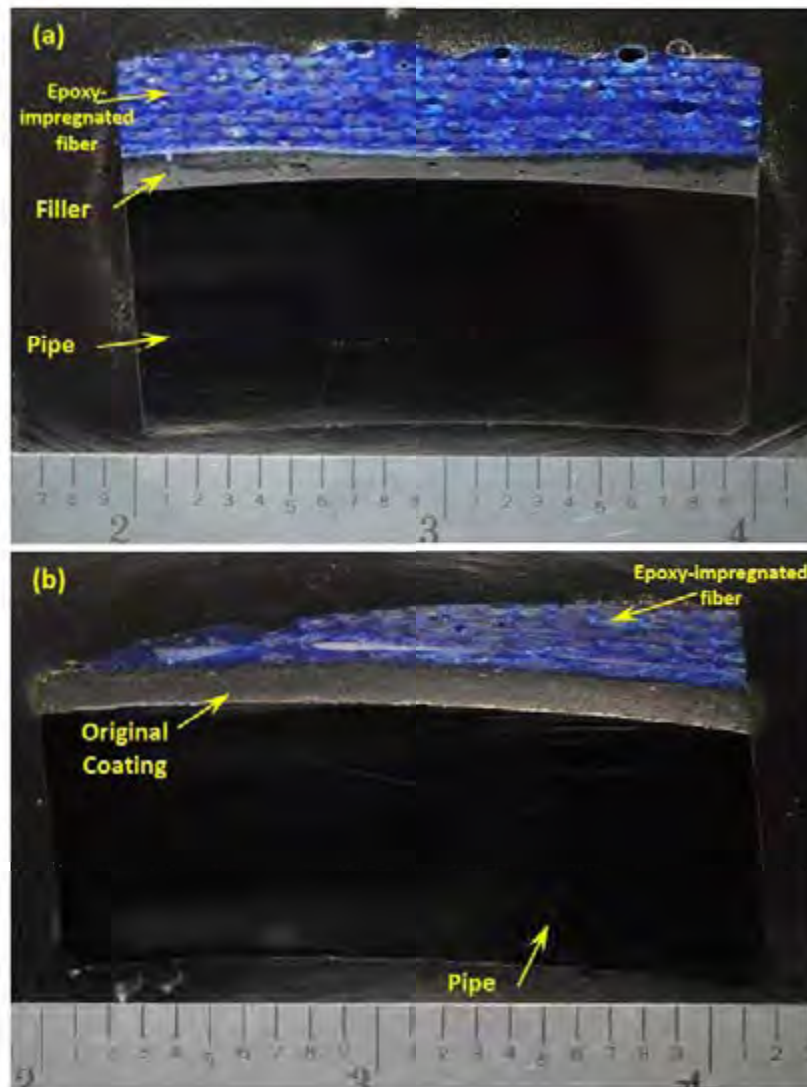
**Figure 21: Metallographic cross-sections through repair Area "A." Section in upper photograph was removed through center of repair where original coating was completely removed down to bare metal. Lower photograph shows edge of repair where fiber wrap covers original coating.**

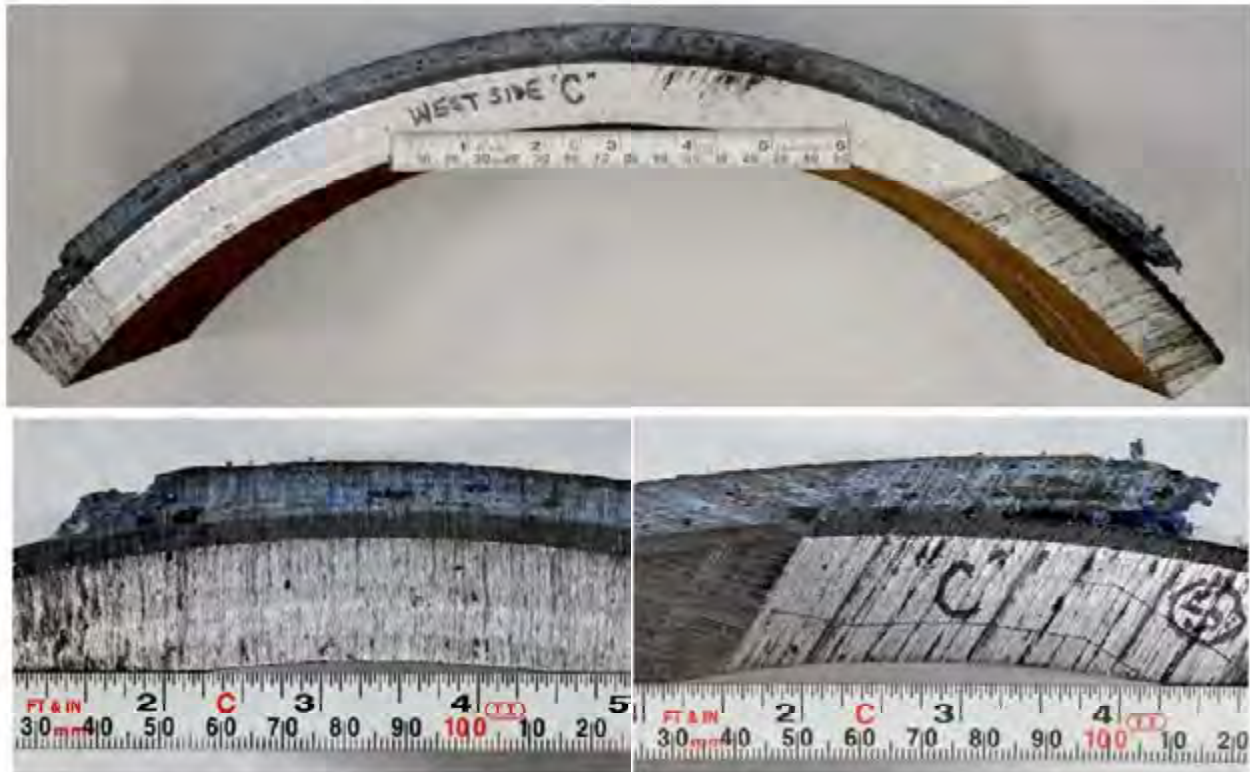
**Figure 26: Rough cut cross-section through repair Area “C,” a patch repair where no structure banding was used. While center of repair was well adhered to pipe wall, perimeter of patch was disbanded from pipe.**

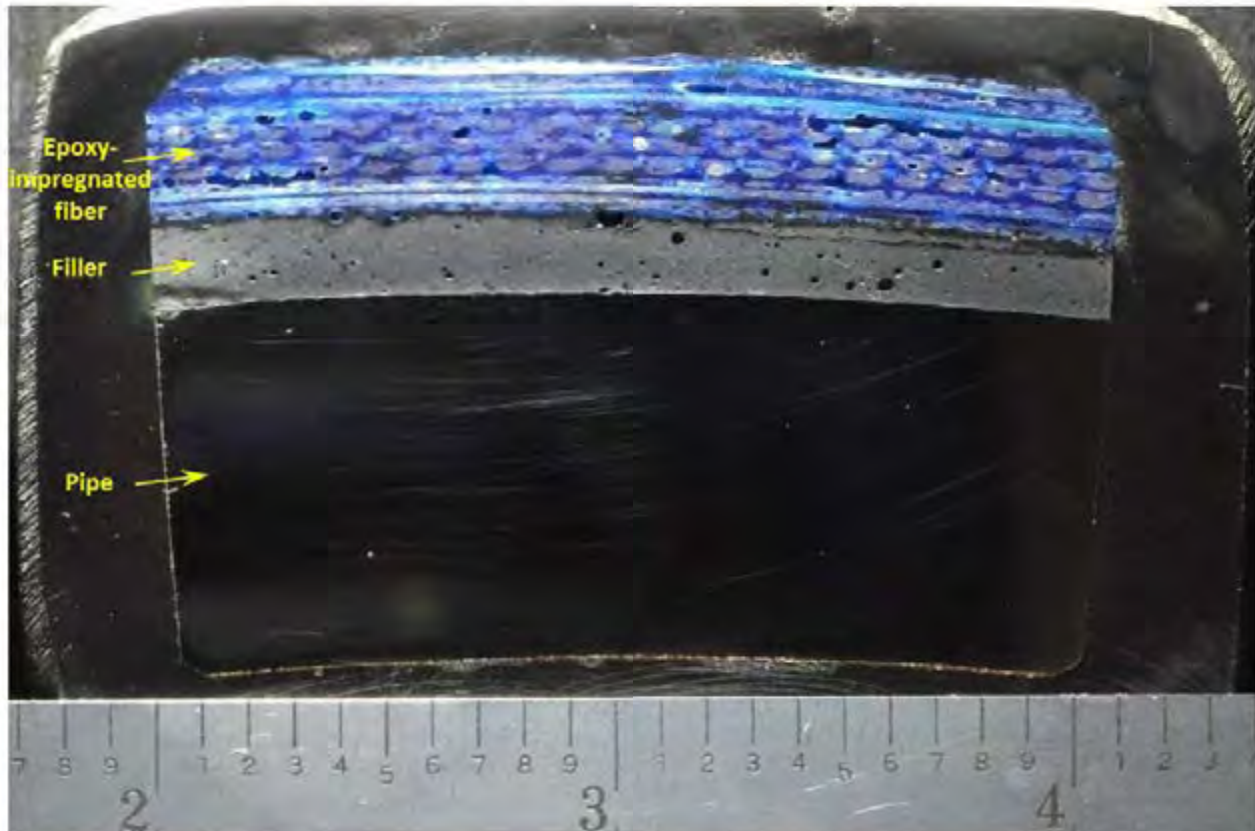
Figure 27: Metallographic cross-section through repair Area "C," a patch repair where no stricture banding was used.
