**Clean Michigan Initiative  
Nonpoint Source Grant**  
Tracking code 2002-0061

## Sebewaing River Watershed Implementation of Physical Improvements

April 1, 2004, through September 30, 2007

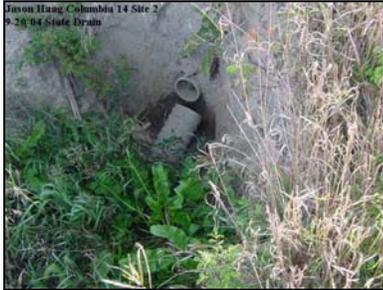
Tile outlet in need of repair. The stream bank was cut back over 20 feet. Sediments and nutrients were entering the water.

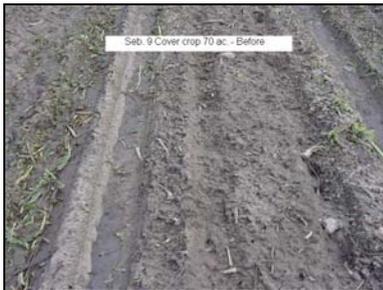
Sugar beet field after harvest had very little residue present to prevent sheet and rill erosion.

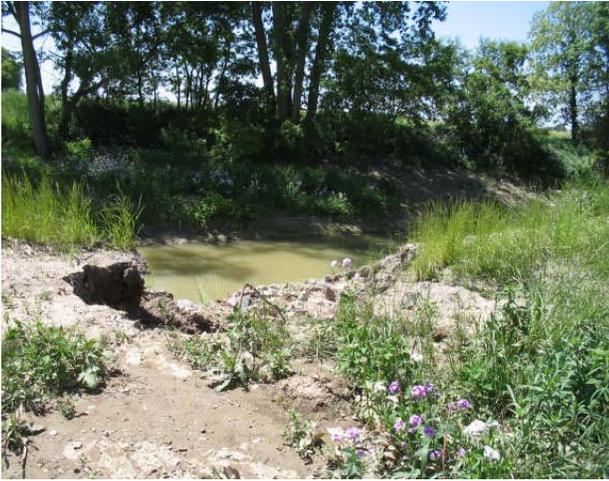
**Typical Washout formed by Runoff  
from Agricultural Fields  
(State Drain Sta. 25+00)**

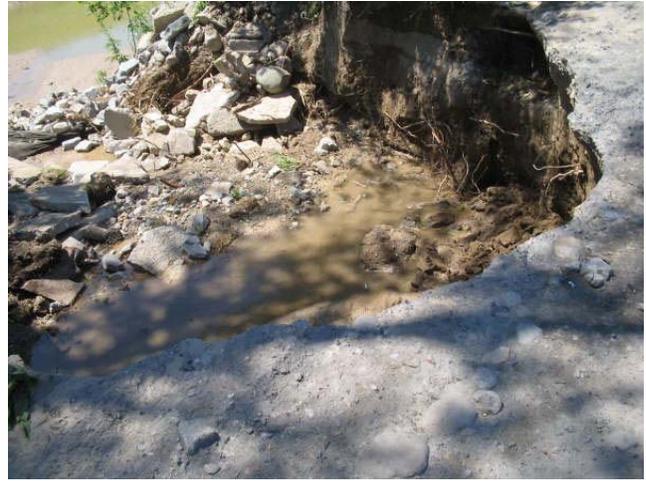
**Typical Washout formed by Runoff  
from Agricultural Fields  
(State Drain Sta. 42+00)**

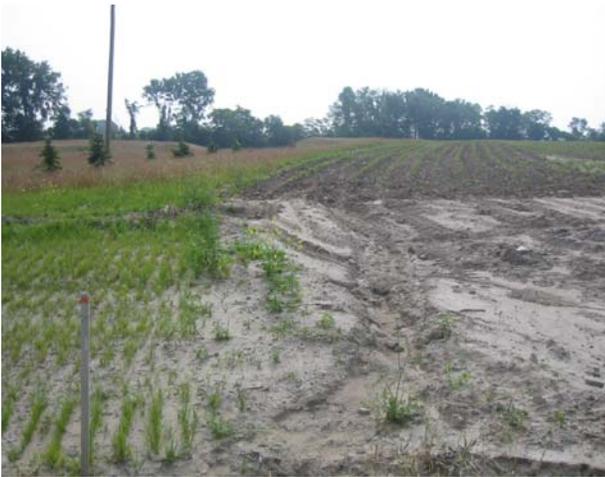
**Typical Rill Erosion formed by Runoff  
from Agricultural Fields  
(Near State Drain Sediment Basin)**

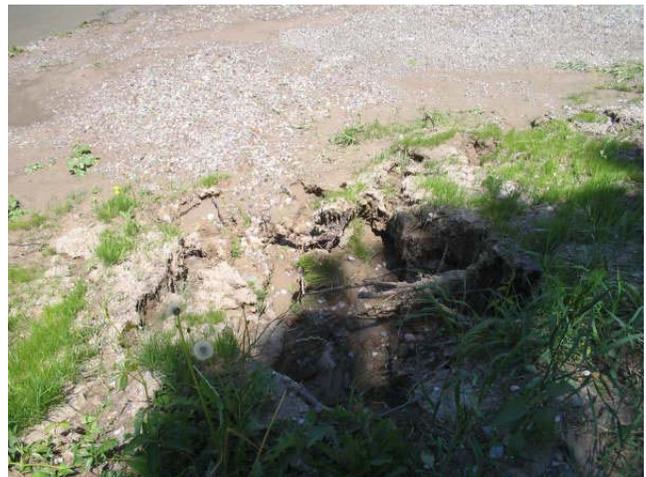
**Typical Rill Erosion formed by Runoff  
from Agricultural Fields  
(State Drain Sta. 118+00)**

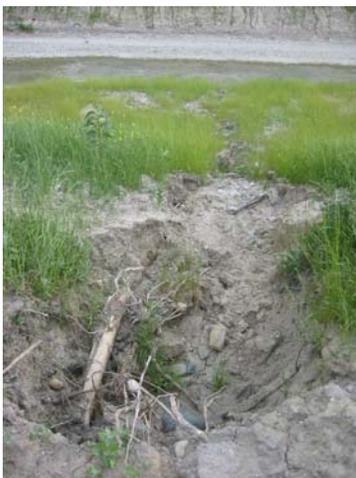
**Typical Gully Erosion formed by Runoff  
from Agricultural Fields  
(State Drain Sta. 178+00)**

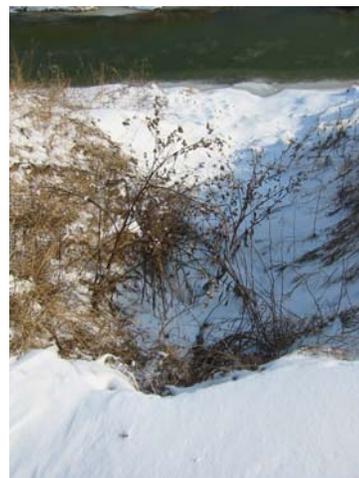
**Typical Gully Erosion formed by Runoff  
from Agricultural Fields  
(State Drain Sta. 280+00)**
