## Hager Creek Restoration

August 1, 2001 through December 31, 2004

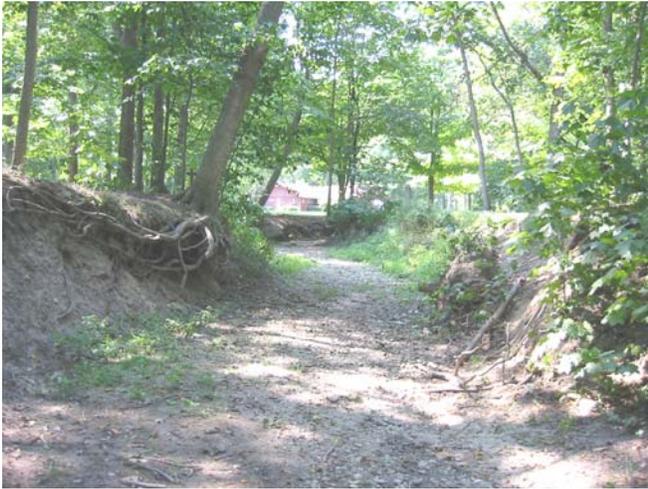
**Before:** Hager Creek east of Park Drive prior to implementation of management practices.

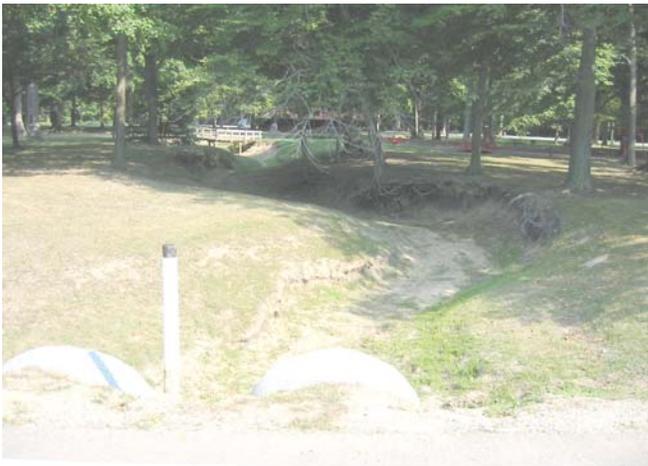
**Before:** Hager Creek at 28<sup>th</sup> Avenue prior to implementation of management practices.
