Clean Michigan Initiative Clean Water Fund Grant

Tracking code 2002-0267

City of Marquette

Whetstone Brook Restoration Project

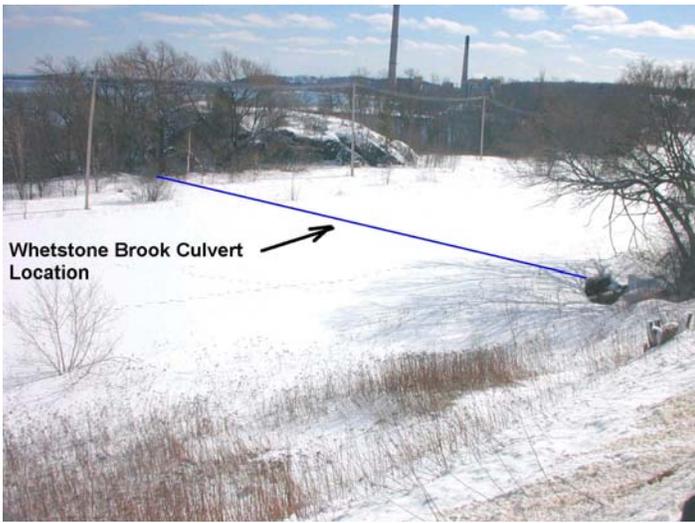
For over 130 years a failing mortared sandstone culvert confined the Whetstone under a railroad siding. The crumbling culvert created sink holes that transferred soil and cinders into the flow of water.

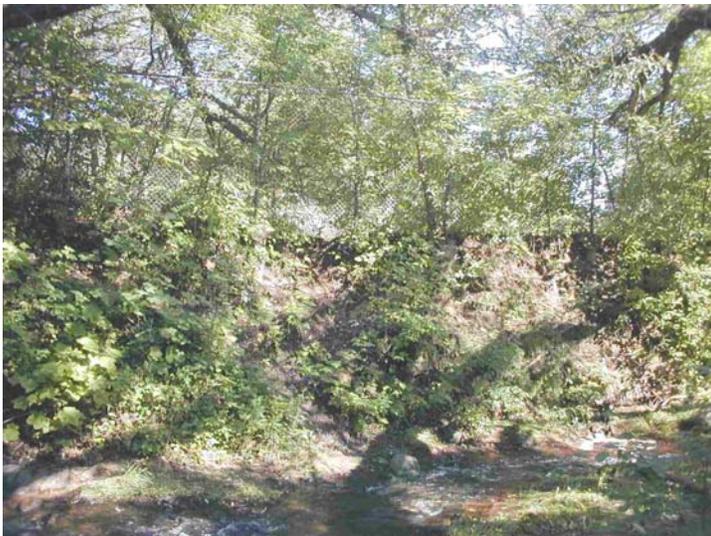
The north stream bank here just east of the culvert removal area used to be almost vertical and in a constant state of erosion.
