Detroit River - High Water Level 2019

Condition of Components

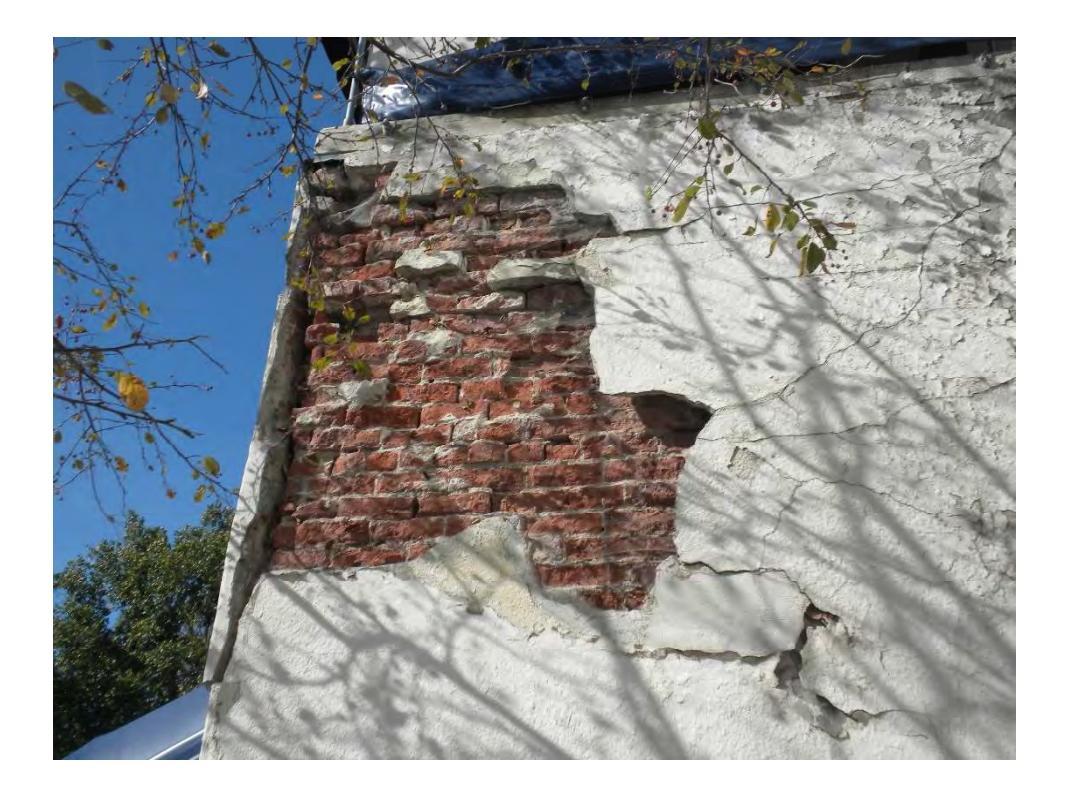
- **Stucco Finish:** Approximately 16,276 sqft, or 78% percent of the exterior stucco finish is affected by one of the following conditions:
 - a. Exposed & Deteriorated Mass Masonry Walls may comprise only a small portion of the total exterior wall area, but the severity of damage represents a structural concern and fall hazard **[Photo 5**].

- a. Approximately 1,765 sqft or 9% percent of the brick comprising the mass masonry walls are exposed due to missing/spalled stucco finish **[Photos 5-6]**.

Photo 5 Damaged/Deteriorated Brick

The overall condition of the stucco façade is **POOR**. Large areas of stucco have either fallen or are debonded and water infiltration/weather exposure has damaged the masonry back-up wall. The stucco should be stripped off, masonry back-up wall repaired and a new drainable stucco system with proper flashings be installed.

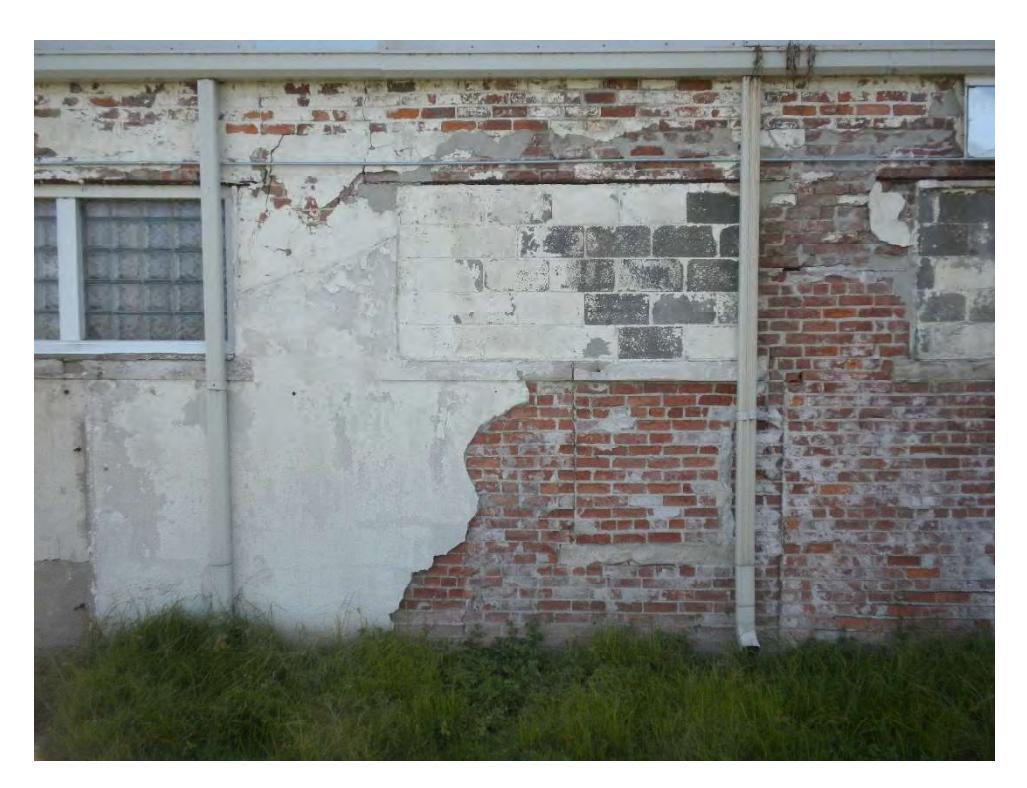
- b. Missing Stucco (i.e. stucco that has spalled or was removed) represents approximately 6 percent of the façade. With the stucco removed, the underlying brick mass masonry is subject to deterioration from exposure to the elements, **[Photo 6]**.

Photo 6 Spalled Stucco

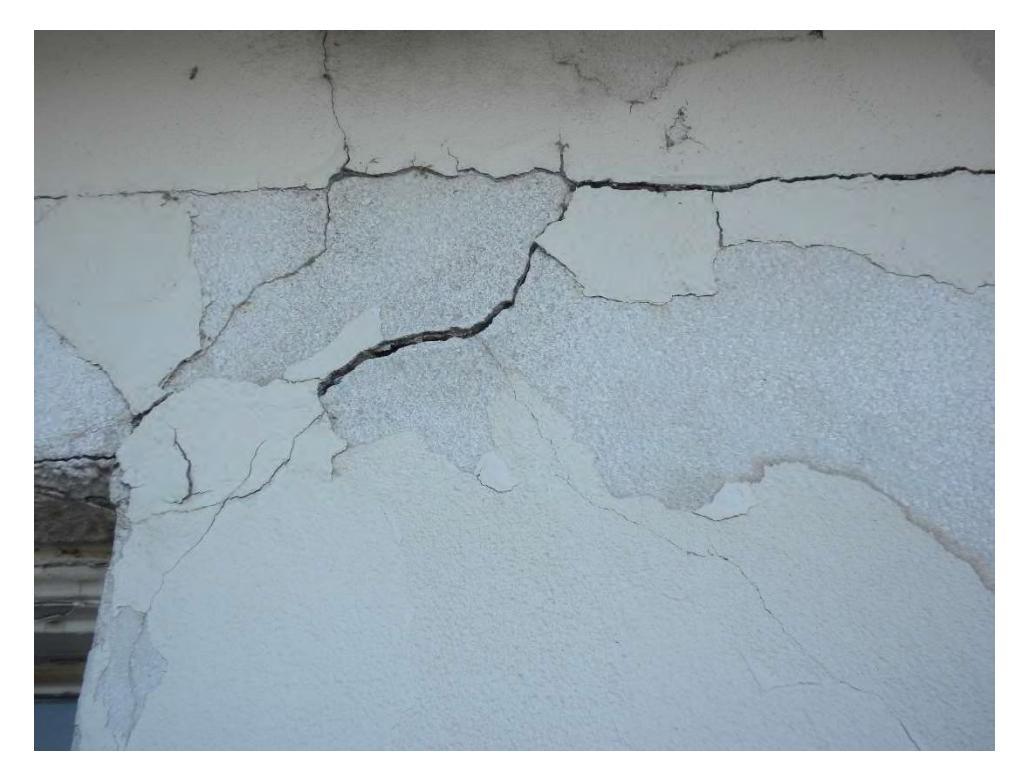
- c. Damaged and/or Debonded Stucco affects almost 70 percent of the façade area. Conditions include cracks, scaled stucco and pealed paint. These conditions may not be as unsightly as stucco that has spalled off the building, they allow water to infiltrate the exterior walls effecting the mass masonry, window lintels and eventually interior finishes [Photos 7-8] The National Parks Service Department of the Interior Preservation Brief #22 supports the replacement of the stucco citing 40-50% disbondment as an appropriate threshold.

Photo 7 Debonded Stucco (Back-side of covered terraces)

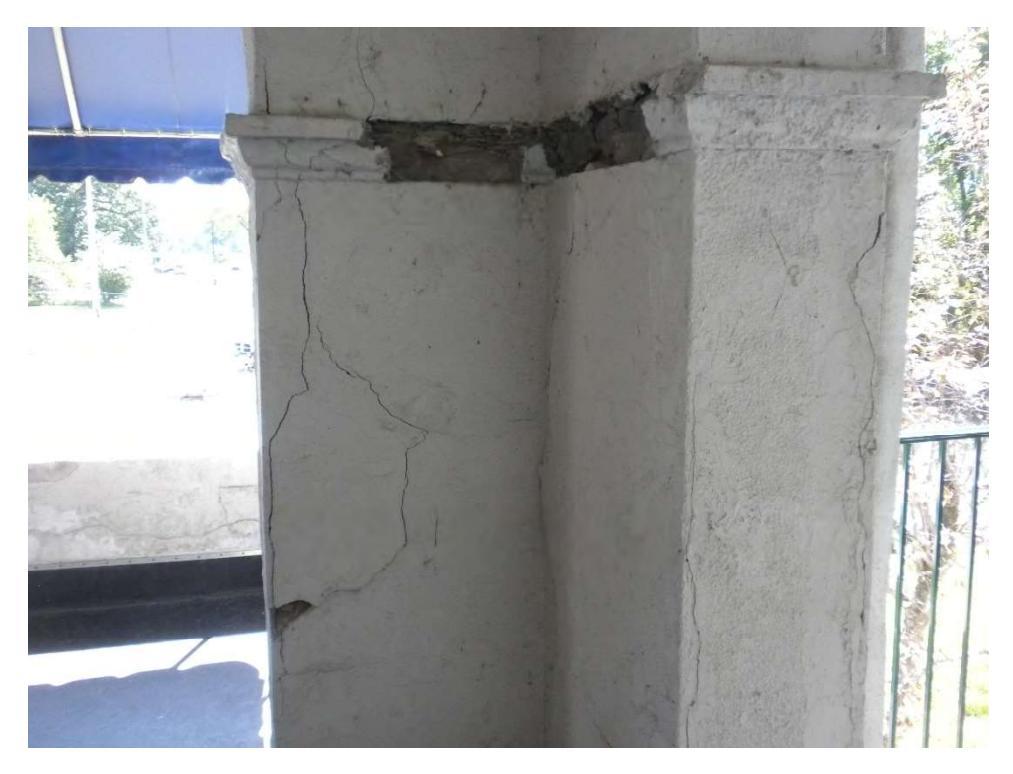
Photo 8 Damaged Stucco - Surface Scaled Finish

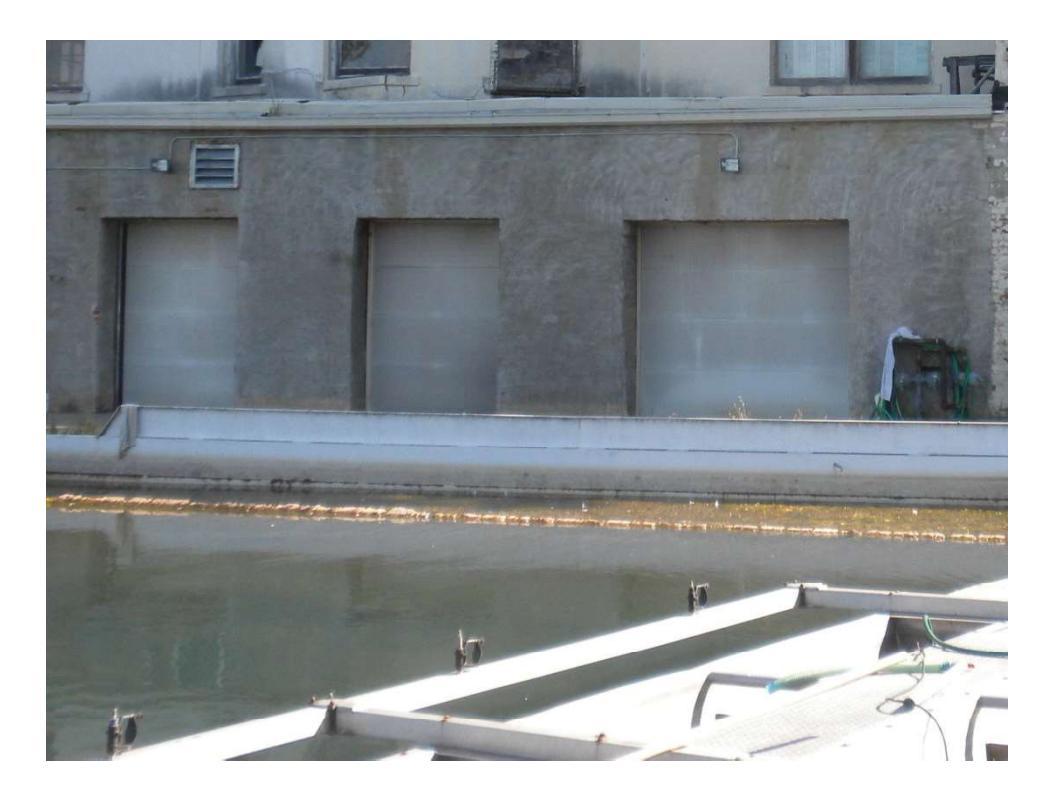
- d. Repaired Stucco exists in one area along the west elevation [Photo 9].
- **Brick Mass Masonry Walls**: The exterior walls are comprised of multi-wythe load or non-load bearing brick.

Photo 9 Previously Repaired Stucco

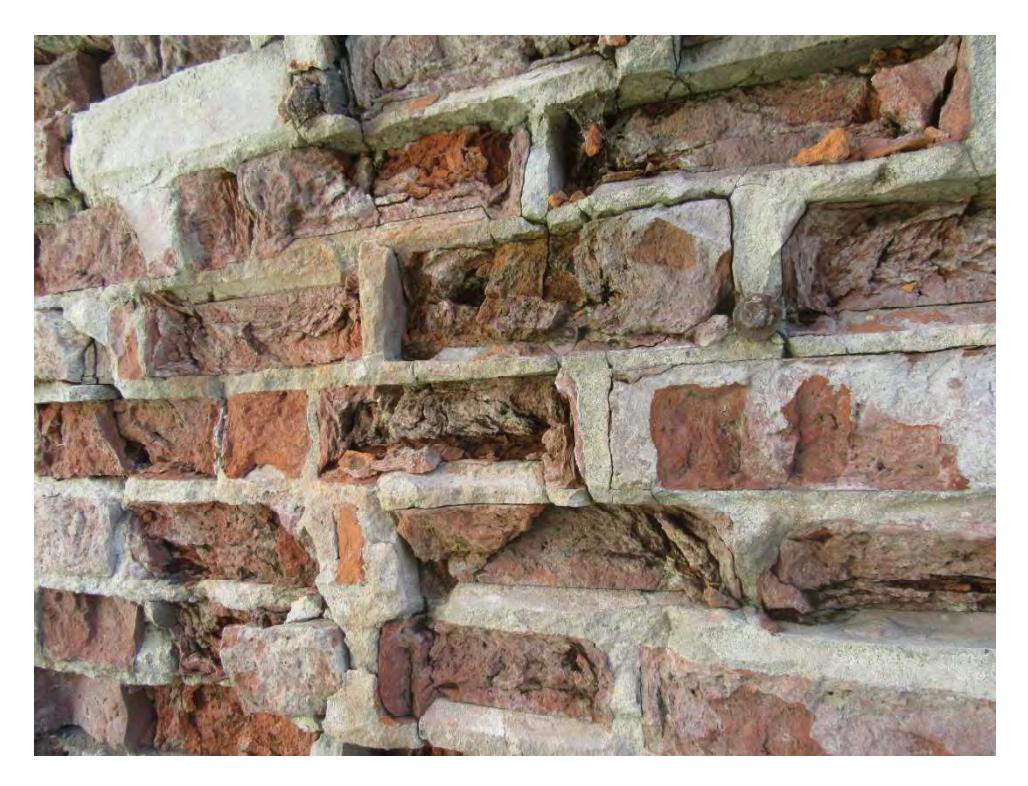
- a. Deterioration of the mass masonry due to exposure has resulted in scaling, spalled and displacement of the brick comprising the effected exterior wall [Photos 10]. These conditions may only affect a small percentage of the exterior walls, but they represent a potential structural concern.

Photo 10 Deteriorated Masonry

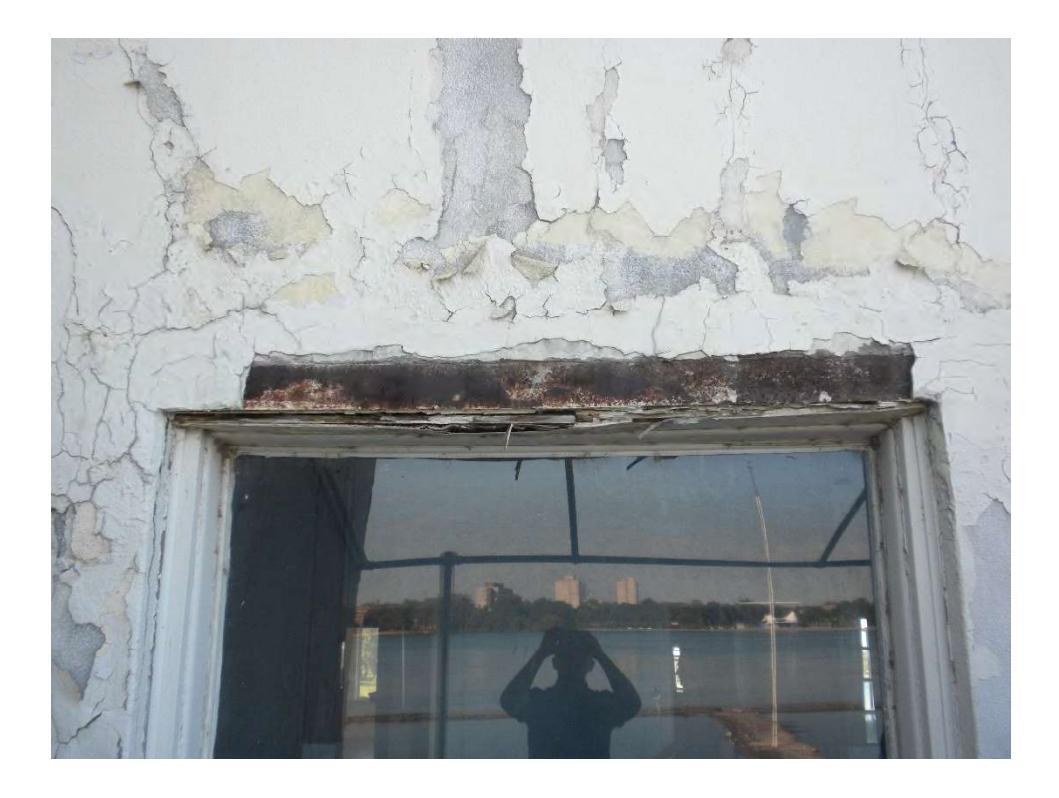
- b. Window Lintels: From observations of the window openings, it appears that a steel angle was anchored to the concrete frame as a lintel to carry the load of the brick above the window. Most of the lintels are corroded to the point that pack rust has displaced the brick and spalled the stucco finish. In severe instances, the lintel has bowed which and now represents a structural concern [Photo 11].

Photo 11 Damaged Lintels

The lintels should be repaired, and new flashing installed. The windows should all be replaced with historically accurate aluminum clad wood windows with insulated glass units.

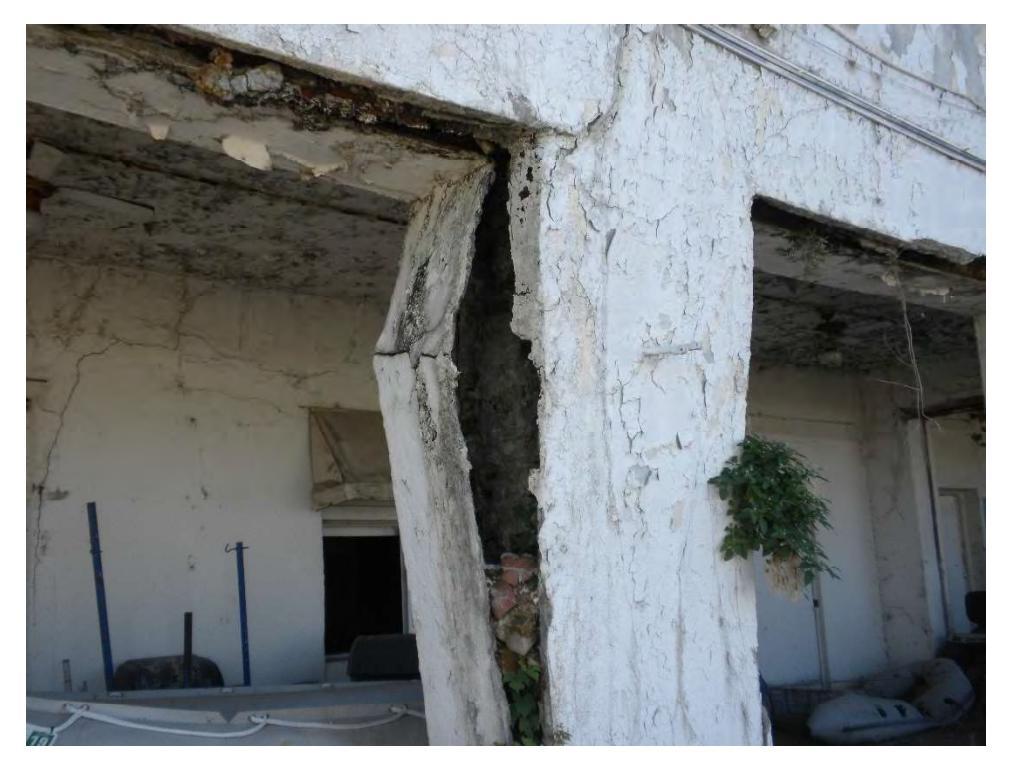
- Deteriorated stucco takes the form of cracked, debonded and spalled stucco [Photos 12].
- Tile wear surface where exposed is in fair condition [Photo 13].
- Tile wear surface was covered by an adhered EPDM membrane on most terraces [Photo 14].
- The concrete ceiling contains areas of scaled and spalled concrete and exposed reinforcing steel [Photo 15-16].
- Guard rails have been upgraded on the second level terraces to meet proper Code height, the terraces on the third level have not been upgraded. The third level terraces should be restricted to prevent occupancy.

Photo 12 Debonded Stucco (Exterior Façade)

The terraces should have all flooring removed and a new waterproofing layer installed below new exterior grade Quarry tile to match the existing. The floor deck of all terraces needs to be repaired where reinforcing steel has been exposed, support steel is corroded and at cracks. New Code compliant guardrails are to be installed.

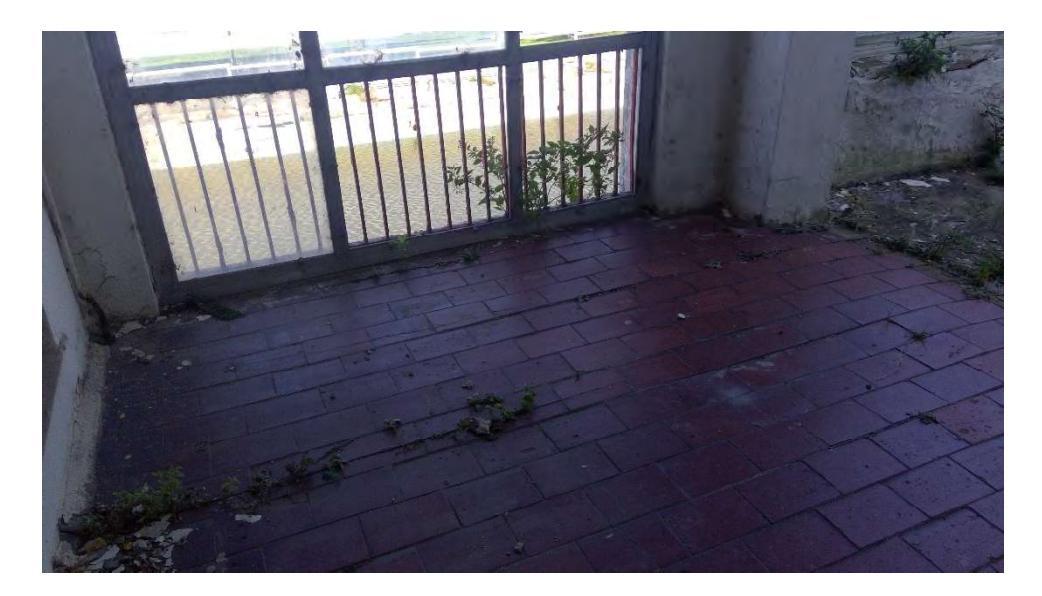
Photo 13 Exposed Terrace Tile

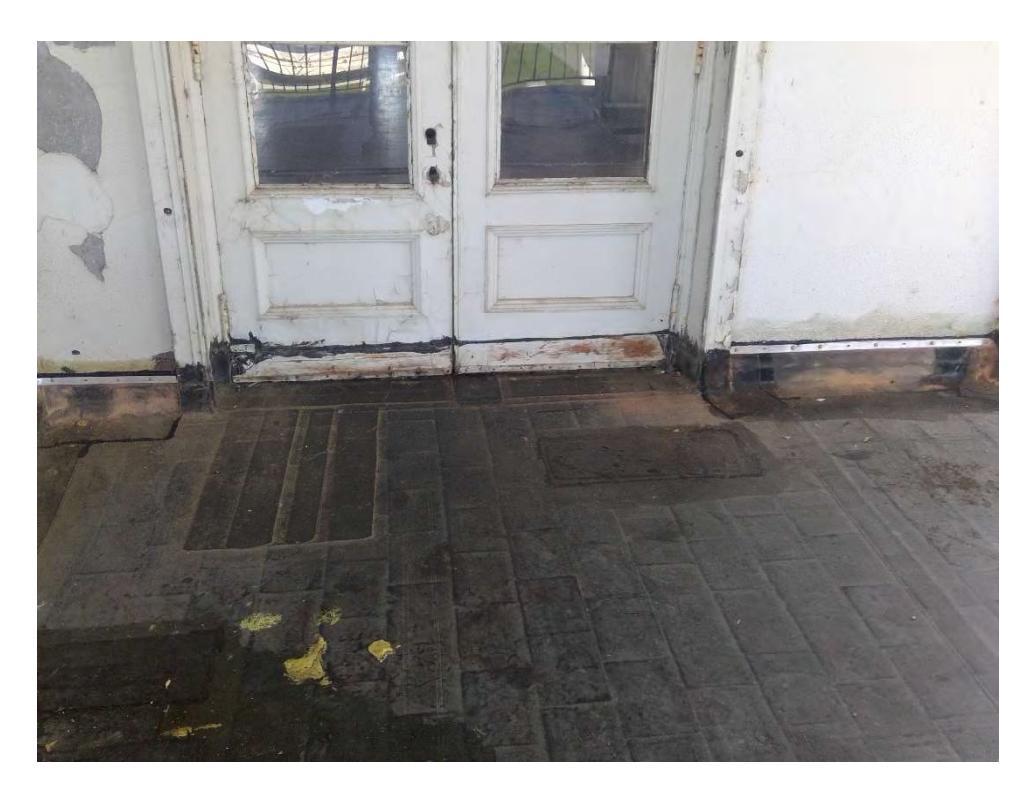
Photo 14 EPDM covered tile terraces

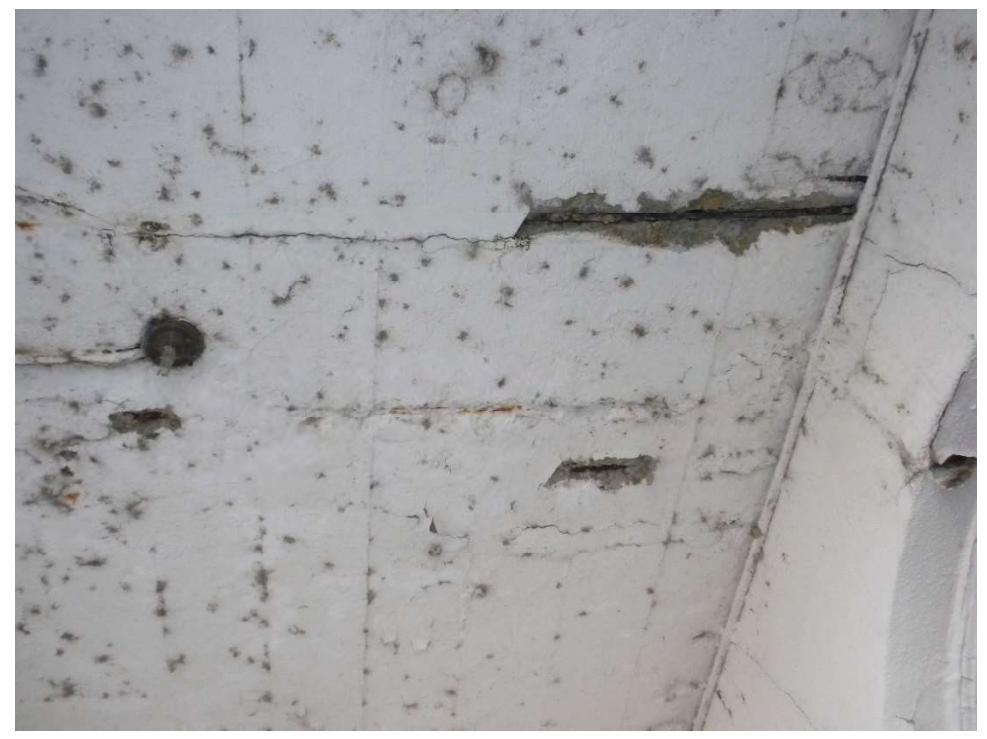
Photo 15 Damaged Stucco - Surface Scaled Finish

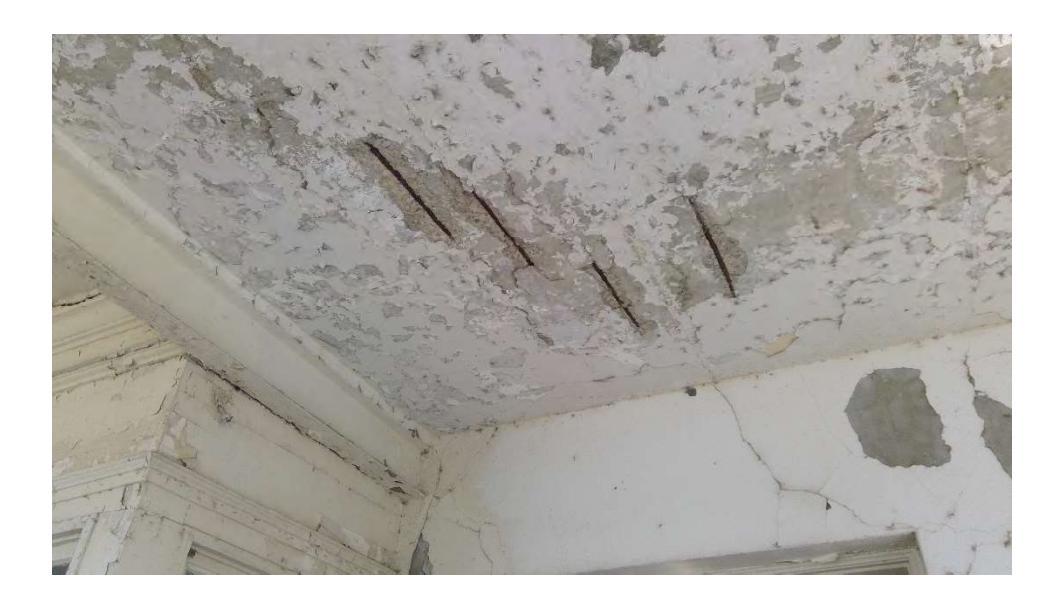
Photo 16 Damaged Stucco - Surface Scaled Finish

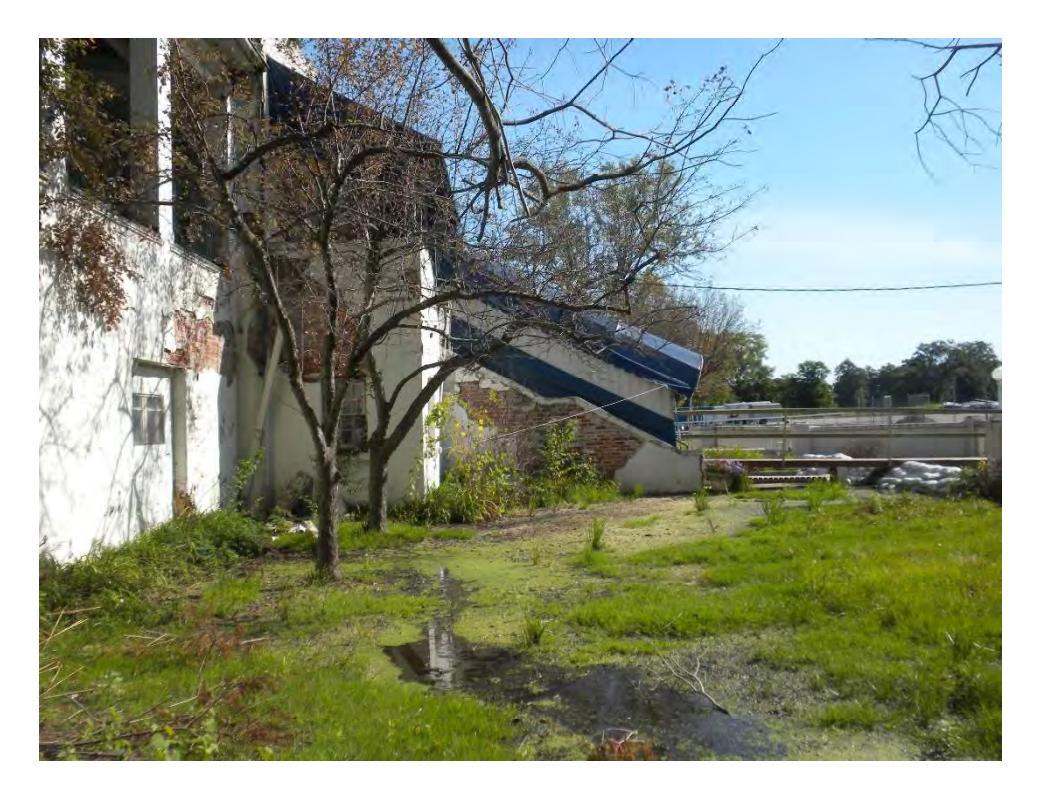
- Mass masonry walls that form the side enclosures of the stairs are deteriorated [Photo 21].
- Concrete stair steps are deteriorated [Photo 22].
- Stair and balcony guard rail concrete copings are cracked and spalled [Photo 23].

Photo 21 South Staircase Deteriorated Masonry

The exterior stairs are generally in **POOR** condition. The main front stair needs to be repaired similar to the exterior terraces. The remaining stairs should be removed and replaced with code compliant stairs that replicate the aesthetics of the original historic stairs.

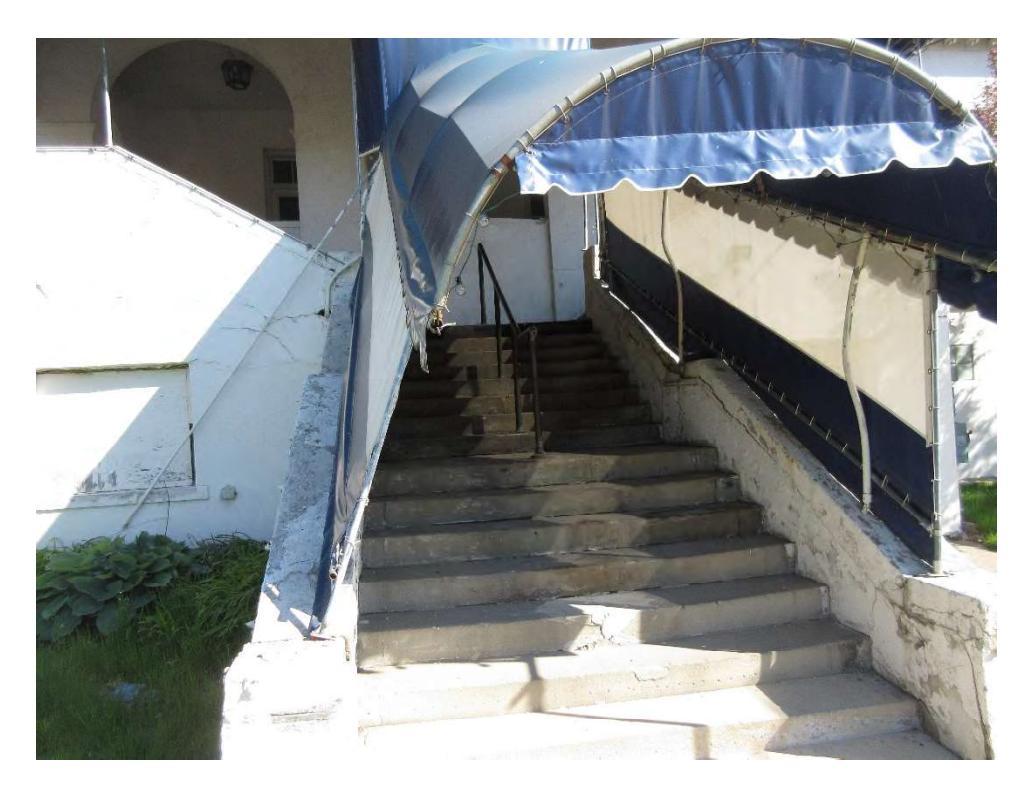
Photo 22 South Staircase Deteriorated Concrete Steps

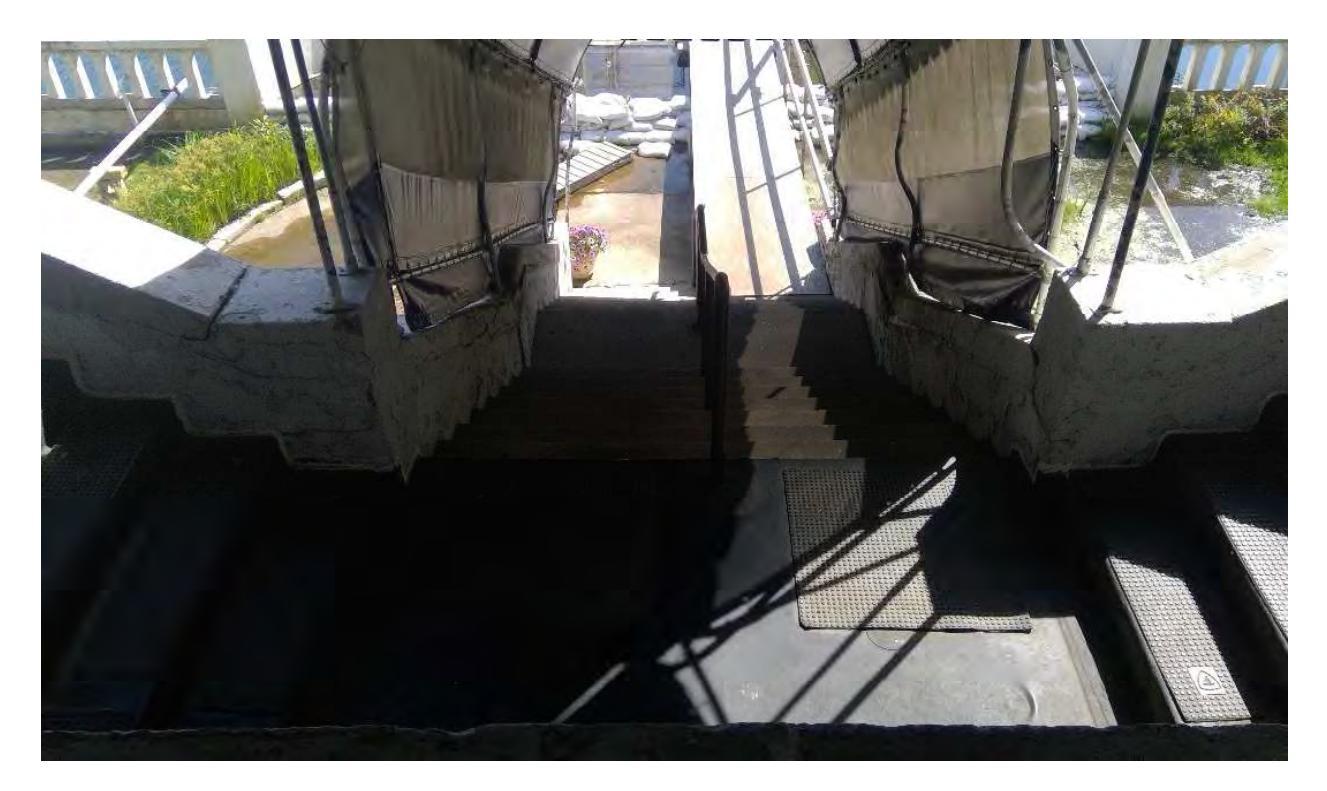
Photo 23 South Staircase Deteriorating Copings

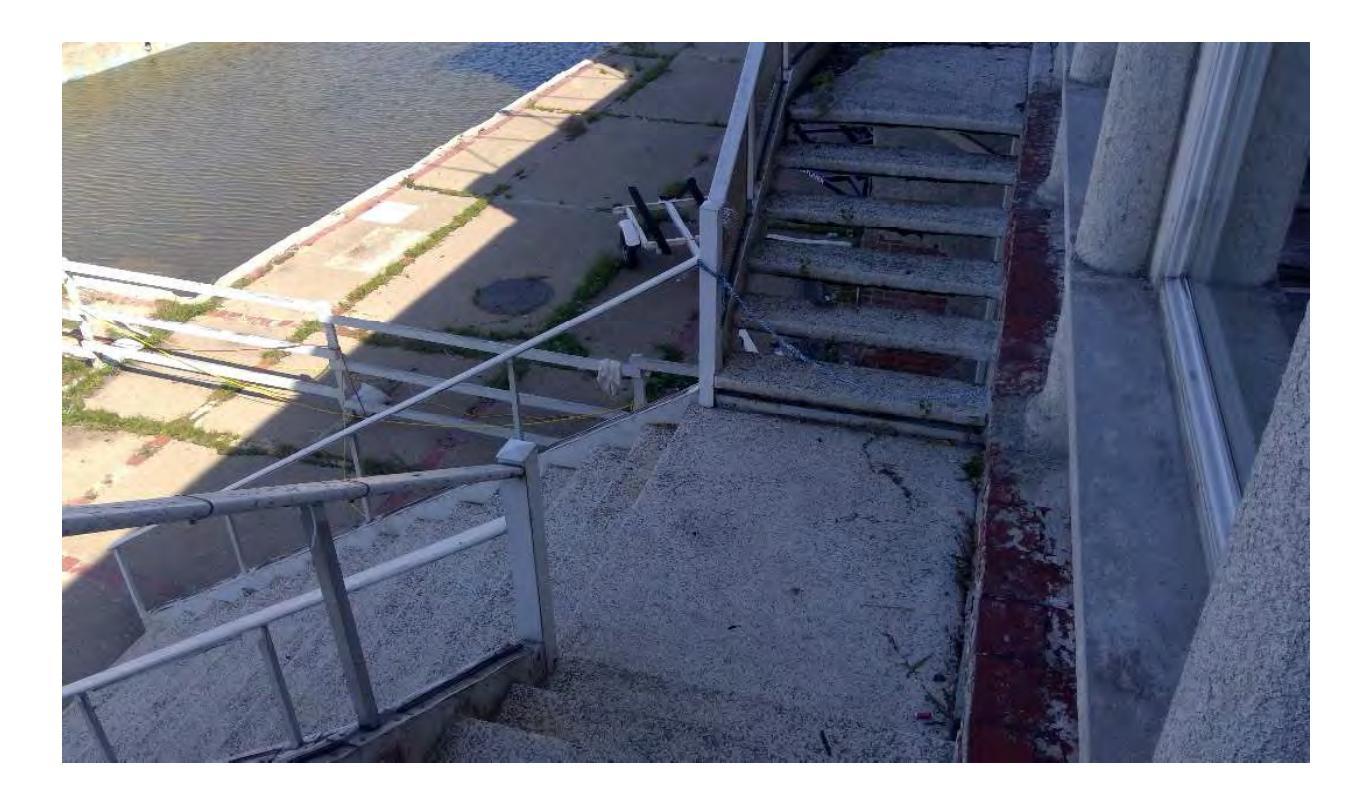
- Terrazzo threads are mostly intact but are affected by deterioration in the form of cracks, a scaled surface and minor spalled terrazzo. [Photo 24].
- Terrazzo landings are severely cracked and spalled [Photo 25].
- Steel frame and guard rails are in fair condition with only minor surface corrosion **[Photo 26]**.

Photo 24 North Staircase Deteriorated Treads

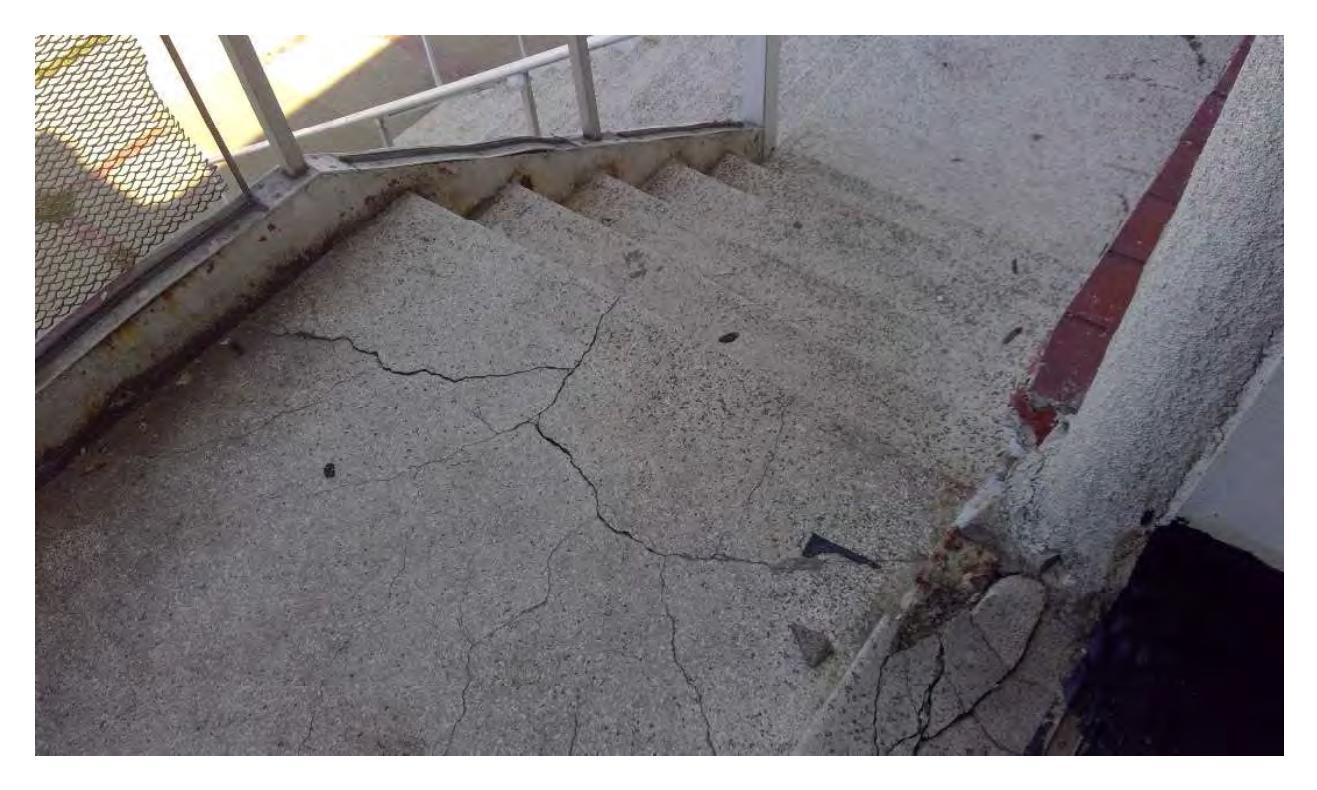
Photo 25 North Staircase Deteriorated Landing

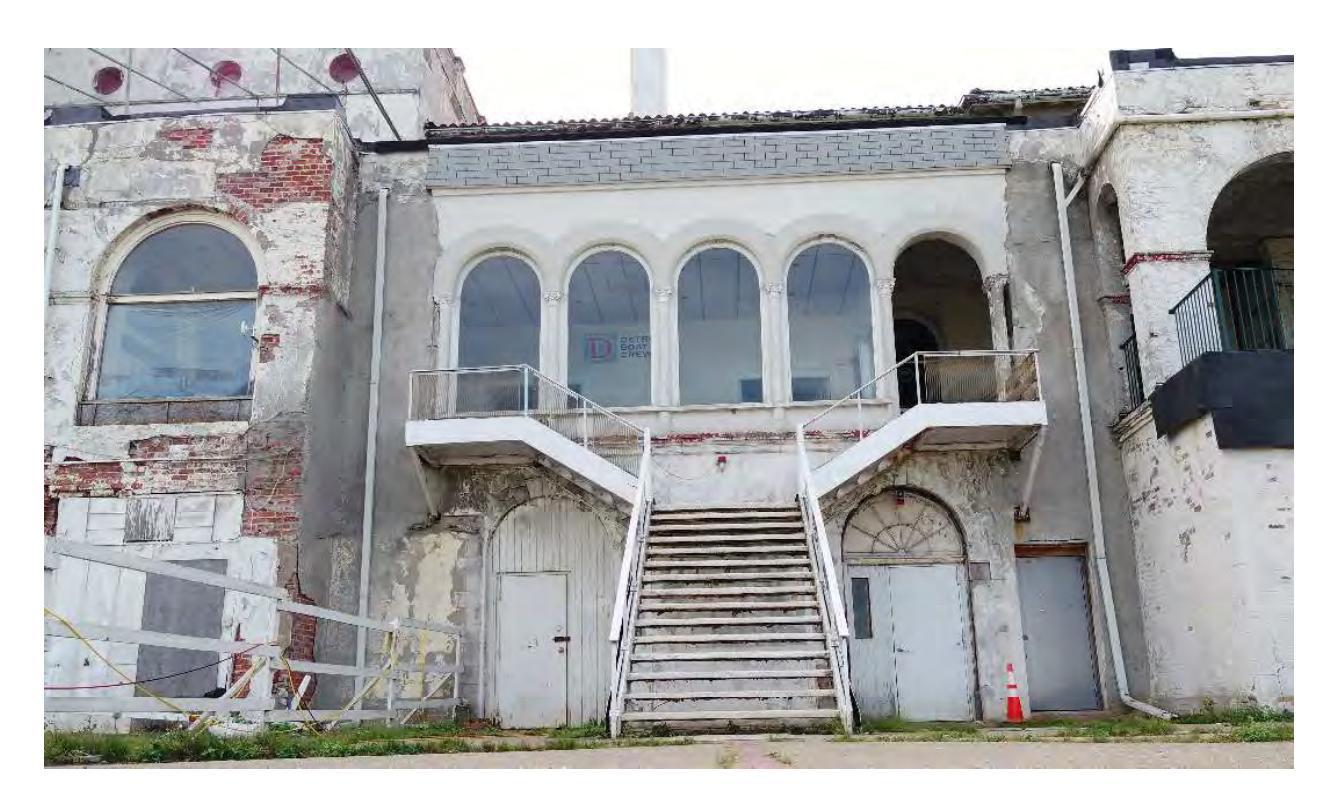
Photo 26 North Staircase Corrosion

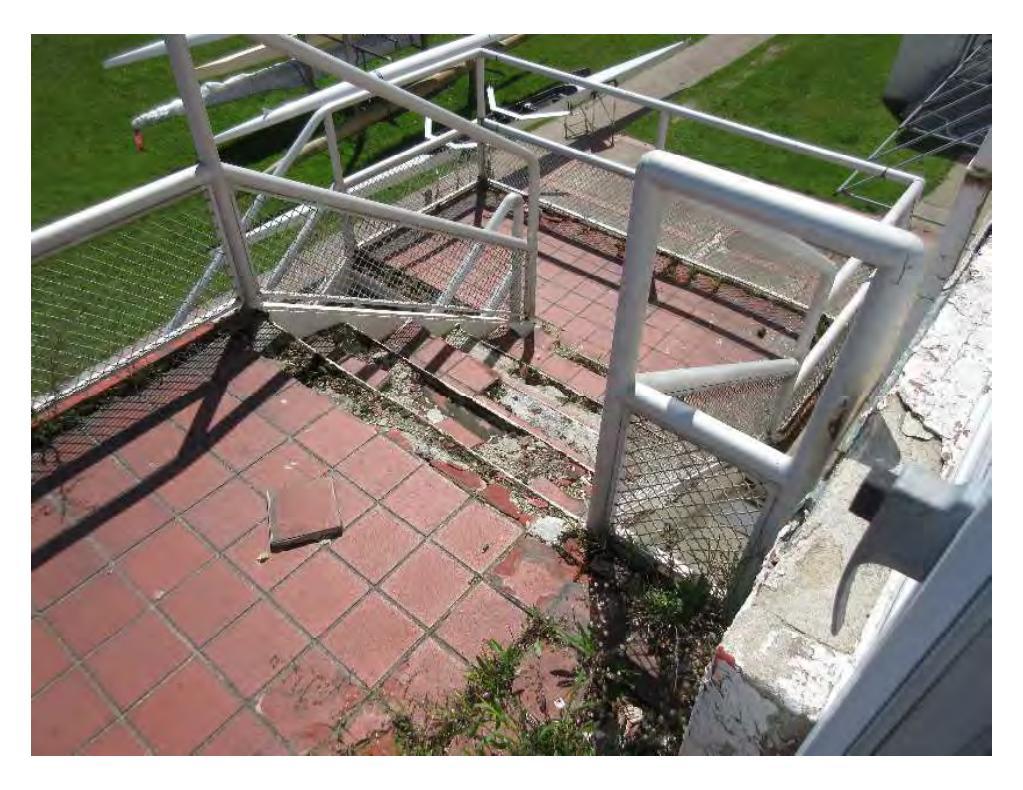
- Concrete infilled threads with tile wear surface are severely deteriorated [Photo 27].
- Steel frame and risers are severely corroded [Photo 28].

Photo 27 Northeast Staircase Deteriorated Treads

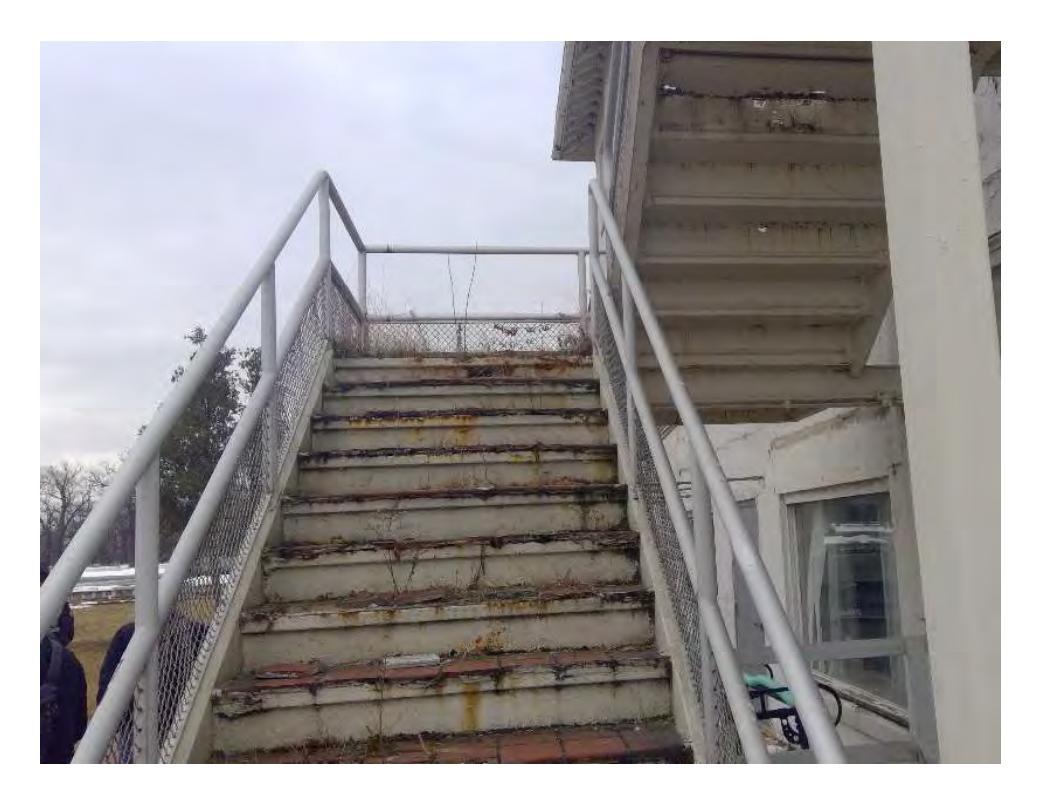
Photo 28 Northeast Staircase Corroded Steel

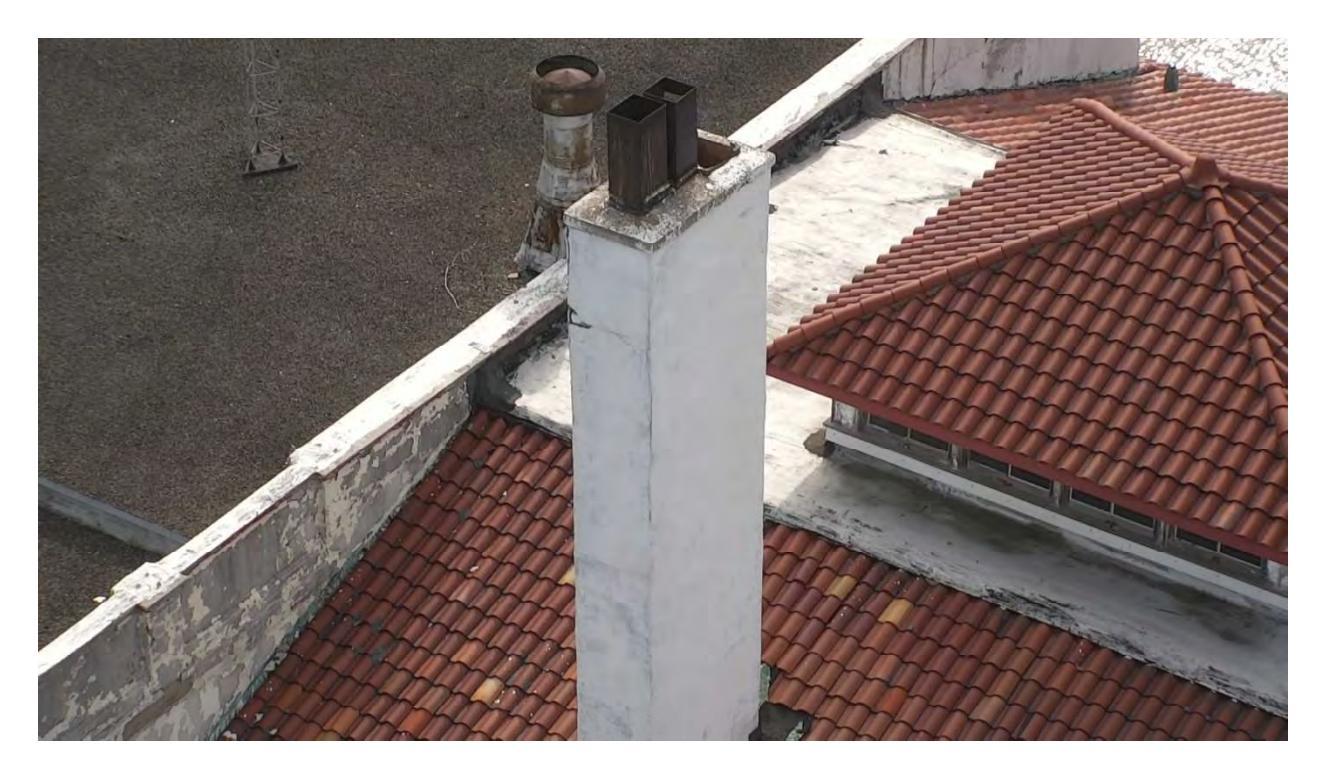
The tallest of the chimneys (west of the tower) is in fair condition with debonded stucco confined to the upper region **[Photo 29].**

Photo 29 Debonding Stucco on Chimney

The chimneys are generally in **POOR** condition. The repair of the chimneys will be similar to the repair of the façade. Inactive chimneys are to be capped.

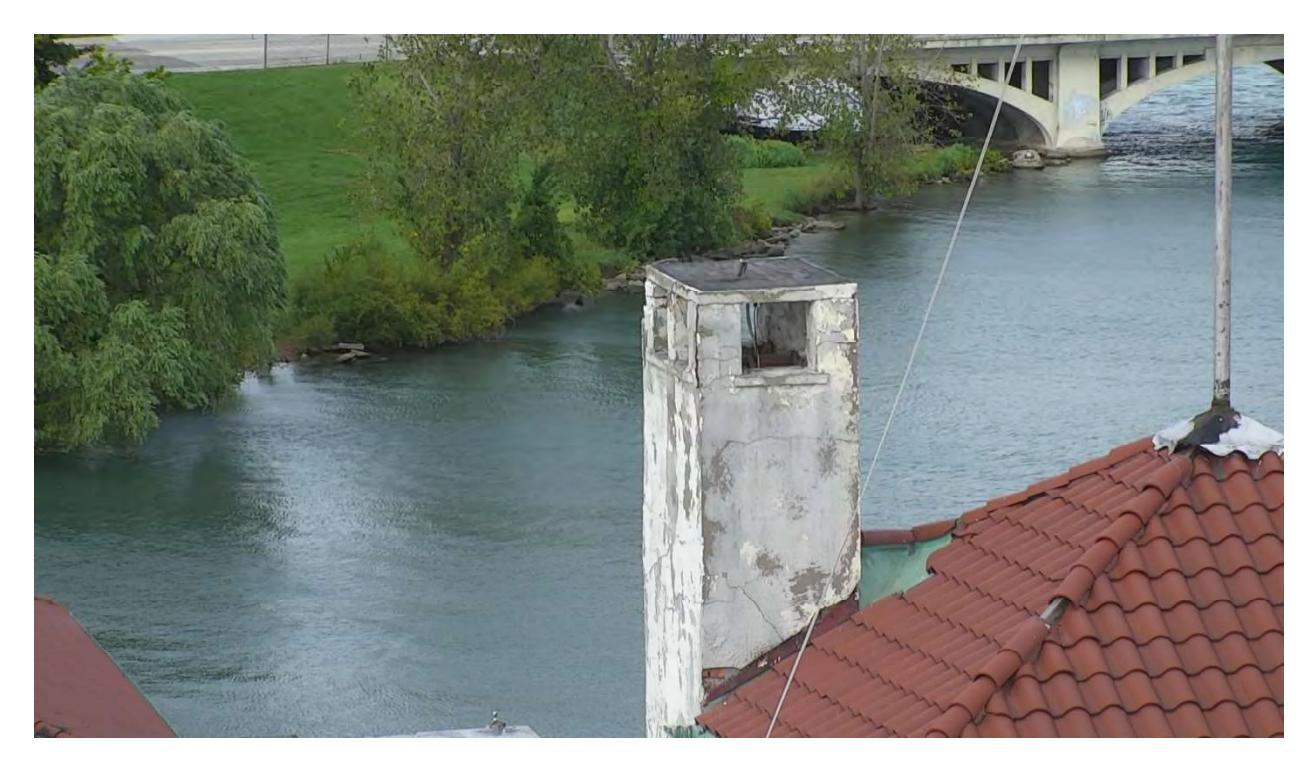
The second stucco chimney (south of the tower is in poor condition with scaled stucco throughout its exterior **[Photo 30].**

Photo 30 Scaled Stucco on Chimney
