Clean Michigan Initiative  
Clean Water Fund Grant  
2002-0254

## Idyl Wyld Regional Storm Water Facility

April 1, 2004 - March 31, 2008

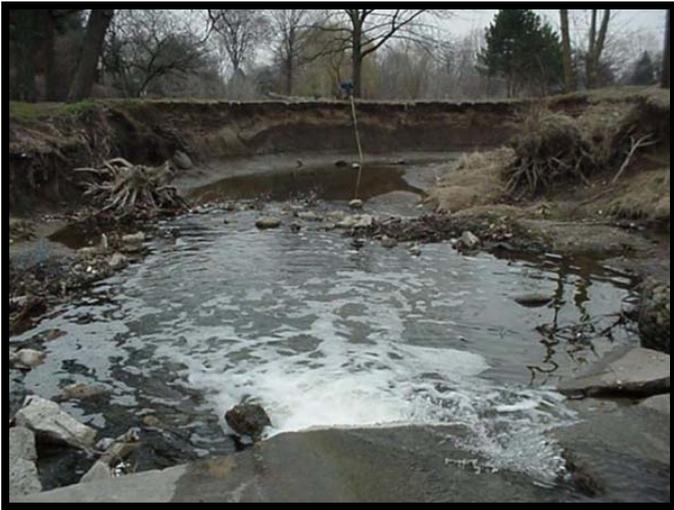
Prior to the project, steep barren embankments 3'-10' high were typical. Adjacent home owners were concerned with the erosion encroaching on their properties at the western end of the area.

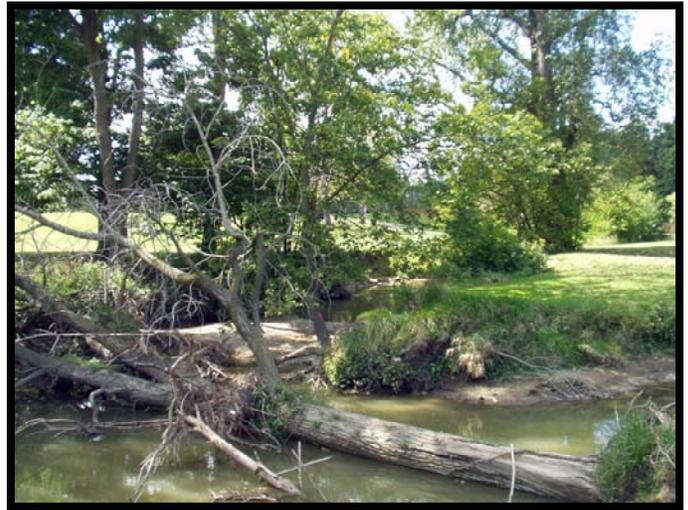
Sediment deposits and woody debris were continual problems.

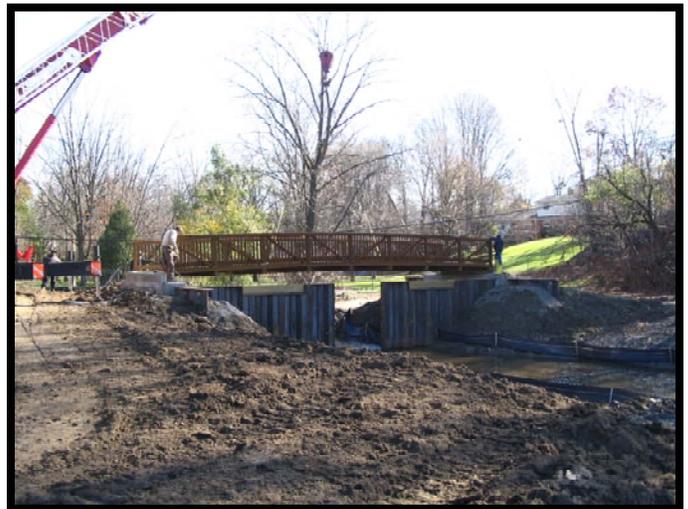
The weirs and ponds reduced peak flows to downstream areas.

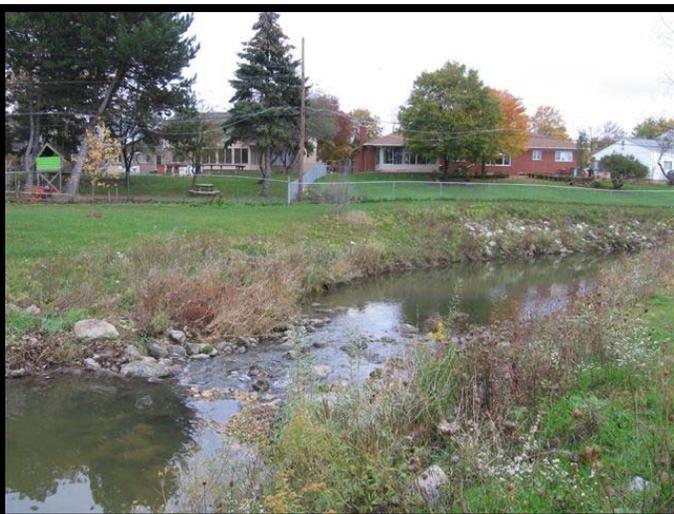
By the fall of 2006, no problems were identified at the most critical upstream end.

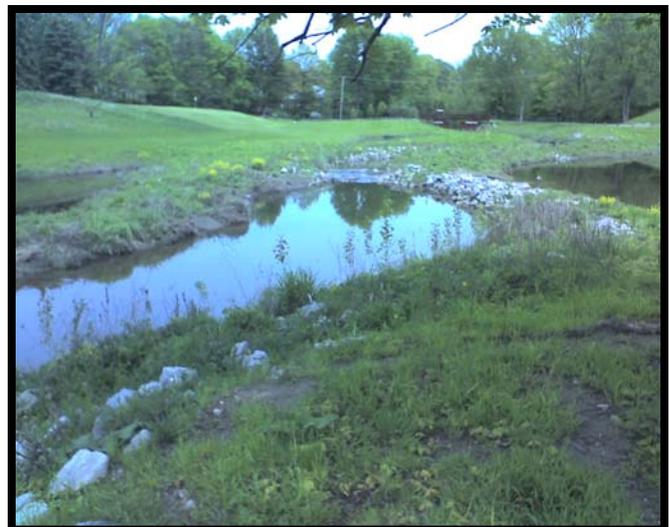
By spring of 2007 the downstream area had also reached a relatively stable condition. Habitat was also enhanced.
