**Clean Michigan Initiative
Nonpoint Source Grant**
Manistee, Wexford, Missaukee,
Kalkaska Counties

Manistee River Watershed Restoration Project

August 1, 2001 through December 31, 2005

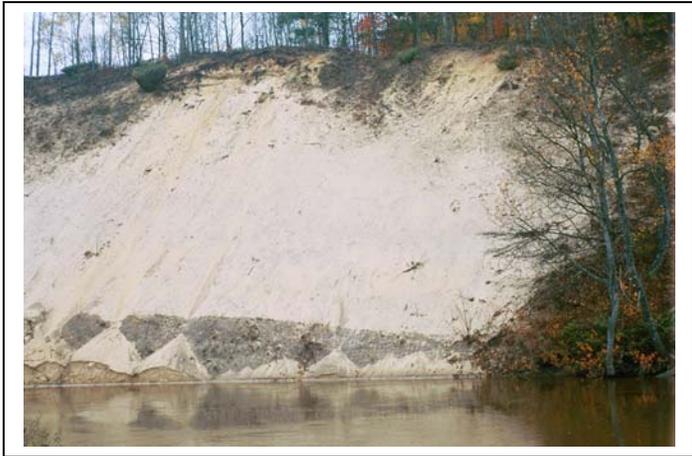
Stream Bank Site #184 Before: This severely eroding streambank was dumping tons of sand into the Manistee River every year. The southerly exposure and sandy conditions prevented the bank from revegetating on its own.

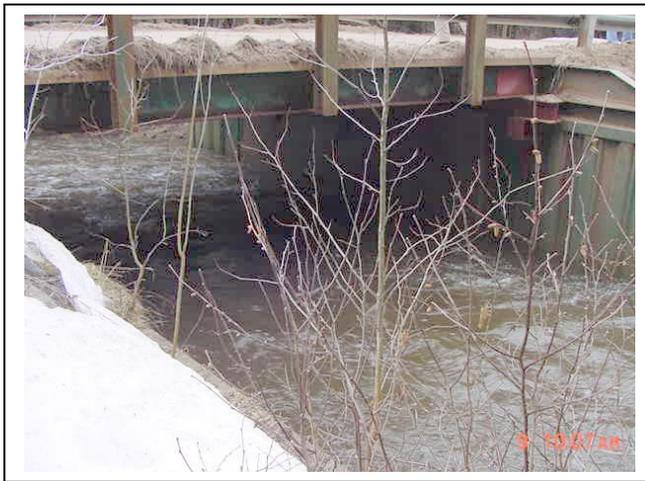
Pine River site O-6 before work. The uncurbed bridge deck and sandy approaches allowed road runoff to directly enter the East Branch of the Pine River during rain events.
