**MICHIGAN DEPARTMENT OF ENVIRONMENTAL QUALITY
WATER RESOURCES DIVISION
JULY 2016**

STAFF REPORT

Biological and water chemistry surveys of selected stations in the Platte and Betsie Rivers watersheds and other coastal watersheds in Benzie, Leelanau, Grand Traverse, and Manistee Counties, Michigan, June 2013.

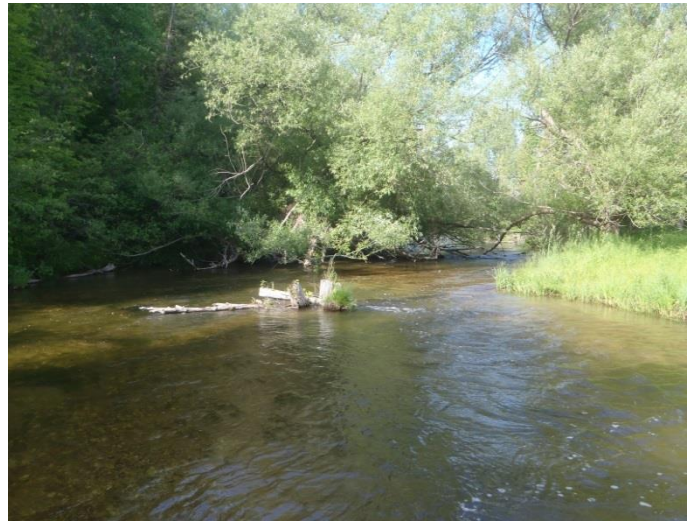
Figure 2. Station 2, Platte River upstream of US-31 near Veterans Park.

The Platte River was sampled at 4 stations (2, 3, 4, and 5). The most upstream station 2 was located upstream of US-31 and downstream of the Platte River State Fish Hatchery (Figure 2). This station is also a trend station for the MDNR, Fisheries Division. The riffle run habitat at Station 2 was rated excellent (169; nonimpaired; Table 6). There were a lot of willow trees growing within the stream channel providing large woody debris, rootwads, and habitat structure for pool development and habitat diversity. Cobble and gravel were available for colonization with sand deposition at constricted areas. Silty areas were restricted to the edge. Filamentous algae, emergent, and submergent vegetation were present.

The macroinvertebrate community scored at the higher end of acceptable (3; Table 3 and 8).

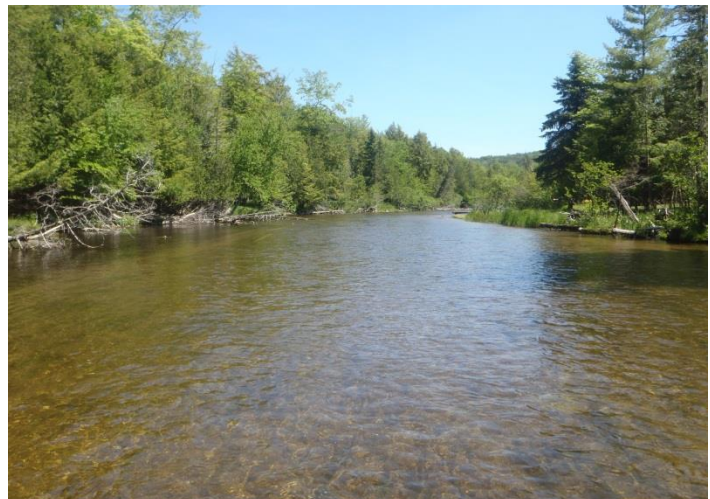
Figure 3. Station 3. Platte River upstream of Pioneer Road.

Station 3 was located on the Platte River upstream of Pioneer Road (Case Bridge). The riffle/run habitat was rated excellent (157; nonimpaired; Table 2). The substrate at this station consisted primarily of a flat gravel area with silt and sand concentrated on the outside of the bend among emergent vegetation (Figure 3). The uniform depth of the station meant a lack of habitat complexity and pool depth diversity. The riparian area was fairly intact with the

exception of a house that had a lawn that was mowed to the edge. The macroinvertebrate community scored at the higher end of acceptable (3; Table 3 and 8).

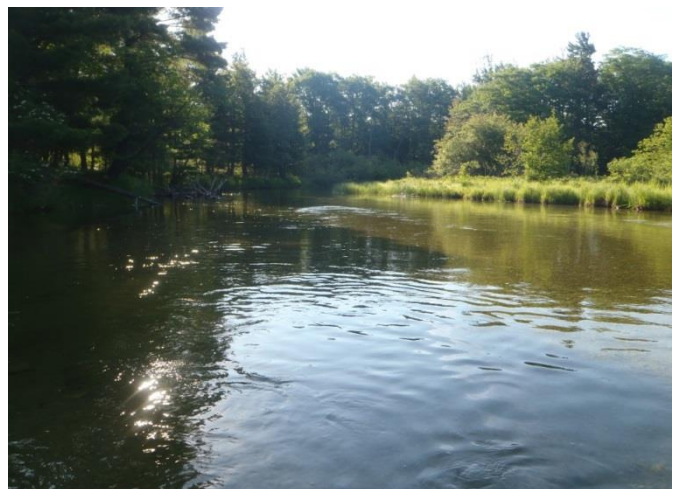
Figure 4. Station 5, Platte River near the mouth at El Dorado Park, Sleeping Bear Dunes National Park.

Station 5 at El Dorado Park off Lake Michigan Drive was the most downstream station sampled on the Platte River (Figure 4). The riffle/run habitat at was rated excellent (178; nonimpaired;

Table 5). A mix of habitat types was available for colonization. Clean gravel and cobble and firm sand was present along with backwater areas. There was a large sand deposit on the inside of the bend. The riparian area was intact but the right bank was missing shrubs and grasses. Large woody debris was present, but not abundant. The macroinvertebrate community scored acceptable (1; Table 6 and 11).

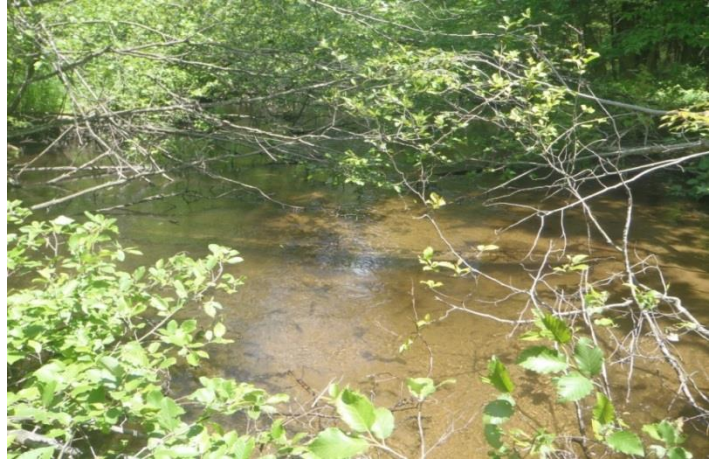
Figure 5. Station 6, Little Betsie River upstream of Nessen Road.

The Little Betsie River was sampled at Nessen Road (Station 6). The glide/pool habitat was rated good (147; slightly impaired;

Table 5). The substrate consisted entirely of shifting sand and silt. Large woody debris and overhanging alders were the primary epifaunal substrate, although the large woody debris was deeply embedded in the sand. The riparian area consisted of a very natural cedar/pine forest and swamp (Figure 5). The macroinvertebrate community scored acceptable (0; Table 6 and 11).

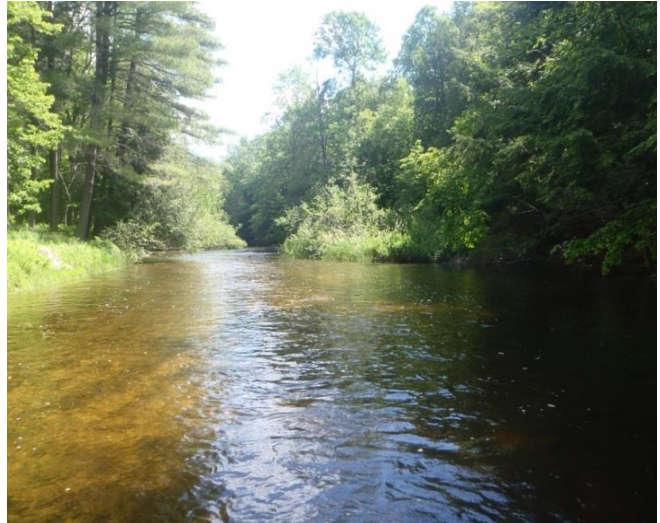
Figure 6. Station 7, Betsie River upstream of Carmen Road.

The Betsie River was sampled at five stations (7, 8, 9, 10, and 11; Figure 1, Table 4) in 2013. The most upstream was Station 7 at Carmen Road. The riffle/run habitat was rated excellent (163; nonimpaired;

Table 5). This station consisted of a fast current over clean riffles (Figure 6). The road crossing was an open bottom bridge. The substrate consisted primarily of gravel and cobble with some areas of sand deposition. Large woody debris and aquatic macrophytes were present as well. The riparian area consisted of a steep wooded bank on the left side and a house with a lawn that could be mowed to the edge, but was currently being left to grow. The macroinvertebrate community scored at the higher end of acceptable (3; Table 6 and 11).

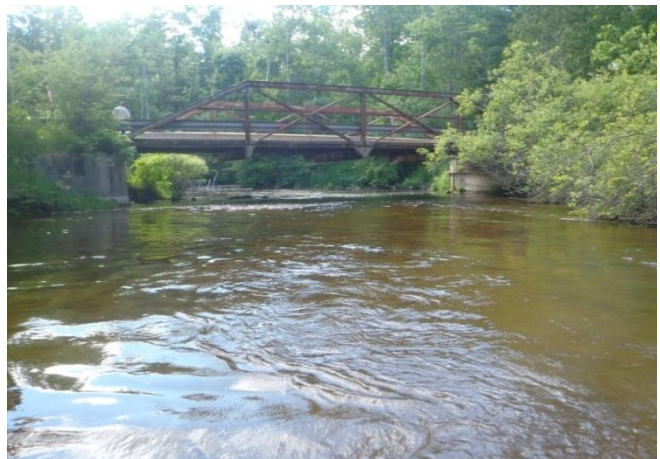
Figure 7. Station 8, Betsie River upstream of Haze Road looking downstream at an old iron bridge crossing.

Station 8 was sampled upstream of an old iron bridge at Haze Road (Figure 7). The riffle/run habitat was rated excellent (155; nonimpaired; Table 8). The habitat consisted of undercut banks, submerged logs, and cobble with a very unstable sandy area at the lower portion of the station. There was a fair amount of large woody debris with some embedded in the sand. The riparian area consisted of open area that was lacking large trees. It looked as if it was cleared at one point in time. The macroinvertebrate community scored at the higher end of acceptable (3; Table 9 and 14).

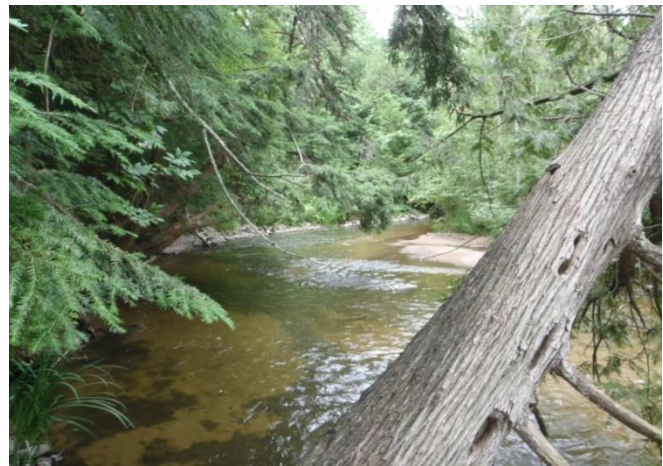
Figure 8. Station 10, Betsie River on private property off of Old Grade Road.

Station 10 is located off of Old Grade Road at the Matousek residence. Permission was granted to sample this trend station. The riffle/run habitat was rated excellent (161; nonimpaired; Table 8). The habitat consisted of submerged logs, macrophytes, cobble, gravel, sand, and silt. Undercut banks were missing as well as slow deep areas. There were some portions of the bank eroding on the right side at the bends. On the left side riprap had

been placed against the bank to save houses that were present (Figure 8). On the right side, the riparian area consisted of a pine and hardwood mix forest. The left side had a grassy wetland area that was naturally missing large trees and further downstream houses were located on the high banks. The macroinvertebrate community scored at the higher end of acceptable (3; Table 9 and 14).

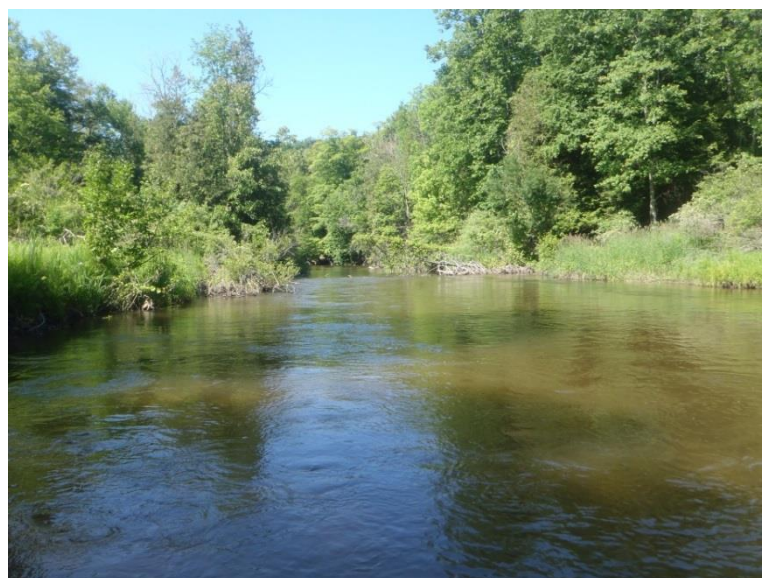
Figure 9. Station 11, Betsie River upstream of M-115.

Station 11 at M-115 was the most downstream station sampled on the Betsie River. The riffle/run habitat was rated excellent (158; nonimpaired; Table 8). The substrate consisted of gravel and cobble in the middle of the channel where the stream velocity was high, but there were a lot of silt and clay areas along the edges. In one area where a large woody debris dam was slowing down the stream velocity, more than three feet of shifting sand had accumulated. Aquatic vegetation was present, but only along the edges. The water was much more turbid at this station in comparison to the clear water observed at all stations sampled upstream and the stream channel was very straight (Figure 9). The riparian area consisted of cedar/pine forest with lots of moss present in the low valley. The macroinvertebrate community scored at the high end of acceptable (4; Table 9 and 14). This is the highest scoring station in the Betsie River watershed.

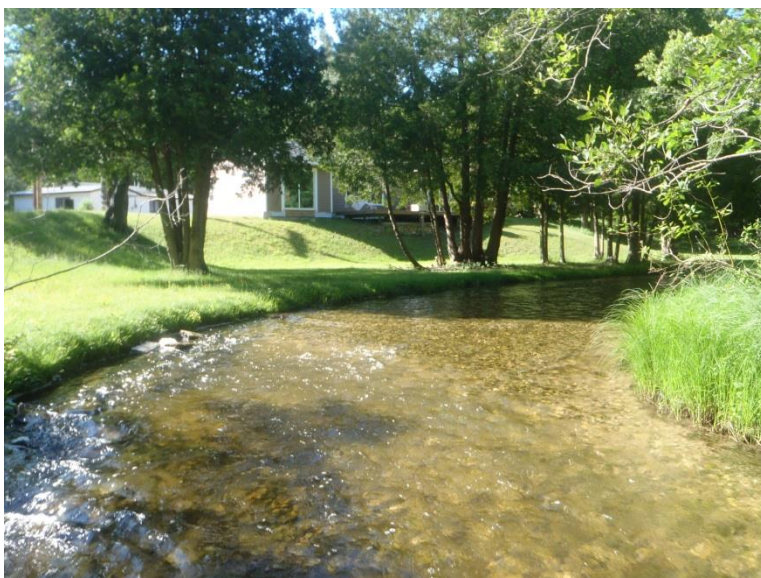
Figure 10. Station 12, Herring Creek upstream of Elberta Resort Road.

Herring Creek is located south of Frankfort and is a tributary to Upper and Lower Herring Lakes (Figure 10). It was sampled at two stations and a third station was only observed and photographed. Station 12 was sampled at Elberta Resort Road, which is located just upstream of Lower Herring Lake. This station was targeted because although volunteer monitoring noted it scored excellent in 2012, it scored acceptable (0) in 2003 (Zbytowski, 2007a). In 2013, the riffle/run habitat was rated excellent (161; nonimpaired; Table 11) and the macroinvertebrate community

scored acceptable (0; Table 12 and 17). The substrate was dominated by clean gravel. The station had a large area that was exposed to the sun and periphyton was abundant as would be expected (Figure 10). Overhanging vegetation and rootwads were also available substrate for biota but large woody debris was sparse. The riparian areas consisted of cedars and birch with houses present further upland on the left side, and on the right side houses with lawns mowed up the edge were abundant. The water was very warm at 73 degrees Fahrenheit.

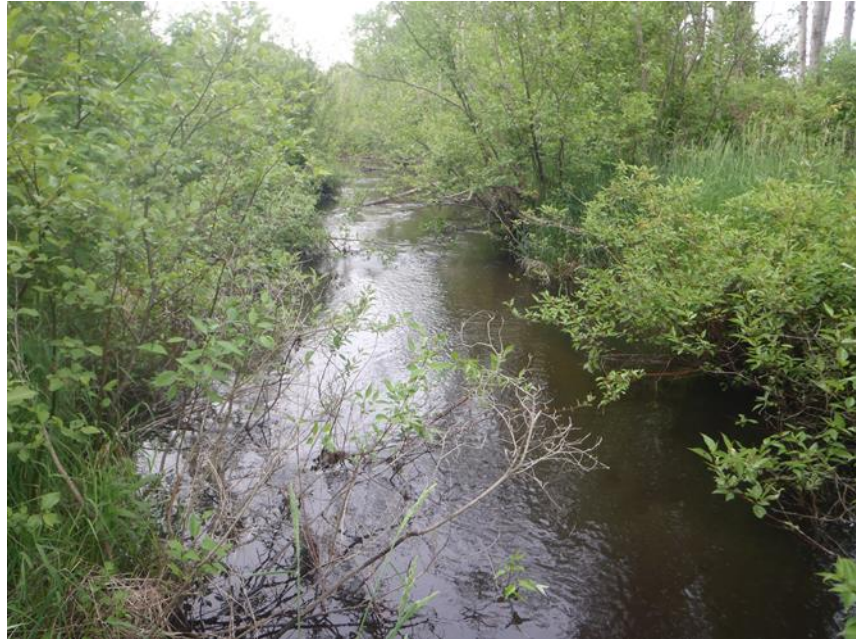
Figure 11. Station 13, Herring Creek upstream of Gorivan Road.

Station 13 was located further upstream on Herring Creek at Gorivan Road, which is very close to the confluence with Upper Herring Lake. The glide/pool habitat was rated good (136; slightly impaired; Table 11). The substrate consisted entirely of silt and sand and it was often knee deep. Elodea was present in 70 percent of the channel. The banks were fairly steep and SWAS staff sampled upstream of a small tributary and deep pool. Large woody debris was present but often embedded deep in the sand. The stream was extremely cold at 57 degrees Fahrenheit, which is substantially cooler than Station 12 located

downstream of Upper Herring Lake. The wetland riparian area consisted of mostly tag alders and red osier dogwood (Figure 11). The macroinvertebrate community scored acceptable (-1; Table 12 and 17). Herring Creek was also observed at Putney Road, Blaine Township, Benzie County, and is discussed in detail below under Objective 3.

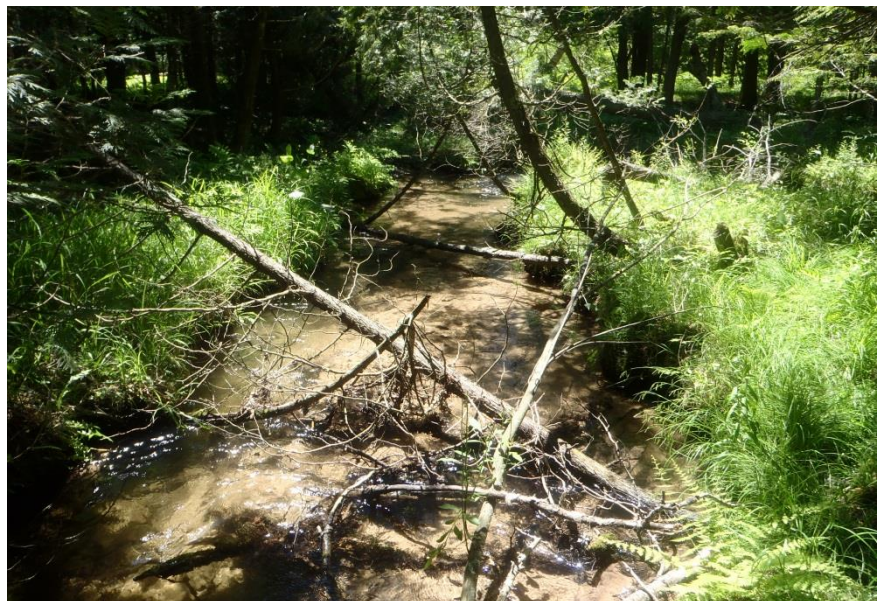
Figure 12. Station 14, Bowens Creek off Iverson Road.

Station 14 was sampled in Bowens Creek off Iverson Road. According to the residents who live up the hill on the east side of the road, the stream had new culverts installed at Iverson Road and the road was relocated in 2012. To reach this site we crossed under a green gate on an old road running perpendicular to Iverson Road, and then headed south in a cleared area to a path that runs past some ponds

(which are likely remnants of the mill). SWAS staff sampled upstream of these ponds. If Bowens Creek was sampled at Iverson Road, it would be downstream of these ponds and would not be representative of the stream reach.

The riffle/run habitat at Station 14 was rated good (139; slightly impaired; Table 11). Bowens Creek is a very cold (53 degrees Fahrenheit), spring-fed stream. Shifting sand dominated the substrate and was as deep as 1.5 feet in places. Leaf packs, undercut banks, and large woody debris were available for biota. The large woody debris made the “riffles” in this reach (Figure 12). The macroinvertebrate community scored at excellent (5; Table 12 and 17). This station was the only one sampled and reported here that scored excellent. Two families of stonefly were present with one family (*Nemouridae*) being the second most dominant family. This stream should be considered as a possible priority for protection in this watershed considering the relatively high percentage of agricultural land use (20 percent) and lost wetlands (9 percent; Table 4) for this area of the state and the fact that sedimentation of the epifaunal substrate is very severe and likely to impact the macroinvertebrate community over time.

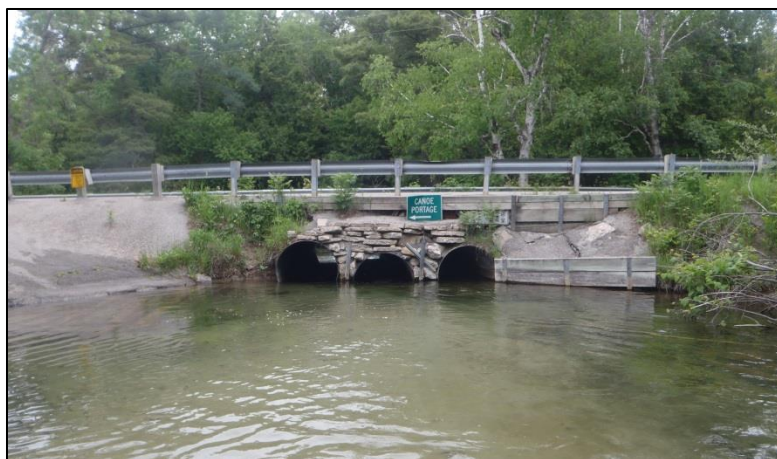
Figure 13. Station 1, Crystal River upstream of Crystal View Road looking downstream at crossing.

As previously noted, the Crystal River at Crystal View Road/County Road 675 is in need of a replacement stream crossing (Figure 13). SWAS staff witnessed people either portaging the road crossing or using one of the three culverts (three feet in diameter) as conduits under the road.

The road crossing is in critical need of replacement. While sampling, SWAS staff witnessed at least two different groups either portaging the road crossing or using one of the three culverts (three feet in diameter) as conduits under the road. These three culverts do not seem to be allowing sufficient flow to move through them resulting in sediment deposition upstream of the culverts and a very wide channel with a uniform stream bottom lacking pool habitat diversity. It would be a good candidate for replacement with a bridge or larger natural bottom culvert.

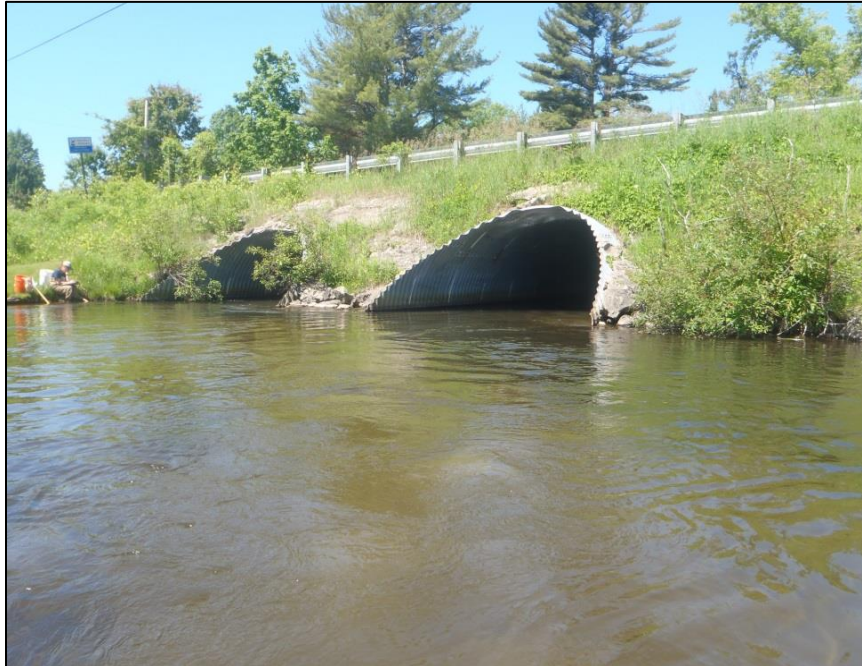
Figure 14. Station 4, Platte River upstream of Indian Hill Road, looking downstream at road crossing.

The road crossing consisted of two ten-foot culverts, which seemed sufficiently large; however, the angle of the culverts did not seem to match the natural angle of the stream and thus a deep pool was being formed just upstream of the culvert (Figure 14). Riprap and cement blocks had been placed on the right bank to help control erosion. The majority of the substrate at this station consisted of sand with very little cobble or gravel and woody debris was silt laden. The erosion and sedimentation is likely, at least partially, due to the misalignment of the culverts.

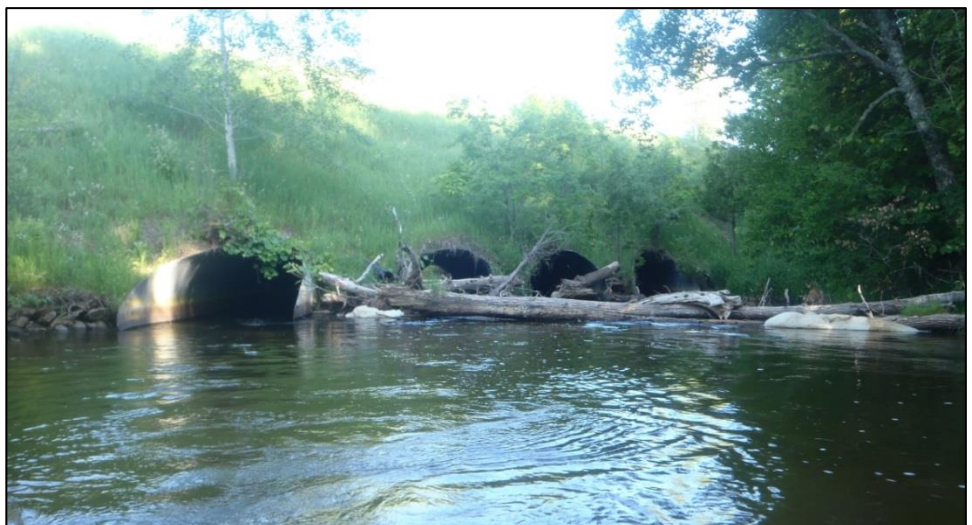
Figure 15. Station 9, Betsie River upstream of Kurick Road looking downstream with a four-culvert road crossing.

The macroinvertebrate community in the Betsie River at Kurick Road was also rated as acceptable (Table 9 and 14) and the habitat was rated as good (Table 8). As noted above, erosion from the road crossing may be a concern, as well as the size of the multiple culverts and should be further evaluated.

Substrate at this station included clay, which has led to bank erosion. It appeared that past stabilization efforts had been made at this station, but all that remained were the stakes that held the wood. This station has extremely high sloping banks to the road and may be a potential source of sedimentation from

erosion. The crossing consists of four culverts approximately six feet in diameter (Figure 15). A timber bridge or other large, open-bottomed culvert would likely help with large woody debris and water backing up during high flows.

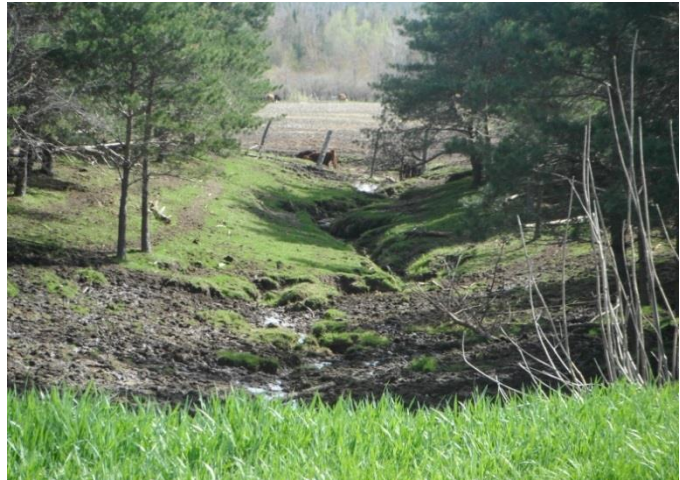
Creek and multiple small intermittent tributaries (Figures 16-18). Trampling of banks from multiple animals is causing bank erosion and subsequent sedimentation to the stream. The potential for *E. coli* contamination and exceedances of the partial and total body contact recreation designated uses is extremely high. Biosurvey reports indicated livestock access has been a problem for more than ten years. This information was passed on to NPS district staff who indicated that local watershed residents are aware of the access and are trying to work with the landowners to address the issues. The landowners are agreeable to fixing the issues if someone can provide funding. Watershed residents indicated that agricultural staff were working to find funding as of 2013. In addition, NPS district staff indicated that Herring Creek has a Watershed Management Plan that has identified agriculture as the single biggest pollutant contributor. The watershed partners are encouraging the agricultural community to be involved and identify what Best Management Practices (BMP) should be included and installed to address the problems. This site should be revisited in 2018 or earlier to determine if any progress has been made in regards to installing BMPs and reducing livestock access to the stream. If nothing has been implemented, *E. coli* sampling should be conducted to determine WQS attainment of the partial and total body contact recreation designated uses.

Figure 16. Tributary to Herring Creek at Puttney Road. Trampling of banks from livestock evident.

Herring Creek should be revisited in 2018 or earlier to determine if any progress has been made in regards to installing BMPs and reducing livestock access to the stream. If nothing has been implemented, *E. coli* sampling should be conducted to determine WQS attainment of the partial and total body contact recreation designated uses.

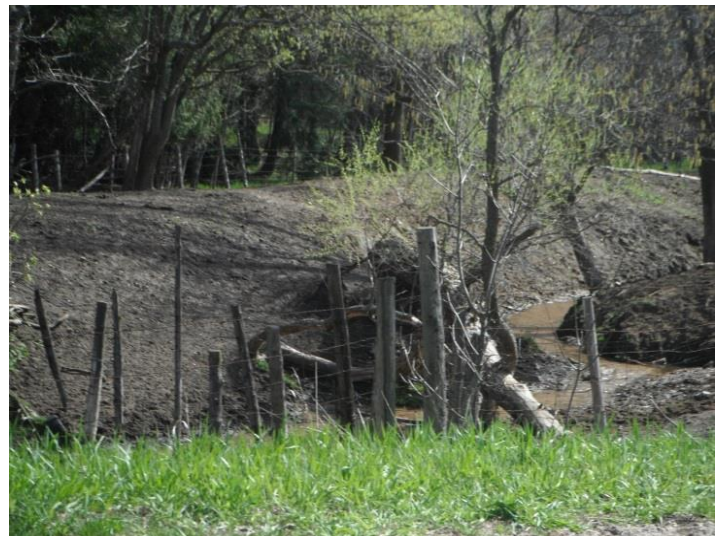
Figure 17. Tributary to Herring Creek at Puttney Road. Bare soil along banks due to livestock access.

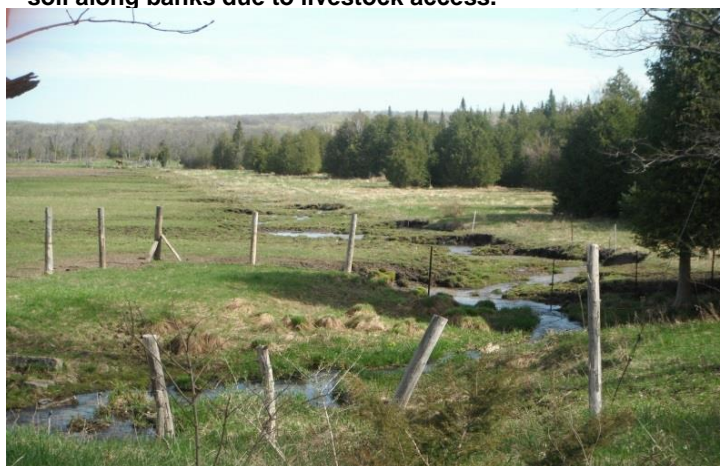
Figure 18. Herring Creek at Puttney Road. Evidence of recent access of livestock to long stretch of stream.

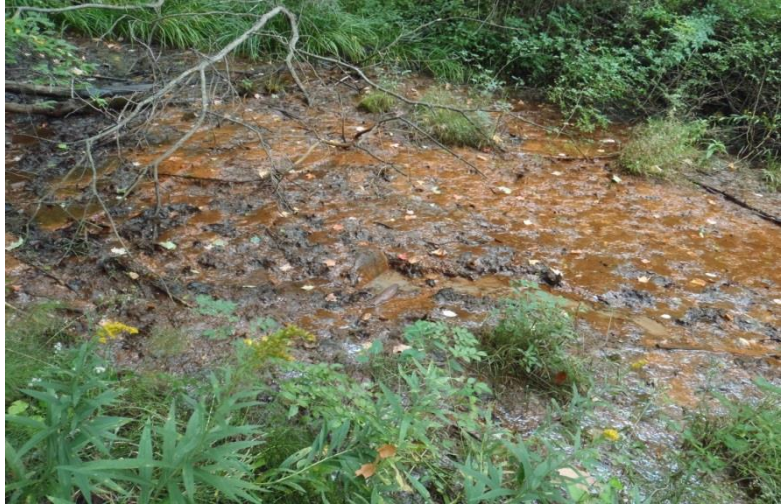
The unnamed tributary to Platte Lake had good (slightly impaired) habitat ratings and acceptable macroinvertebrate scores. The lowest score (-3; acceptable; Tables 4 and 5) was found in the west branch of the tributary that is being impacted by groundwater that was contaminated by food processing waste (Figure 19). A separate report explaining in detail the results of these Procedure 51 biosurveys and additional quantitative macroinvertebrate and periphyton community sampling is available (Lipse, 2014). DO and BOD sampling indicated the west branch of the unnamed tributary was not meeting the 7.0 milligrams per liter minimum DO WQS (Carpenter, 2013). Sampling in 2014 indicated that water from one sample from the west branch did not meet the WQS of 10 parts per billion for arsenic.

Figure 19. Groundwater seep area to west branch of unnamed tributary to Platte Lake, upstream of US-31. Note reddish/brown color of bacterial slimes on substrate.

Unnatural color, bacterial slimes, and odor also remained a problem (Carpenter, 2014). The west branch of the unnamed tributary to Platte Lake will remain on the Section 303(d) nonattainment list [Goodwin et al., 2014 and 2016 (in draft)] but is listed as Category 4b (meaning that pollution control mechanisms are in place and are reasonably expected to result in attainment of the designated use within a practical time frame) because enforcement and remediation efforts are currently taking place.
