CITY OF FLINT, MICHIGAN

RE: MDEQ July 23, 2018 letter regarding Lead Service Line Identification and Replacement Program

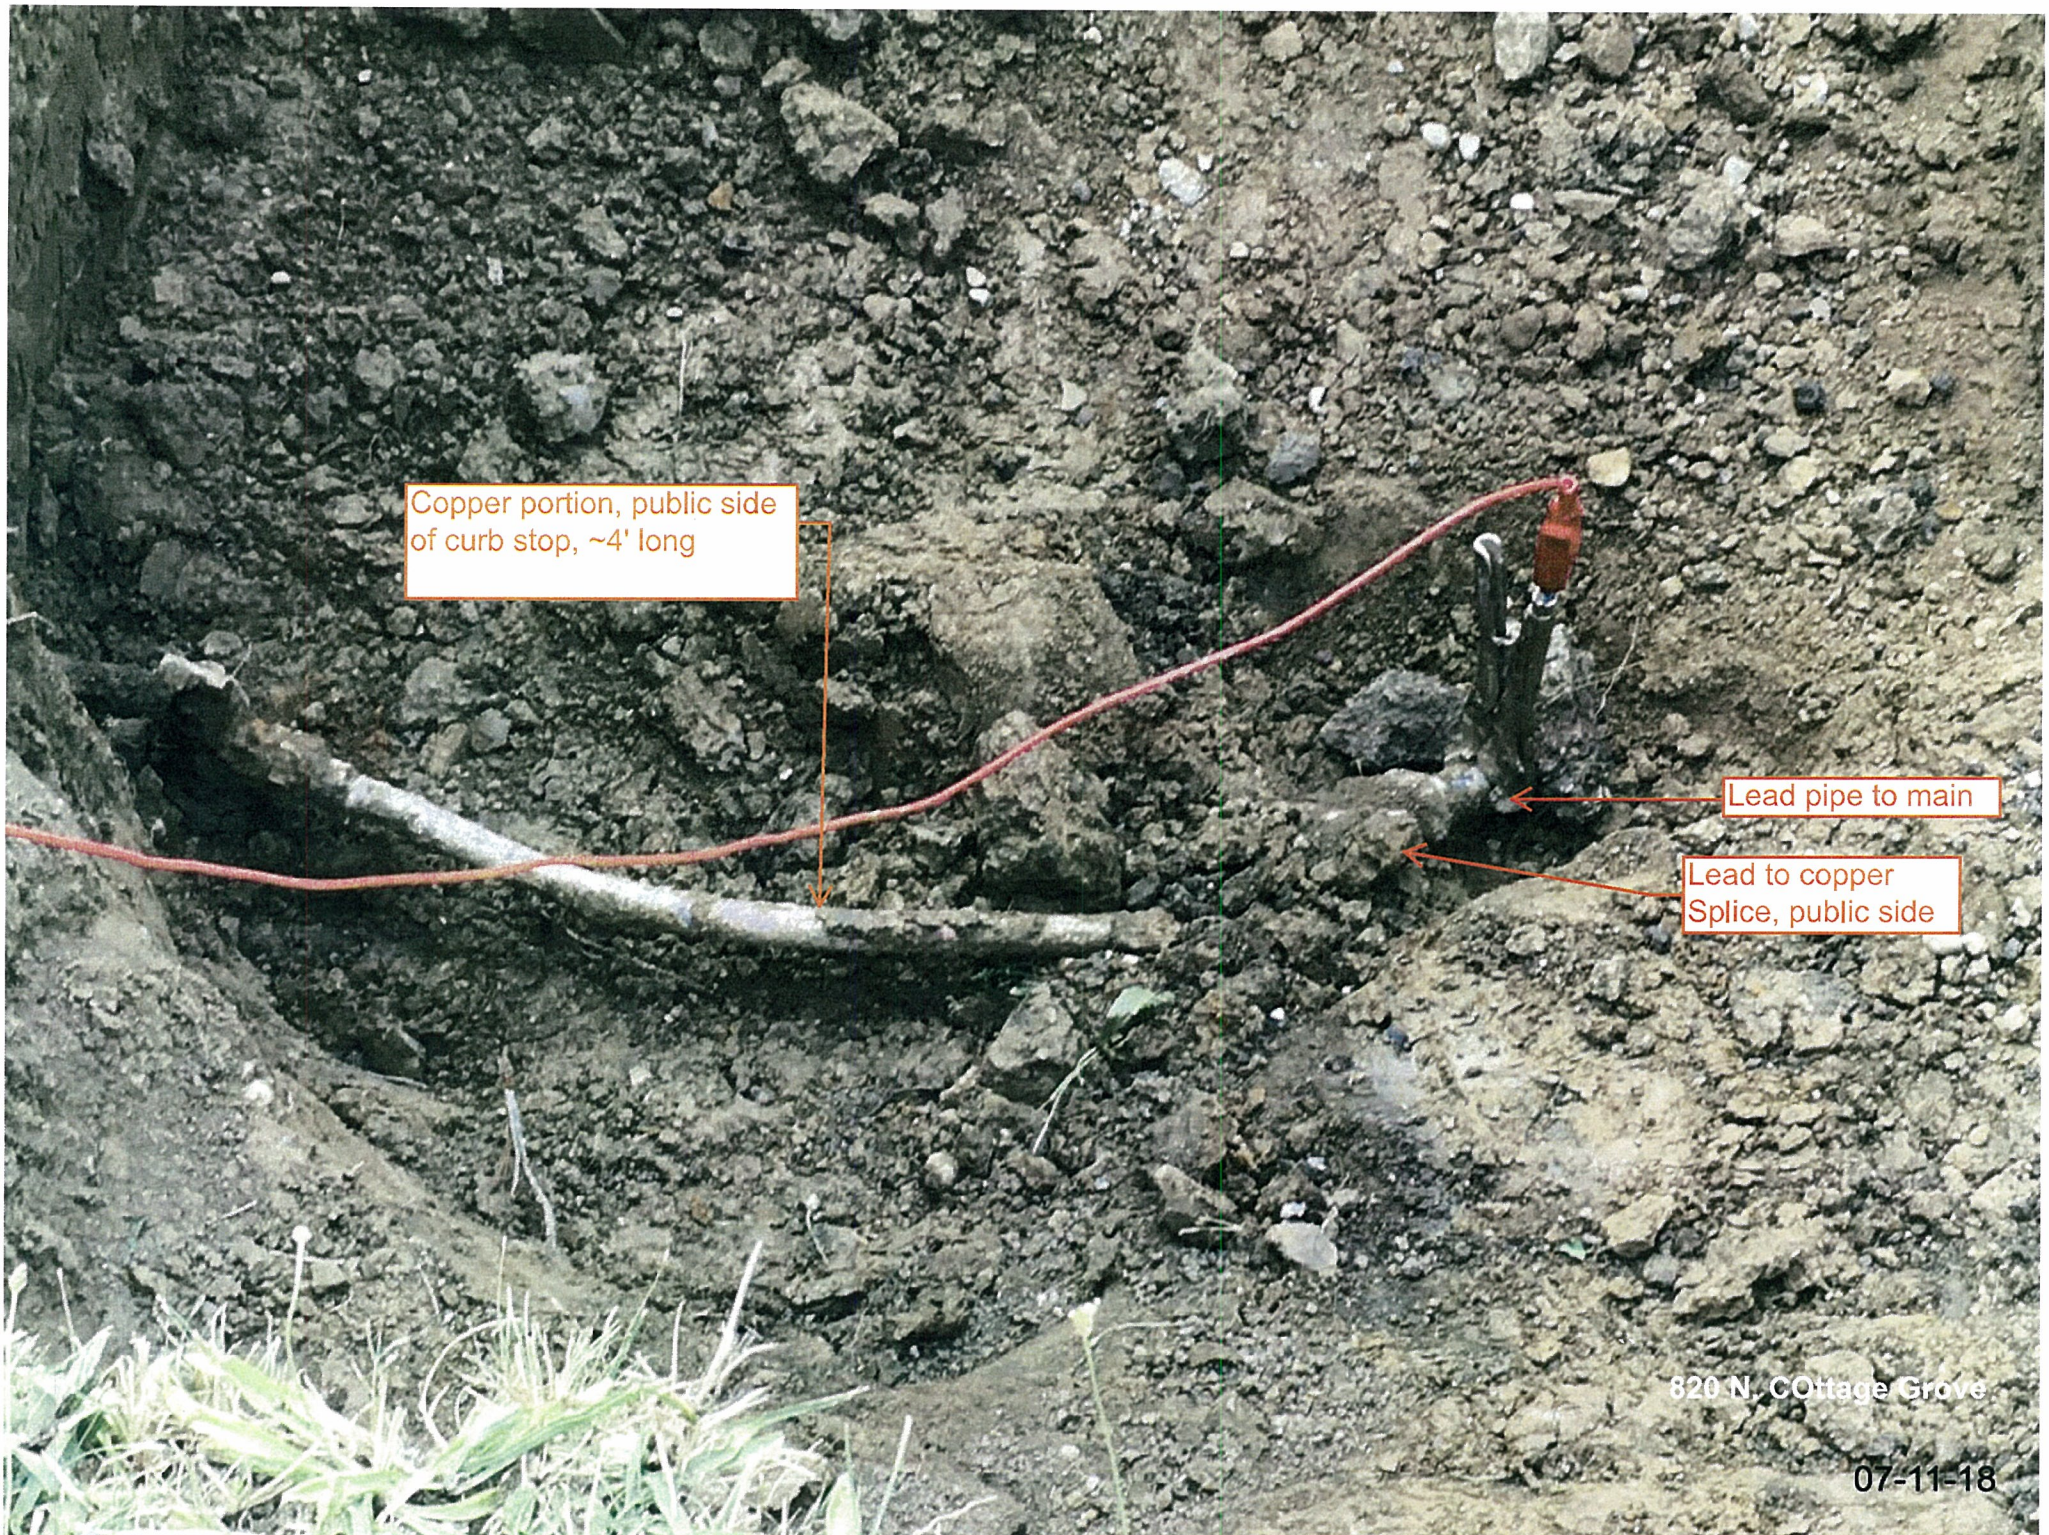
820 N. Cottage Grove

But-for the usage of the traditional open cut excavation at the 820 Cottage Grove address, it would not have been discovered that the line was spliced because the lines were not installed perpendicular to the property. The hydro-excavation process would not have exposed the splice, because the process bores holes 12 to 18 inches in diameter. Attached are photographic examples of non-copper splices.

Copper portion, public side
of curb stop, ~4' long

Lead pipe to main

Lead to copper
Splice, public side

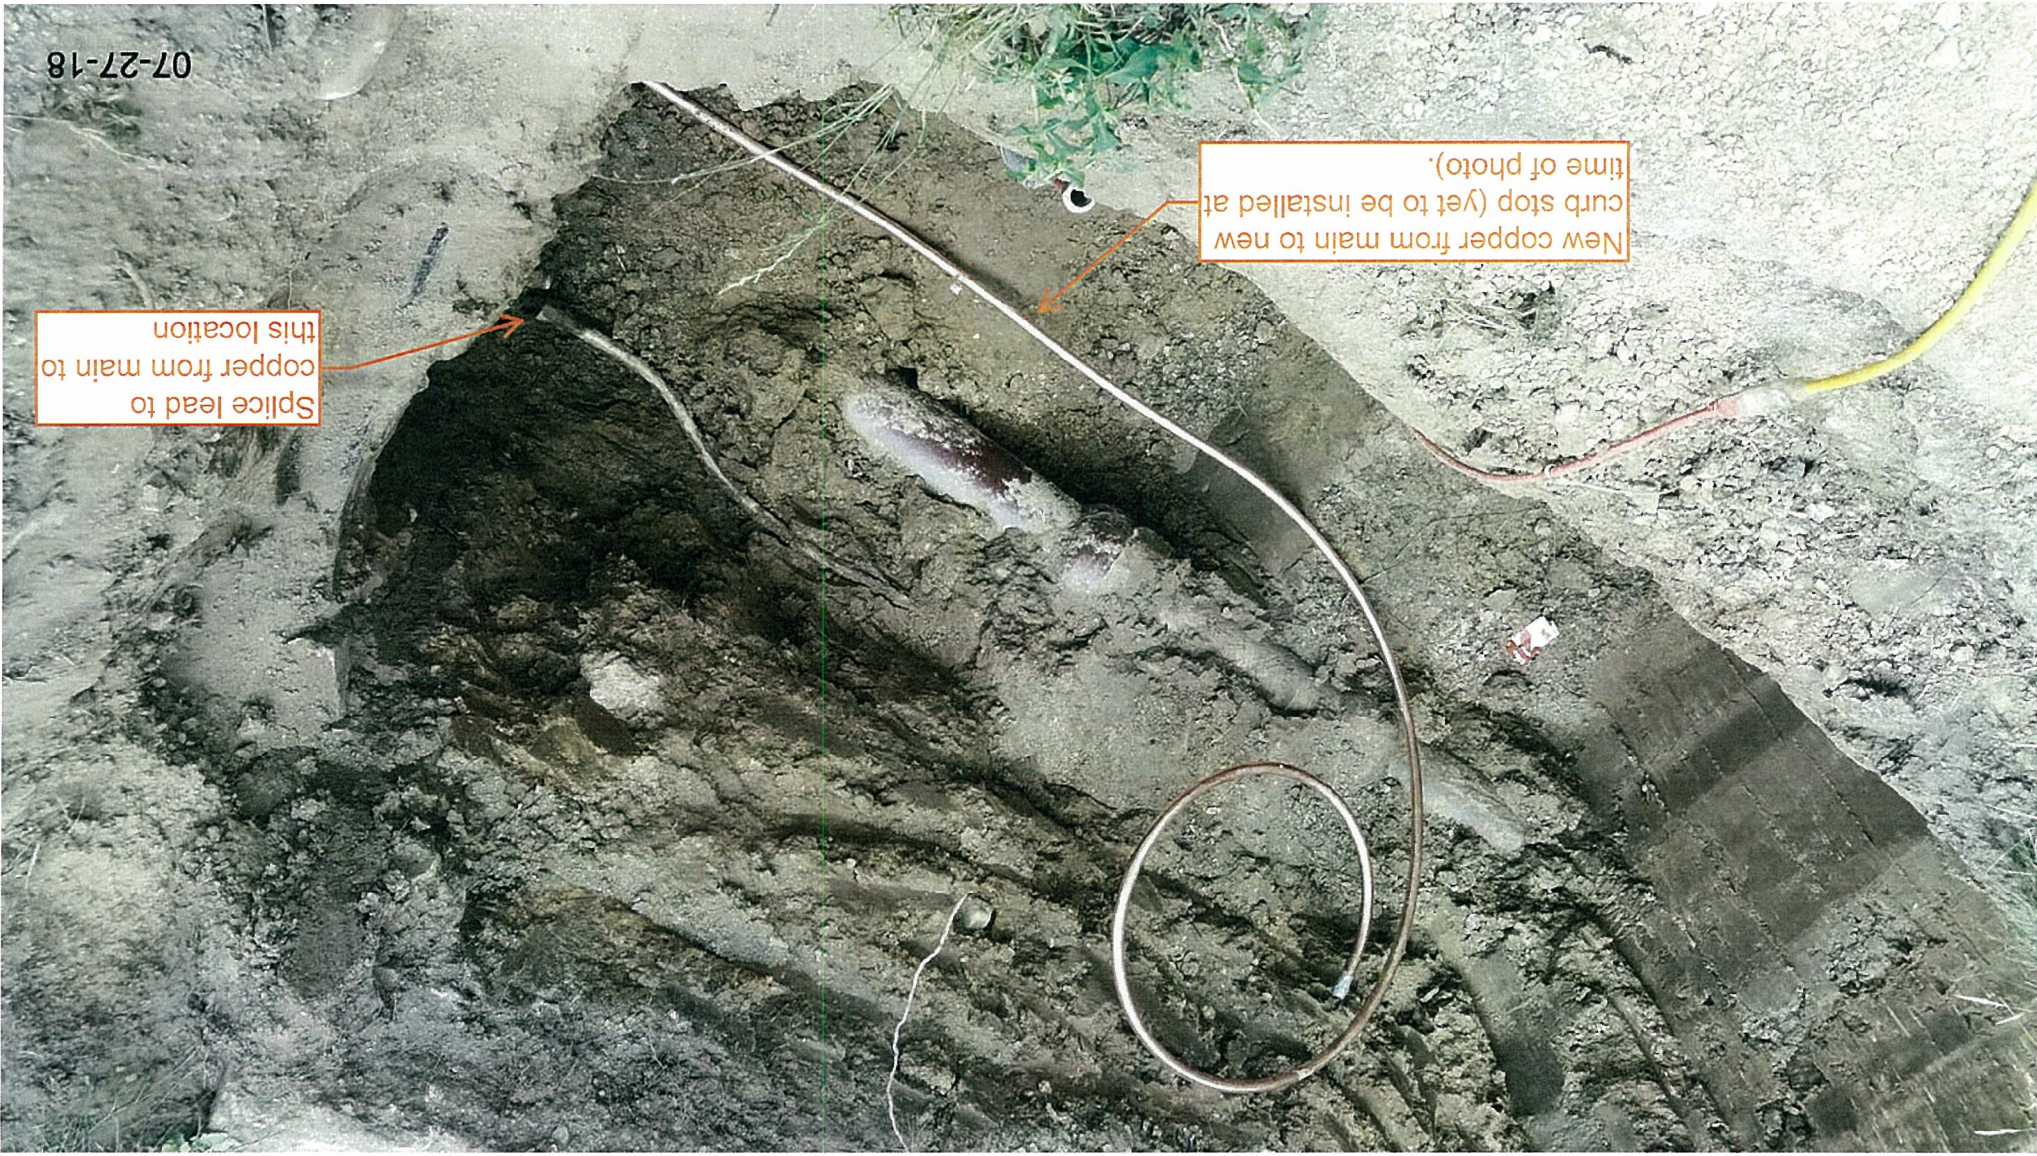
07-27-18

New copper from main to new curb stop (yet to be installed at time of photo).

Splice lead to copper from main to this location
